Re: Construction of New 230kV Tap Line in Littleton, New Hampshire NH  
SEC Docket No. 2014-02; Wetland Permit No. 2014-00407  
Post-Construction Wetlands Restoration Report

**Appendix 4 - National Grid**  
**Storm Water, Wetlands & Priority Habitat Environmental Compliance**  
**Site Inspection / Monitoring Report**

**PROJECT: NEW 230KV TAP LINE FROM C203 TRANSMISSION LINE, LITTLETON, NEW HAMPSHIRE**

**INSPECTION DATE: NOVEMBER 21, 2014**

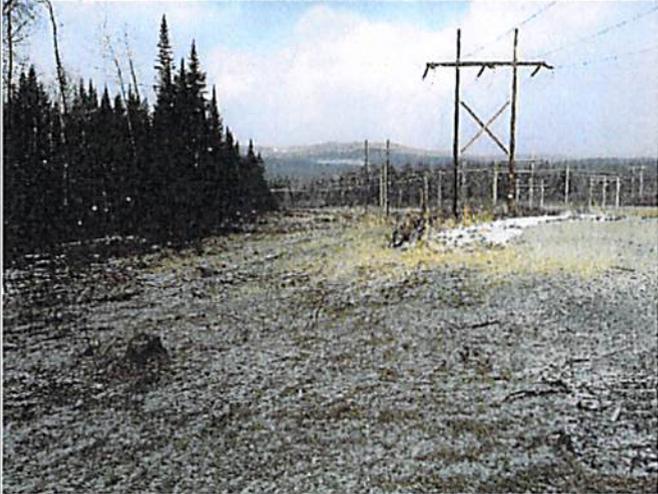
Photo #1: View north at back gate of Littleton Sub.	Location: New 230kV Tap Line, Littleton, NH

Description: View of recently restored area that was previously rutted by logging operations. Ruts removed and heavy straw mulch applied. No additional measures needed.
Photo #2: View north of restored area near Structure 1.	Location: New 230kV Tap Line, Littleton, NH

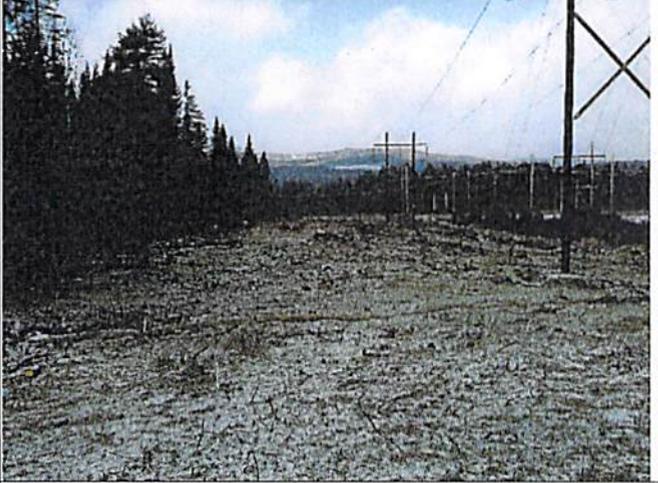
Description: Restored area sufficiently stabilized with straw mulch.
Photo #3: Recently restored area b/wn Structure 1 & 2.	Location: New 230kV Tap Line, Littleton, NH

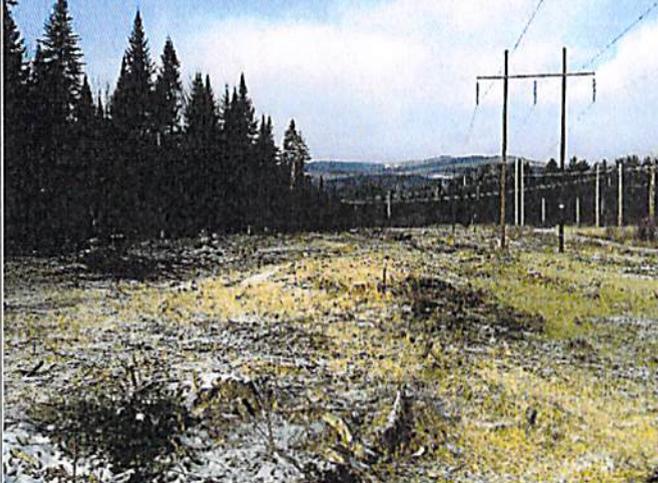
Description: Area along west side of ROW where logging ruts were recently removed and mulch applied. Area looks to be in good condition and fully stabilized at this time.

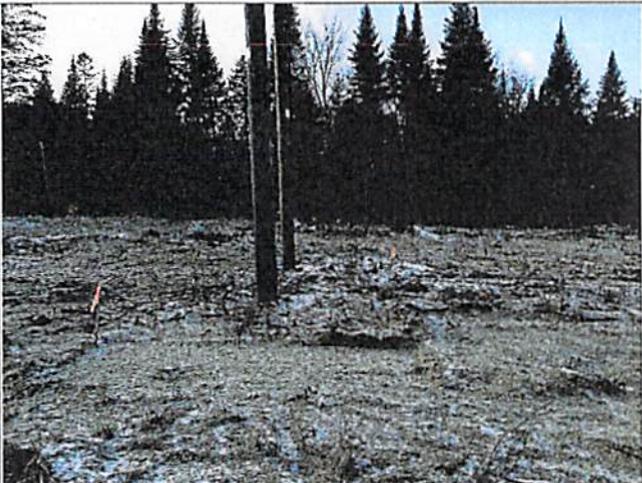
<p>Photo #4: Mulched area near Structure 2.</p>

<p>Location: New 230kV Tap Line, Littleton, NH</p> <p>Description Recently mulched area and stabilized area near Structure 2.</p>
<p>Photo #5: View of mulched area near Structure 3.</p>

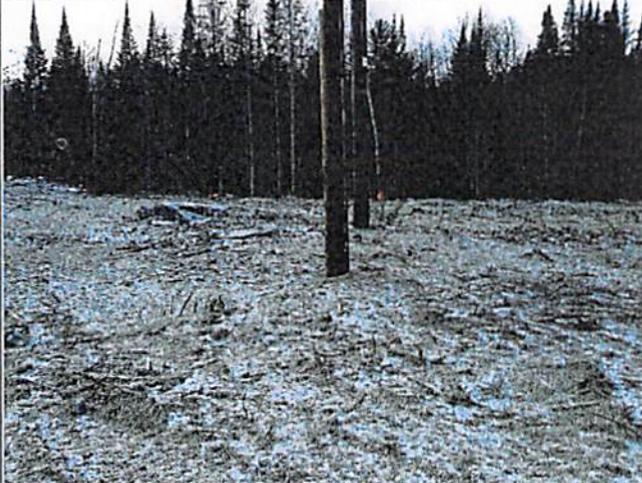
<p>Location: New 230kV Tap Line, Littleton, NH</p> <p>Description: Recently mulched near Structure 3.</p>
<p>Photo #6: View north of restored ruts near Structures 2 &amp; 3.</p>

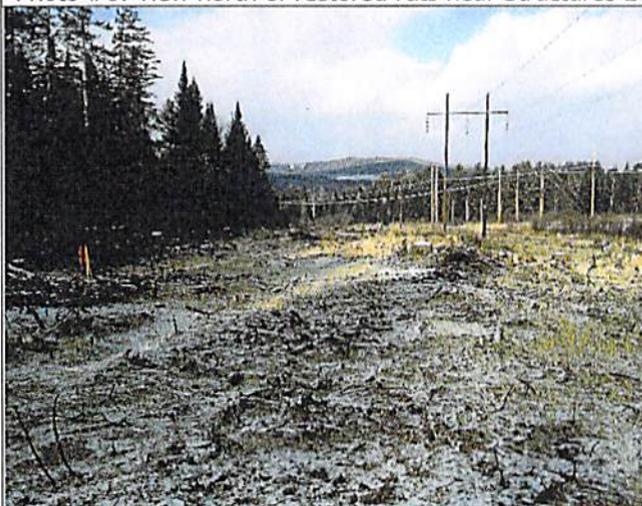
<p>Location: New 230kV Tap Line, Littleton, NH</p> <p>Description: Restored rutted areas between Structures 2 &amp; 3. No further work needed.</p>

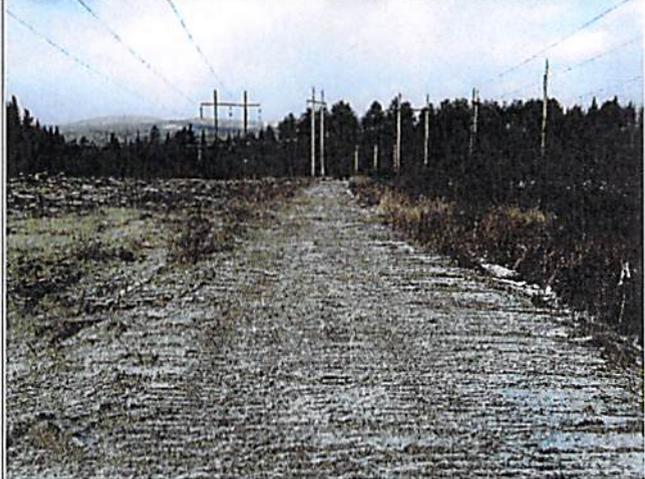
<p>Photo #7: View north along access road near Structure 2.</p>

<p>Location: New 230kV Tap Line, Littleton, NH          Description: Access road with mats removed is in good shape and no further work needed.</p>
<p>Photo #8: Restored and mulches area near Structure #3</p>

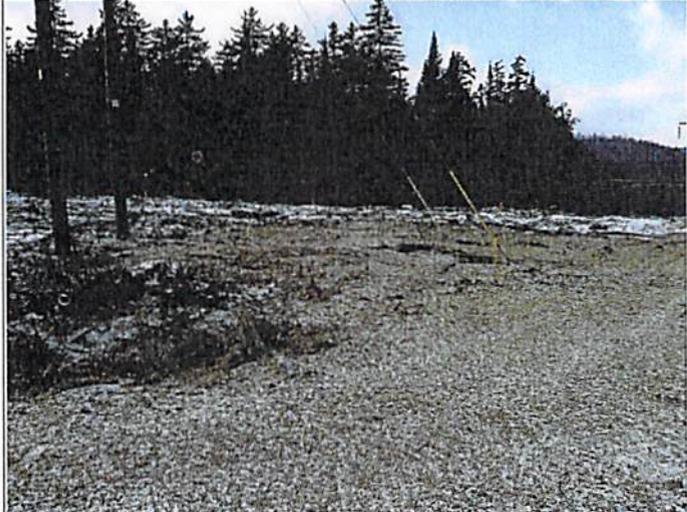
<p>Location: New 230kV Tap Line, Littleton, NH          Description: Restored and mulched area near Structure #3. No further work necessary</p>
<p>Photo #9: Access road looking south with mats removed.</p>

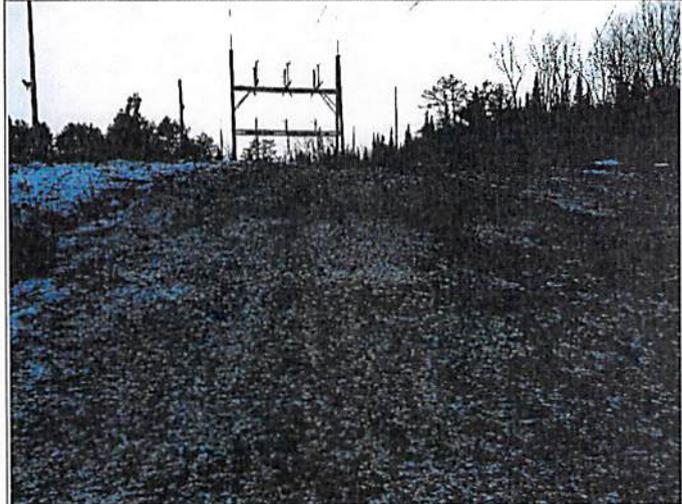
<p>Location: New 230kV Tap Line, Littleton, NH          Description: Access road in good shape looking up hill to substation.</p>
