**Subject: Granite Reliable Power, LLC;
High Elevation Restoration Tree Survival Monitoring Update**

Evaluation of Success of Tree Planting:
Final Report
for property managed by Granite Reliable Power

Millsfield, New Hampshire

Submitted by:
Kevin S. Evans
Professional Forester
N.H. License # 81
November 2017

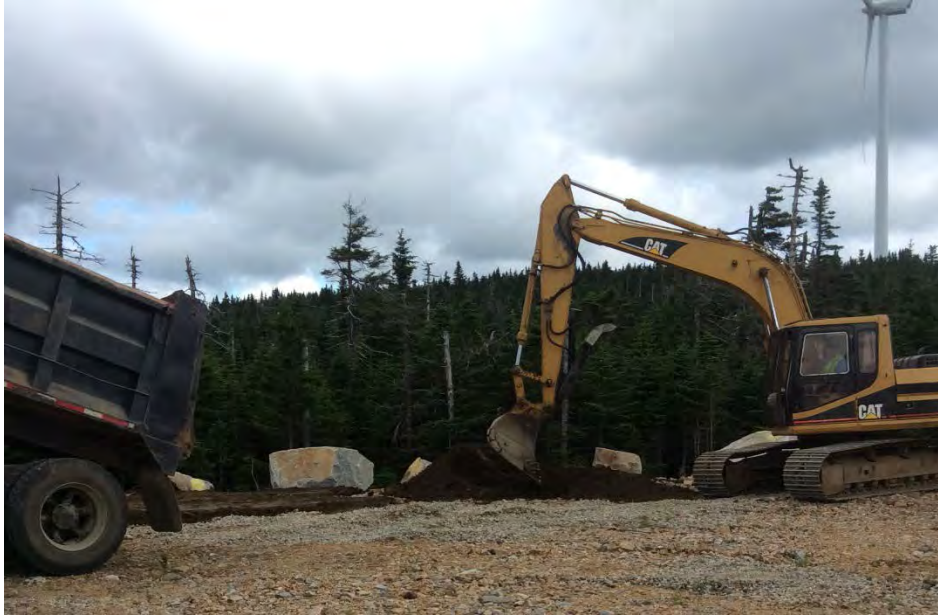
Figure 1: Pad 10: soil spread with excavator (to decrease soil compaction), Dump truck placing soil on pad area delineated with paint. Excavator operator is spreading to specified soil depth for specific pad depths. Machine was then used to tread site once for soil stabilization.

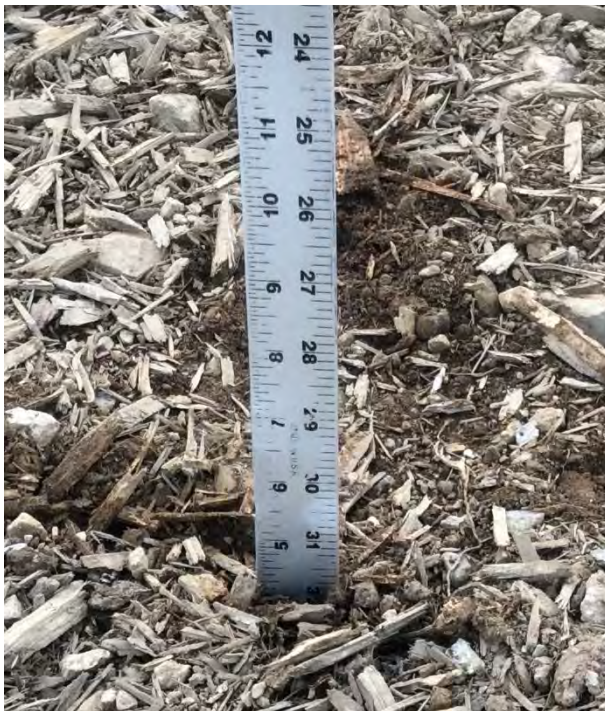
Figure 2: Soil depths were checked at random points on all Pads. They were also coordinated with having wood chips or Jute Mat. This is a 4-inch soil depth with wood chips.

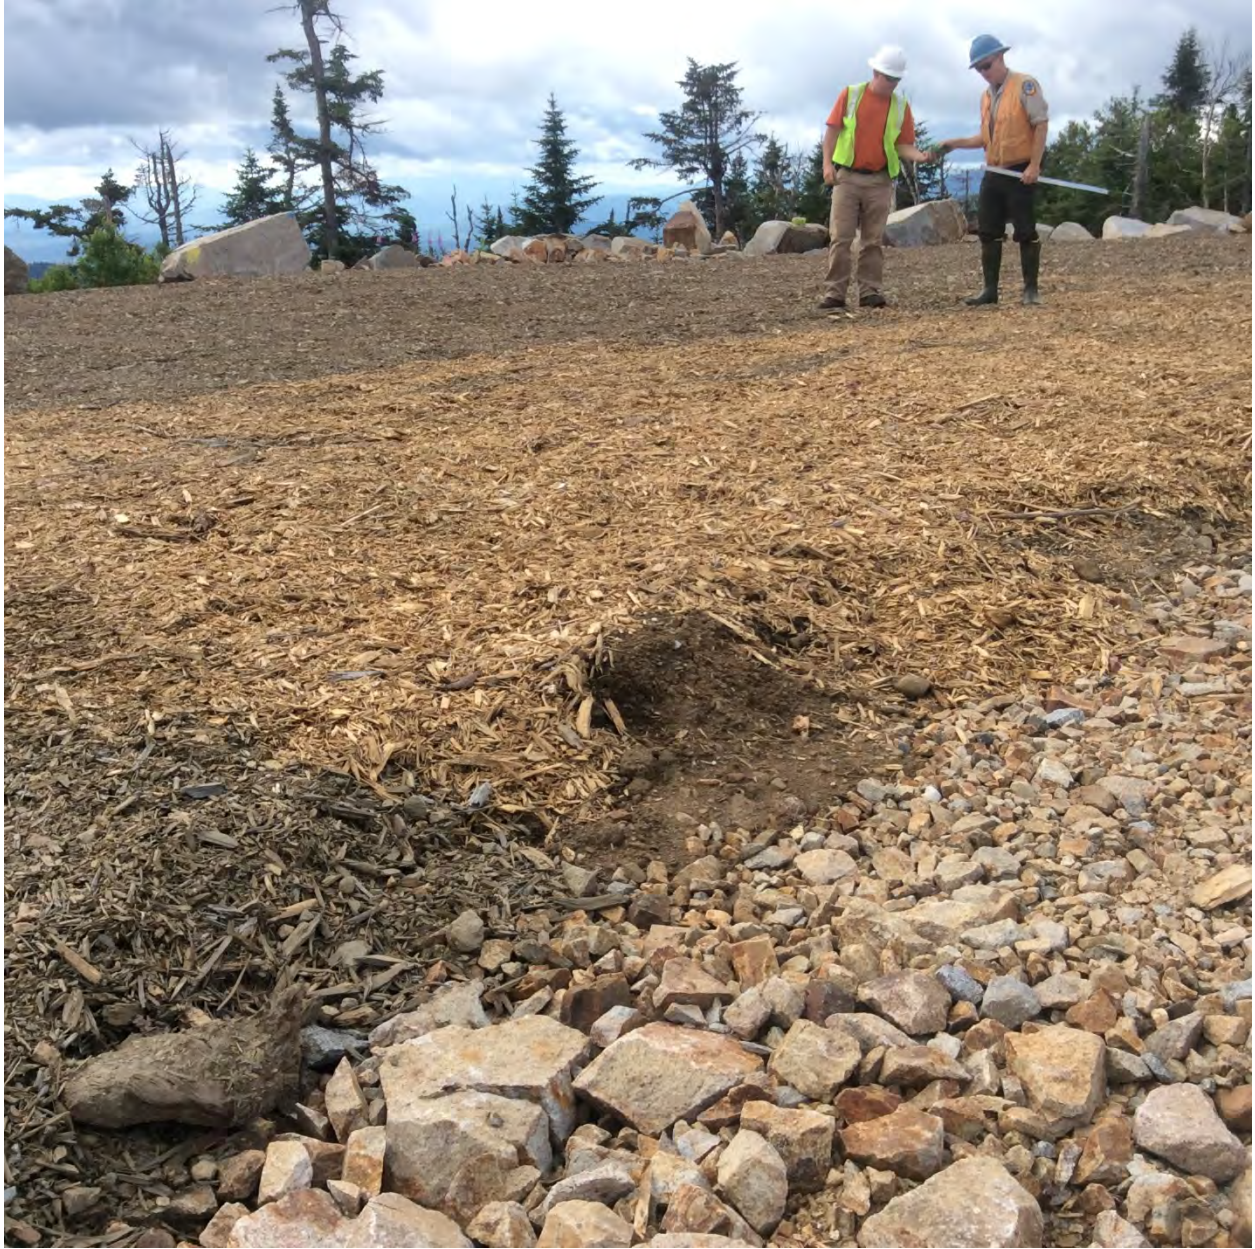
Figure 5: Pad area ready for planting, with correct soil depth and woodchips

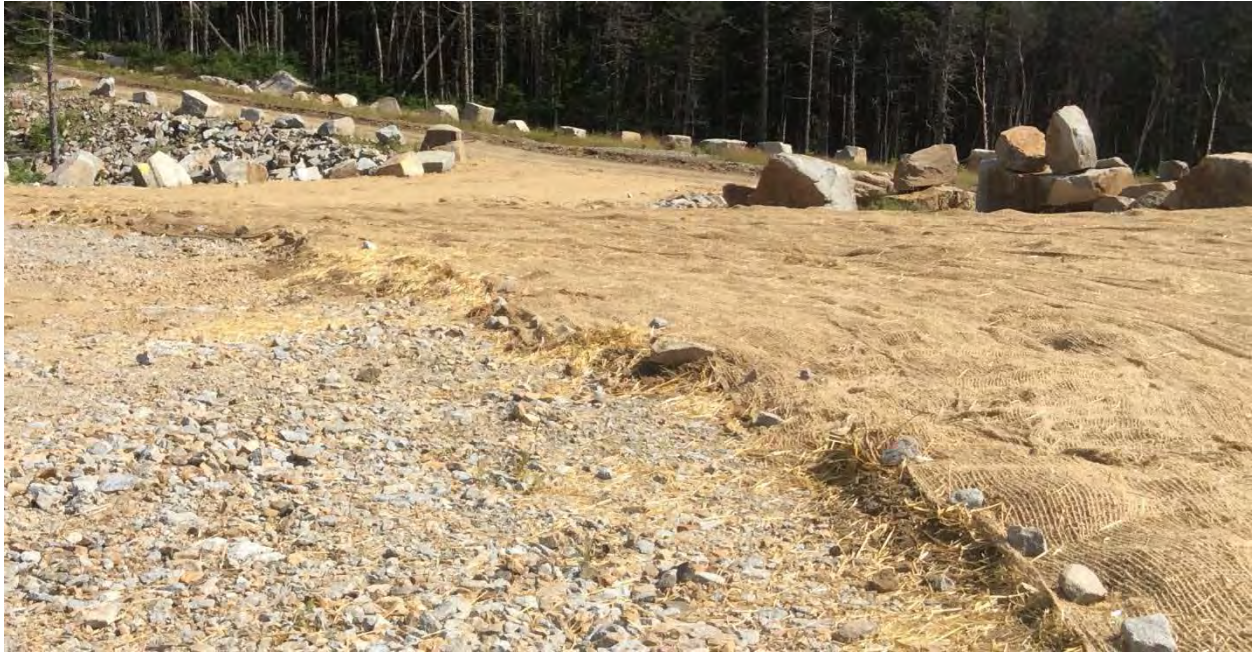
Figure 6: Pad 13- Ready for planting with 4 inches of soil, straw and Jute erosion cloth

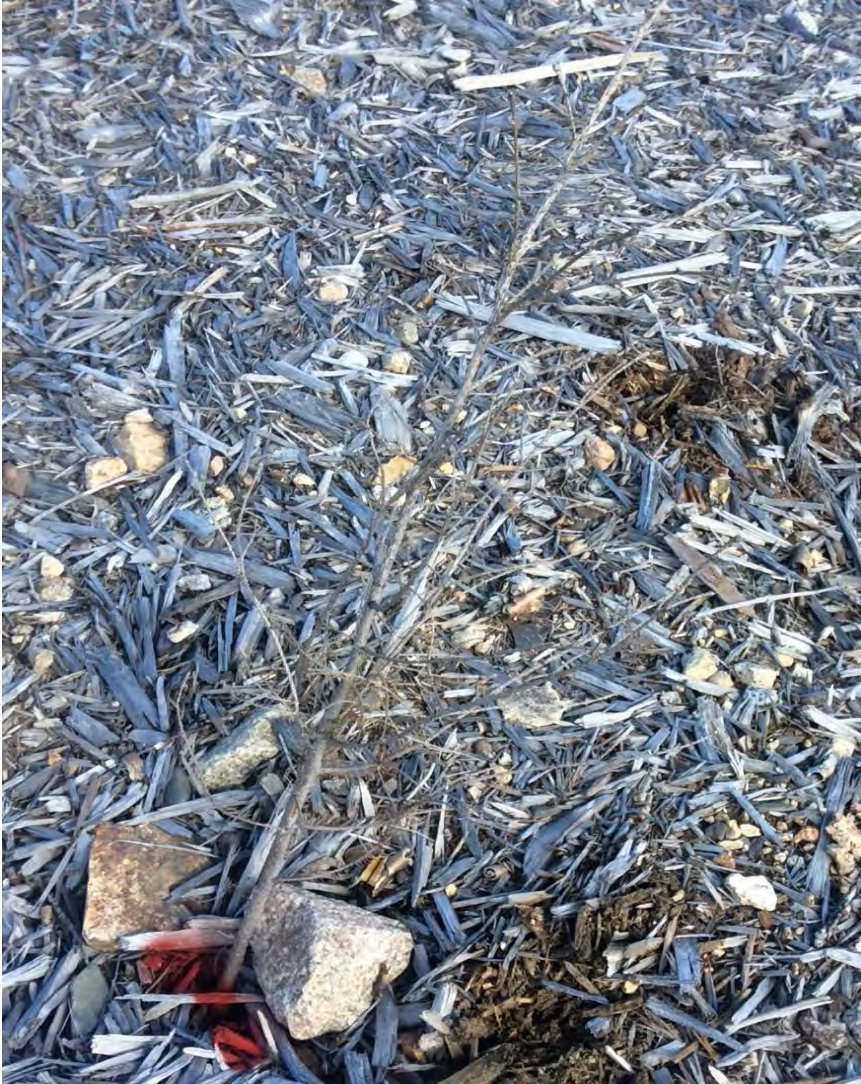
Figure 12: Dead tree. All dead trees, if in question were tested using the Scratch test to make sure they were dead.

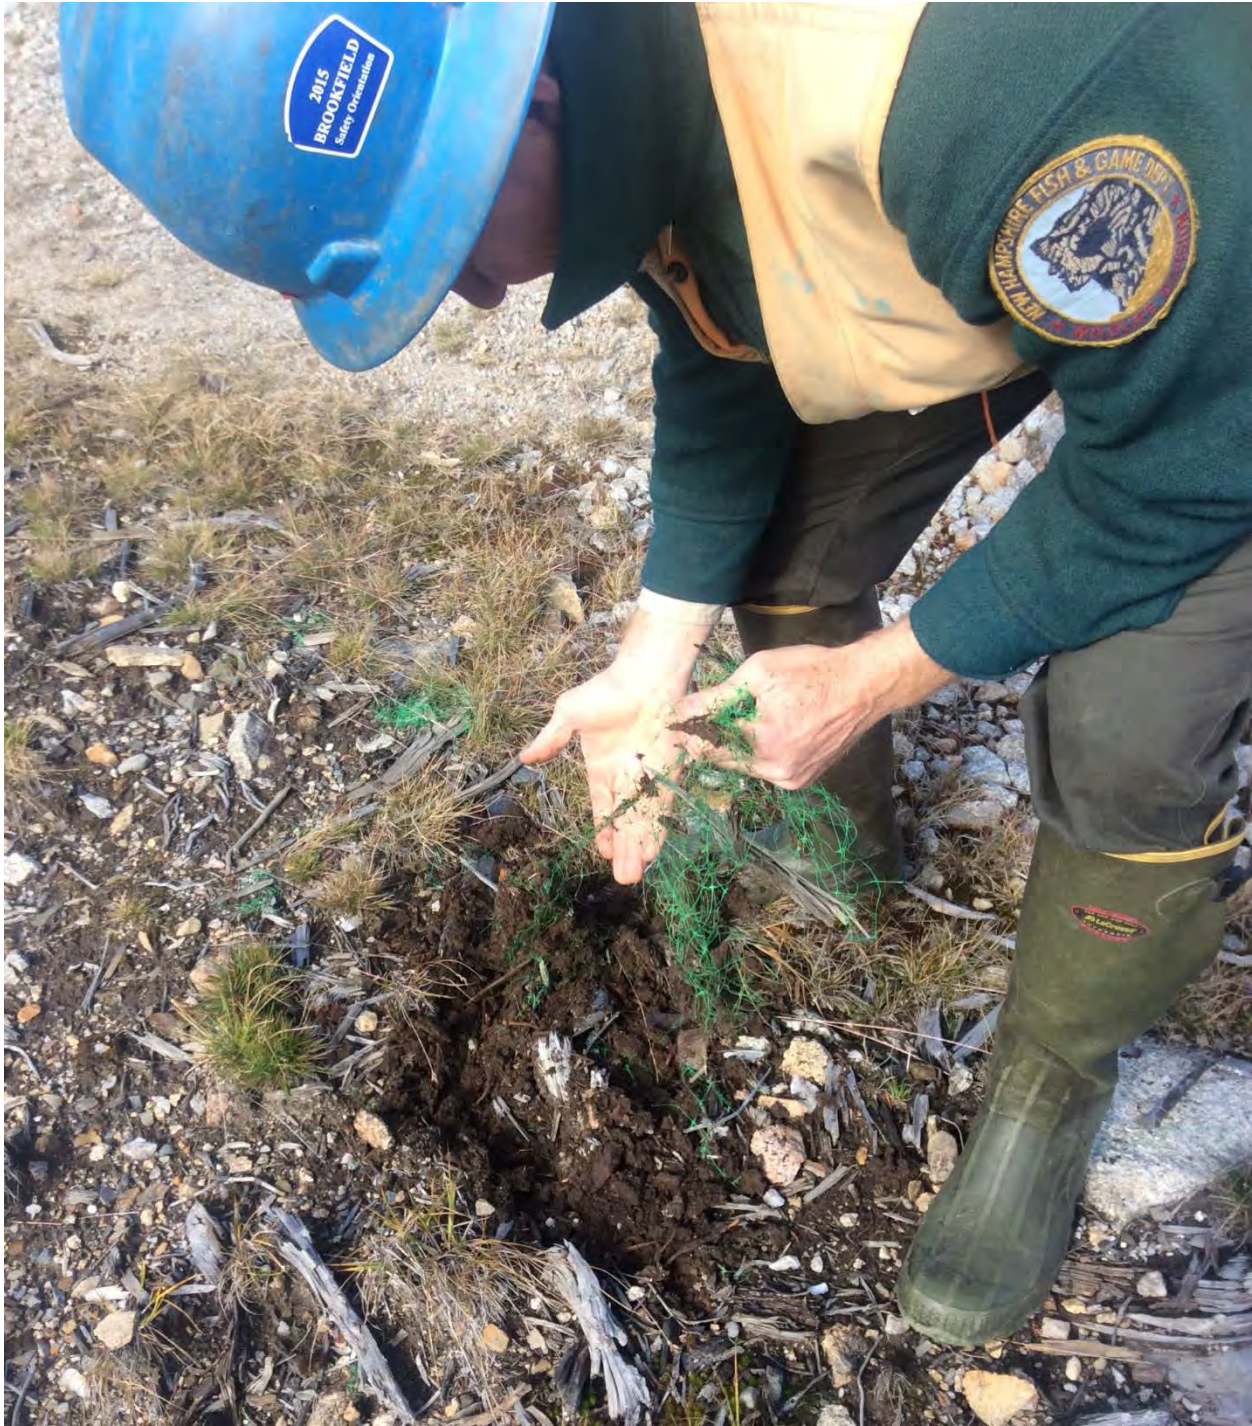
Figure 13: Green erosion mesh. This was picked up from soil removed from roadside, and was then still in the soil on pads after re soiling the pads.

Green Mesh: Over five years after construction the mesh has not started to disappear. It is a wildlife hazard and still seems to be no closer to deteriorating as it did 3 years ago. This should be removed from the site where ever possible.

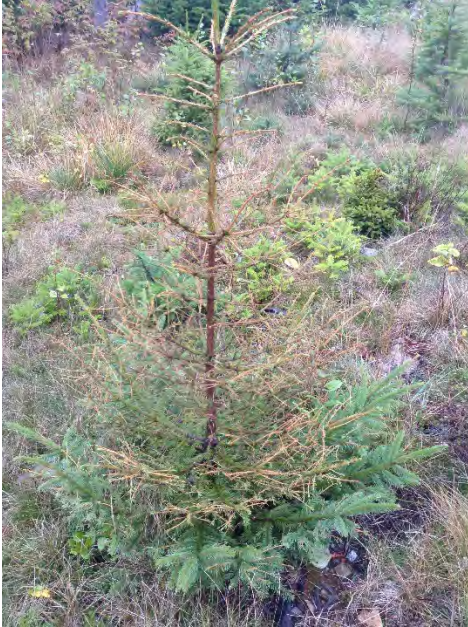
Figure 14: spruce tree showing signs of winter damage. Possible from wind and freezing. This may occur when trees don't have adequate snow cover.

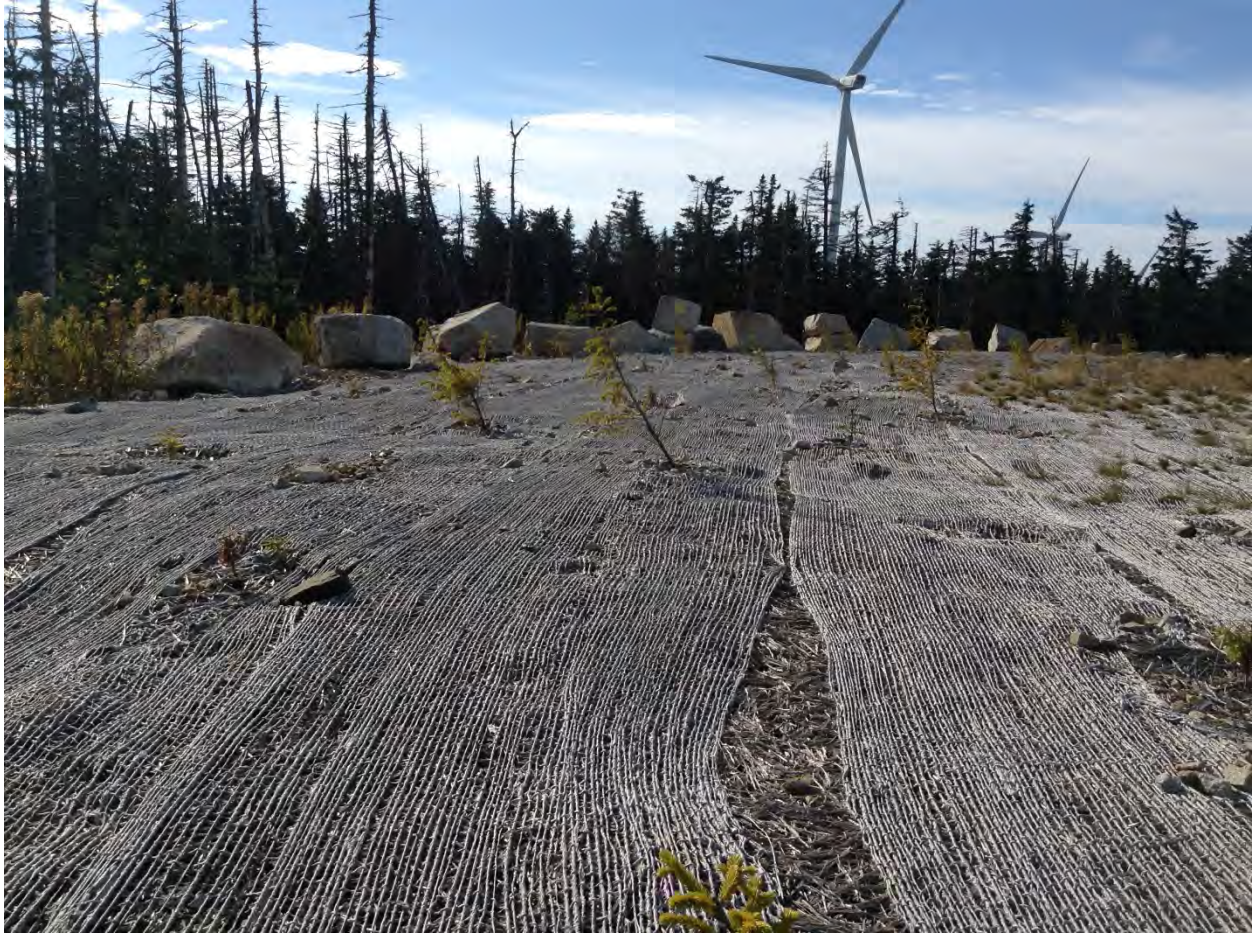
The most dominant factor for seedling mortality is wind. Planted trees on pad sites that are exposed to severe westerly winds seem to have experienced the most damage. On pad 12, picture included, trees are leaning to the East due to wind pounding from the West. The West side of this site has 80% survival, as it is protected from the winds by trees off but adjacent to the pad. Contrast this to the East side of the pad where the survival rate is reduced to 40%. Pad 14 has the same problem, with 40% survival on the East side and 80% on the Western area. Pad 15 is the most windblown pad from the West and only has a survival rate of 30%, which is significantly down from a 70% survival rate one year before. It

Figure 15: Pad 12: Eastside of the pad showing the effects of the westerly winds. Difference in survivability from east to west is 50% less.

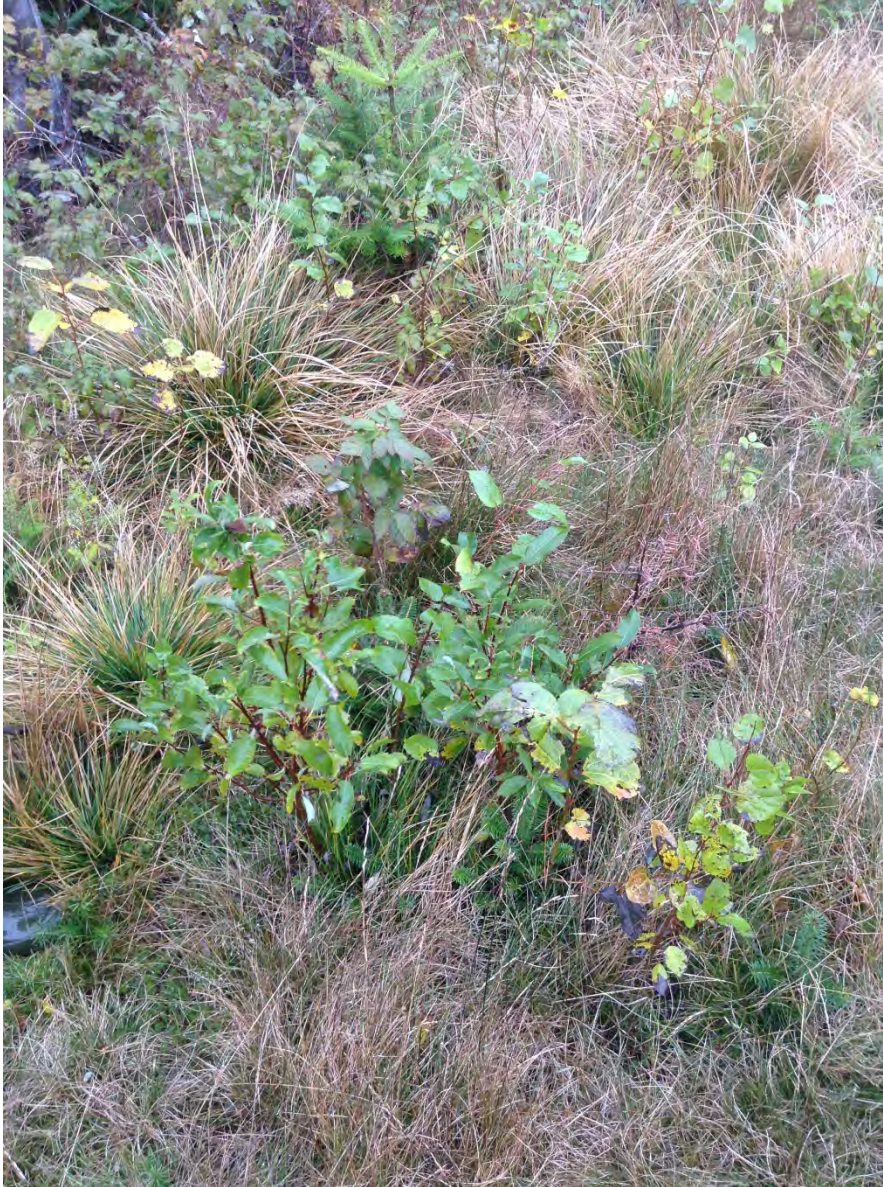
Figure 17: Area showing the introduction of invasive species to the area. Aspen, willow species and non-native grasses.

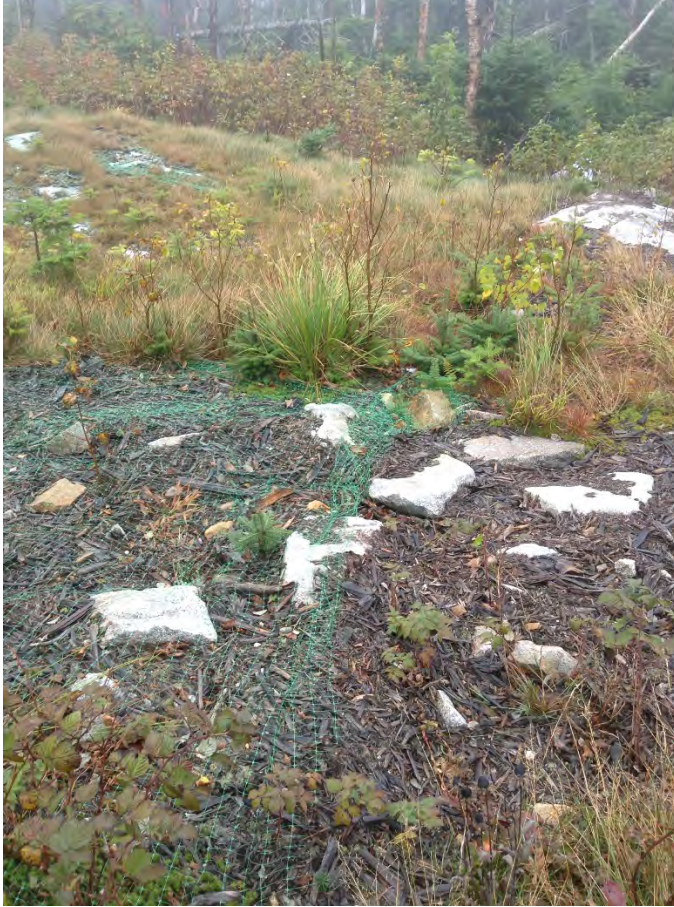
Figure 18: Green mesh: Continues to be present on the landscape. This shows the importance of using something like Jutte which is flexible and breaks down over time

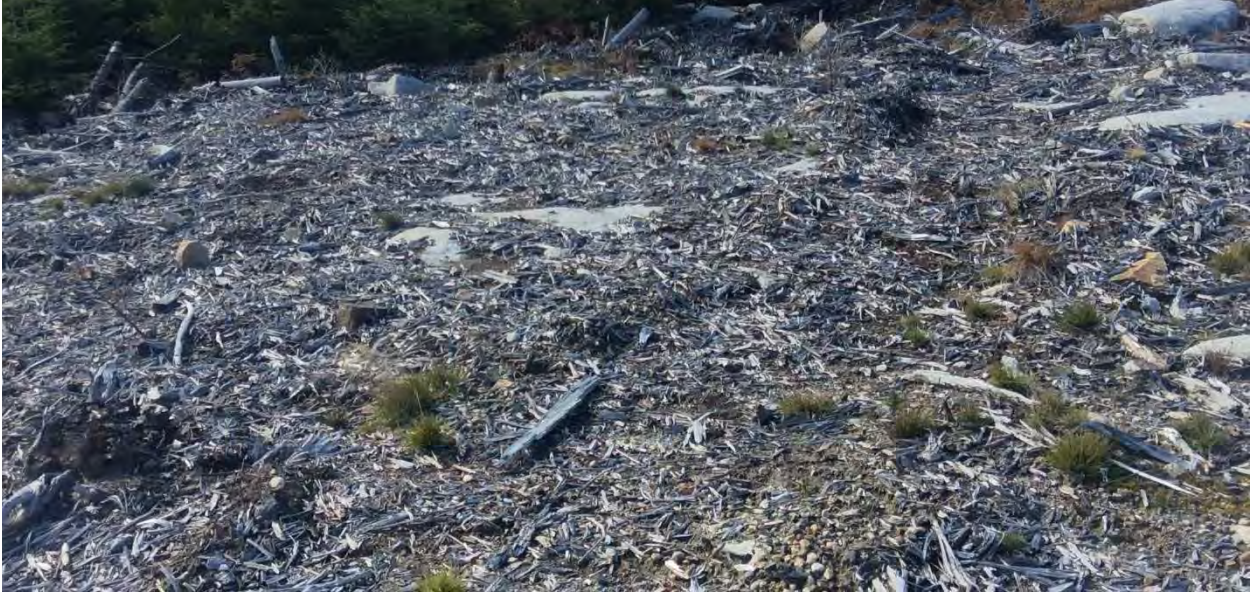
Woodchips: As can be seen in many of the photos taken at the pads and other areas, where there are wood chips there is little or no natural growth. Wood chip are very high in nitrogen and deters vegetation from getting established. There is also likely some effect of temperature on seedlings and soil in the direct sunlight. On a late October day when measuring seedlings, there was a very dramatic difference in soil temperature. The dark soil was really absorbing the sun. In this particular area, the survivability of this site was 50%. On area close to this site with no bark and natural grass mortality was in the 80-90%.

Figure 20: Woodchips 5+ years after construction. Grass having trouble getting established, no natural seedlings.

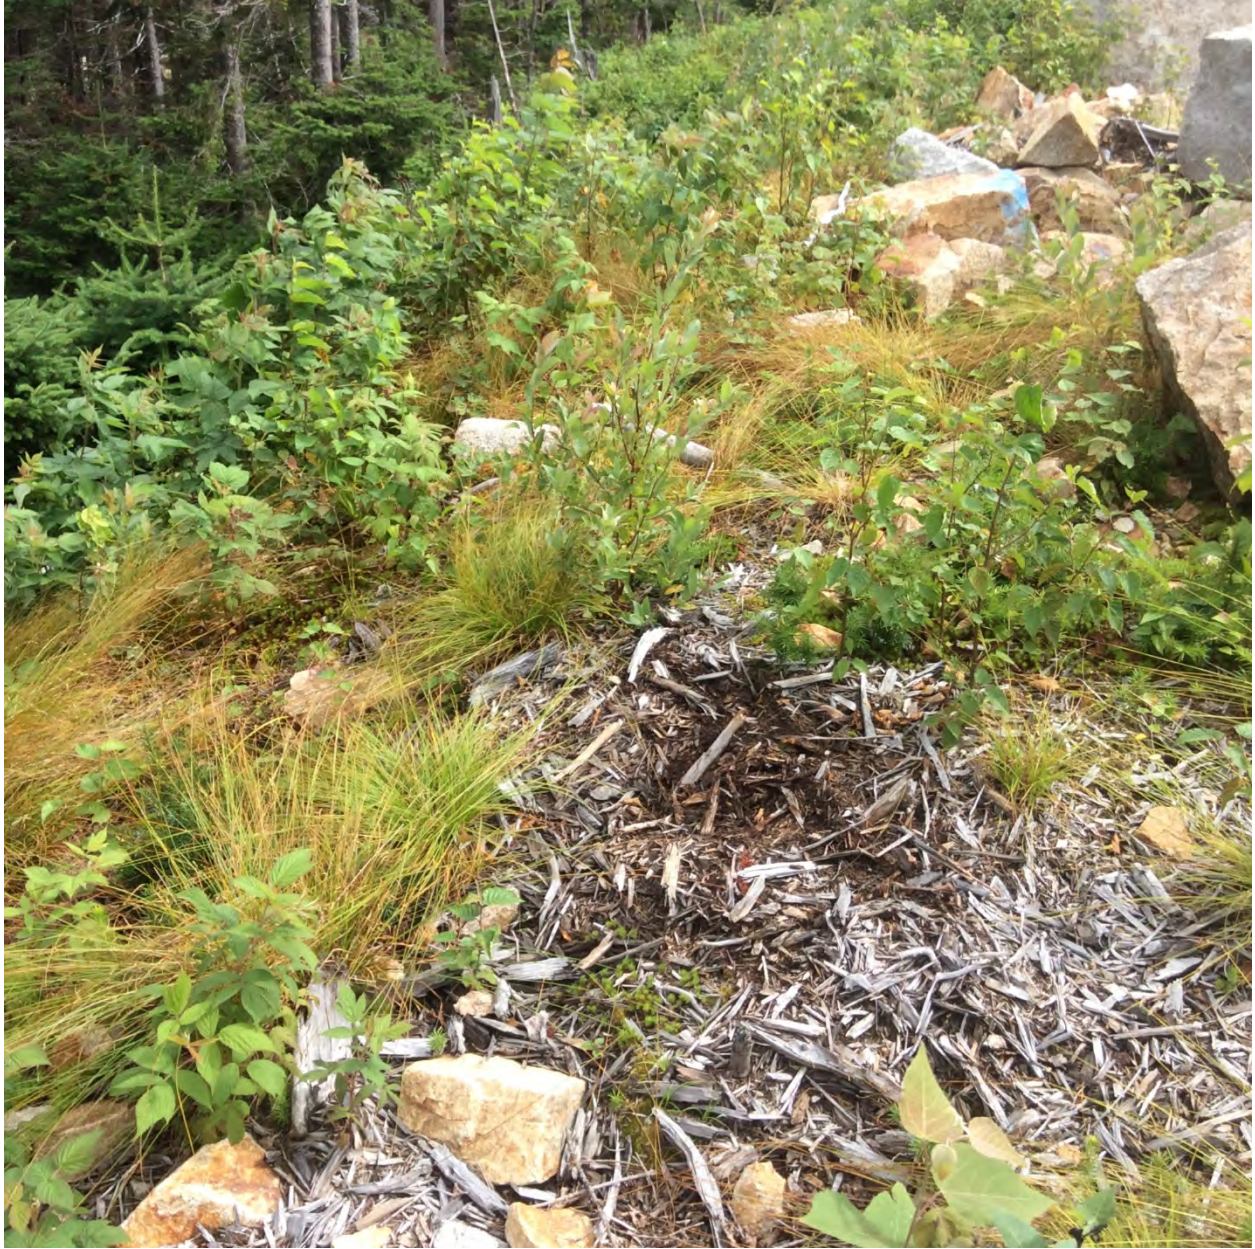
Figure 21: "Dirty Rock" showing signs of recovery where area with woodchips still devoid of any vegetation

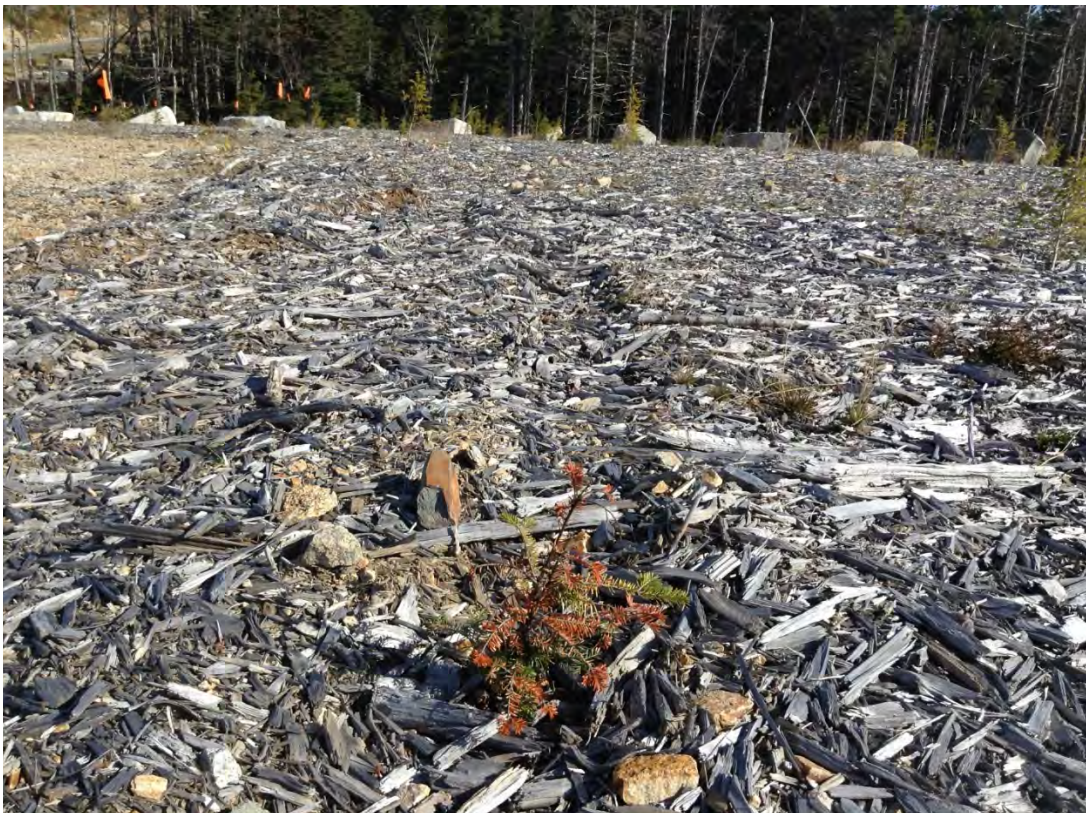
There was significant damage to seedlings which were driven over by equipment on one of the pads.

Figure 24 : Care must be taken when working on the pads. Here are truck tracks on pad 11. As can be seen many trees were run over with death to follow. This was not on the edge it was 10 to 12 feet in from the edge of the pad planting. Orange stakes in the picture show the area was marked as a no entrance zone
