# Non-Conformance Report

Report No.	Date	Project
1	11/20/2018	Antrim Wind Project

Antrim NH Wind: Culvert SD-4: Box culvert stability and streambed  
Non-conformance analysis and report

Conformance Plan: SD-4 Box Culvert

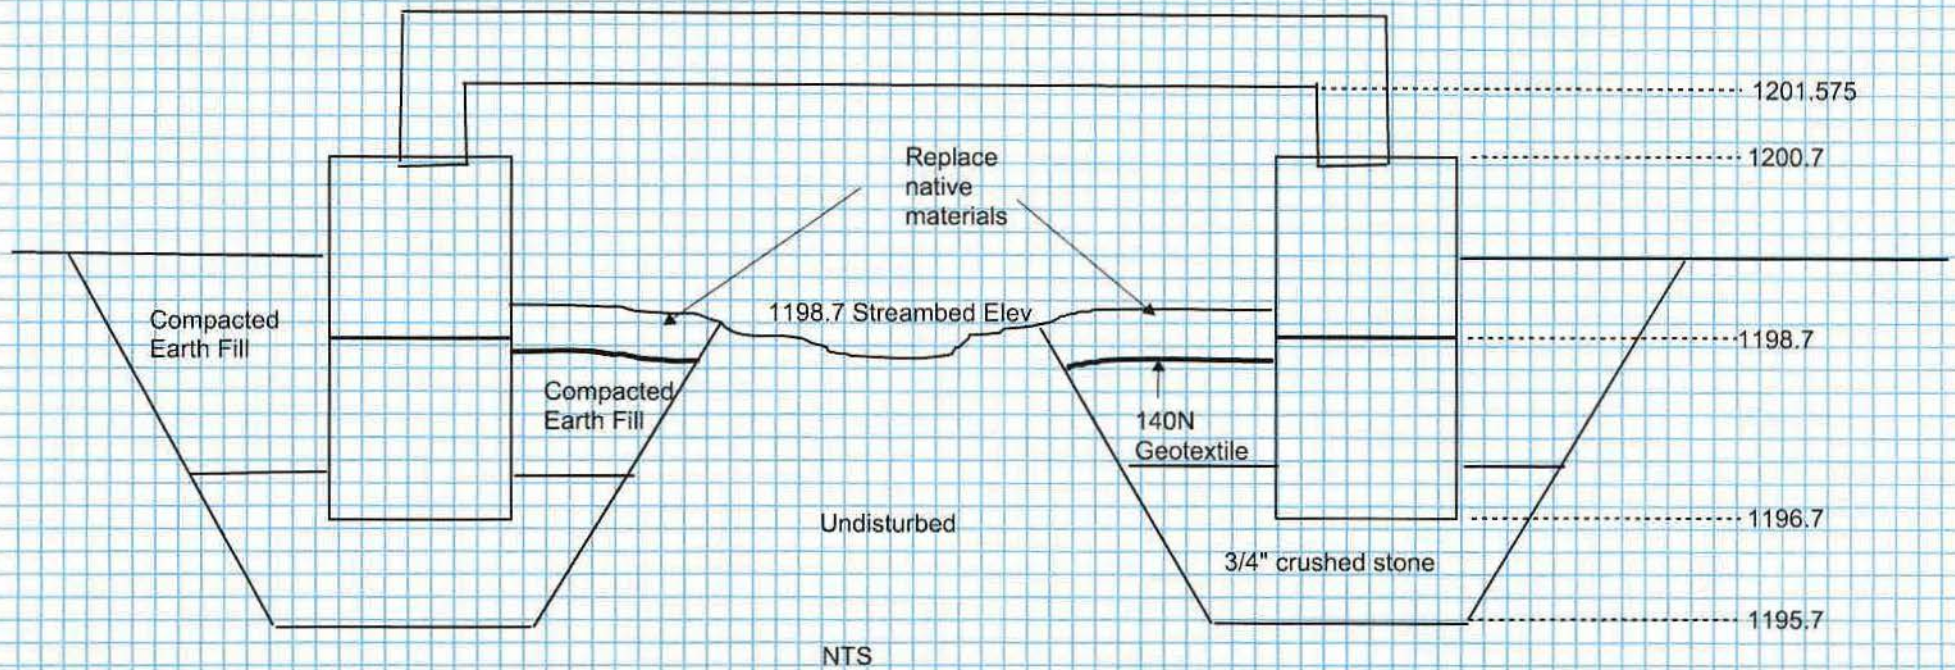
Undisturbed channel

Upstream streambed elevation: 1198.7'.  
Minimum required between streambed and bottom of culvert decking: 2'.

To address the non-conformance issues, Sargent proposes to increase the footer depth with a second course of footer blocks, isolate the footer bedding from stream flow, and re-establish to mimic the natural streambed. See attached "Conformance Plan" for details of this plan.

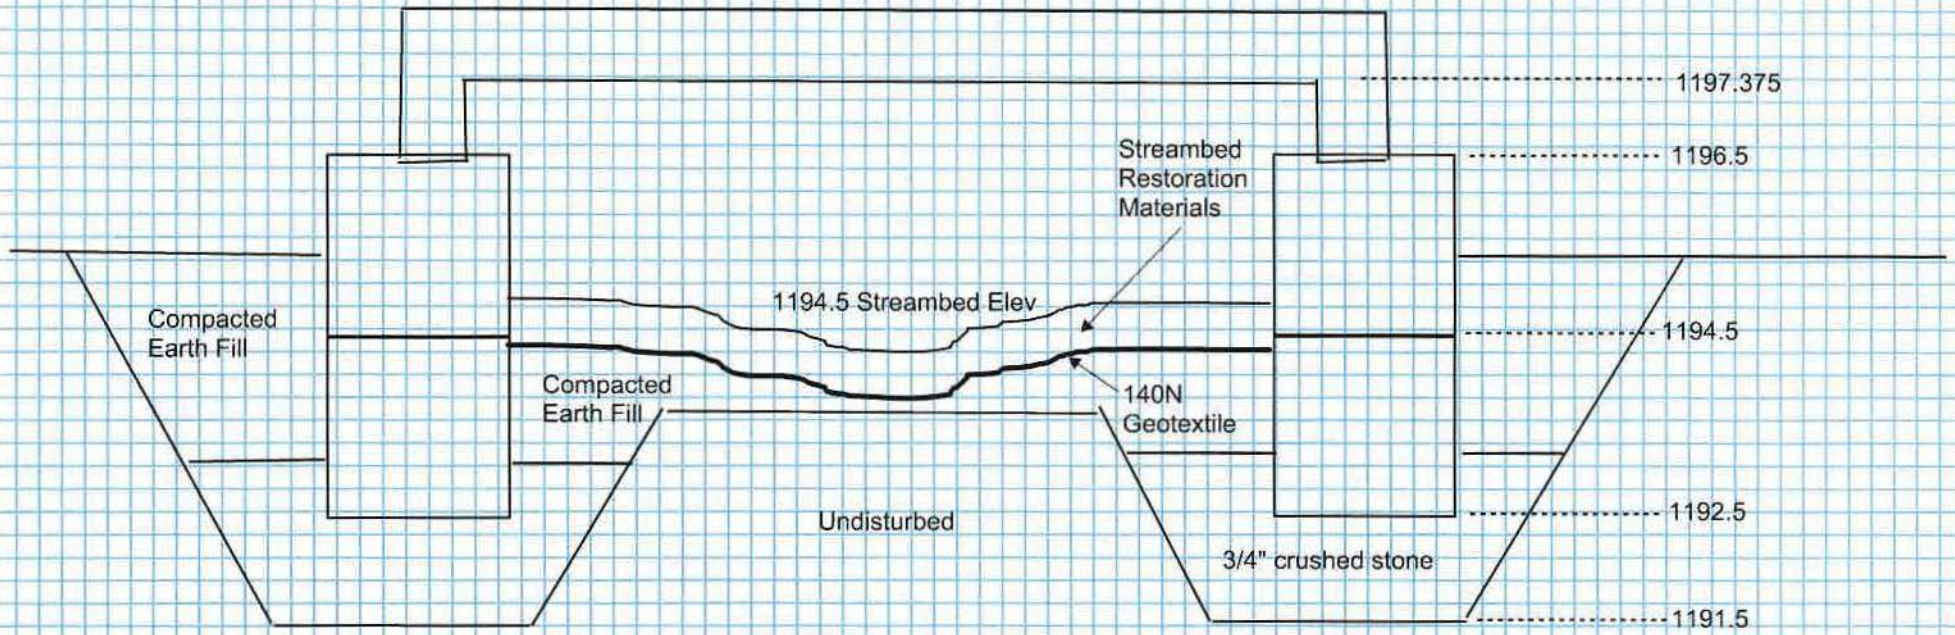
Disturbed streambed restoration

Downstream streambed elevation: 1194.5  
Minimum required between streambed and bottom of culvert decking: 2'.  
NTS

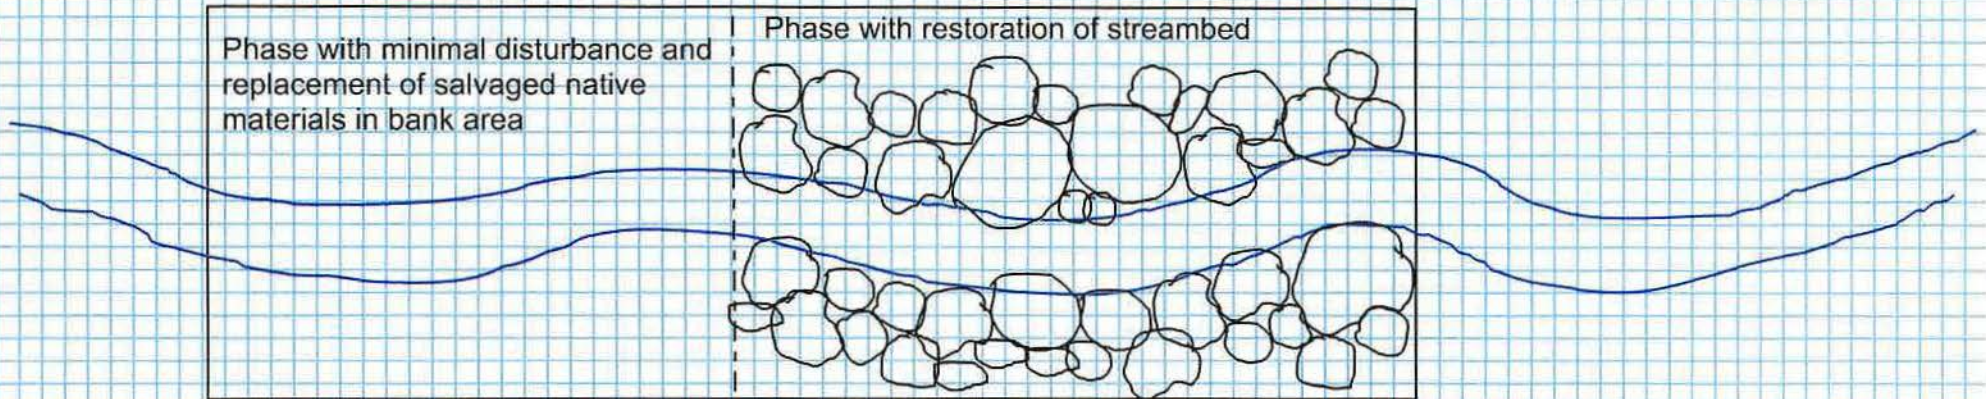
Site rocks placed randomly.  
Rocks to be chinked in place  
with smaller stone (not shown).

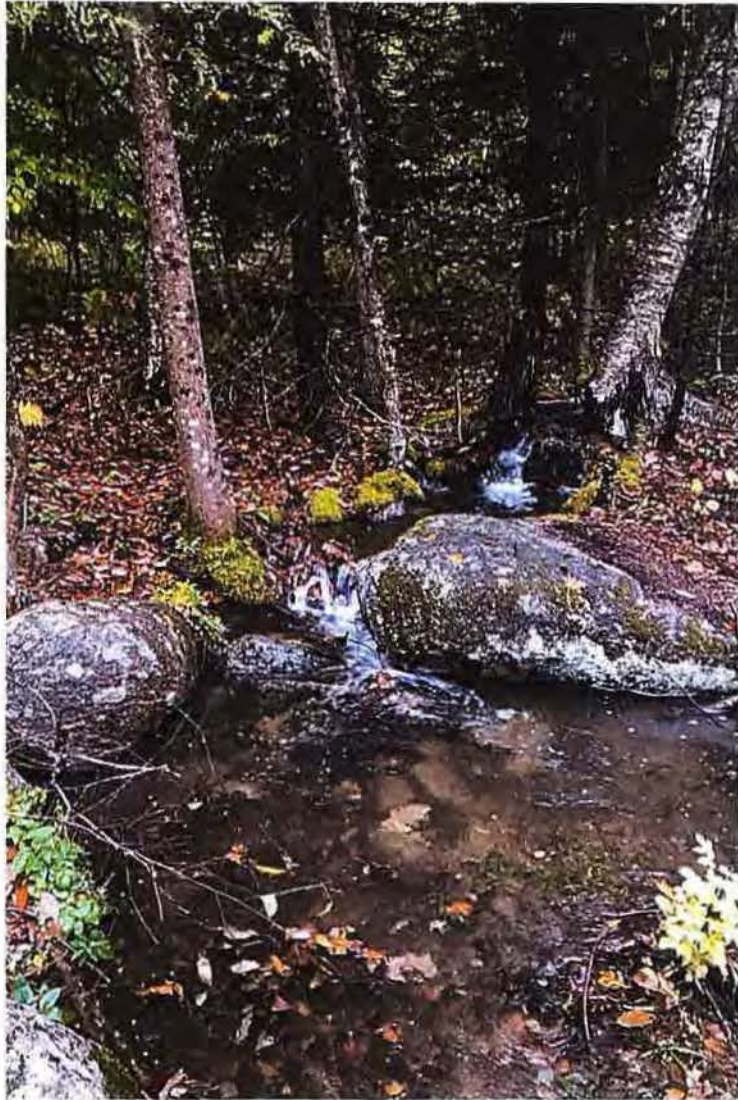
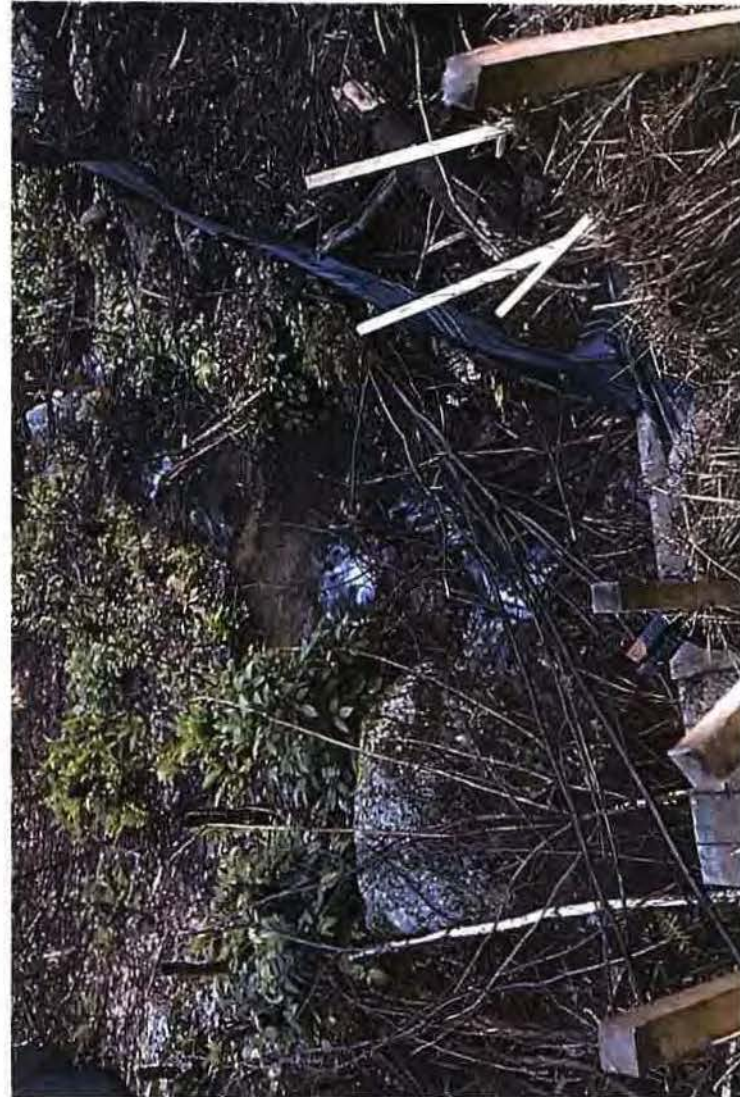
Undisturbed stream conditions near box culvert

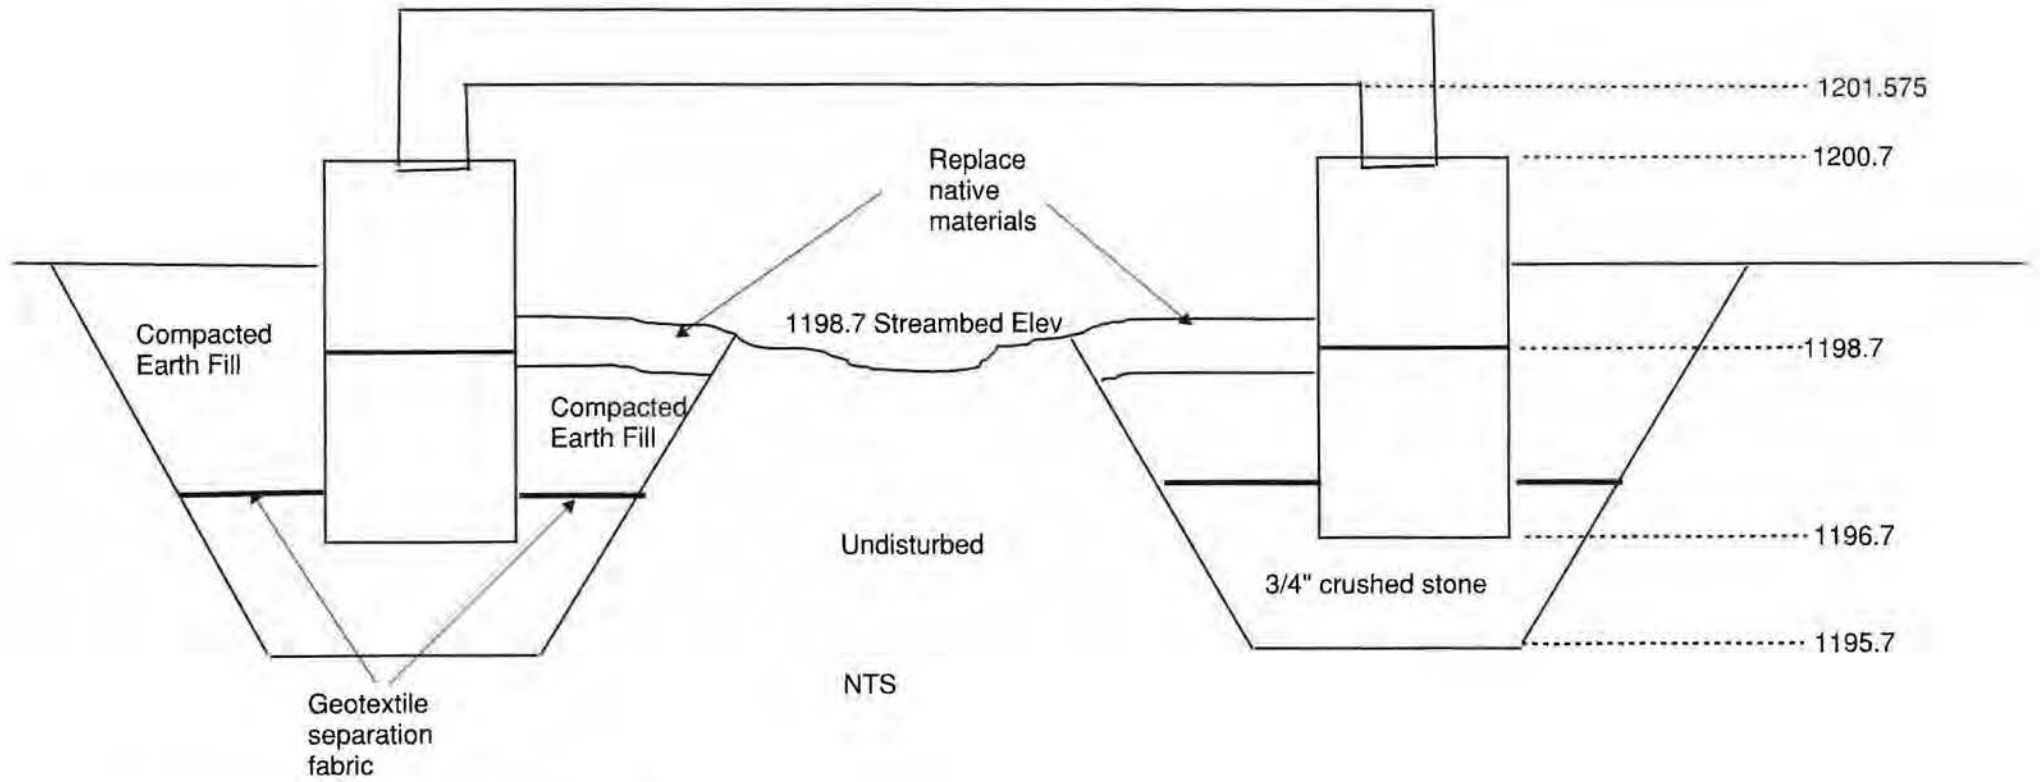
Undisturbed channel

Upstream streambed elevation: 1198.7'.  
Minimum required between streambed and bottom of culvert decking: 2'.

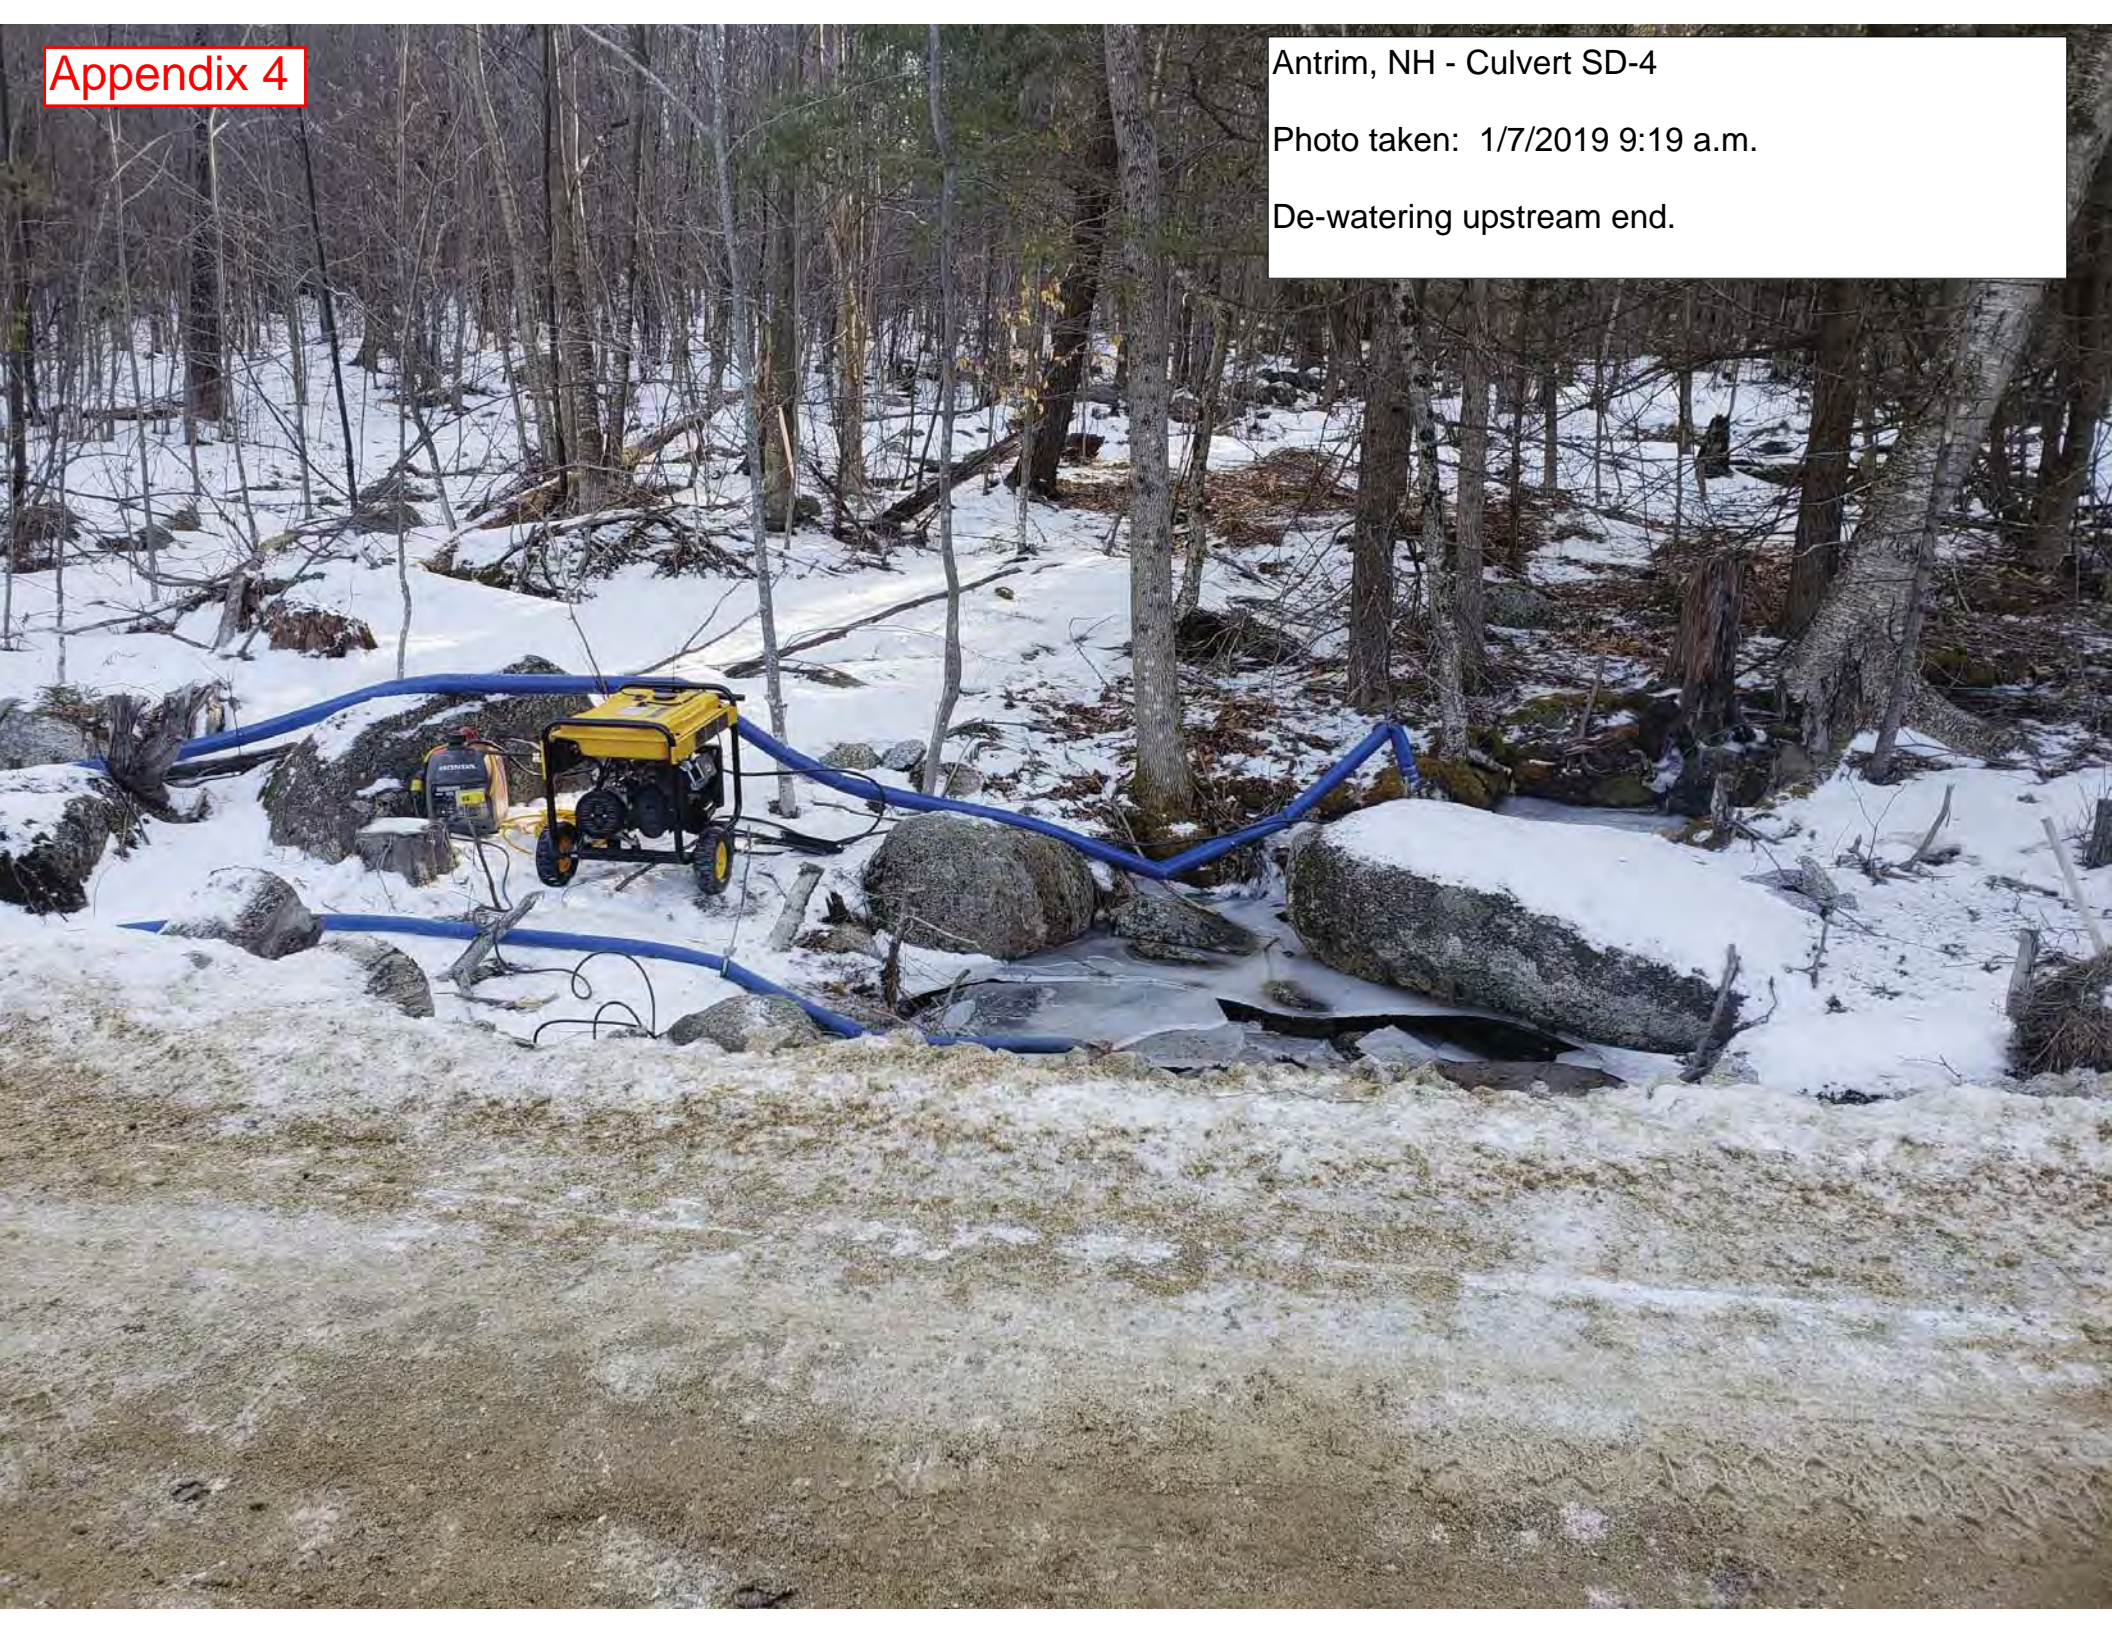
Photo taken: 1/7/2019 9:19 a.m.

De-watering upstream end.

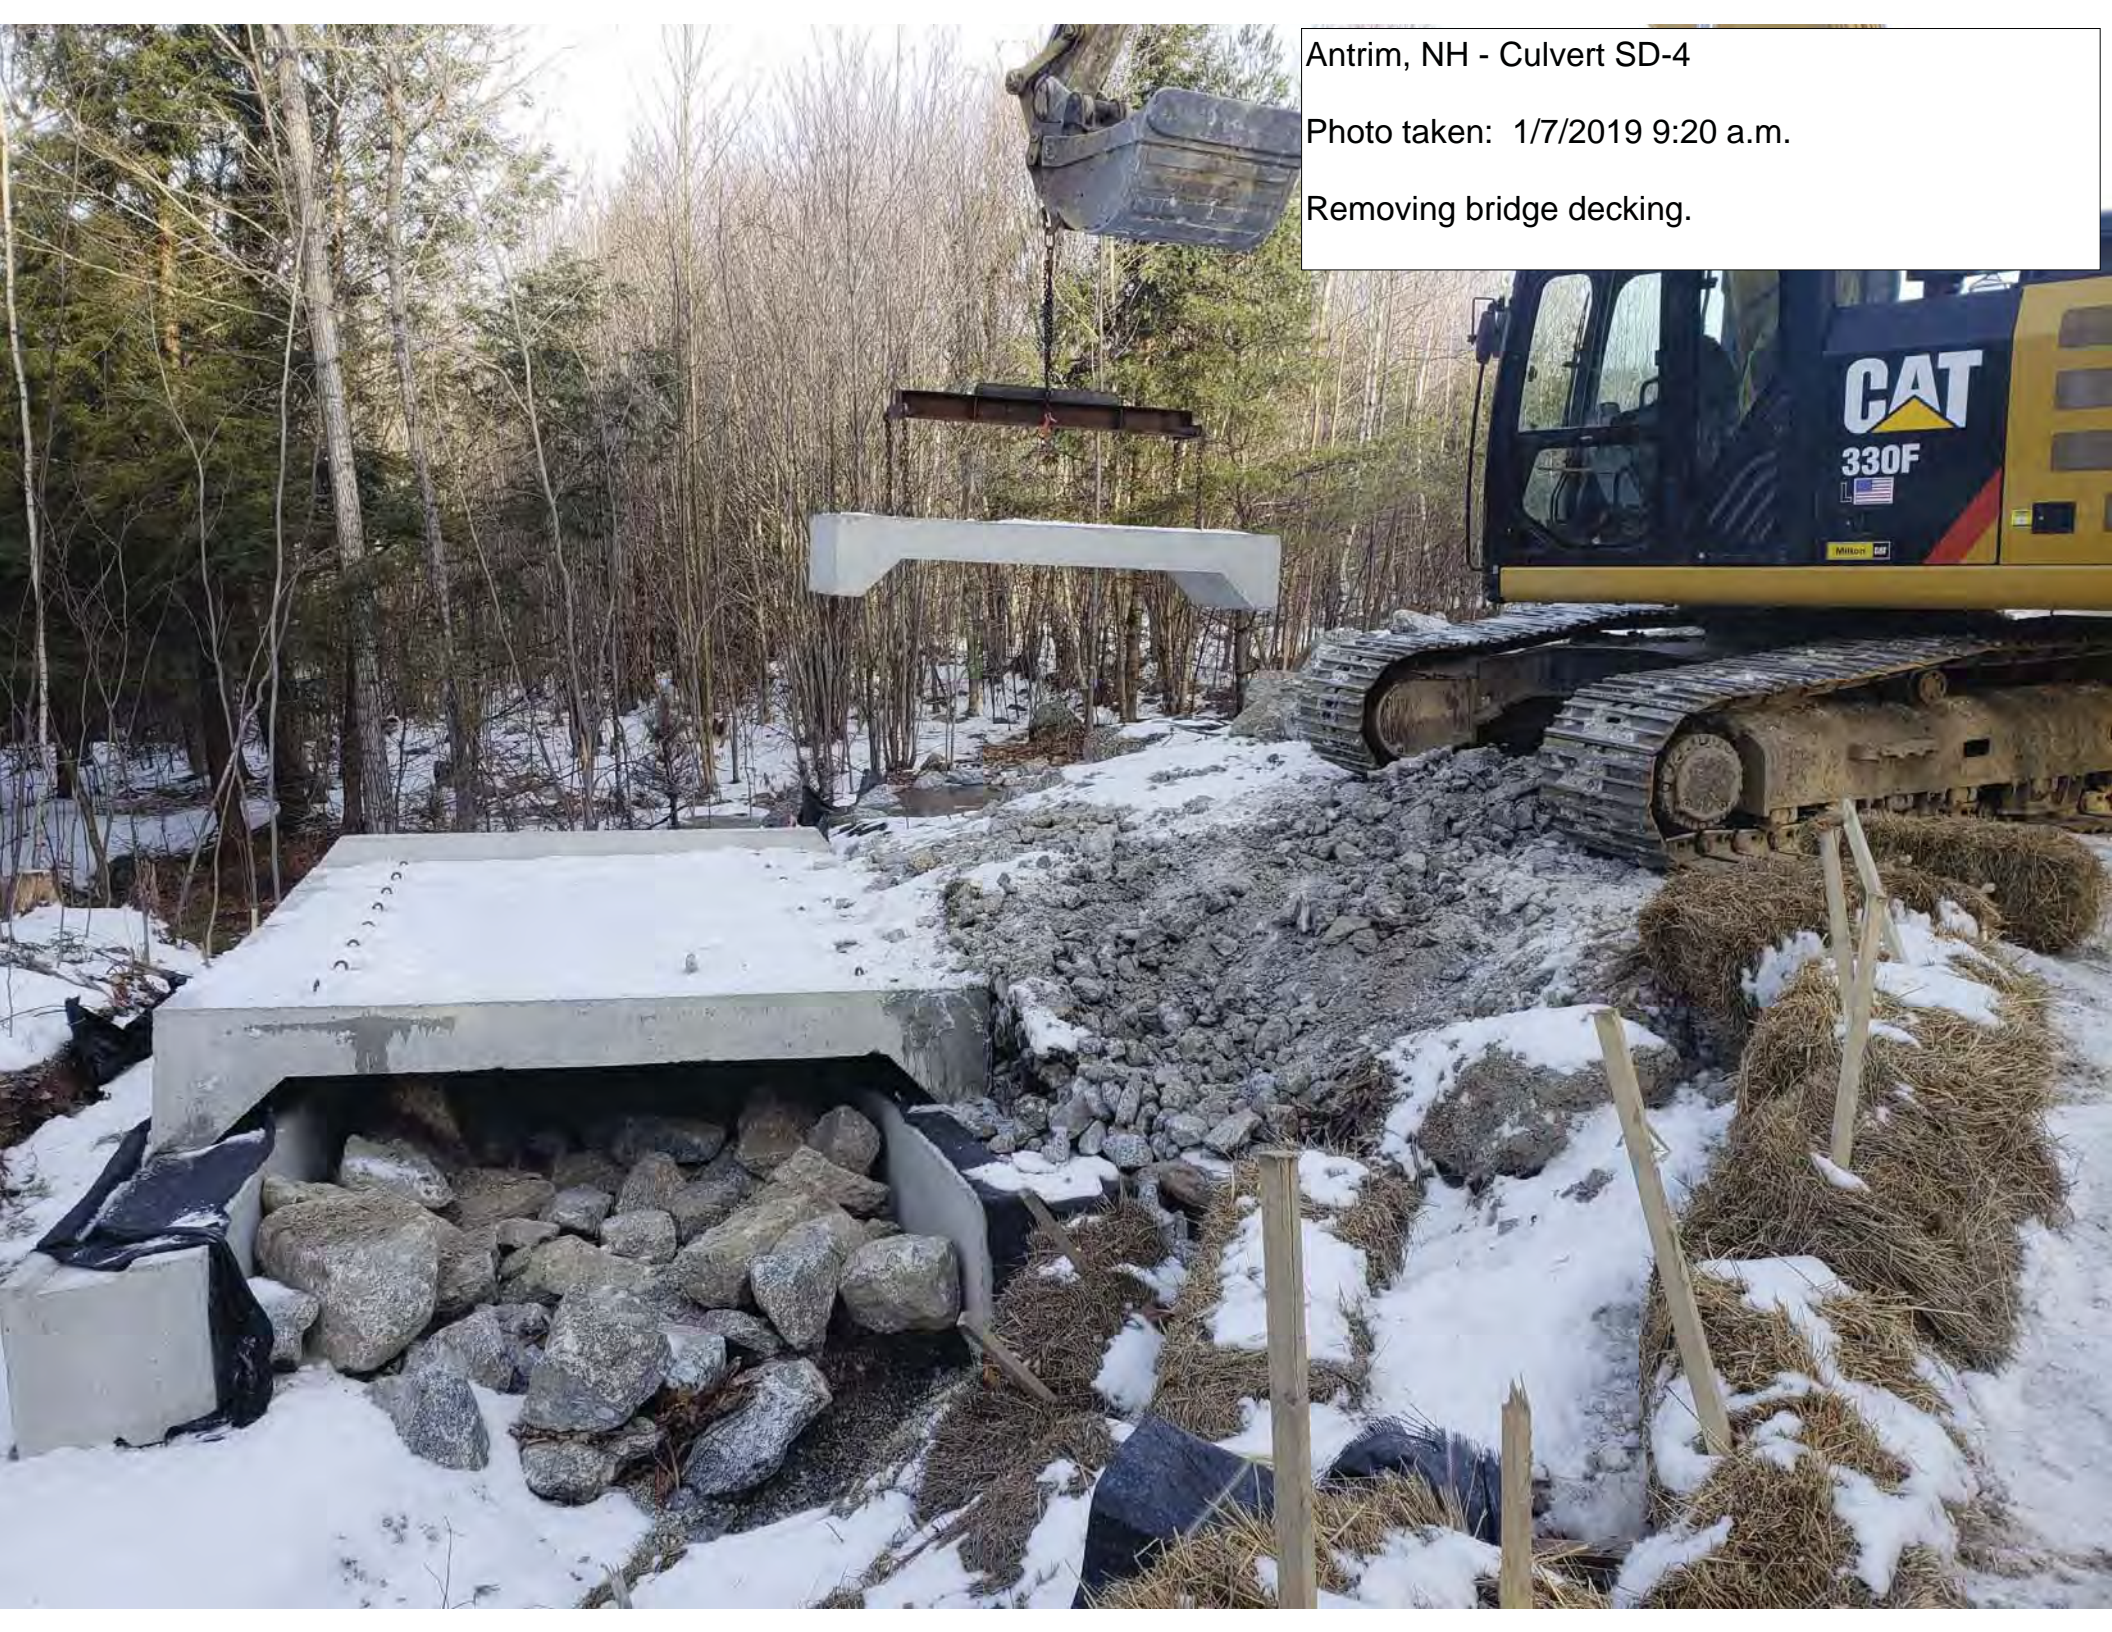
Photo taken: 1/7/2019 9:20 a.m.

Removing bridge decking.

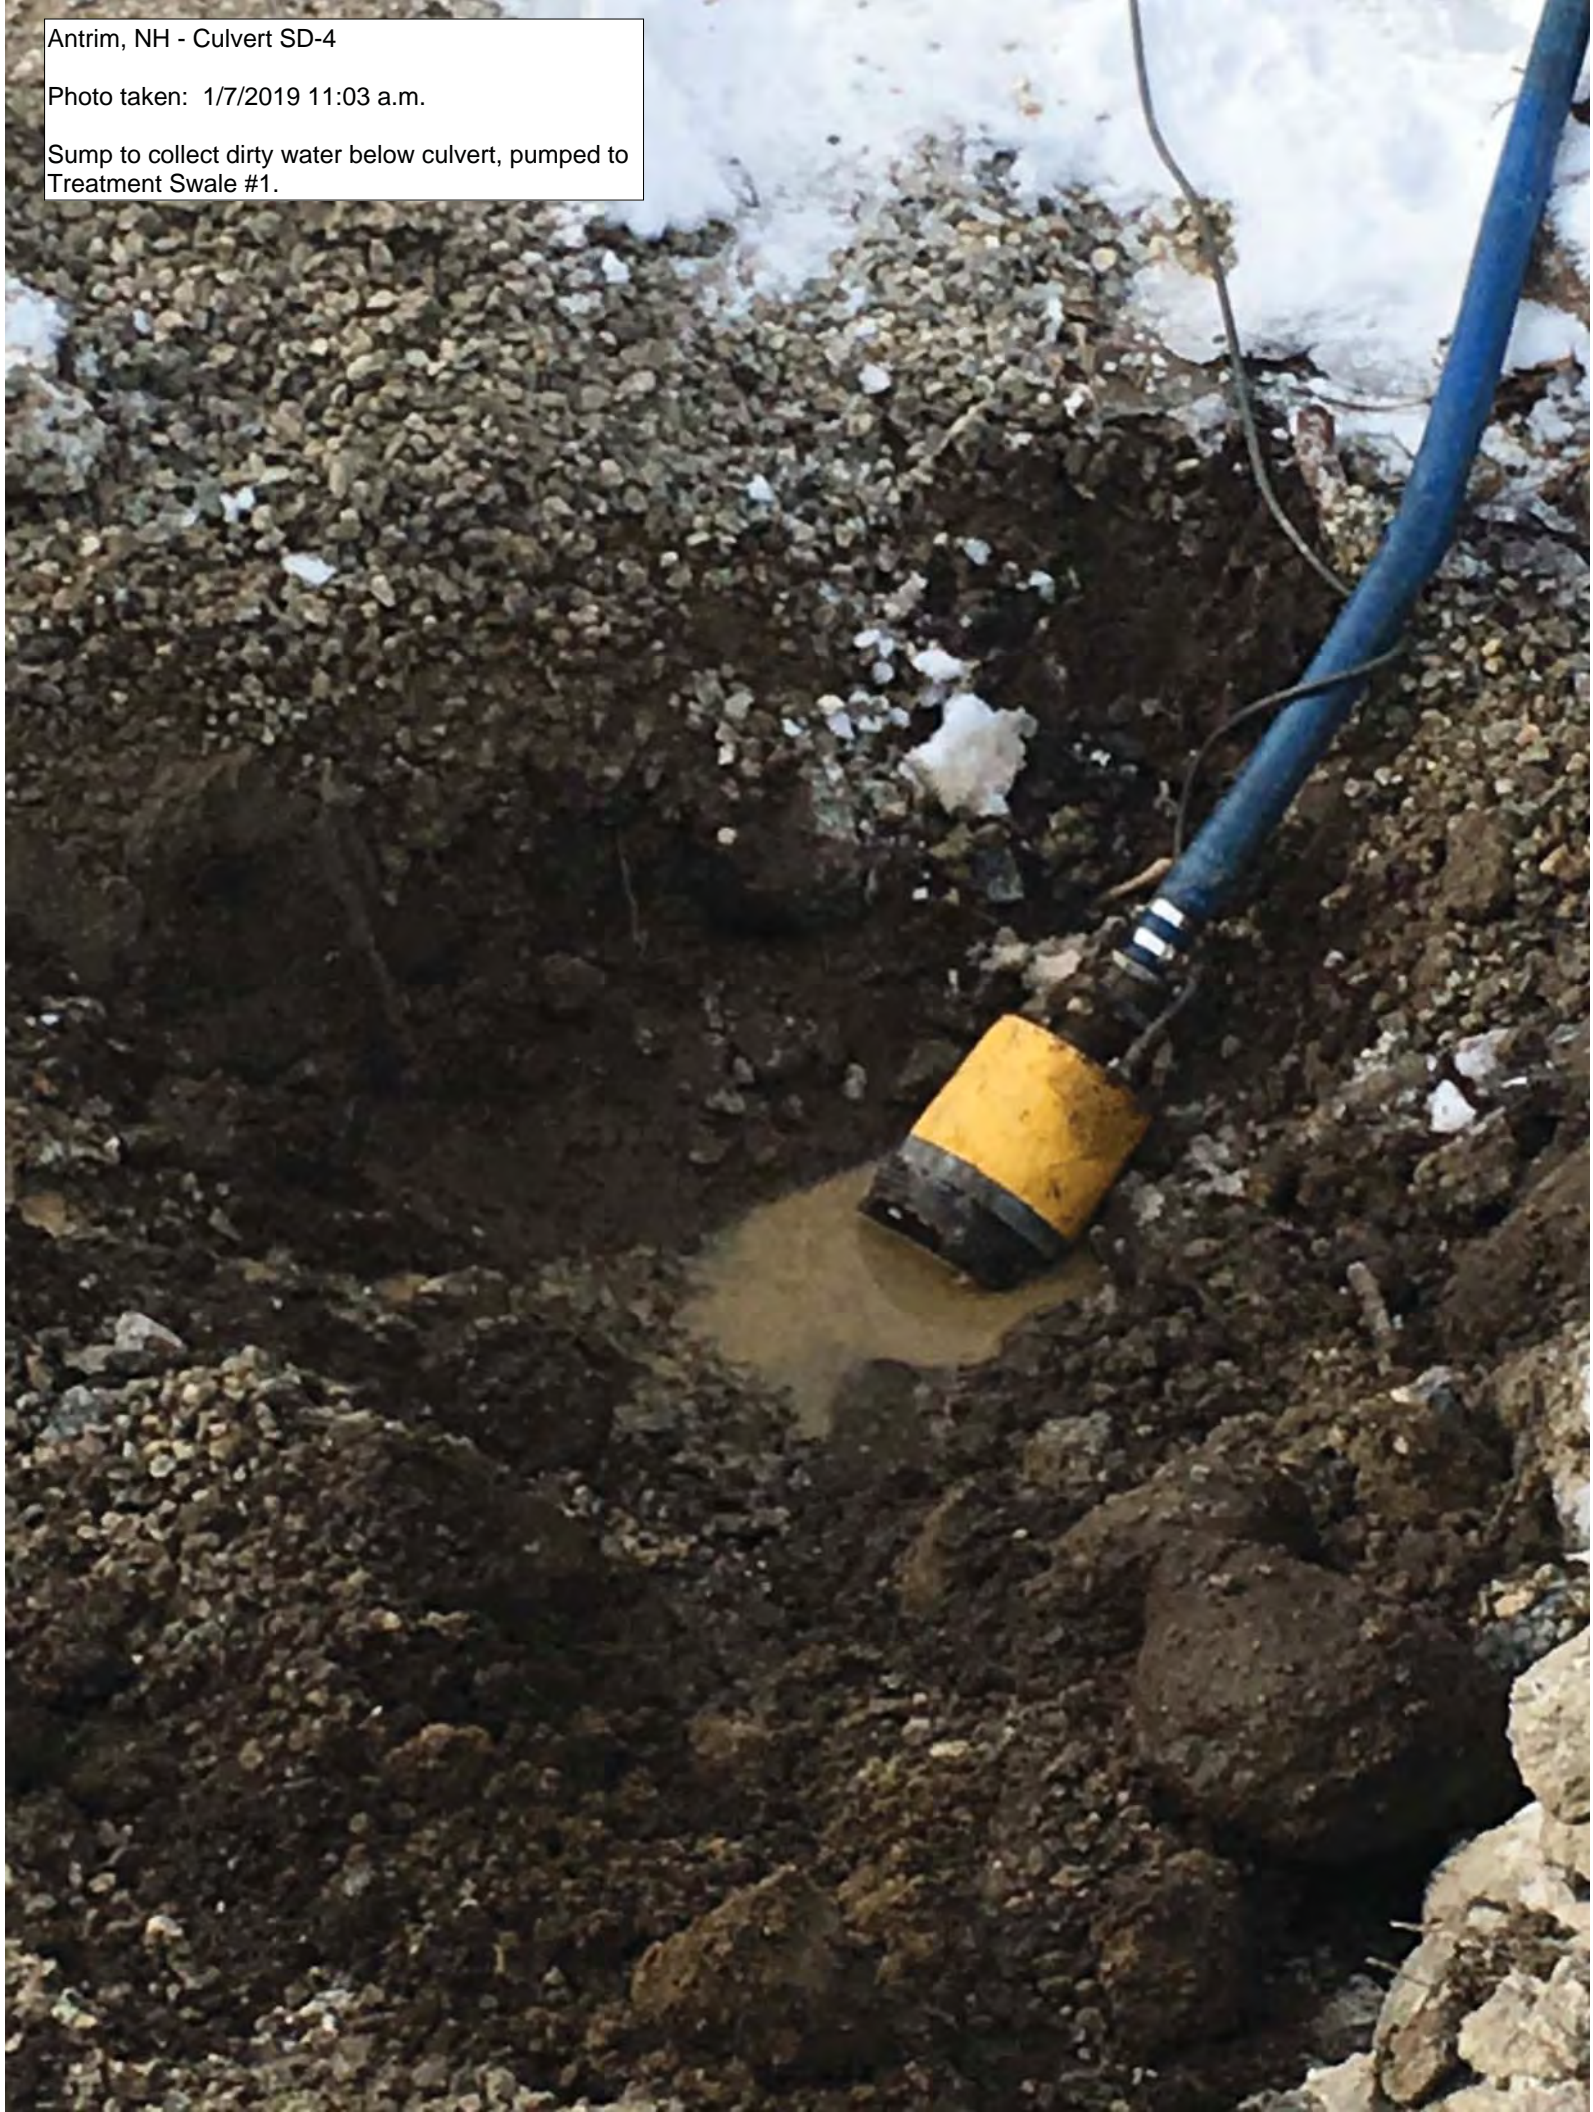
Photo taken: 1/7/2019 11:03 a.m.

Sump to collect dirty water below culvert, pumped to Treatment Swale #1.

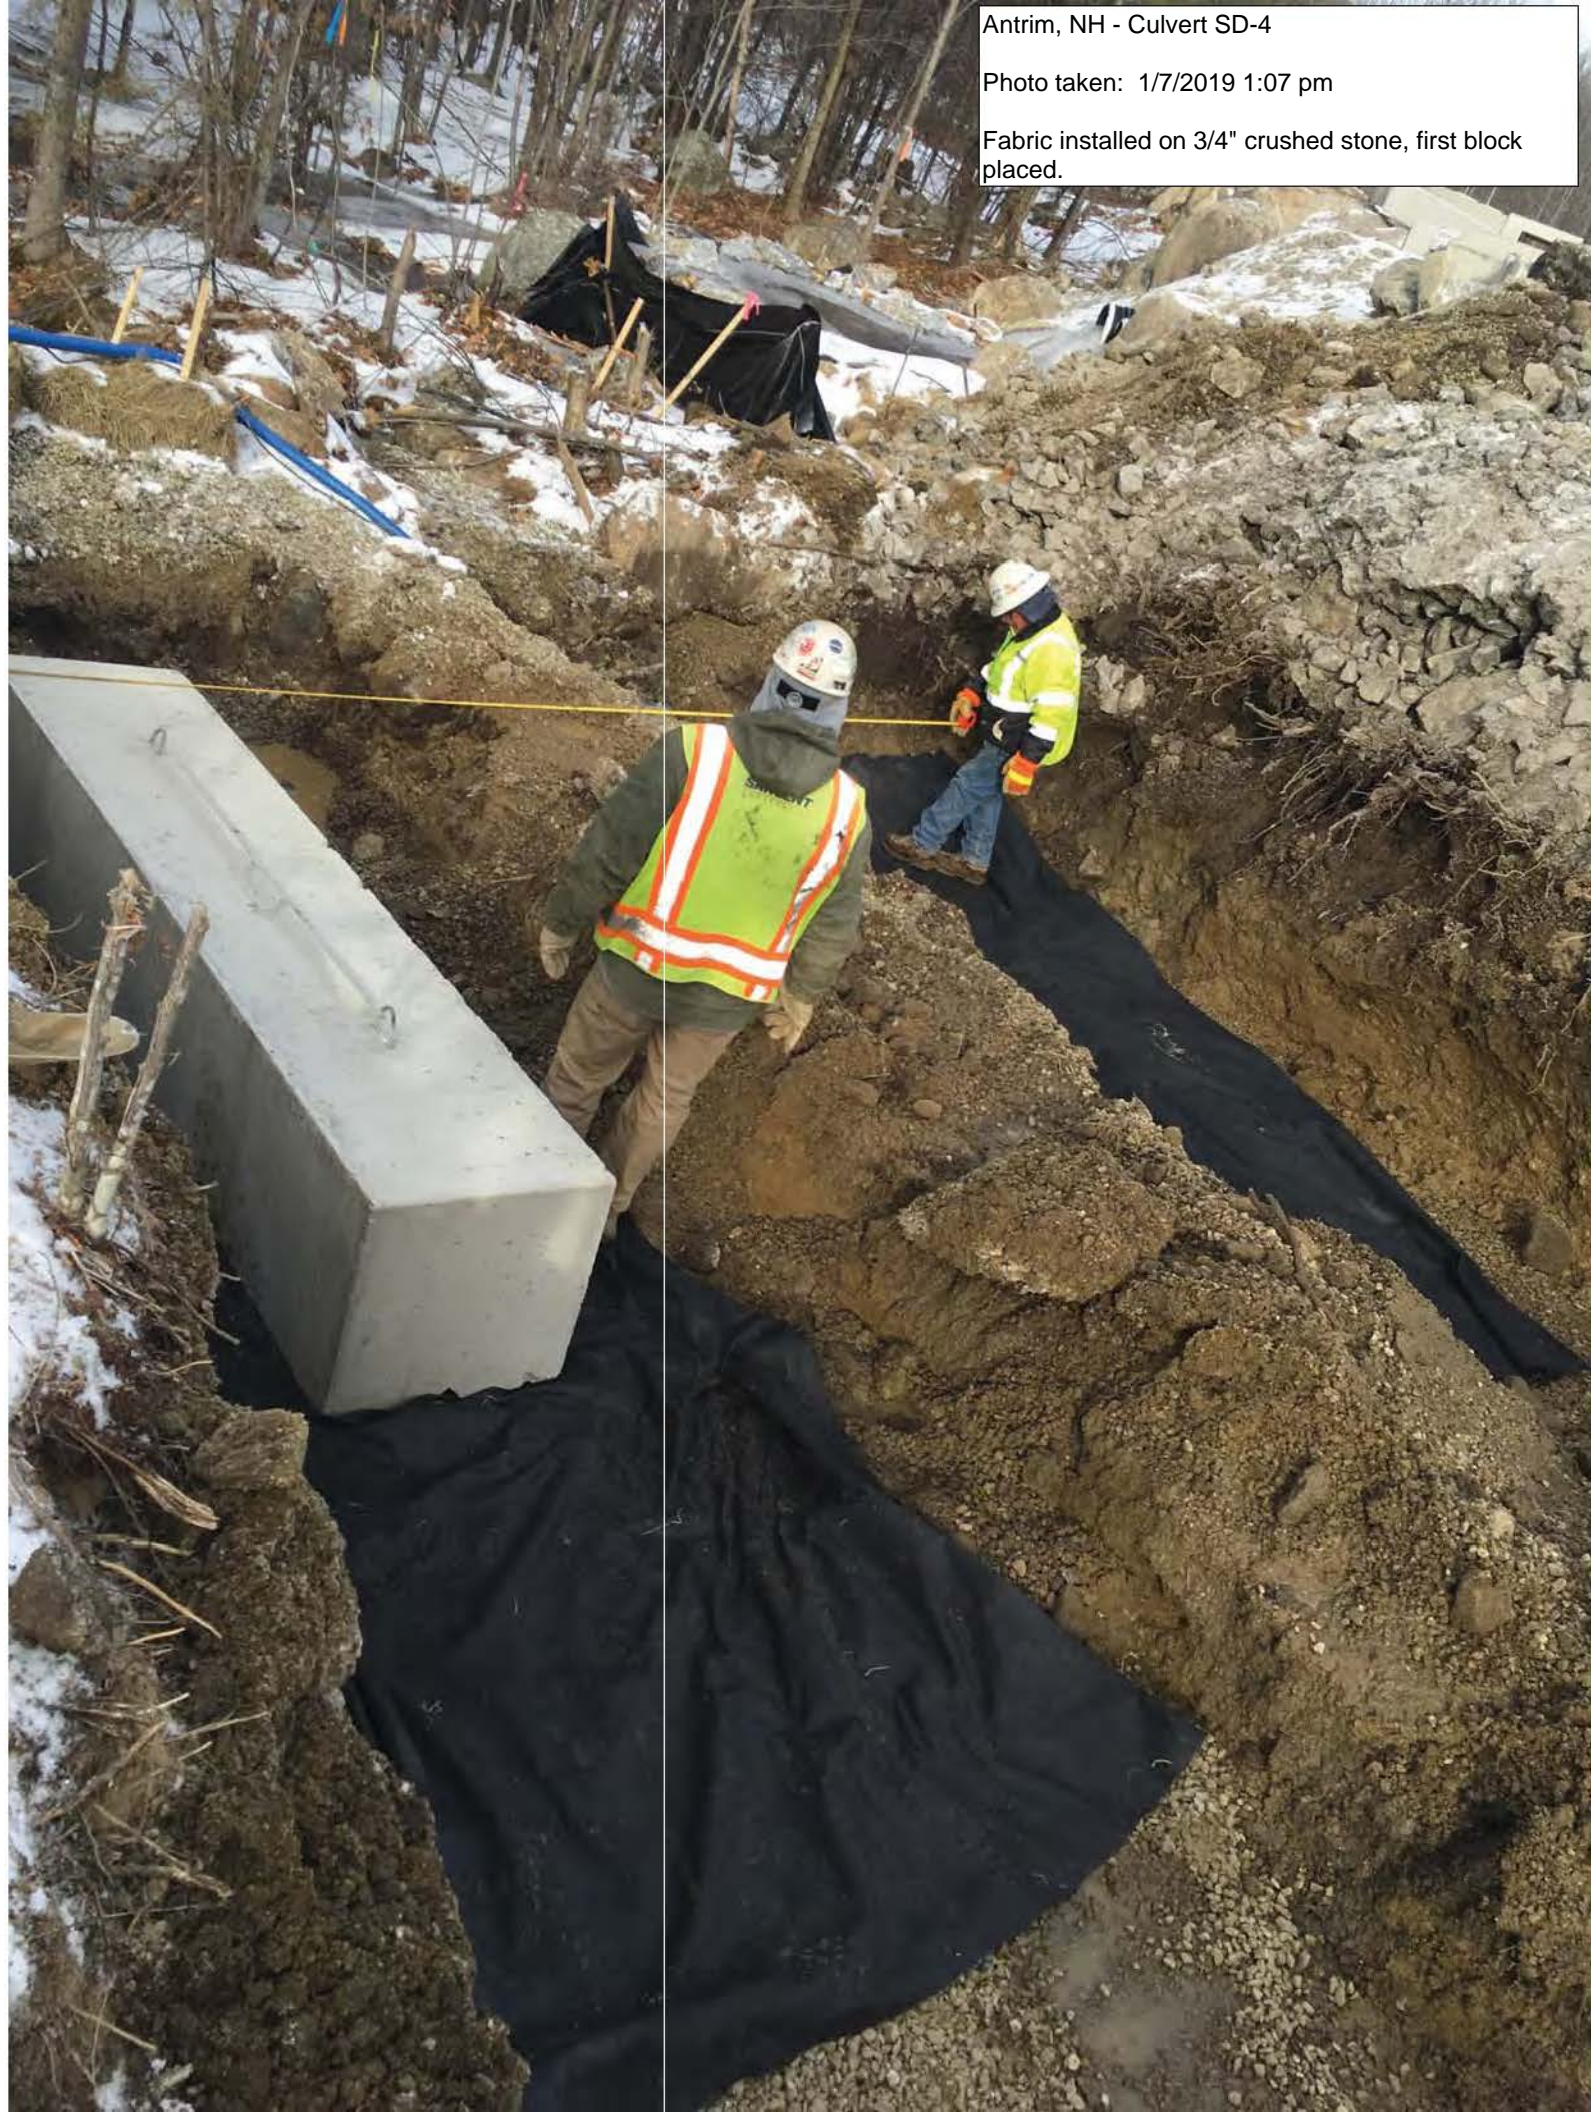
Photo taken: 1/7/2019 1:07 pm

Fabric installed on 3/4" crushed stone, first block placed.
