# Non-Conformance Report

Report No.	Date	Project
1	11/20/2018	Antrim Wind Project

Antrim NH Wind: Culvert SD-4: Box culvert stability and streambed  
Non-conformance analysis and report

Conformance Plan: SD-4 Box Culvert

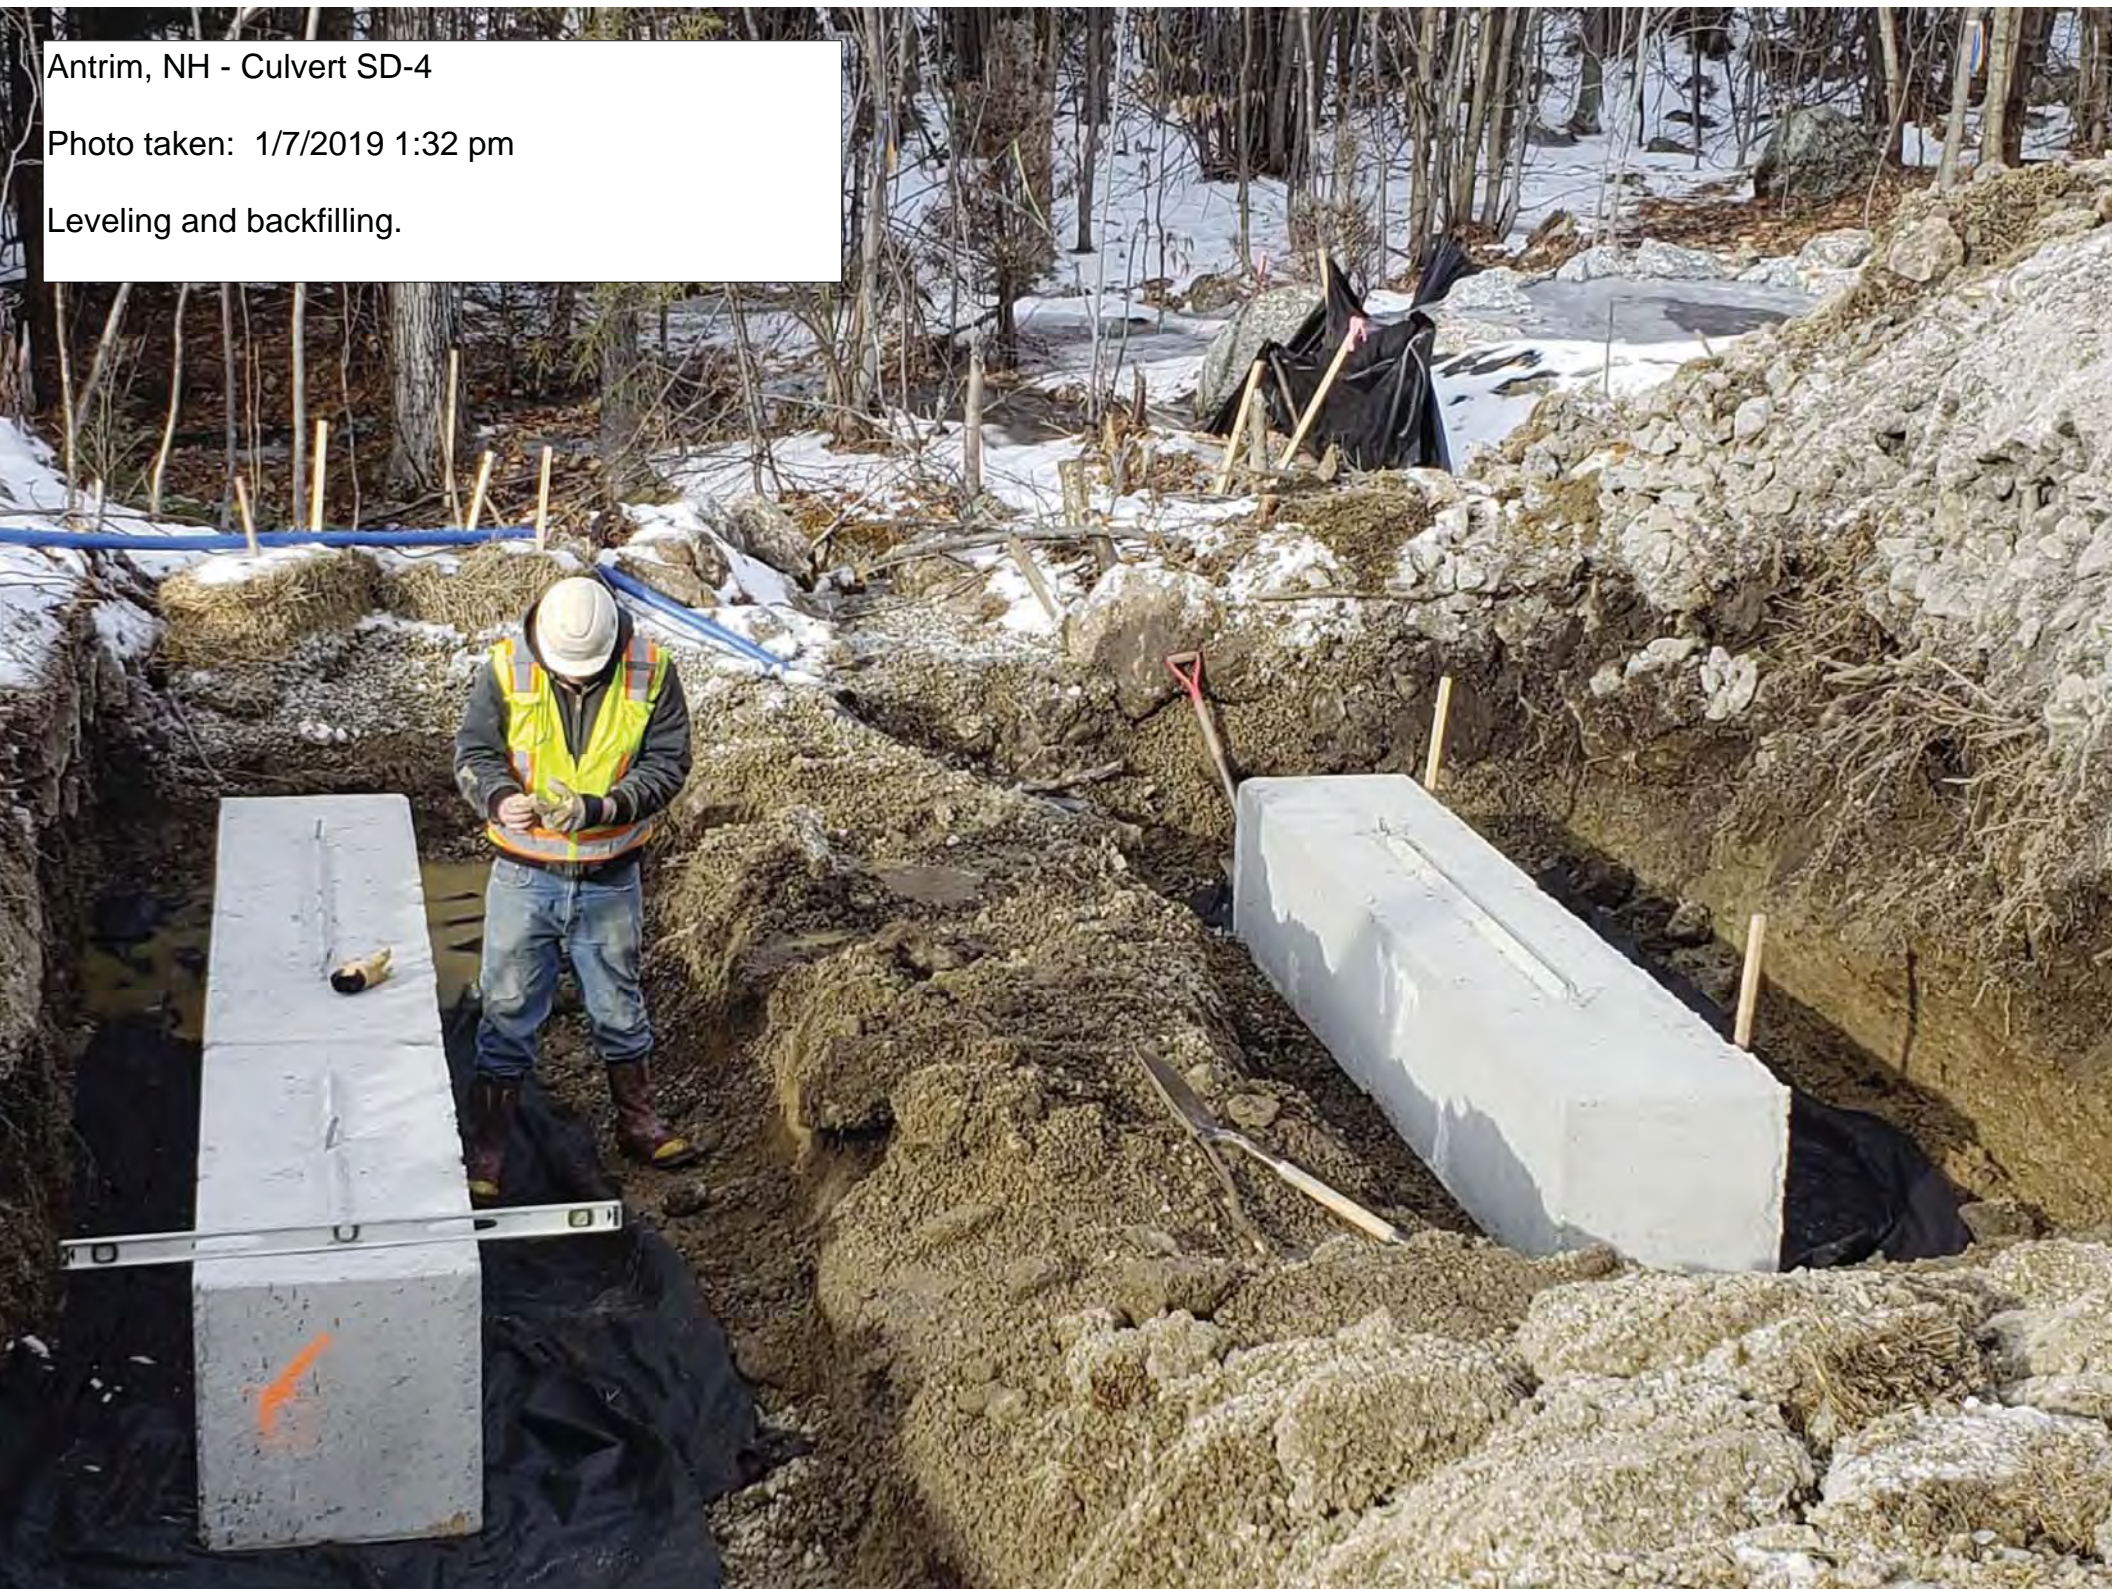
Photo taken: 1/7/2019 1:32 pm

Leveling and backfilling.

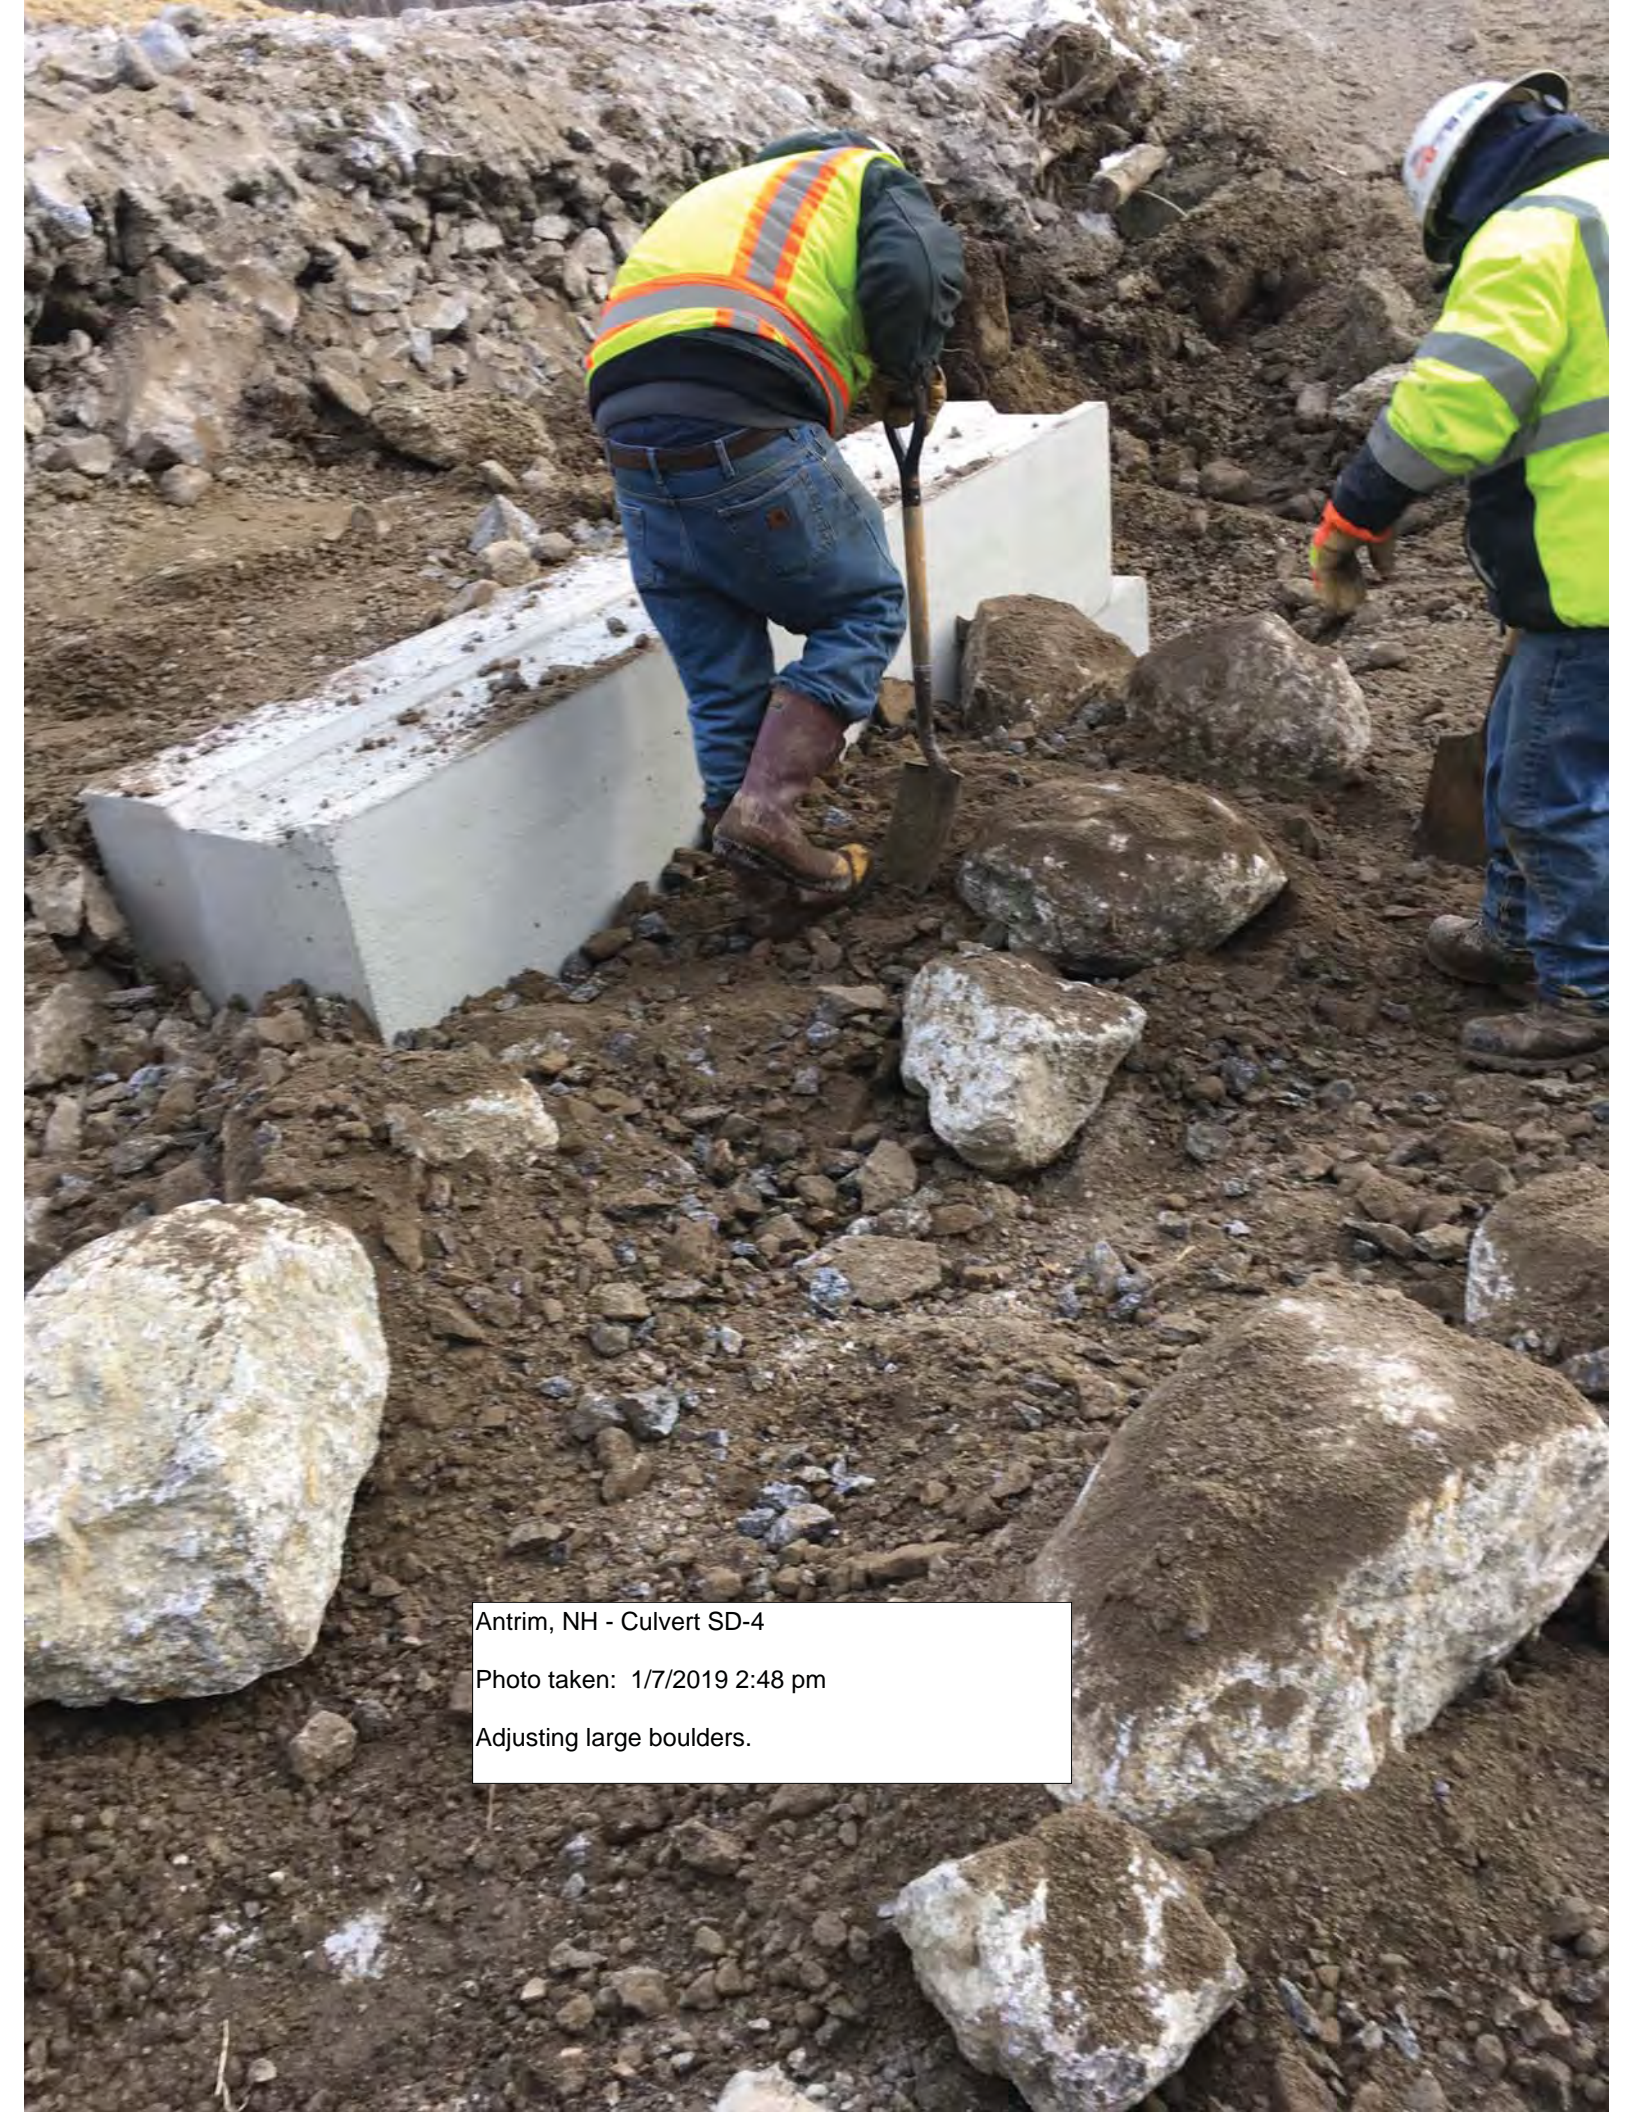
Photo taken: 1/7/2019 2:24 pm

Compacting earth backfill.

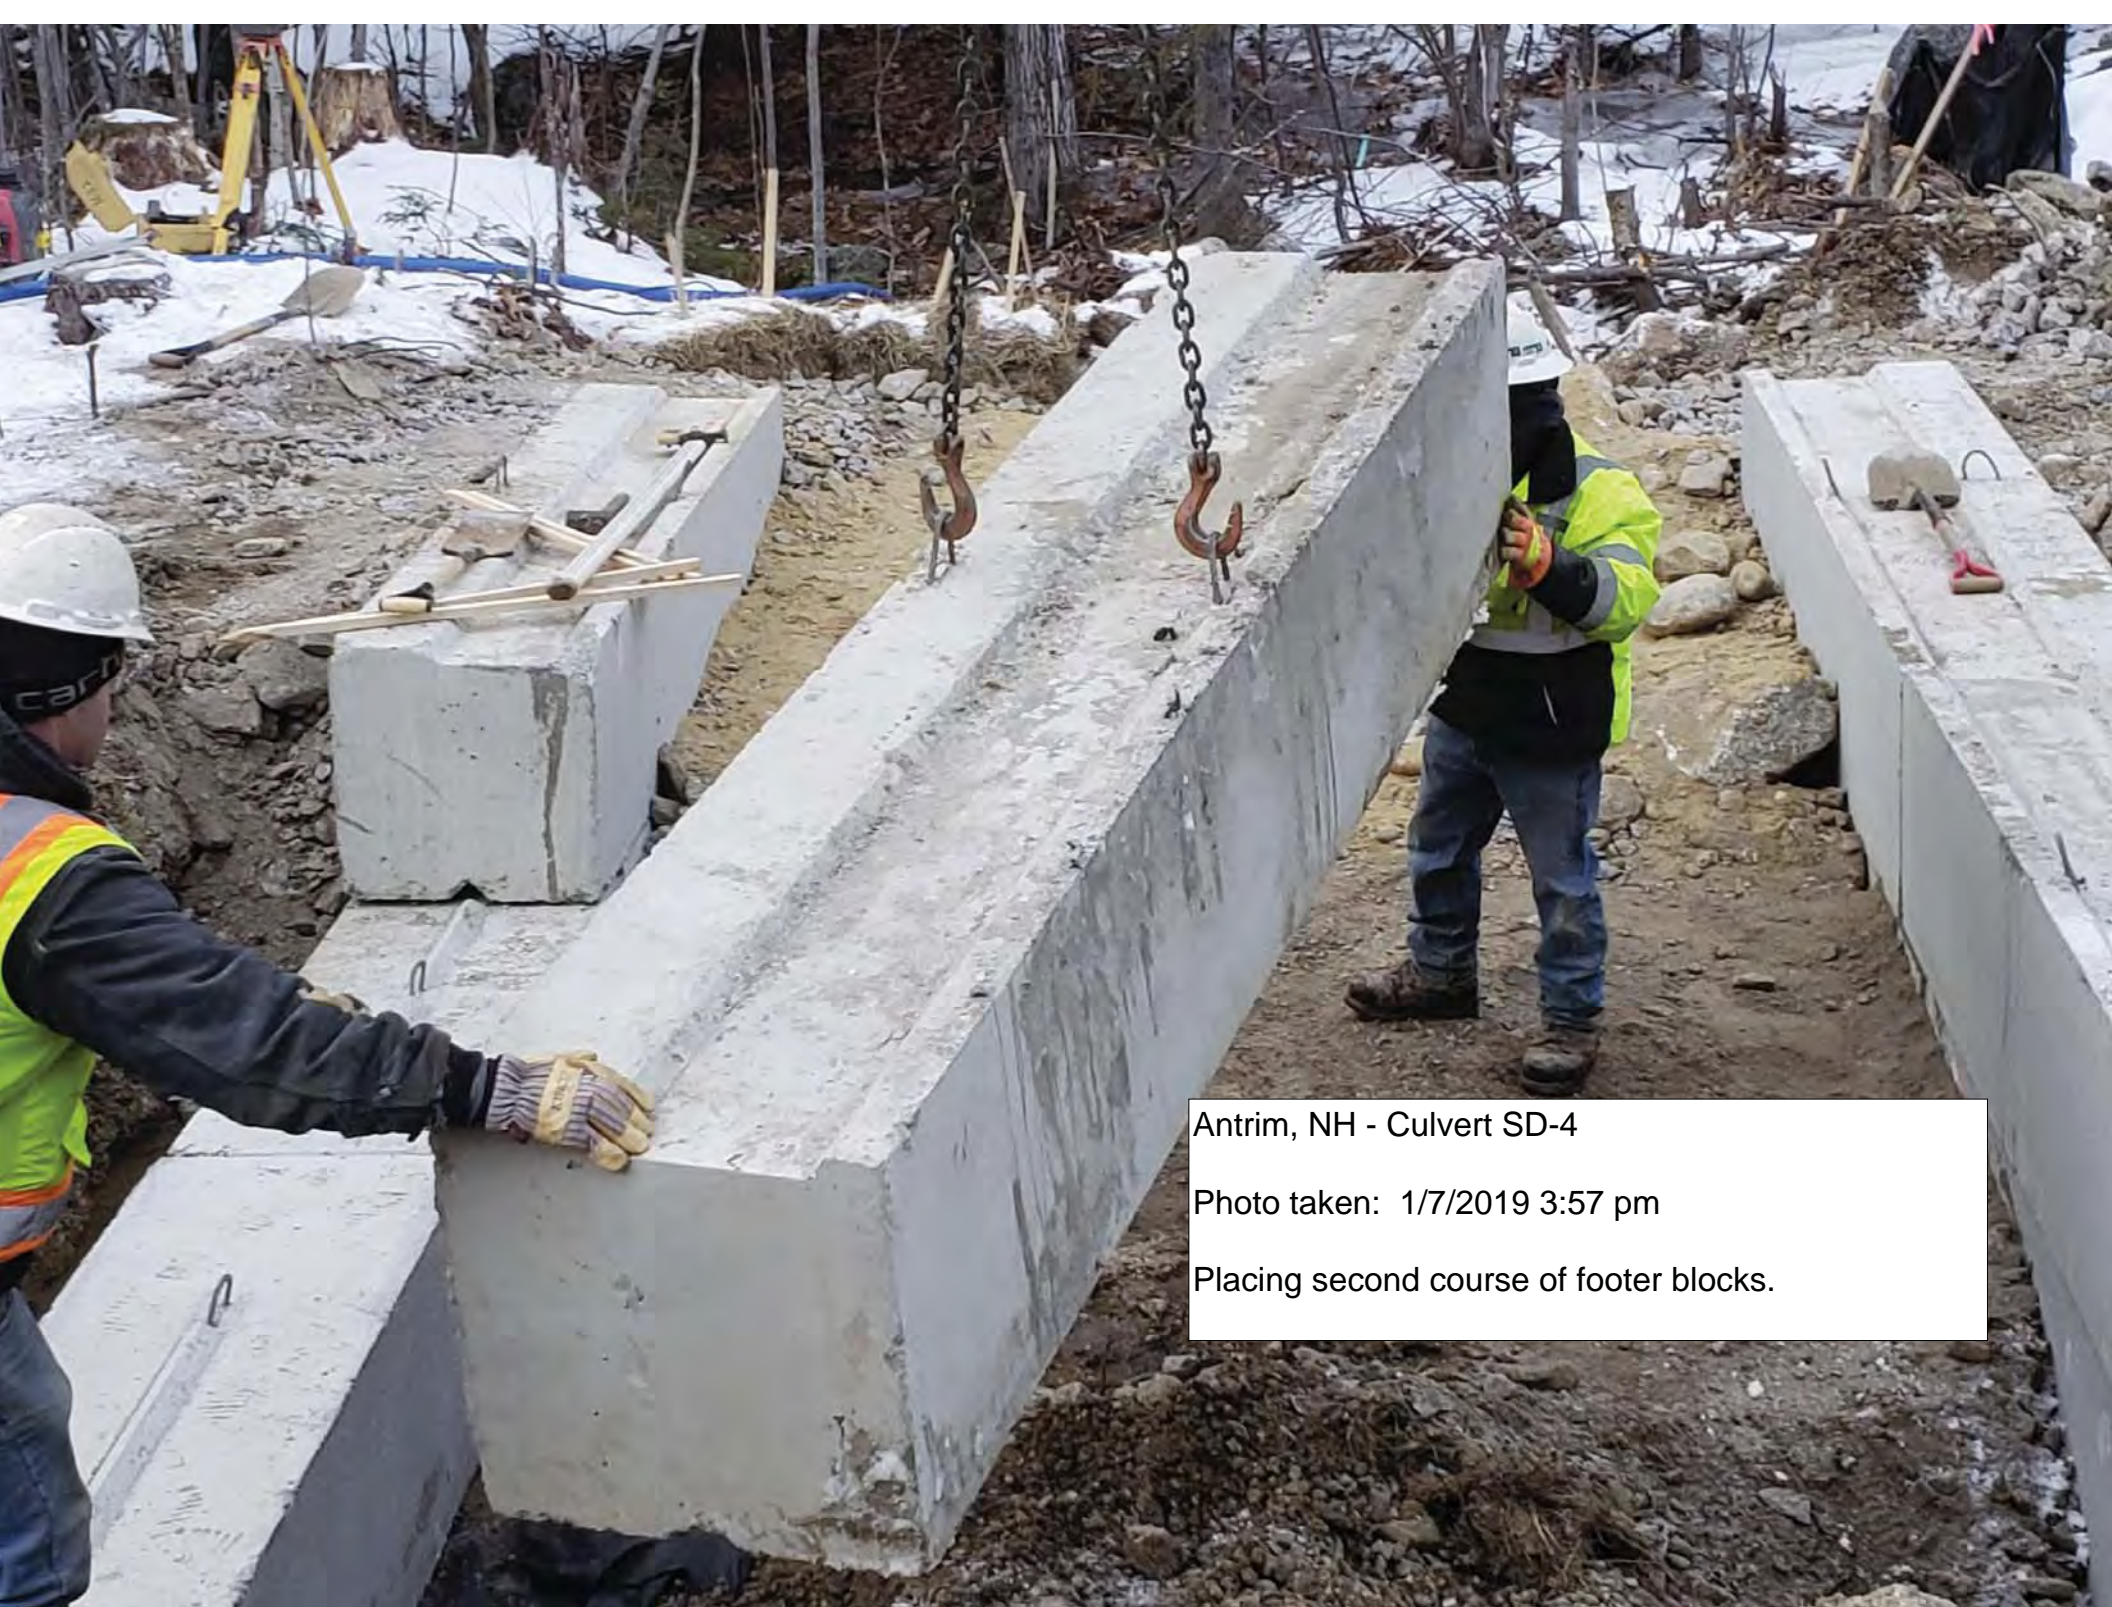
Photo taken: 1/7/2019 2:48 pm

Adjusting large boulders.

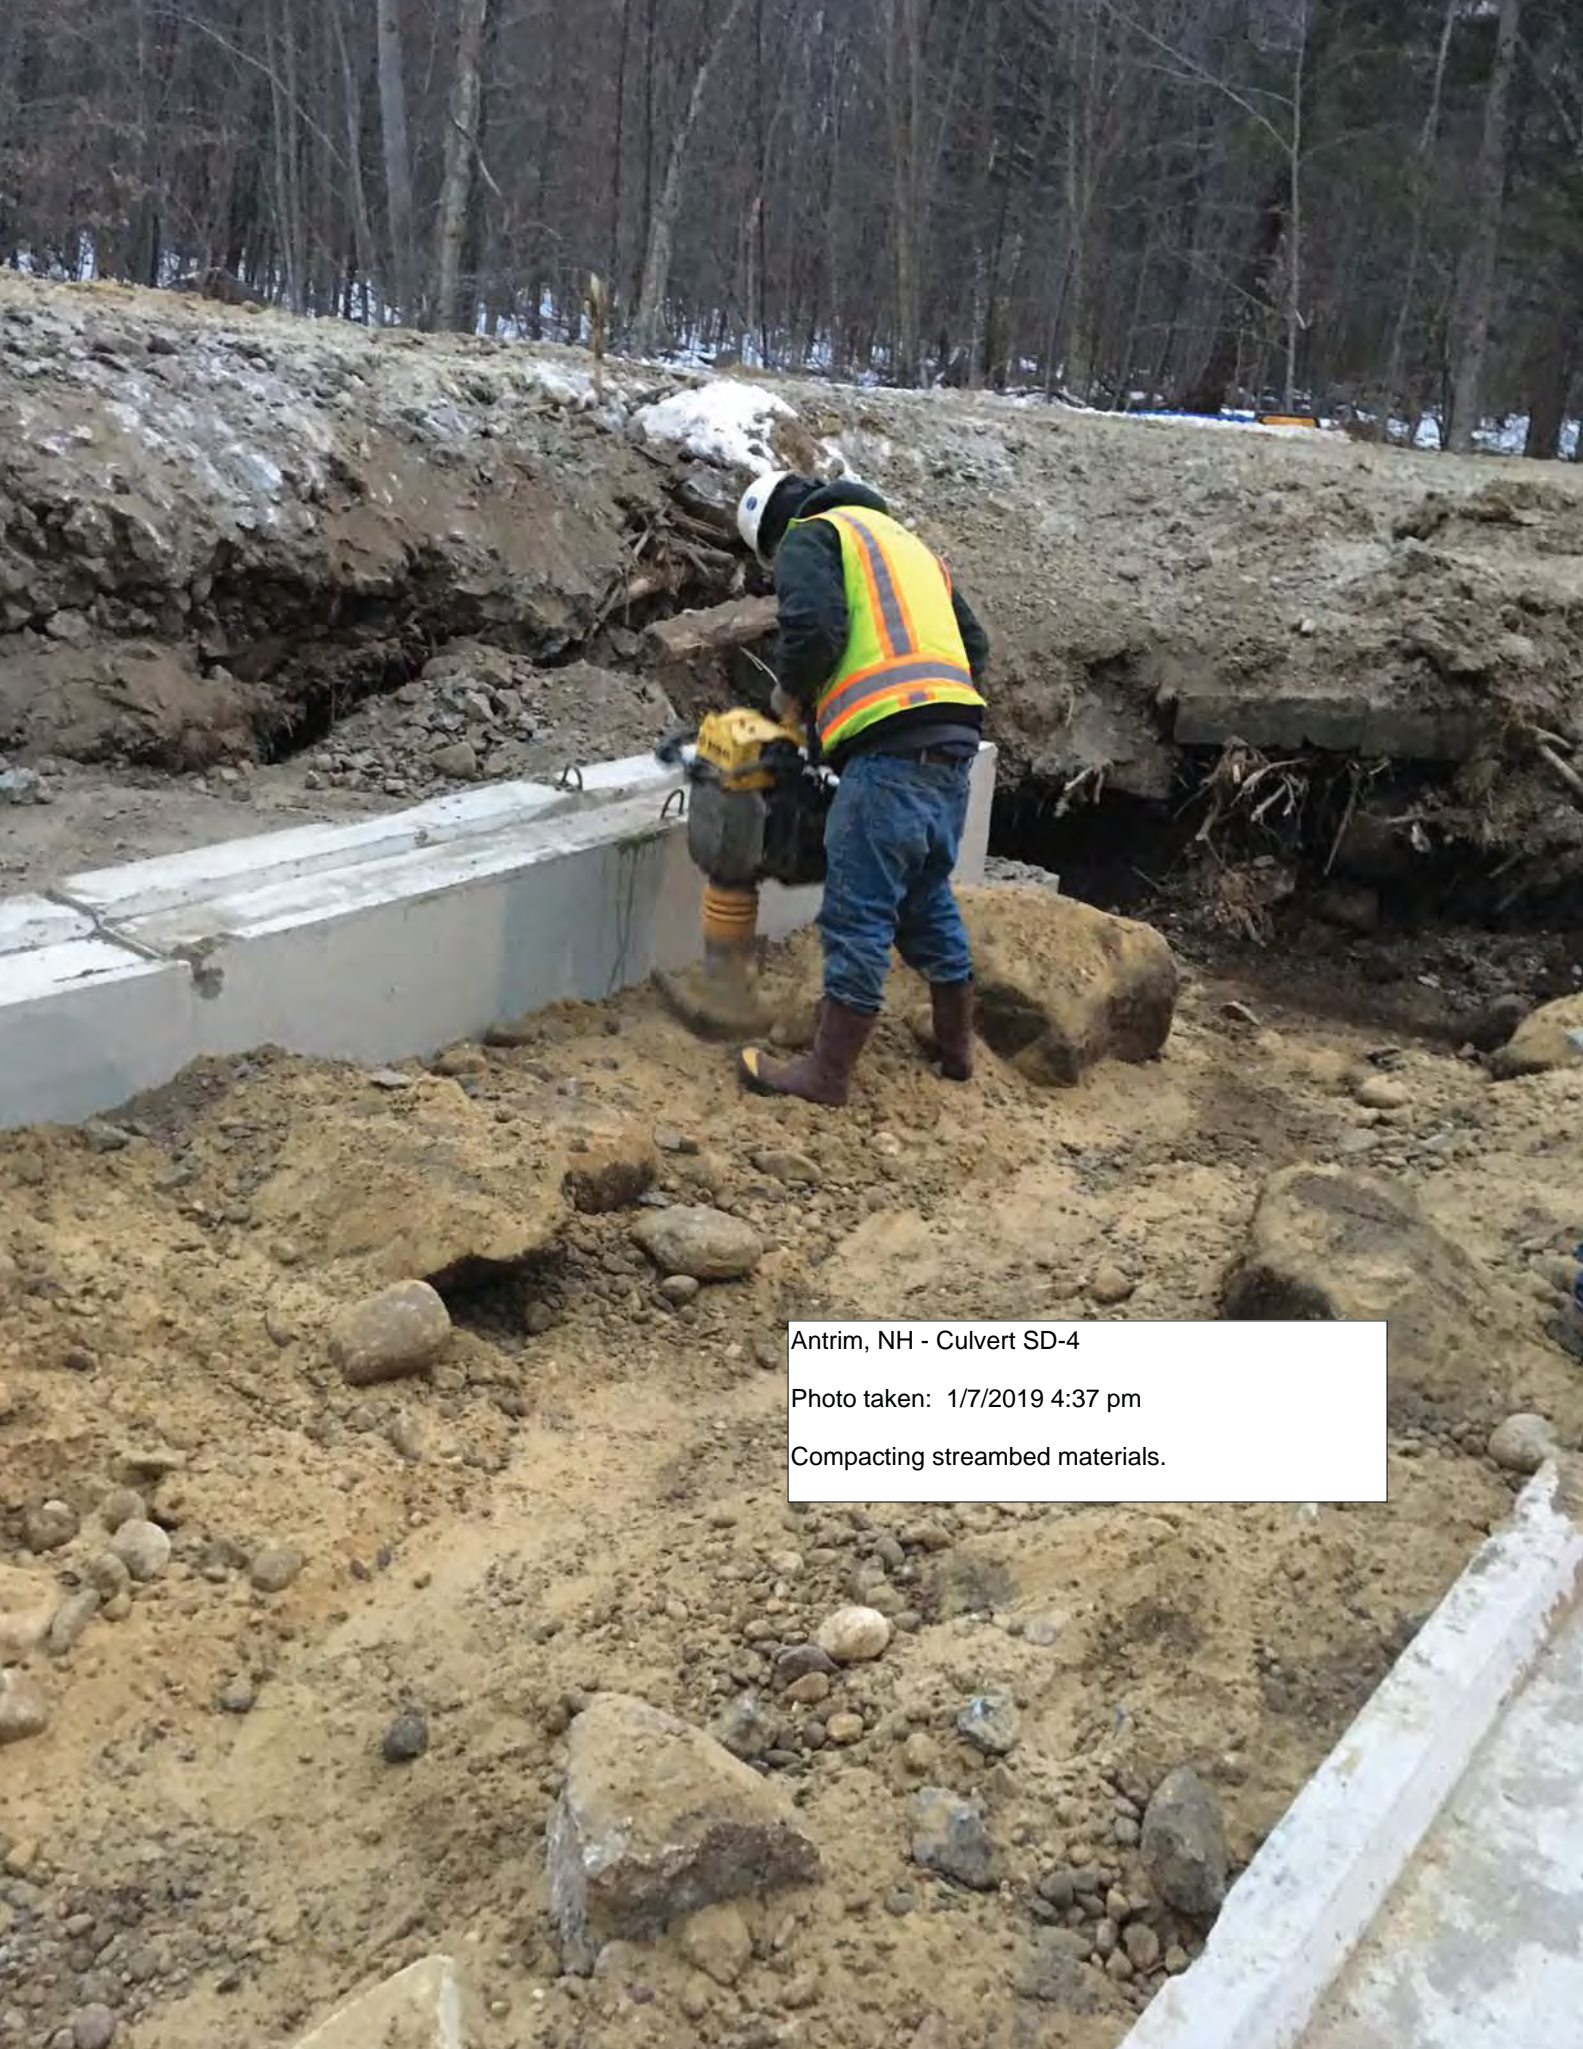
Photo taken: 1/7/2019 3:57 pm

Placing second course of footer blocks.

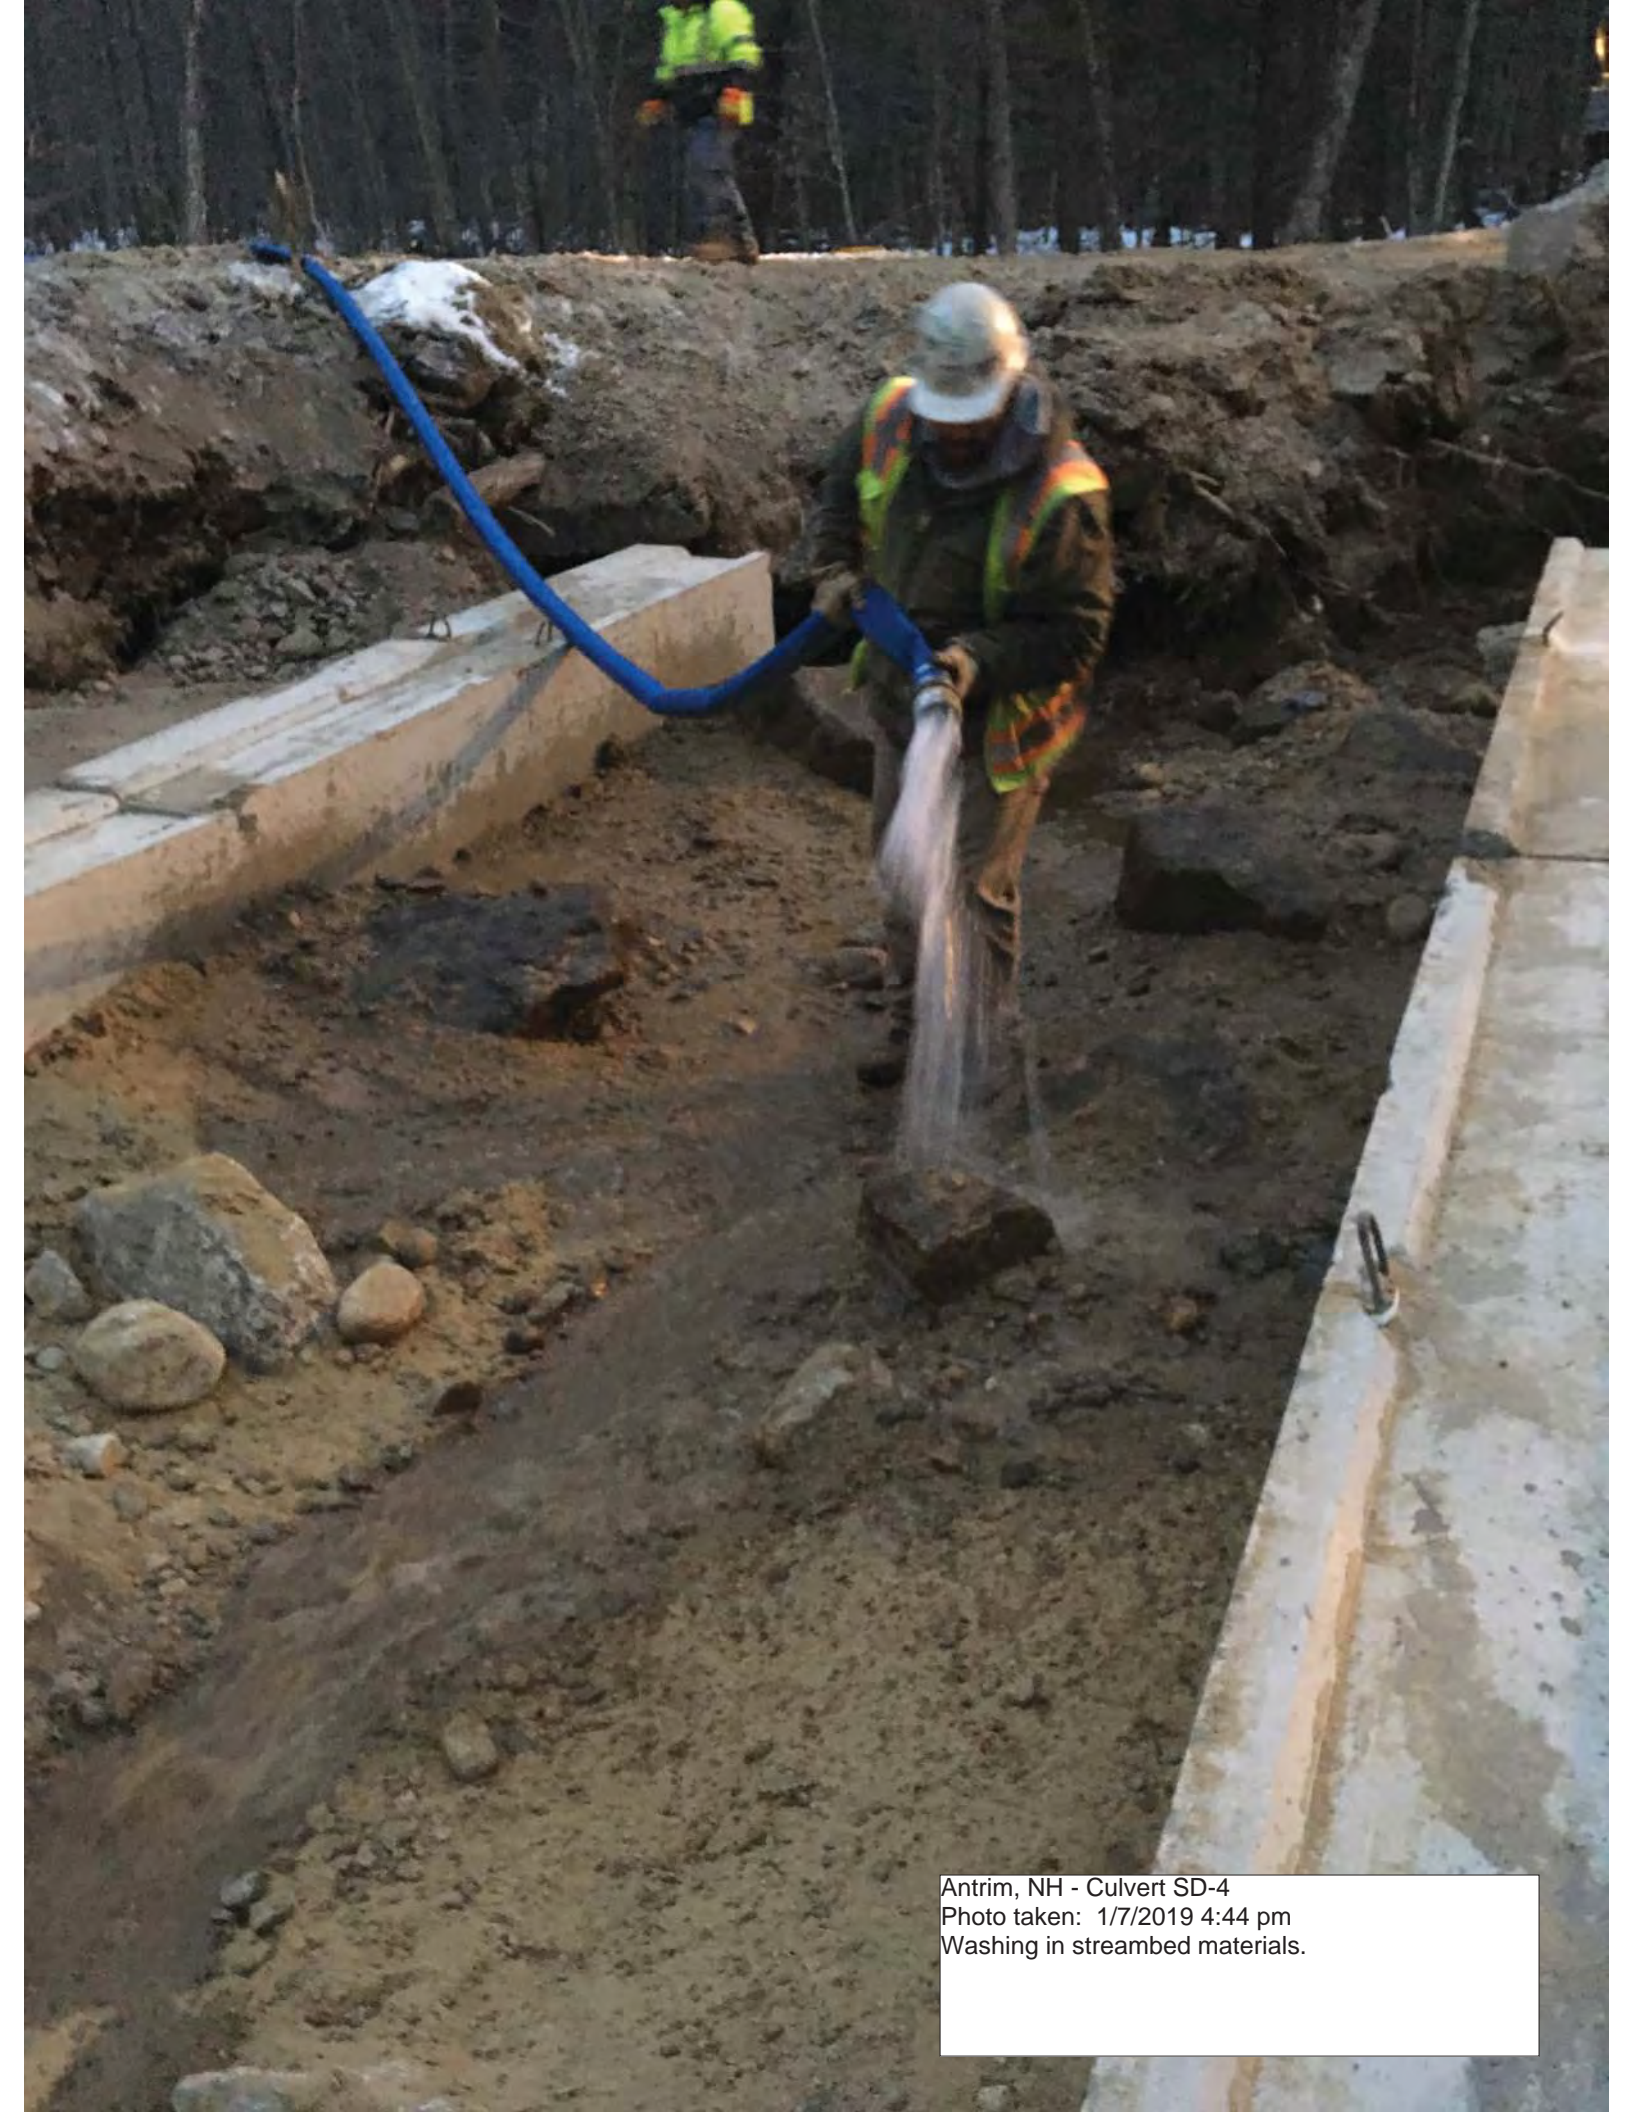
Antrim, NH - Culvert SD-4  
Photo taken: 1/7/2019 4:44 pm  
Washing in streambed materials.

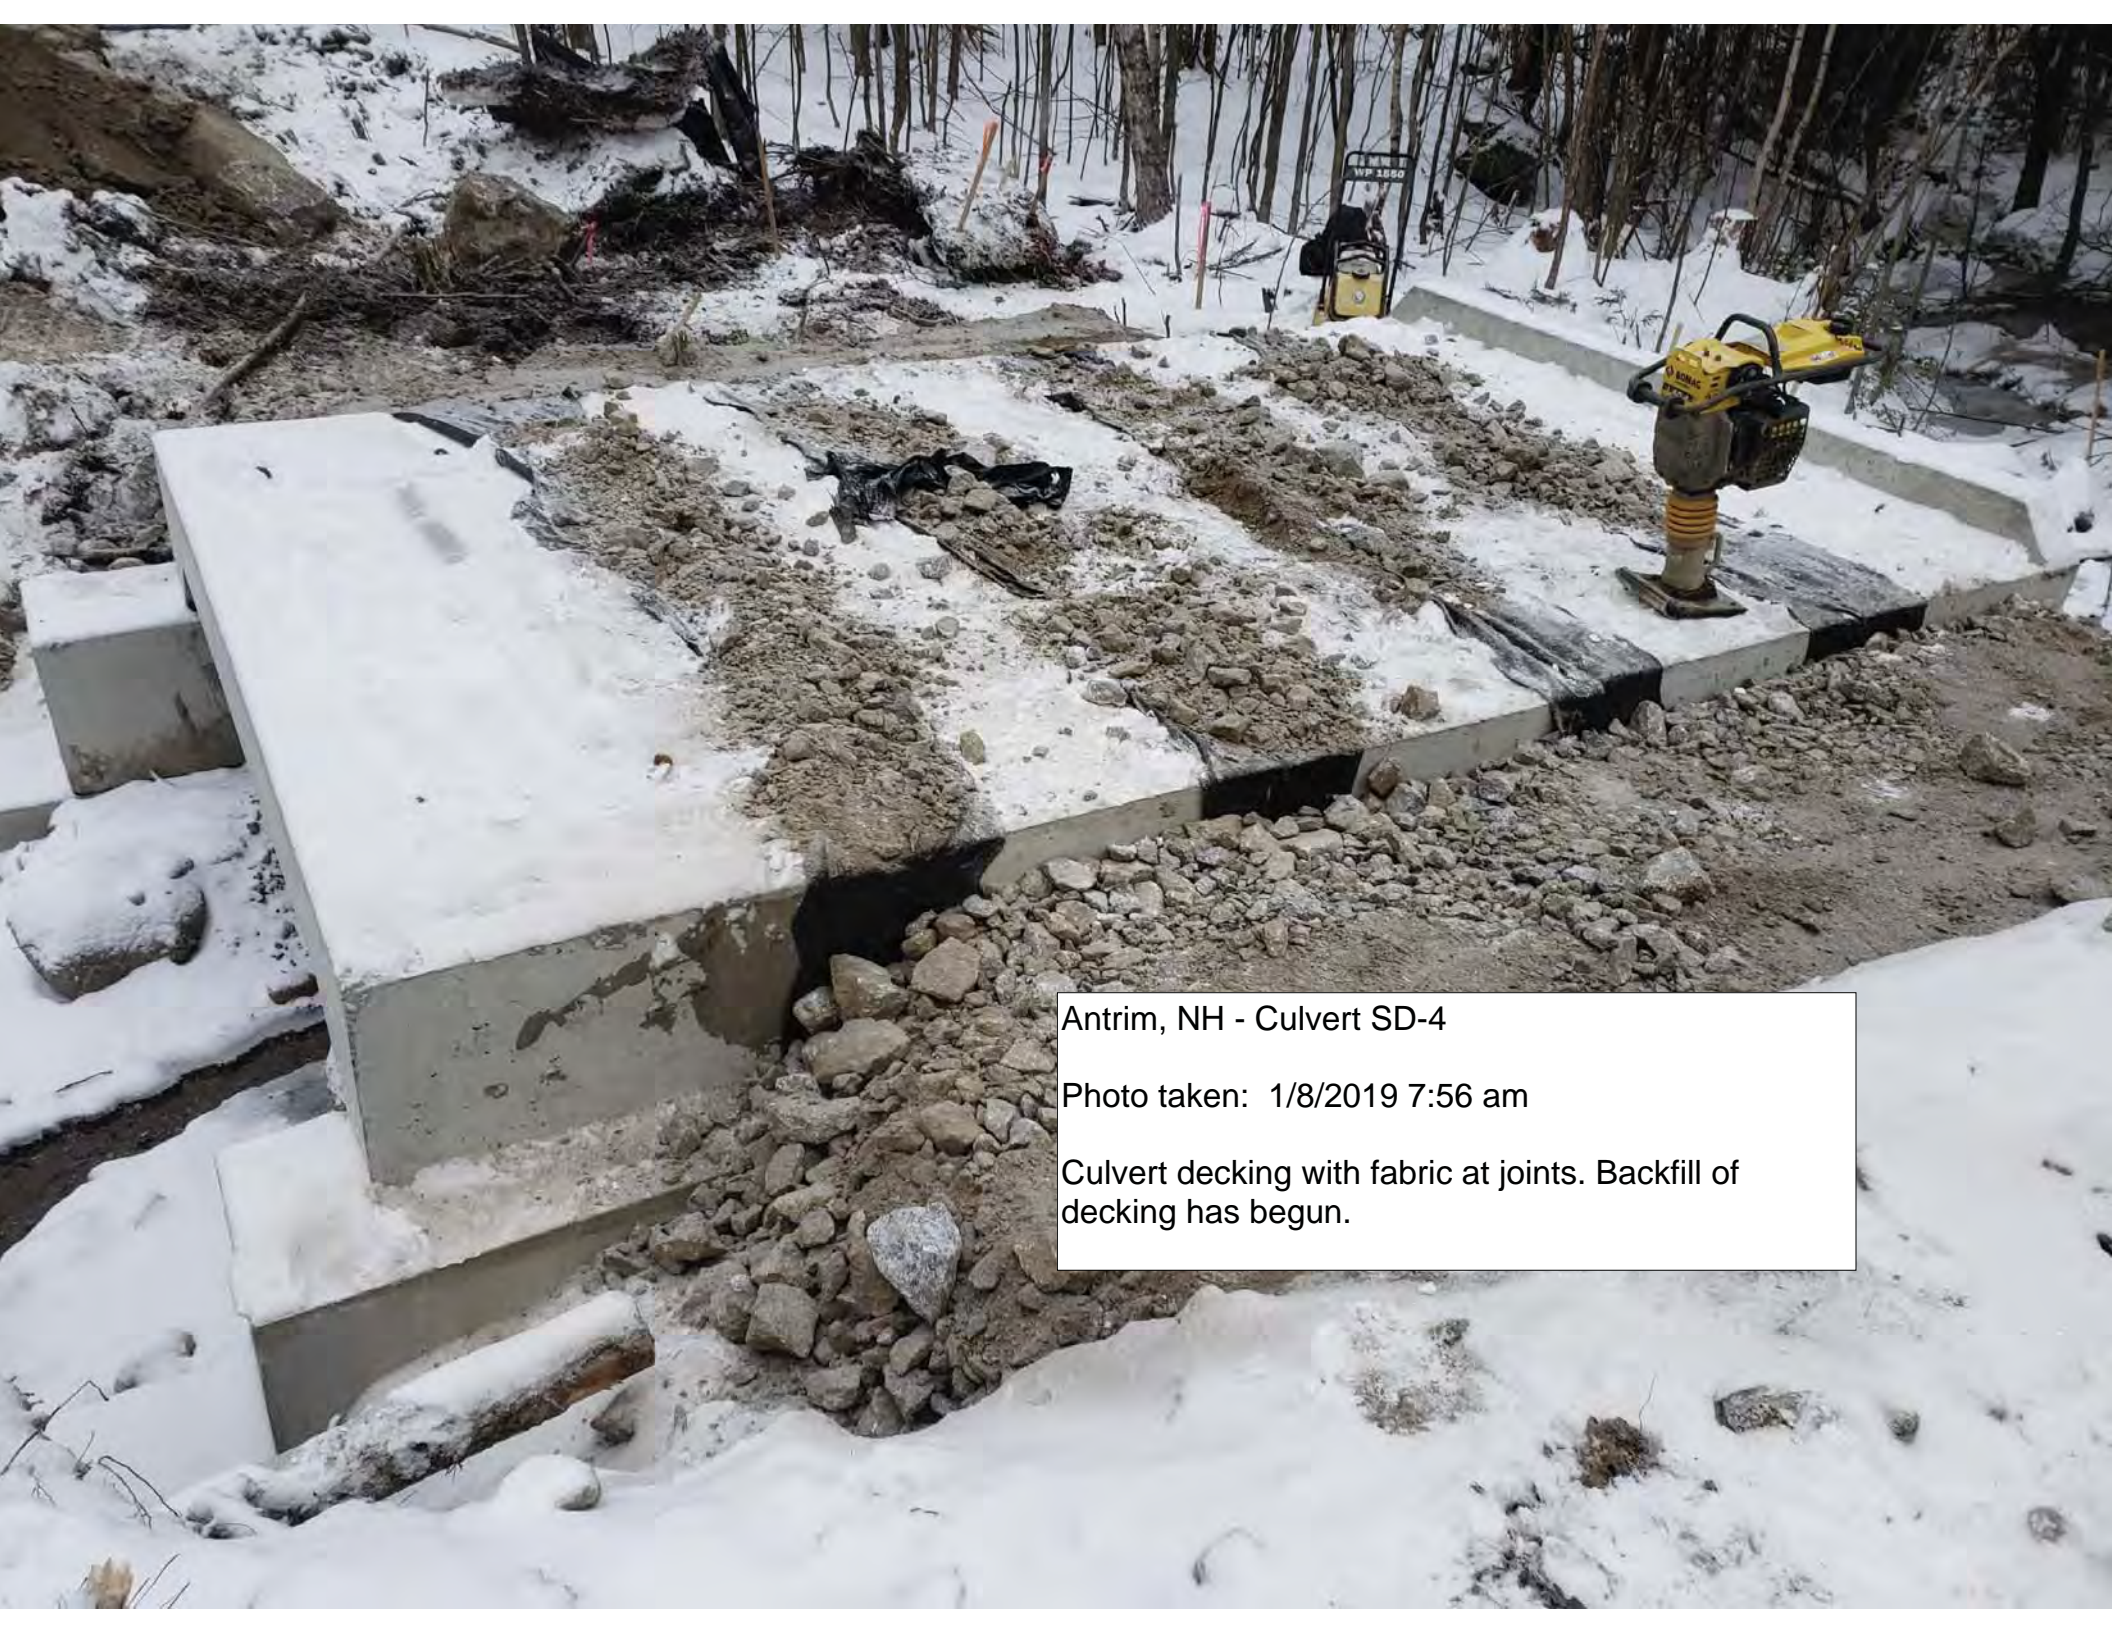
Antrim, NH - Culvert SD-4  
Photo taken: 1/7/2019 4:45 pm  
Streambedded after washing in material. Low-flow area visible.
