# Non-Conformance Report

Report No.	Date	Project
1	11/20/2018	Antrim Wind Project

Antrim NH Wind: Culvert SD-4: Box culvert stability and streambed  
Non-conformance analysis and report

Conformance Plan: SD-4 Box Culvert

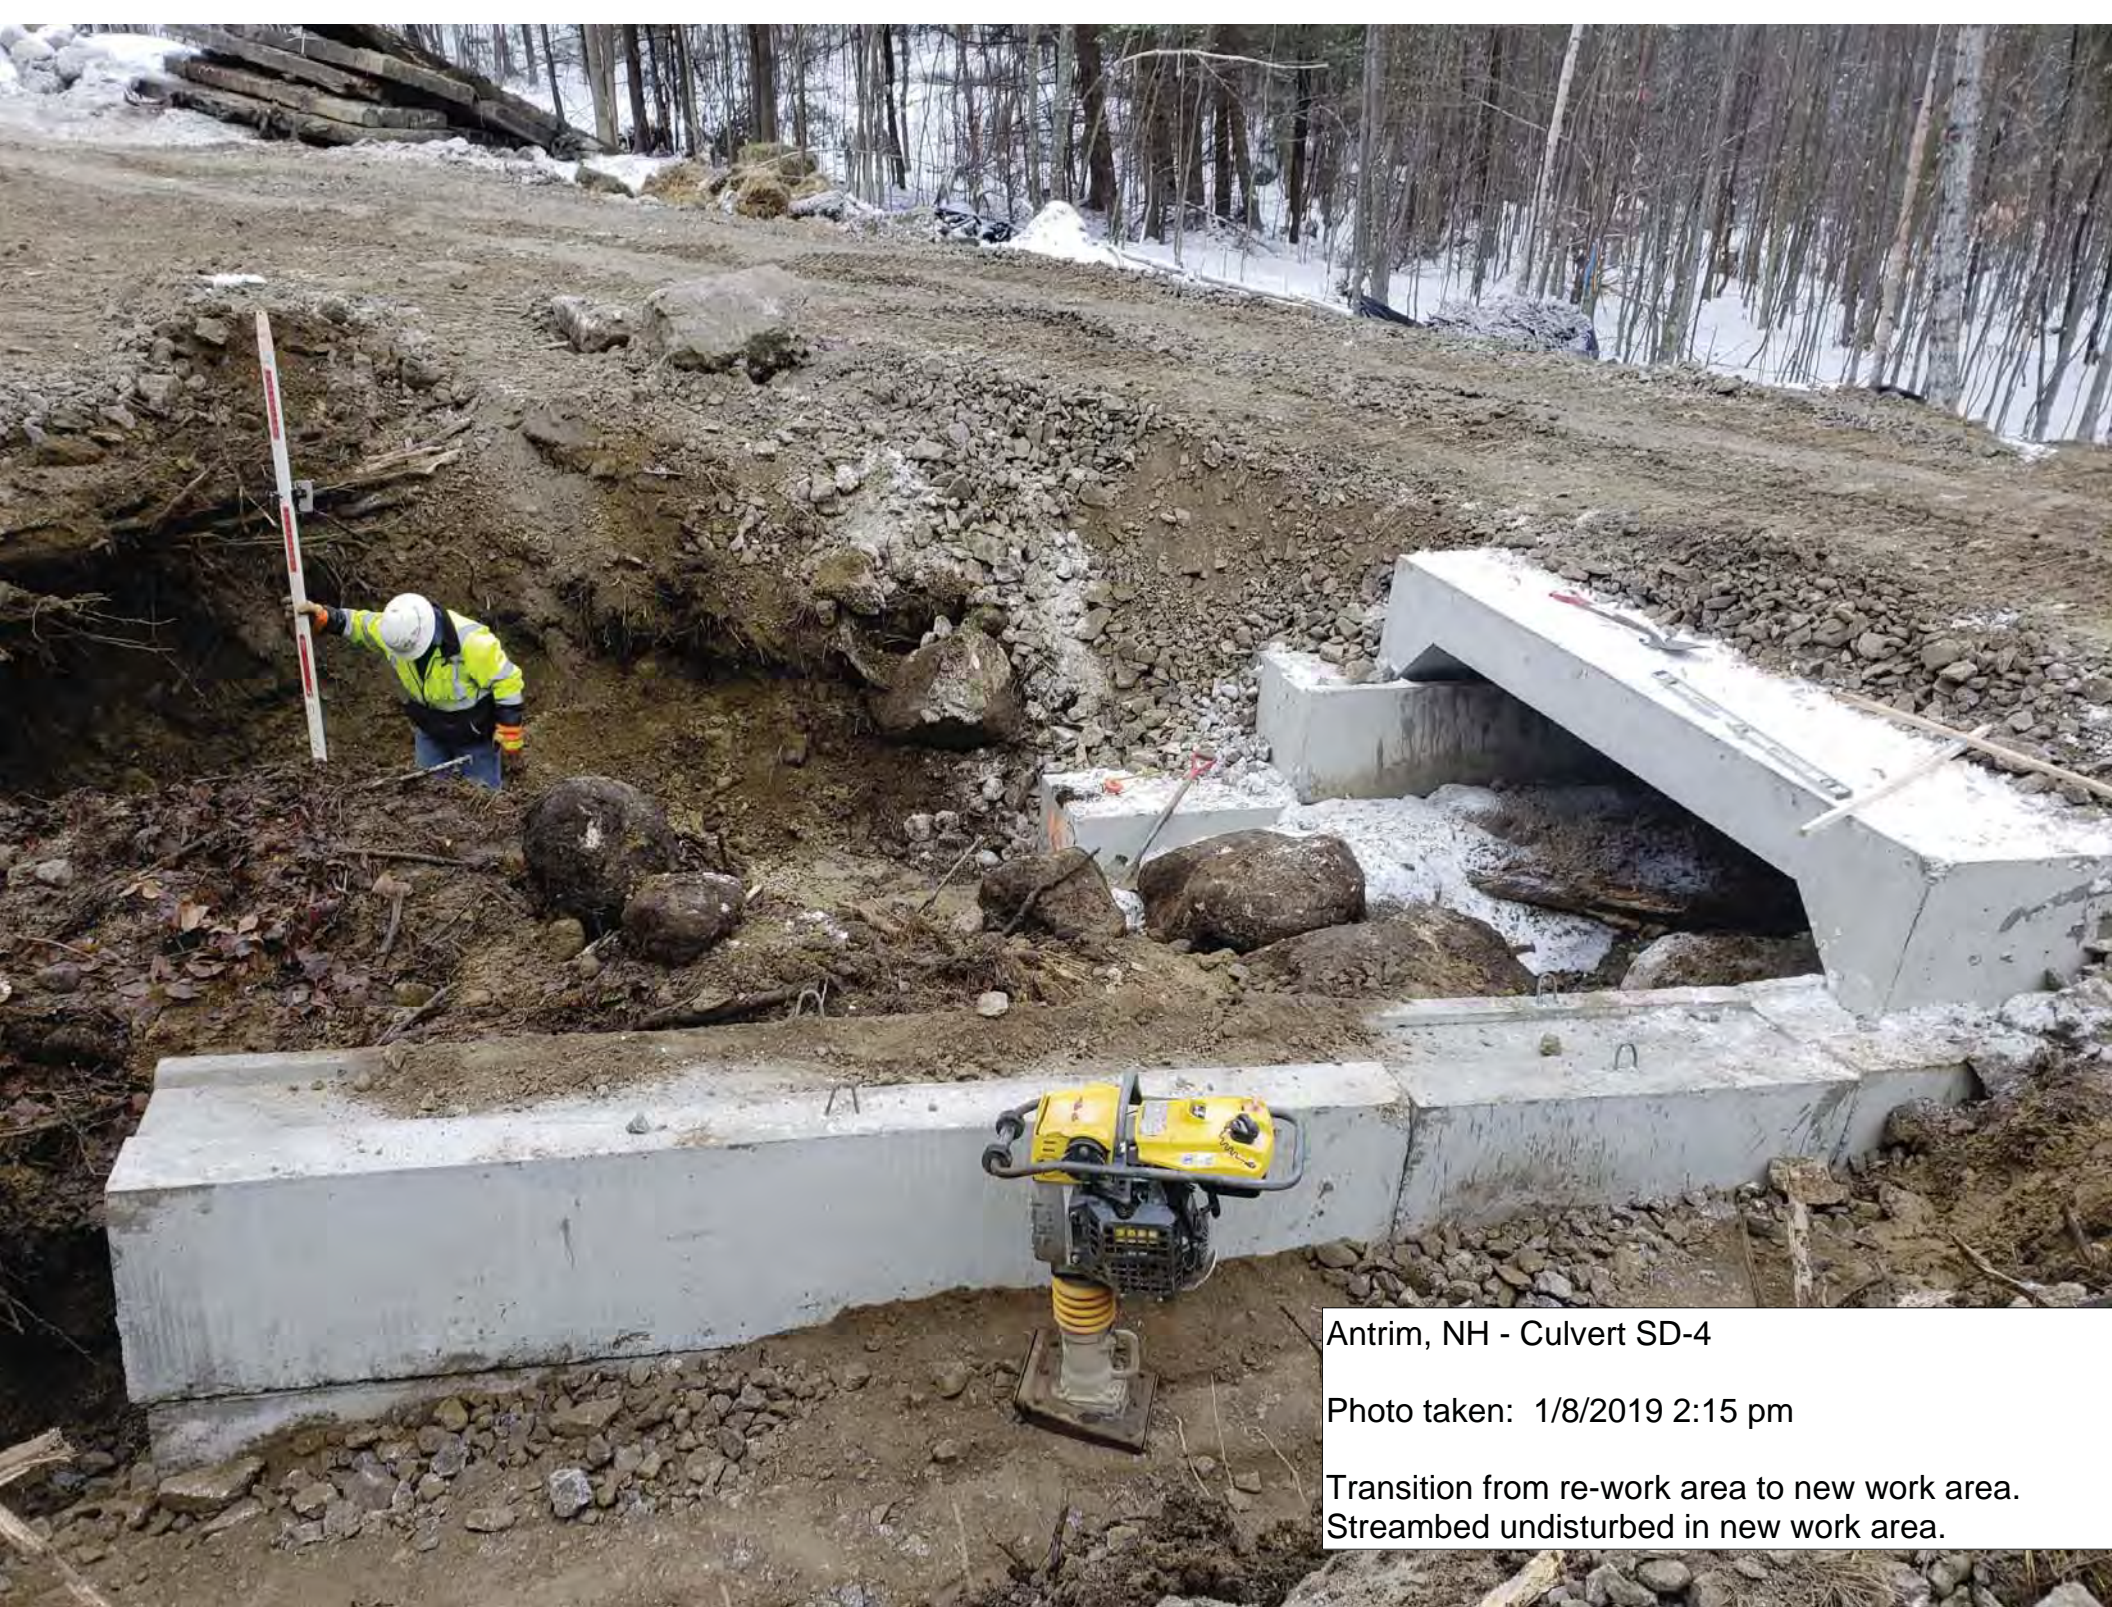
Photo taken: 1/8/2019 7:56 am

Culvert decking with fabric at joints. Backfill of decking has begun.

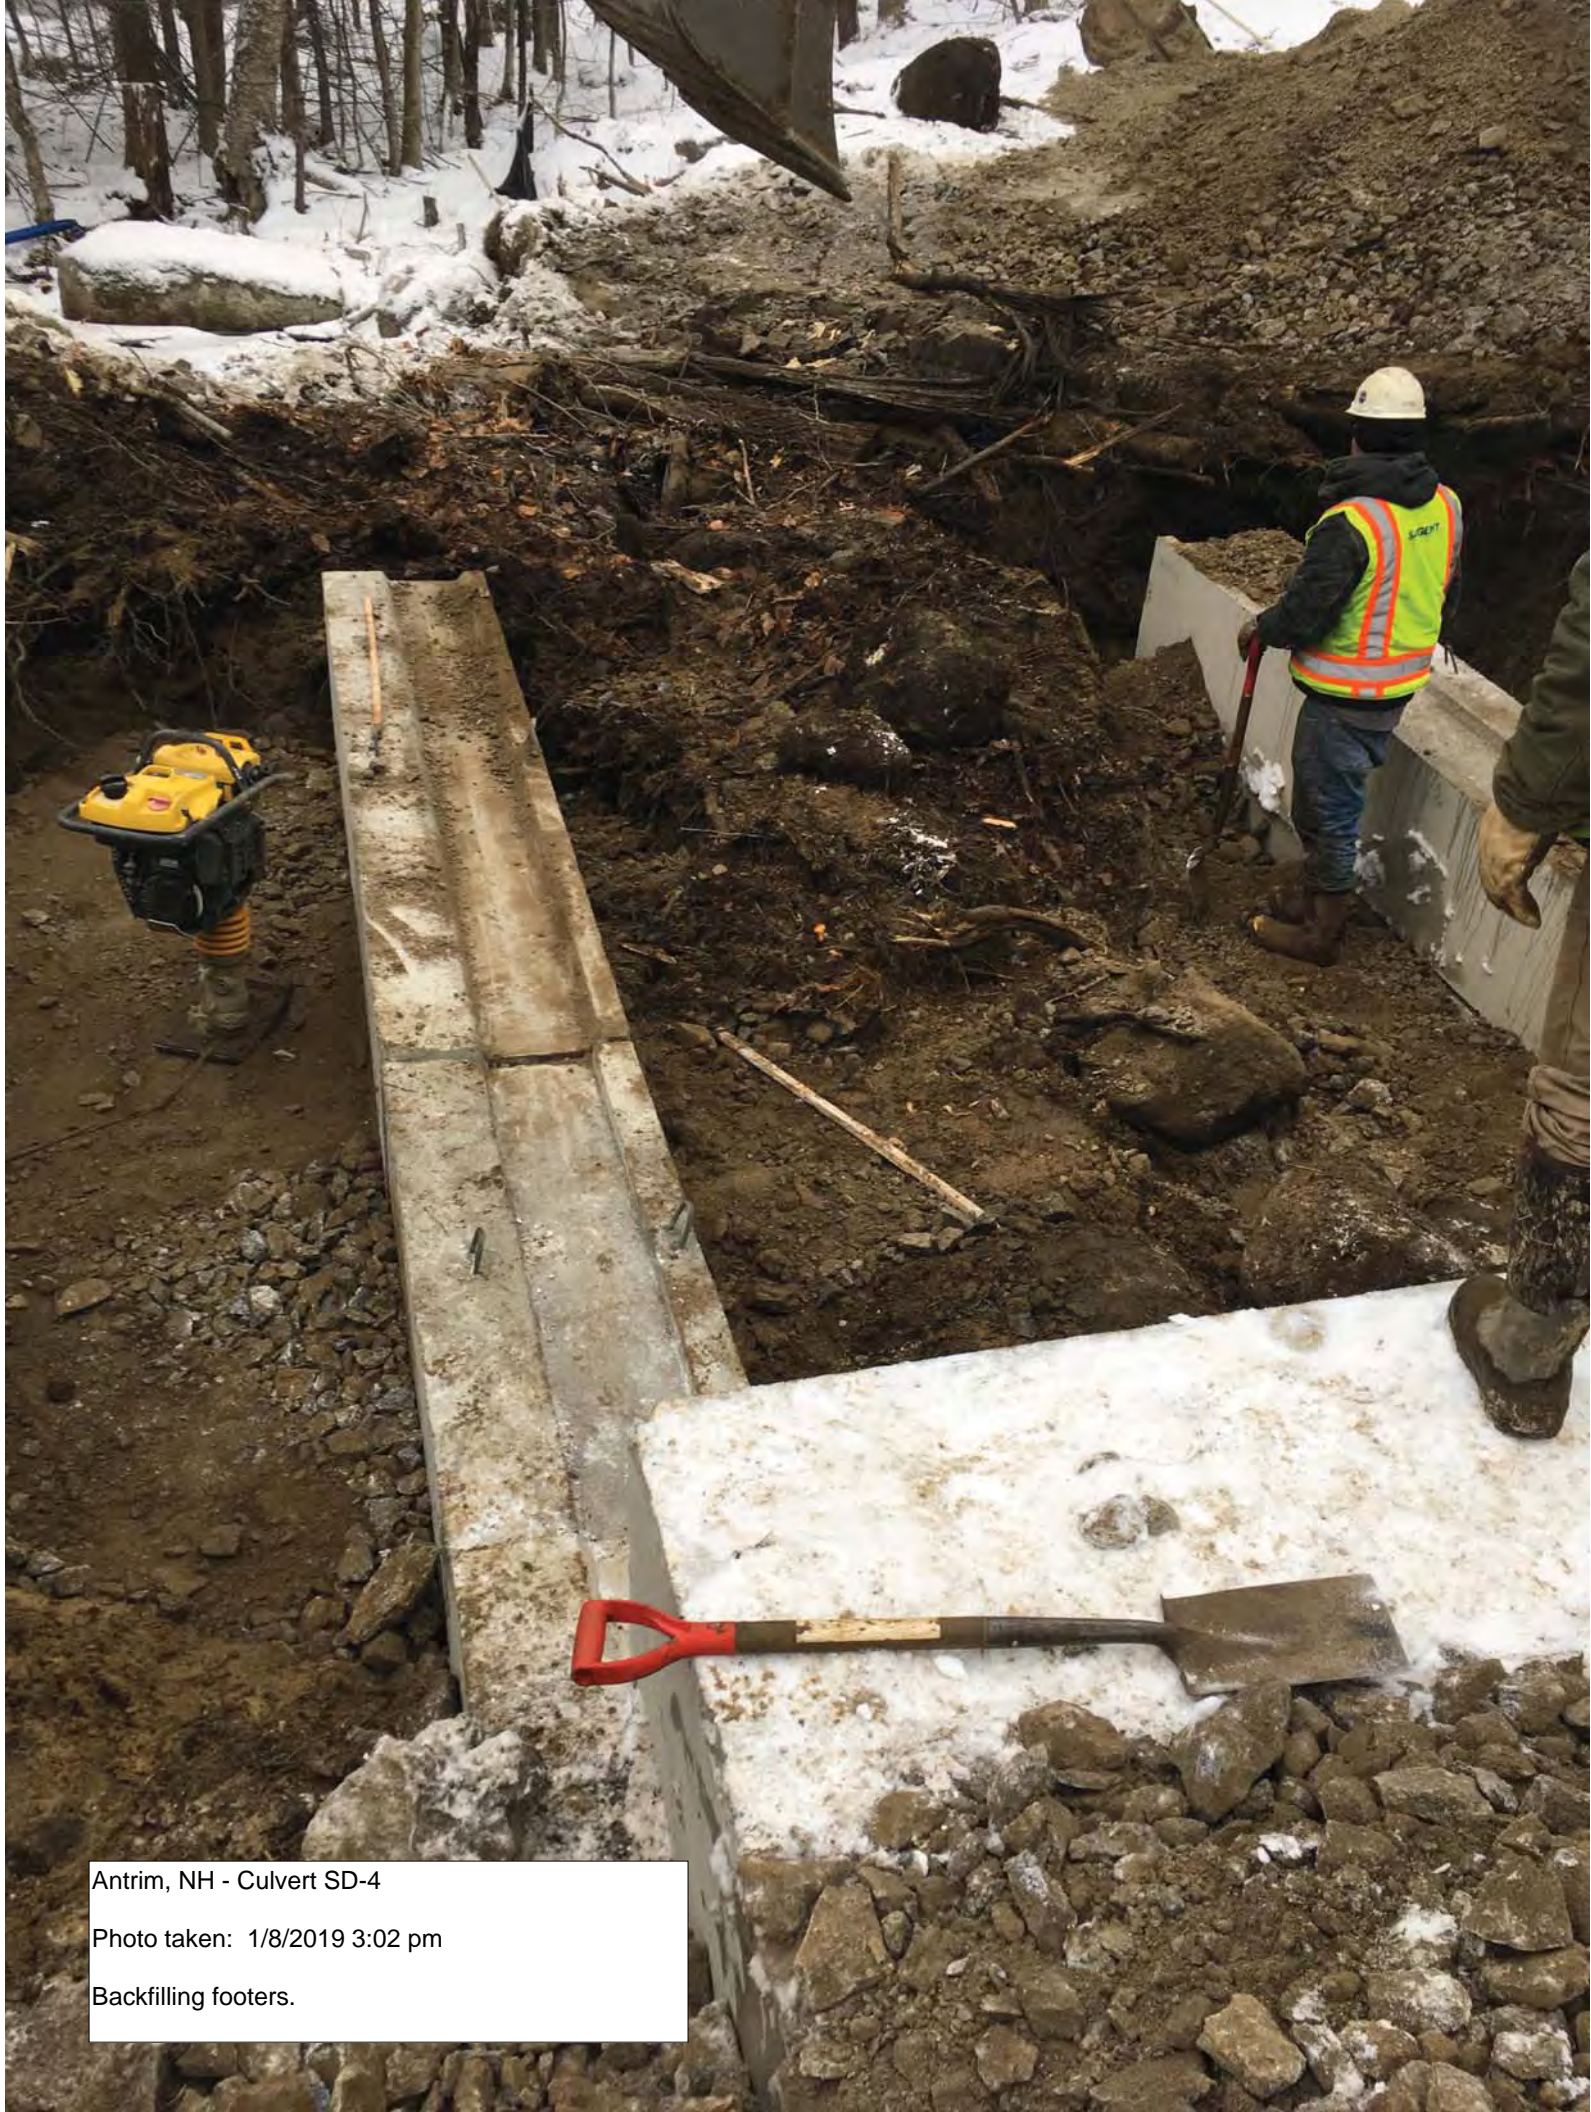
Photo taken: 1/8/2019 2:15 pm

Transition from re-work area to new work area.  
Streambed undisturbed in new work area.

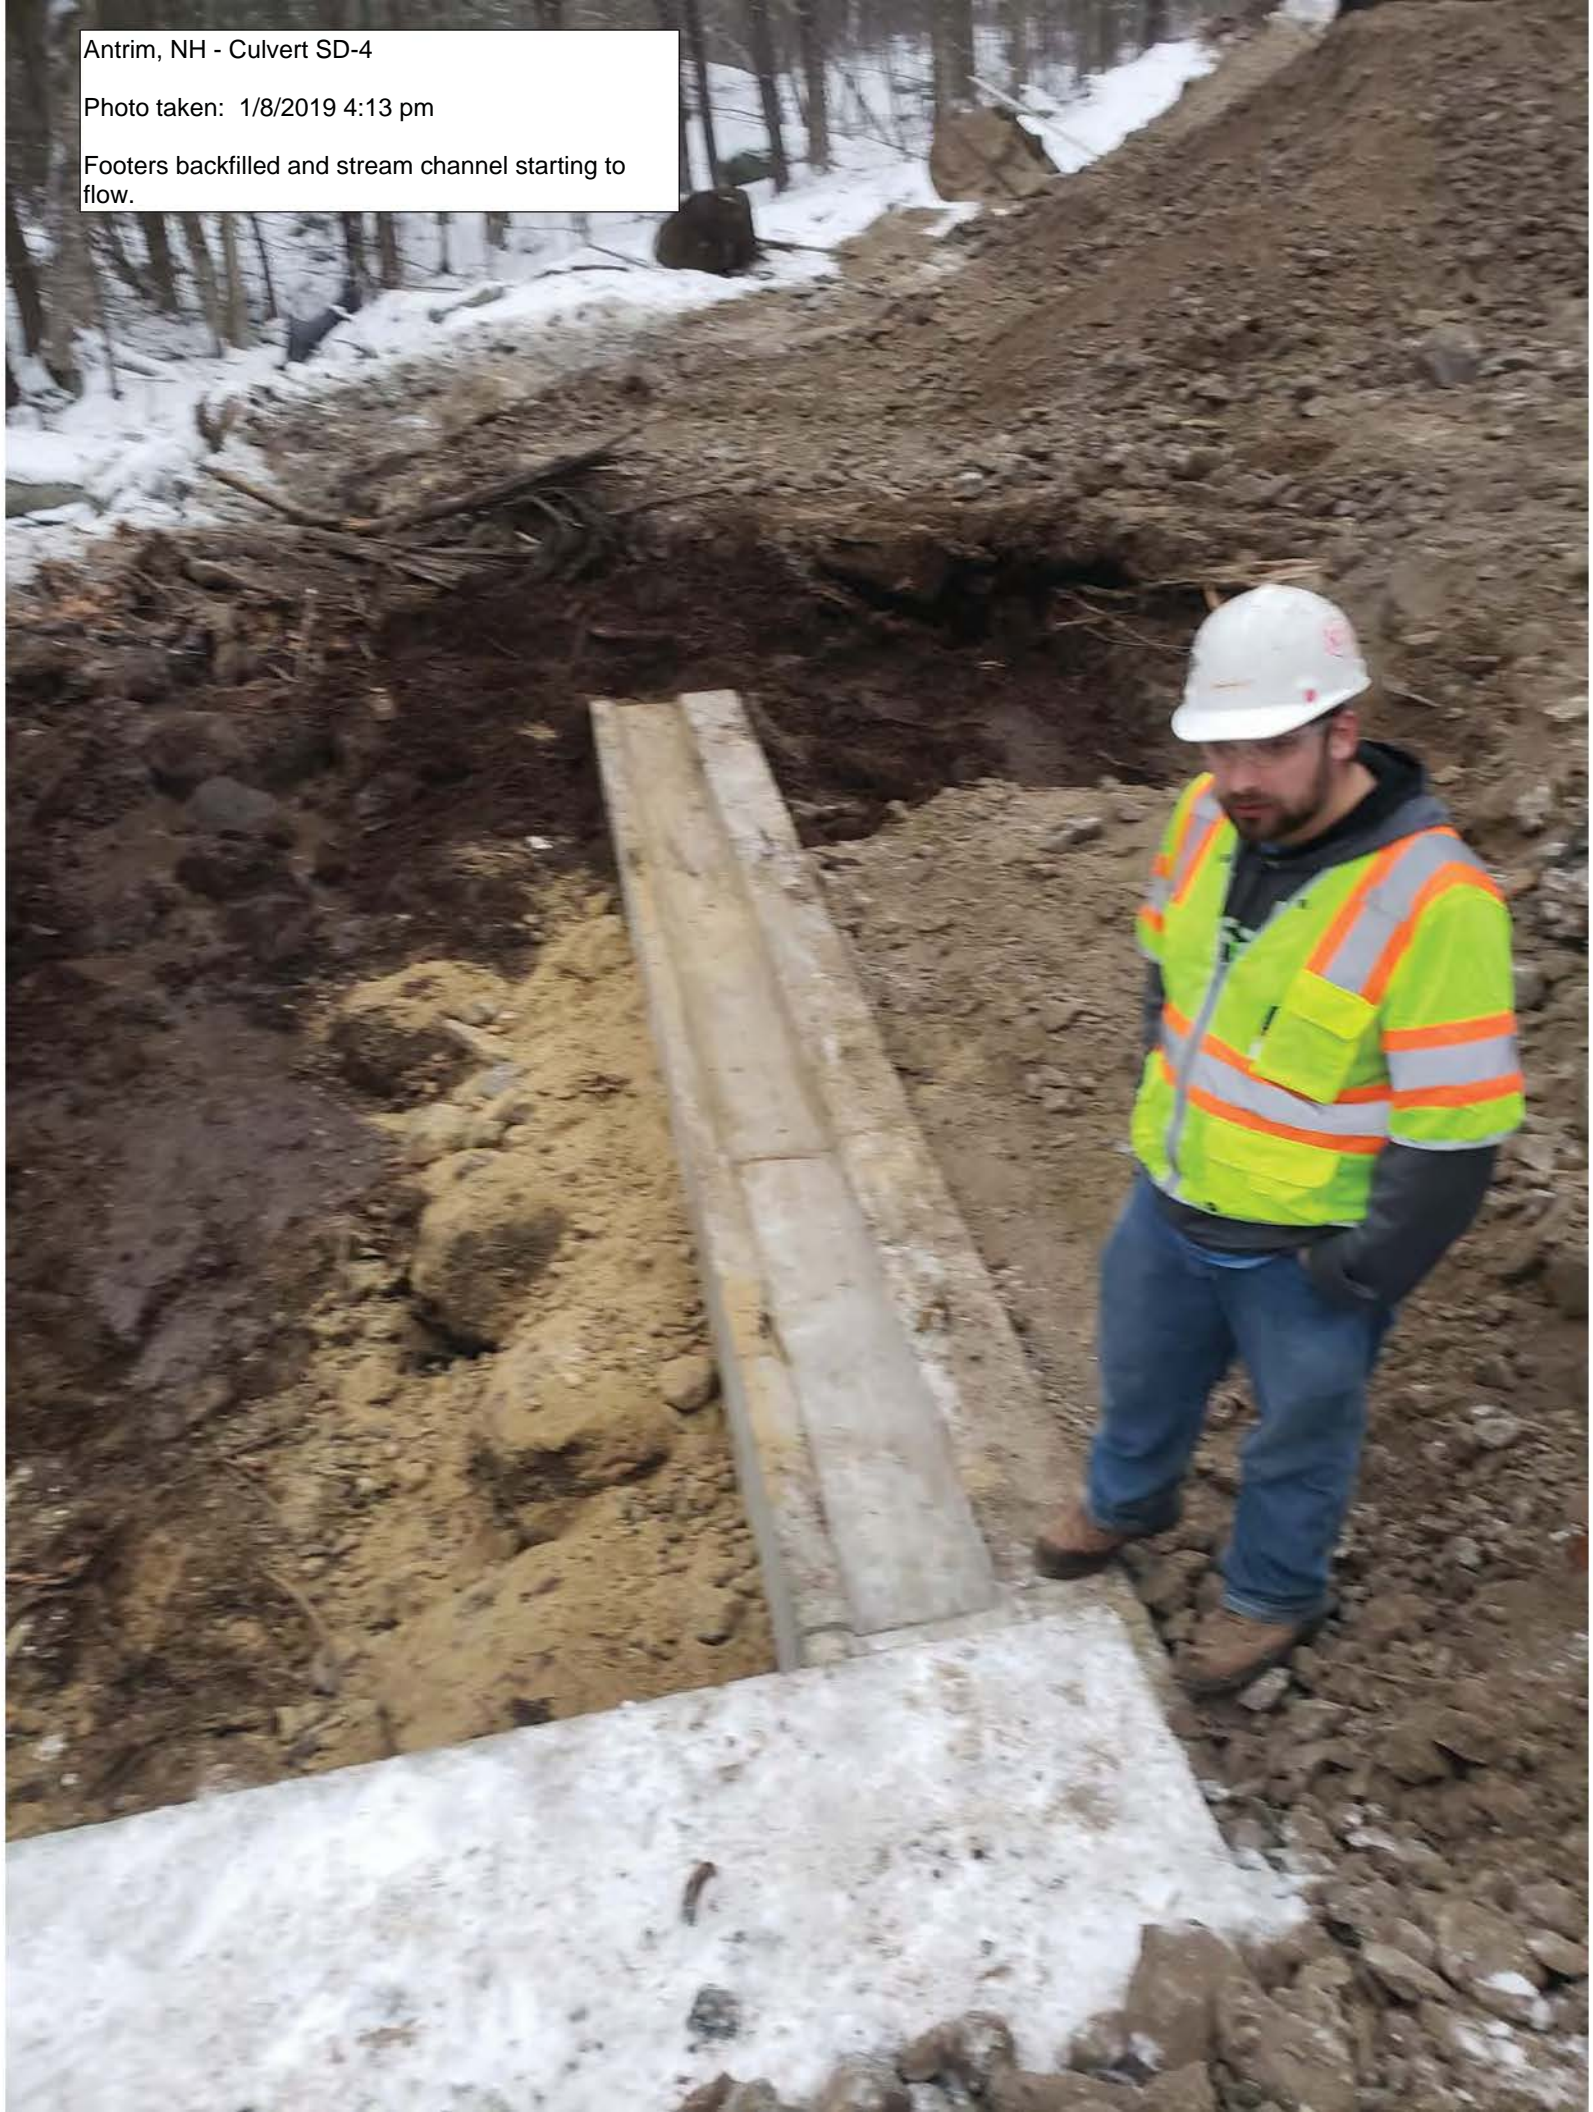
Photo taken: 1/8/2019 4:13 pm

Footers backfilled and stream channel starting to flow.

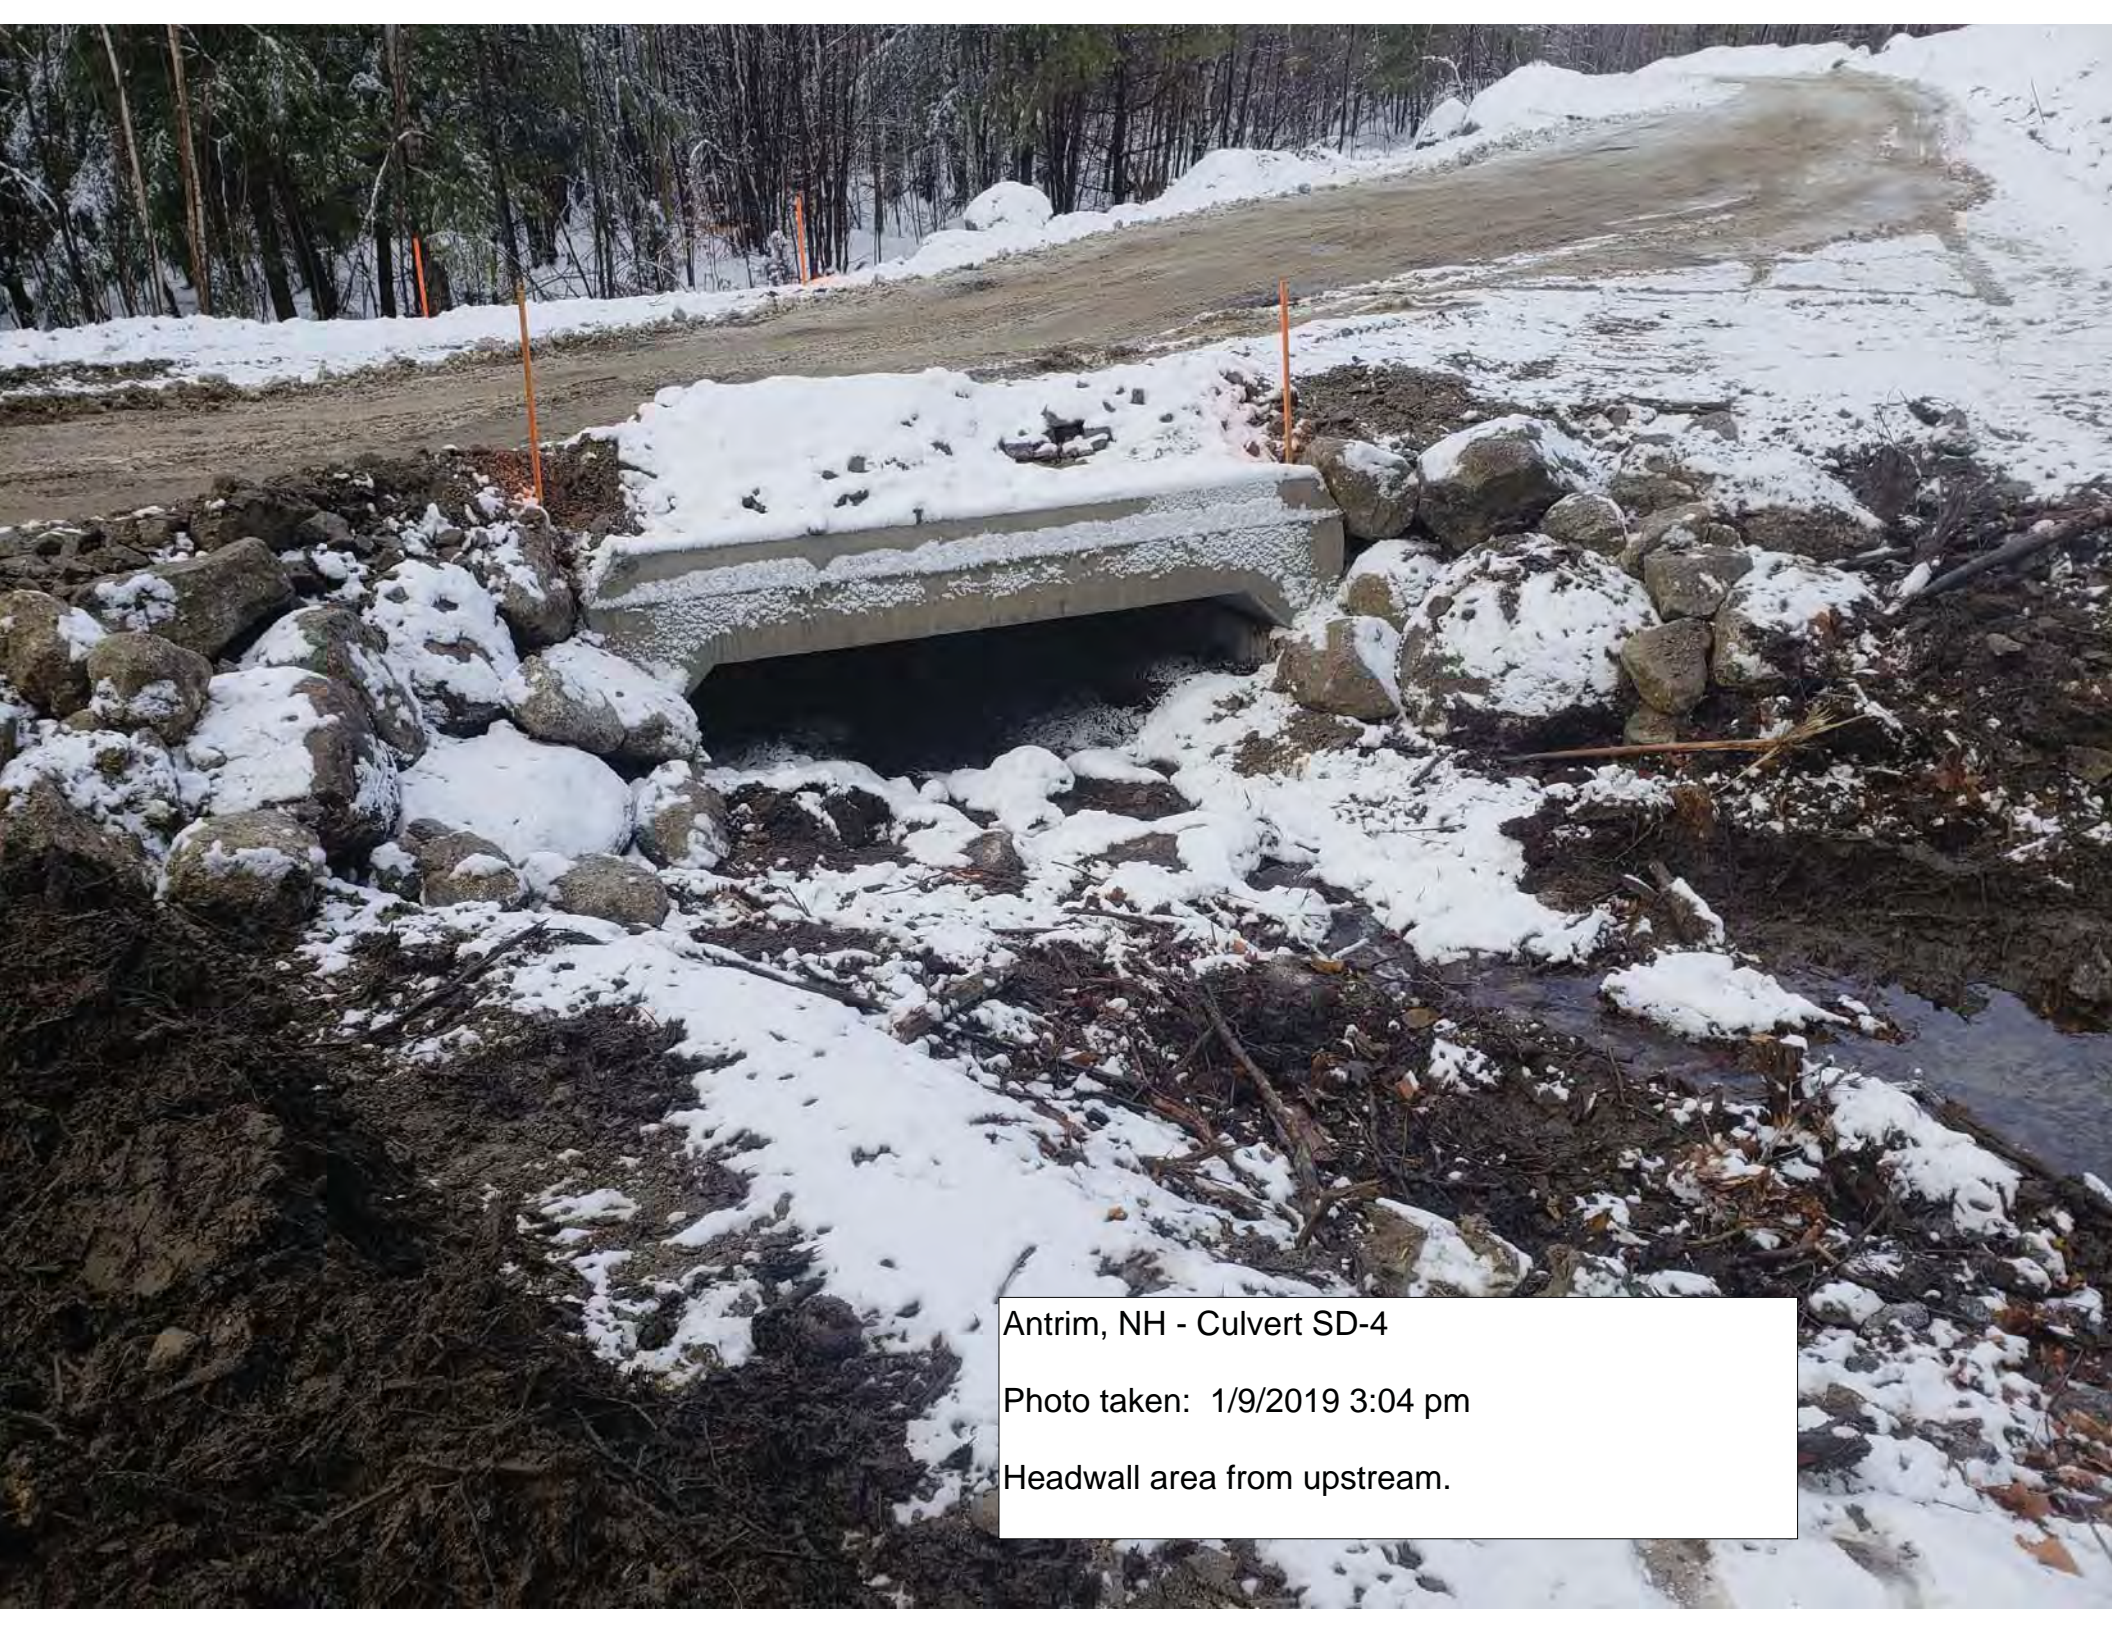
Antrim, NH - Culvert SD-4  
Photo taken: 1/8/2019 4:20 pm  
Backfilled and stream flowing.
