Spring 2019 Monitoring of SD-4 Box Culvert

Updated 6/28/2019

ANTRIM WIND PROJECT ANTRIM, NEW HAMPSHIRE

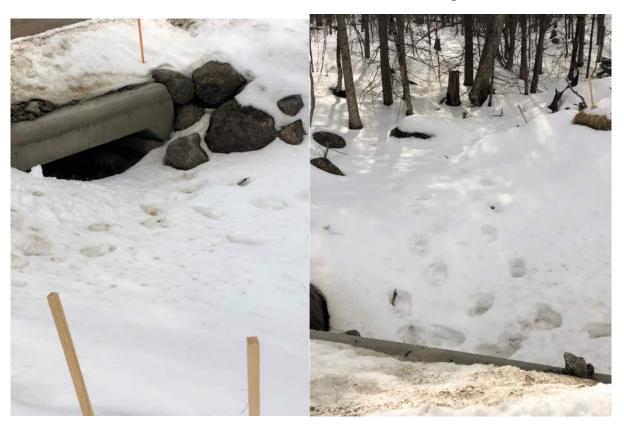
March 15, 2019:

Tim Blais: Snow covered, no visible flow but can hear water running.

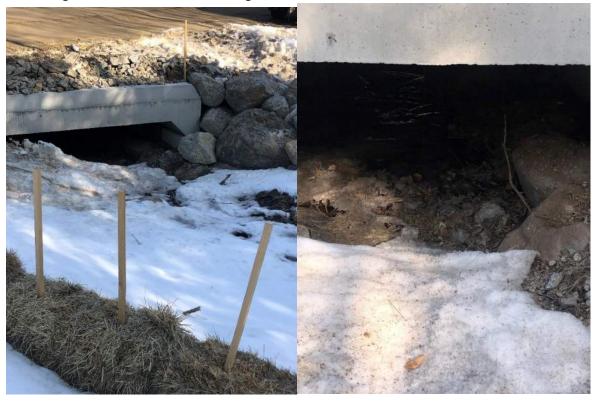
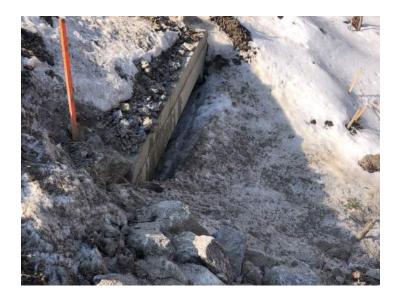
March 20, 2019

Tim Blais: No changes this week. Can here water running under ice and snow. Water visible in stream 50' downstream from bridge in the woods. Water flowing in stream bed is clear.

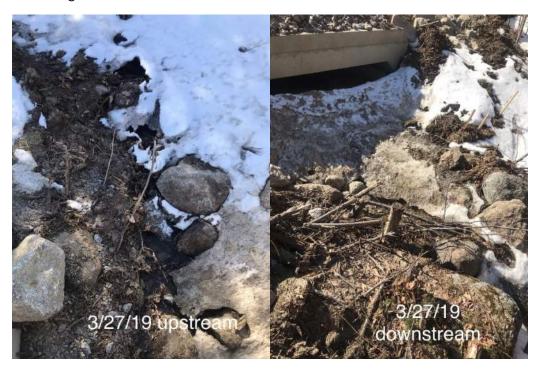
March 27, 2019

Mark Wright: water is clear.

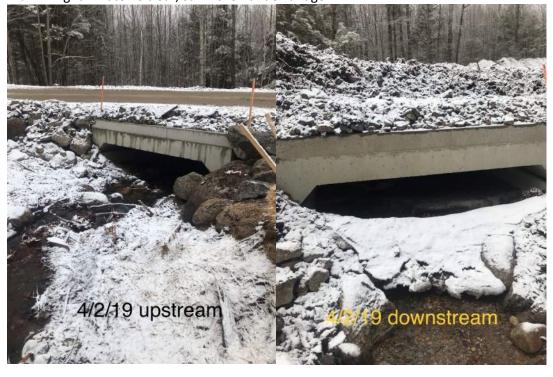
April 2, 2019:

Mark Wright: Water is clear, still frozen under bridge.

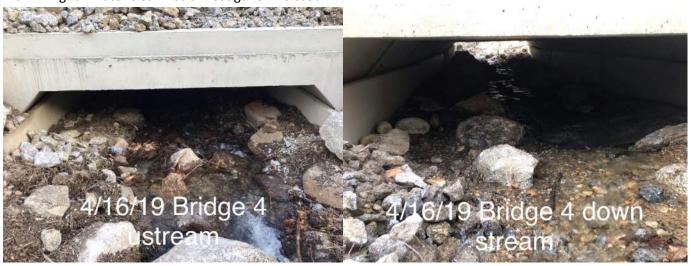
April 16, 2019:

Mark Wright: Water clear. Ice almost gone. No scour.

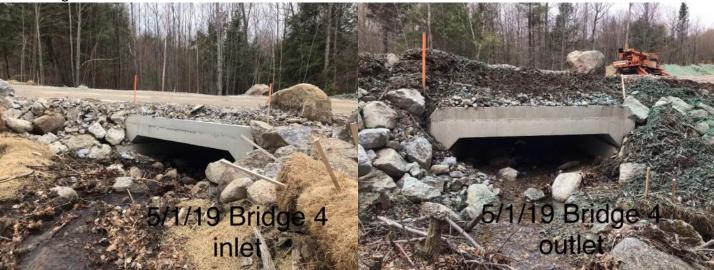
May 1, 2019:

Mark Wright: Stream bed looks natural.

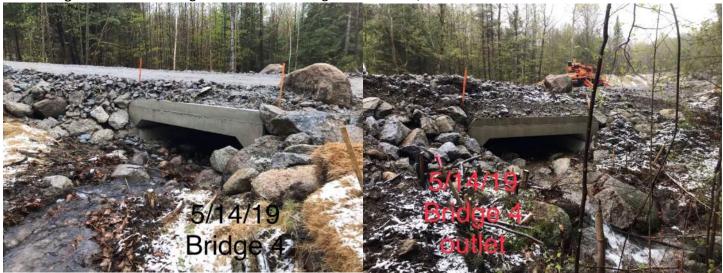
May 14, 2019:

Mark Wright: Water is running clear. Stream looking natural after 1/2-inch rainstorm.

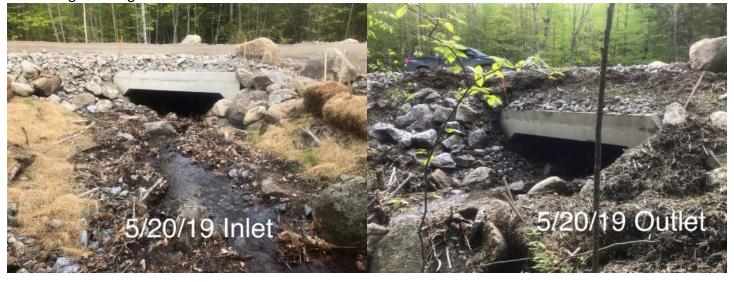
May 20, 2019:

Mark Wright: Bridge 4 is stable.

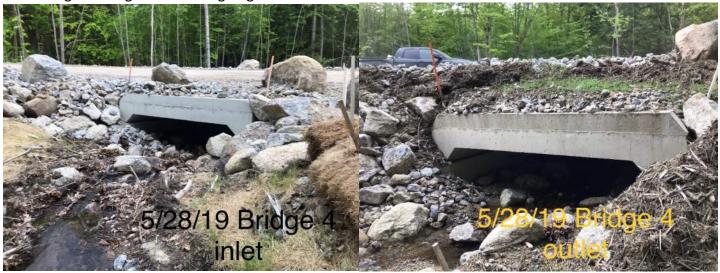
May 28, 2019:

Mark Wright: The grass is starting to grow.

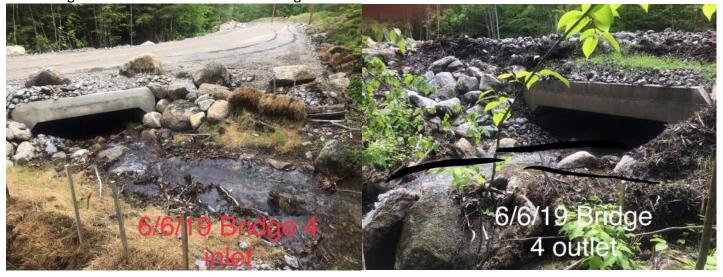
June 6, 2019:

Mark Wright: Almost 2 inches of rain overnight.
