October 21, 2019

This letter has been prepared on behalf of Antrim Wind Energy LLC (Antrim Wind) in response to your letter dated September 10, 2019 and received on September 11, 2019. In the letter, NHDES summarized their observations from a July 26, 2019 inspection at the Antrim Wind Park project. In the letter, NHDES requested the following remedial actions be taken:

## **Antrim Wind Energy Project Photographic Log**

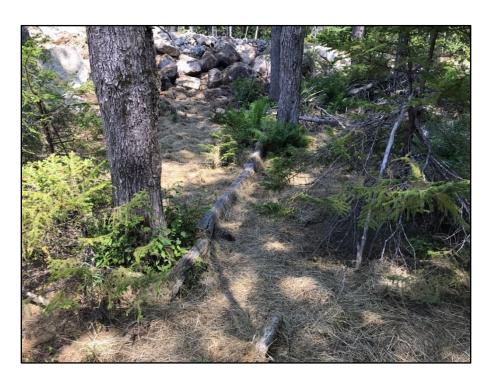
- 1. Please install appropriate permanent stabilization BMP's at the base of the rock slope adjacent to wetland AN-41 and remove any accumulated sediment which has been deposited outside of the approved impact area. NHDES believes this can be accomplished within 20 days. Please submit photos documenting compliance was achieved. NHDES believes this can be accomplished within 7 days of completing the work.

**Photo 1:** Image taken on 8/2/2019. Image showing the base of the rock slope adjacent to wetland AN-41 was stabilized with straw mulch per NHDES recommendations during 7/26/2019 inspection.

- 1. See the attached photo log which provides documentation that temporary stabilization in the form of straw mulch and seeding has been installed in the permitted wetland impact area and at the toe of the rock slope adjacent to AN-41. During the site visit on July 26, 2019, it was recommended and agreed to by NHDES that the sediment would be mulched to be stabilized and the area would be monitored for revegetation. This area was stabilized within one week of the NHDES site visit as demonstrated in the inspection report completed on August 2, 2019.

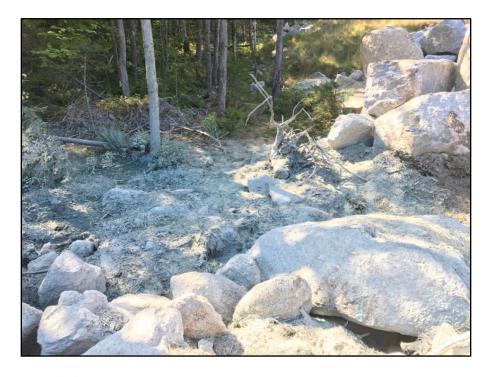
**Photo 2:** Image taken on 8/28/2019. Image showing the base of the rock slope adjacent to wetland AN-41 was hydroseeded prior to the inspection on 8/28/2019.

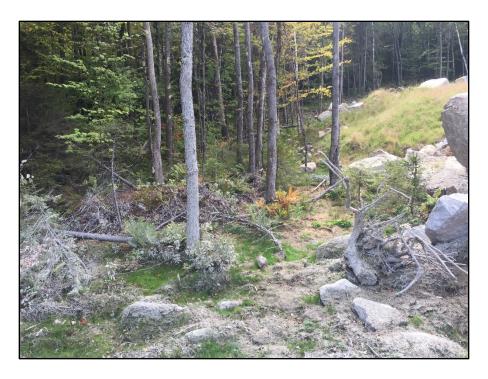
**Photo 3:** Image taken on 9/26/2019. Image showing revegetation progress at the base of the rock slope adjacent to wetland AN-41.

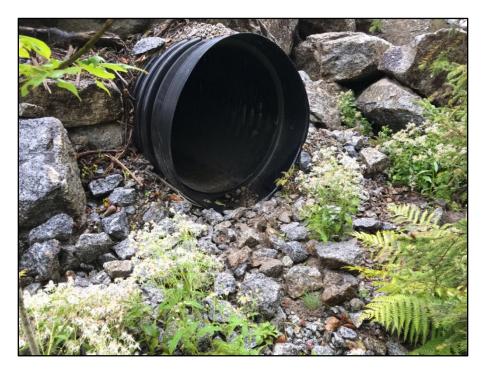
- 2. Within 20 days of the date of this letter provide DES with a plan for review, to re-establish the hydrology through culvert SD-26 to alleviate perched conditions at the inlet.

**Photo 4:** Image taken on 9/12/2019. Image showing fill and small diameter blast rock has been added to raise the elevation of the ground upstream of the inlet at culvert SD-26, alleviating the perched condition of the culvert inlet. Corrective actions to address perched conditions were taken prior to receipt of the letter from NHDES dated 9/10/2019.

- 2. The earthwork contractor has added fill and small diameter blast rock to raise the elevation of the ground upstream of the inlet, alleviating the perched condition of the culvert inlet. See attached photo log for documentation. This work had been completed as a response to comments made by NHDES staff during the July 26, 2019, site inspection and was completed prior to receipt of the September 10, 2019, letter requesting remedial actions.
