DRAINAGE MONITORING REPORT

F107 - Seacoast Reliability Project

Newington, New Hampshire

04.0190967.00

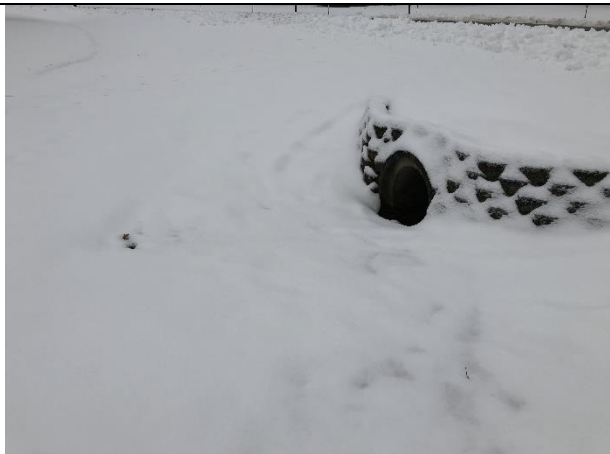
29 Gundalow - 1 (Drainage Area)

Observations/Notes: Soil frozen with approx. 2" of accumulated ice and snow cover.

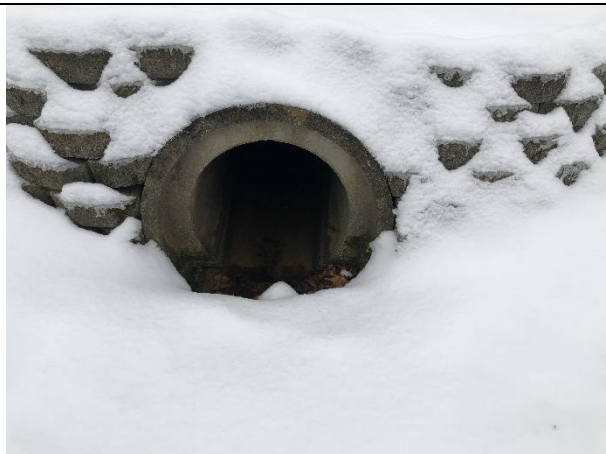
29 Gundalow - 2 (Culvert)

Observations/Notes: Water at culvert inlet, approx. max depth 2.0".

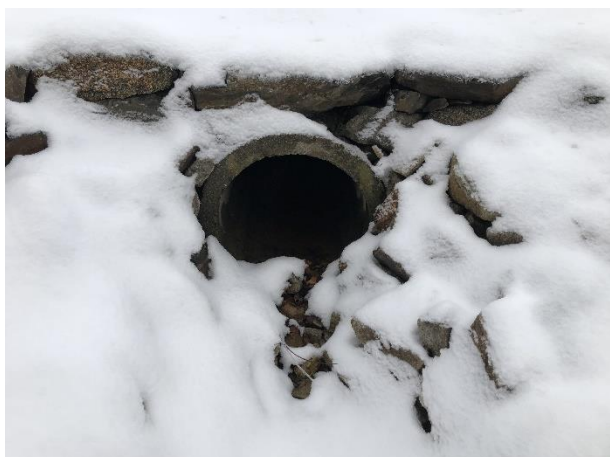
64 Gundalow - 1 (Drainage Course)

Observations/Notes: Small amount of water draining from culvert, approx. depth 1". Water in culvert observed to be cloudy with floating sheen (fine suspended solids).

- Sediment continues to be observed within culvert at 64 Gundalow – 1.

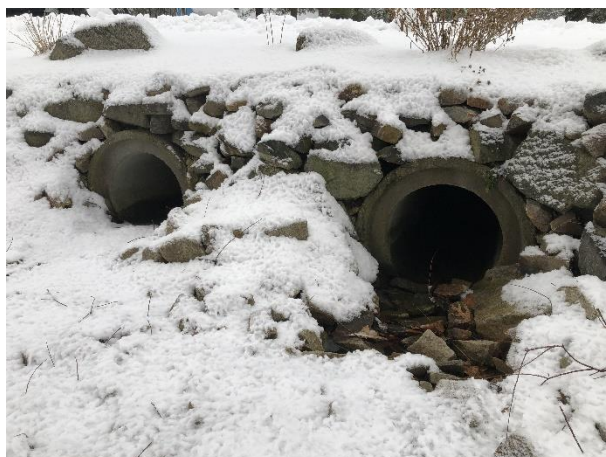
64 Gundalow - 2 (Drainage Course)

Observations/Notes: Area of water in front of culvert inlets, approx. max depth 3.5".

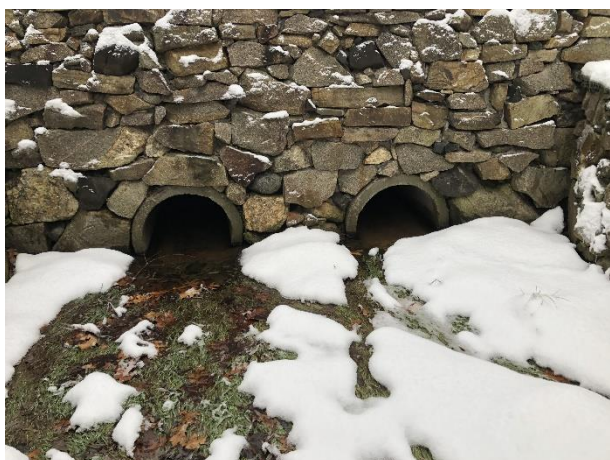
4 Brickyard Circle - 1 (Drainage Course)

Observations/Notes: Area of water adjacent to culvert outlets. Approx. max depth 6.0".

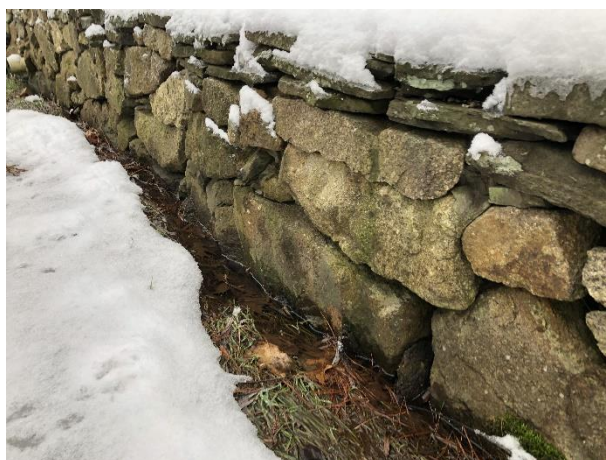
4 Brickyard Circle - 1 (Drainage Course)

Observations/Notes: Area of water adjacent to south wall of raceway, max depth approx. 2.0 x".

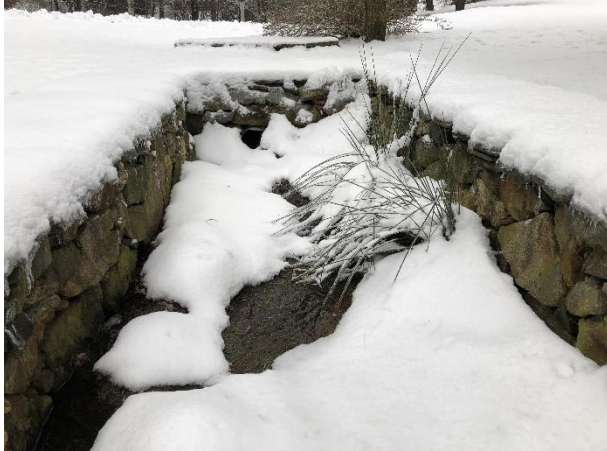
4 Brickyard Circle – 3 (Drainage Course)

Observations/Notes: Area of water in center of raceway, max depth approx. 3.0".

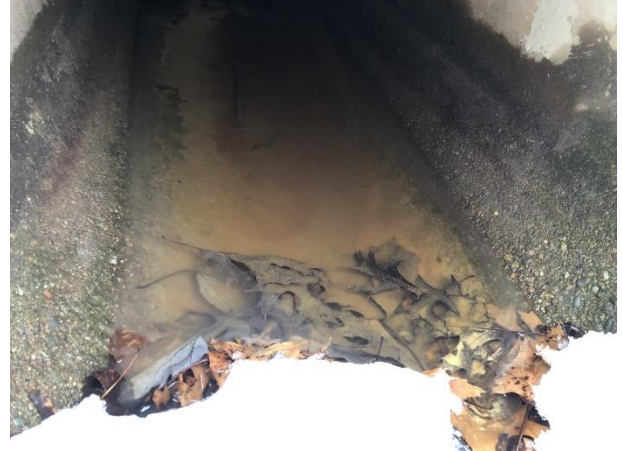
Film on water surface at 64 Gundalow – 1 culvert.
