# **CONSTRUCTION MONITORING REPORT**

Eversource Transmission Lines: F107

### Construction Monitoring Report #6

Eversource Seacoast Reliability Project

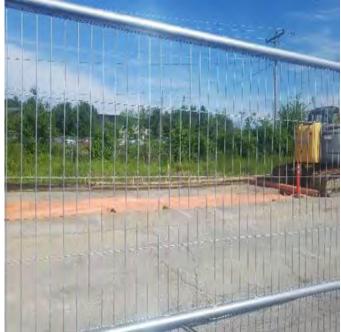
Fig 1: McCourt continues to trench and assemble duct bank in A lot. They laid filter fabric over the exposed trench to prevent water from running through. Viewing southeast. (6-10-19)

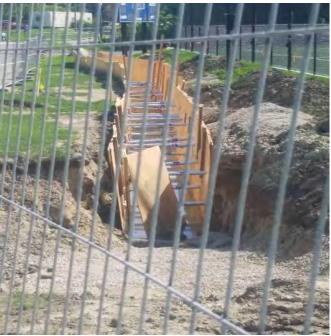
Fig 2: Water is still present in the trench near the rain garden, along Colovos Rd. Viewing south. (6-10-19).

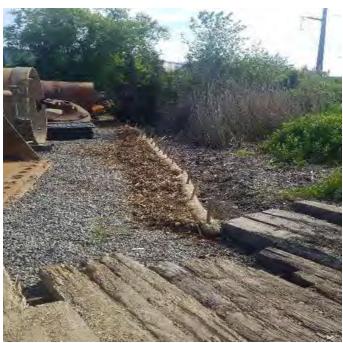
Fig 3: Combined berm installed around lay down area off of Gosling Rd. Viewing south. (6-10-19).

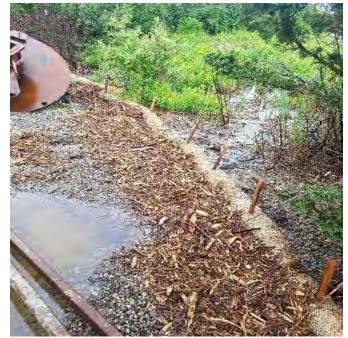
- Straw waddle installed around the lay down area off of Gosling Rd may need to be staked in more. The stakes are somewhat loose to the touch and in a serious rain event they could come loose and break apart. The waddles are a part of a combined berm installed next to/on the slope of the gravel lay down yard, see photos 4 & 5 below. Sam Eames has been notified of this corrective action.

Fig 4: Combined berm installed around lay down yard cont. Viewing south. (6-11-19).

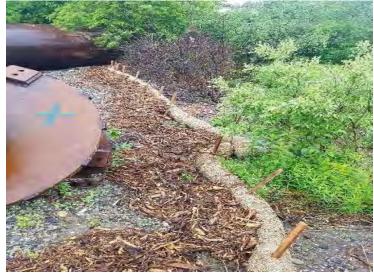
Fig 5: Combined berm installed around lay down yard cont. Viewing south. (6-11-19).

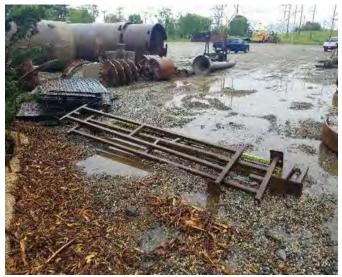
Fig 6: Combined berm installed around the lay down yard cont. Viewing northeast. (6-11-19).

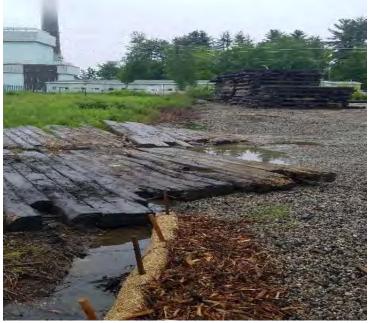
Fig 7: Combined berm installed around the lay down yard cont. Viewing north. (6-11-19).

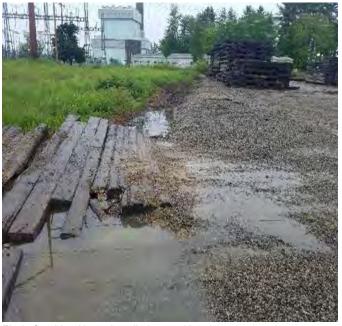
Fig 8: Combined berm installed around lay down yard, notice the water Runoff underneath the matting. Viewing north. (6-11-19).

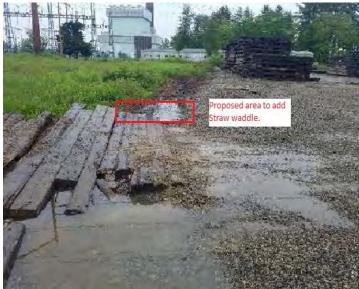
Fig 9: Proposed area in lay down yard to add straw bales, this would help filter The runoff water that channels under the timber matting. Viewing north. (6-11-19). Fig 10: Straw bales installed correctly between Str. F107-139 and NW37. Viewing north. (6-11-19).

- It has been recommended that additional BMPs be installed in one area of the lay down yard, see photo 9.
  - McCourt installed a temporary water diversion system in A lot to direct the water over their trench, see photos 13 & 14.

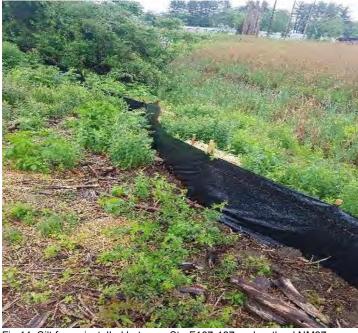
Fig 11: Silt fence installed between Str. F107-137 and wetland NM37, no maintenance needed. Viewing east. (6-11-19).

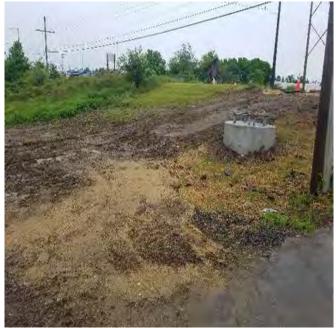
Fig 12: Foundation for Str. F107-136. A utility crew working along Woodbury Ave has excavated through the area that our crew finished and mulched with straw. There is now exposed soil in that area. (6-11-19).

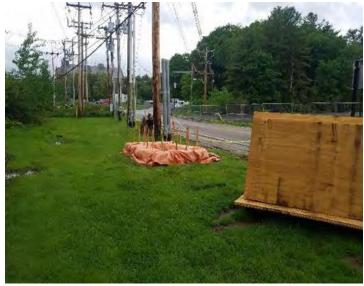
- BMPs
  - McCourt installed a dewatering discharge BMP structure next to Colovos Rd, north of College Brook. I did not see a filter bag installed as had been discussed; this bag is on order. The BMP structure may need to be built larger when the crew begins to pump water into the filter bag encased within the BMP structure.

Fig 13: The dewatering discharge BMP basin the McCourt installed for the trench dewatering activities next to Colovos Rd. Viewing south. (6-11-19).

Due to the sediment discharge incident that accrued on 06/03/19, McCourt installed a dewatering apparatus
next to their trenching activities north of College Brook (06/11/19). The BMP that they installed consisted of
straw bales staked to the ground with filter fabric draped overtop of the bales creating a basin inside the
bales, see photos 13 & 14. The dewatering structure looks great except that there isn't a filter bag installed
yet, and the basin needs to be expanded in order to fit the filter bag inside once they start pumping water out
of the trench.

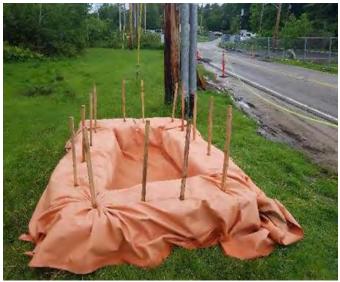
Fig 14: The dewatering discharge basin next to Colovos Rd. The BMP structure will need to be expanded to encase the filter bag. Viewing south. (6-11-19).

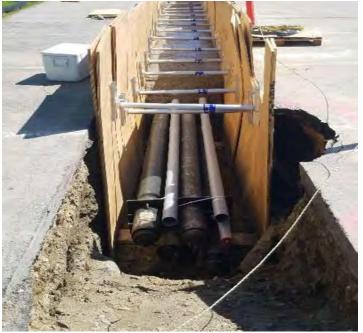
Fig 15: McCourt began to pour concrete duct bank over installed pipe in A lot. Viewing south. (6-12-19)

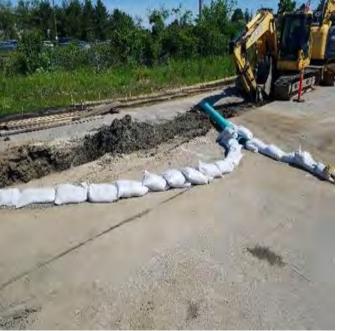
Fig 16: McCourt's temporary water diversion plan; diverting water run off over their trench. Located in the low area in A lot. Viewing southeast. (6-12-19)

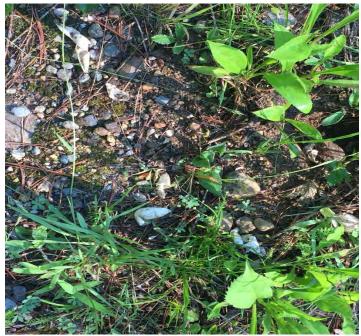
- Crews did not work at UNH Friday June 7<sup>th</sup> due to the Special Olympics event at UNH.
- The Doucet crew spotted a painted turtle and a predated turtle nest while working off of Durham point Rd, across from driveway 283. See photos 17 & 18.

Fig 17: Predated turtle nest the Doucet crew reported off of Durham Point Rd. (6-12-19).

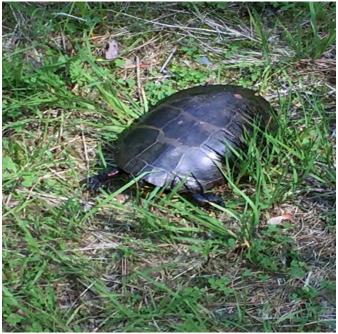
Fig 18: Painted turtle the Doucet crew reported near Durham Point Rd. (6-12-19).
