### CONSTRUCTION MONITORING REPORT

Eversource Transmission Lines:  
**F107**

**TYPE OF INSPECTION:**     Weekly     Storm Event     Incident     Corrective Action

NAI Project No:  
**23840.39**

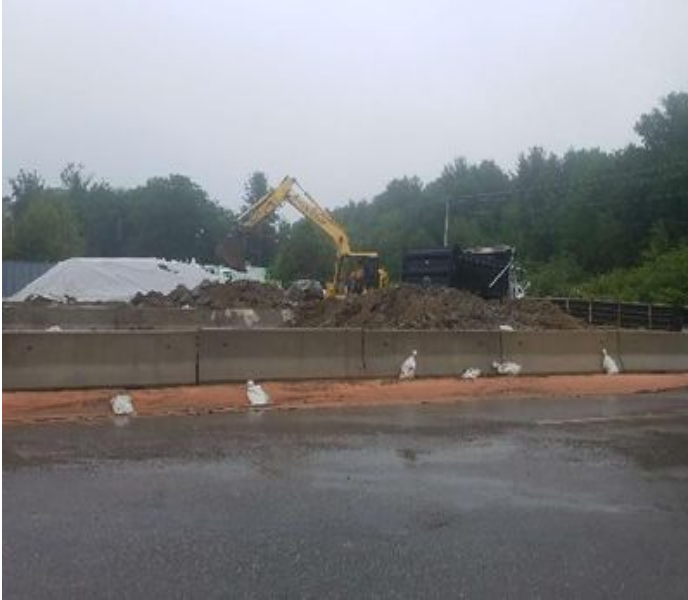
Fig 1: GZA continues to haul out soil from stockpile area in "A" lot. Viewing north. (6-20-19).

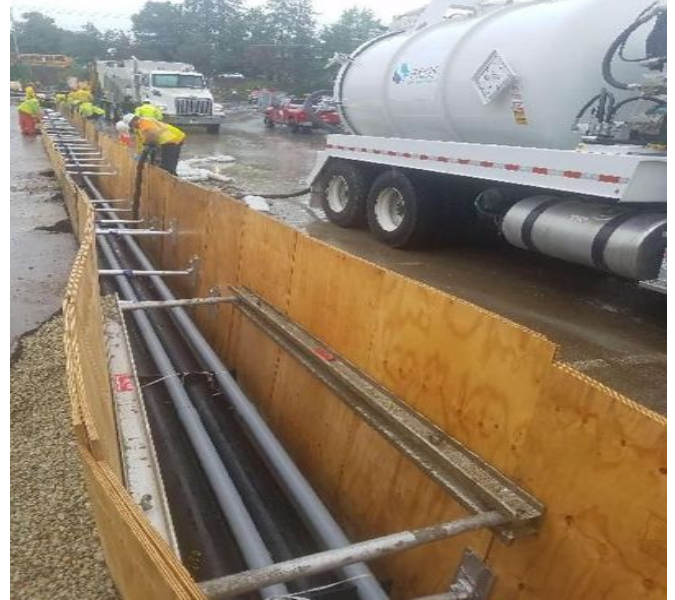
Fig 2: Vac truck is used to pump rain water out of trench in "A" lot. Viewing south. (6-20-19).

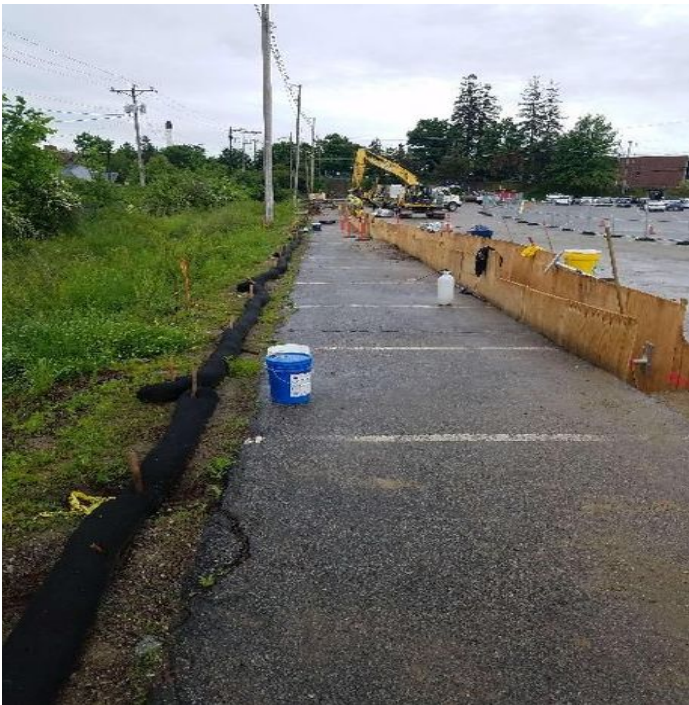
Fig 3: Silt sock installed along trenching activities in "A" lot. Viewing south. (6-21-19).

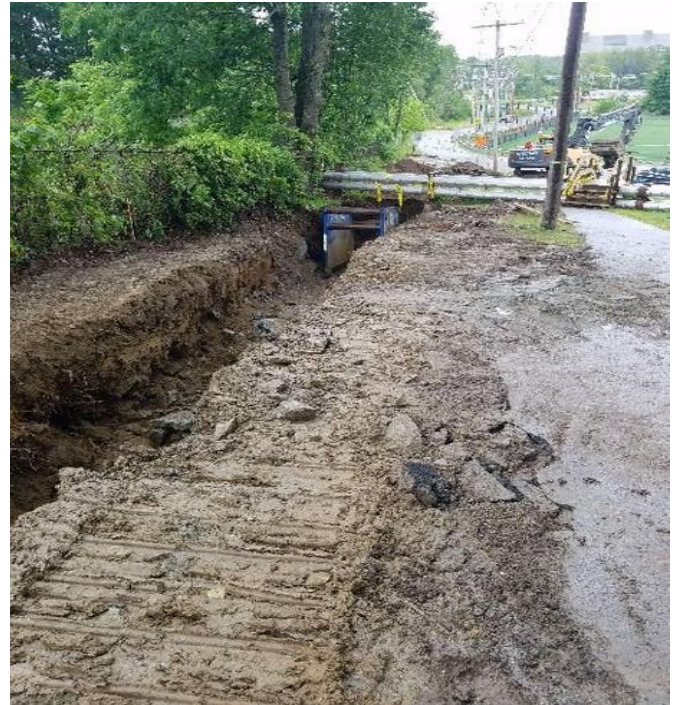
Fig 4: Trenching for duct bank next to field house at UNH. Viewing south. (6-21-19).

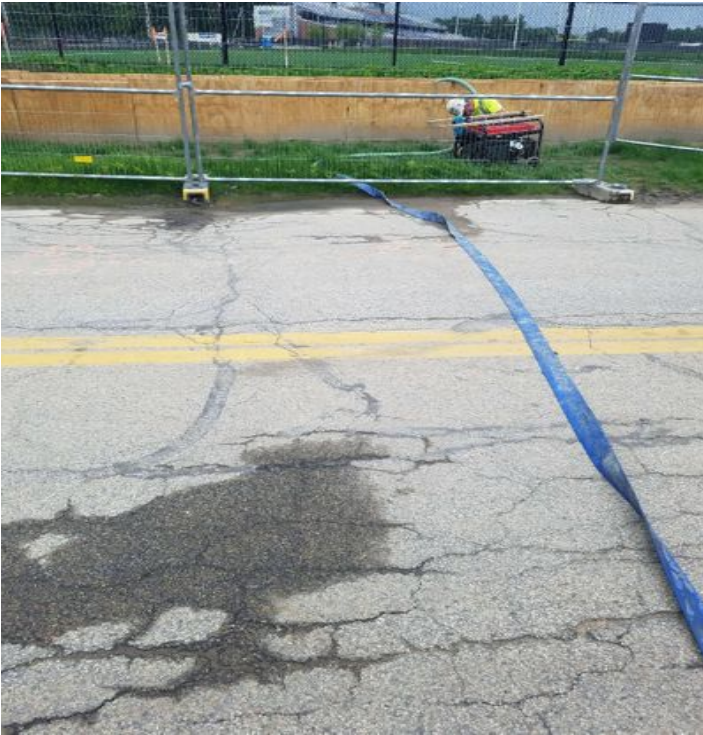
Fig 5: Test pump, 2in electric pump pumping rain water from trench. Viewing west. (6-21-19).

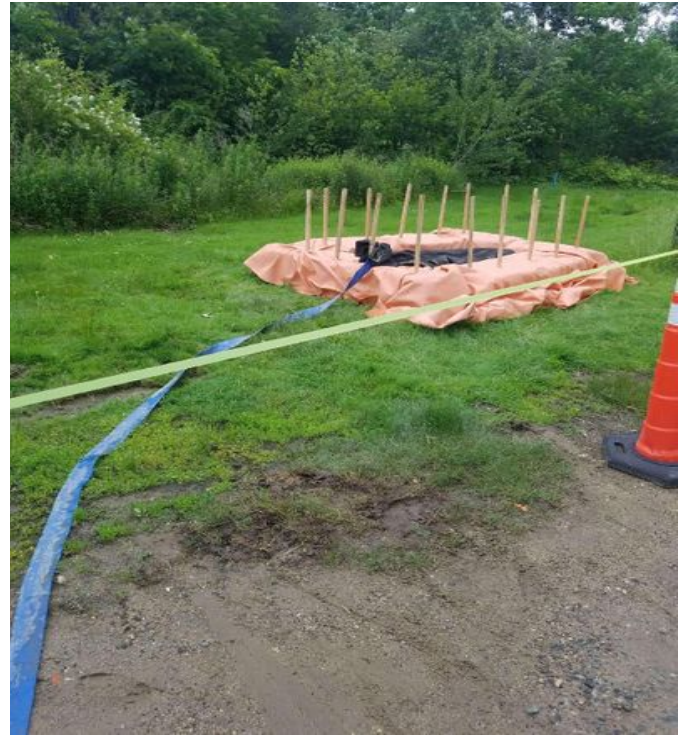
Fig 6: Rain water pumped across Colovos Rd into dewatering apparatus. Viewing southeast. (6-21-19)

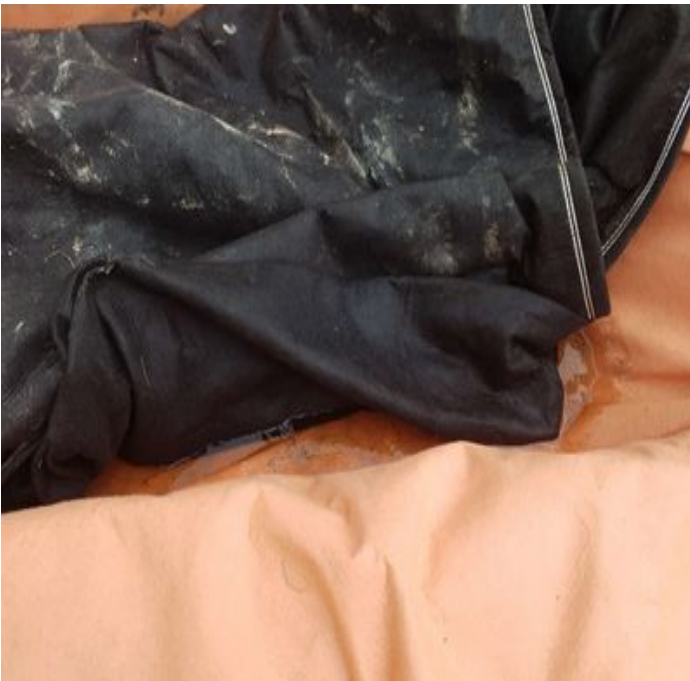
Fig 7: Rain water filtering out through the filter bag inside the dewatering Apparatus. (6-21-19).

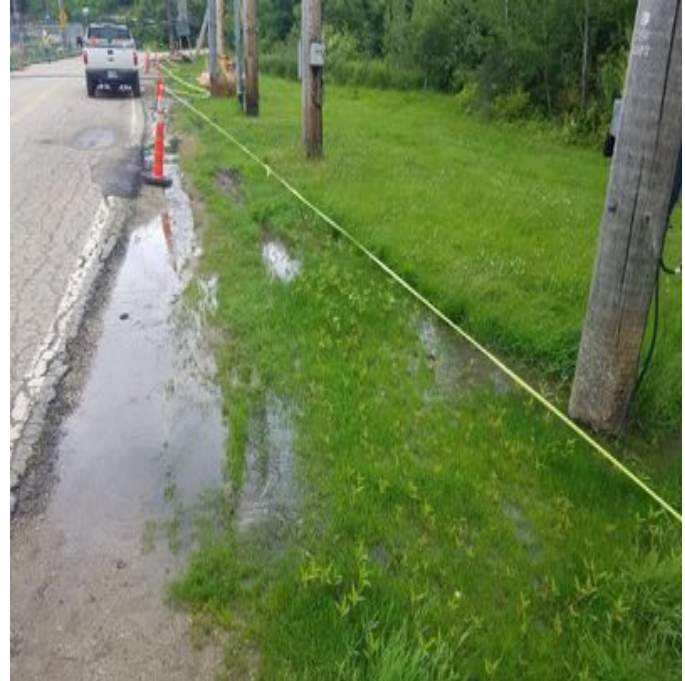
Fig 8: Filtered water flowing next to Colovos and back into grassy area north of College Brook. Viewing north. (6-21-19).

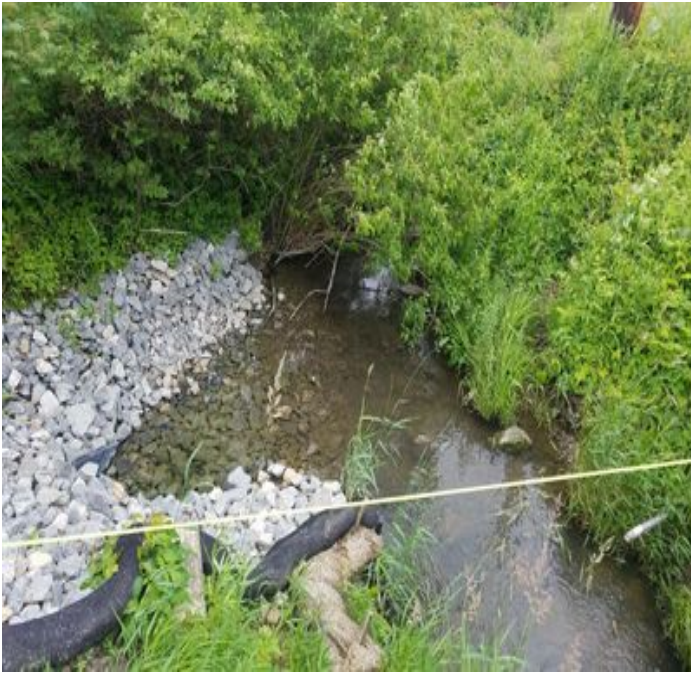
Fig 9: No sediment observed discharging into College Brook as a result of trench dewatering activities next to Colovos Rd. Viewing east. (6-21-19).

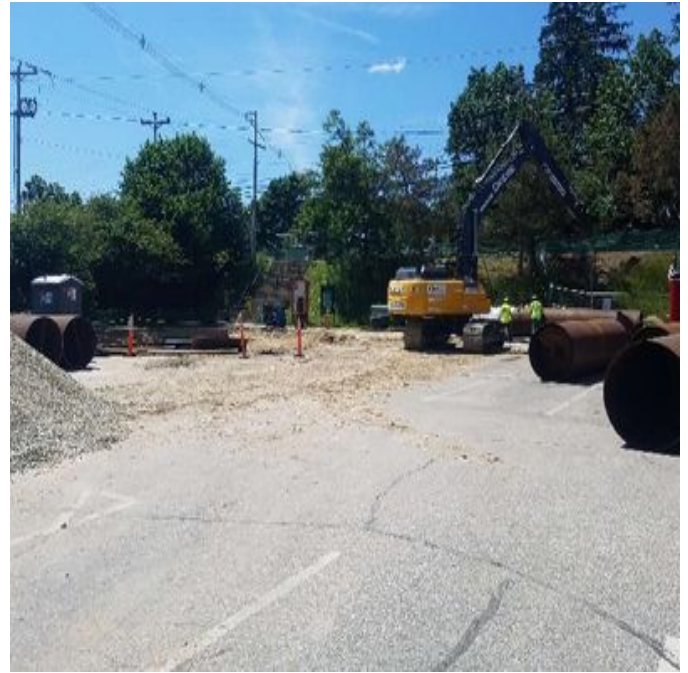
Fig 10: Midwest Mole Inc. Prepping to begin drilling this week. Viewing south. (6-24-19).

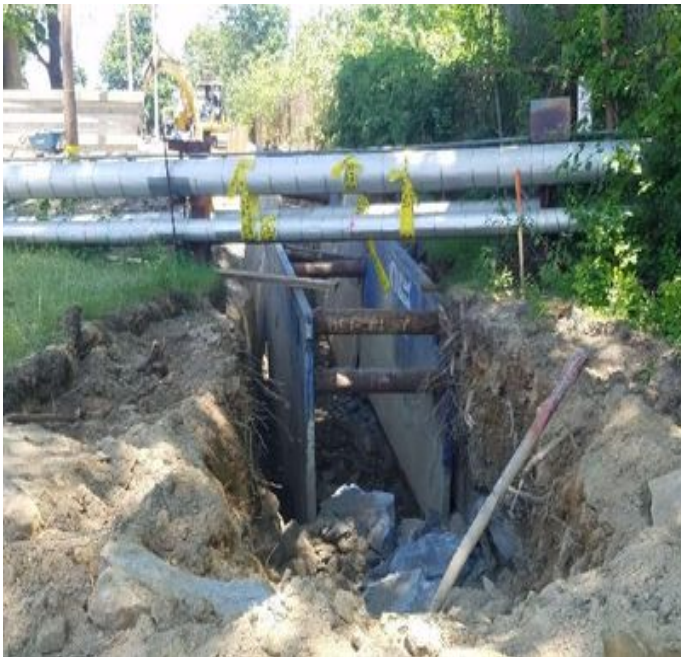
Fig 11: Excavation next to the field house, under steam pipe. Viewing north. (6-24-19).

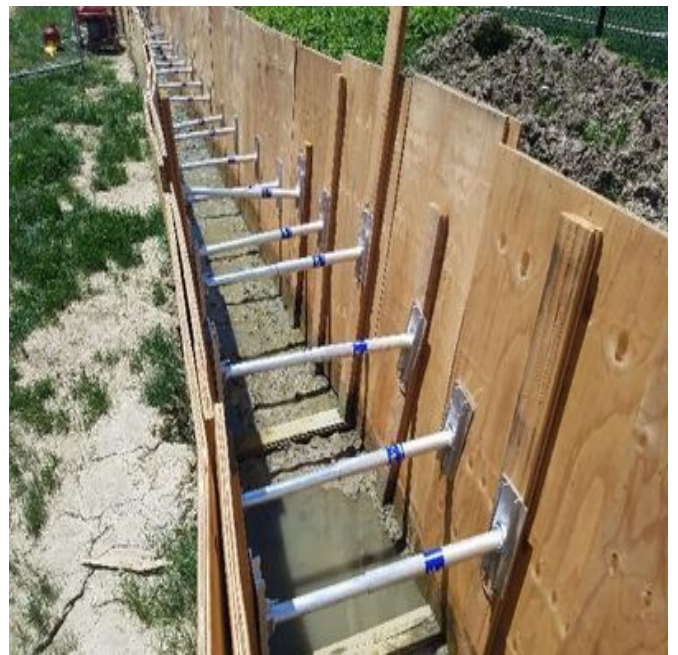
Fig 12: About half of the water in the trench along Colovos Rd has been pumped out. Viewing south. (6-24-19).

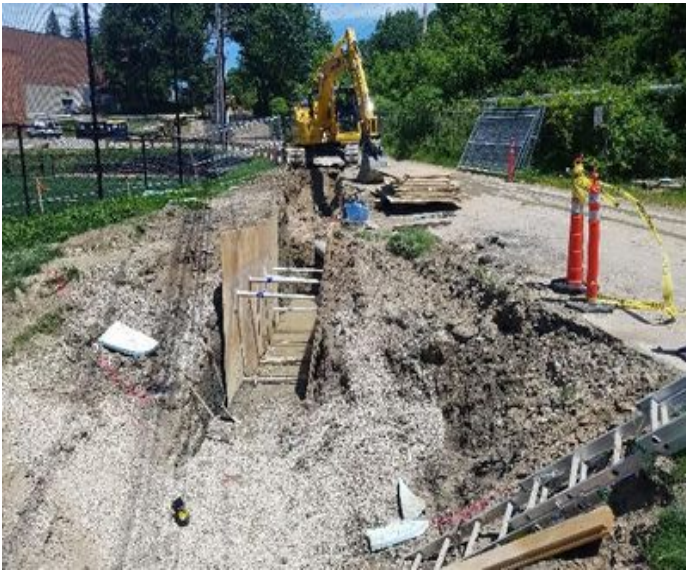
Fig 13: Excavation north of trench along Colovos Rd, moving towards steam pipe. Viewing north. (6-24-19).

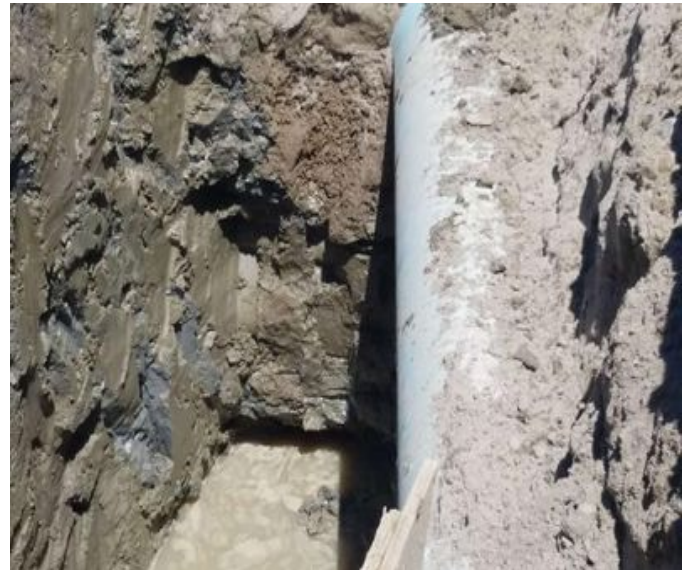
Fig 14: Residual water/rain water seeping out during excavation. Viewing north. (6-24-19).

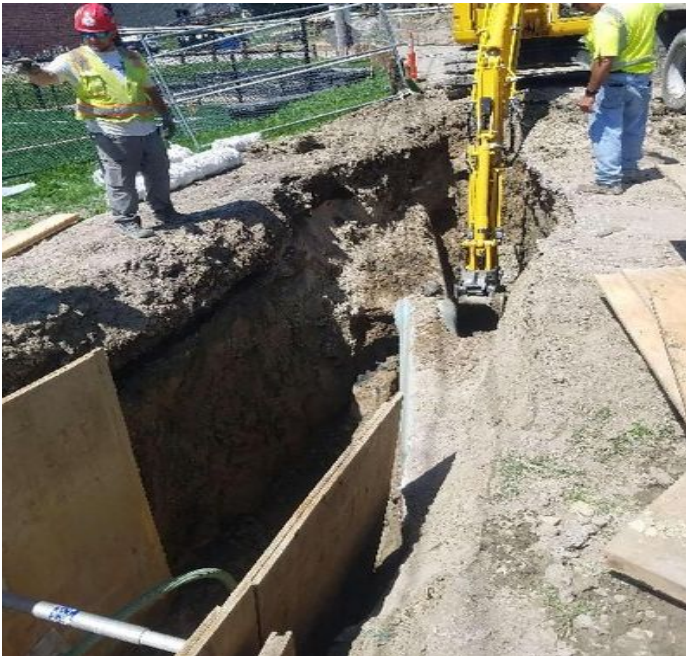
Fig 15: McCourt uncovered an old asbestos water line during excavation. Viewing north. (6-24-19).

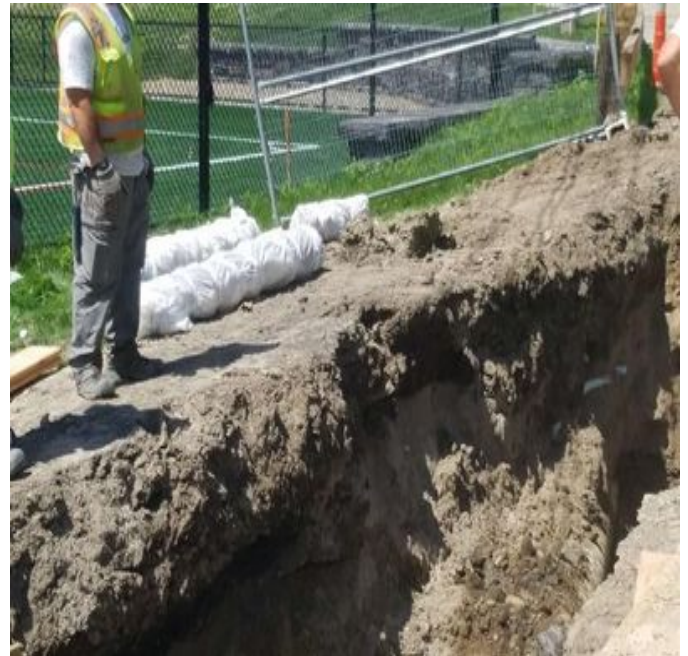
Fig 16: Asbestos pipe properly secured, waiting to be picked up. Viewing north. (6-24-19).

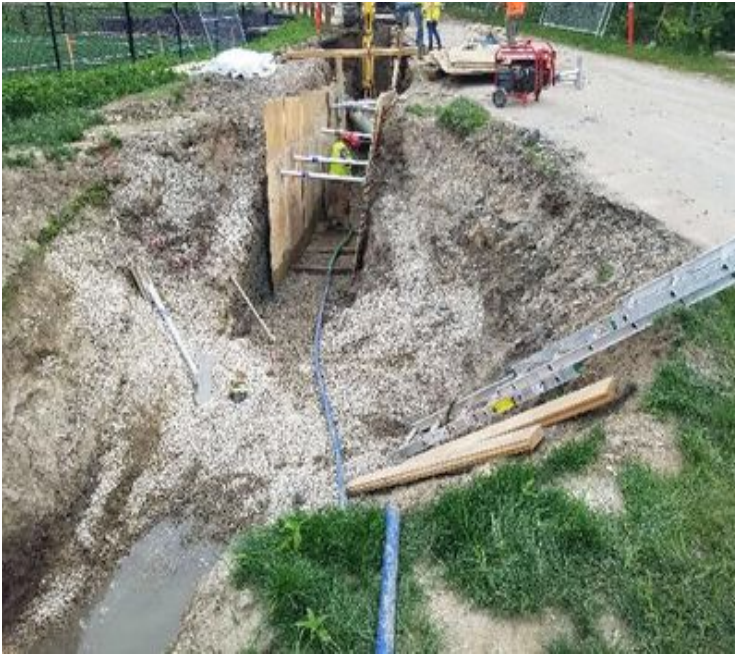
Fig 17: McCourt excavating next to Colovos Rd, north of existing trench, moving towards steam pipe. Viewing north. (6-25-19).

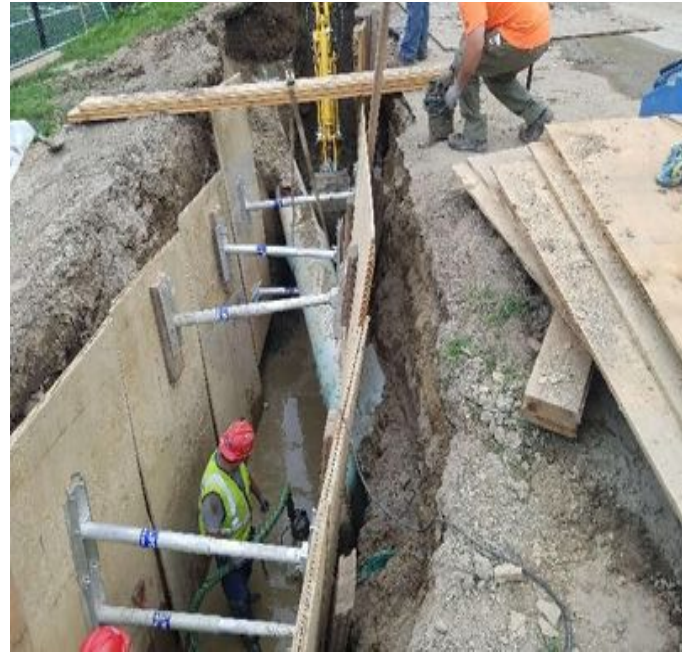
Fig 18: McCourt pumping water out of trench into existing trench. Viewing north. (6-25-19).

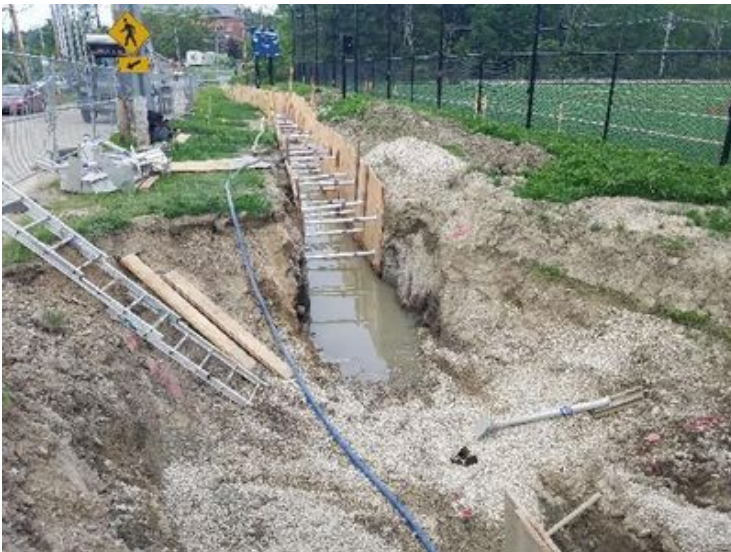
Fig 19: McCourt pumping residual water out of current work area, into existing Trench along Colovos Rd. Viewing south. (6-25-19).

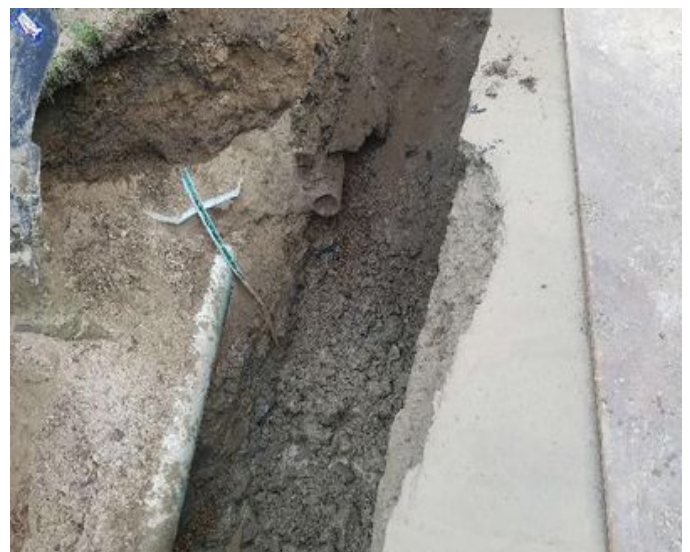
Fig 20: Residual water seeping out from stone beneath old water pipe. Viewing north. (6-25-19).

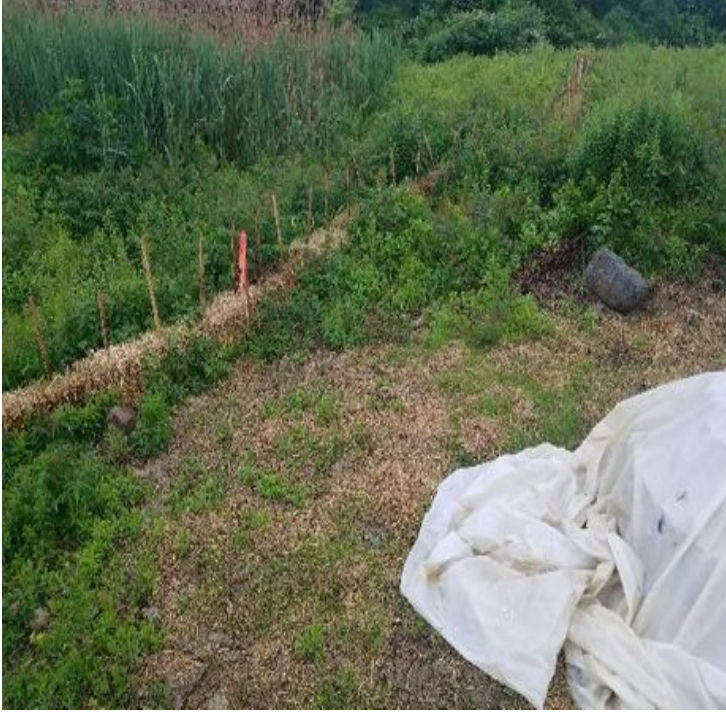
Fig 21: Straw bales installed between Str. F107-138 and wetland NW37. Viewing north. (6-25-19).

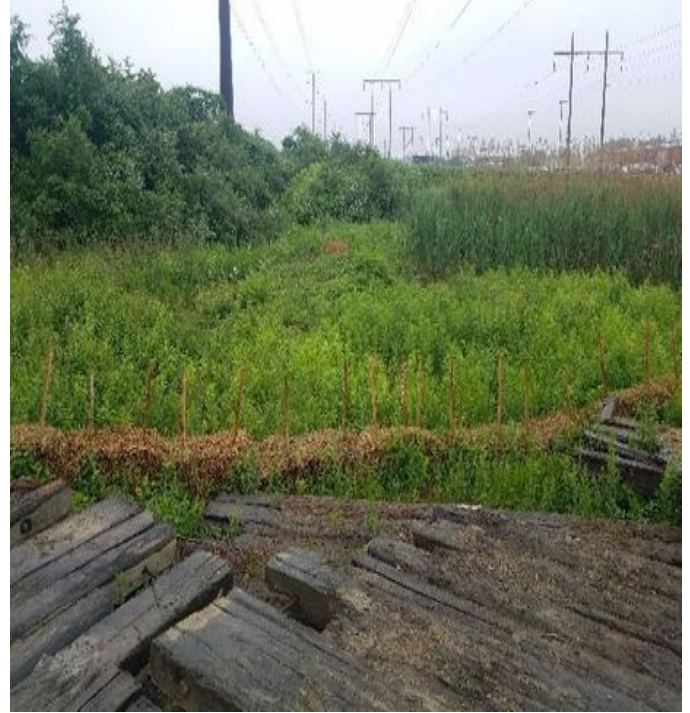
Fig 22: Straw bales installed between Str. F107-138 and wetland NW37. Viewing west. (6-25-19).

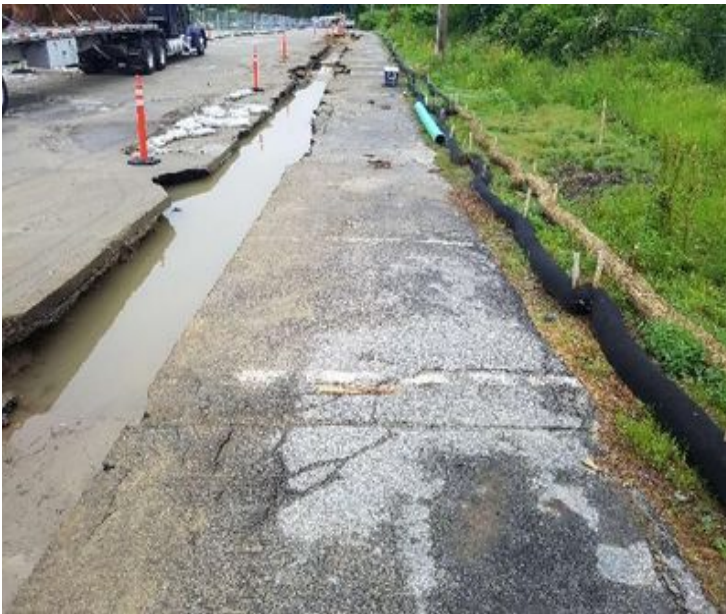
Fig 23: Silt sock installed next to trenching activities in "A" lot. Viewing north. (6-26-19).

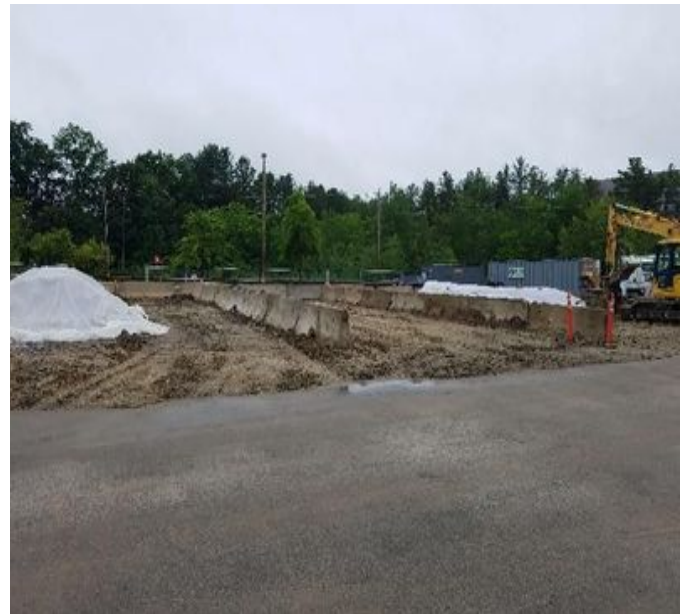
Fig 24: Most of the soil in "A" lot has been hauled off site. Viewing west. (6-26-19).

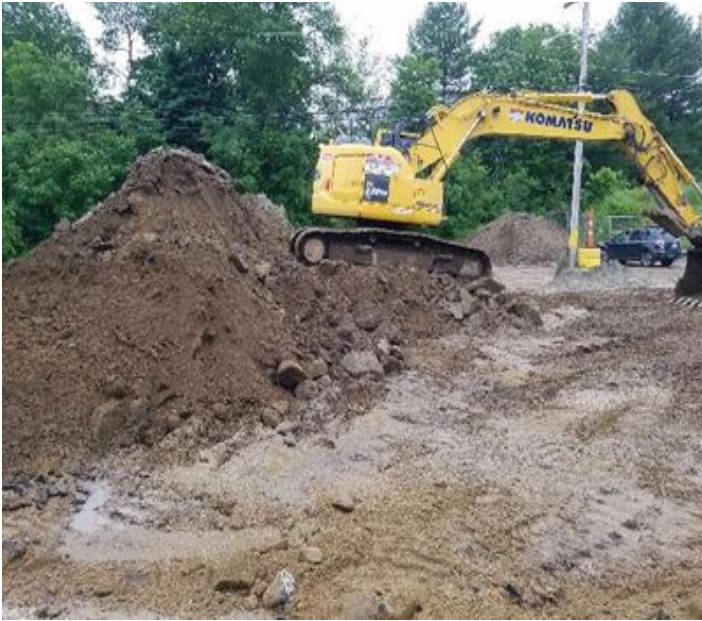
Fig 25: Soil stockpiled in the Waterworks Rd laydown yard continue to be Hauled off. Viewing east. (6-26-19).

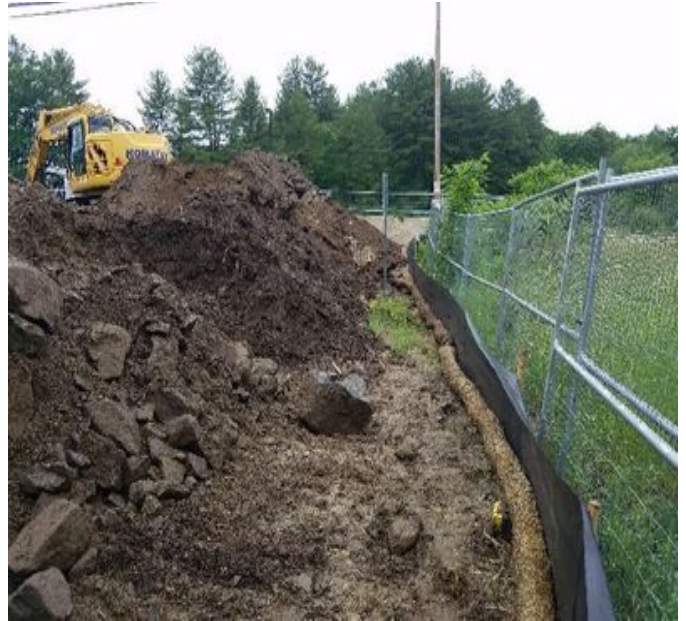
Fig 26: Silt fence and straw wattle installed between Waterworks Rd laydown yard and wetland DW65. Viewing west. (6-26-19).

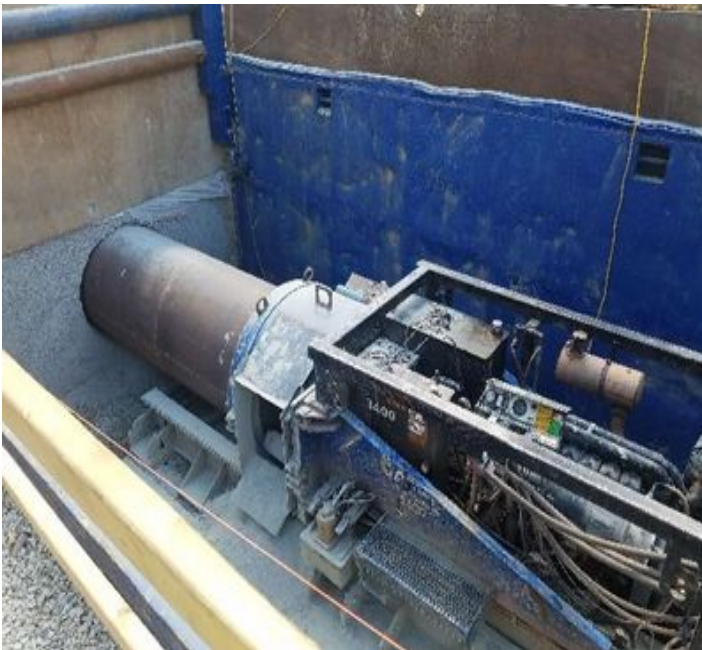
Fig 27: Midwest Mole Inc. continues to drill through ledge underneath Main St. Viewing southwest. (6-26-19).
