# **CONSTRUCTION MONITORING REPORT**

### Eversource Seacoast Reliability Project

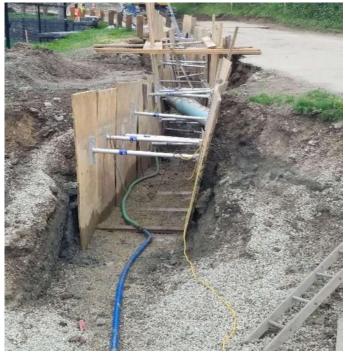
Fig 1: McCourt continues to trench along Colovos Rd, moving north. Viewing north. (6-27-19).

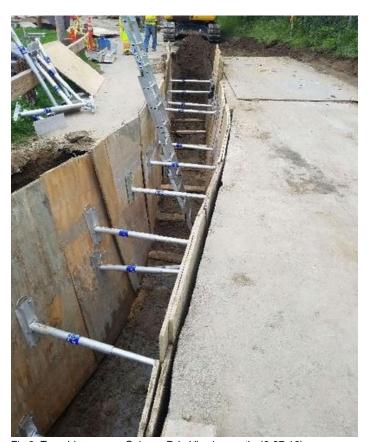
Fig 3: Trenching across Colovos Rd. Viewing north. (6-27-19)

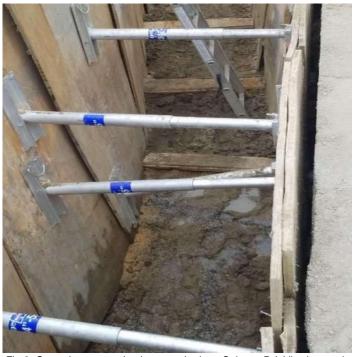
Fig 2: Groundwater seeping into trench along Colovos Rd. Viewing north. (6-27-19).

As McCourt continues to pump rain water out of the trench along Colovos Rd, they've been reminded to pump three times a day for 30min as agreed.

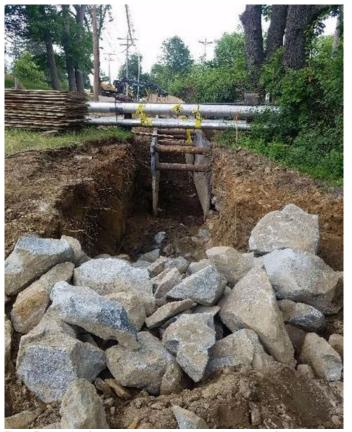
Fig 4: Excavating for trench under the steam pipe next to field house. Viewing north. (6-27-19).

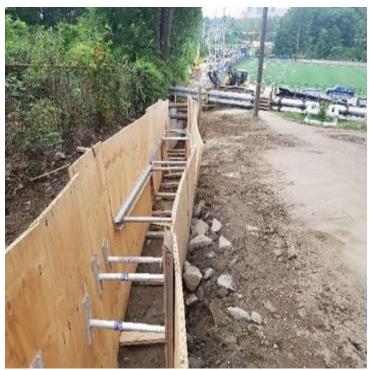
Fig 5: Excavating trench next to field house, working towards steam pipe. Viewing south. (6-27-19).

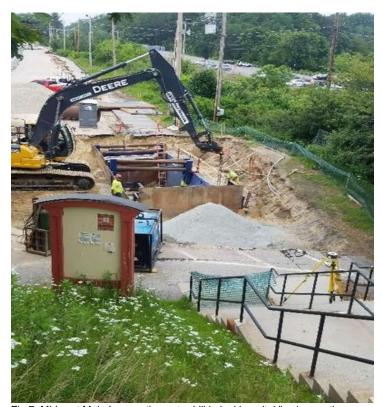
Fig 7: Midwest Mole Inc. continues to drill in jacking pit. Viewing north. (6-27-19).

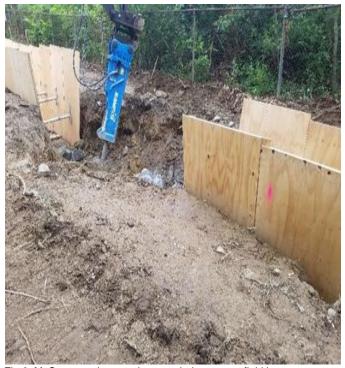
Fig 6: McCourt continues to hammer ledge next to field house. Viewing northeast. (6-27-19)

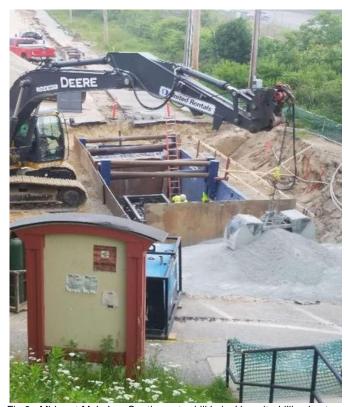
Fig 8: Midwest Mole Inc. Continues to drill in jacking pit, drilling is at 35ft. Viewing north. (6-28-19).

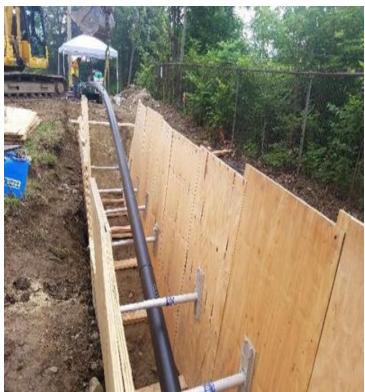
Fig 9: McCourt fusing pipe in trench next to field house. Viewing north. (6-28-19).

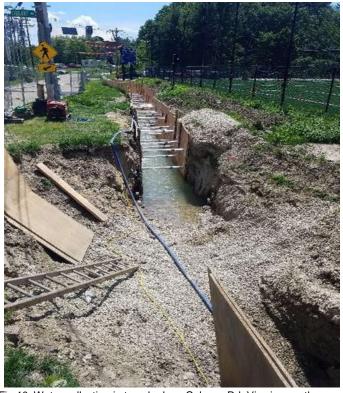
Fig 10: Water collecting in trench along Colovos Rd. Viewing south. (6-28-19).

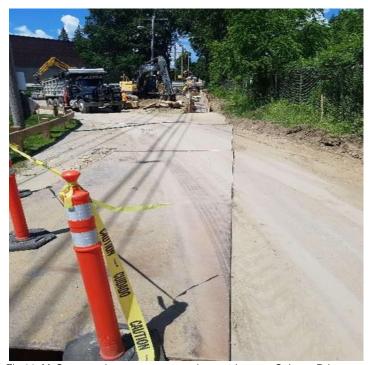
Fig 11: McCourt continues to excavate along and across Colovos Rd. Viewing north. (6-28-19).

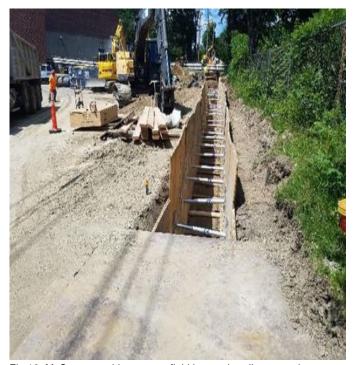
Fig 12: McCourt trenching next to field house, heading towards steam pipe. Viewing north. (6-28-19).

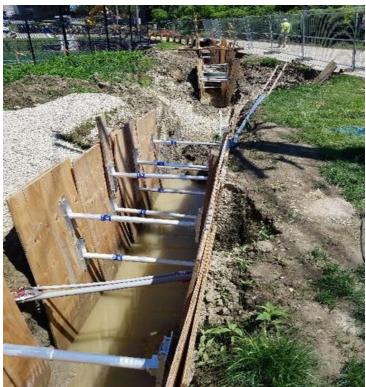
Fig 13: Water collecting in trench along Colovos Rd. Viewing north. (7-01-19).

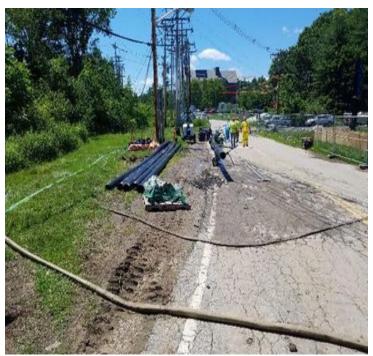
Fig 15: McCourt cont. to fuse pipe to install in trench along Colovos Rd. Viewing south. (7-01-19).

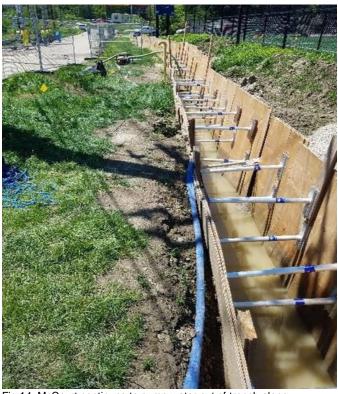
Fig 14: McCourt continues to pump water out of trench along Colovos Rd. Viewing north. (7-01-19).

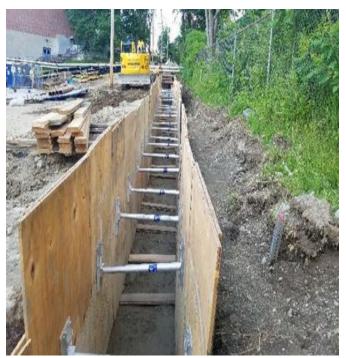
Fig 16: Trench next to Colovos Rd, heading towards steam pipe. Viewing north. (7-01-19).

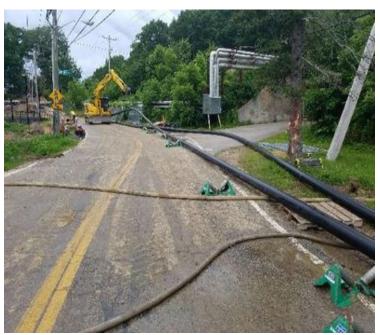
Fig 17: McCourt fusing and installing pipe in trench along Colovos Rd. Viewing north. (7-02-19).

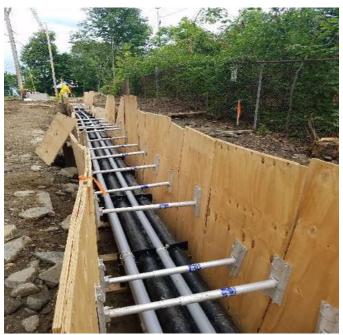
Fig 18: McCourt continues to install pipe in trench next to field house. Viewing north. (7-02-19).

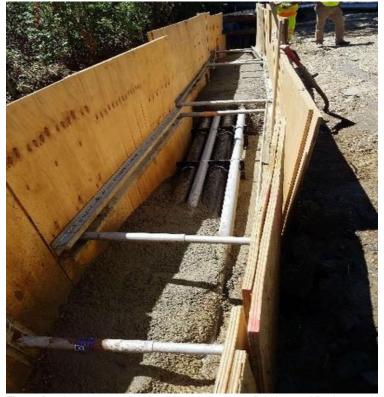
Fig 19: Pouring concrete duct bank in trench next to field house. Viewing south. (7-02-19).
