CONSTRUCTION MONITORING REPORT

Eversource Transmission Lines:
F107

**Madbury, Durham,
Newington, Portsmouth,
NH**

TYPE OF INSPECTION: Weekly Storm Event Incident Corrective Action

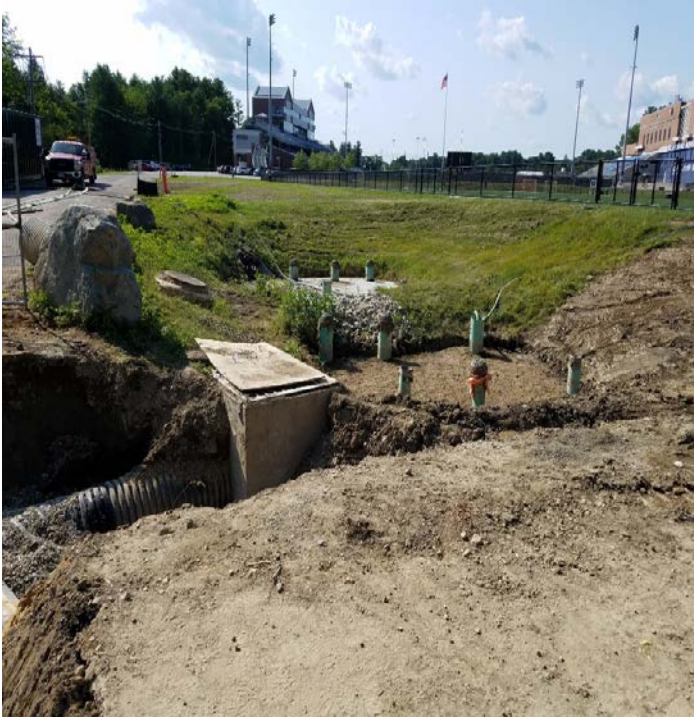
Fig 1: McCourt excavating through the rain garden. Viewing west. (7-25-19).

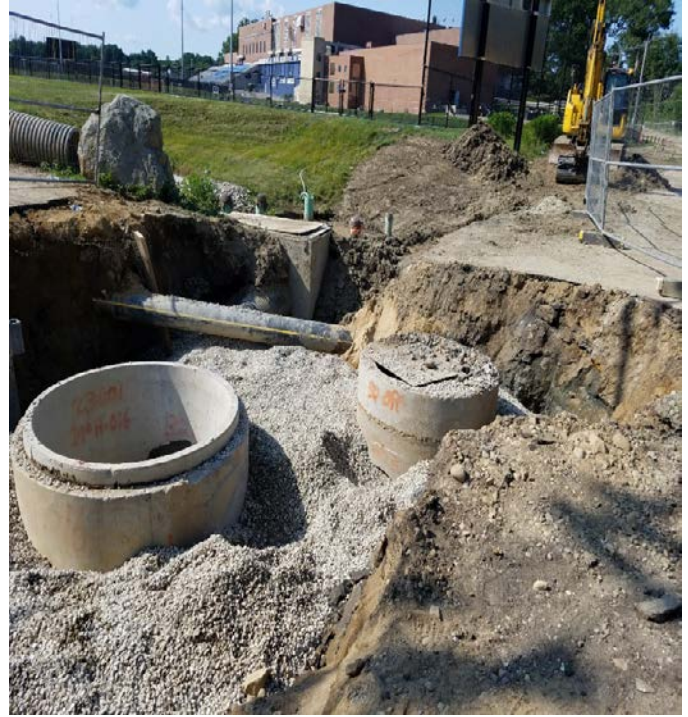
Fig 2: Placing manhole structures next to Colovos Rd. Viewing north. (7-25-19).

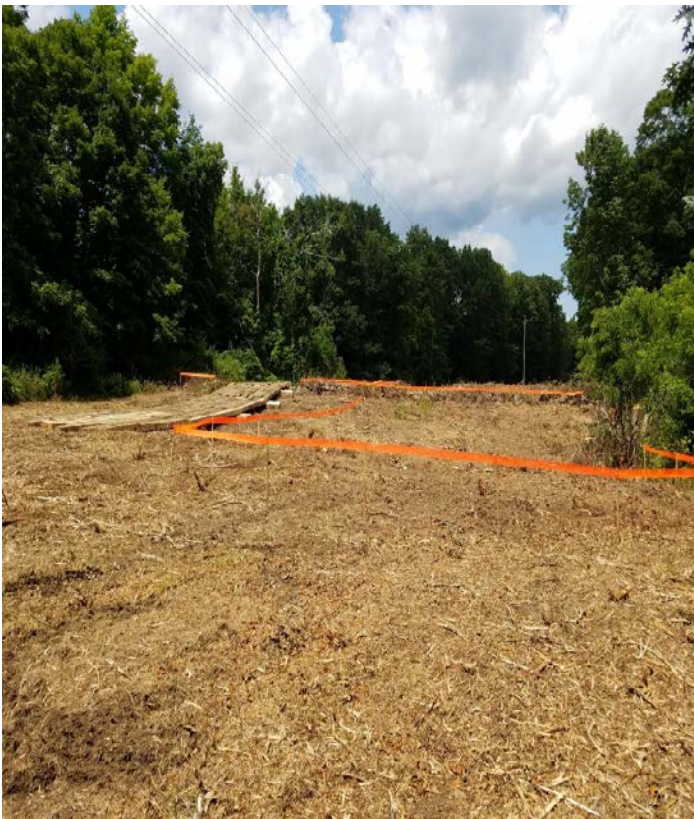
Fig 3: RTE plant sensitive area and stonewall WP-7 & WP-8 marked with orange ribbon. Viewing north. (7-25-19).

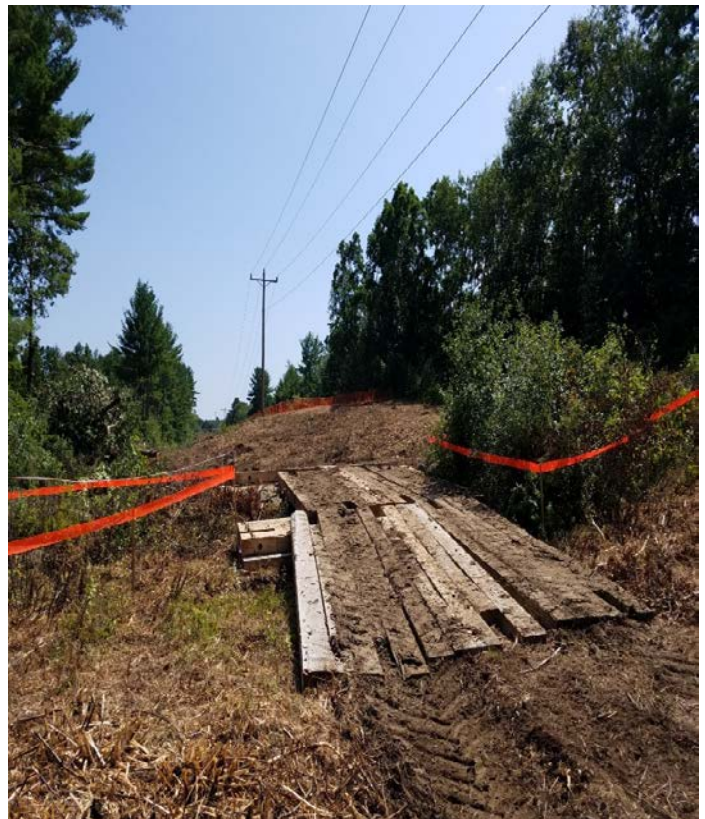
Fig 4: Stonewall WP-11 crossing. Viewing south. (7-25-19).

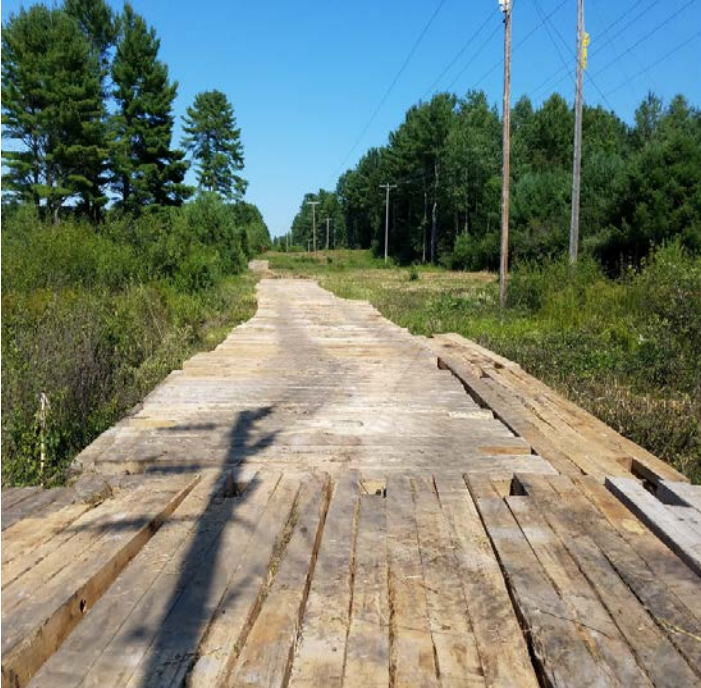
Fig 5: Timber matted access route through wetland DW56 towards Str. 49. Viewing east. (7-25-19).

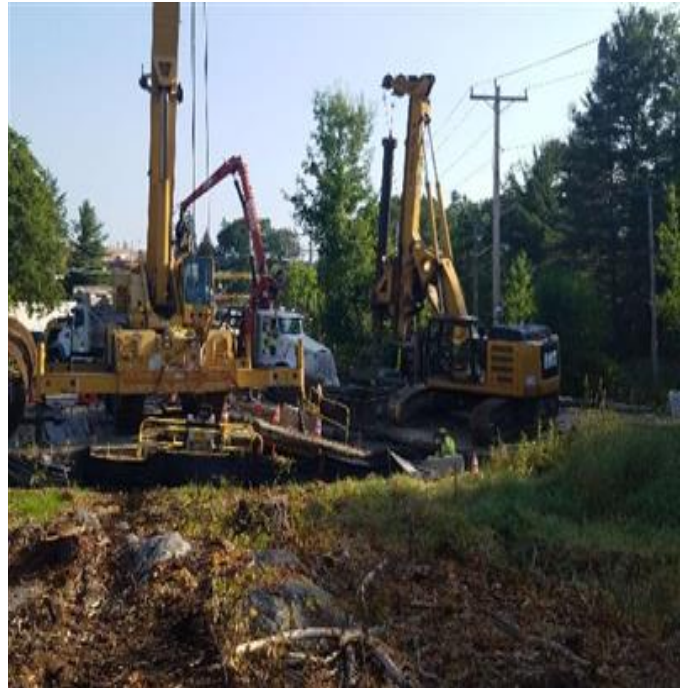
Fig 6: MJ drilling Str. 23. Viewing north. (7-26-19).

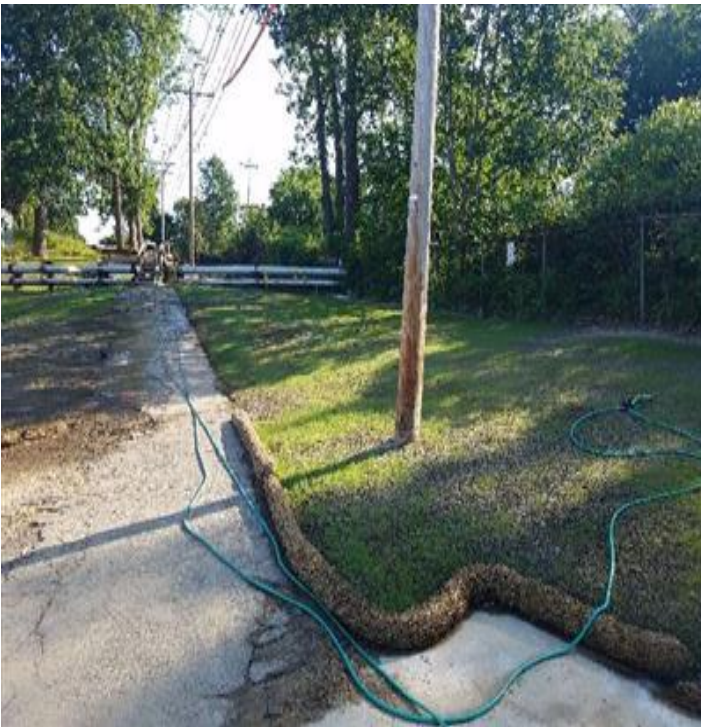
Fig 7: Restoration around steam pipe next to field house at UNH. house. Viewing north. (7-26-19).

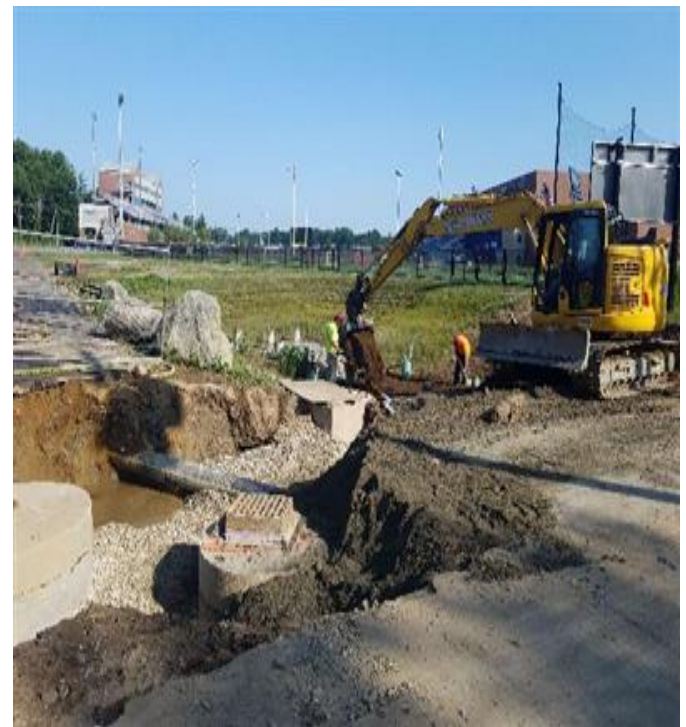
Fig 8: Restoration around the rain garden at UNH. Viewing northwest. (7-26-19).

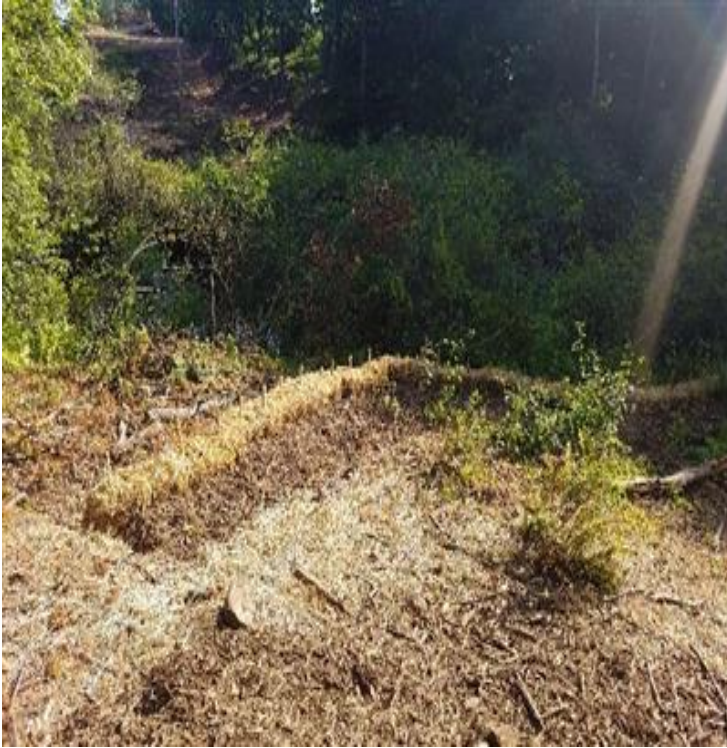
Fig 9: Combined straw bale and stump grinding berm, south of Oyster River. Viewing north. (7-26-19).

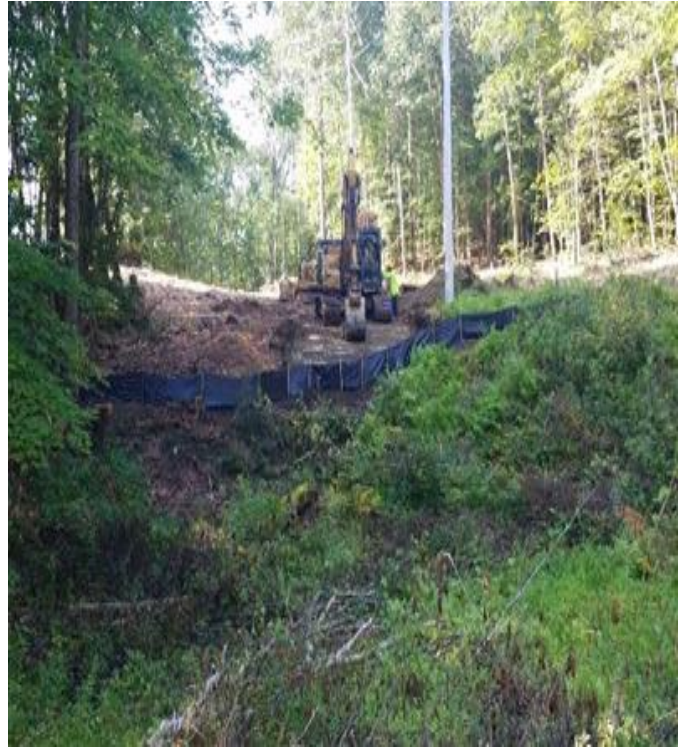
Fig 10: Building new access road to Str. 28. Viewing south. (7-26-19).

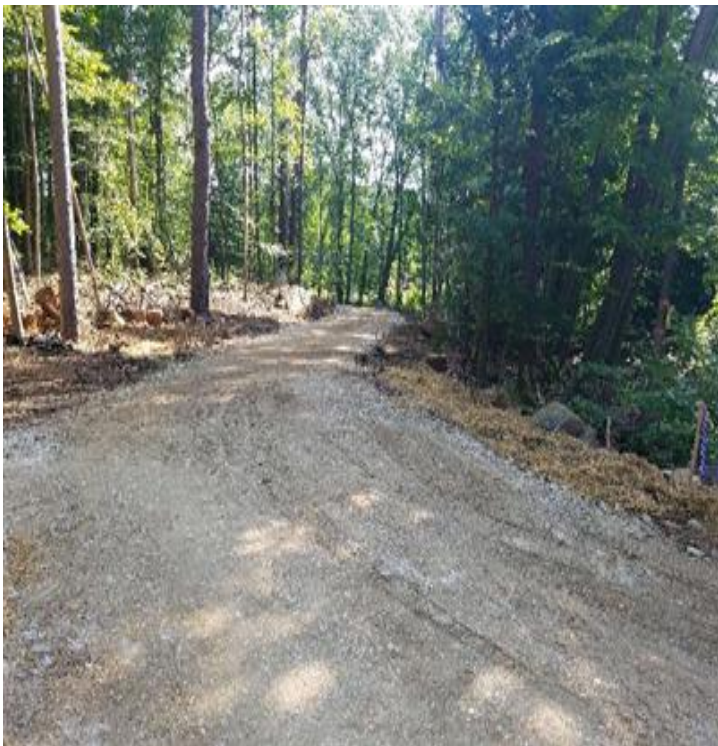
Fig 11: Access road to Str. 29, off of Mill road. Viewing north. (7-26-19).

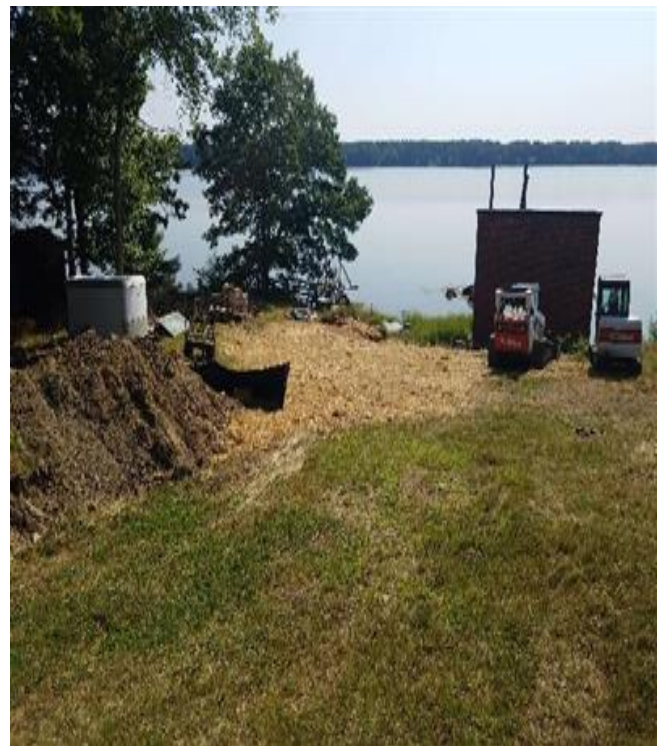
Fig 12: Erosion controls installed around cable house due to excavation. Viewing east. (7-26-19).

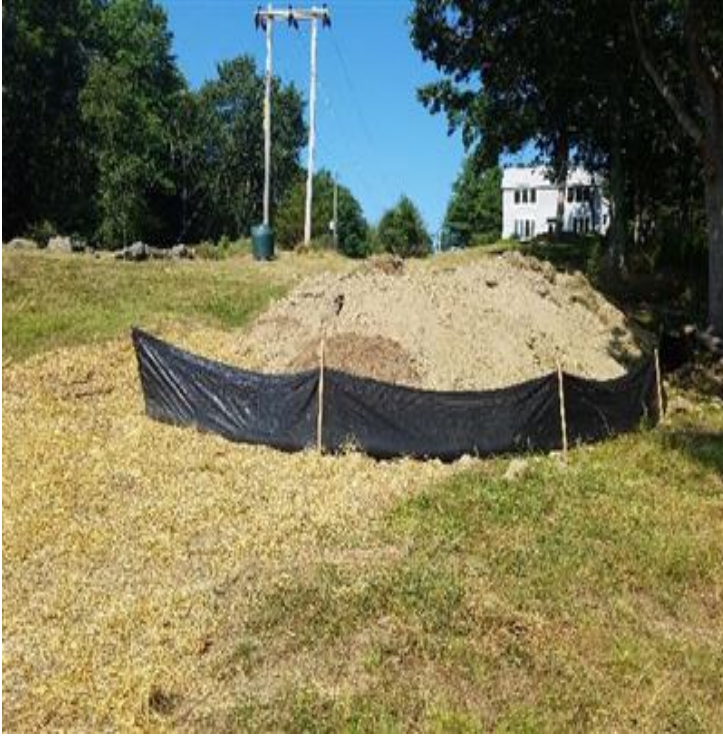
Fig 13: Stockpiled soil from cable house excavation. Viewing west. (7-26-19).

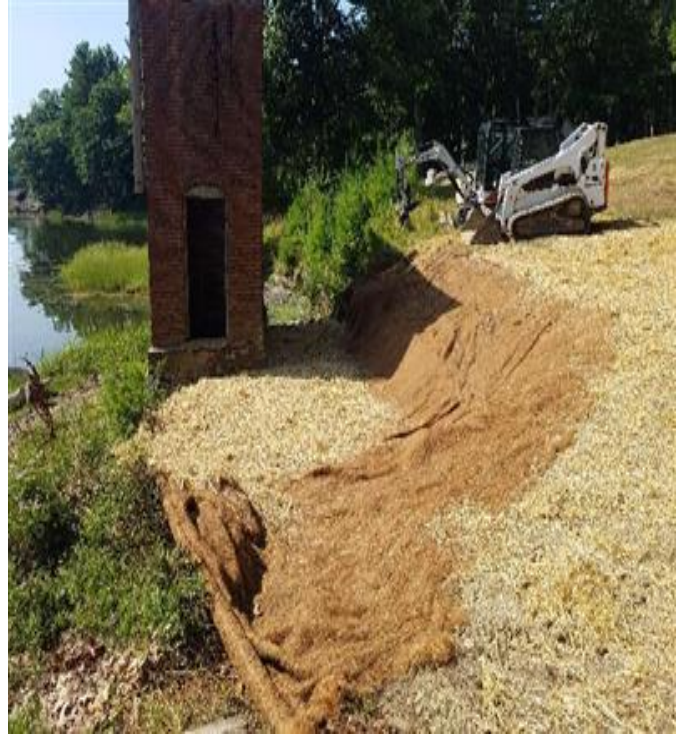
Fig 14: 4ft excavation around the cable house with erosion controls. Viewing north. (7-26-19).

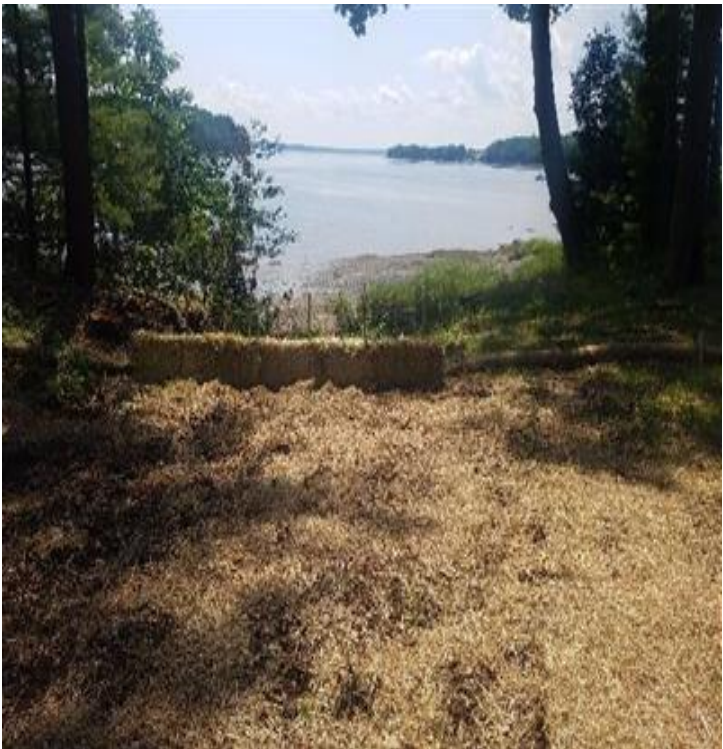
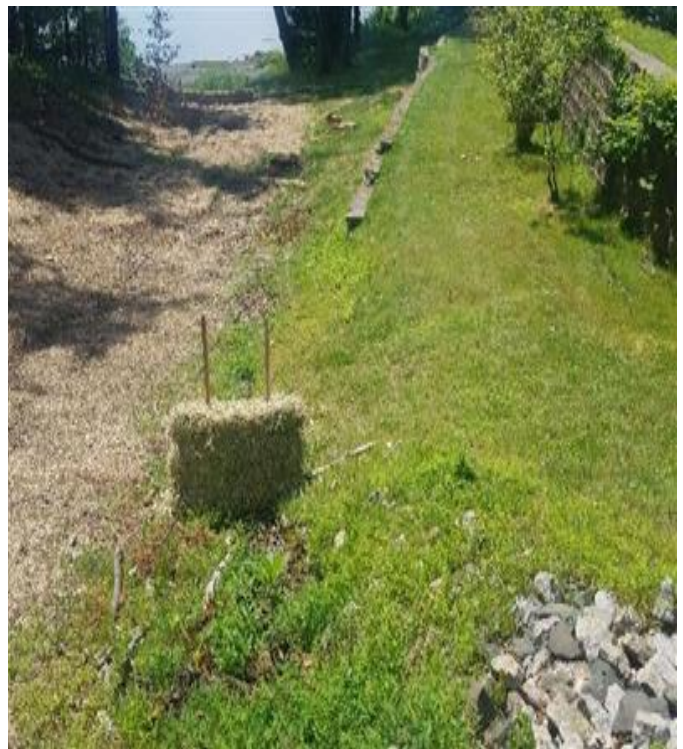
- None
- **BMPs**
 - Additional erosion controls have been installed at Gundalow Landing (straw bales and filter sock). See photos 15 & 16.
 - Straw bales need to be installed between trench location and wetland DW69 before work can continue in that area.
 - Straw bales should be installed in front of the silt fence in low area in Waterworks Rd laydown yard.
 - Straw wattle are no longer an approved BMP. The use of stump grindings, BioWattle, filter socks, or woven jute matting if necessary are approved replacement BMPs.

Fig 15: Additional erosion controls installed at Gundalow Landing. Viewing southwest. (7-26-19).

Fig 16: Additional erosion controls installed at Gundalow Landing. Viewing southwest. (7-26-19).

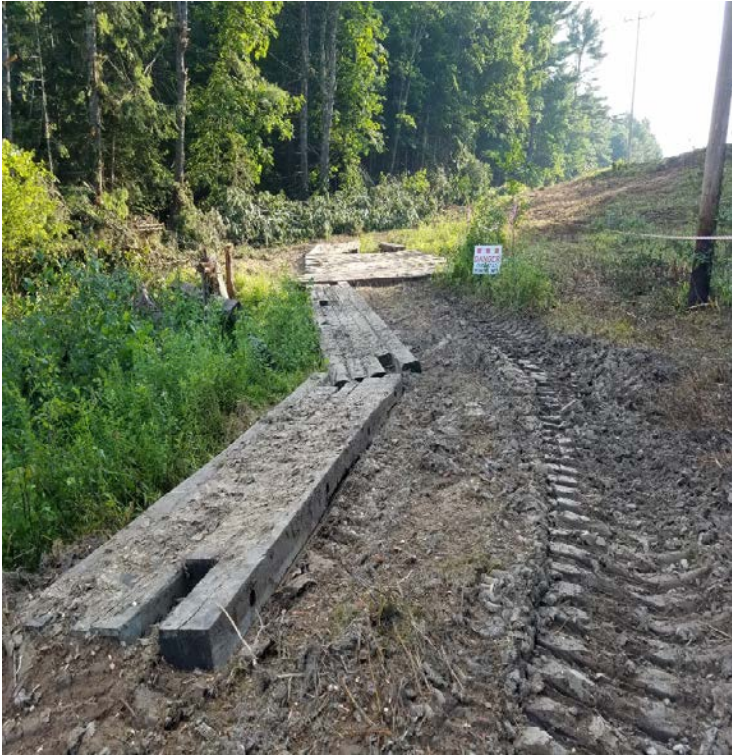
Fig 17: Access route between wetlands DW48 and DW50 (stream DS46 is down the slope to the left). Viewing north. (7-29-19).

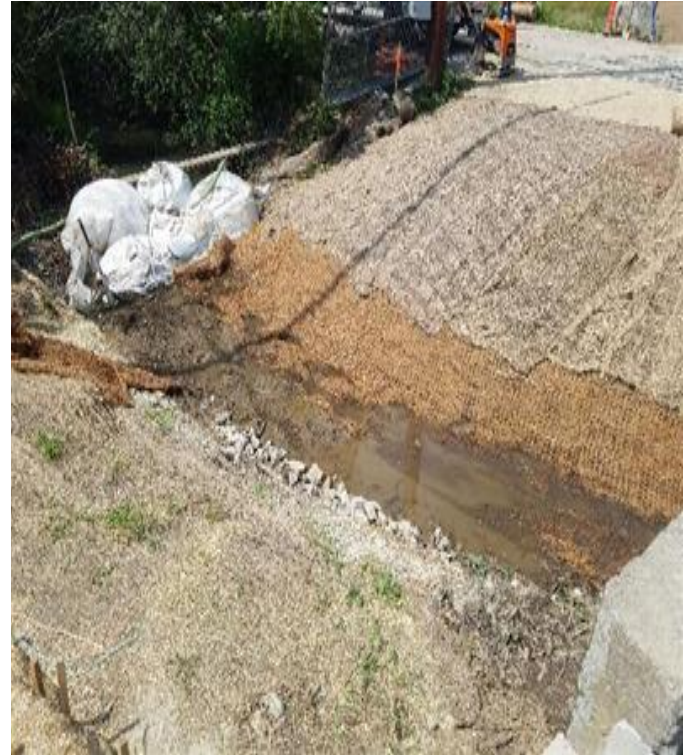
Fig 18: Installing coconut liner in College Brook. Viewing north. (7-29-19).

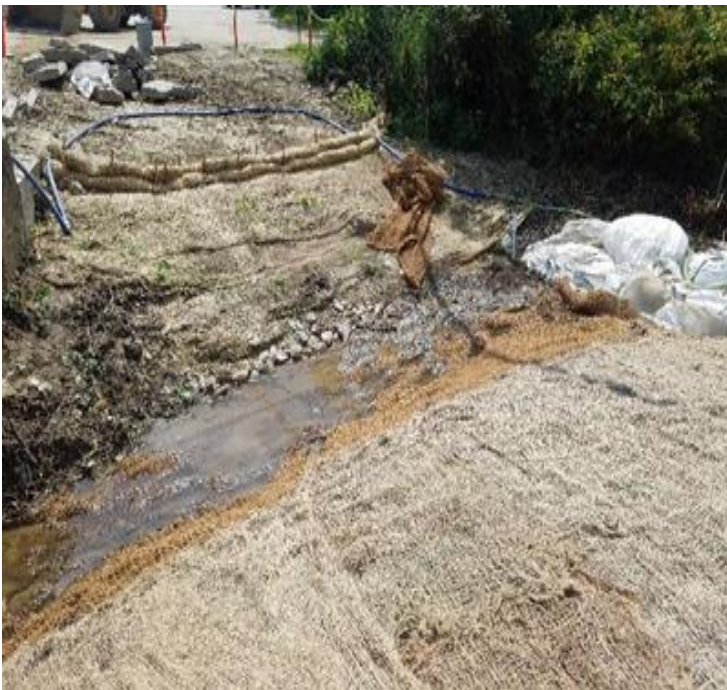
Fig 19: Installing coconut liner in College Brook. Viewing south. (7-29-19).

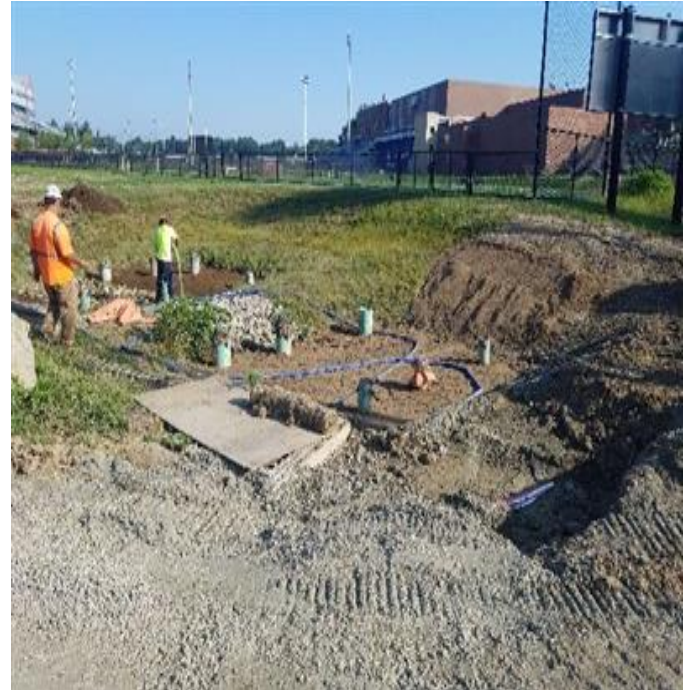
Fig 20: Restoring rain garden at UNH. Viewing northwest. (7-29-19).

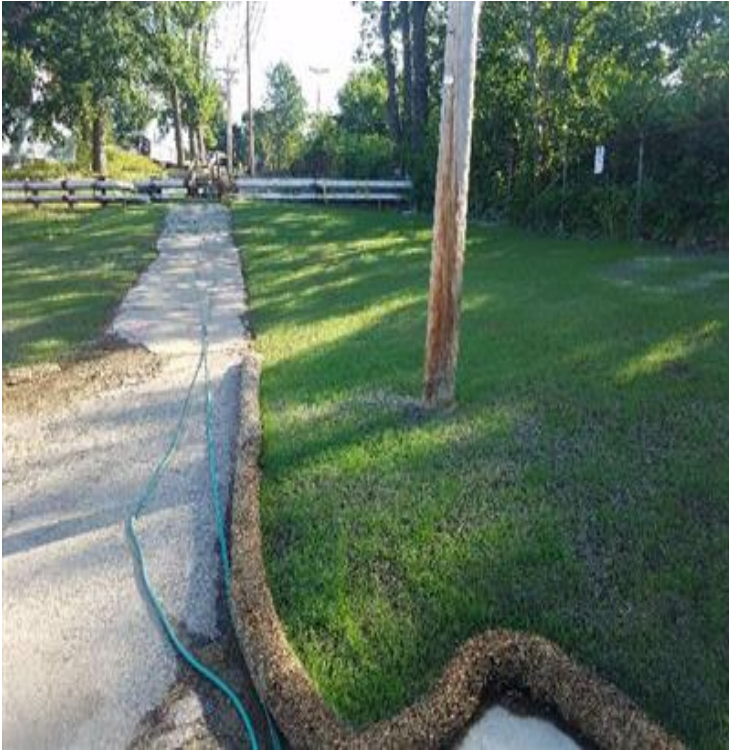
Fig 21: Vegetation growth south of steam pipe. Viewing north. (7-29-19).

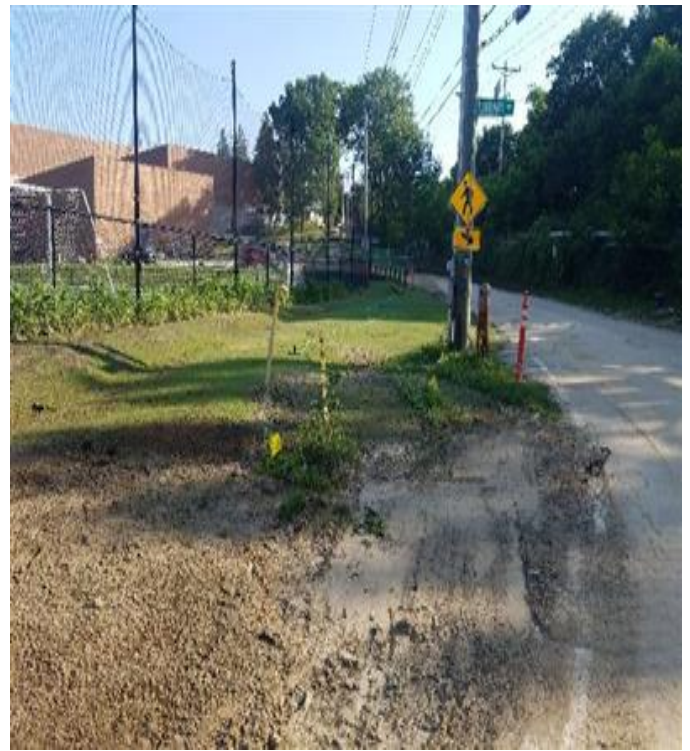
Fig 22: Vegetation growth along Colovos Rd. Viewing north. (7-29-19).

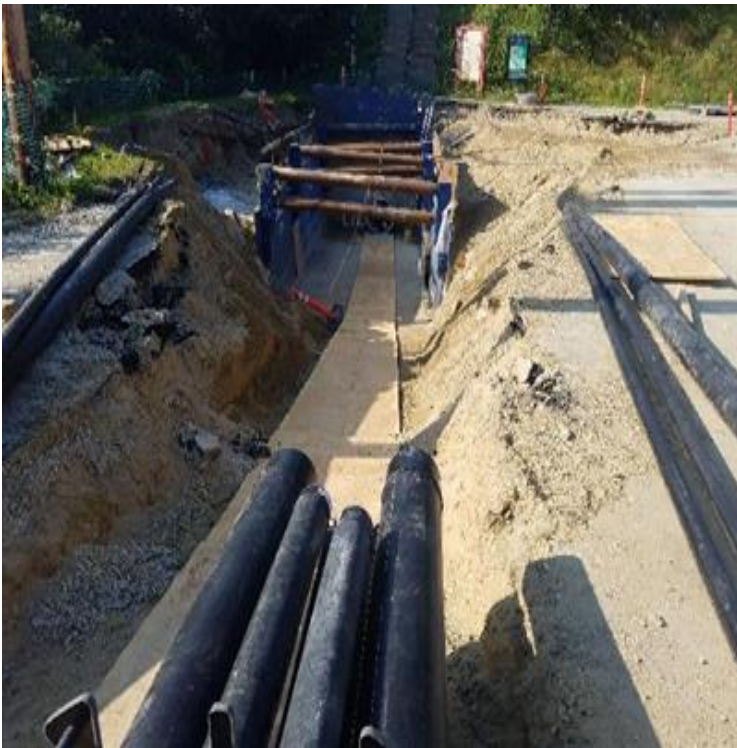
Fig 23: Prep work at jacking pit. Viewing south. (7-29-19).

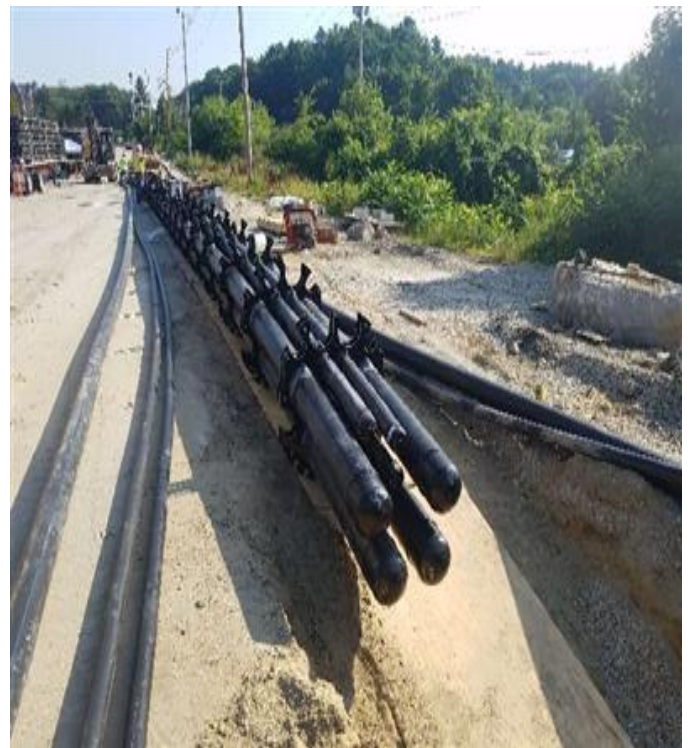
Fig 24: Assembling bundle before they install it in the HOBAS pipe. Viewing north. (7-29-19).

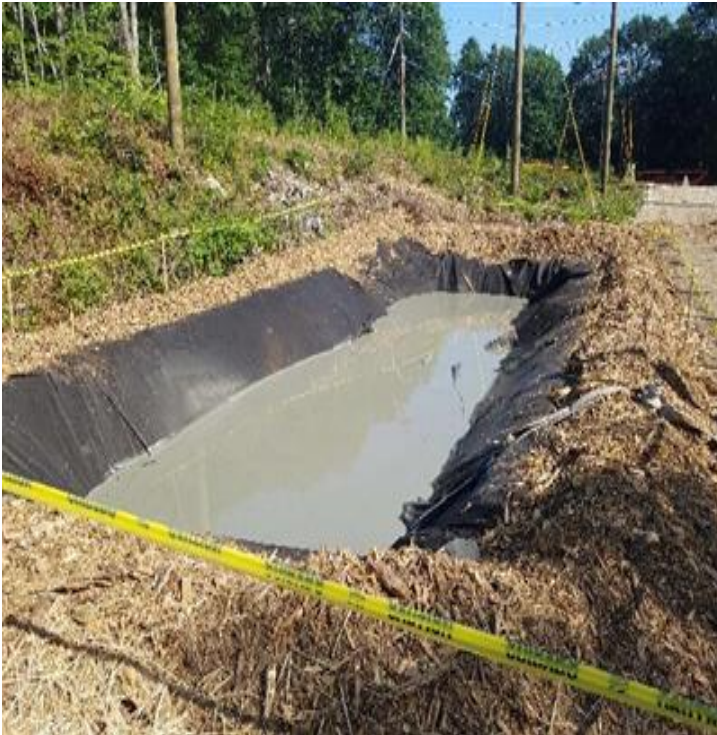
Fig 25: Dewatering basin next to Str. 32, lined with filter fabric. Viewing north. (7-29-19).

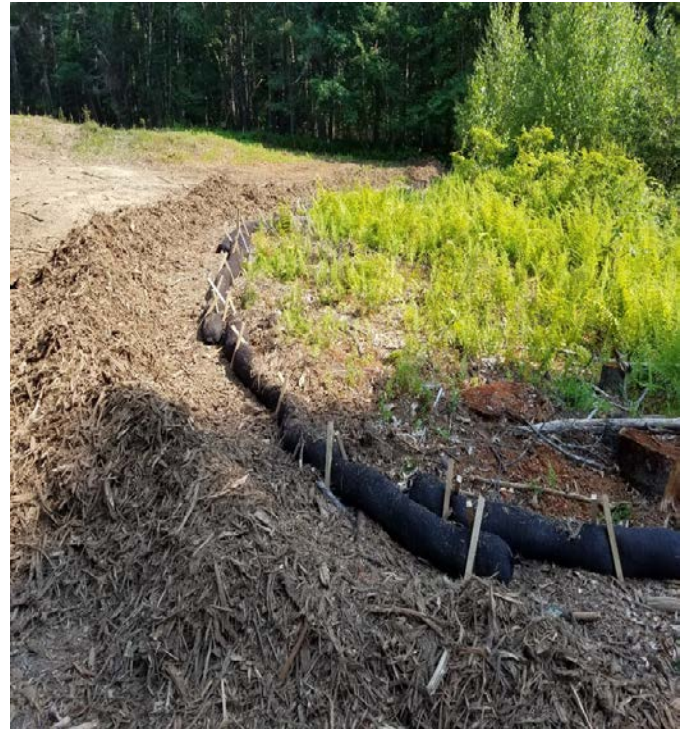
Fig 26: Combined berm between Str. 100 and wetland NW4. Viewing south. (7-30-19).

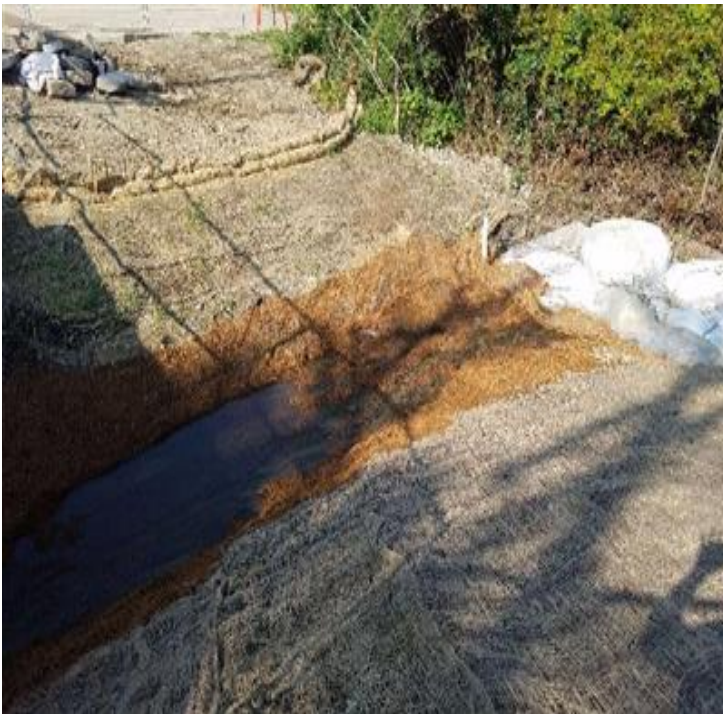
Fig 27: Continuing to install coconut liner in College Brook. Viewing south. (7-30-19).

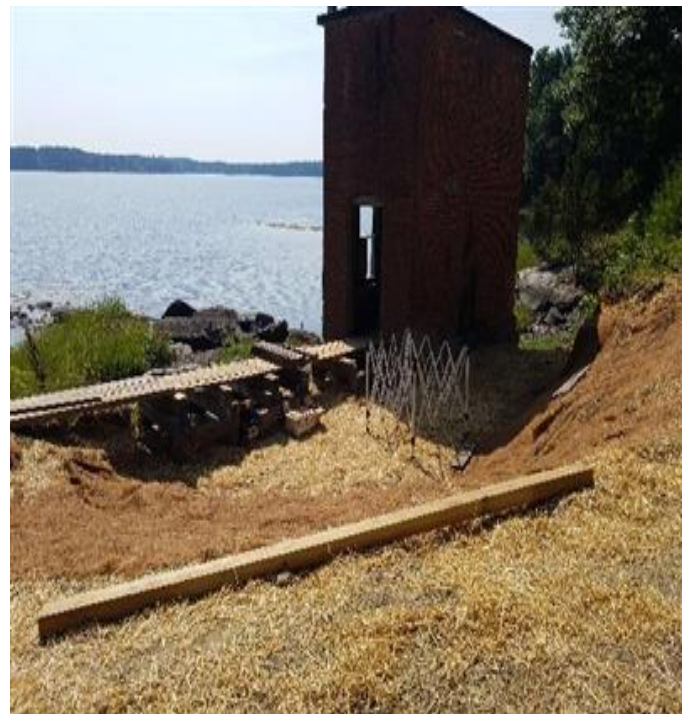
Fig 28: Cable house progress. Viewing south. (7-30-19).

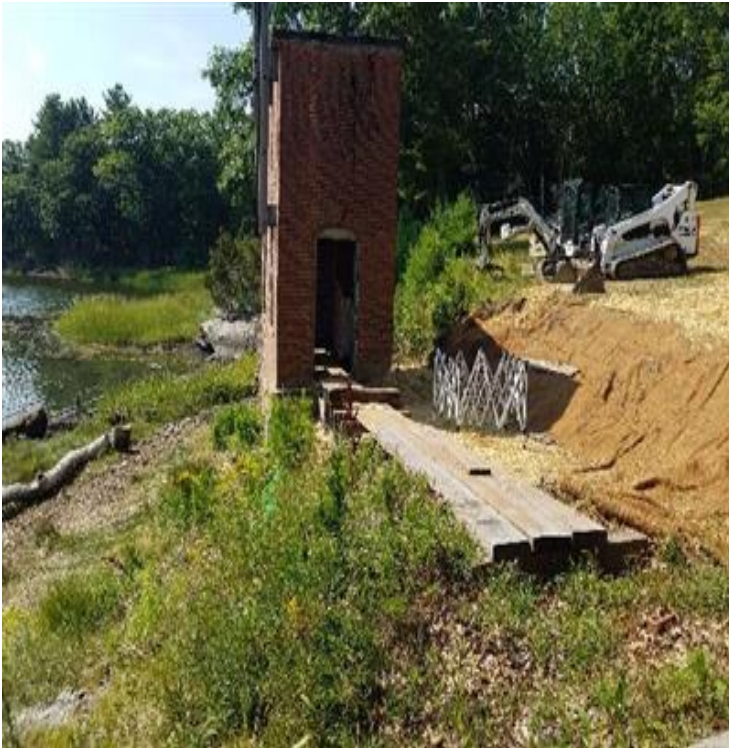
Fig 29: Cable house progress. Viewing south. (7-30-19).

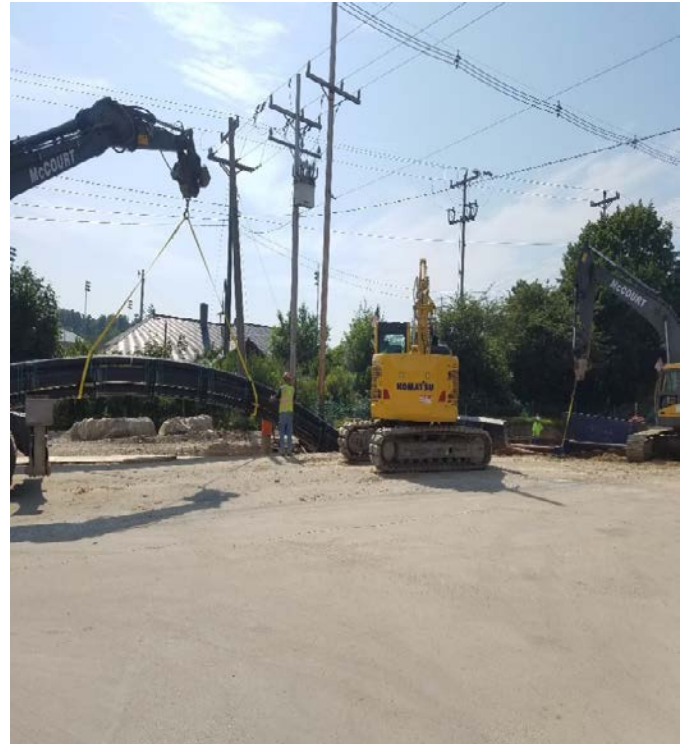
Fig 30: McCourt installing pipe through HOBAS pipe under Main St. Viewing east. (7-31-19).

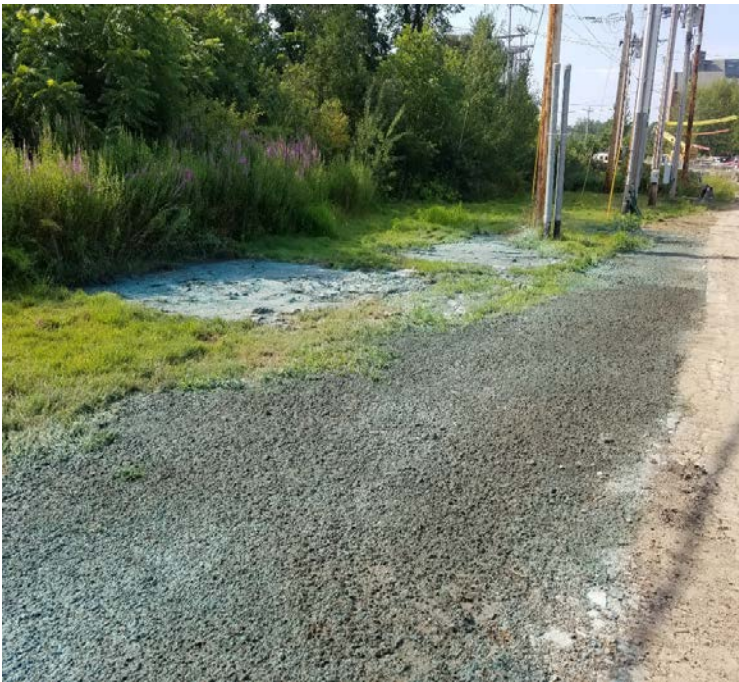
Fig 31: Restoration next to Colovos Rd where dewatering apparatus was installed. Viewing south. (7-31-19).

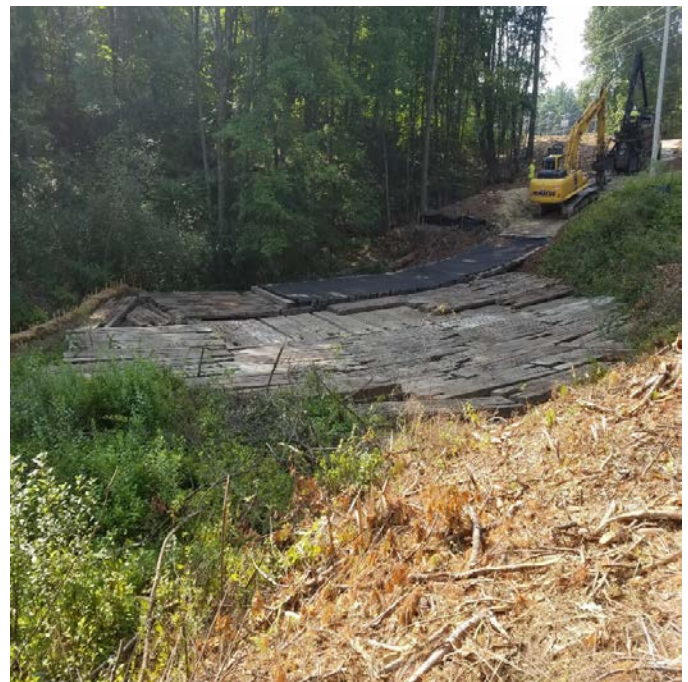
Fig 32: JCR installing timber matting and filter fabric around Str. 28, south of Oyster River. Viewing south. (7-31-19).

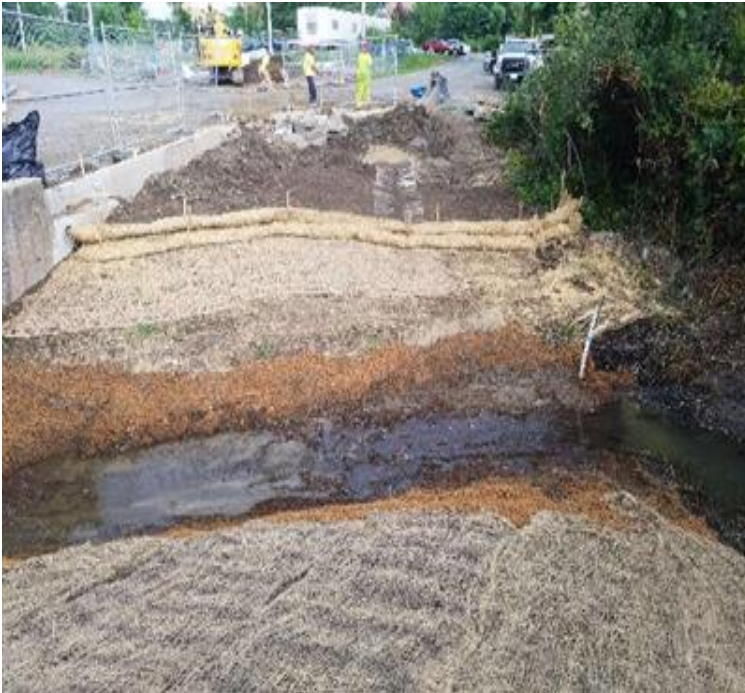
Fig 33: College Brook, finished restoration. Viewing south. (7-31-19).
