### CONSTRUCTION MONITORING REPORT

Eversource Transmission Lines:  
**F107**

**TYPE OF INSPECTION:**     Weekly     Storm Event     Incident     Corrective Action

Date: **08/08/19**    Time: **12:00pm**    'Does this report include a 0.25" storm event?  Yes     No  
If yes, how did you determine whether a 0.25" storm event has occurred?  Rain Gauge     Weather Station  
Storm event information is from Pease Air Force Base.

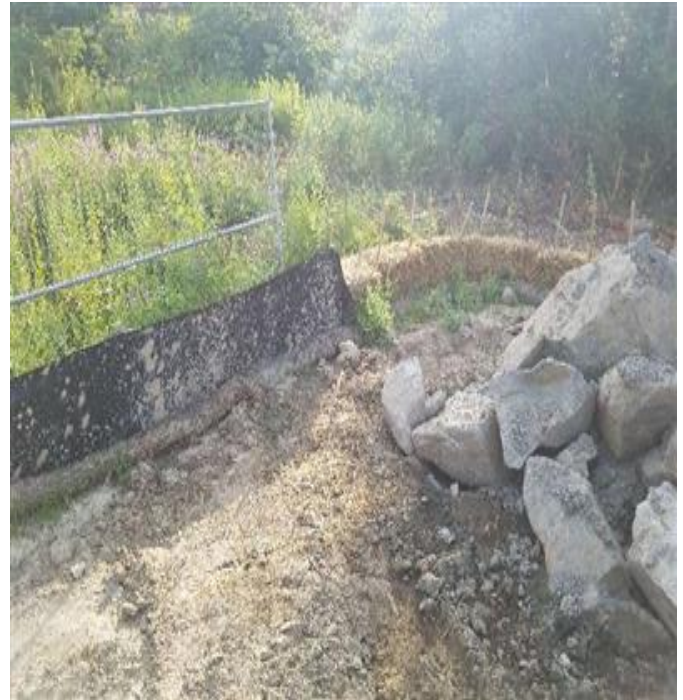
- **BMPs**
  1. Straw bales should be installed in south of the silt fence in low area in Waterworks Rd laydown yard. See photo 8 below.
  2. Silt fence and perimeter fence installed at the Waterworks Rd laydown yard needs repair. Soil and stone has overtopped the silt fence and has punctured the perimeter fence. Soil needs to be pulled back. See photographs 26 & 27 below.

Fig 8: Straw bales installed in the wrong location in the Waterworks Rd laydown yard. Viewing east. (8-03-19).

- Yes, see items 1,2 and 4 above. Others are routine maintenance.

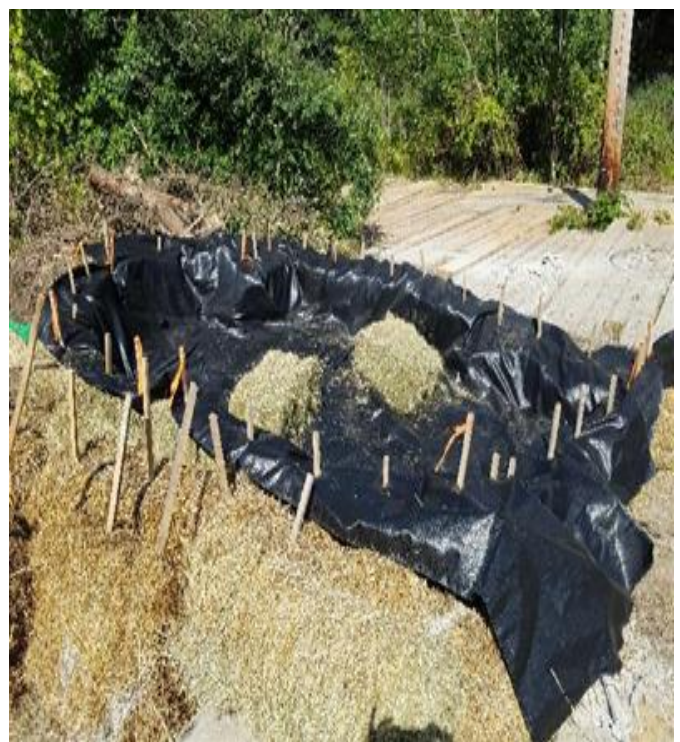
3. Straw bales along Gregg Hall Rd trenching activities need to be installed tightly together, currently there are significant gaps.
  4. Newly constructed dewatering apparatus needs repair. The use of Marafi type fabric was installed instead of the geotextile filter fabric that was previously used. See photographs 12 and 23 below.

Fig 12: Dewatering apparatus installed near Str. 23 for McCourt's trenching activities. Viewing east. (8-05-19).

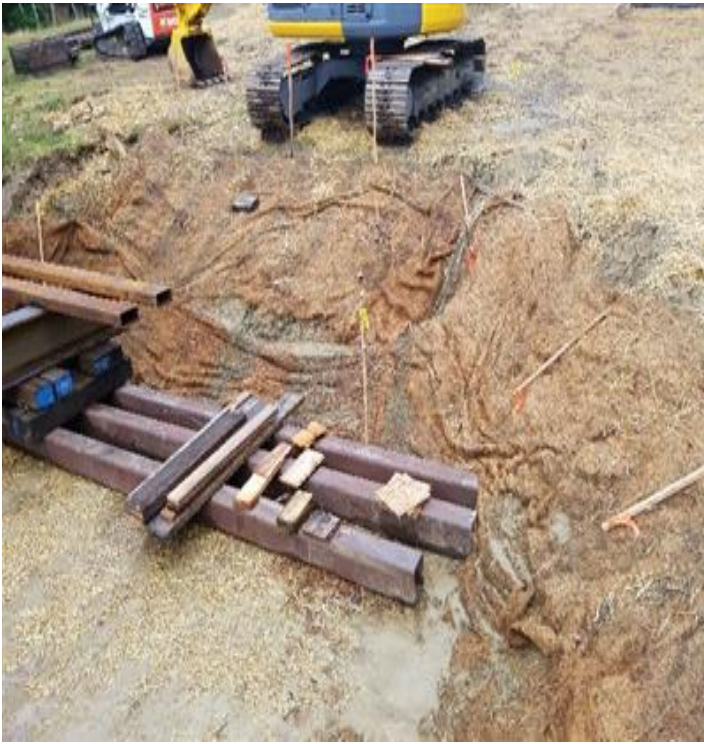
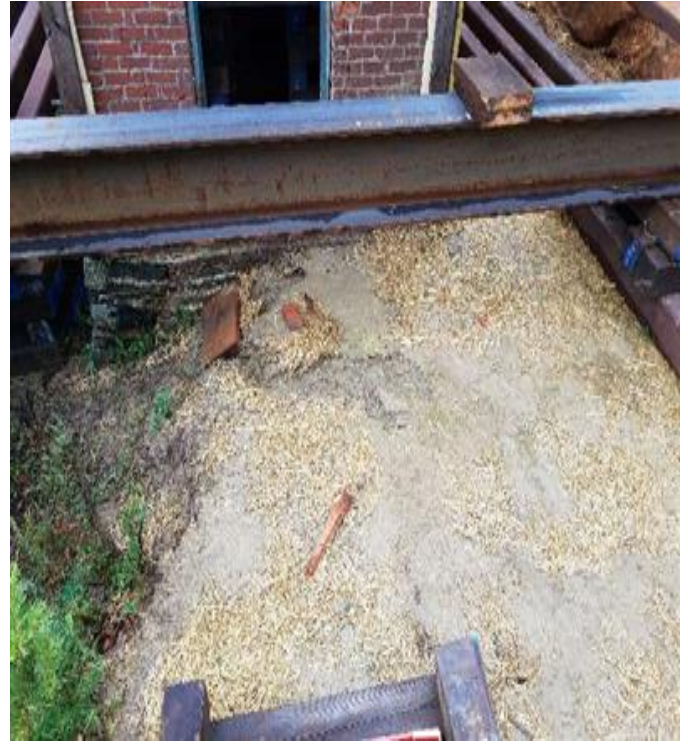
7. Minor slope stabilization at the cable house and additional filter sock needs to be installed. See photos 21 & 22 below.
  8. Slopes of rain garden need repair. Slope erosion due to rain event. See photo 25 below.

Fig 21: Slope erosion at cable house. Viewing west. (8-08-19)

Fig 22: Slope erosion at cable house cont. Viewing west. (8-08-19).

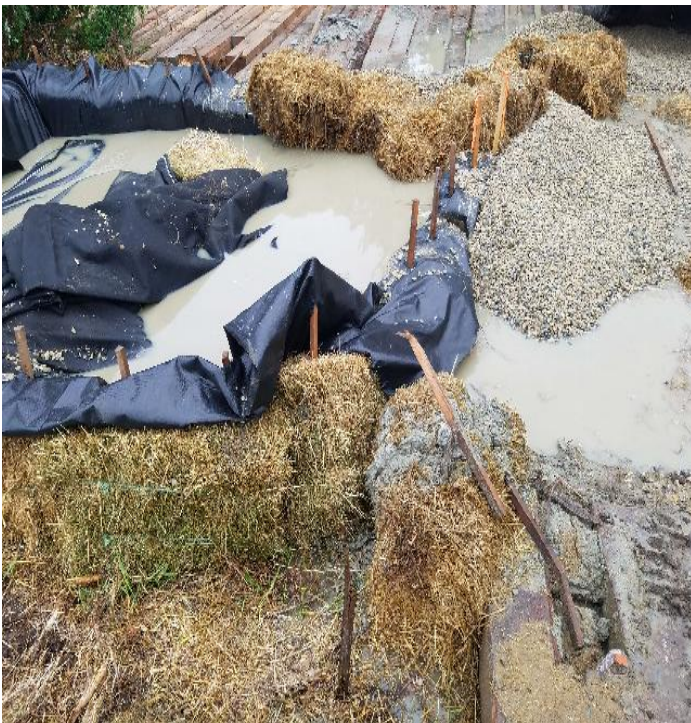
Fig 23: Newly installed dewatering apparatus for trenching activities through Gregg Hall Rd. Viewing east. (8-08-19).

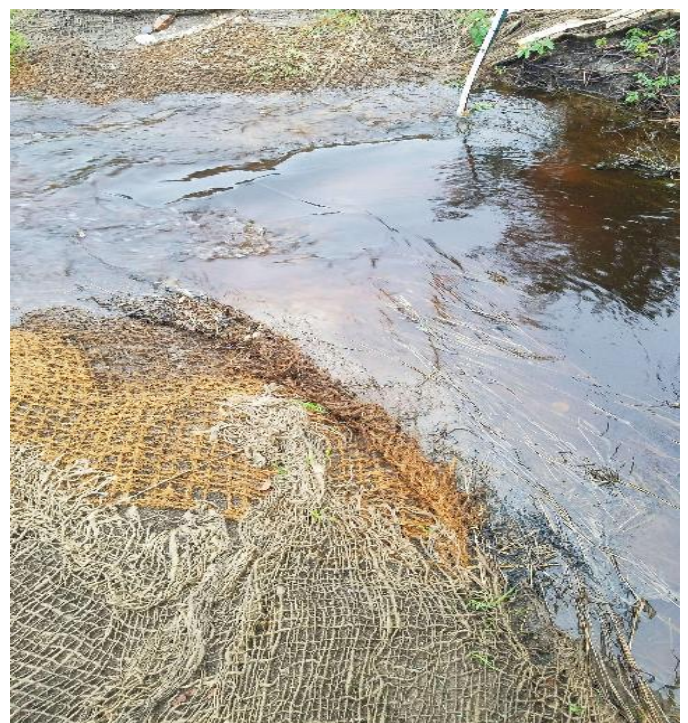
5. Erosion control liner in College Brook needs to be toed in. See photo 24 below.
  6. Minor repairs need to be made to the silt fence around Flynn Pit.

Fig 24: Restored section of College Brook. Viewing south. (8-8-19).

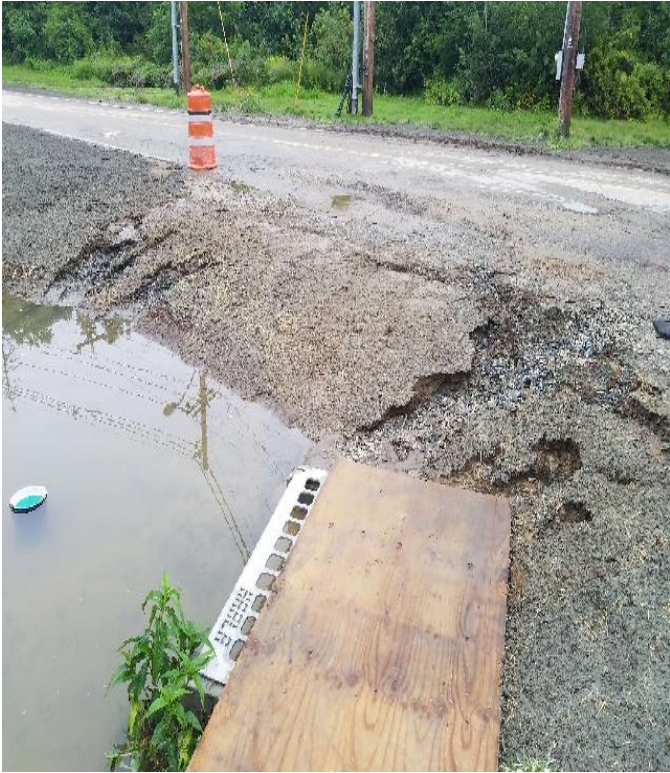
Fig 25: Slope erosion at the rain garden. Viewing northeast. (8-08-19).

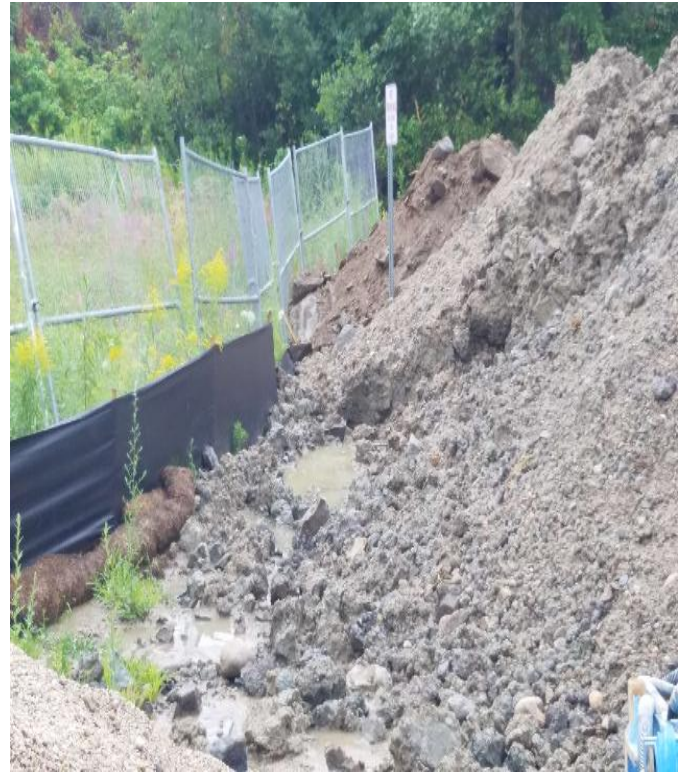
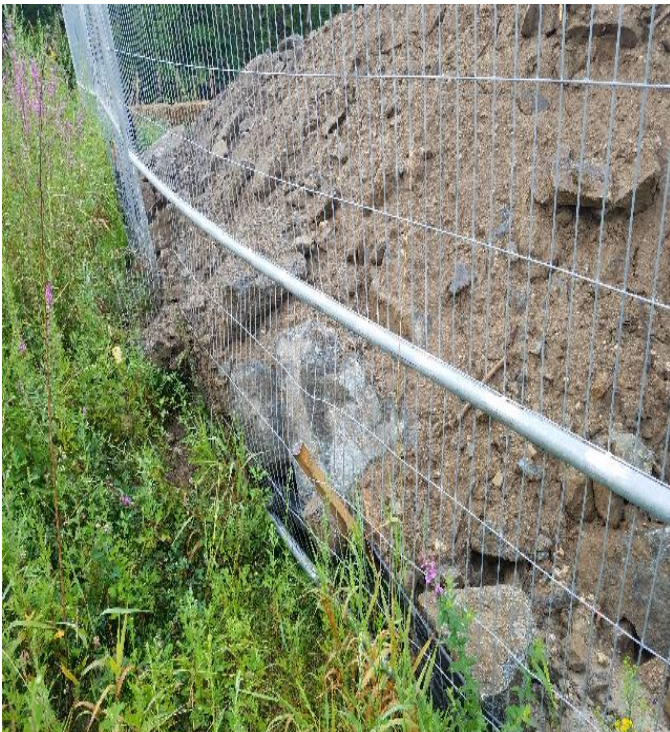
Fig 26: Waterworks Rd laydown yard. Viewing east. (8-08-19).

Fig 27: Waterworks Rd laydown yard. Viewing east. (8-08-19).
