CONSTRUCTION MONITORING REPORT

Eversource Transmission Lines:
F107

**Madbury, Durham,
Newington, Portsmouth,
NH**

TYPE OF INSPECTION: Weekly Storm Event Incident Corrective Action

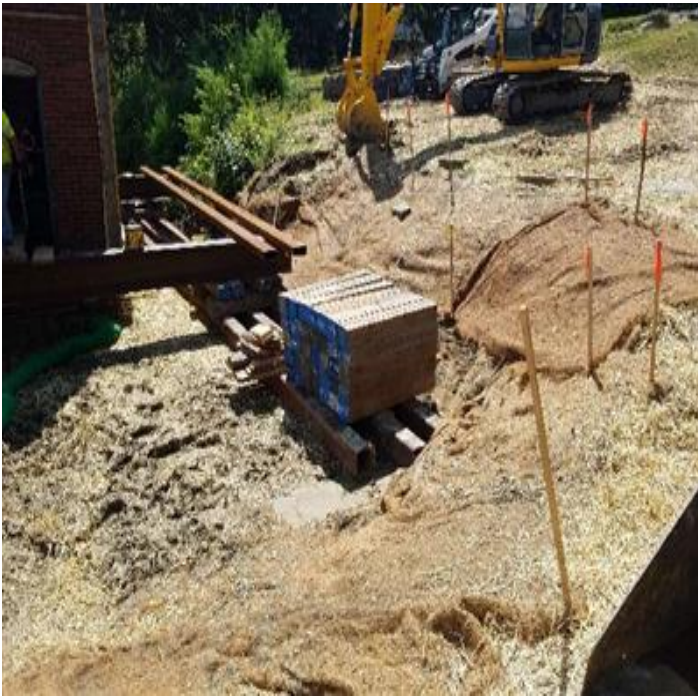
Fig 1: Maintaining blankets around cable house. Viewing south. (8-09-19).

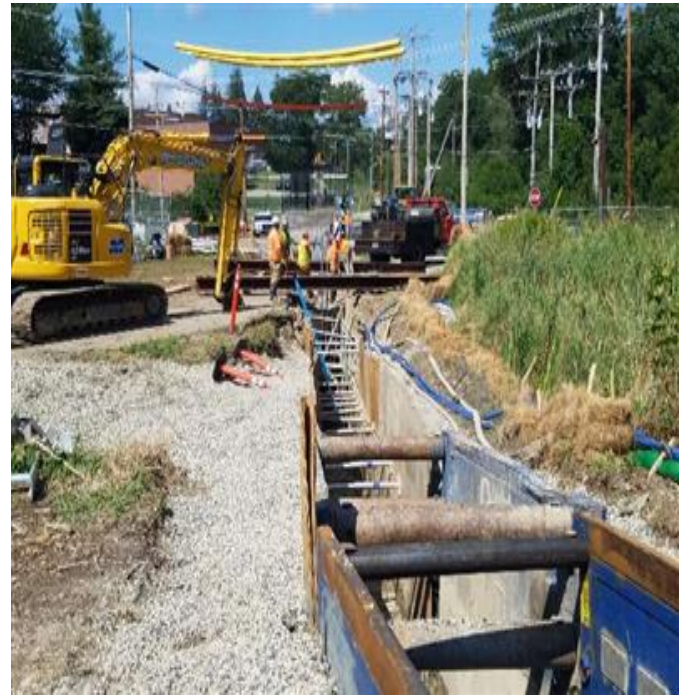
Fig 2: Trenching towards Str. 23. Viewing north. (8.09-19).

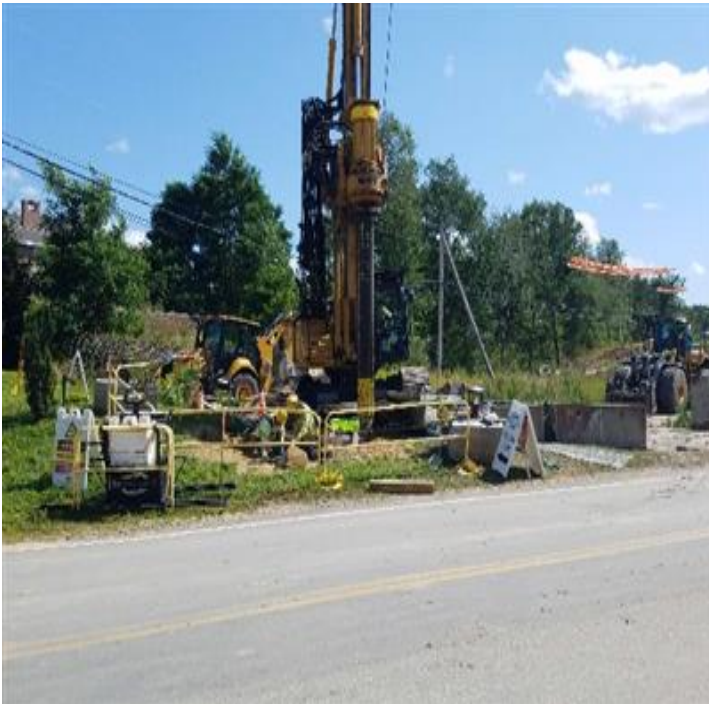
Fig 3: Drilling Str. 24. Viewing southeast. (8-09-19)

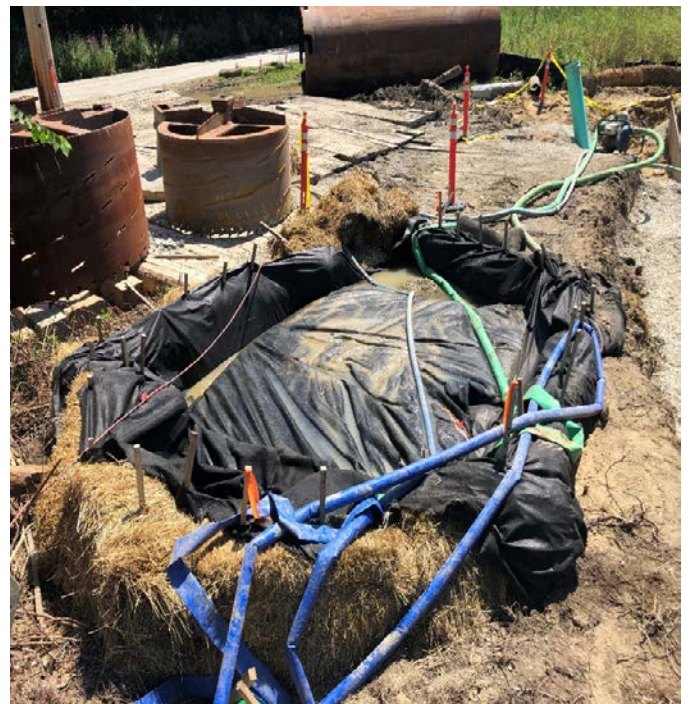
Fig 4 Geotextile fabric installed in dewatering apparatus at Str 23. Viewing south. (8-10-19).

- Waterworks Rd laydown area has been corrected. (Items 1 & 2 in Report 19.) See photo 8 below.
- Newly constructed dewatering apparatus has been repaired. (Item 4 in Report 19.) See photo 4 & 7 below.

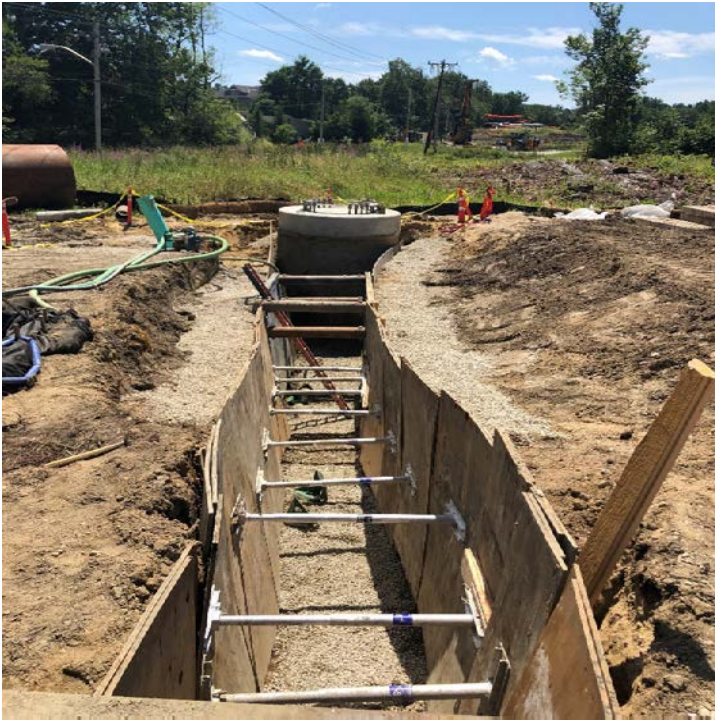
Fig 5: Trenching towards Str. 23. Viewing south. (8-10-19).

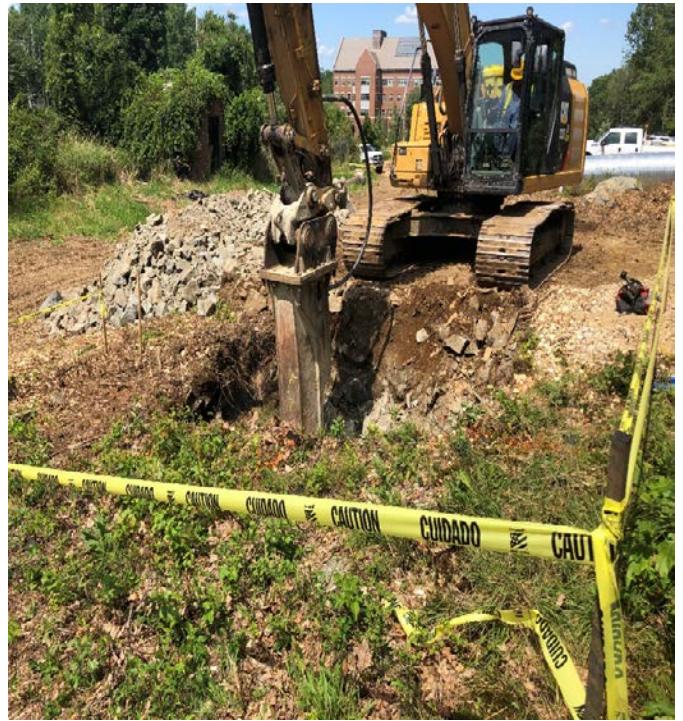
Fig 6: Began excavation for Str. 26. Viewing north. (8-10-19).

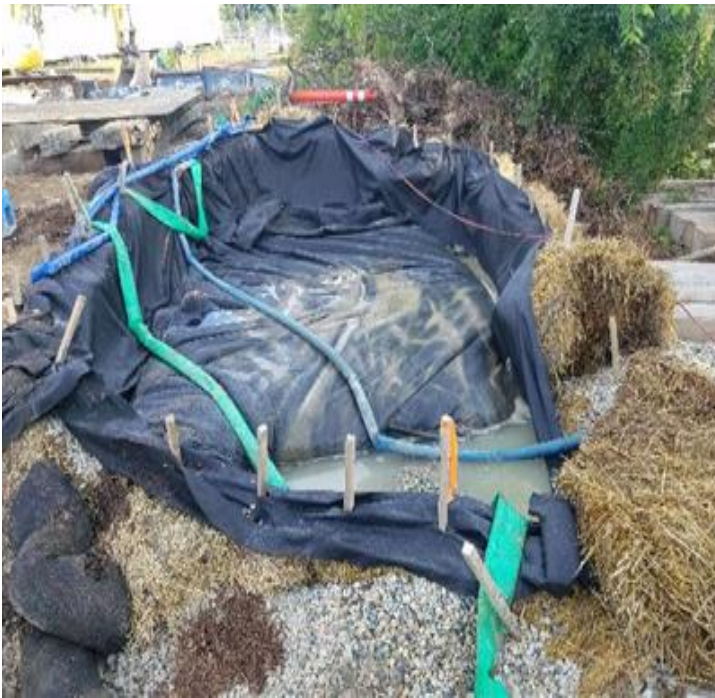
Fig 7: Geotextile filter fabric installed in dewatering apparatus. Viewing north. (8-12-19).

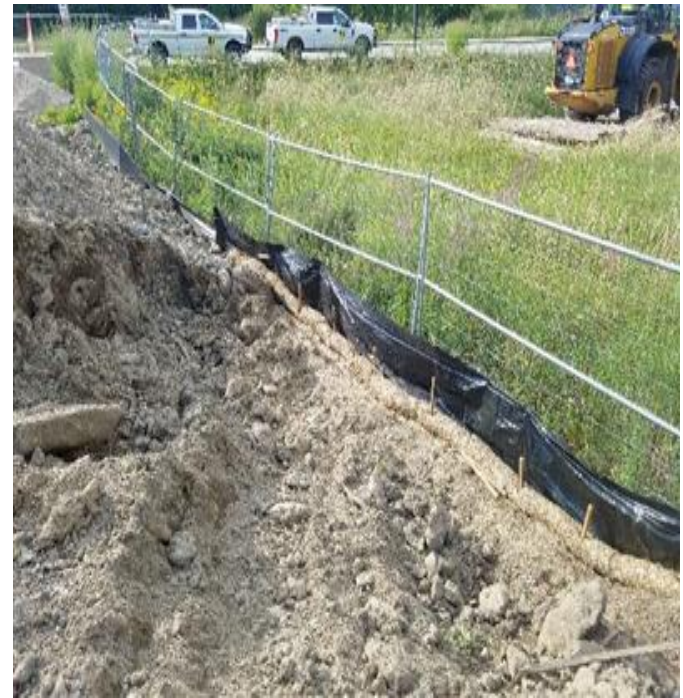
Fig 8: Perimeter and silt fence repairs made in Waterworks Rd laydown yard. Viewing west. (8-12-19).

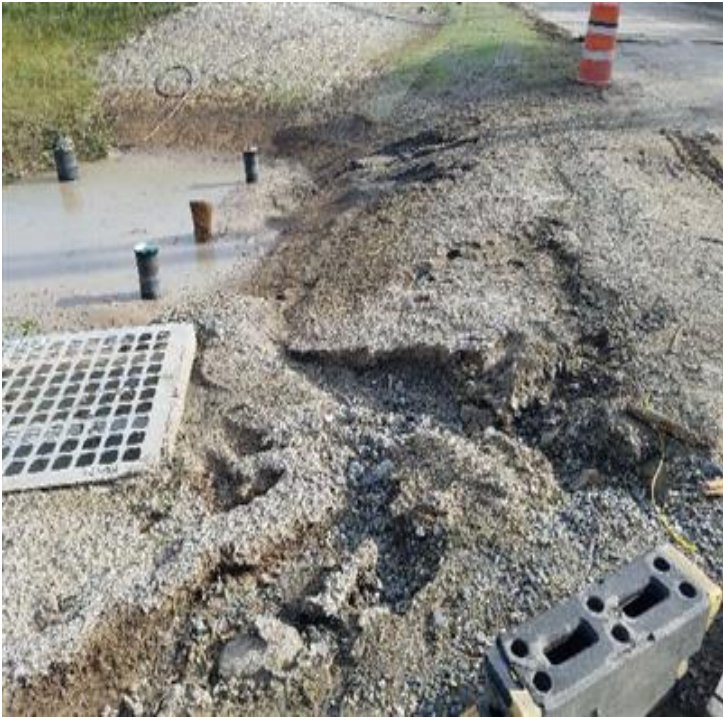
- Environmental liner in College Brook has been toed in. See photo 12 below.
- **BMPs**
 1. Minor repairs need to be made to the silt fence around Flynn Pit.
 2. Slopes of rain garden need repairs. Slope erosion due to rain event. See photo 9 & 11 below.

Fig 9: Erosion rills observed on slopes of the rain garden. Viewing north. Viewing south. (8-12-19).

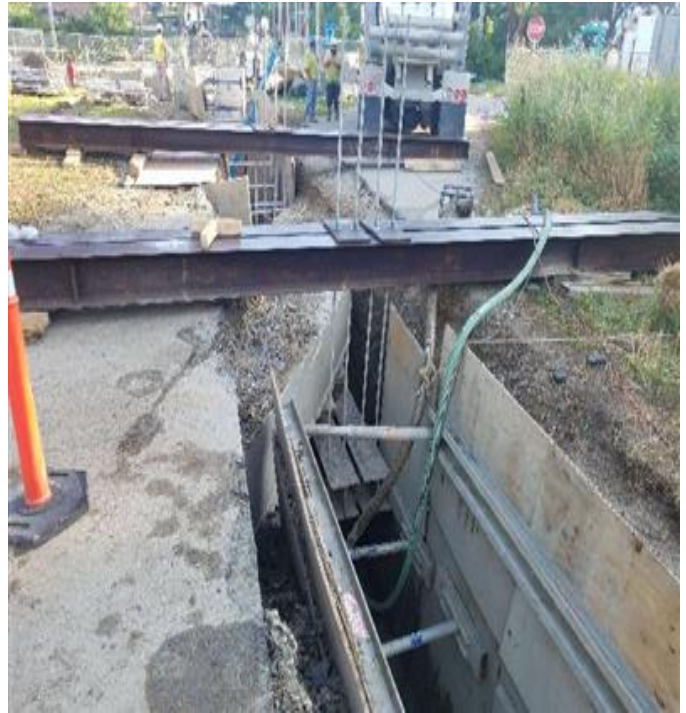
Fig 10: Support beam for duct bank and trenching activities. Viewing north. (8-12-19).

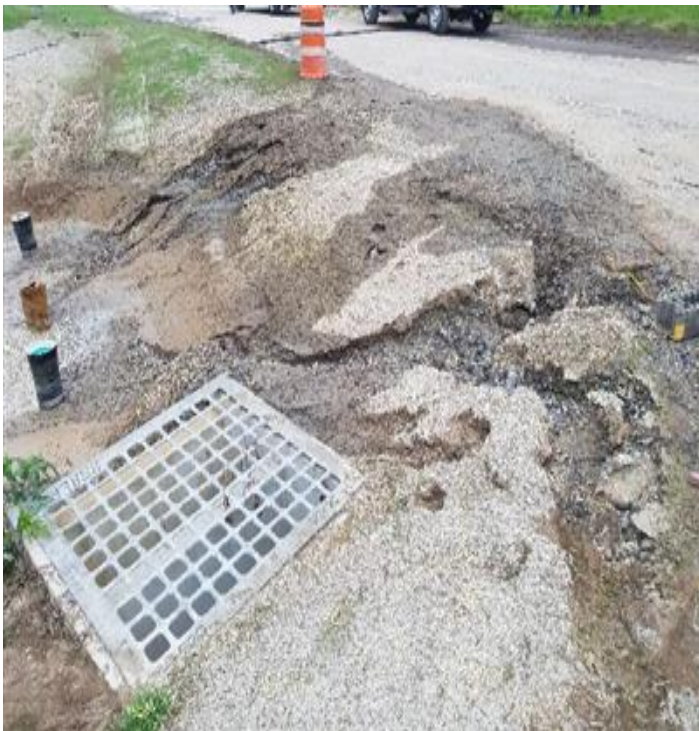
Fig 11: Erosion rills observed on slopes of the rain garden cont. Viewing north. (8-13-19).

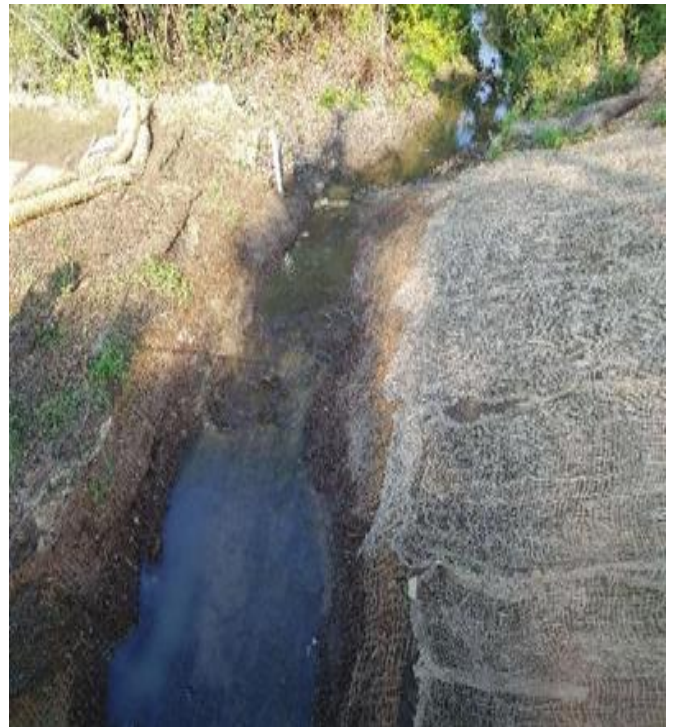
Fig 12: Repairs made to jute liner / blanket in College Brook. Viewing west. (8-13-19).

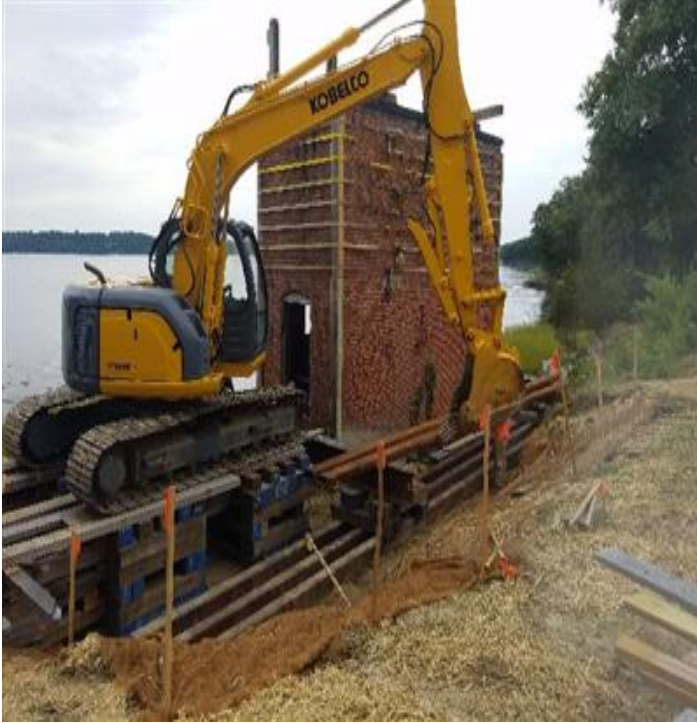
Fig 13: Gratan continues to assemble braces for the cable house. Viewing west. (8-13-19).

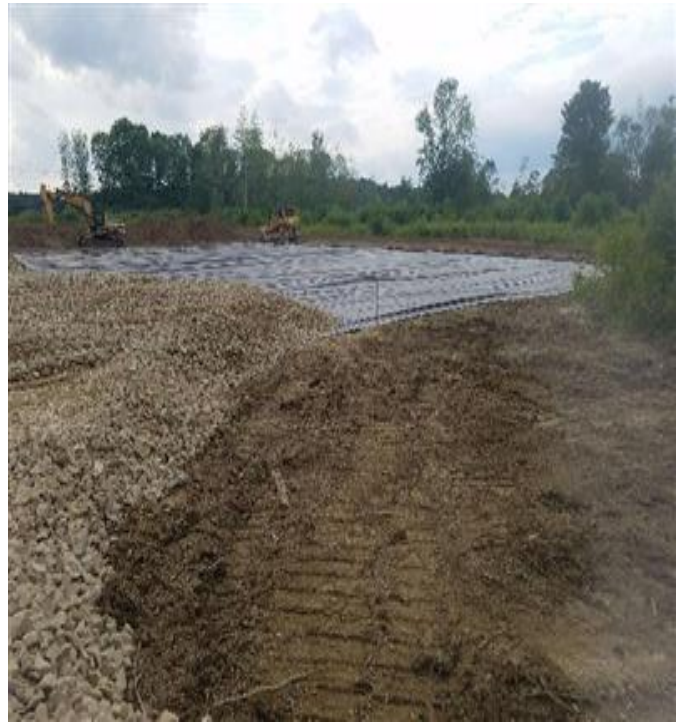
Fig 14: Progress of the Shattuck Road laydown area. Viewing west. (8-13-19).

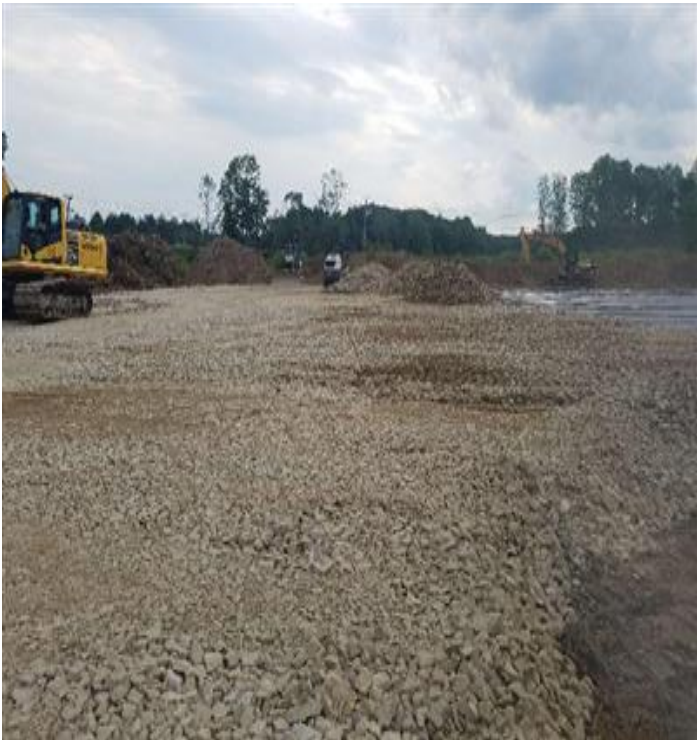
Fig 15: Progress of the Shattuck Road laydown area. Viewing west. (8-13-19).

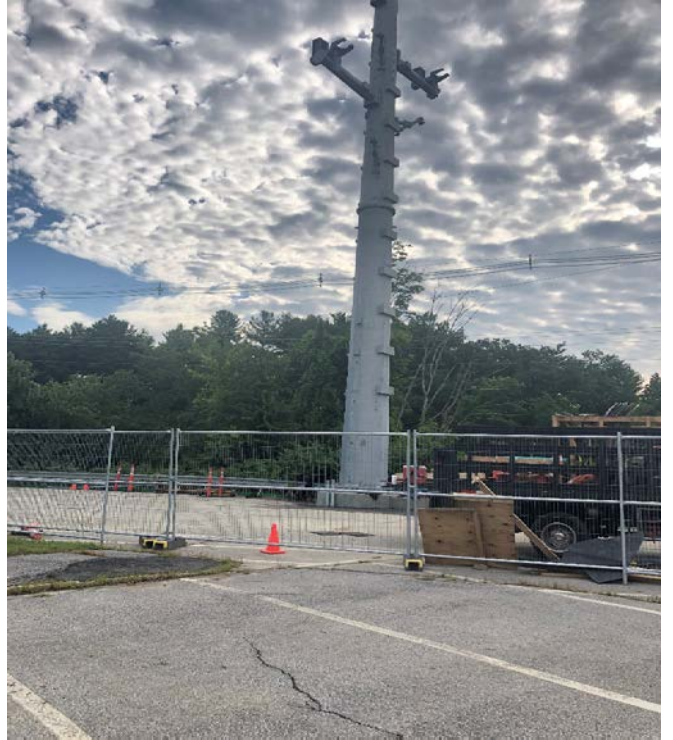
Fig 16: Str. 22 assembled in (A) Lot. Viewing east. (8-14-19).

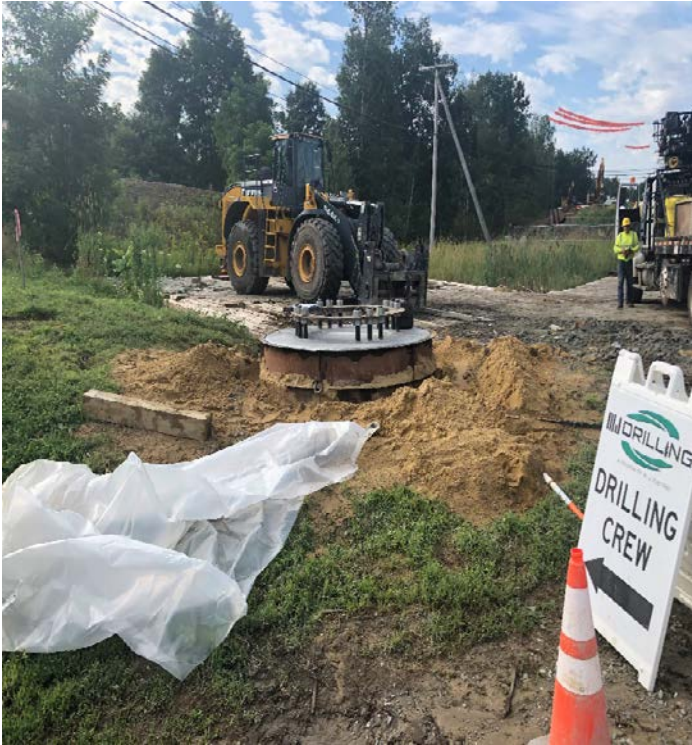
Fig 17: Str. 24 foundation. Viewing south. (8-14-19).

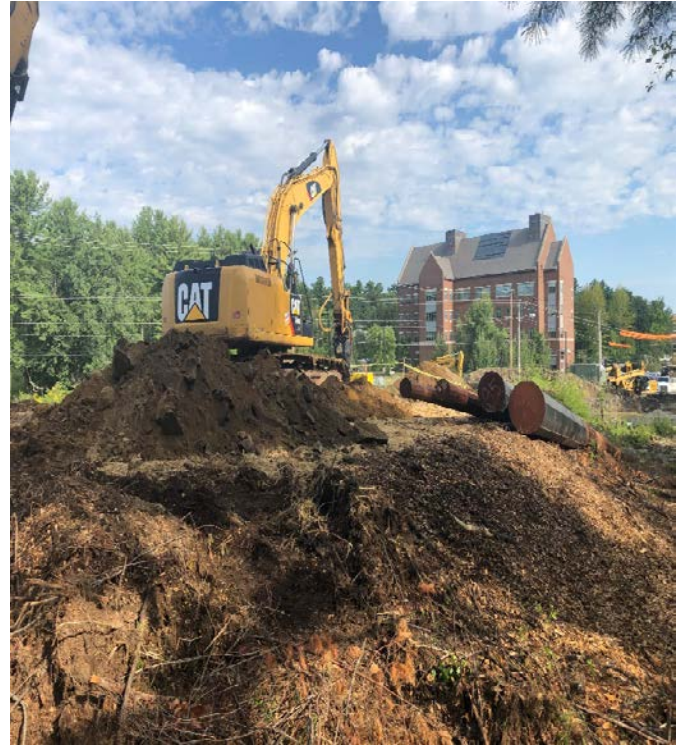
Fig 18: Excavating for Str. 25. Viewing north. (8-14-19).

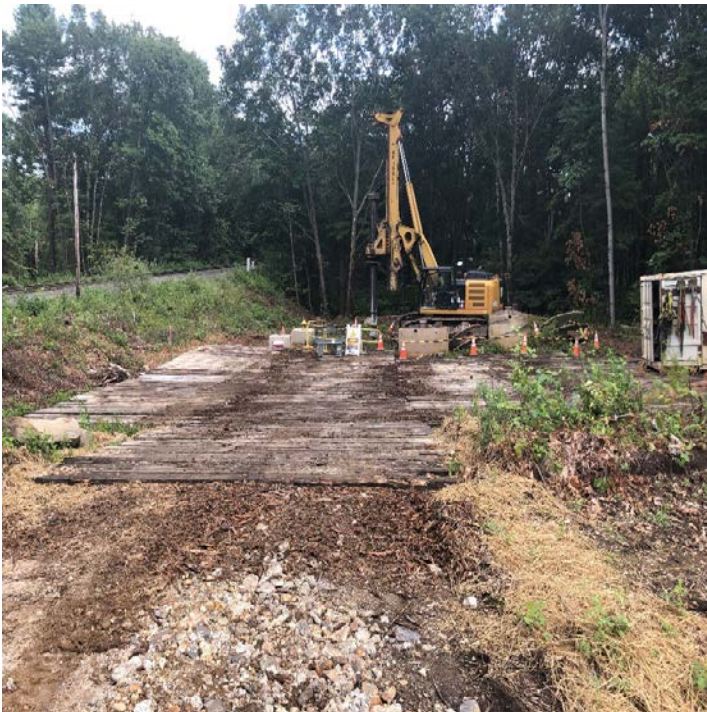
Fig 19: Prepping to drill Str. 30. Viewing south. (8-14-19).

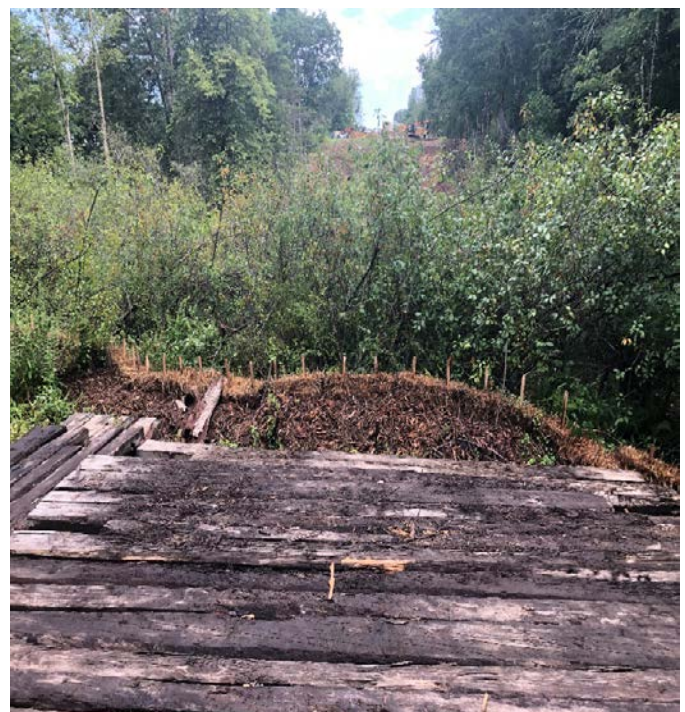
Fig 20: Siltation controls installed between Str. 28 work pad and wetland DW49. Viewing north. (8-14-19).
