### CONSTRUCTION MONITORING REPORT

Eversource Transmission Lines:  
**F107**

**Madbury, Durham,  
Newington, Portsmouth, NH**

**TYPE OF INSPECTION:**     Weekly     Storm Event     Incident     Corrective Action

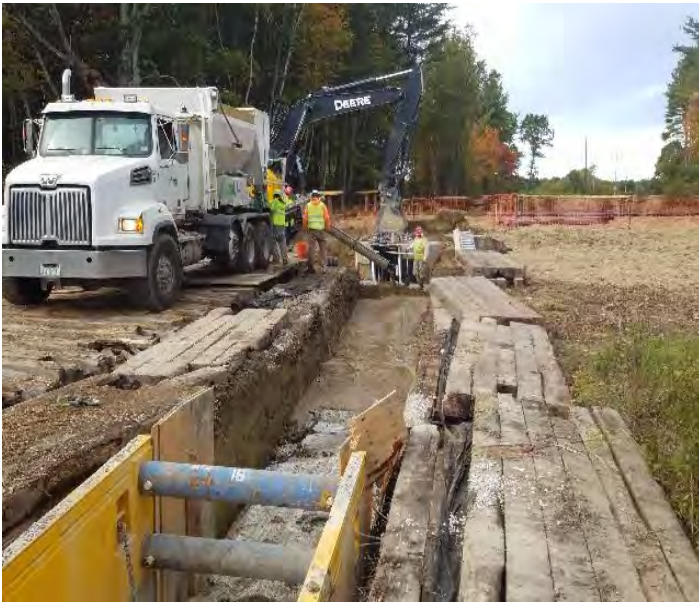
Fig 1: Pouring float fill in trench at Str. 106. Viewing west. (10-11-19).

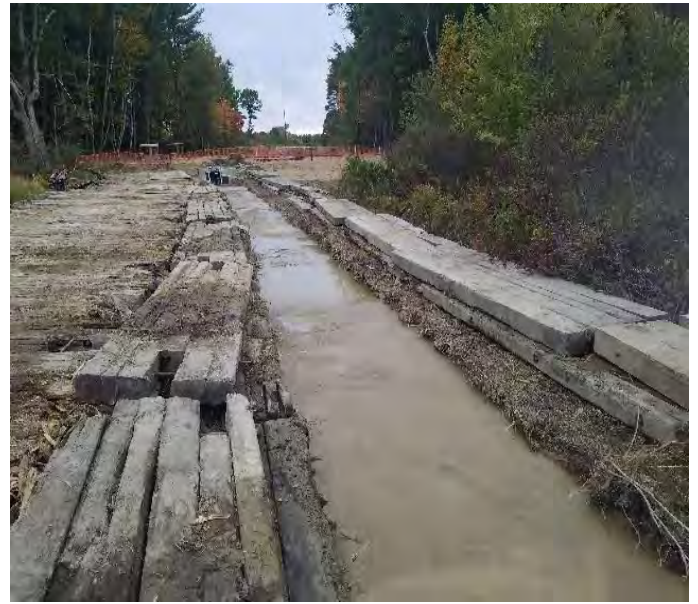
Fig 2: Float fill in trench at Str. 106. Viewing east. (10-11-19).

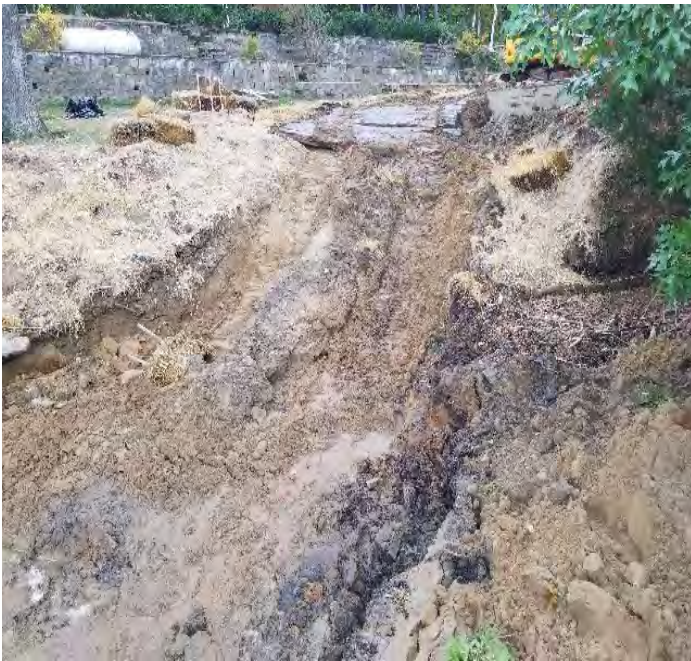
Fig 3: Blu Rock began trenching activities in intertidal zone at Beswick property. Viewing northeast (10-11-19).

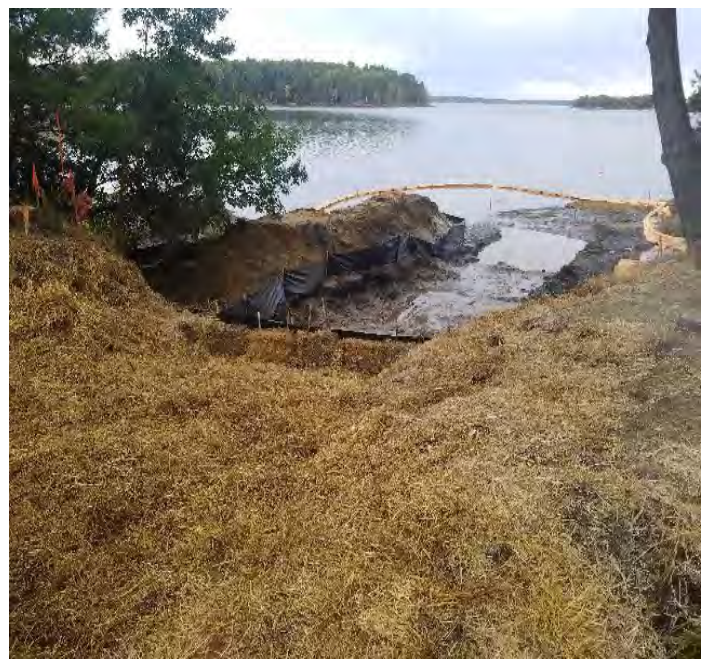
Fig 4: Sediment controls installed on the east side of the Bay. Viewing west. (10-11-19).

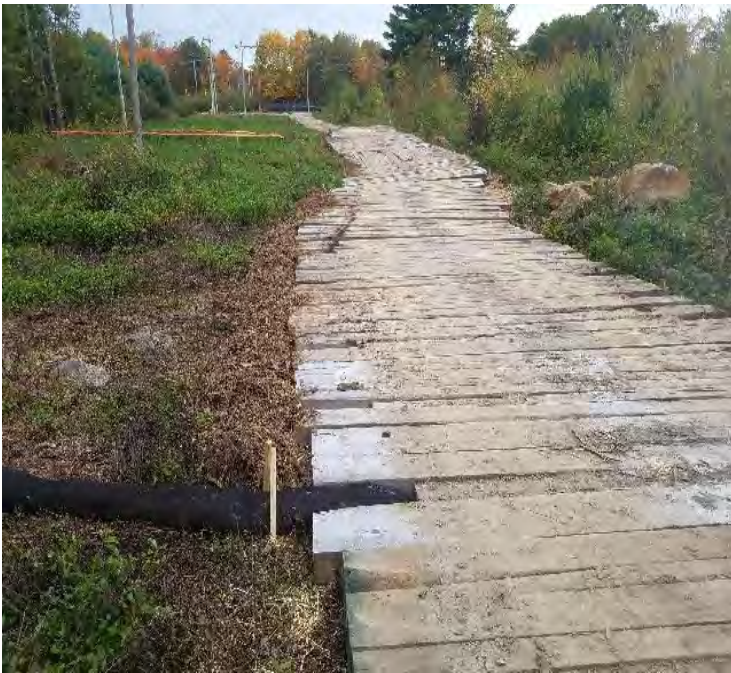
Fig 5: Access road to Str. 48. Viewing west. (10-11-19).

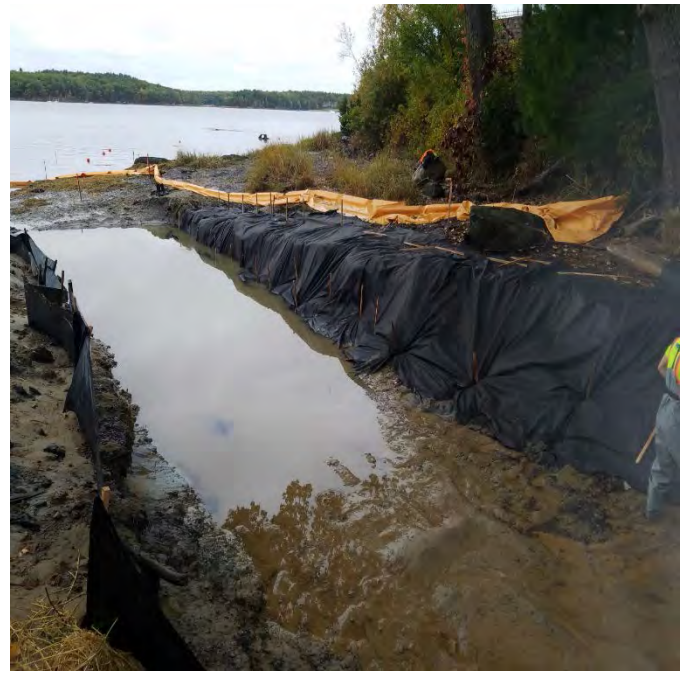
Fig 6: Bank stabilization in trench on the east side of the Bay. Viewing west. (10-12-19).

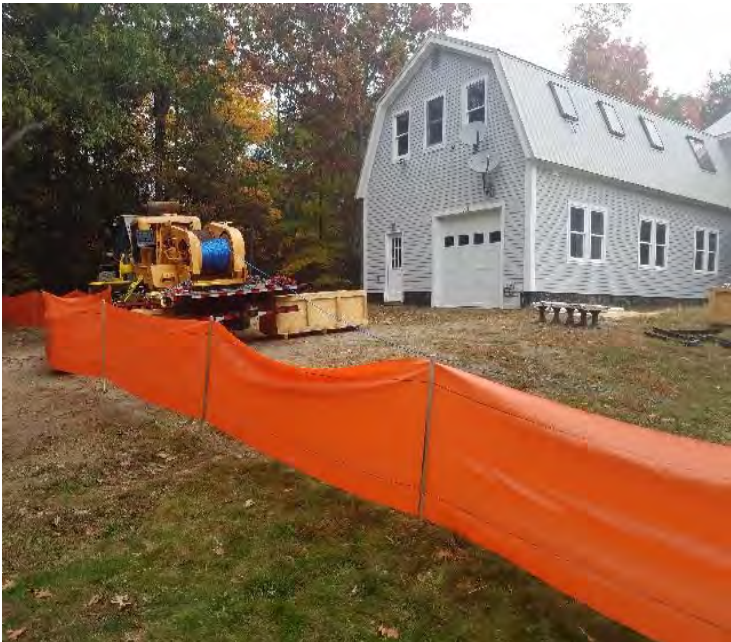
Fig 7: Red zone established at the Getchell property. Viewing north. (10-14-19).

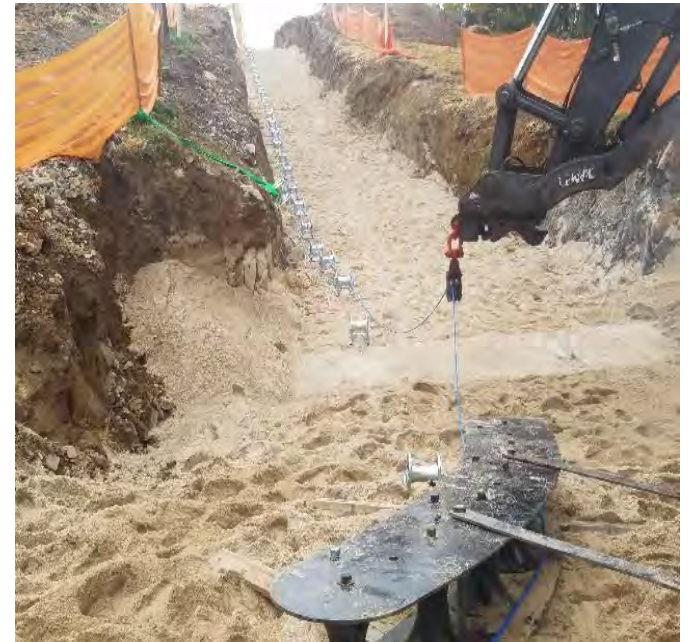
Fig 8: Prepping to pull the cable at the Getchell property. Viewing east. (10-14-19).

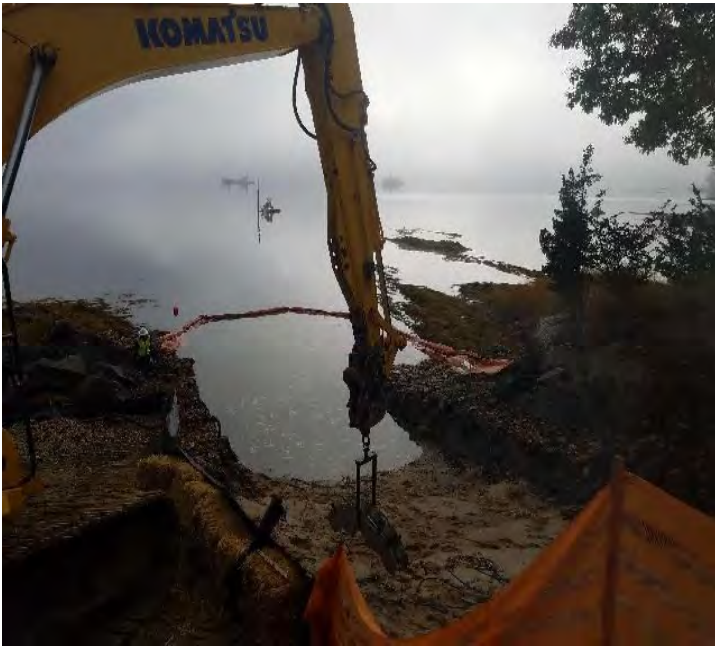
Fig 9: Prepping to pull the cable at the Getchell property. Viewing east. (10-14-19).

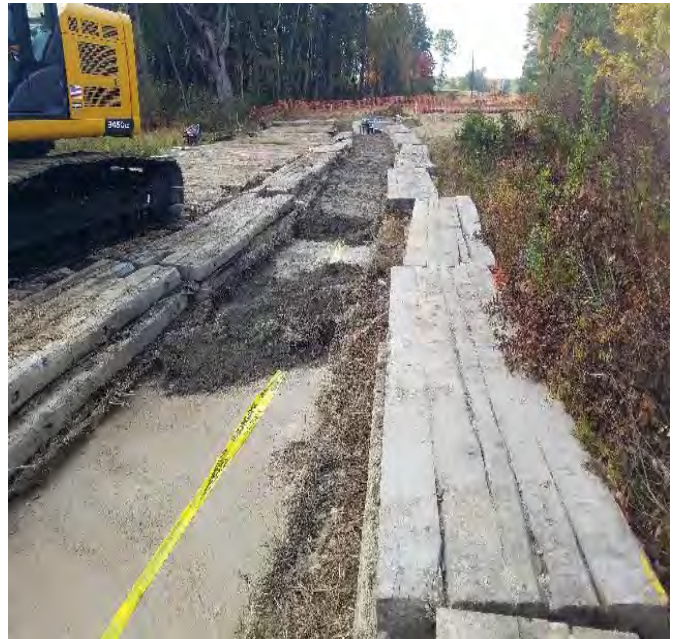
Fig 10: Restoration of trench through wetland NW16 on the Frink farm. Viewing west. (10-14-19).

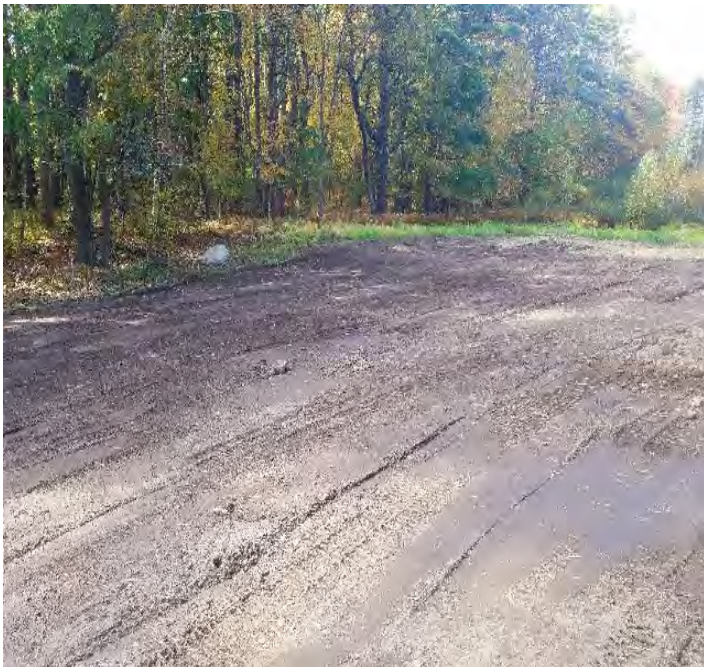
Fig 11: Spreading loam at Str. 100. Viewing west. (10-14-19).

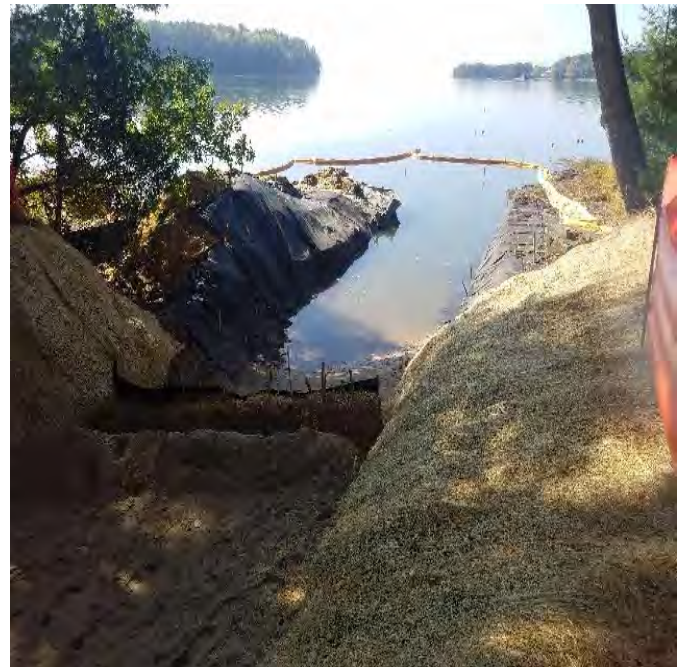
Fig 12: Sediment controls on the east side of the Bay. Viewing west. (10-14-19).

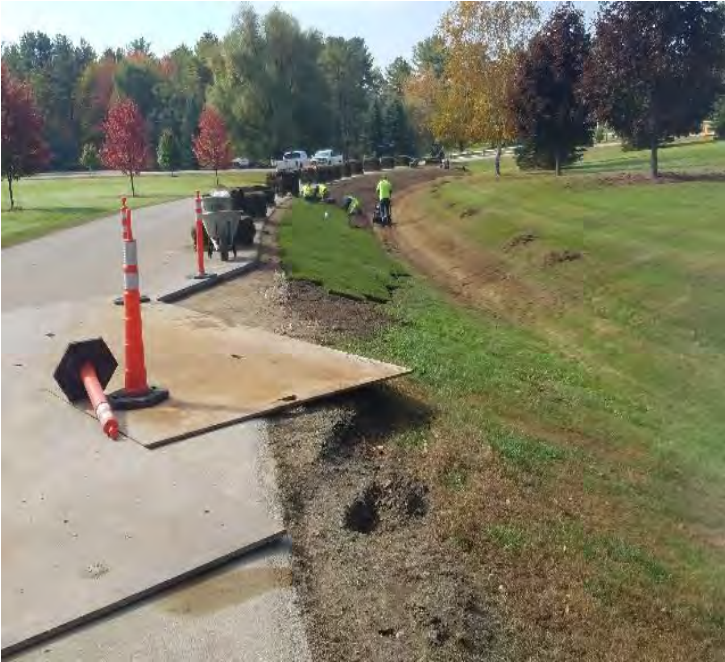
Fig 13: Crew placing sod over restored trench along Gundalow landing. Viewing west. (10-14-19).

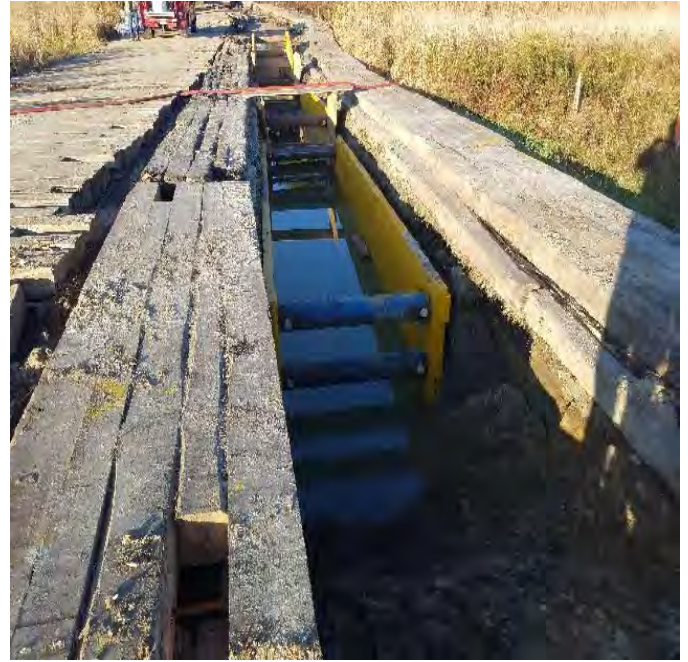
Fig 14: Accumulation of groundwater in trench at Frink farm. Viewing west. (10-15-19).

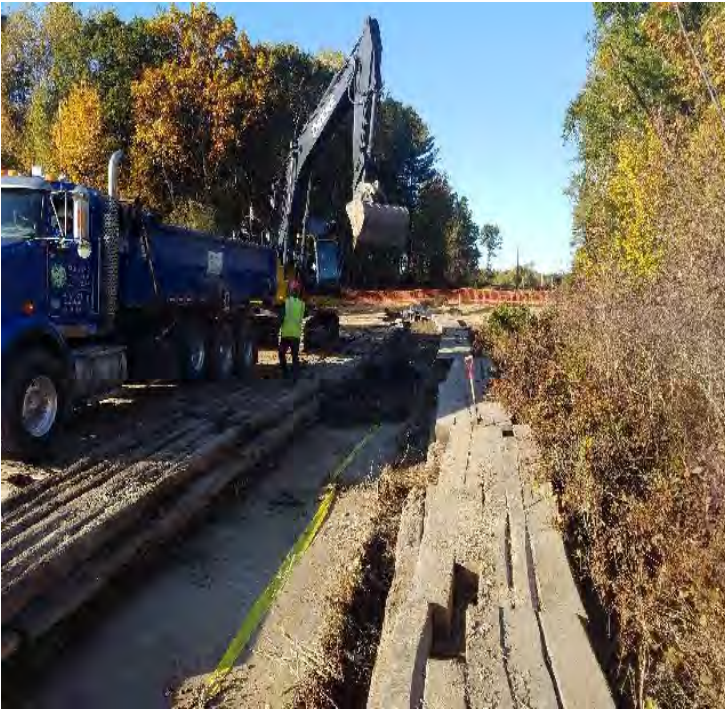
Fig 15: Restoring wetland NW16. Viewing west. (10-15-19).

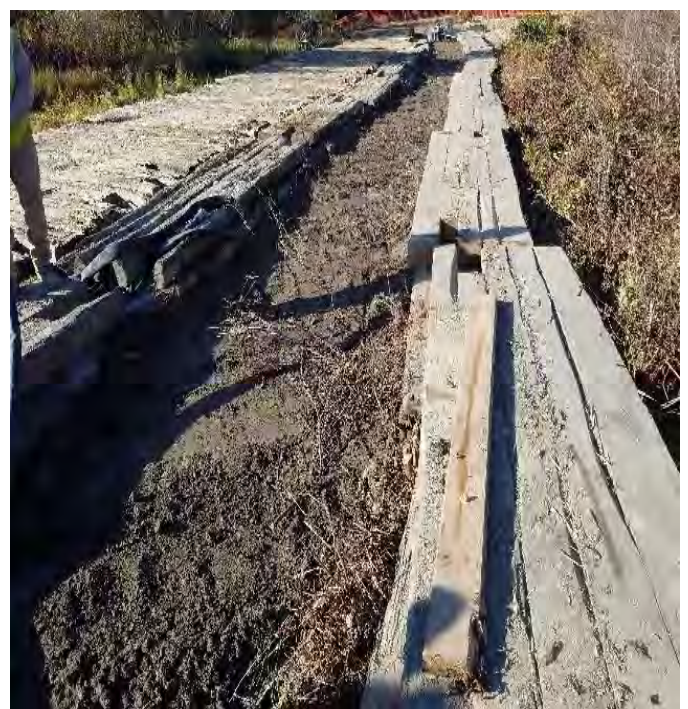
Fig 16: Restoring wetland NW 16. Viewing west. (10-15-19).

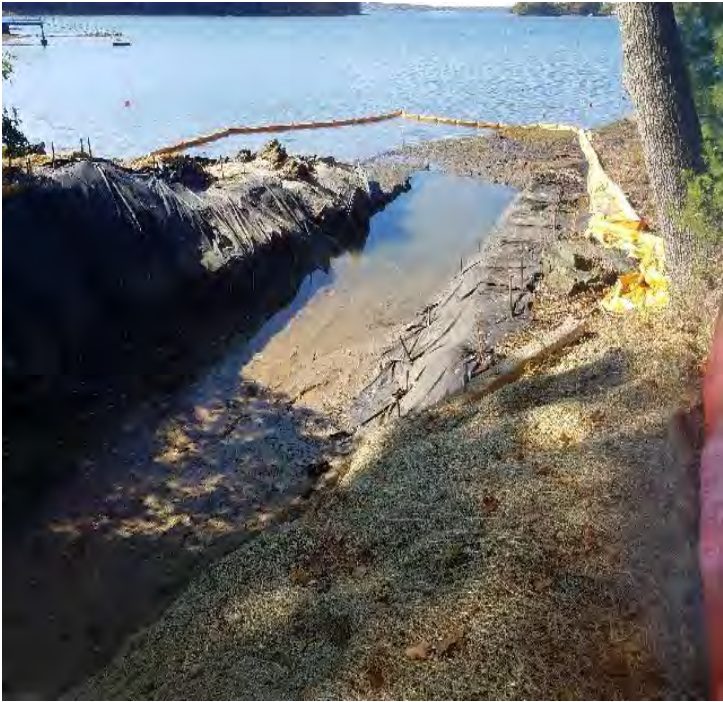
Fig 17: Intertidal trench on the east side of the Bay. Viewing southwest. (10-15-19).

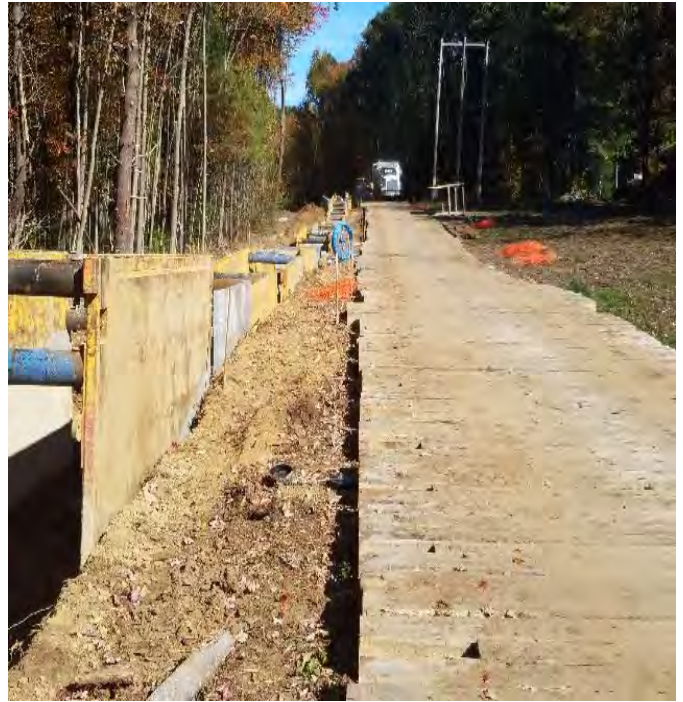
18: Trenching activities from Str. 107 westward. Viewing east. (10-15-19).

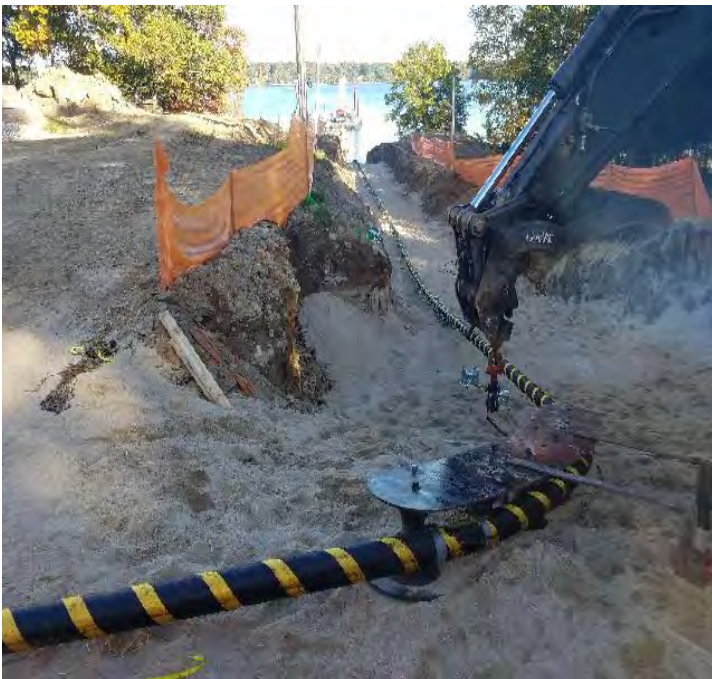
Fig 19: Cable pull on the west side of the Bay. Viewing east. (10-15-19).

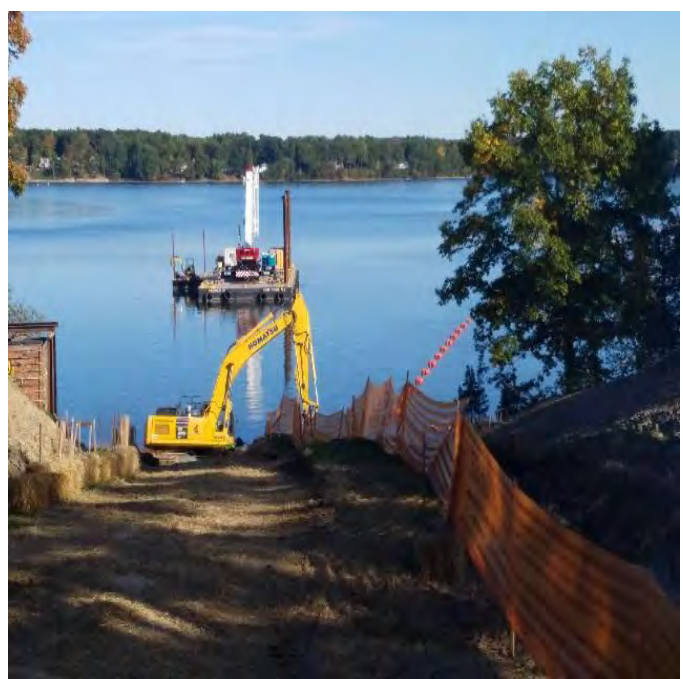
Fig 20: Cable pull on the west side of the Bay. Viewing east. (10-15-19).

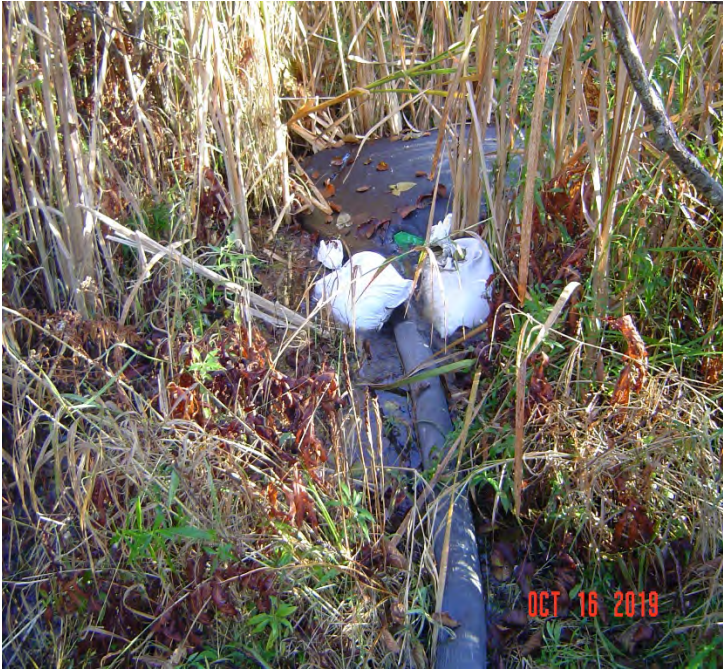
Fig 21: Knights brook diversion discharge area. Viewing north. (10-16-19).

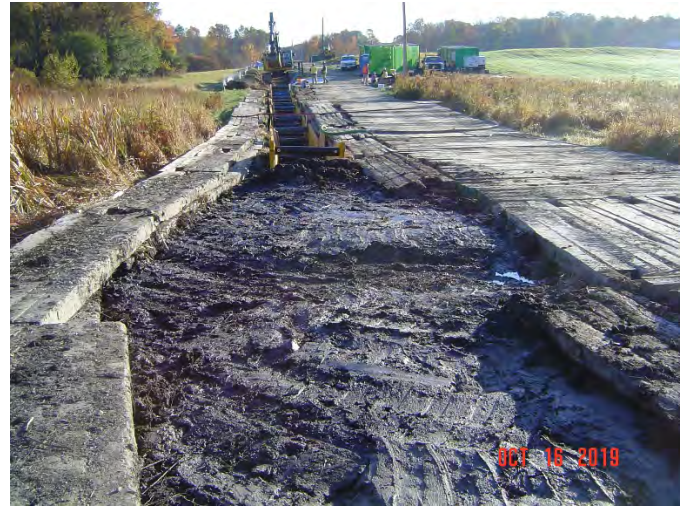
Fig 22: Restoring wetland soils in wetland NW 16. Viewing east. (10-16-19).

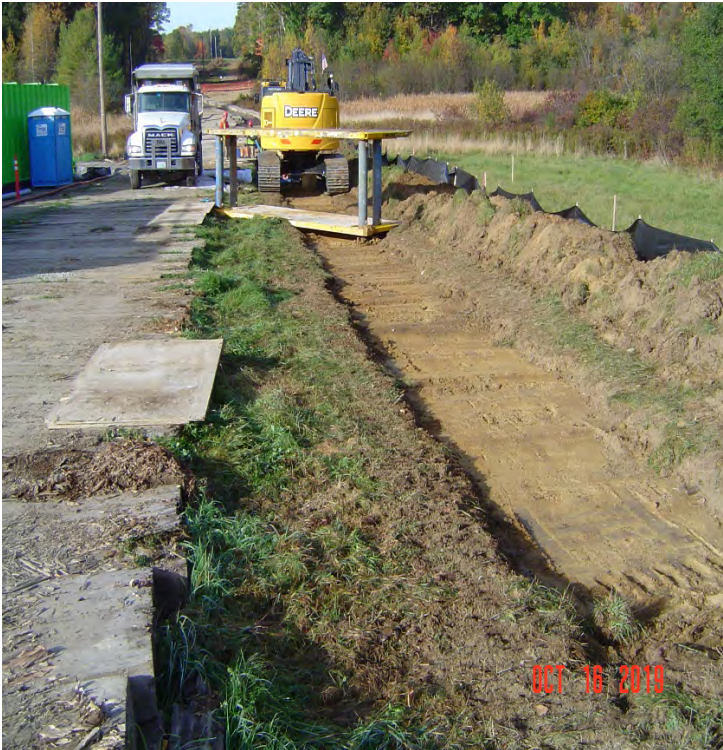
Fig 23: Stripping topsoil in agricultural zone at Frink farm. Viewing west. (10-16-19).

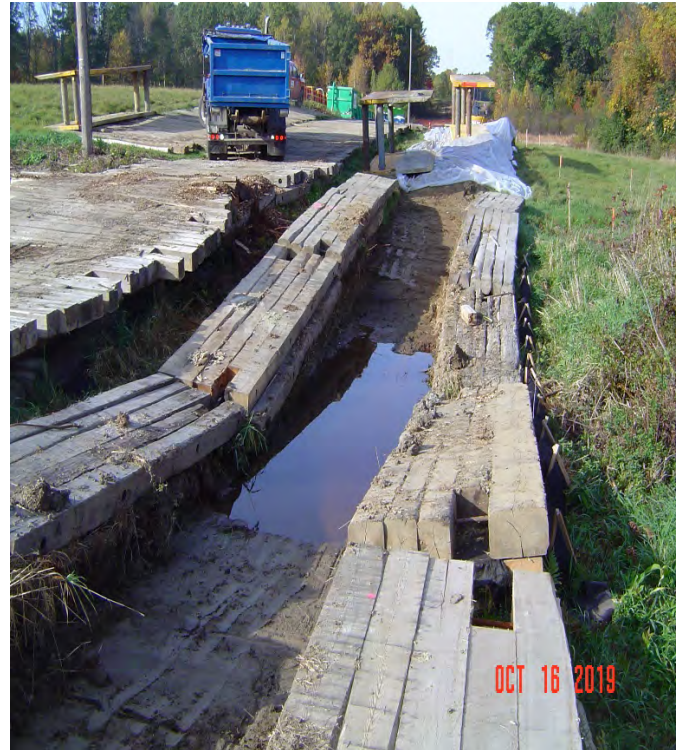
Fig 24: Stripping topsoil through wetland NW 18. Viewing west. (10-16-19).

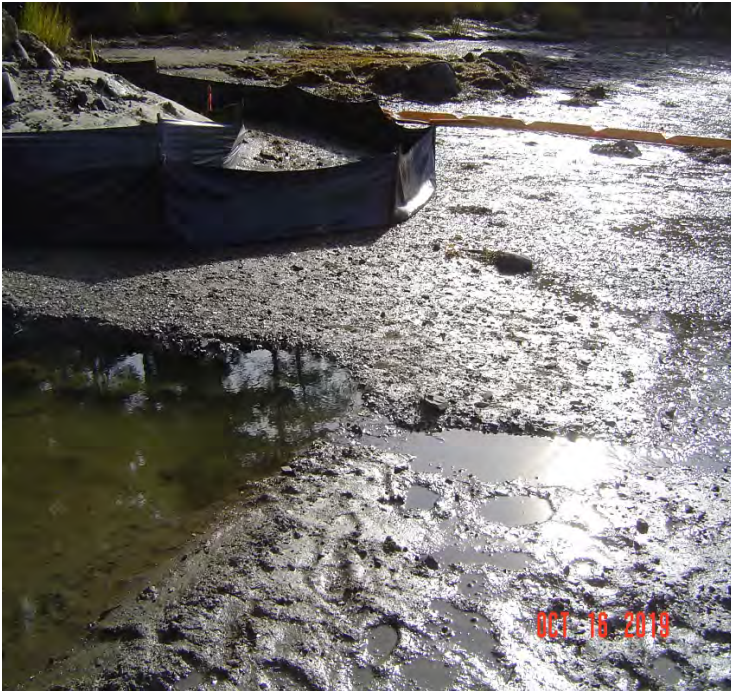
Fig 25: Sediment controls in intertidal zone on the east side of the Bay.

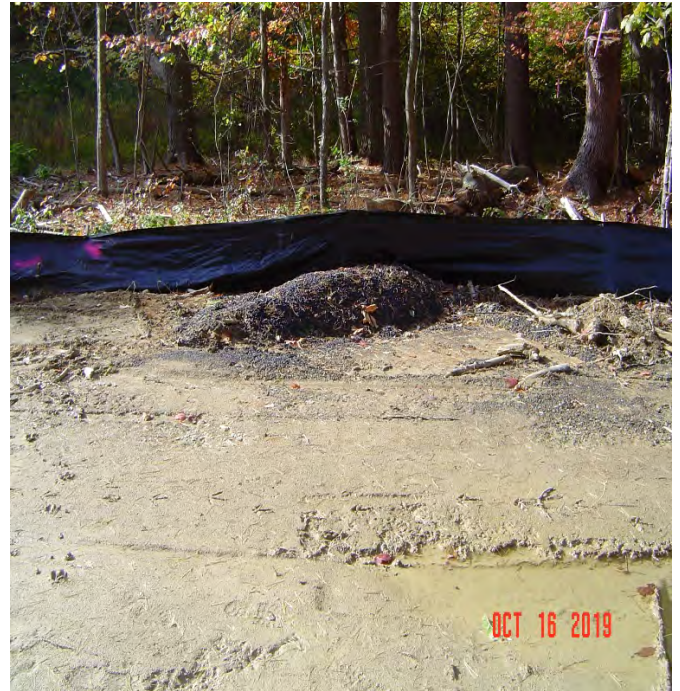
- **BMPs**
  - Cold patch asphalt needs to be removed from the site at Flynn pit. See photo 26 below.

Fig 26: Cold patch asphalt needs to be removed at Flynn Pit. Viewing south. (10-16-19).

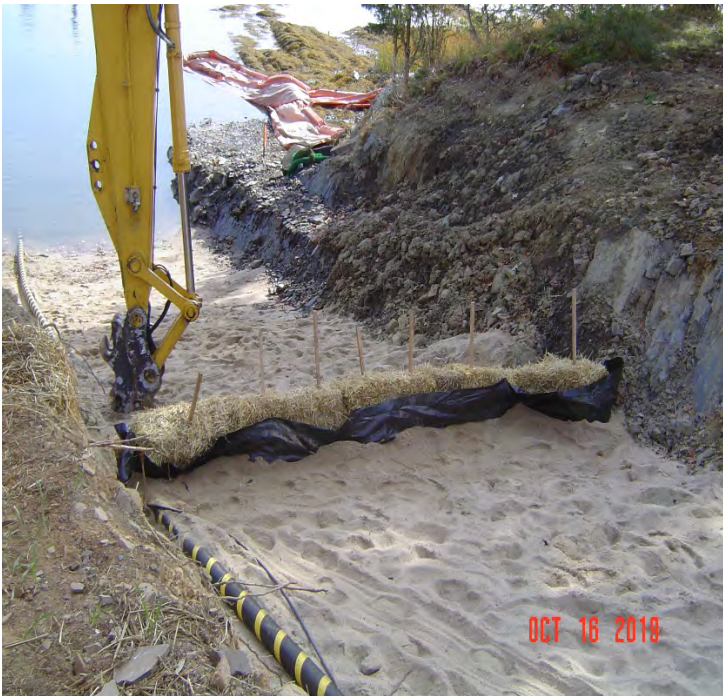
Fig 27: Sediment controls on the west side of the Bay. Viewing east. (10-16-19).

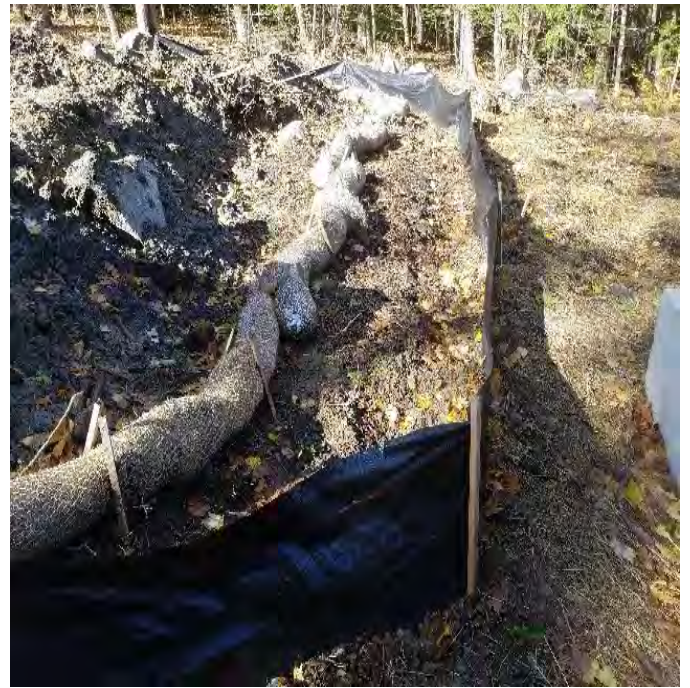
Fig 28: Sediment controls downslope from Str. 29. Viewing west. (10-18-19).

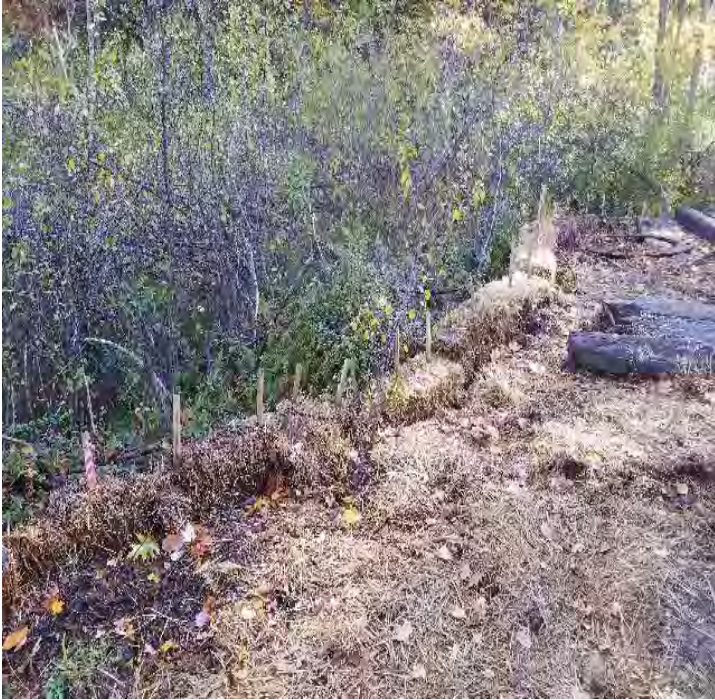
Fig 29: Sediment control upkeep and maintenance along Oyster River. Viewing east (10-18-19).

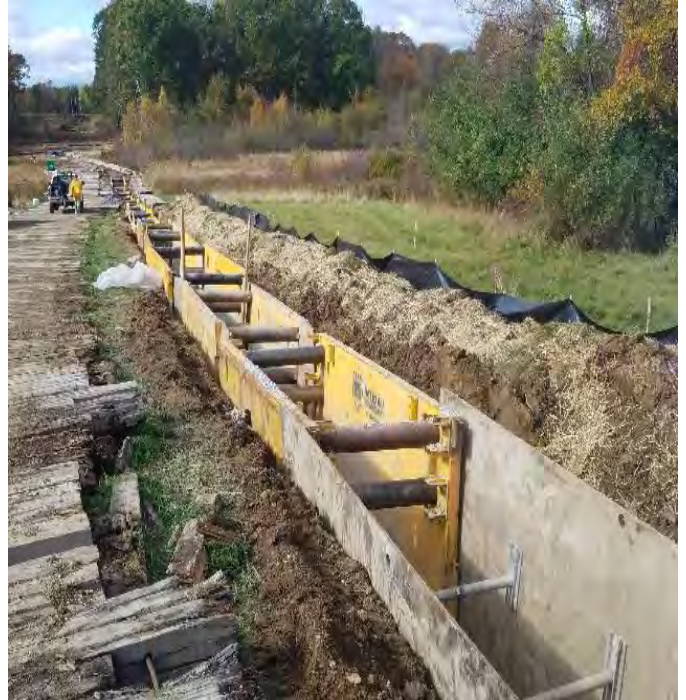
Fig 30: Trenching activities in upland agricultural zone at Frink farm. Viewing west. (10-18-19).

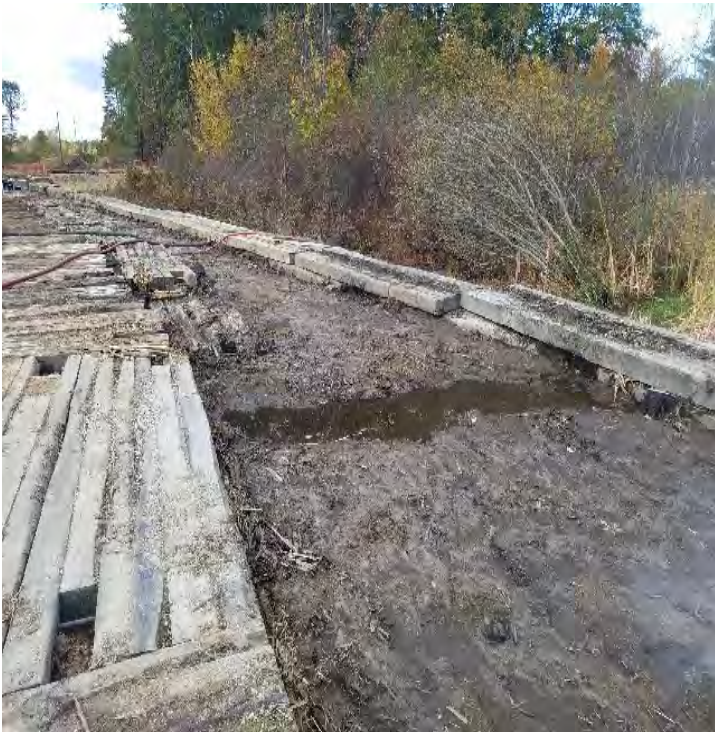
Fig 31: Rain water accumulation in Knights Brook restoration at Frink farm. Viewing west. (10-18-19).

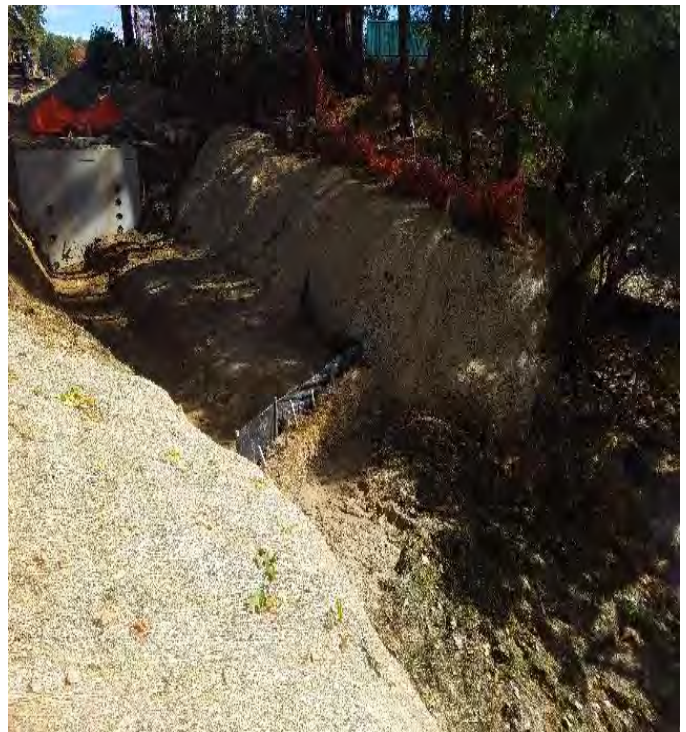
Fig 32: Sediment controls in trench on the east side of the Bay. Viewing east. (10-18-19).
