To: New Hampshire Site Evaluation Committee, Pam G. Monroe, Administrator
From: Public Service Company of New Hampshire d/b/a Eversource Energy
Date: October 21, 2019
Subject: SEC Docket No. 2015-04: Public Service Company of New Hampshire d/b/a Eversource Energy; Documentation of Shared Driveway at 297 Durham Point Road, SEC Certification Condition #90

Figure 2. Photo Journal of Existing Conditions as of July 10, 2019

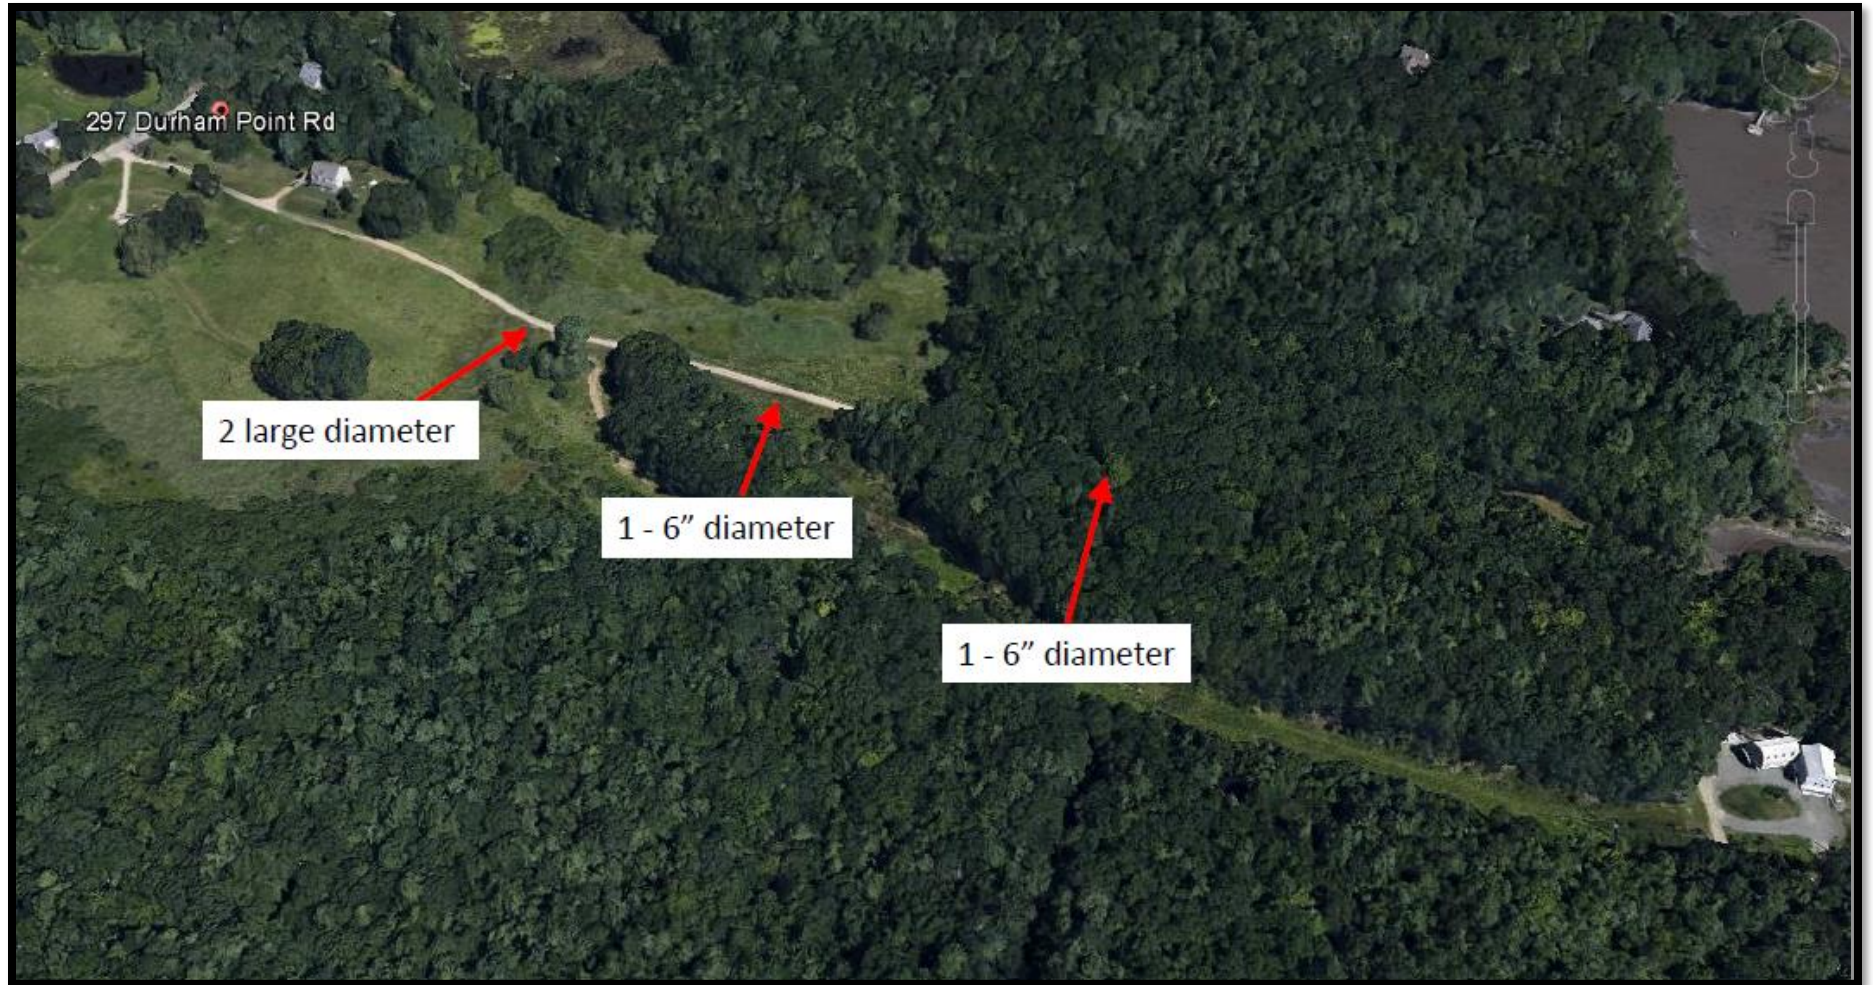
**Figure 1. Shared Gravel Driveway for 291, 295 and 297 Durham Point Road
Durham, New Hampshire**

There are three locations where culverts exist, a 6" corrugated metal pipe (cmp) culvert, a 6" steel culvert and (2) tandem large diameter culverts. The approximate locations of these culverts are shown in Figure 1. The 6" CMP culvert is completely buried under the road gravel but appears to be constricted with leaf and dirt debris. The 6" steel pipe is exposed along the road on the south side. The two large diameter culverts are buried under the road and appear to be functioning properly.

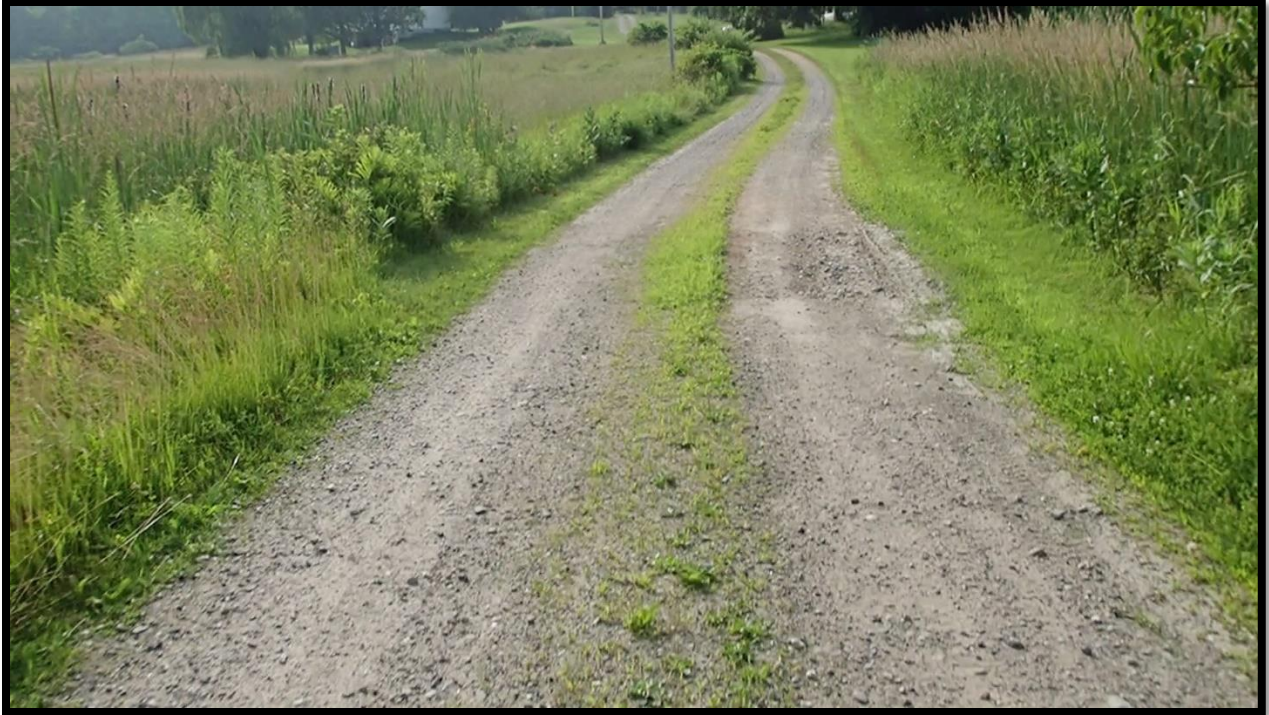
Photo 7. Facing West through wetland area, approximate location of (2) large diameter culverts
