### CONSTRUCTION MONITORING REPORT

Eversource Transmission Lines:  
**F107**

**Madbury, Durham,  
Newington, Portsmouth, NH**

NAI Project No:  
**23840.39**

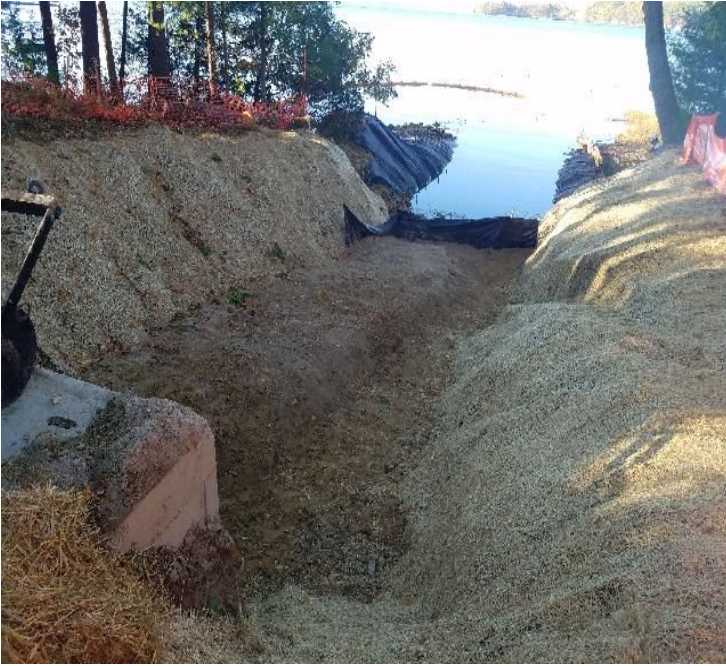
Fig 5: Sediment controls on the east side of the Bay at the Beswick property. Viewing west. (10-21-19).

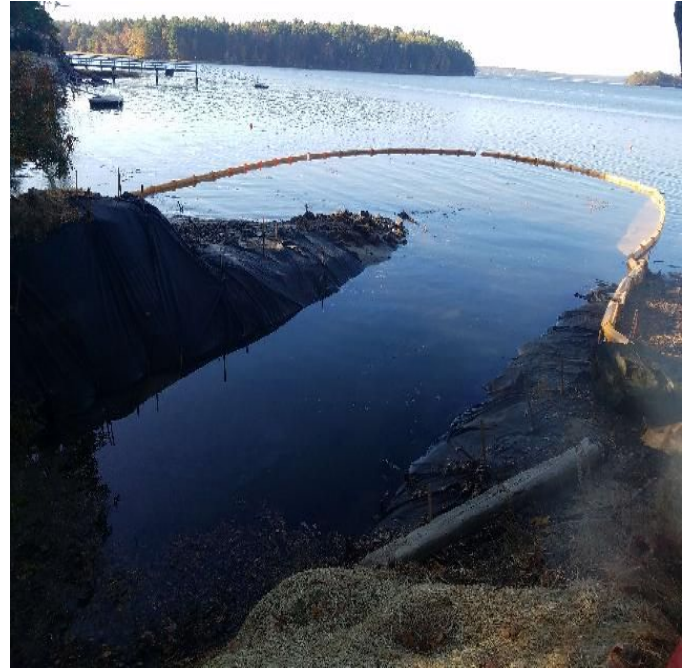
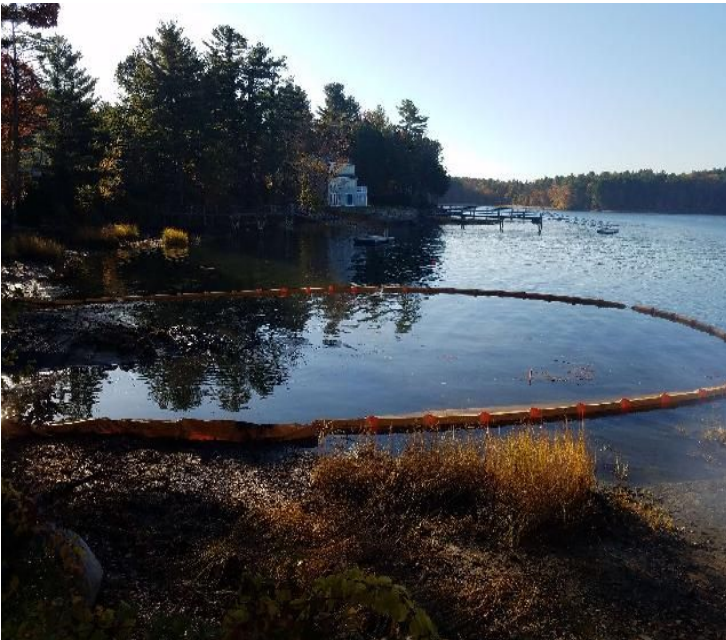
Fig 6: Silt curtain installed on the east side of the Bay. Viewing west. (10-21-19).

Fig 7: Silt curtain installed on the east side of the Bay. Viewing west. (10-21-19).

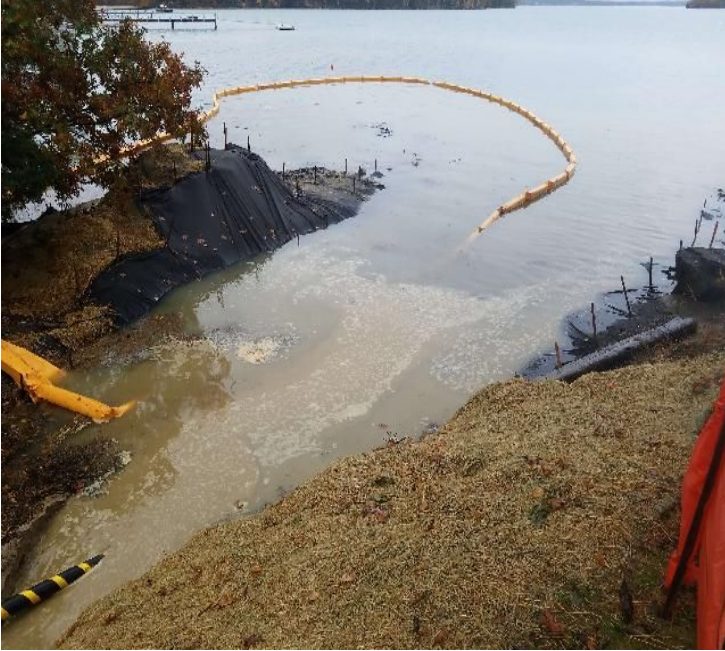
- Trench at the Beswick property partially collapsed due to the 10-23-19 rain event, causing visual plumes of sediment and turbid water into the Bay (crews were notified and responded in a timely manner to temporarily repair these issues). We are working together to develop and implement a plan to minimize sediment loss from adjacent uplands into tidal waters. See photos 13, 14, 15, 20, 21, 22 below.
- Turbid water visible in Knights Brook around stream diversion pump. Turbidity is a result of ruts near Str. 106. See photos 17, 18, 19. Tamp down ruts and re-mulch.

Fig 13: Visible turbidity plume in the Bay at Beswick property. (10-23-19).  
Viewing southwest. (10-23-19).

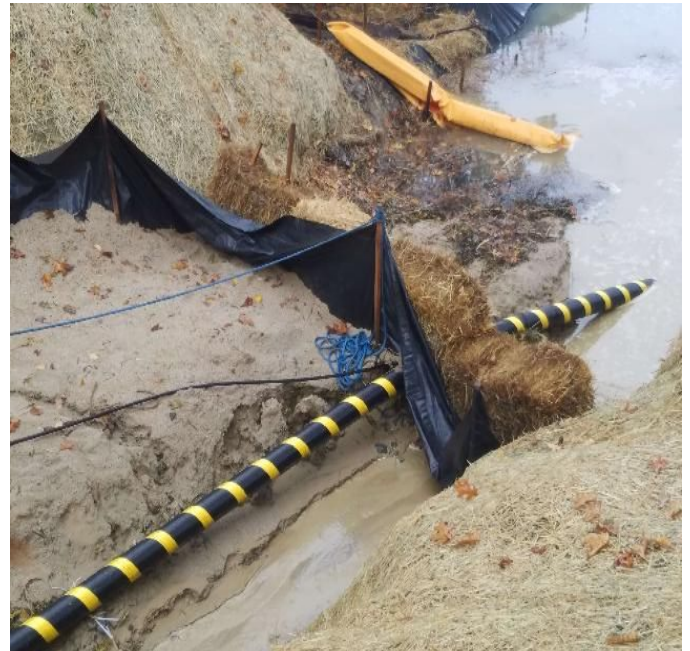
Fig 14: BMP failure around cable location. Viewing southwest.  
(10-23-19).

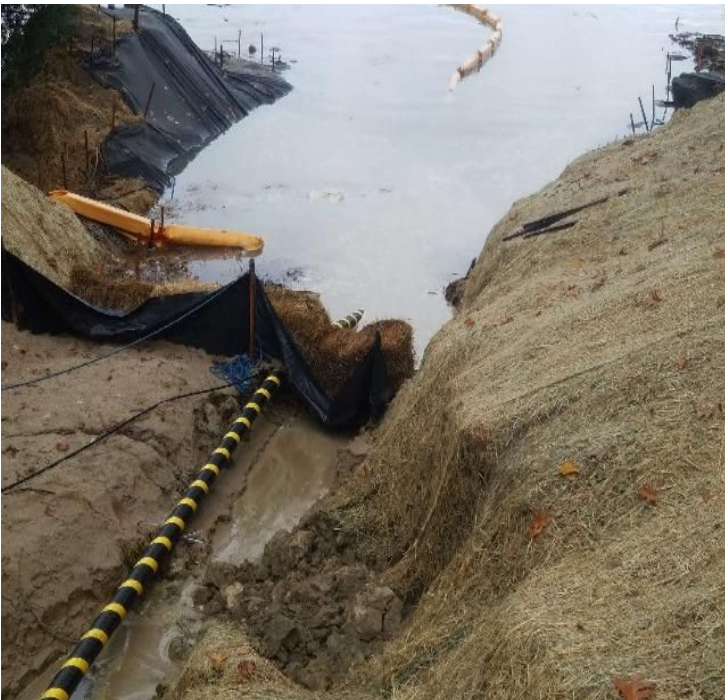
Fig 15: Trench walls washed out at Beswick Property. Viewing west.  
(10-23-19).

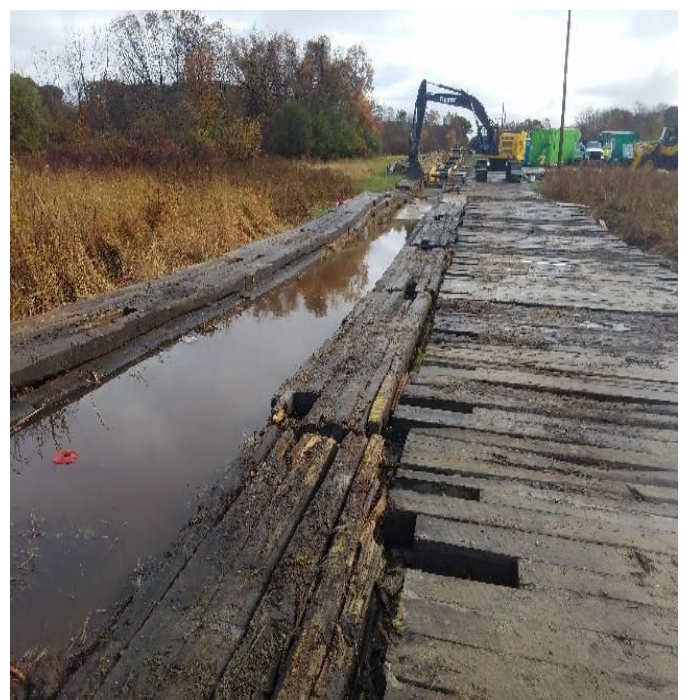
Fig 16: Approximately 1.5ft of water on top of float fill in trench at  
Frink farm. Viewing east. (10-23-19).

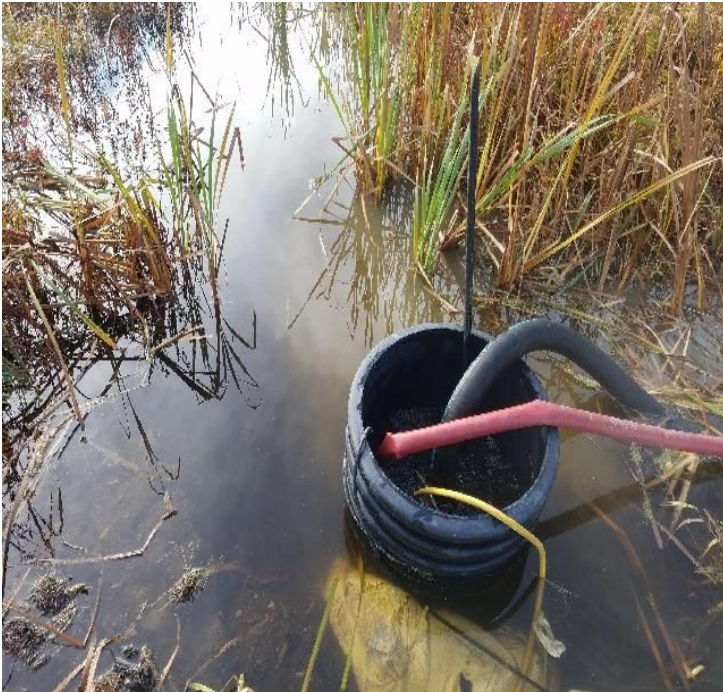
Fig 17: Turbidity visible around stream bypass pump in Knights Brook. Viewing south. (10-23-19).

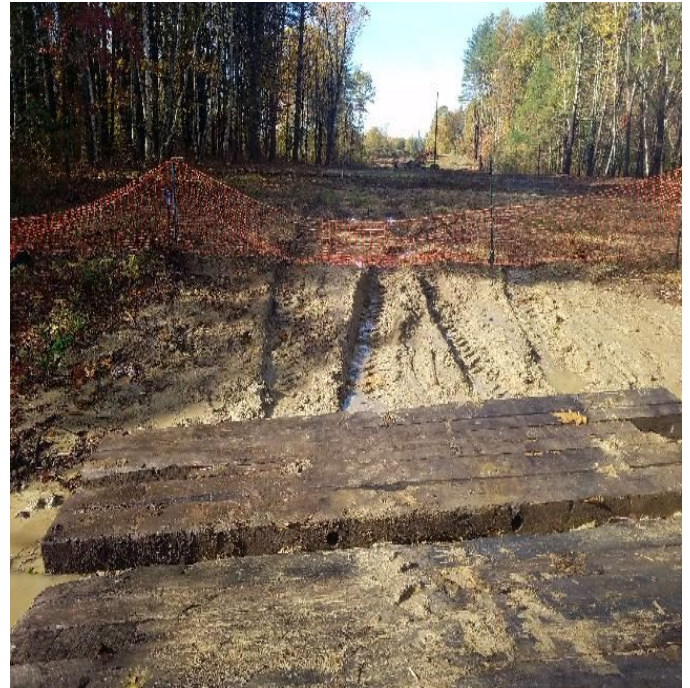
18: Ruts in previously restored area near Str. 106 causing sediment loss. Viewing west. (10-23-19).

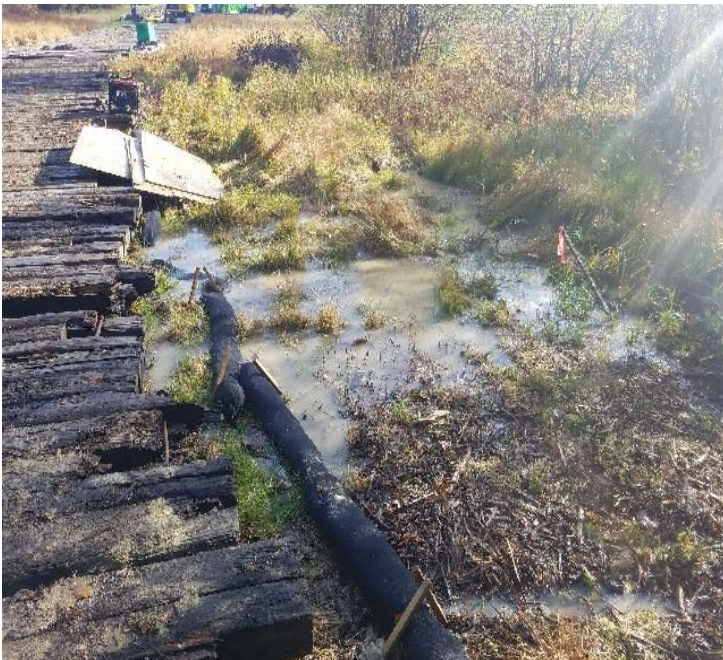
Fig 19: Turbid water, a result of the rutting near Str. 106. Viewing east. (10-23-19).

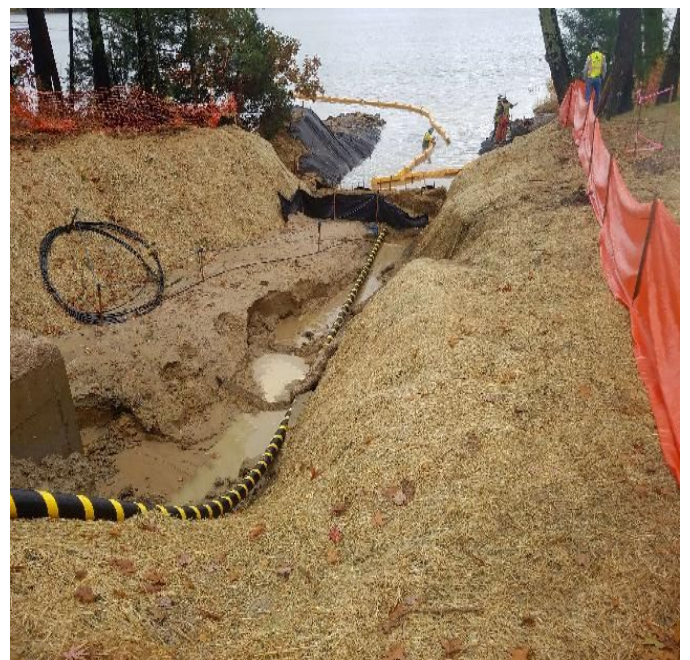
Fig 20: LS Cable and Blu Rock on site to patch sediment and erosion Controls at Beswick Property. Viewing west. (10-23-19).

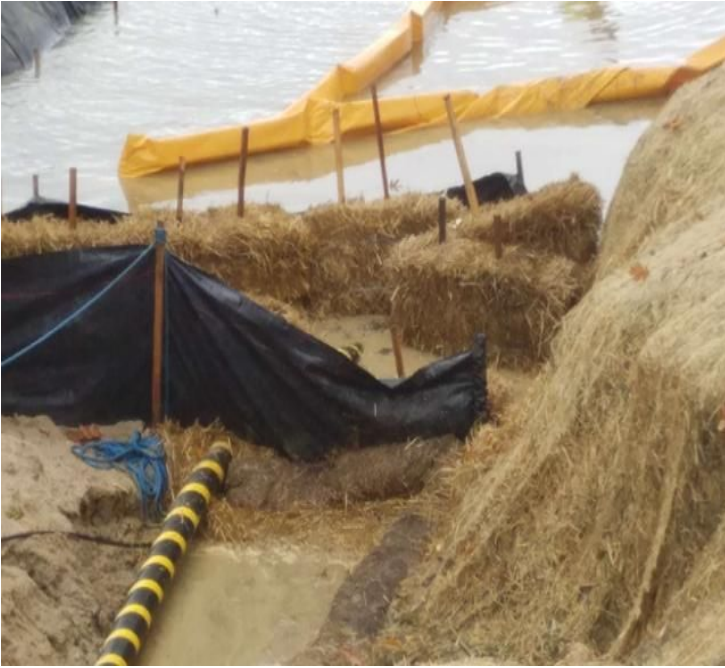
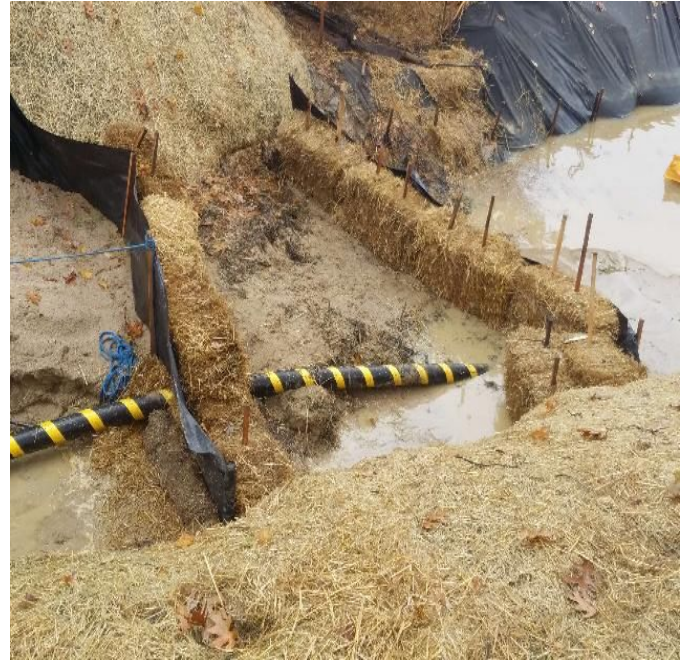
Fig 21: Temporary repairs made to sediment and erosion controls at Beswick property. Viewing west. (10-23-19).

Fig 22: Temporary repairs made to sediment and erosion controls at Beswick property. (10-23-19).
