CONSTRUCTION MONITORING REPORT

Eversource Transmission Lines:
F107

**Madbury, Durham,
Newington, Portsmouth, NH**

NAI Project No:
23840.39

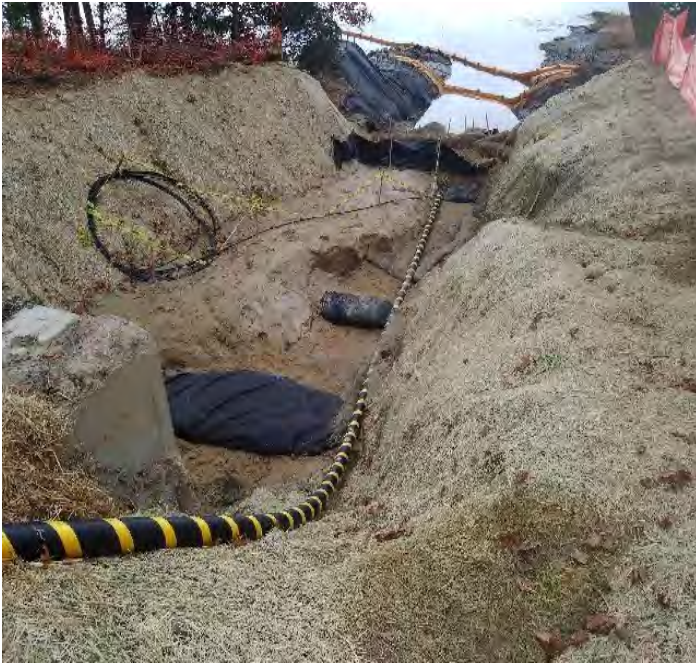
Fig 1: Berms installed in trench at Gundalow landing/east side of the Bay. Viewing west. (10-25-19).

Corrective actions identified 10-23-19 have been addressed on 10-23-19 through 10-26-19. See photos 1-6 and 28.

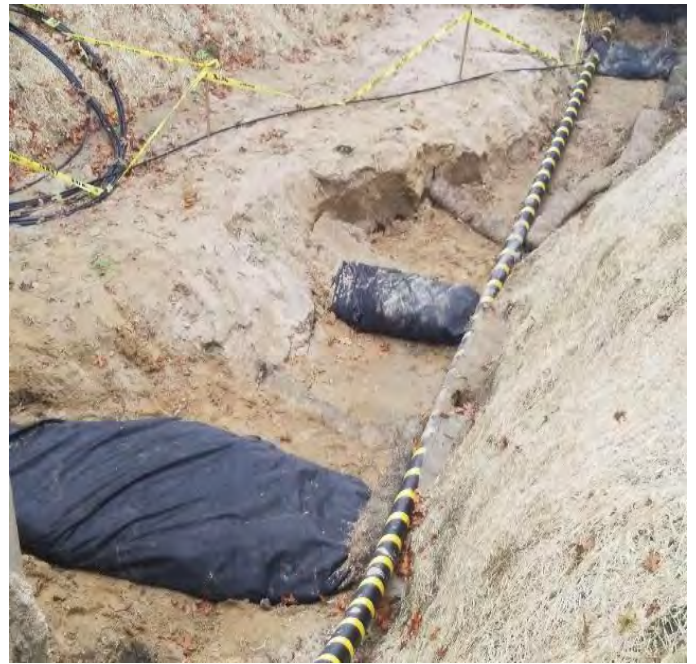
Fig 2: Berms installed in trench at Gundalow landing/east side of the Bay. Viewing west. (10-25-19).

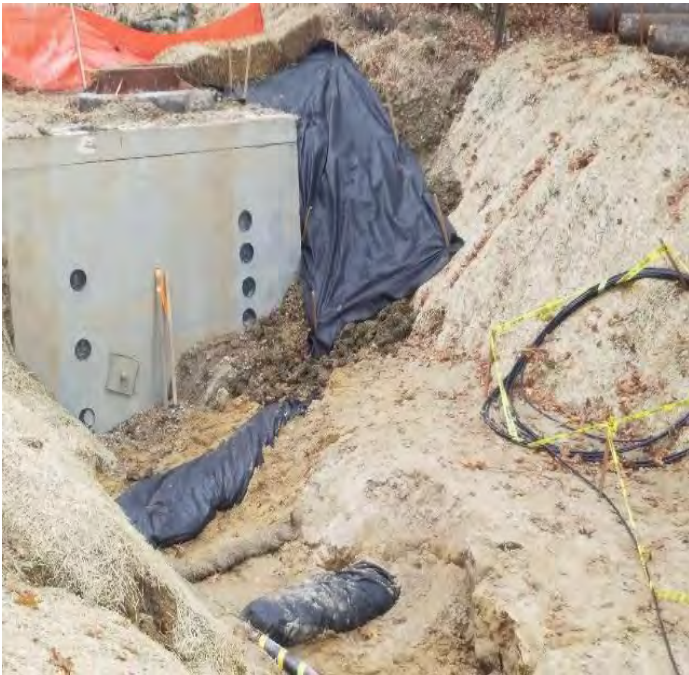
Fig 3: Trench faces in trench at Gundalow landing/east side of the Bay have been covered and secured. Viewing southeast. (10-25-19).

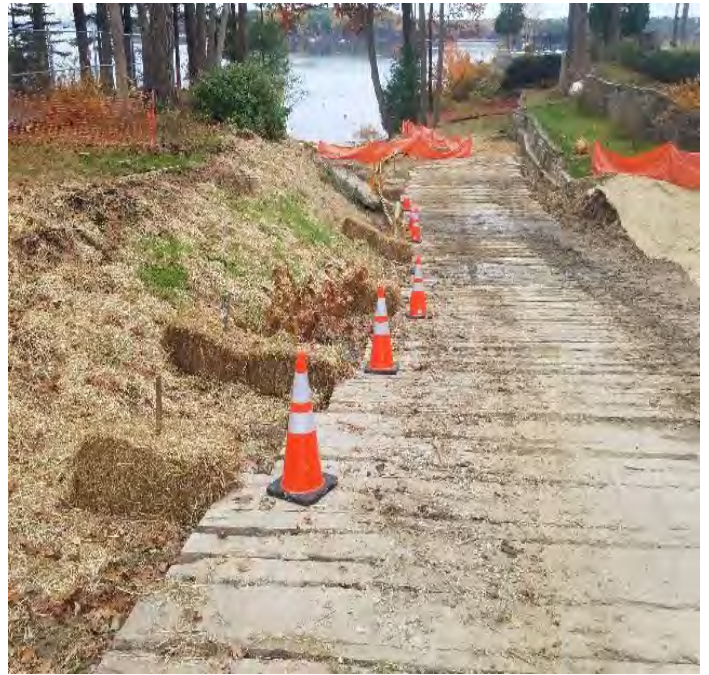
Fig 4: Straw bales installed in swale next to access to vault and trench at Gundalow landing/east side of the Bay. Viewing west. (10-25-19).

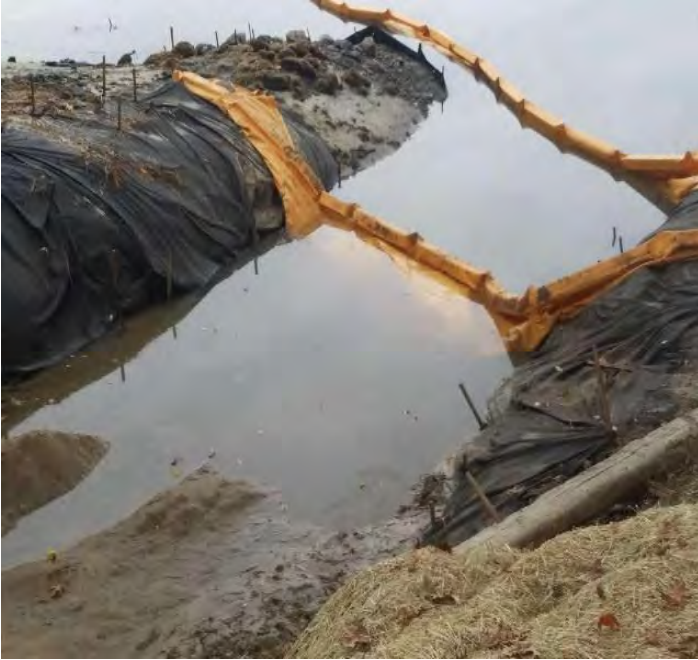
Fig 5: Two rows of silt curtain installed at Gundalow landing/east side of the Bay. Viewing west. (10-25-19).

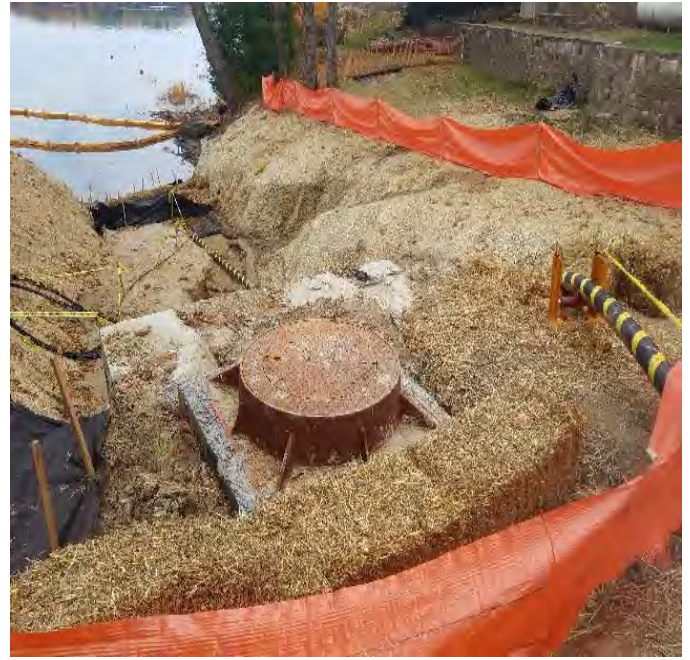
Fig 6: Vault and trench at Gundalow landing/east side of the Bay. Viewing west. (10-25-19).

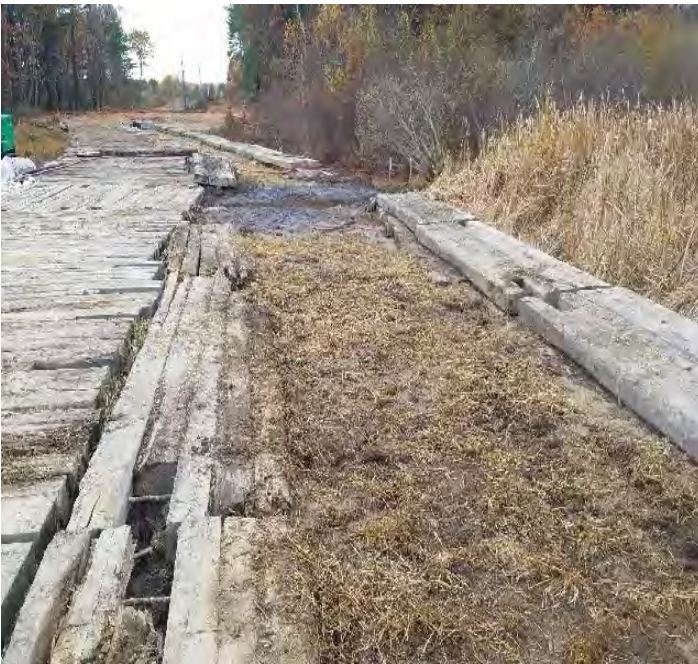
Fig 7: Wetland NW 16 and Knights Brook tributary restoration. Viewing east. (10-25-19).

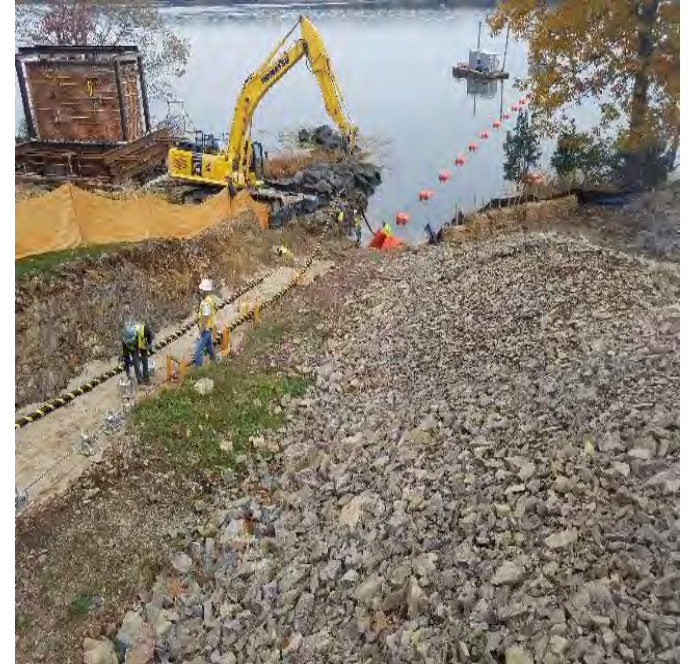
Fig 8: Pulling cable at Getchell property/west side of the Bay. Viewing east. (10-25-19).

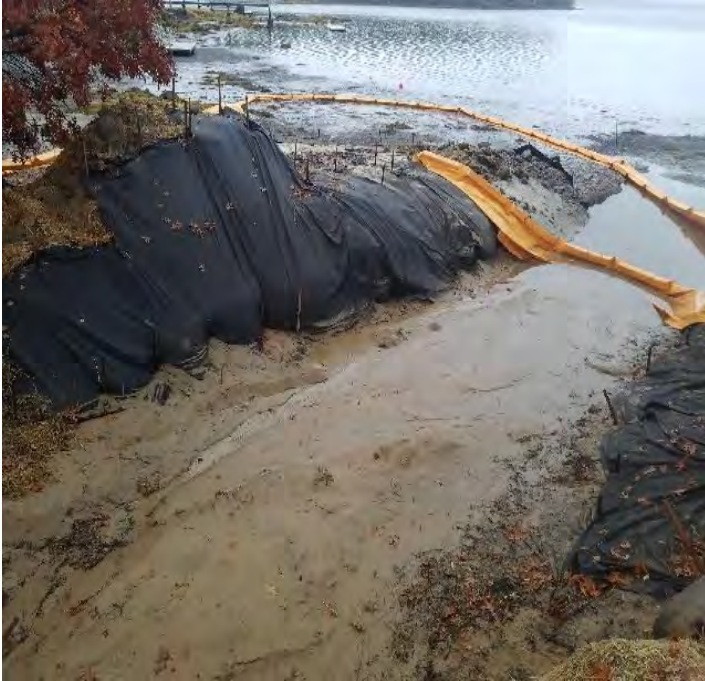
Fig 9: Trench in intertidal zone at Gundalow landing/east side of the Bay. Viewing west. (10-28-19).

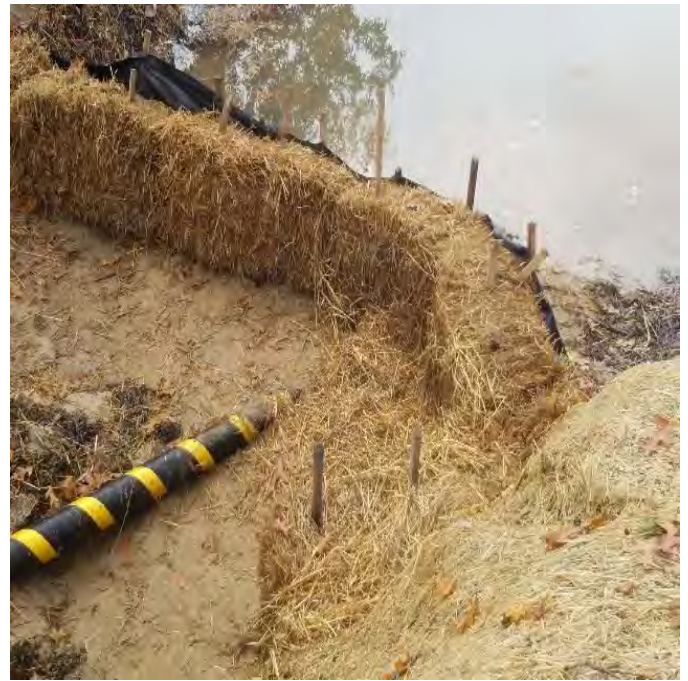
Fig 10: Sediment controls in trench at Gundalow landing/east side of the Bay. Viewing west. (10-28-19).

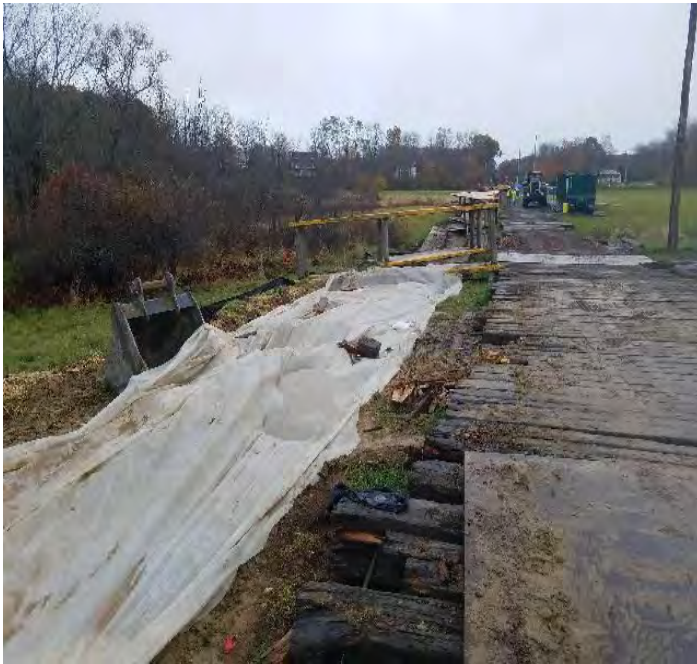
Fig 11: Exposed soils covered at Frink farm. Viewing west. (10-28-19).

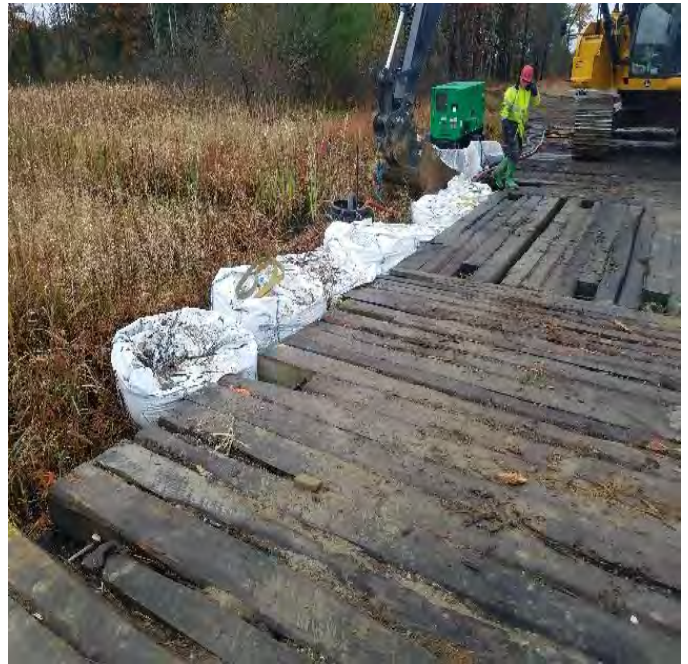
Fig 12: Beginning to remove stream bypass in Knights Brook tributary. Viewing west. (10-28-19).

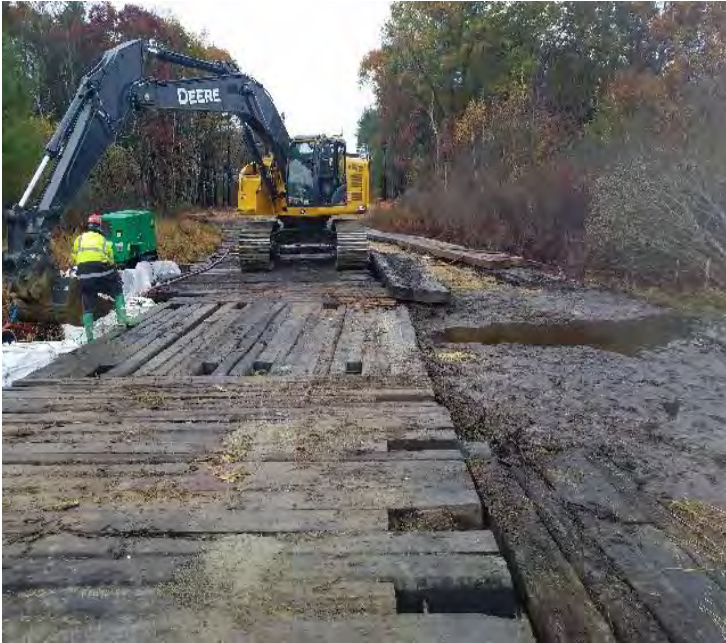
Fig 13: Beginning to remove stream bypass in Knight's Brook tributary. Viewing west. (10-28-19).

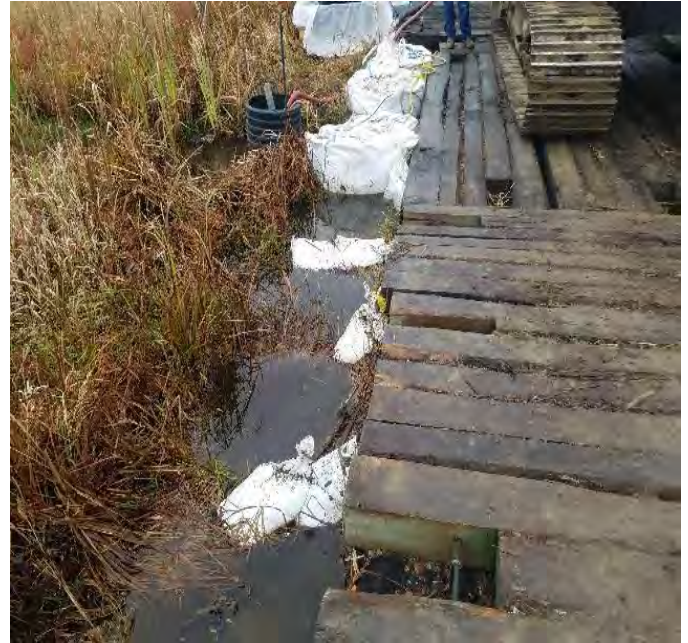
Fig 14: Removing bypass at Knight's Brook tributary. Viewing west. (10-28-19).

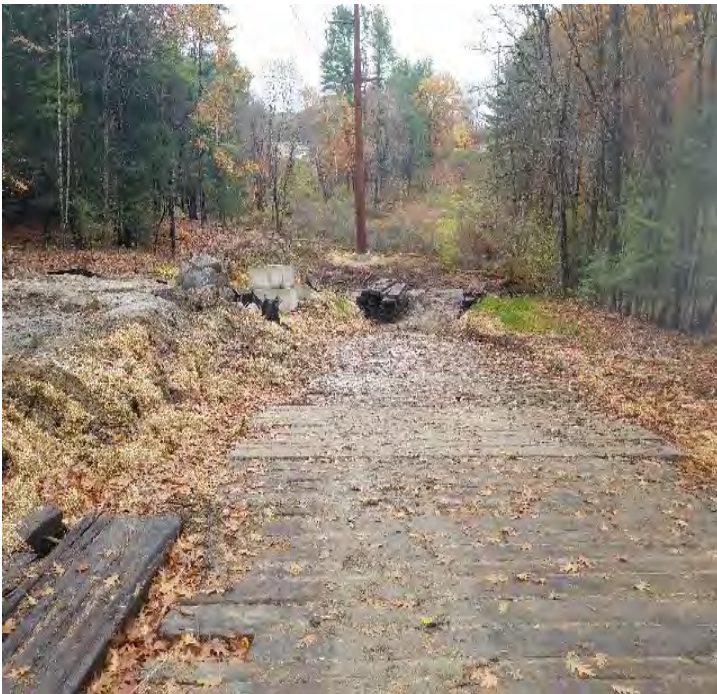
Fig 15: Timber mats are being removed around Strs. 28-29. Viewing north. (10-28-19).

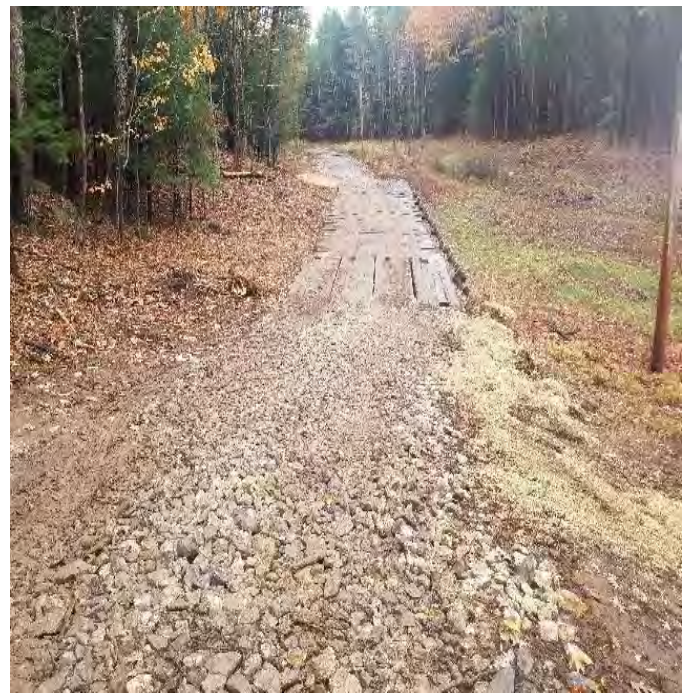
Fig 16: Access road to Str. 99. Viewing east. (10-28-19).

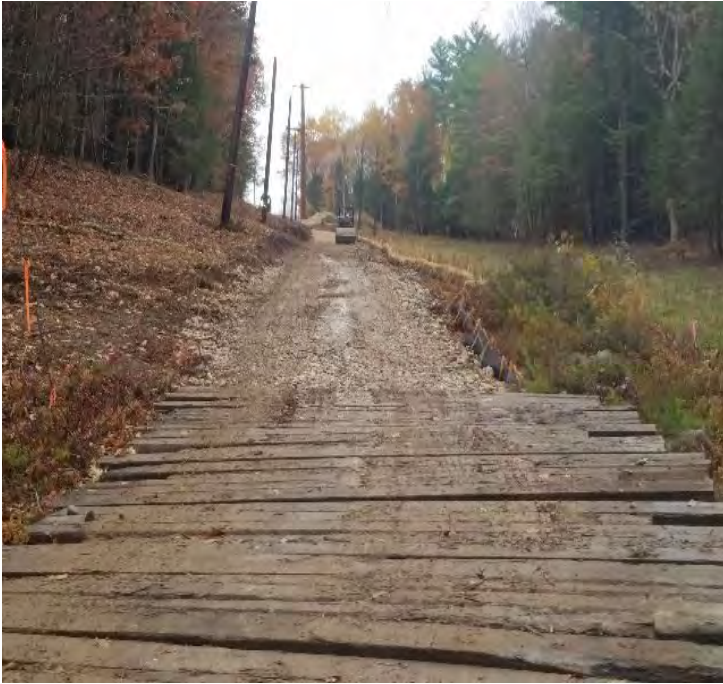
Fig 17: Access road to Str. 99. Viewing east. (10-28-19).

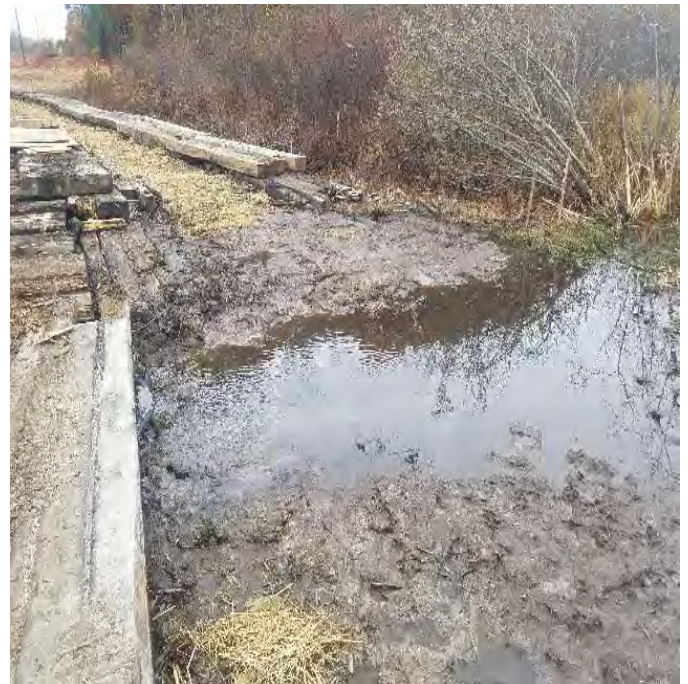
Fig. 18: Knight's Brook tributary flowing after bypass removed. Viewing east. (10-28-19).

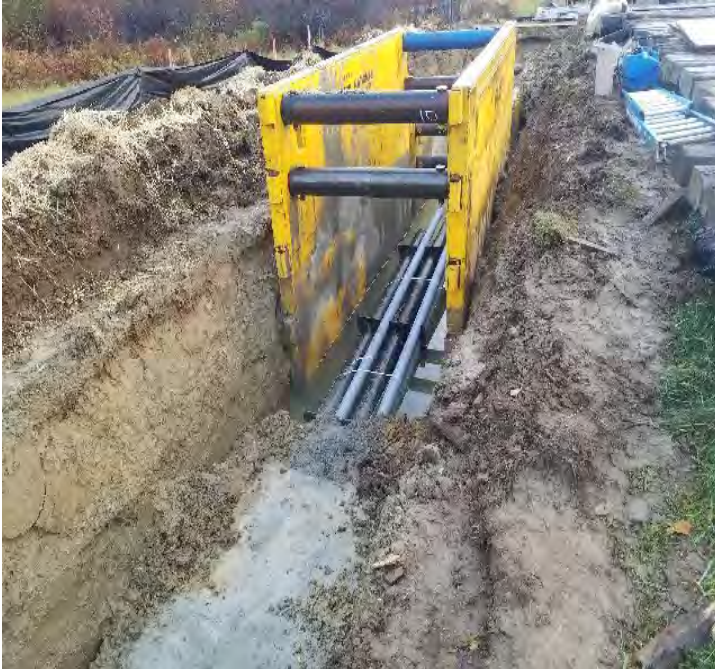
Fig 19: Groundwater in trench at Frink farm. Viewing west. (10-29-19).

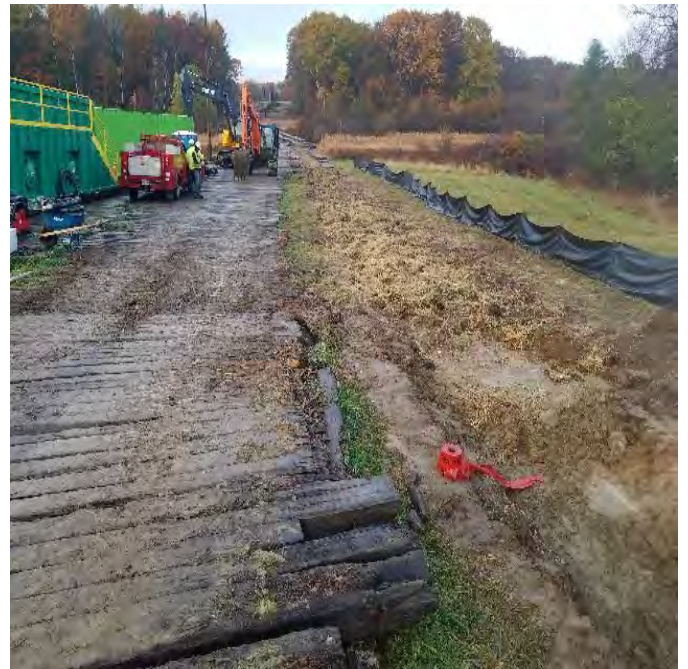
Fig 20: Restored trench area in agricultural zone at Frink farm. Viewing east. (10-29-19).

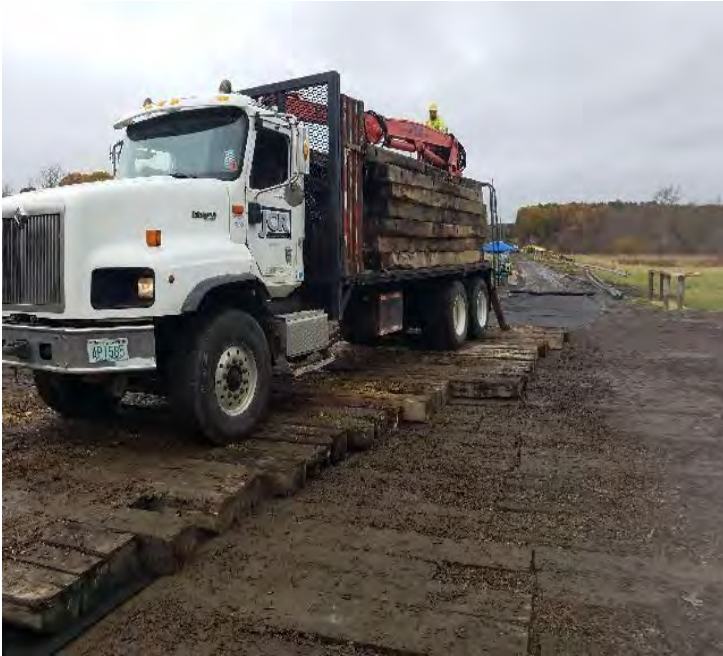
Fig 21: Crew installing second row of timber mats on access road at Frink viewing east. (10-29-19).

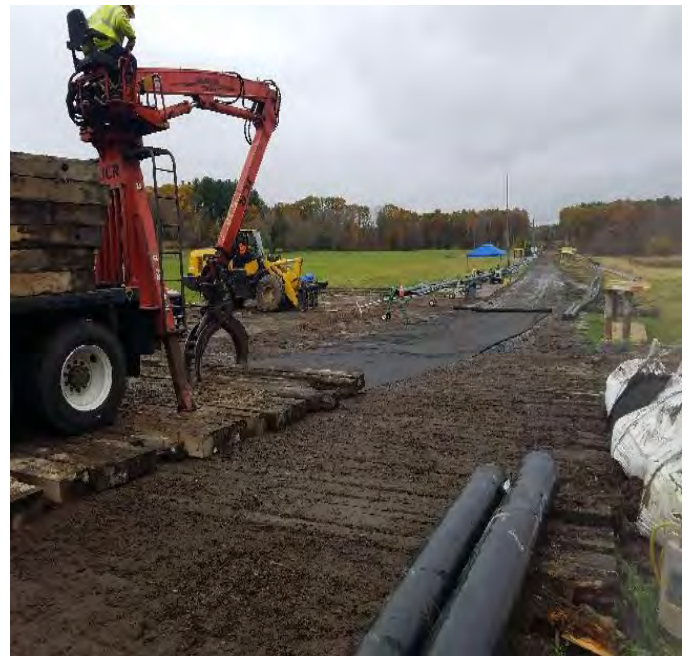
Fig 22: Crew installing second row of timber mats on access road at Frink farm. (10-29-19).

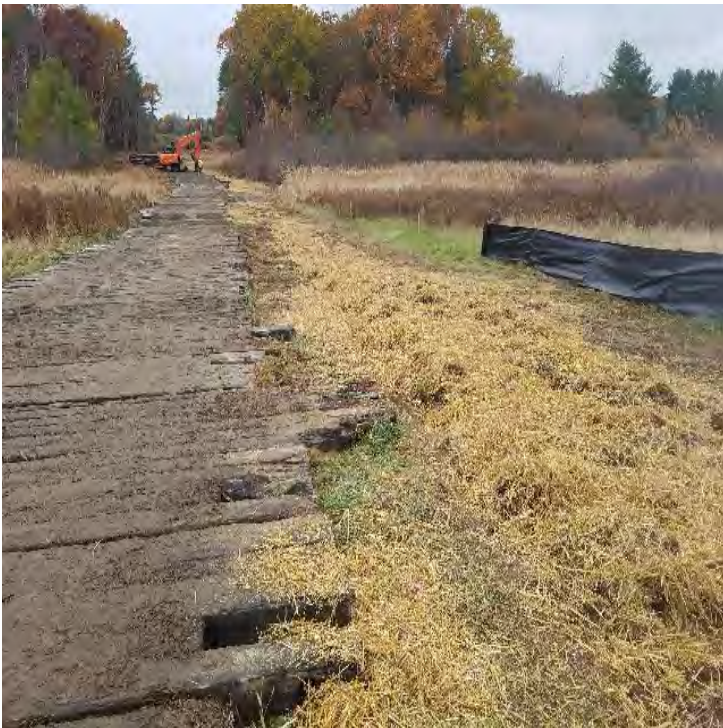
Fig 23: Crew added more straw cover over restored trench areas at Frink farm. Viewing east (10-29-19).

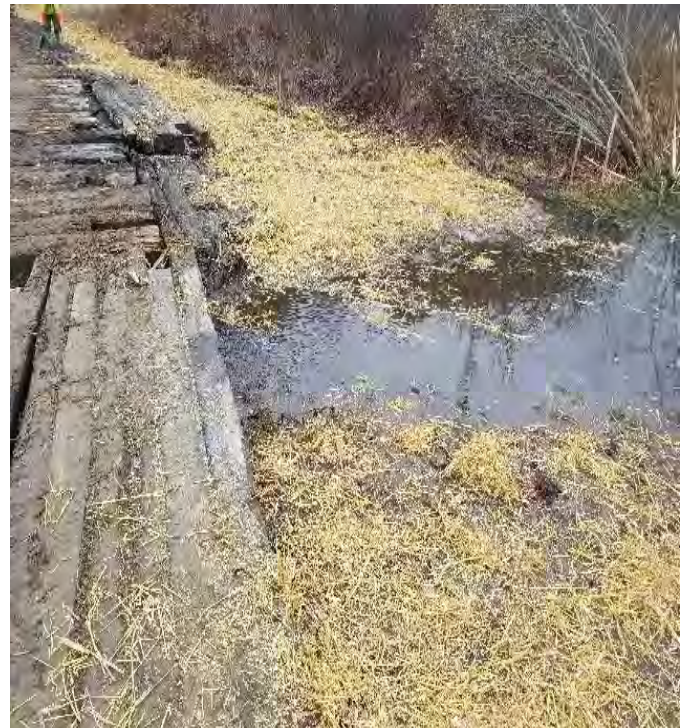
Fig 24: Knights Brook flowing after by pass removal at Frink farm. Viewing east. (10-29-19).

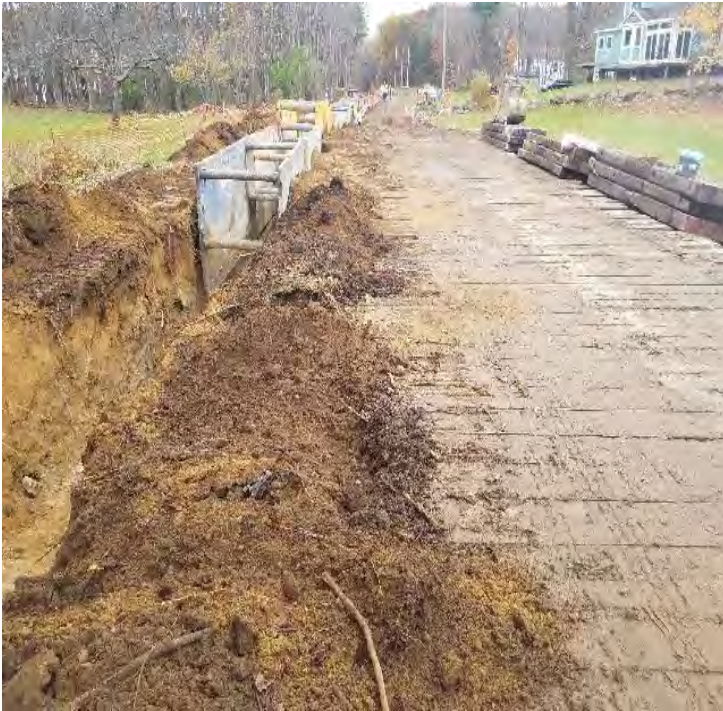
Fig 25: Trenching from Str. 107 to Nimble Hill road. Viewing west. (10-29-19).

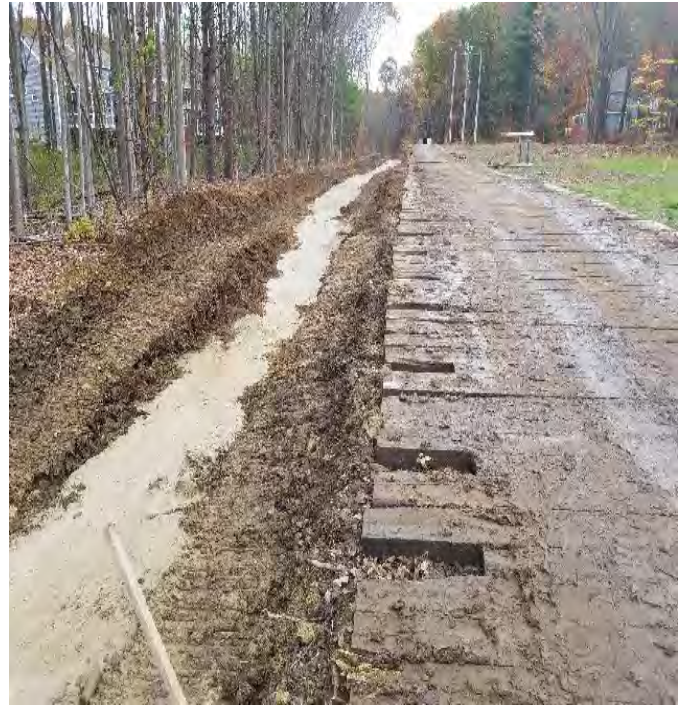
Fig 26: Float fill poured in trench between Str. 107 and Nimble Hill Road. (10-29-19).

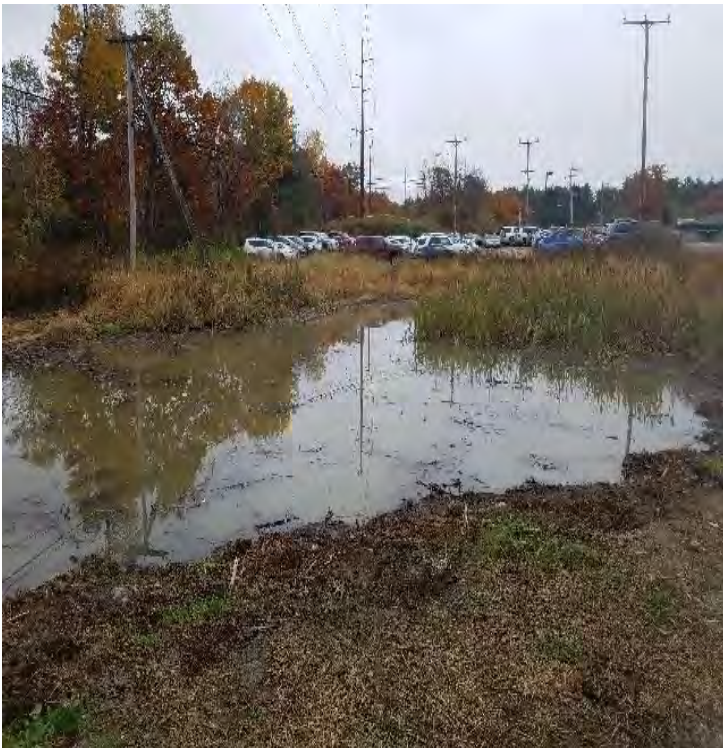
Fig 26: Timber mats removed in wetland around Str. 24. Viewing east. (10-29-19).

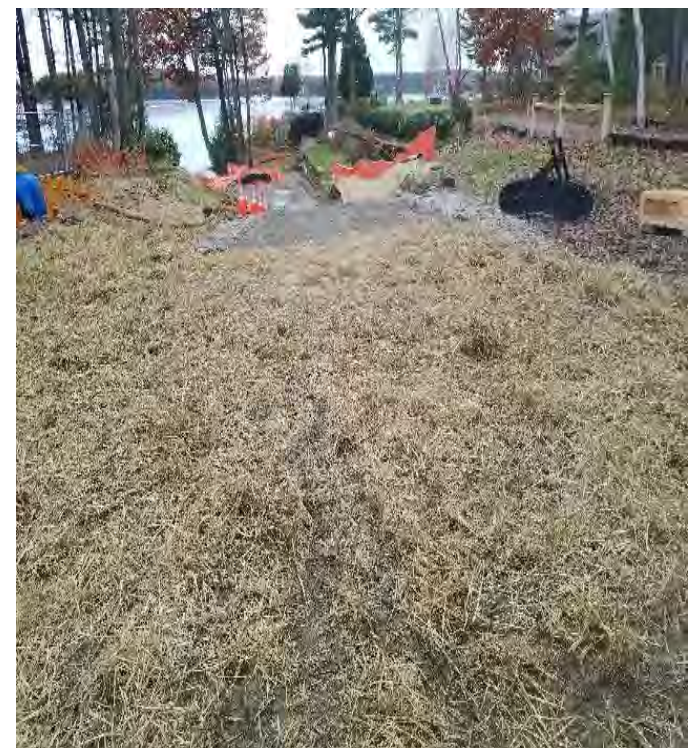
Fig 27: Access down to vault and trench at Gundalow landing/east side of the Bay. Viewing west. (10-29-19).

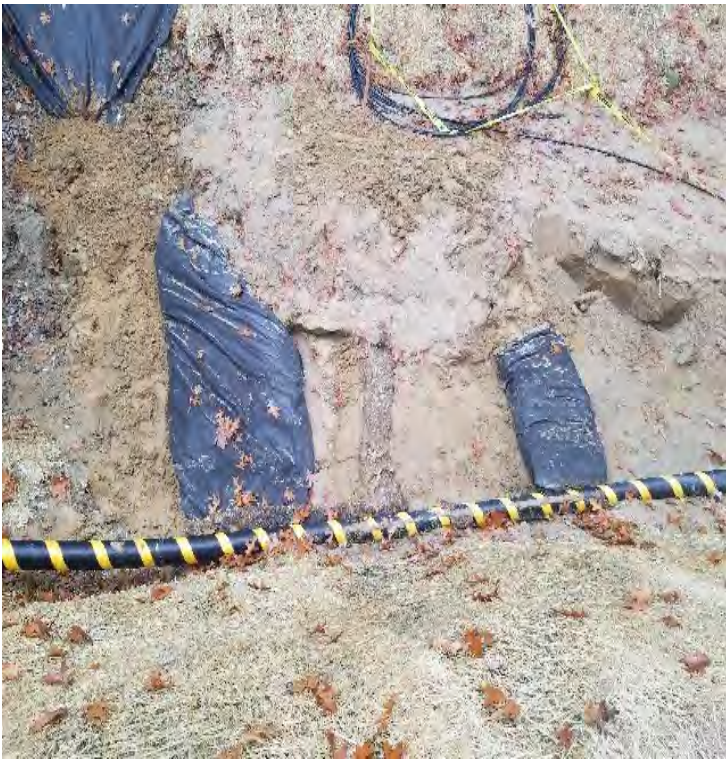
Fig 28: Crew removed sediment build up from check dam in trench at Gundalow Landing/east side of the Bay. Viewing south. (10-29-19).

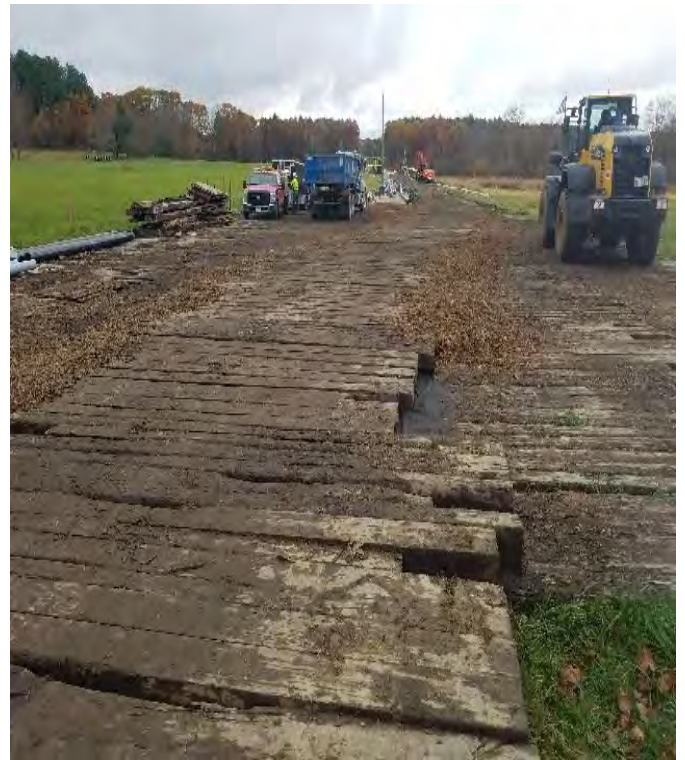
Fig 29: Additional mats and stump grindings added to access road at Frink farm. Viewing east. (10-30-19).

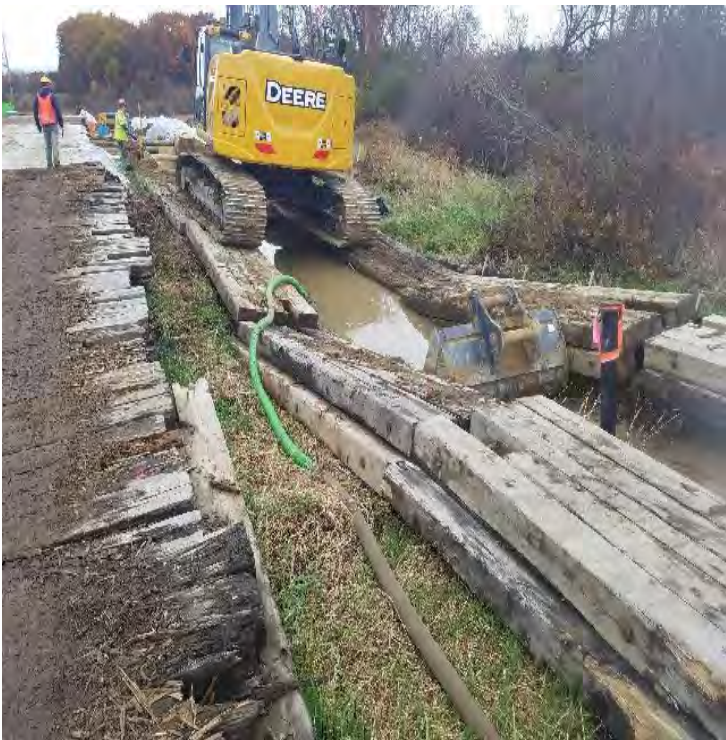
Fig 30: Pumping water out of trench in NW18 at Frink farm. Viewing east. (10-30-19).

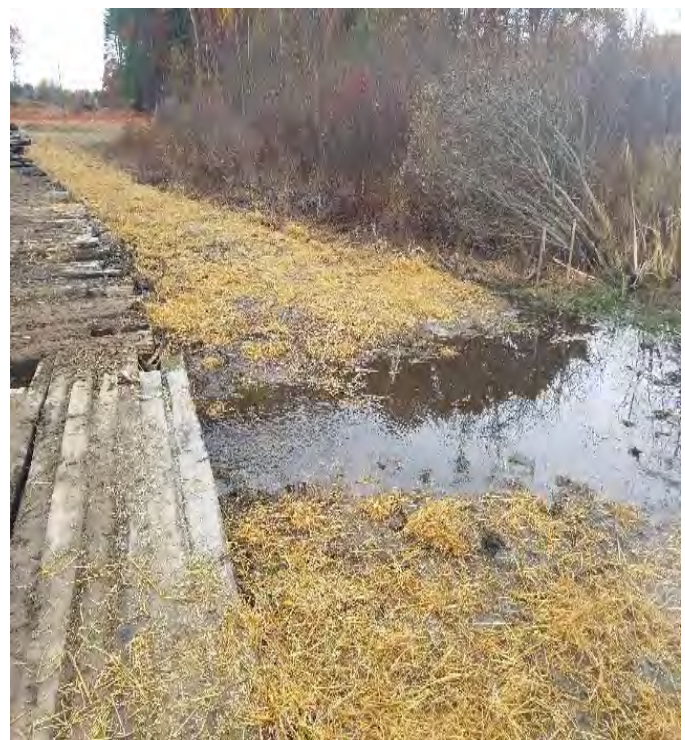
Fig 31: Knights Brook restoration. Viewing east. (10-30-19).
