CONSTRUCTION MONITORING REPORT

Eversource Transmission Lines:
F107

**Madbury, Durham,
Newington, Portsmouth, NH**

TYPE OF INSPECTION: Weekly Storm Event Incident Corrective Action

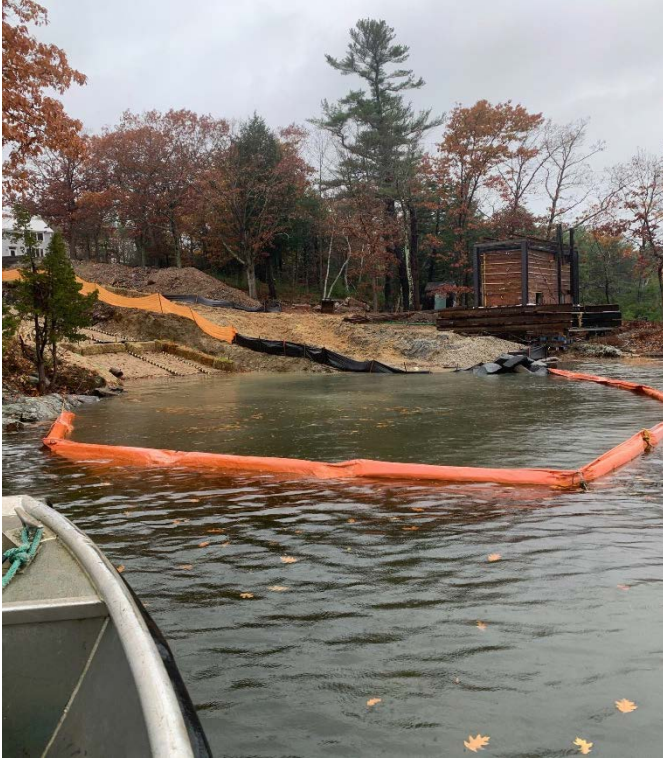
Fig 1: Silt curtain repaired on the Getchell property/west side of the Bay. Viewing west. (10-31-19).

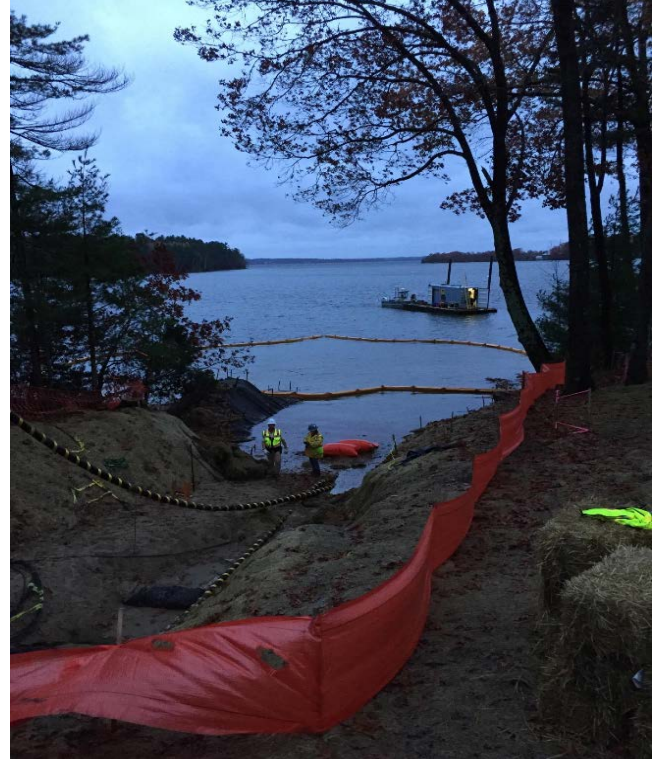
Fig 2: Silt curtain re-installed at Gundalow landing/east side of the Bay after pulling in Cable 2. Viewing west. (10-31-19).

- **BMPs**
 - Silt curtain for the on-shore trenches should be reinstalled immediately after completion of cable pull and preferably before the end of each work day.
 - Some straw was added but additional straw needs to be spread over restored trenched areas at the Frink farm.
 - Silt socks in the wetland area NW 18 at the Frink farm were damaged but have since been replaced.

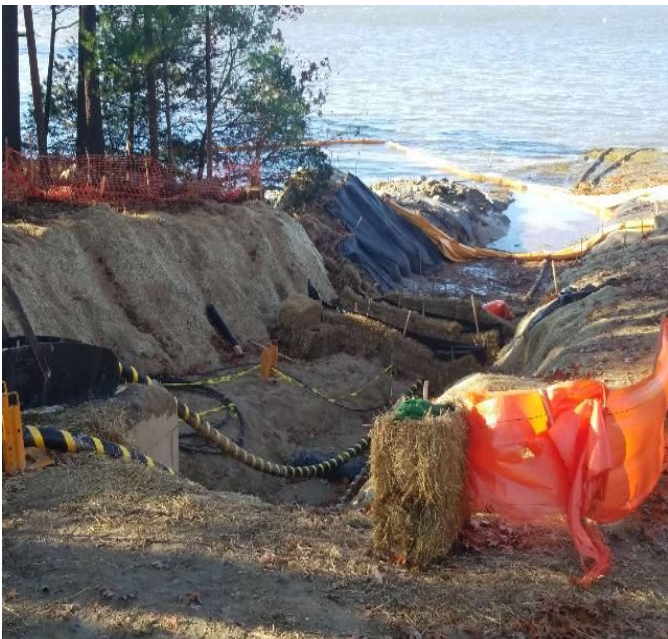
Fig 3: Triple row of sediment controls in trench at Gundalow Landing/east side of the Bay. Viewing west. (11-01-19).

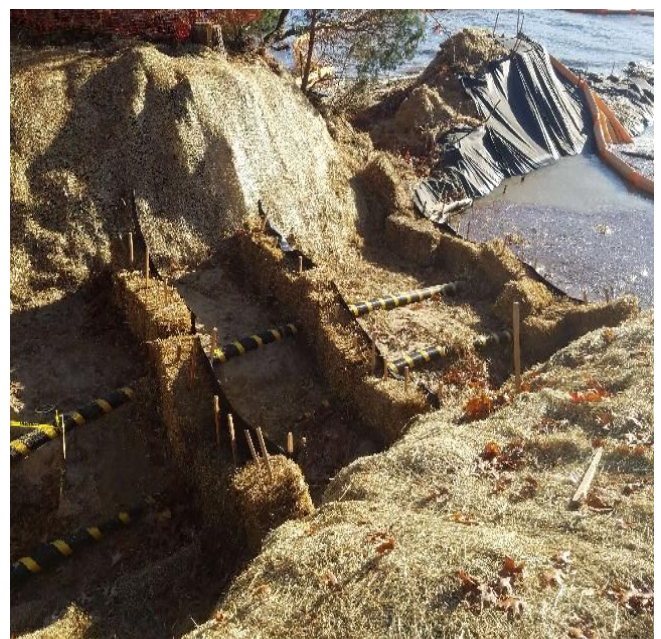
Fig 4: Triple row of sediment controls in trench at Gundalow Landing/ east side of the Bay. Viewing west. (11-01-19).

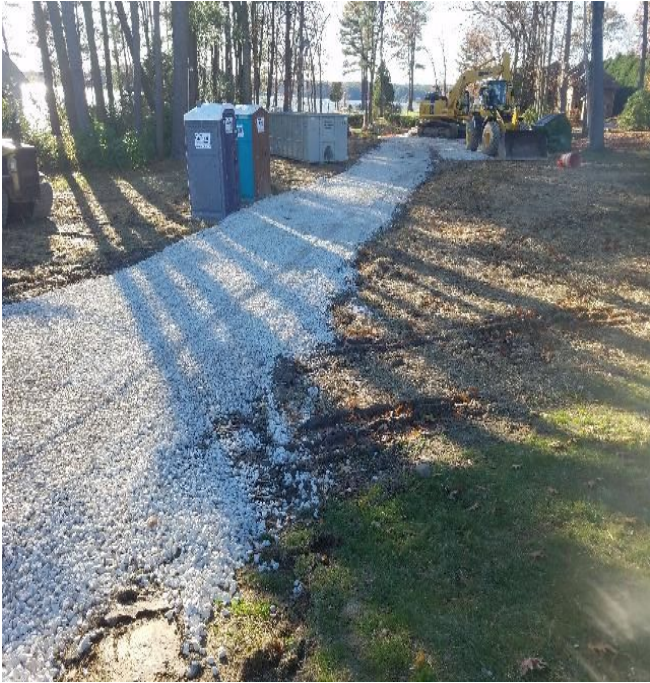
Fig 5: Crew placed fabric and stone on access to trench at Gundalow Landing/east side of the Bay. Viewing west. (11-01-19).

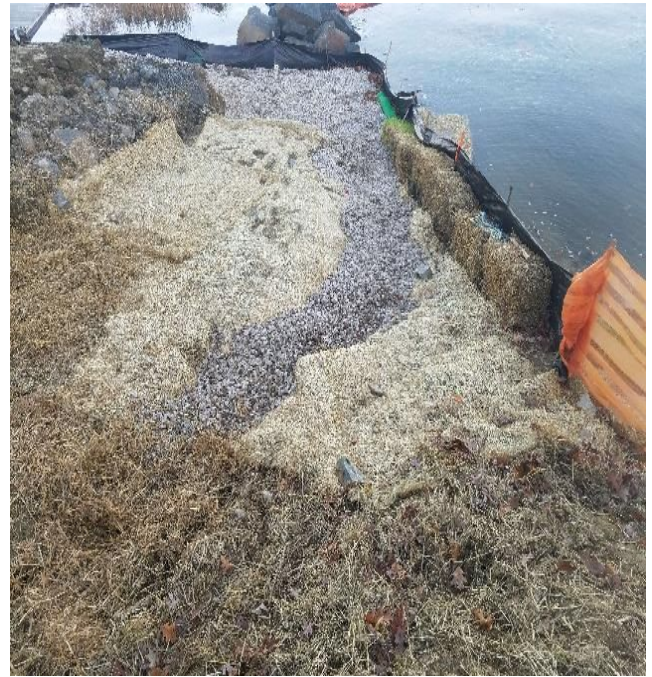
Fig 6: Stone swale installed next to trench at Getchell property/ West side of the Bay to divert water flow. Viewing east. (11-01-19).

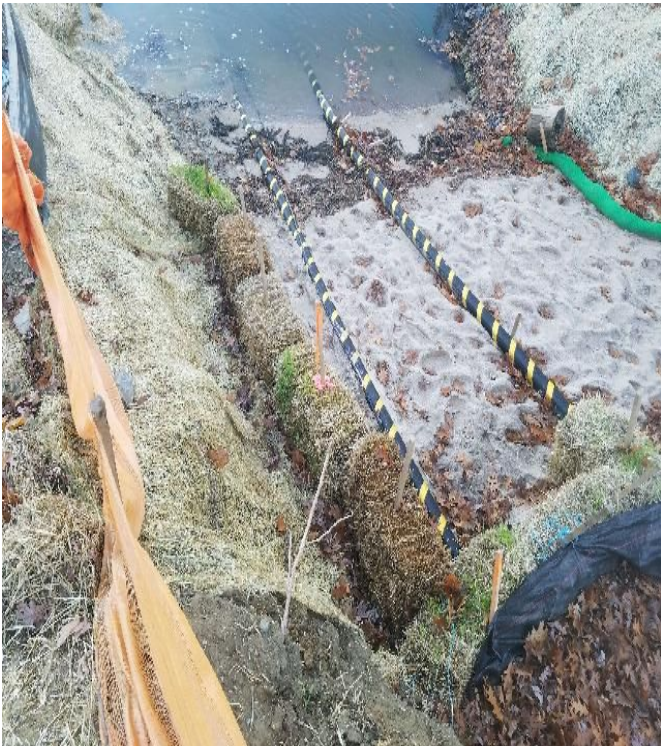
Fig 7: Bank stabilization in trench at Getchell property/west side of The Bay. Viewing east. (11-01-19).

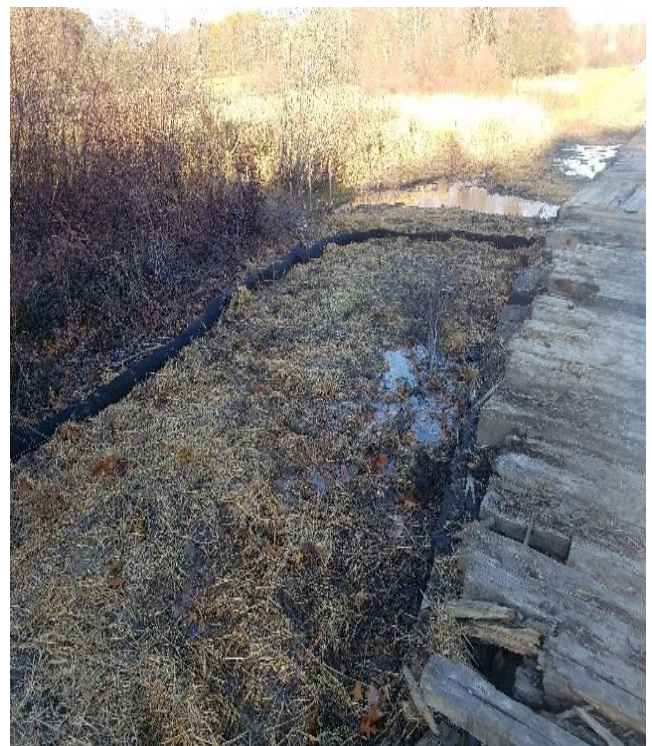
Fig 8: Filter sock installed around restored trench in NW 16 to protect Knights Brook tributary from sediment laden water. Viewing west. (11-01-19).

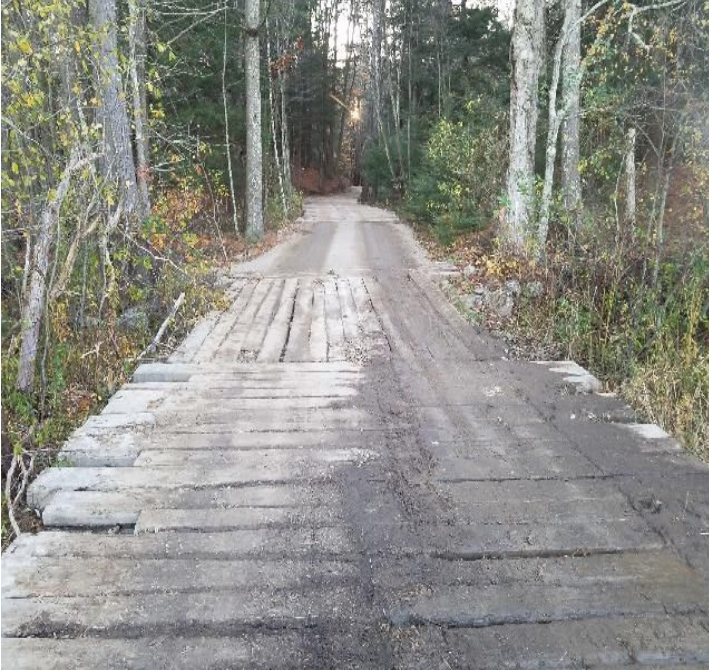
Fig 9: Access road to Str. 9-13. Viewing east. (11-02-19).

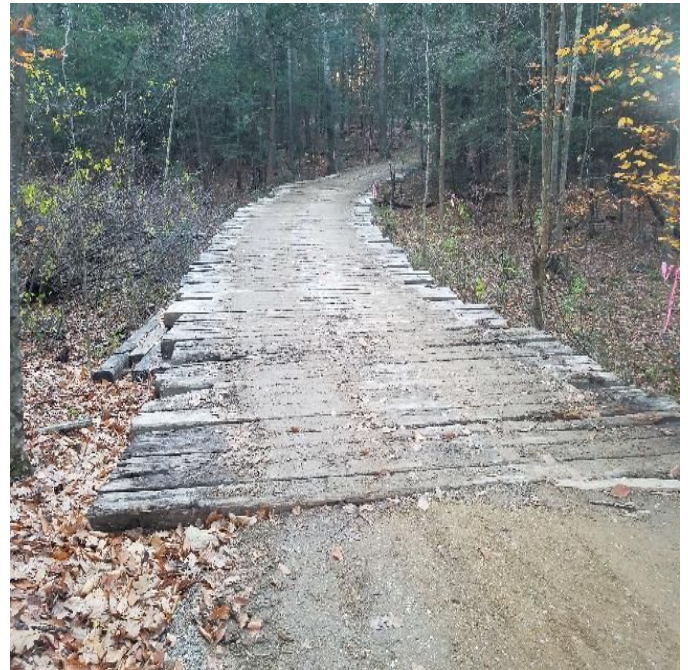
Fig 10: Access road to Str. 9-13. Viewing east. (11-02-19).

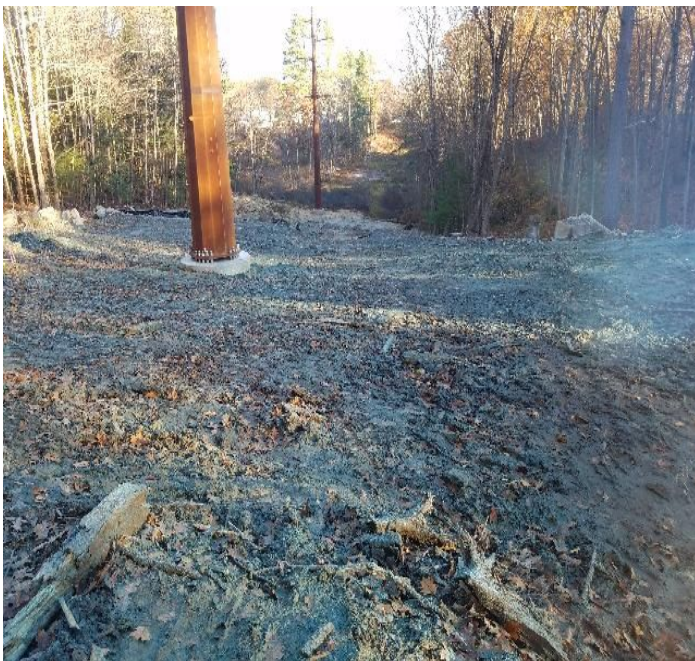
Fig 11: Hydro-seeded area around Str. 29. Viewing north. (11-02-19).

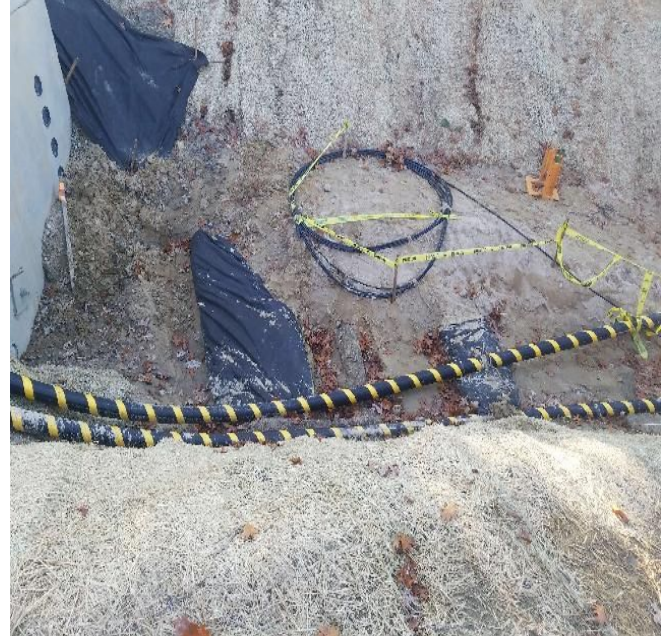
Fig 14: Sediment controls in trench at Gundalow landing/east side of the Bay. Viewing south. (11-04-19).

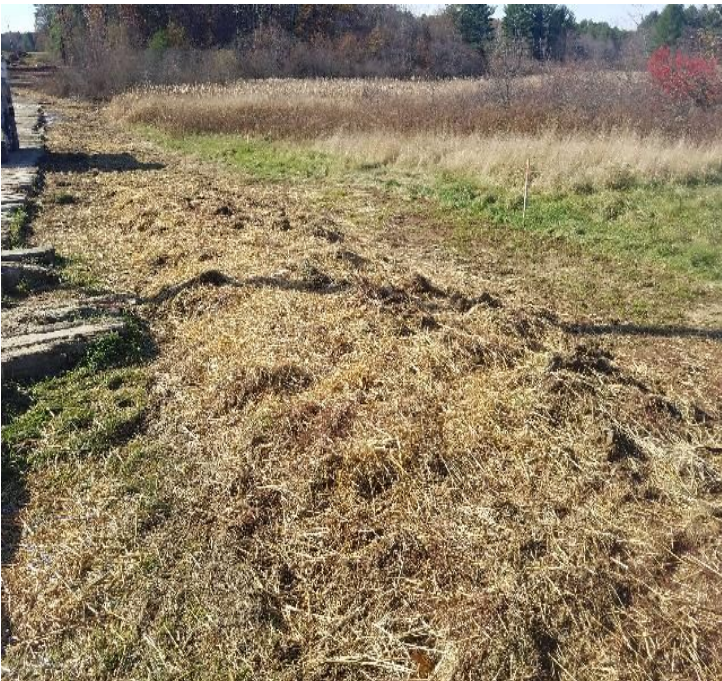
Fig 15: Winter rye germination in agricultural zone of restored trench at Frink farm. Viewing east. (11-04-19).

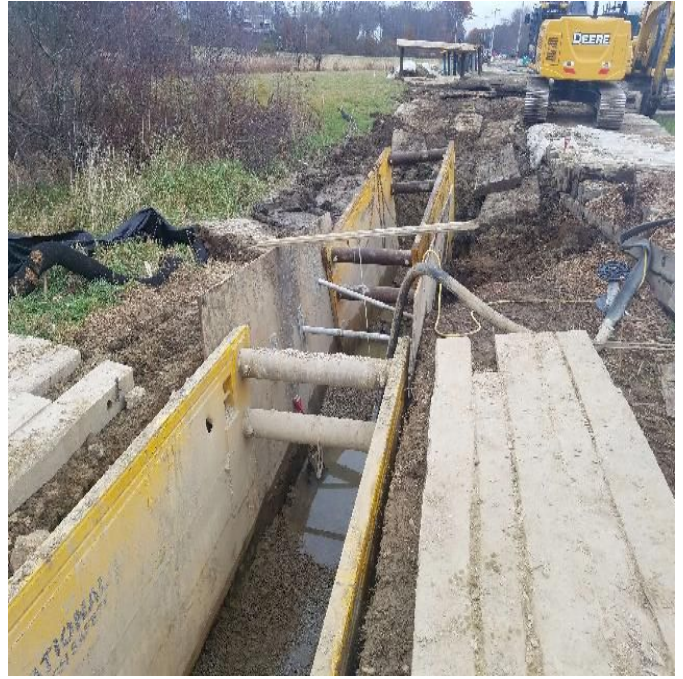
Fig 18: Pumping groundwater out of trench in wetland NW18. Viewing west. (11-05-19).

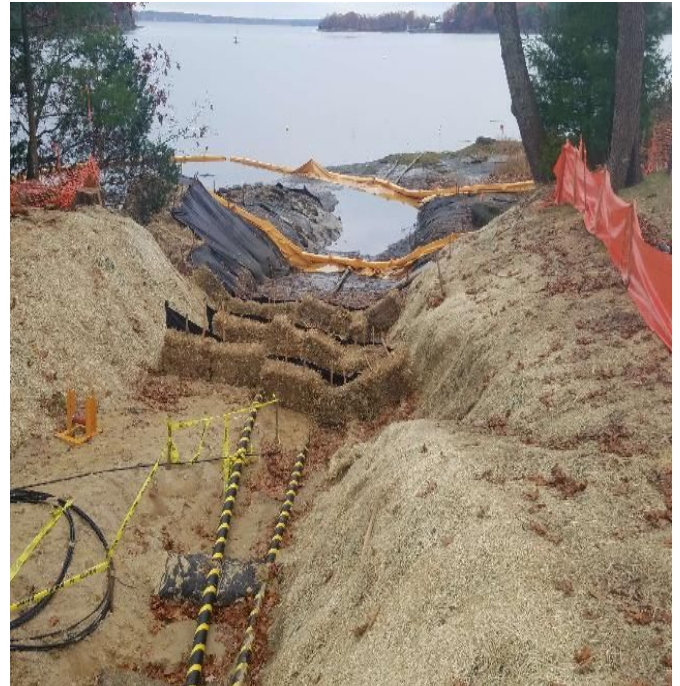
Fig 22: Sediment controls in trench at Gundalow landing/east side of the Bay. Viewing west. (11-05-19).

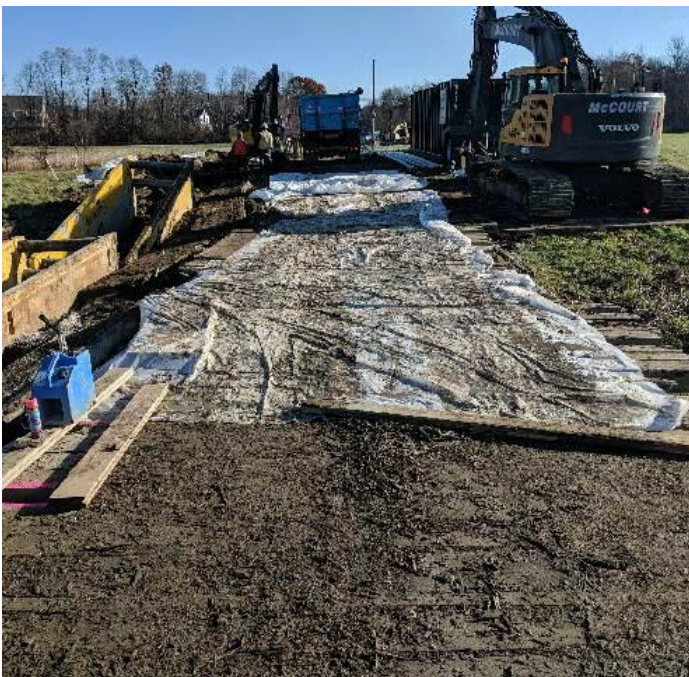
Fig 23: Poly sheeting over timber mats at Frink farm. Viewing east. (11-06-19).

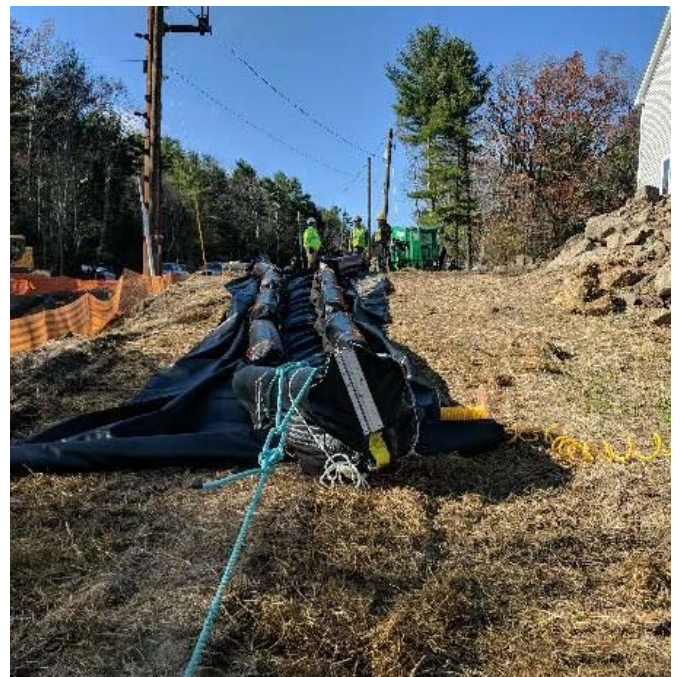
Fig 24: Turbidity barrier for hand jetting prior to installation at Getchell property - west side of the bay . Viewing west. (11-06-19).

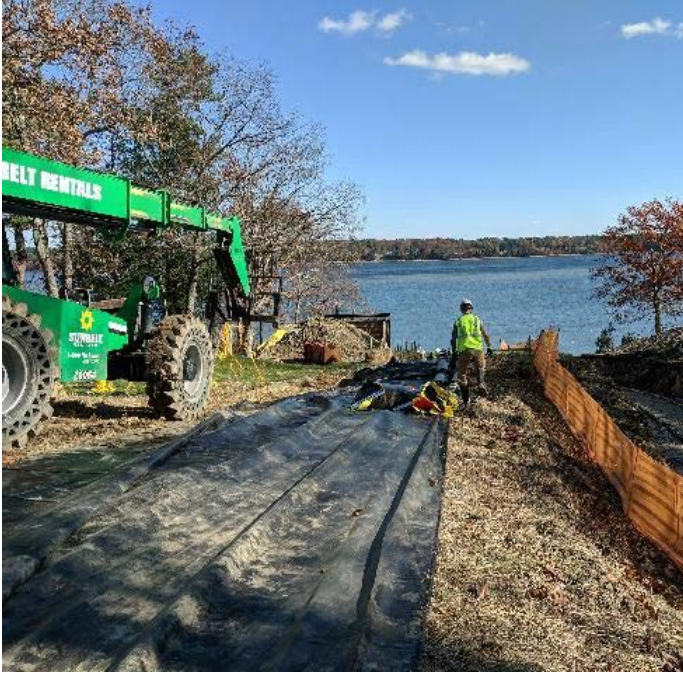
Fig 25: Deploying the turbidity barrier for hand jetting at the Getchell property Viewing east. (11-06-19).

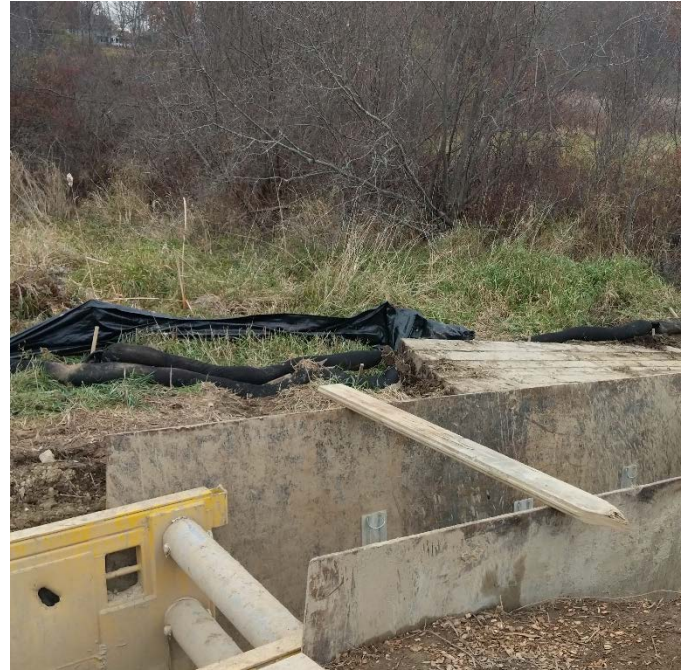
Fig 26: Silt socks replaced in kind at the Frink Farm at NW18. Viewing north. (11-06-19)

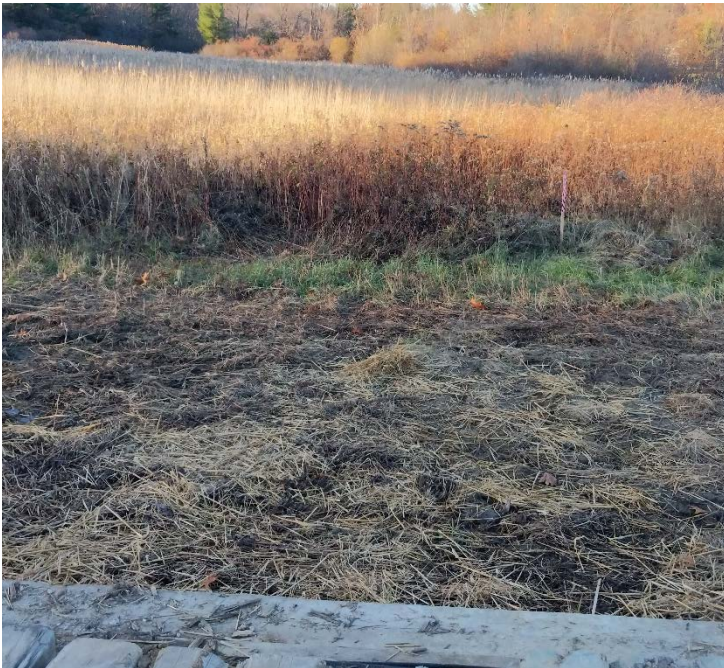
Fig 27: Bare ground under straw mulch at Frink Farm. Viewing north. (11-06-19).
