Seacoast Reliability Project SWPPP Monitoring Form

Submitted Date: 11/08/2019

Project/Site:	SRP		
Start Date:	Nov 8, 2019	End Date:	Nov 8, 2019
Observer	Brian	Others Present:	Bluroc
Name/Title:	Emlaw/Environmental		
	Monitor		
Town:	Newington/Durham		
Address:	Durham Point Rd access/Mill Rd/Gundalow Landing/Nimble Hill Rd		
Location geopoint:	Dame Rd City of Portsmouth, NH, Es	ri, HERE, Garmin, INCREMEN	Little Bay Rockingham NT P, N Powered by Esri

Inspection Type: Storm Event

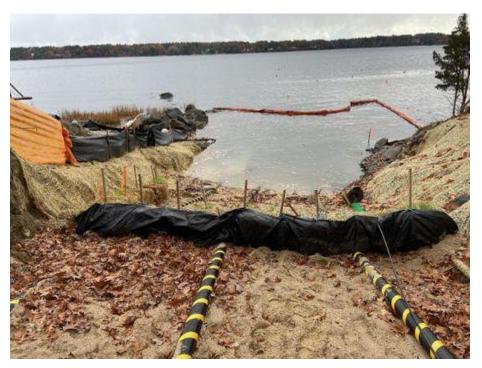
Photo 1. Cable trench, view of silt fence/straw bail barrier at edge of underwater cable crossing, facing east, Durham NH.

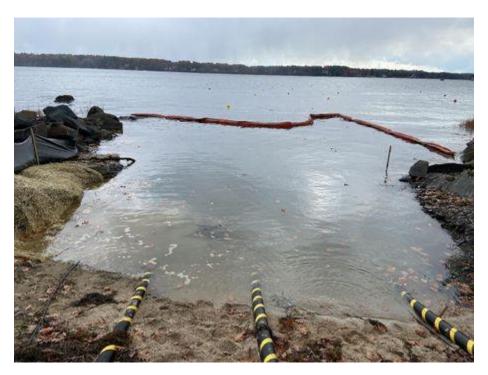
Photo 2. Turbidity barrier installed at edge of cable install, view east, Durham, NH.

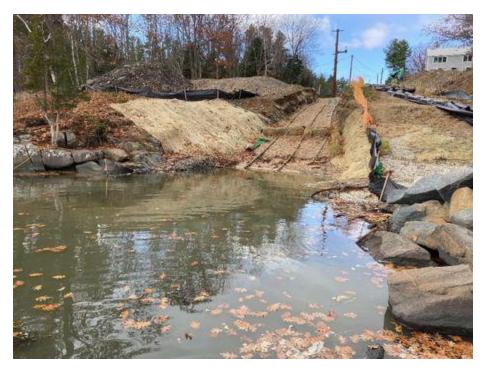
Photo 3. Cable trench, view west, Durham NH.

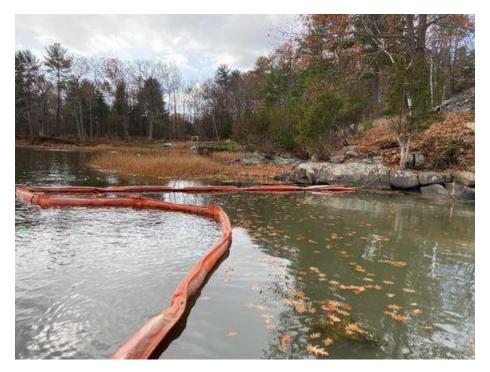
Was stormwater discharge observed onsite?	Slight discharge observed at underwater	
	cable crossing, Durham NH.	
Stormwater discharge comment	Discharge is contained by installed turbidity	
	barrier, (Photo 4). Turbid water may also be a	
	result of tide changes at open trench.	
Was turbidity observed as a result of the discharge?	Yes	
Location(s) of discharge:	Northern bank of cable trench at Durham	
	cable crossing.

Photo 4. Turbidity barrier, view south, Durham, NH.

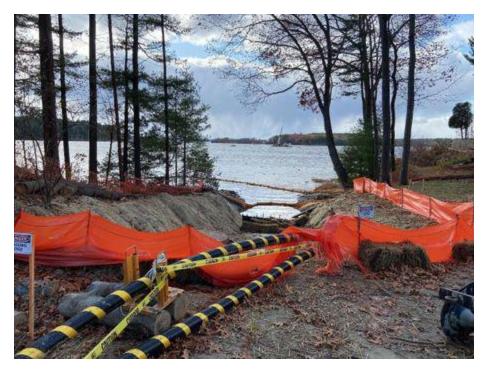
Photo 5. Cable trench, view southwest, Newington, NH.

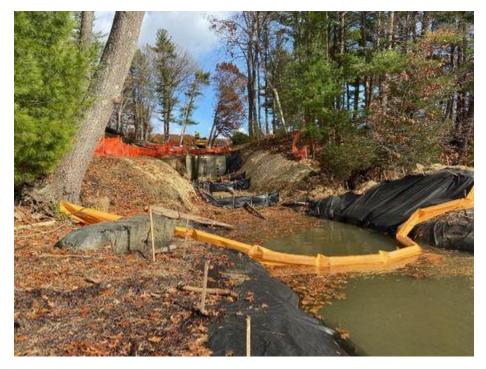
Photo 6. Cable trench, view east, Newington, NH.

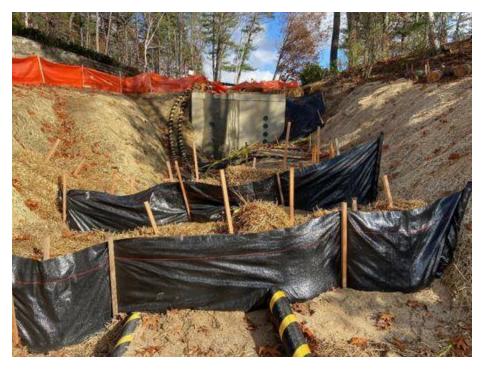
Photo 7.Cable trench, facing manhole, view northeasst, Newington, NH.

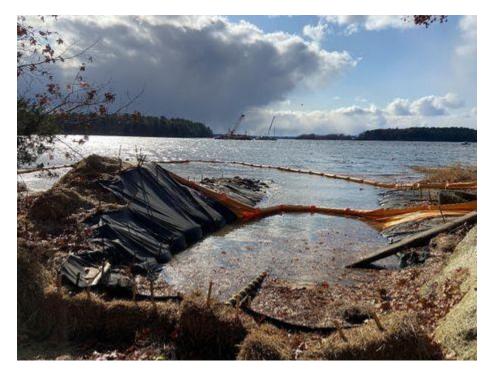
Photo 8. Turbidity barrier, view southwest, Newington, NH.

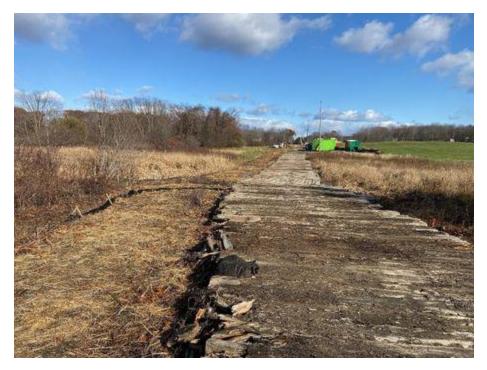
Photo 9. Wetland NW16, view east, Newington, NH.

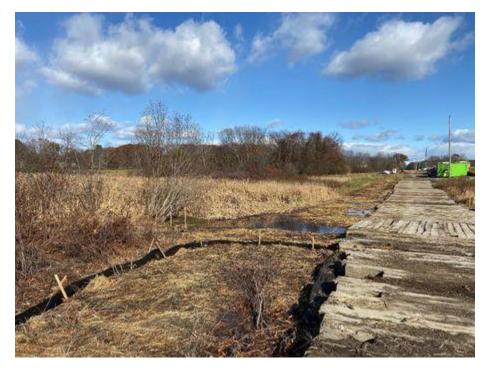
Photo 10. Wetland NW16 erosion controls, view east, Newington, NH.

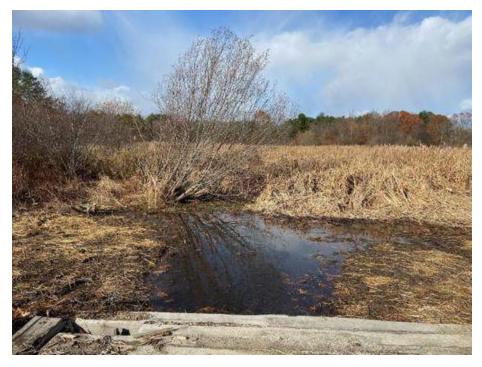
Photo 11. Restored stream NS107 diversion area, view north, Newington, NH.

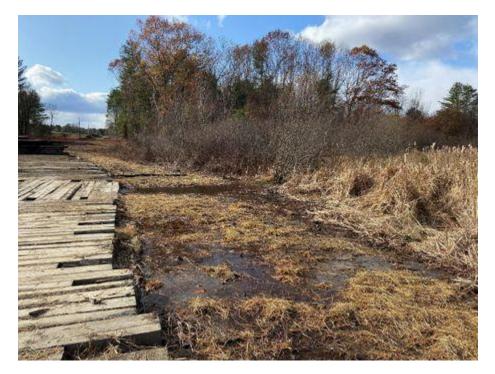
Photo 12. Restored stream NS107 diversion area, view northwest, Newington, NH.
