CONSTRUCTION MONITORING REPORT

Eversource Seacoast Reliability Project

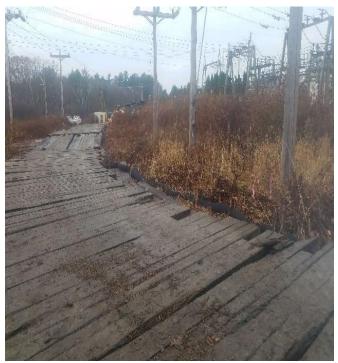
Fig 5: Filter sock installed along access road to Str. 1 and 2. Viewing south. (11-22-19).

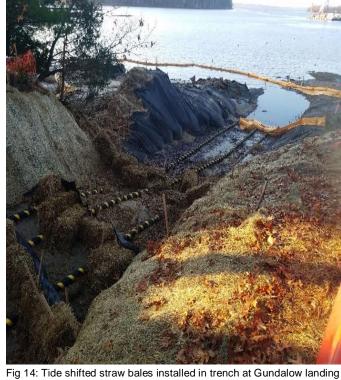
Fig 14: Tide shifted straw bales installed in trench at Gundalow landing /east side of the Bay. (Corrected each day.) Viewing west. (11-25-19).

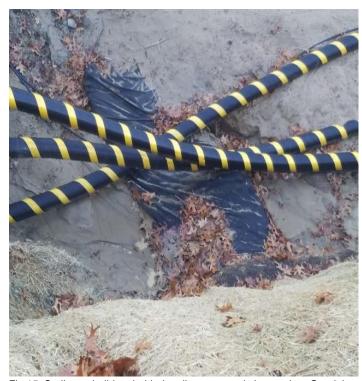
Fig 15: Sediment build up behind sediment controls in trench at Gundalow landing/ east side of the Bay. Viewing south. (11-25-19).

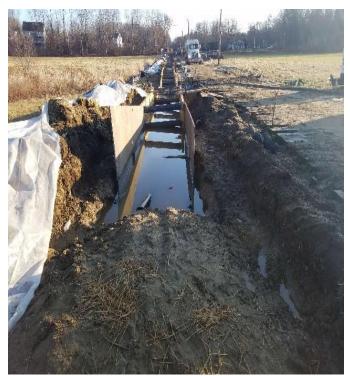
Fig 16: Rain water in trench at Frink farm. Viewing east. (11-25-19).

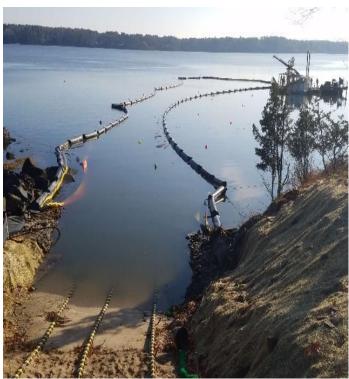
Fig 17: Turbidity curtain shifted at Getchell property/west side of the Bay. Viewing east. (11-25-19).

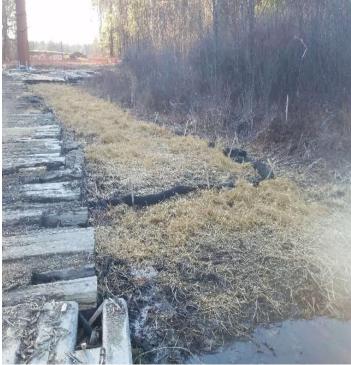
- Straw needs to be spread over wetland NW20 once trench is backfilled and restored. Please consult with environmental monitor.
- Straw was broadcast over wetland NW18 and NW16, met the application standards, approved by environmental monitor. See photos 19, 21 and 22 below.
- Mulch/straw has been spread on slope around Str. 29. See photo 24 below.
- o BMPs have been installed along access roads in wetlands. See photo 5 below.
- Temporary blankets installed at Getchell property/west side of Bay depicted in Figures 28 and 29 will be replaced with wildlife friendly jute.

Fig 19: Straw correctly applied over wetland NW16. Viewing east. (11-25-19).

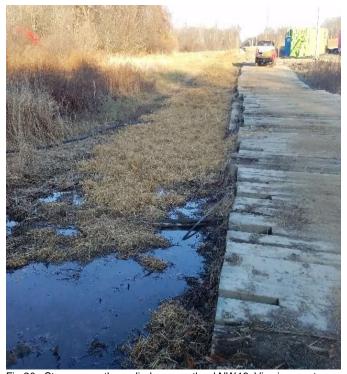
Fig 20: Straw correctly applied over wetland NW16. Viewing west. (11-25-19).

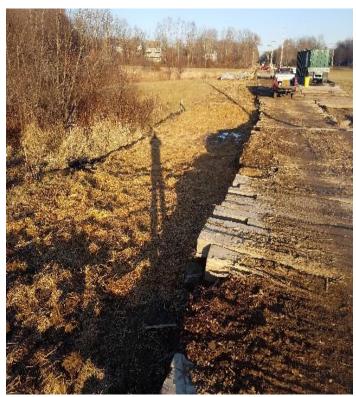
Fig 21: Straw correctly applied over wetland NW16. Viewing east. (11-25-19).

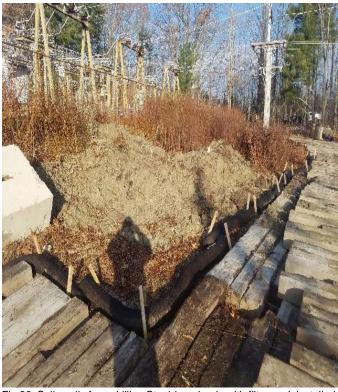
Fig 22: Soil spoils from drilling Str. 1 in uplands with filter sock installed around perimeter. Viewing north. (11-26-19).

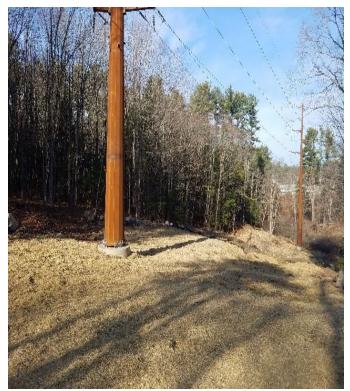
Fig 24: Ground surface around Str. 29 mulched with straw. Viewing north. (11-26-19).

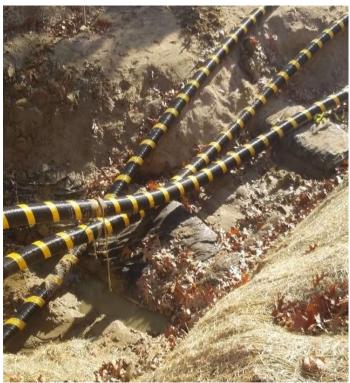
Fig 25: Sediment build up removed from BMPs in trench at Gundalow landing/east side of the Bay. Viewing west. (11-26-19).

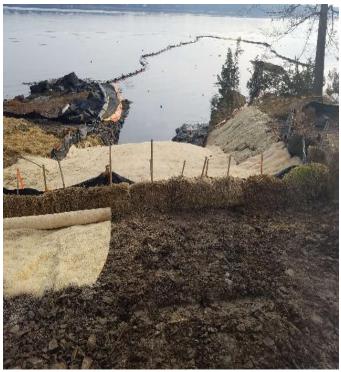
Fig 28: Trench at Getchell property/west side of the Bay backfilled with Temporary erosion blankets installed. Viewing east. (11-27-19).

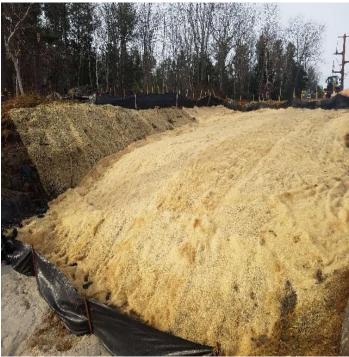
Fig 29: Temporary erosion blanket on restored slope at Getchell property/ west side of the Bay. Viewing west. (11-27-19).
