CONSTRUCTION MONITORING REPORT

Eversource Transmission Lines:
F107

**Madbury, Durham,
Newington, Portsmouth, NH**

TYPE OF INSPECTION: Weekly Storm Event Incident Corrective Action

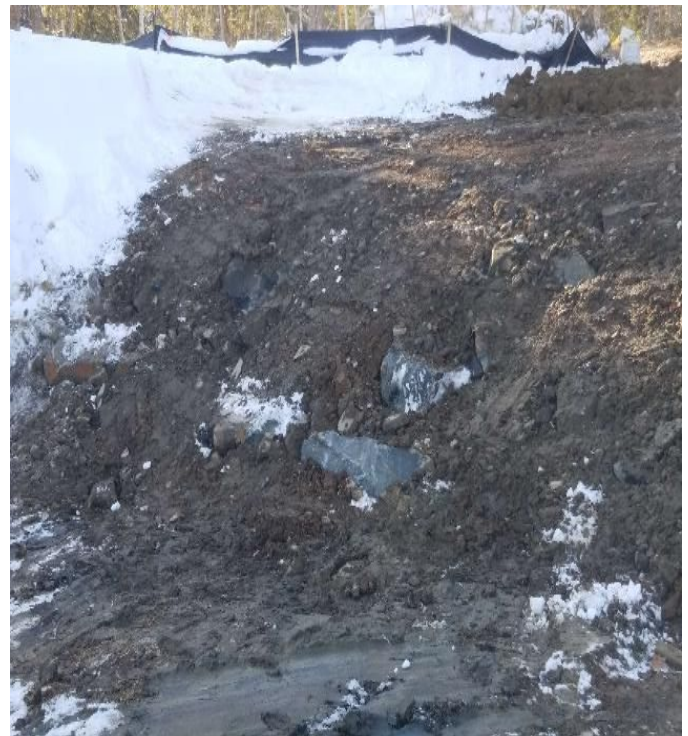
Fig 12: Large diameter boulders placed to stabilize toe of slope at Getchell property/west side of bay.. Viewing west. (12-07-19).

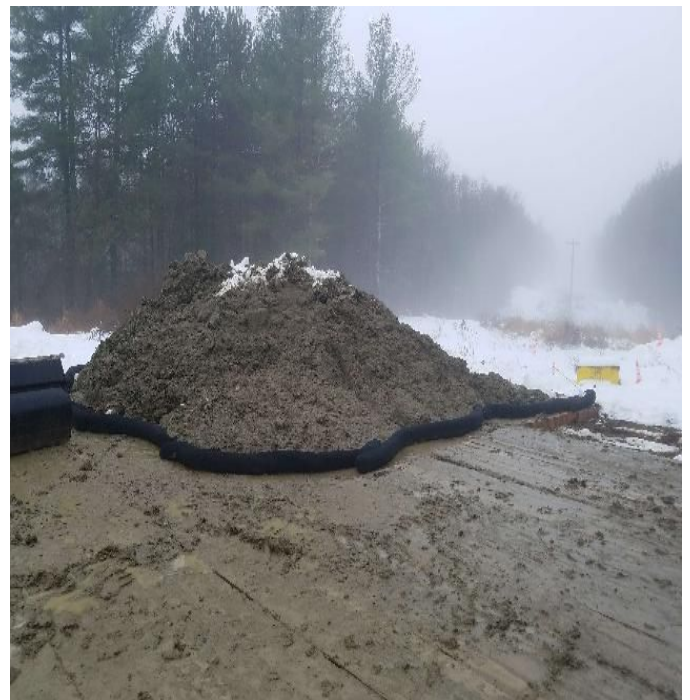
- **BMPs**
 - Wetland NW20 has been properly restored and mulched. See photo 23 below.
 - Soil piles must have sediment controls installed around them.
 - BMPs must be installed along access roads in wetlands simultaneous to construction the access roads.

Fig 16: Filter sock installed around soil pile at Str. 85. Viewing west. (12-09-19).

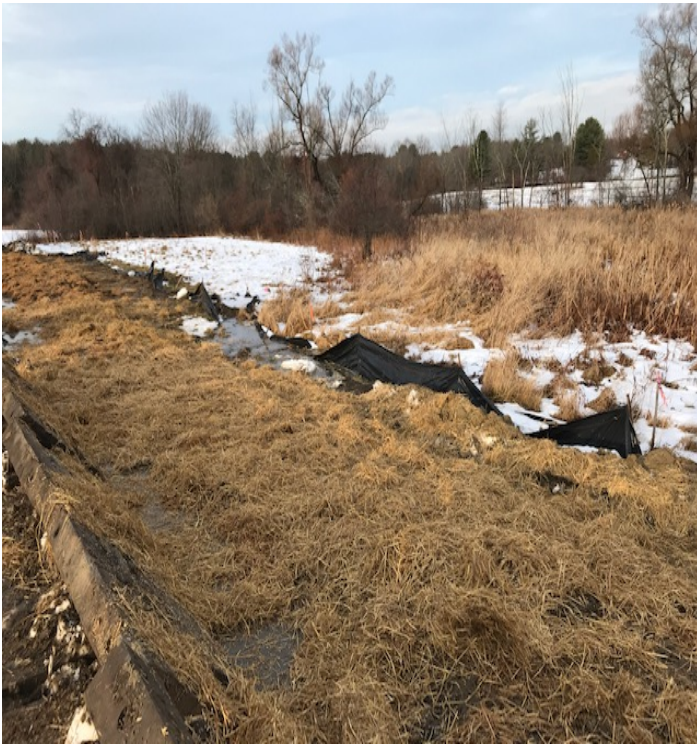
Fig 23: Wetland NW20 restored and mulched. The limit-of-work silt fence has been removed. Viewing west. (12-10-19).

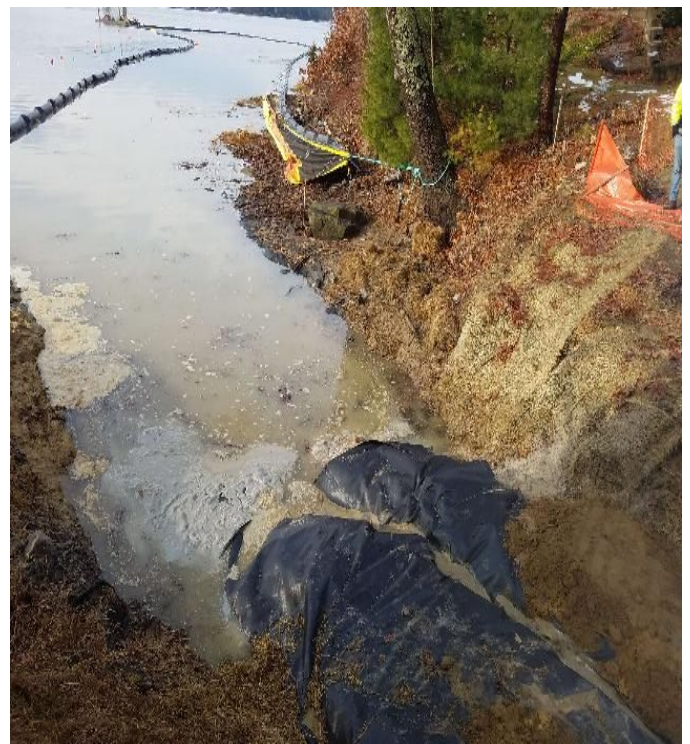
- The crews had to remove existing sediment controls at Gundalow Landing in order to begin restoration. A rain event, supplemented by significant snow melt, during onshore trench restoration resulted in sediment laden water being discharged into the Bay. The Crew was able to continue to backfill and pack in material to slow the flow of water. At the end of the day crews re-installed the sediment controls and silt curtain. All of the sediment laden water was enclosed by the turbidity barrier that is installed for the diver cable burial. See photos 24-30 below.

Fig 24: Sediment laden water discharging into the Bay during restoration Activities at Gundalow landing/east side of the Bay. Viewing west. (12-10-19).

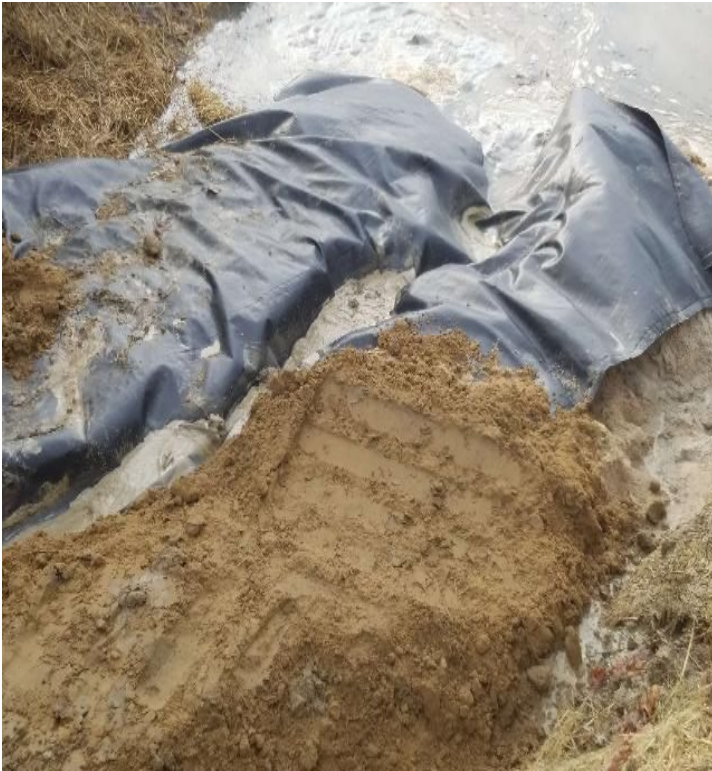
Fig 25: Sediment laden water discharging into the bay at Gundalow Landing/east side of the Bay. Viewing west. (12-10-19).

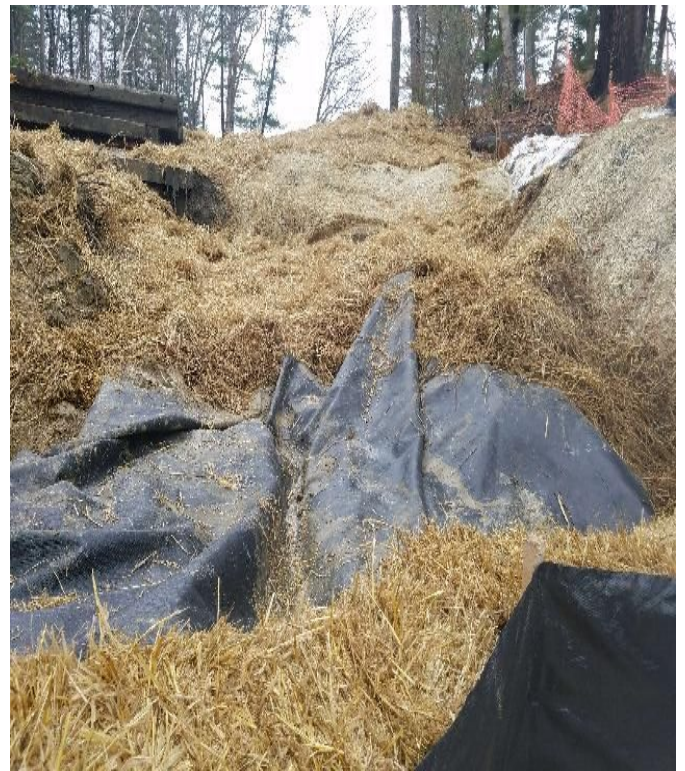
Fig 26: Crew re-installed sediment controls at Gundalow landing/east Side of the Bay. Viewing east. (12-10-19).

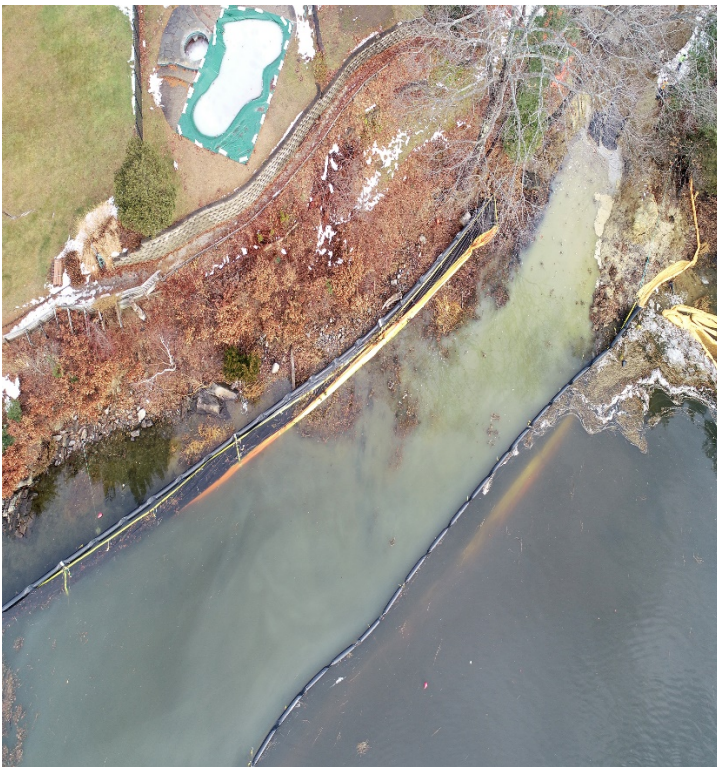
Fig 27: Sediment plume contained by turbidity barrier. Aerial photograph. Bay

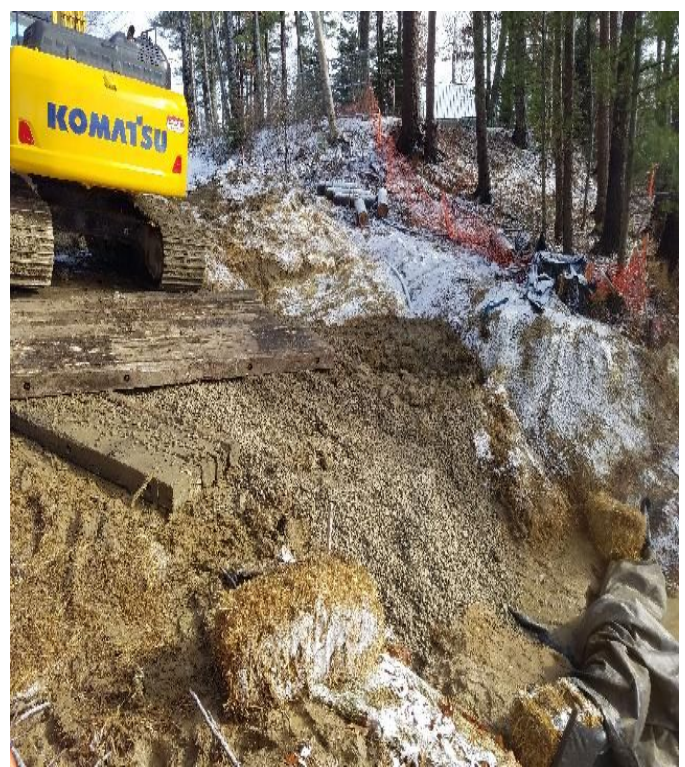
Fig 28: Crushed stone added to Gundalow landing/east side of the Bay

to temporarily stabilize ground surface. Viewing southeast. (12-11-19).

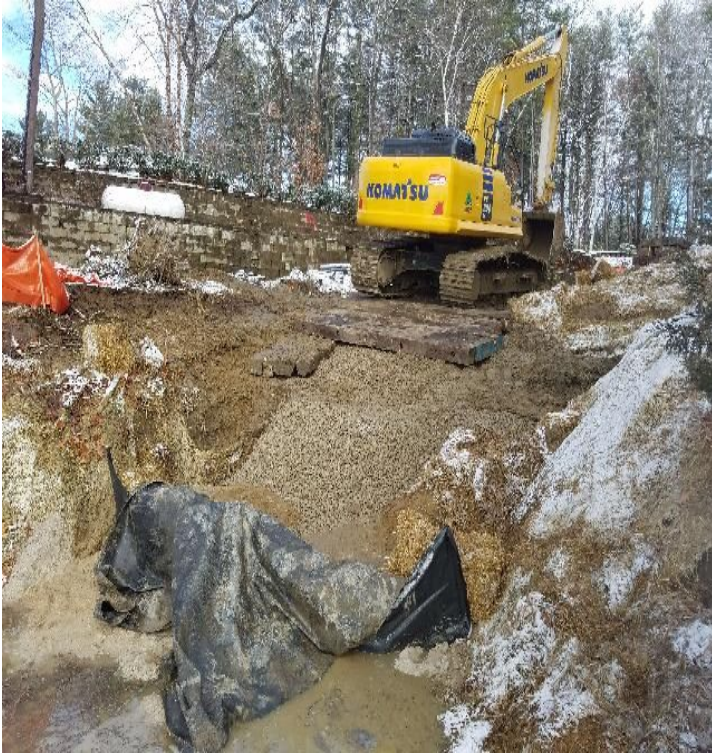
Fig 29: Crushed stone added to Gundalow landing/east side of the Bay. Viewing east. (12-11-19).

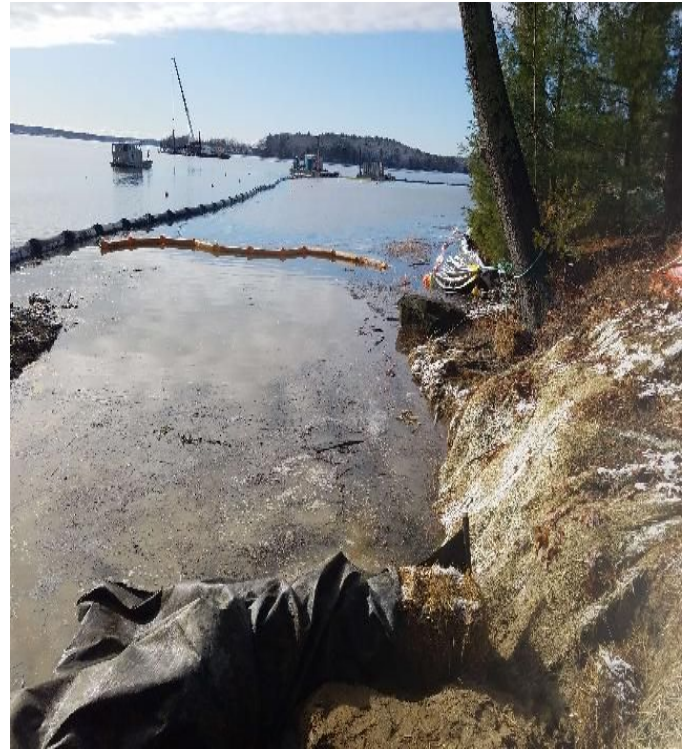
Fig 30: Crews installing silt curtain at Gundalow landing/east side of the Bay to contain sediment discharge. Viewing west. (12-11-19).
