CONSTRUCTION MONITORING REPORT

Eversource Transmission Lines:
F107

**Madbury, Durham,
Newington, Portsmouth, NH**

TYPE OF INSPECTION: Weekly Storm Event Incident Corrective Action

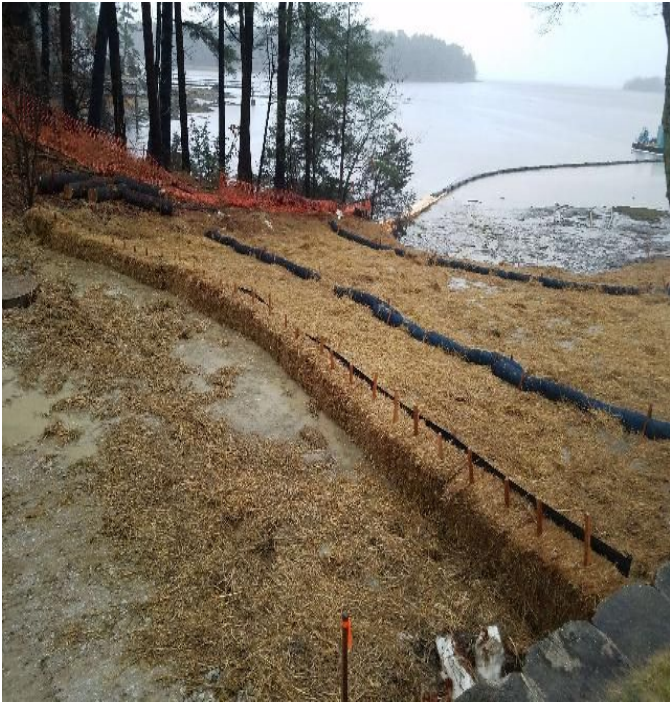
Fig 1: Restored slope at Gundalow landing/east side of the Bay. Viewing southwest. (12-14-19).

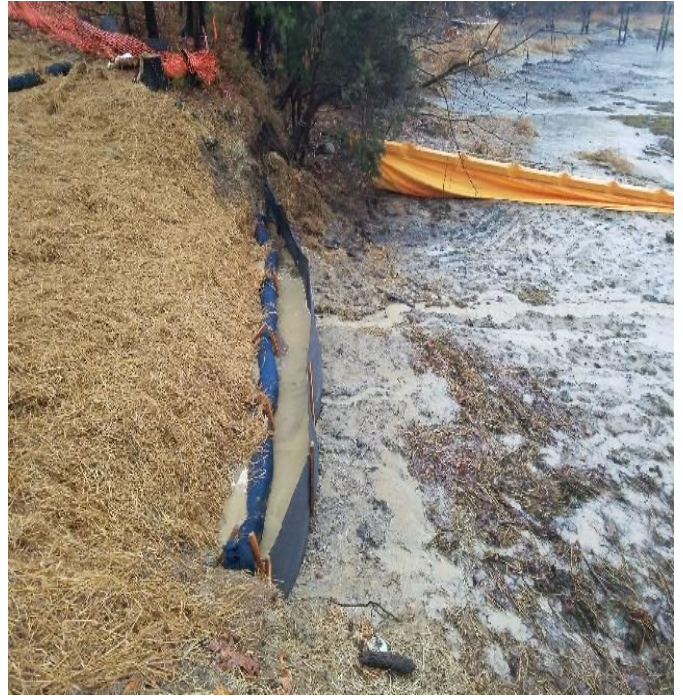
Fig 2: Sediment build up at silt fence. Note undercutting. Turbid water mostly contained by turbidity barrier. Gundalow Landing. Viewing south. (12-14-19).

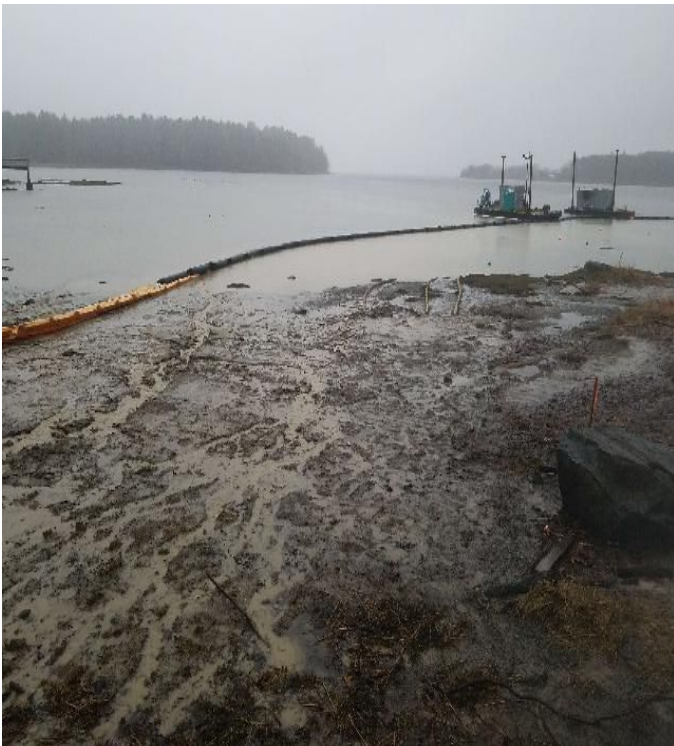
Fig 3: Restored intertidal substrates at Gundalow landing/east side of the Bay. Viewing west. (12-14-19).

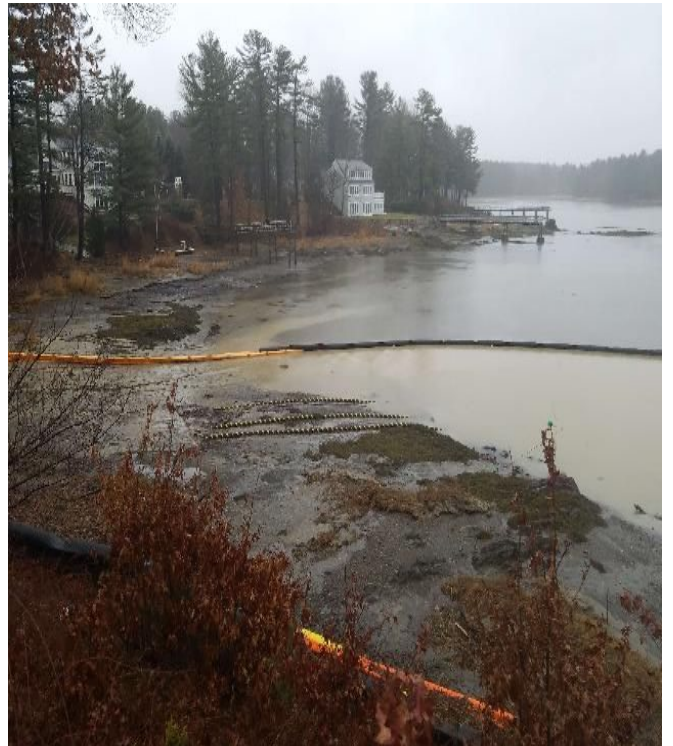
Fig 4: Most of the sediment being contained by the turbidity barrier at Gundalow landing/east side of the Bay. Viewing south. (12-14-19).

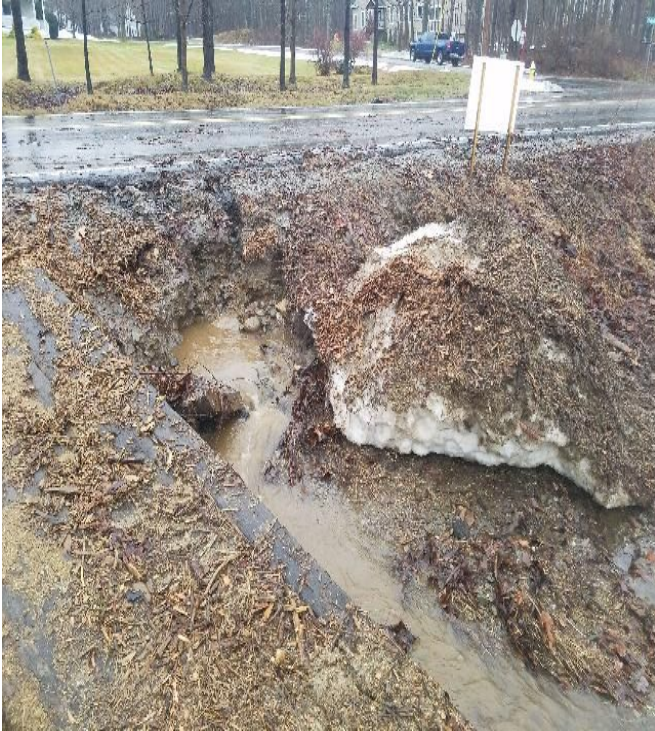
Fig 5: Bank eroded away off of Nimble Hill Rd, flooding Frink farm. Viewing east. (12-14-19).

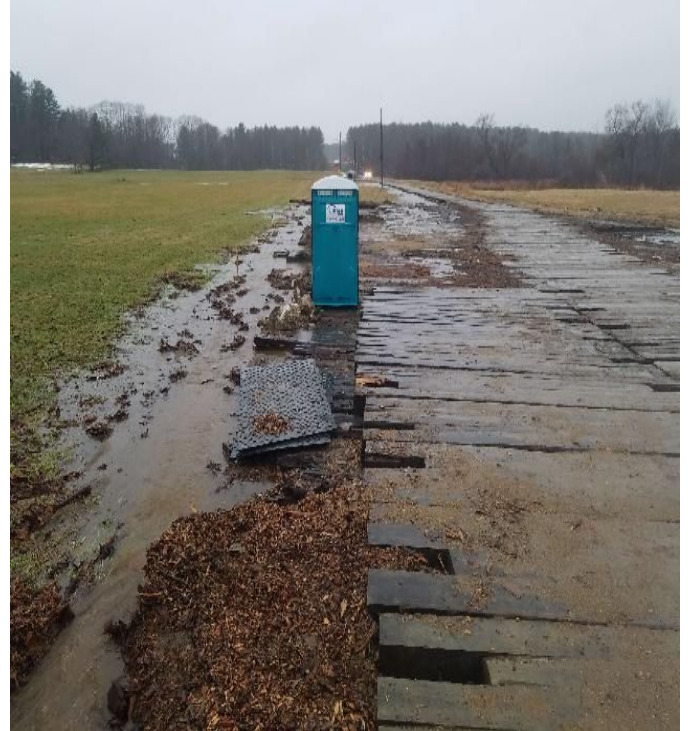
Fig 6: Runoff from Nimble Hill Rd through Frink farm. Viewing west. (12-14-19).

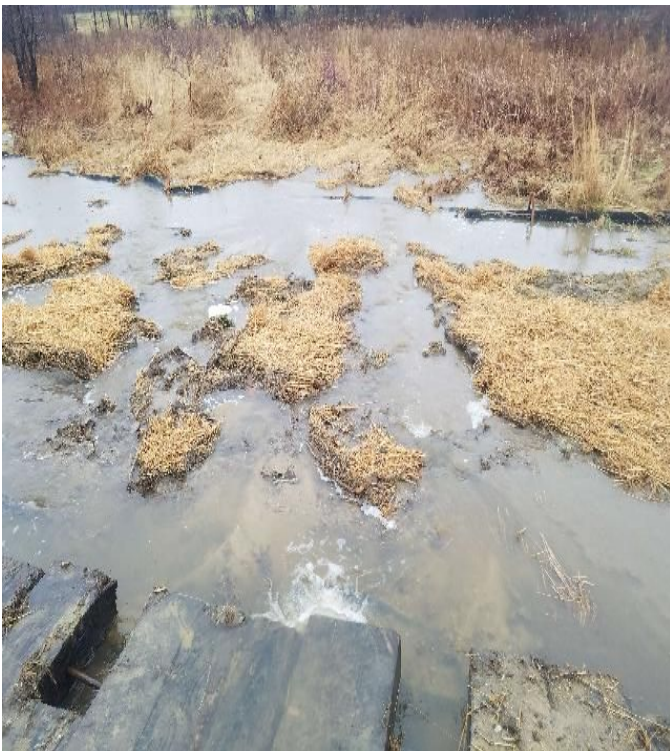
Fig 7: Wetland NW20 at Frink farm. Viewing north. (12-14-19).

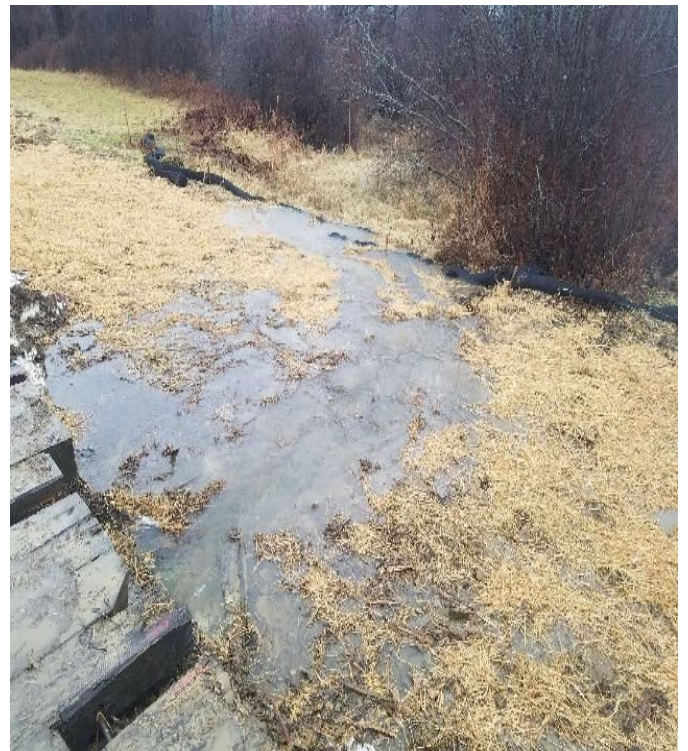
- Filter sock installed in NW18 at Frink farm needs to be installed correctly. See photo 8 below.
 - Straw bales along access road to Str. 99 should extend all the way to and surrounding work pad for Str. 99, as it is shown on the construction drawings. See photo 10 below.

Fig 8: Wetland NW18 at Frink farm. Filter sock not installed correctly. Viewing north. (12-14-19).

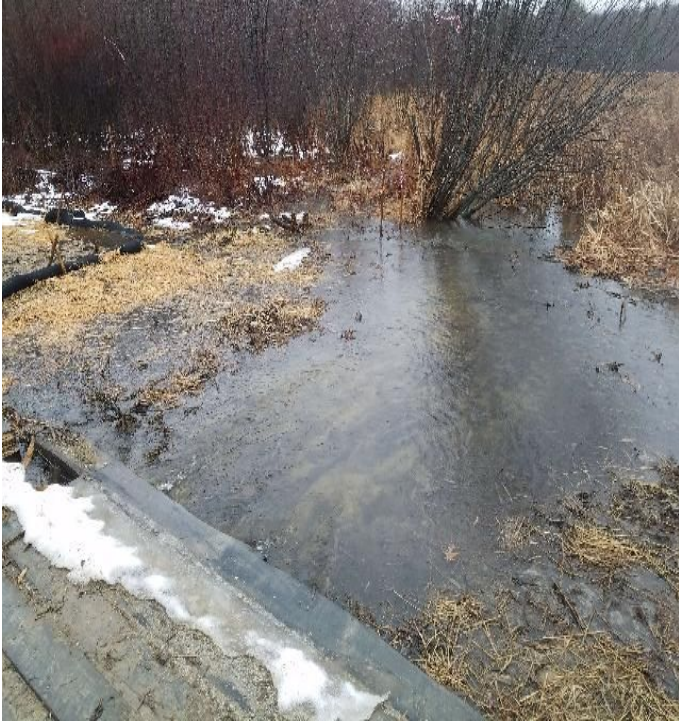
Fig 9: Knights Brook tributary at Frink farm, no issues. Viewing north. (12-14-19).

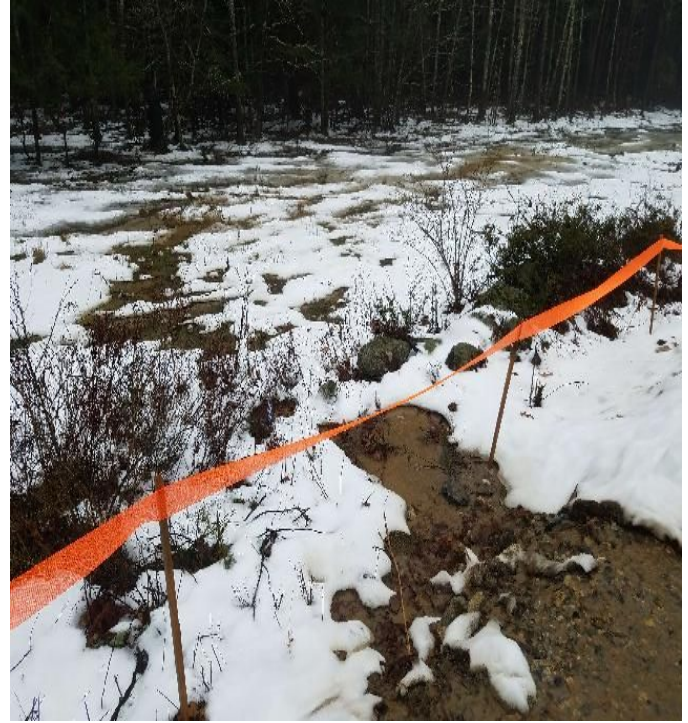
Fig 10: Turbid water discharging into wetland DW2, along access road To Str. 99. Viewing west. (12-14-19).

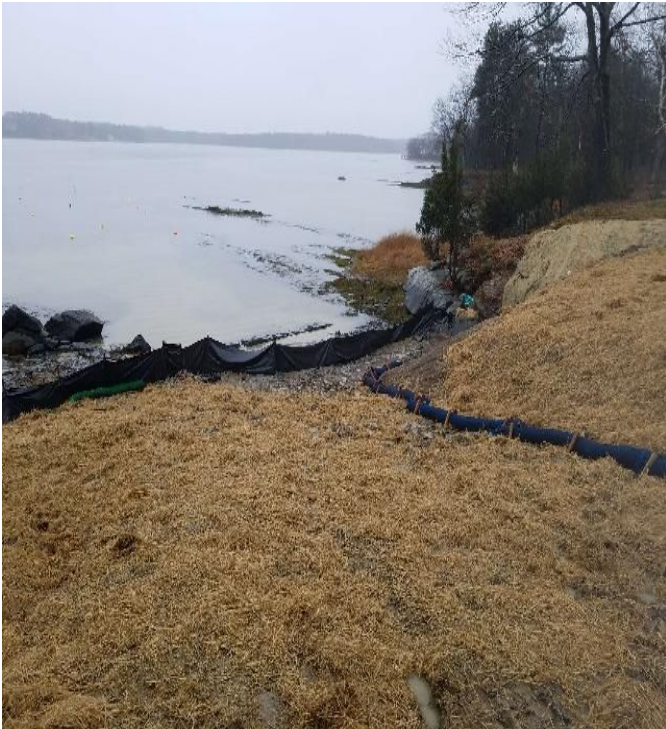
Fig 11: Restoration of slope at Getchell property/west side of the Bay. Viewing east. (12-14-19).

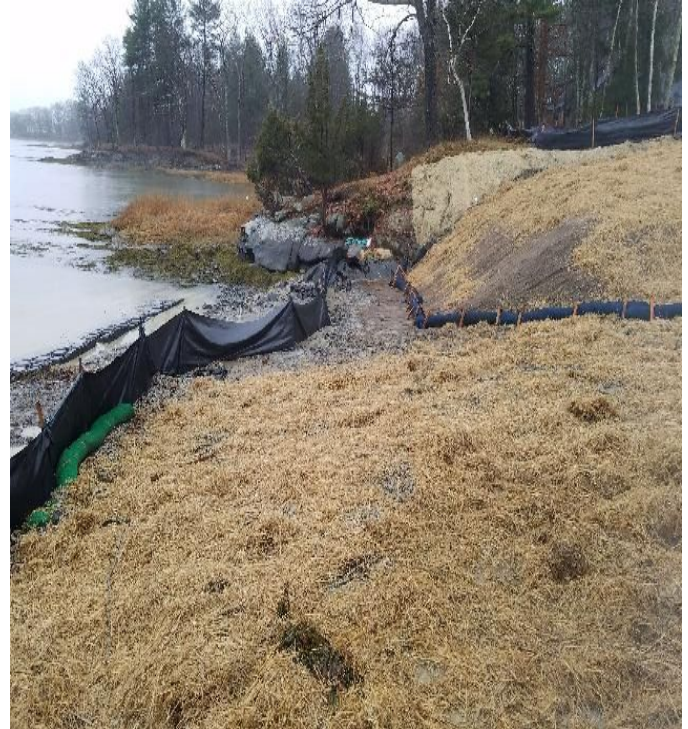
Fig 12: Salt marsh and slope restoration at getchell property/west side of the Bay. Viewing south. (12-14-19).

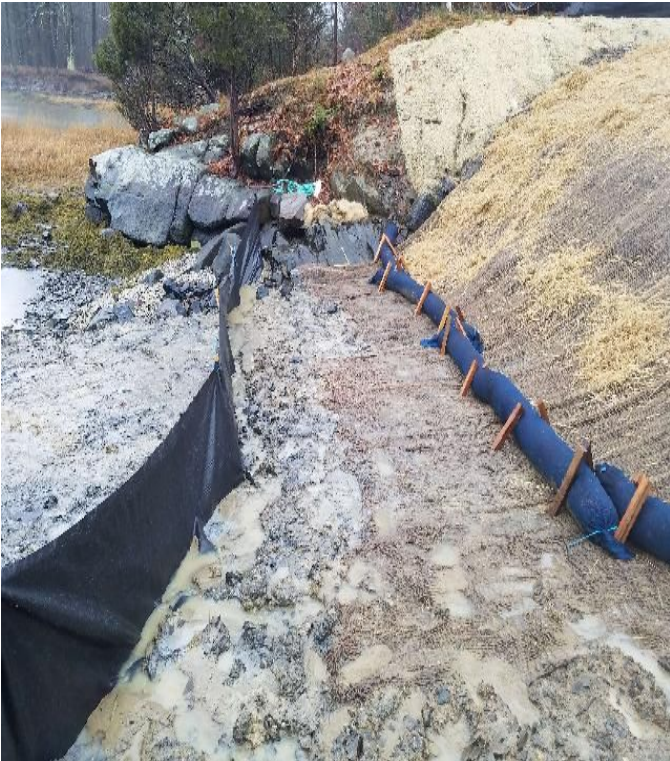
Fig 13: Salt marsh and slope restoration at Getchell property/west side of the Bay. Viewing south. (12-14-19).

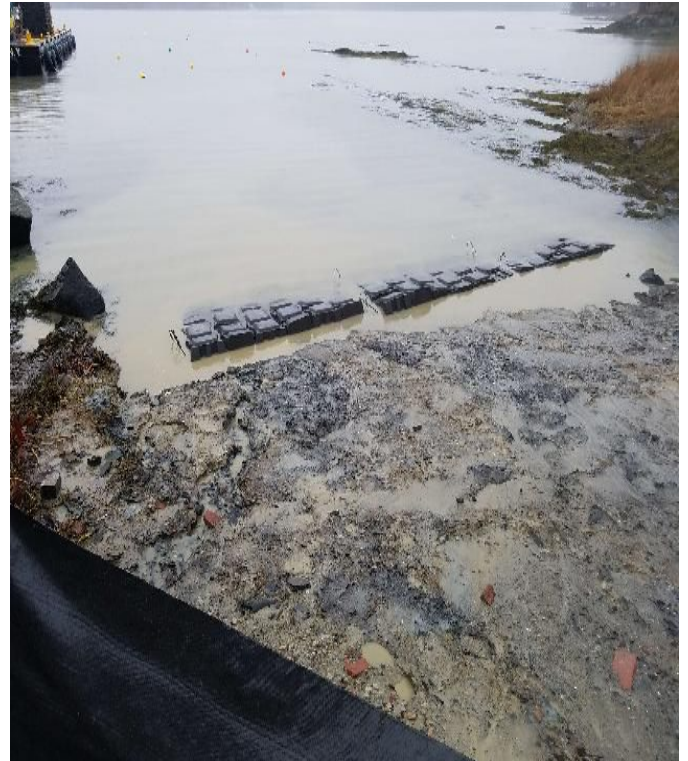
Fig 14: Concrete mattresses installed at Getchell property/west side of the Bay. Viewing wet. (12-14-19).

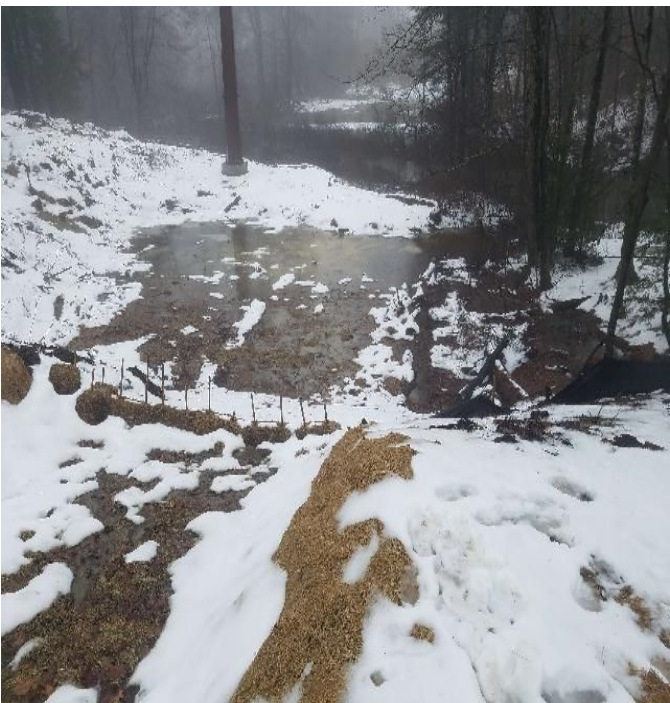
Fig 15: Str 28, no issues. Viewing north. (12-14-19).

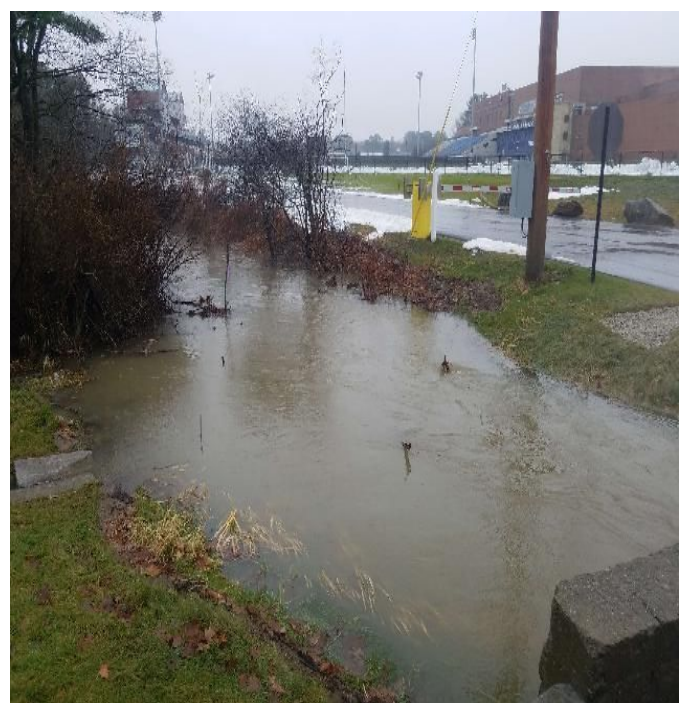
Fig 16: College Brook at UNH, no issues. Viewing east. (12-14-19).

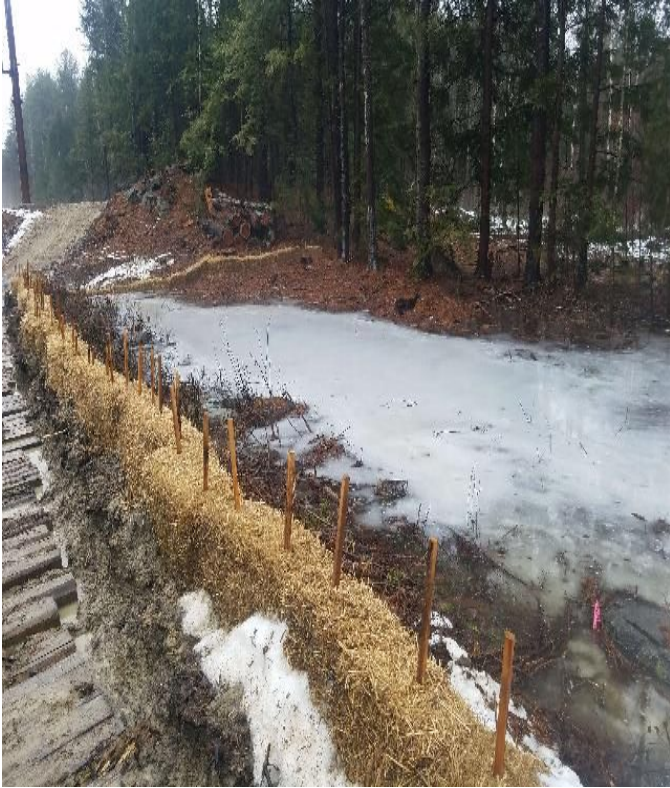
Fig 17: Wetland DW400N iced over, no issues. Viewing south. (12-14-19).

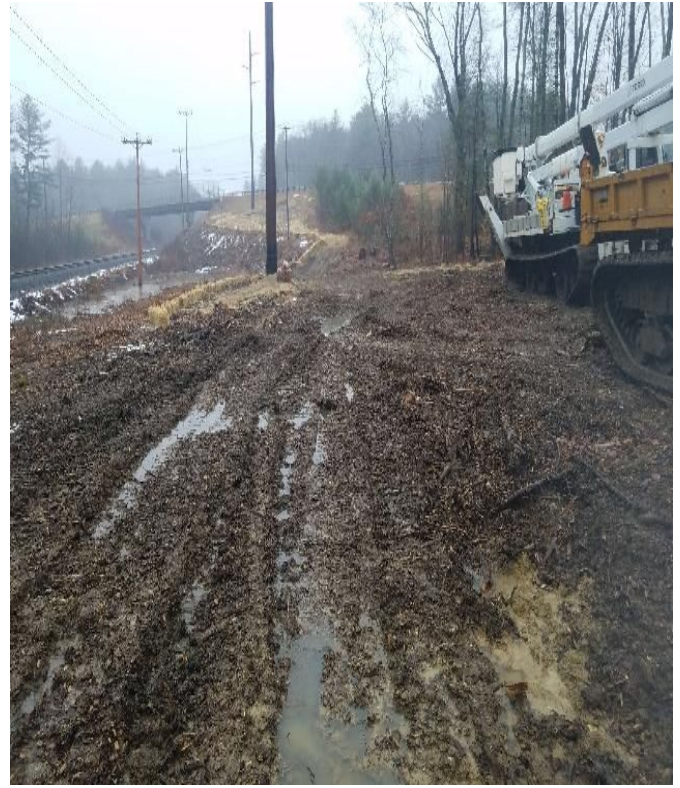
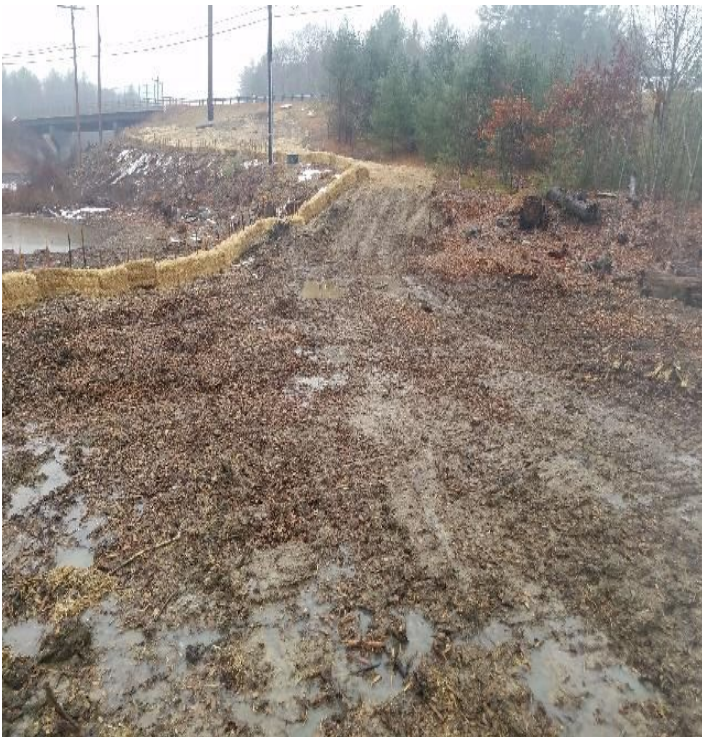
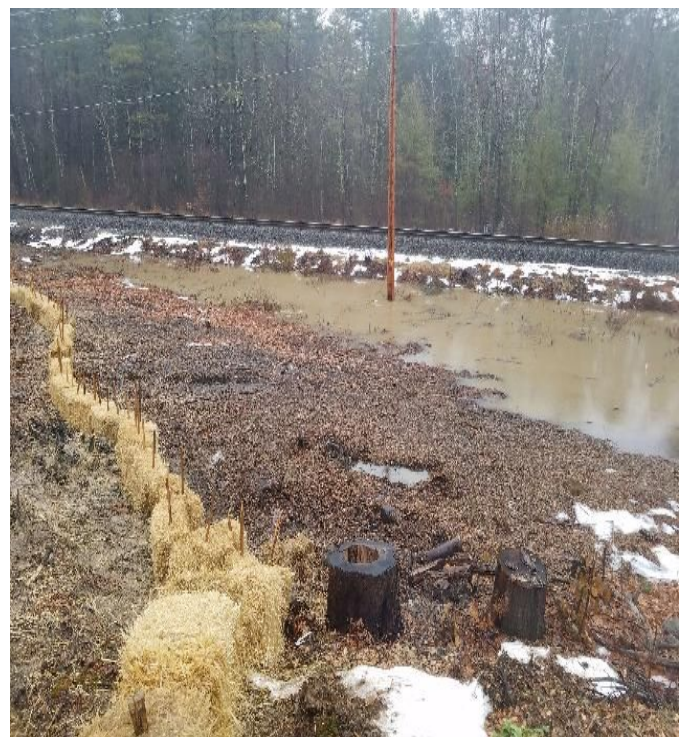
- Straw bales installed between wetland MW1 and Strs. 5 and 6 were installed last night after construction was complete. Getting proper ground contact at night is questionable. All required BMPs should be installed while building the access roads. Turbid water discharging into wetland MW1 is a result of this. See photos 18, 19 and 20 below.

Fig 18: Ruts in access road to Strs. 5 and 6. Viewing south. (12-14-19).

Fig 19: Ruts and exposed soils in access road to Strs. 5 and 6. Viewing south. (12-14-19).

Fig 20: Sediment discharging into wetland MW1 between Strs. 5 and 6. Viewing south. (12-14-19).

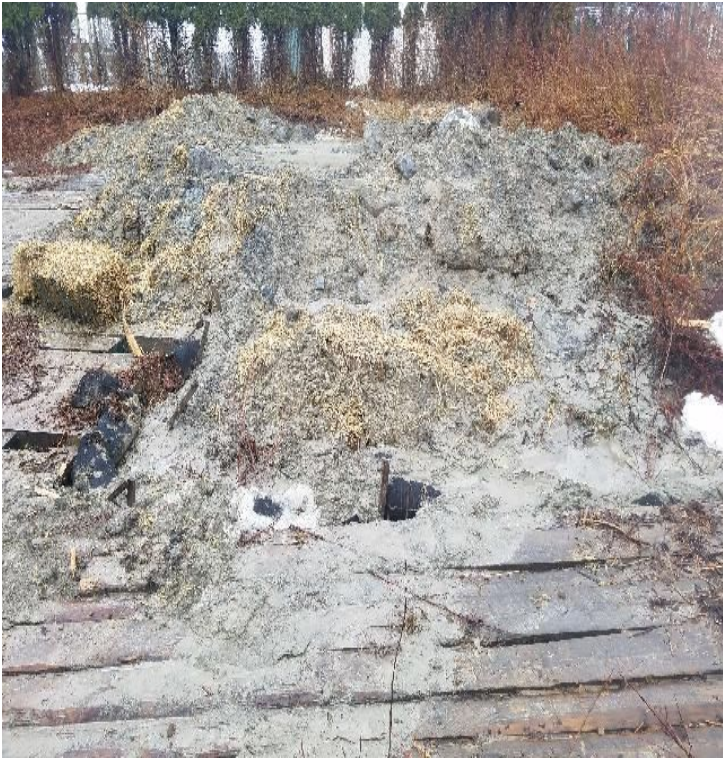
- **BMPs**
 - Soil piles must have sediment controls installed around them. Soil cannot overtop BMPs. See photo 21.
 - BMPs must be installed along access roads in wetlands simultaneous to construction of access roads. See photo 25 below.

Fig 21: Soil pile at Str 1. Sediment overtopping filter sock. Viewing east. (12-14-19).

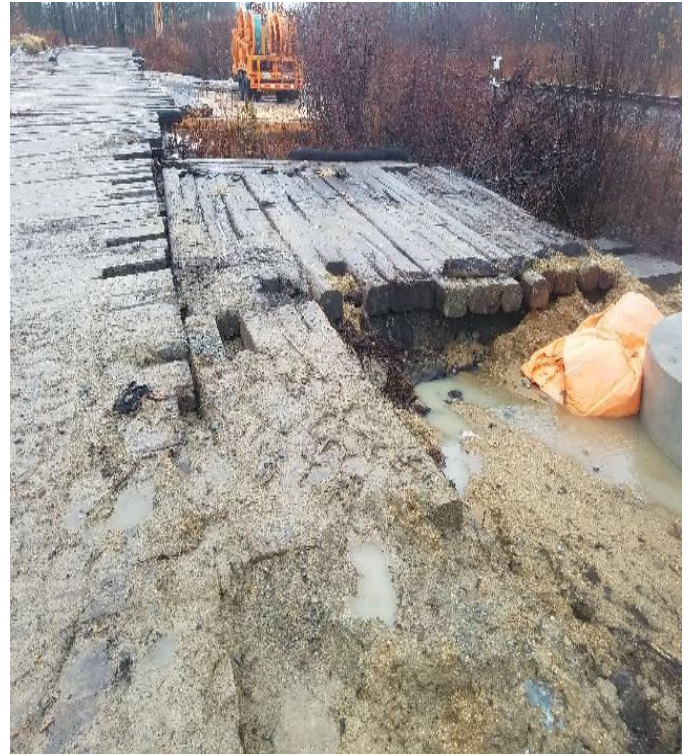
- Timber matted access roads are to be swept and maintained. See photo 22 below.
 - If BMPs are damaged during construction or line pulling they need to be replaced or repaired. See photo 24 below.

Fig 22: Turbid water from stockpiled soil flowing under mats around Str. 2. Viewing north. (12-14-19).

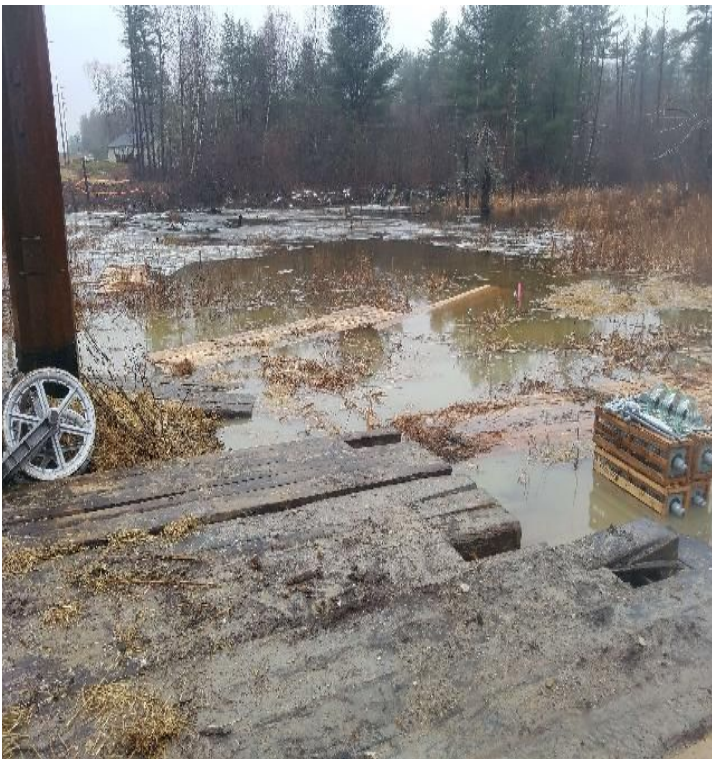
Fig 23: Area around Str. 3. No BMPs installed between work pads and wetland MW2. Viewing south. (12-14-19).

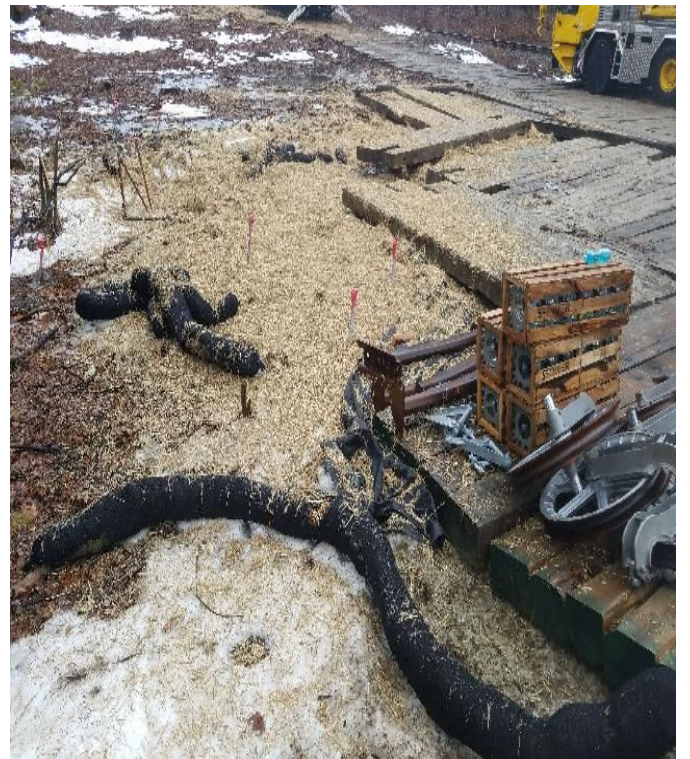
Fig 24: Filter sock around work pad for Str. 8. Viewing south. (12-14-19).

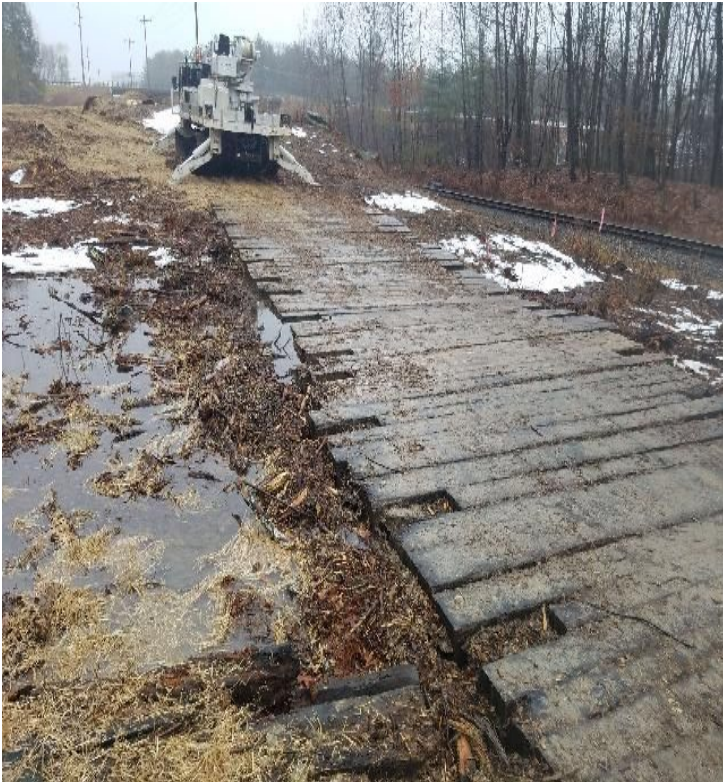
Fig 25: No required BMPs installed along access road through wetland DW93. Viewing south. (12-14-19).
