CONSTRUCTION MONITORING REPORT

Eversource Seacoast Reliability Project

Construction Monitoring Report #41

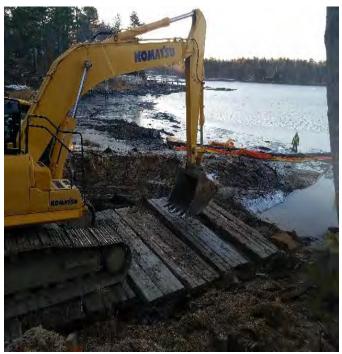
Fig 1: Intertidal restoration at Gundalow landing/east side of the Bay. Viewing southwest. (12-12-19).

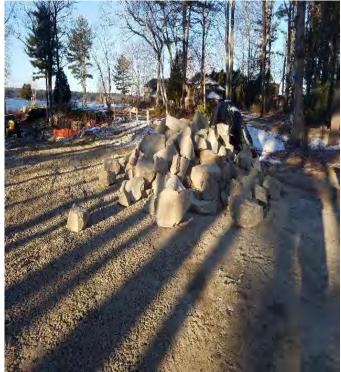
Fig 3: Large diameter stone used for restoring the slope at Gundalow landing/east side of the Bay. Viewing west. (12-12-19).

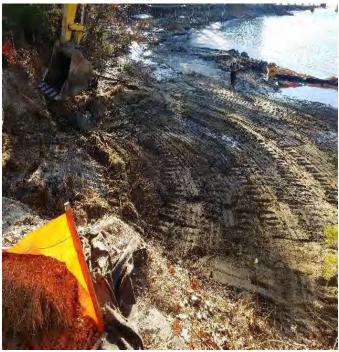
Fig 2: Intertidal restoration at Gundalow landing/east side of the Bay. Viewing south. (12-12-19).

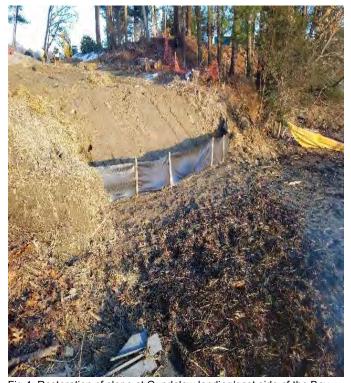
Fig 4: Restoration of slope at Gundalow landing/east side of the Bay. Viewing east. (12-12-19).

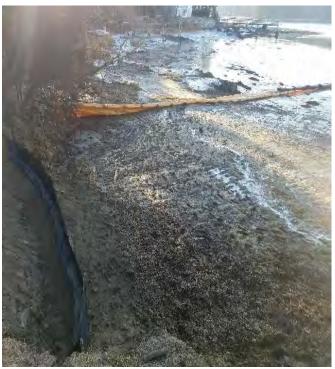
Fig 5: Silt curtain and BMPs installed at Gundalow landing/east side of the Bay. Viewing south. (12-13-19).

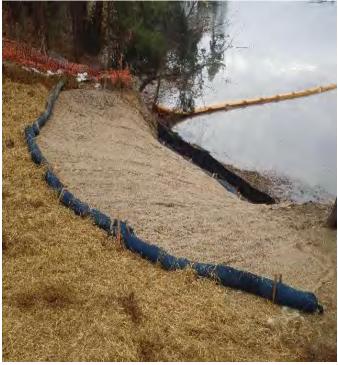
Fig 7: Crew installing sediment and erosion controls at Gundalow landing/east side of the Bay. Viewing south. (12-13-19).

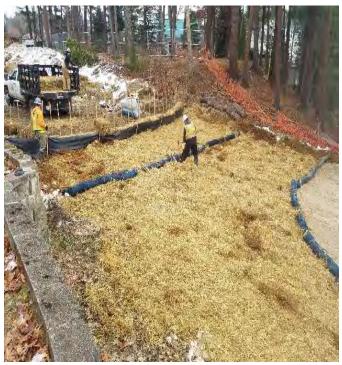
Fig 6: Crew installing sediment and erosion controls at Gundalow landing/east side of the Bay. Viewing east. (12-13-19).

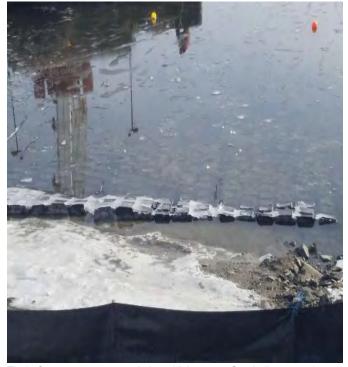
Fig 8: Concrete mattresses in intertidal zone at Getchell property/ west side of the Bay. Viewing east. (12-13-19.

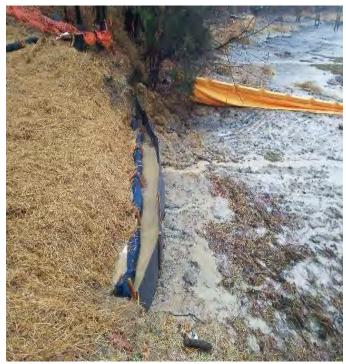
Fig 9: Sediment build up behind silt fence at Gundalow landing/east side of the Bay. (Corrections made.) Viewing south. (12-14-19).

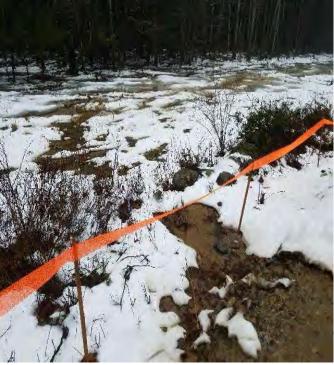
Fig 11: Sediment discharging into wetland DW2, recommend extending BMPs to this area. (Corrections made.) Viewing west. (12-14-19).

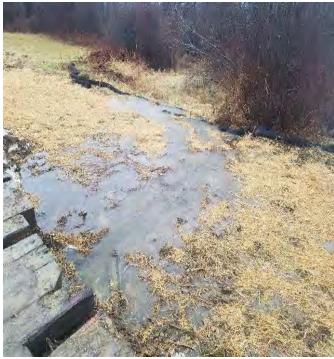
Fig 10: Filter sock needed fixing at wetland NW18 at Frink farm. Viewing north. (Corrections made.) (12-14-19).

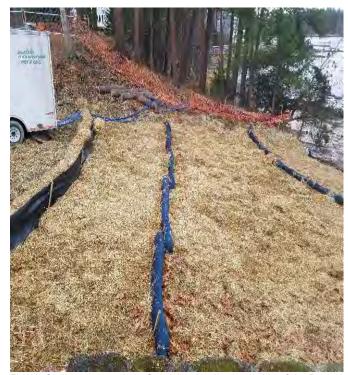
Fig 12: Sediment controls at Gundalow landing/east side of the Bay. Viewing south. (12-15-19).

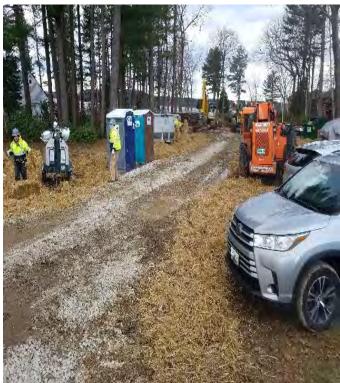
Fig 13: Crew spreading straw over exposed soils at Gundalow landing/east side of the Bay. Viewing west. (12-15-19).

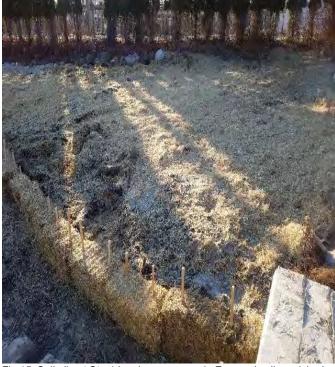
- o Soil pile removed from Str. 1. See photo 15 below.
- BMPs must be installed along access roads in wetlands simultaneous to construction of access roads.
 See photos 18-22 & 25 below.
- o Filter sock installed in NW18 at Frink farm has been repaired. See photo 23 below.
- Straw bales along access road to Str. 99 have been extended all the way to work pad for Str. 99. See photo 24 below.
- o BMPs have been installed around str. 8. See photo 21 below.

Fig 15: Soil pile at Str. 1 has been removed. Exposed soils mulched And BMPs installed downslope. Viewing southwest. (12-16-19).

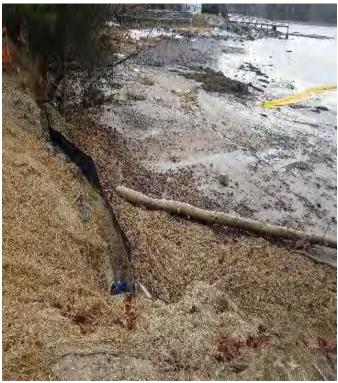
Fig 14: Sediment build up behind silt fence removed at Gundaow landing/east side of the Bay. Viewing south. (12-16-19).

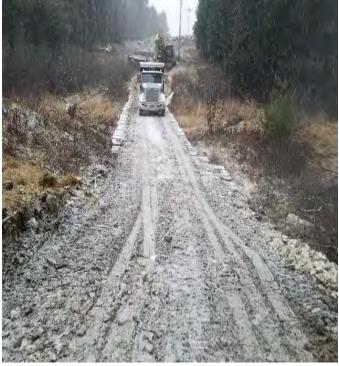
Fig 16: Building access road from Str. 50 to 58. Viewing northeast. (12-17-19).

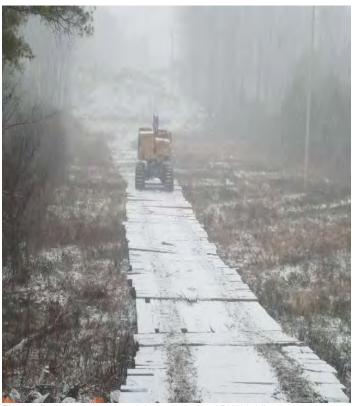
Fig 17: Building access road through wetland DW33. Viewing northeast. (12-17-19).

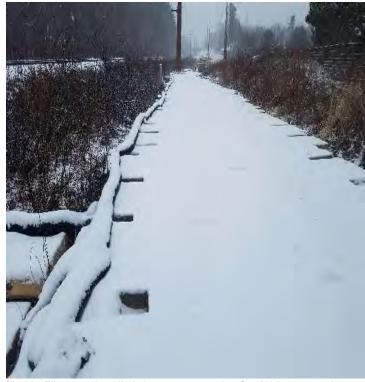
Fig 19: Filter sock installed along access road to Str. 3. Viewing south. (12-17-19).

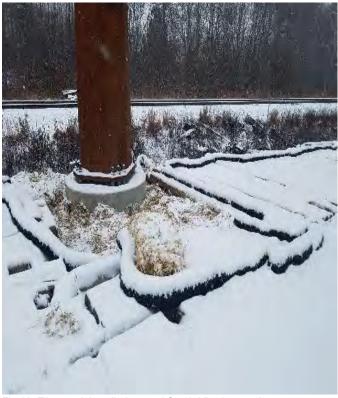
Fig 18: Filter sock installed around Str. 1. Viewing southeast. (12-17-19).

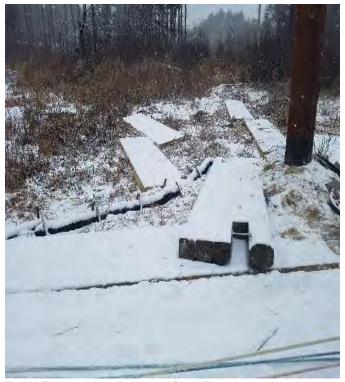
Fig 20: Filter sock installed around Str. 3. Excess mats are removed once line is pulled. Viewing west. (12-17-19).

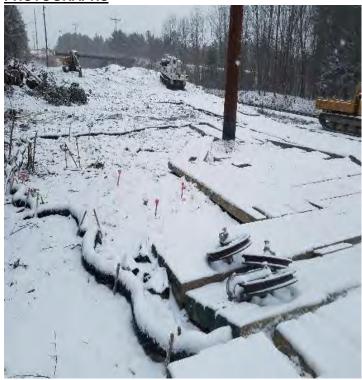
Fig 21: Filter sock installed around Str. 8. Viewing north. (12-17-19).

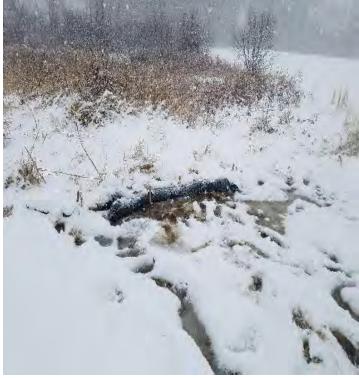
Fig 23: Filter sock repaired in wetland NW18 at Frink farm. Viewing north. (12-17-19).

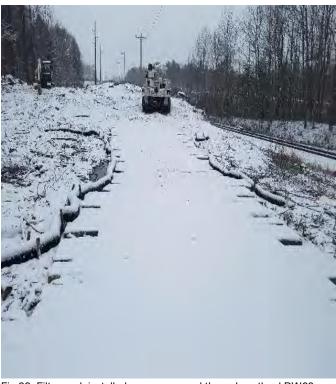
Fig 22: Filter sock installed on access road through wetland DW93. Viewing north. (12-17-19).

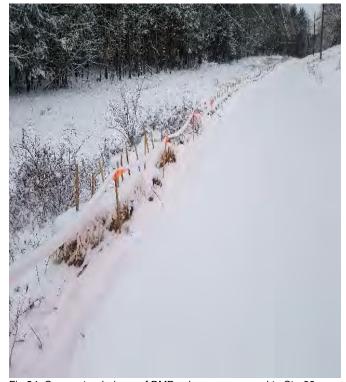
Fig 24: Crew extended row of BMPs along access road to Str. 99. Viewing west. (12-18-19).

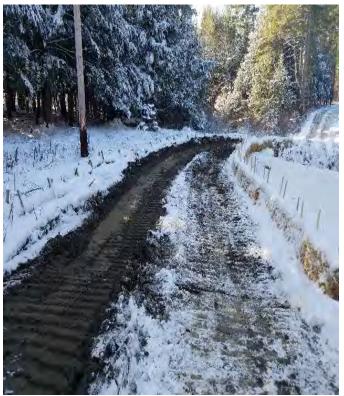
Fig 25: BMPs installed along access road to Str. 58, between wetlands DW48 and DW50. Viewing southwest. (12-18-19).

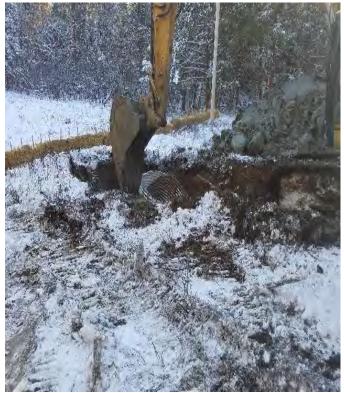
Fig 26: Setting can for Str. 54. Viewing east. (12-18-19).
