CONSTRUCTION MONITORING REPORT

Eversource Transmission Lines:
F107

**Madbury, Durham,
Newington, Portsmouth, NH**

NAI Project No:
23840.39

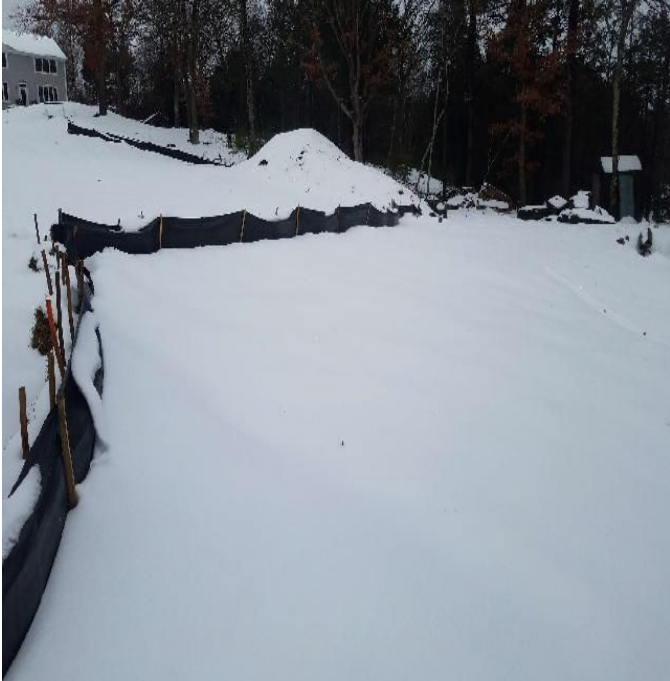
Fig 1: Silt fence installed on slope at Getchell property/west side of the Bay. Viewing north. (01-02-20).

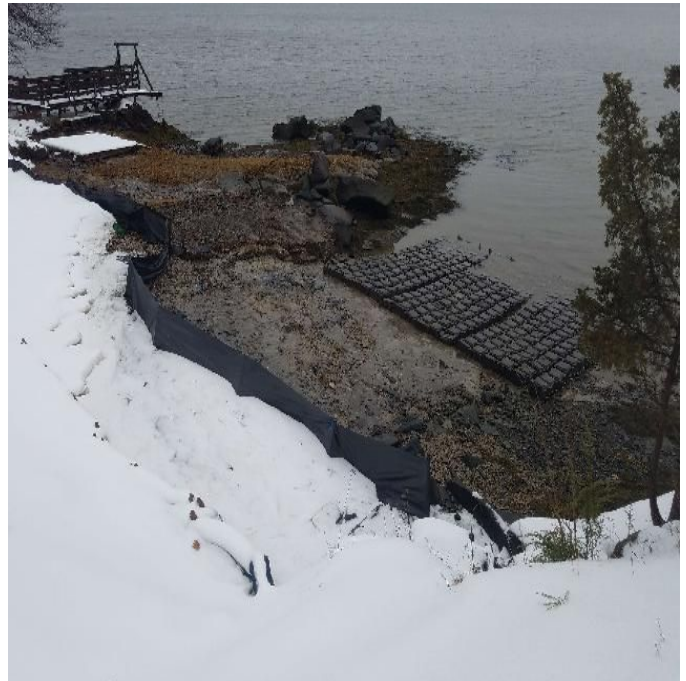
Fig 2: BMPs and concrete mattresses at Getchell property/west side of the Bay. Viewing north. (01-02-20).

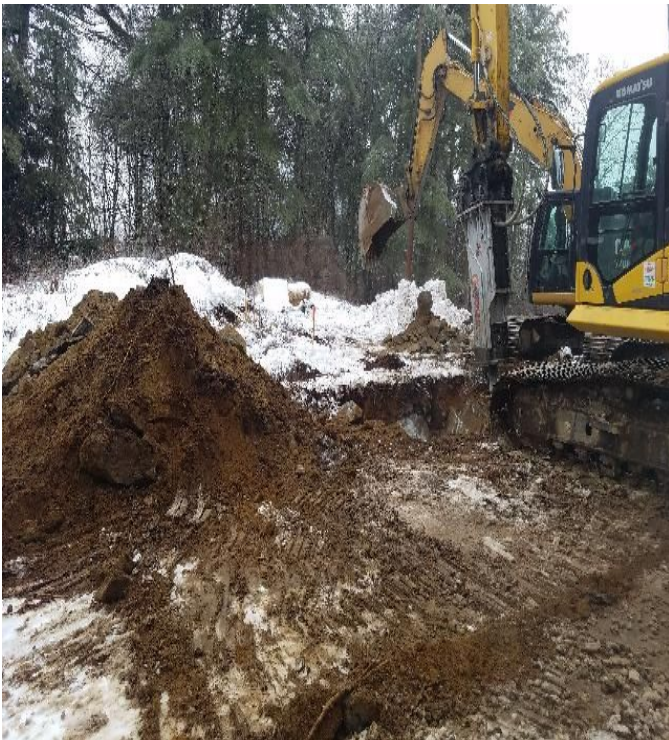
Fig 3: Crew hammering ledge for foundation at Str. 56. Viewing south. (01-02-20).

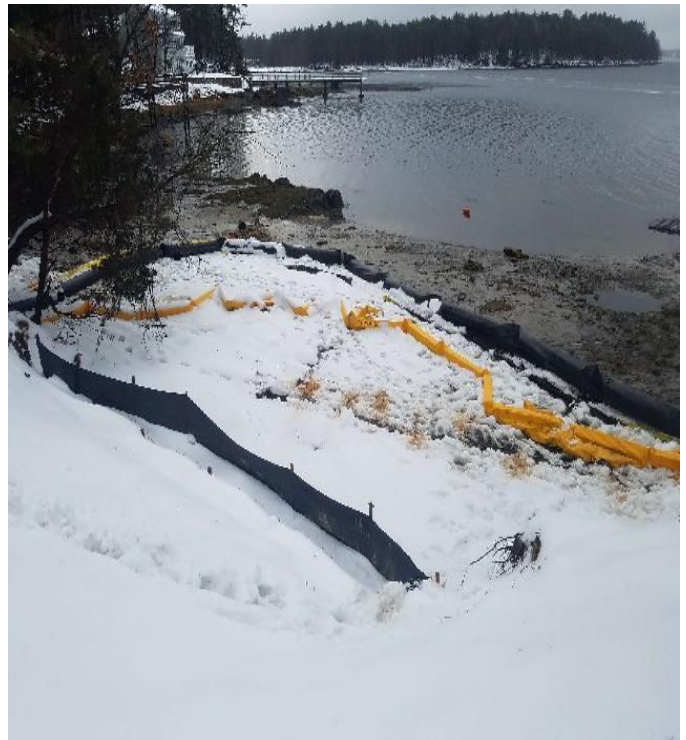
Fig 4: BMPs and turbidity curtain at Gundalow landing/east side of the Bay. Viewing south. (01-02-20).

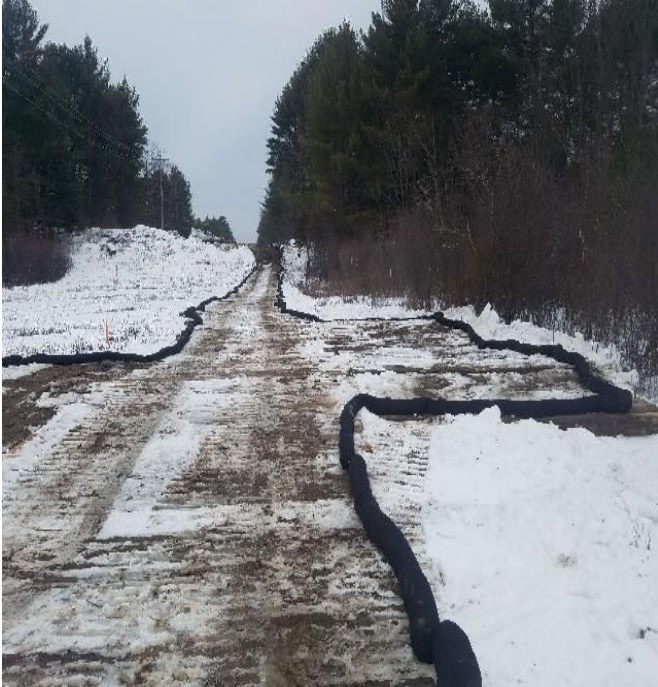
Fig 5: Crew installing filter sock along access through wetland DW31. Viewing west. (01-02-20).

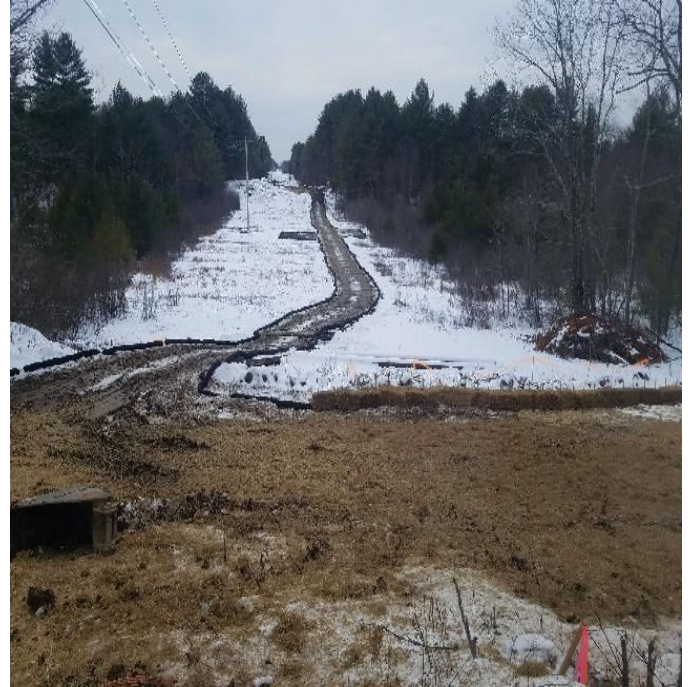
Fig 6: Crew finished installing BMPs on access through wetland DW31 and prepped the site to begin excavation for Str. 57 foundation. Viewing west. (01-02-20).

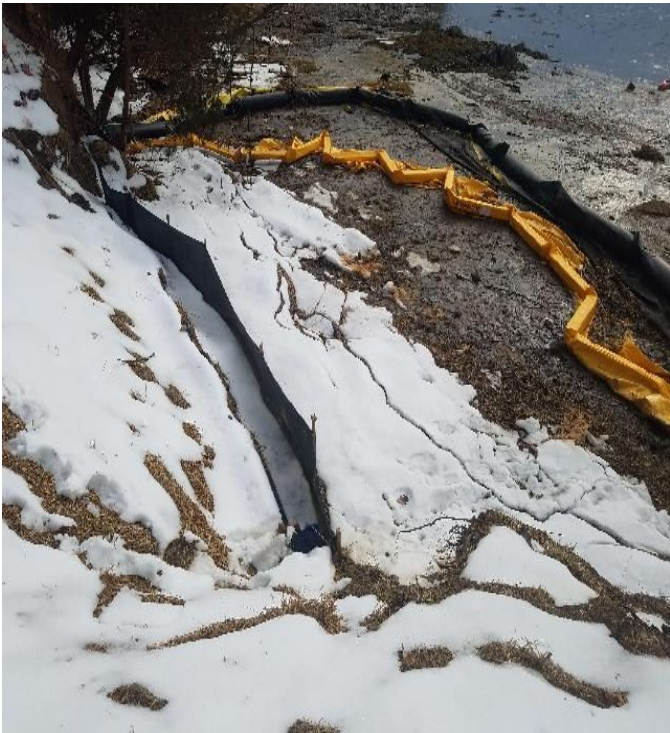
Fig 7: BMPs at Gundalow landing/east side of the Bay. Viewing south. (01-02-20).

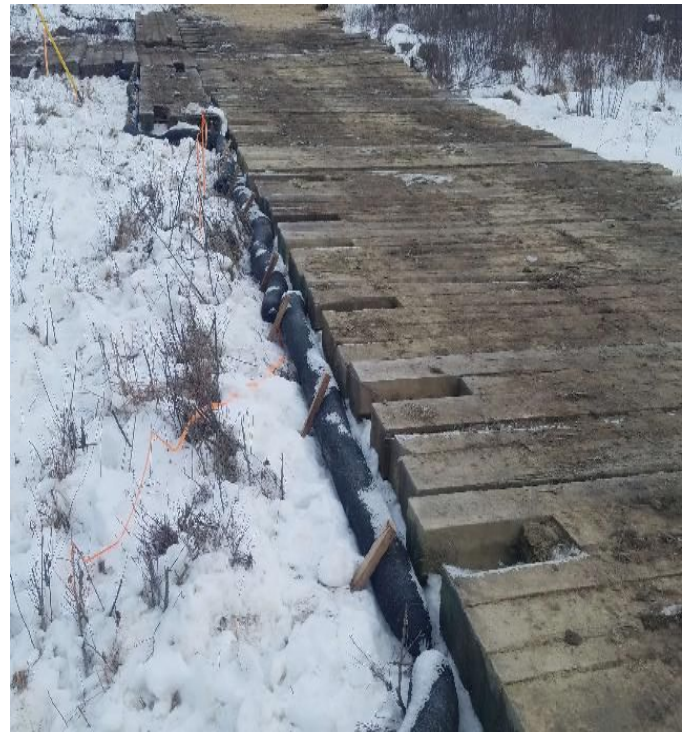
Fig 8: BMPs installed along access road through wetland DW56. Viewing north (01-06-20).

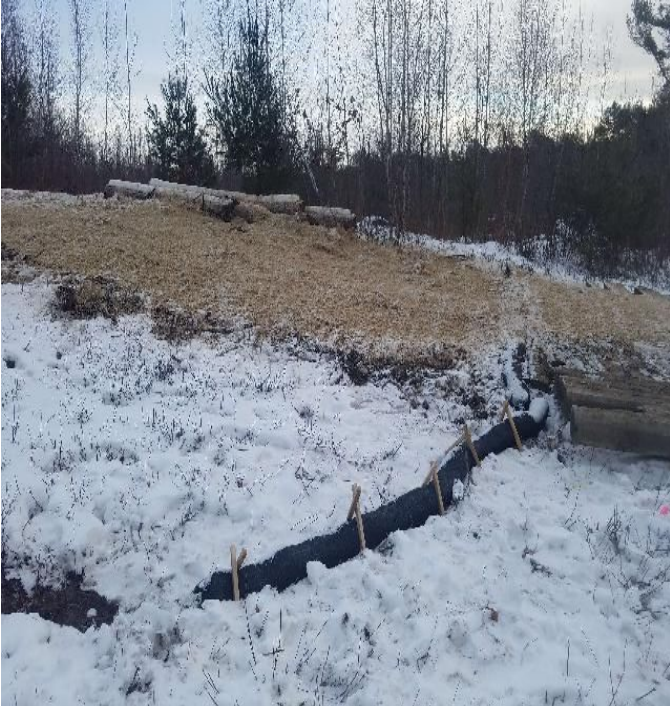
Fig 9: BMPs installed and straw broadcast on access road between Strs. 47-46. Viewing west. (01-06-20).

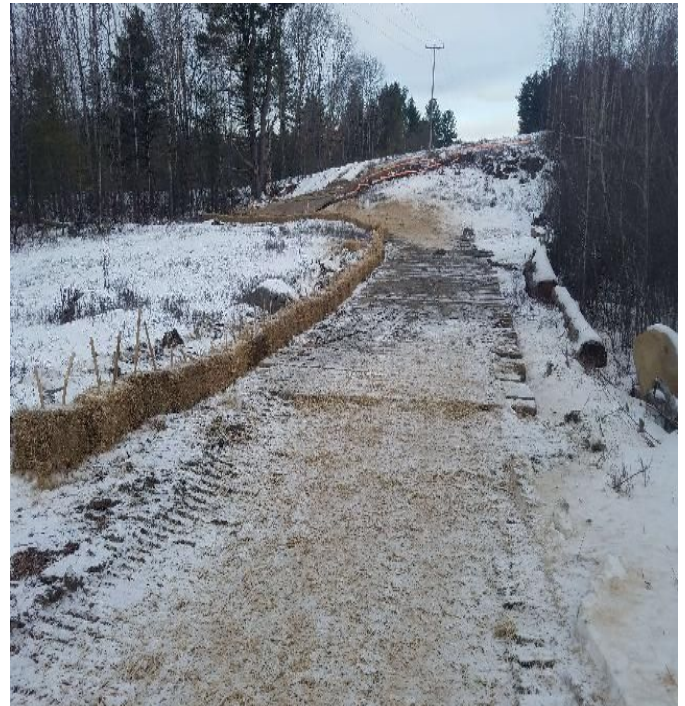
Fig 10: BMPs installed along access road between Strs. 47-46. Viewing north. (01-06-20).

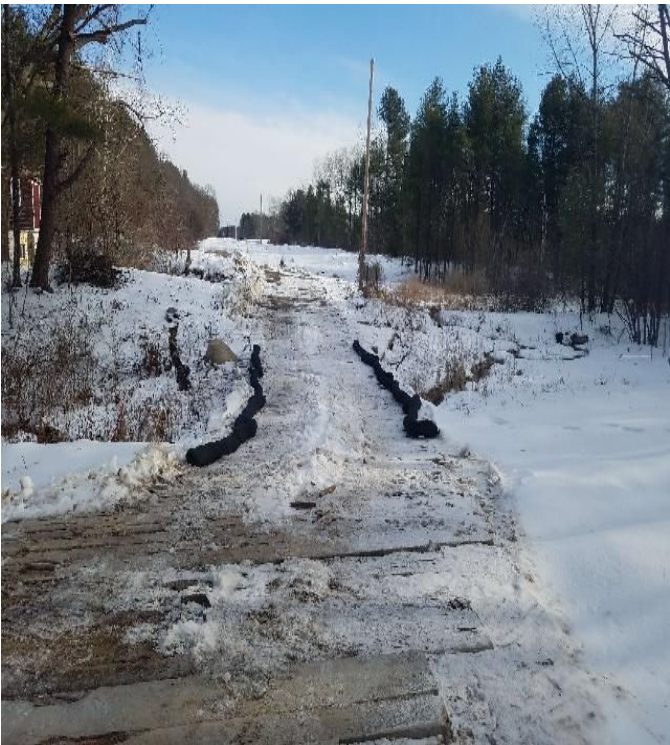
Fig 11: Filter sock installed on timber-bridge over stream NS8, between Strs. 102 and 103. Viewing northeast. (01-06-20).

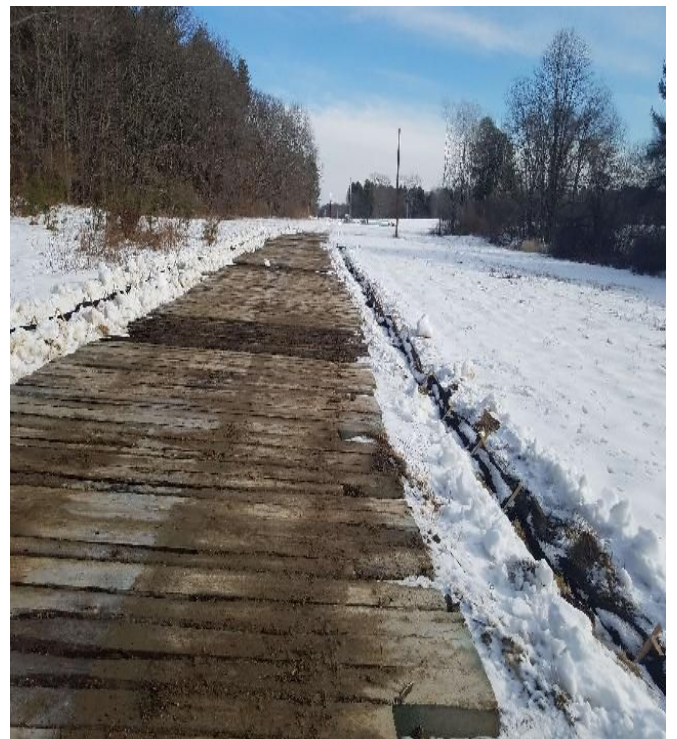
Fig 12: Filter sock installed along access road through wetland NW 10. Viewing northwest (01-06-20).

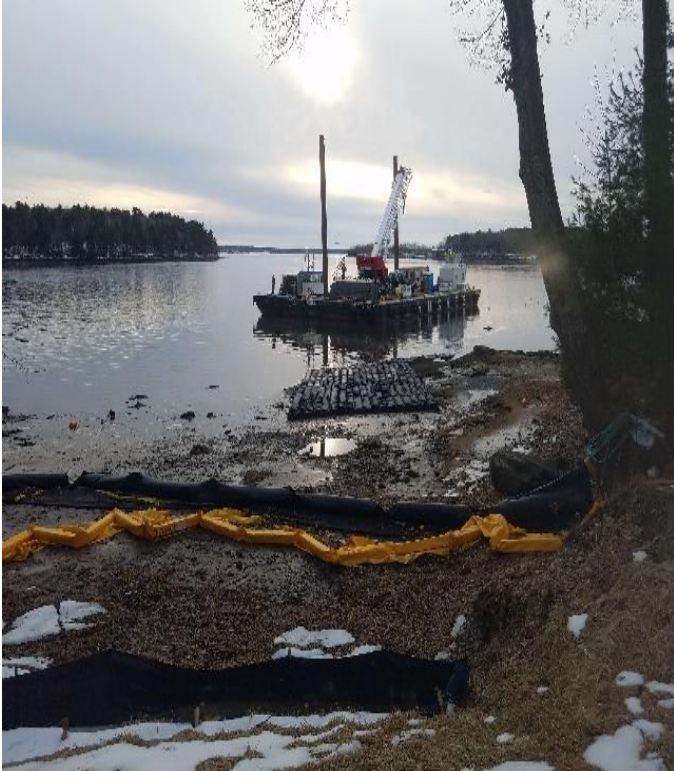
Fig 13: Installing concrete mattresses at Gundalow landing/east side of the Bay. Viewing west. (01-07-20).

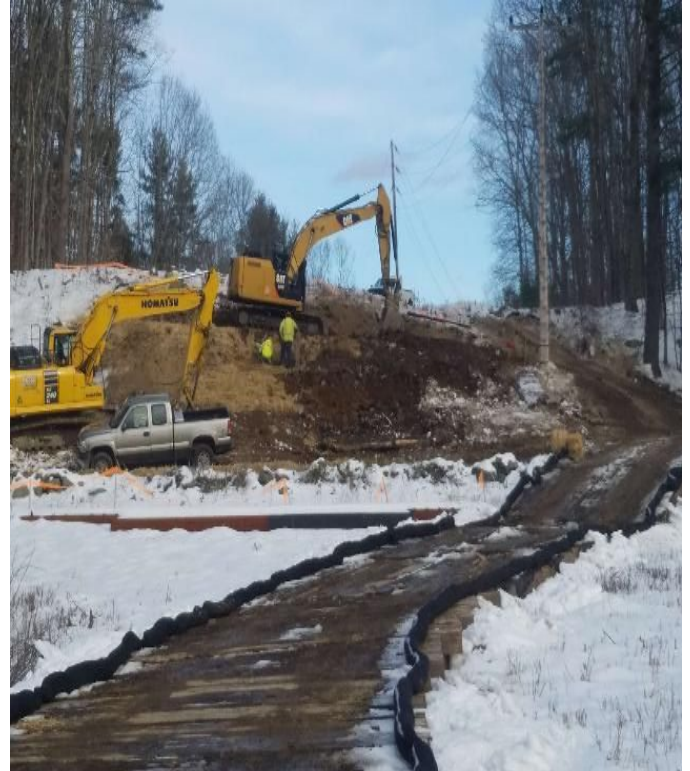
Fig 14: Crew setting foundation cans for Str. 57. Viewing northeast. (01-07-20).

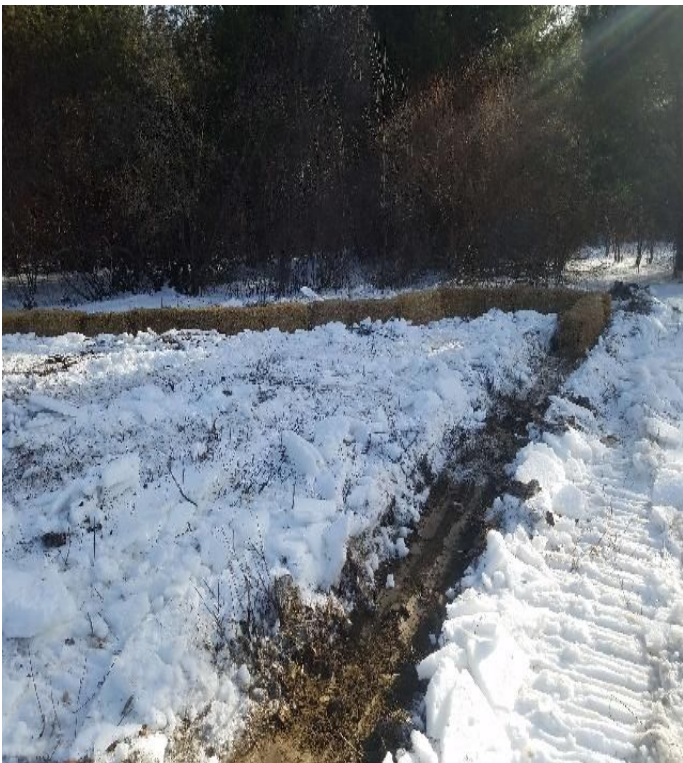
Fig 15: Crew installing perimeter sediment controls for soil spoils from Str.48. Designated turtle nesting area. Viewing east. (01-07-20).

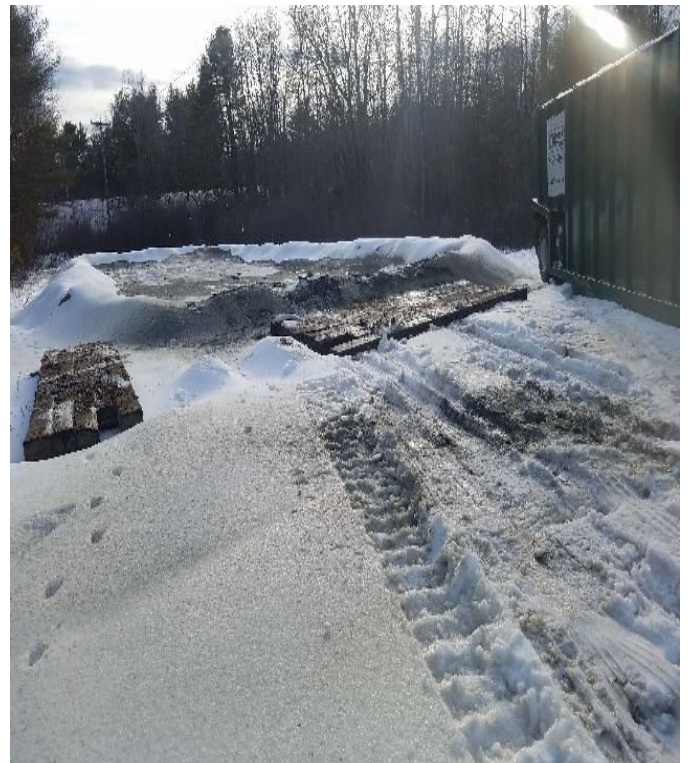
Fig 16: Dewater basin and frac tank for Str. 48 dewatering. Viewing southwest. (01-07-20).

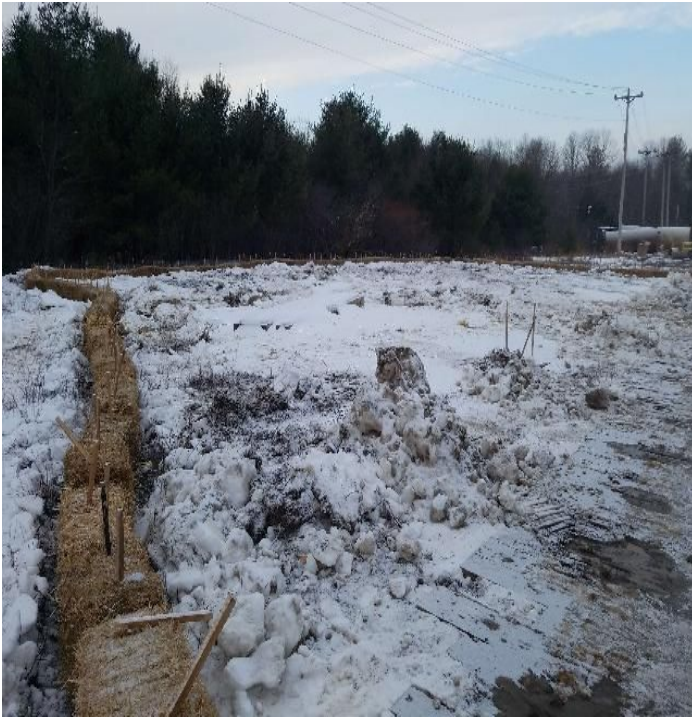
Fig 17: Crew finished installing straw bales around perimeter of turtle nesting area. Viewing southwest. (1-08-20).

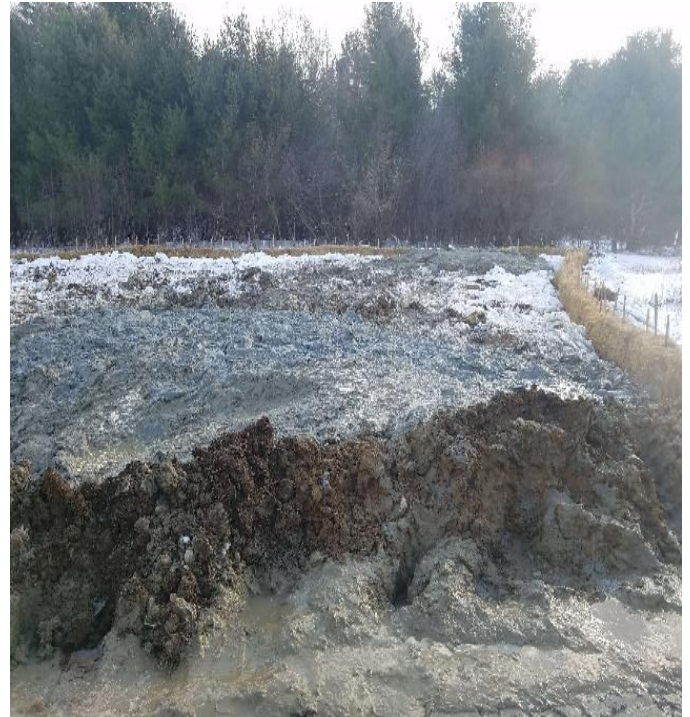
Fig 18: Soil from drilling Str. 48 foundations being used to build turtle nesting area. Viewing south. (1-08-20).

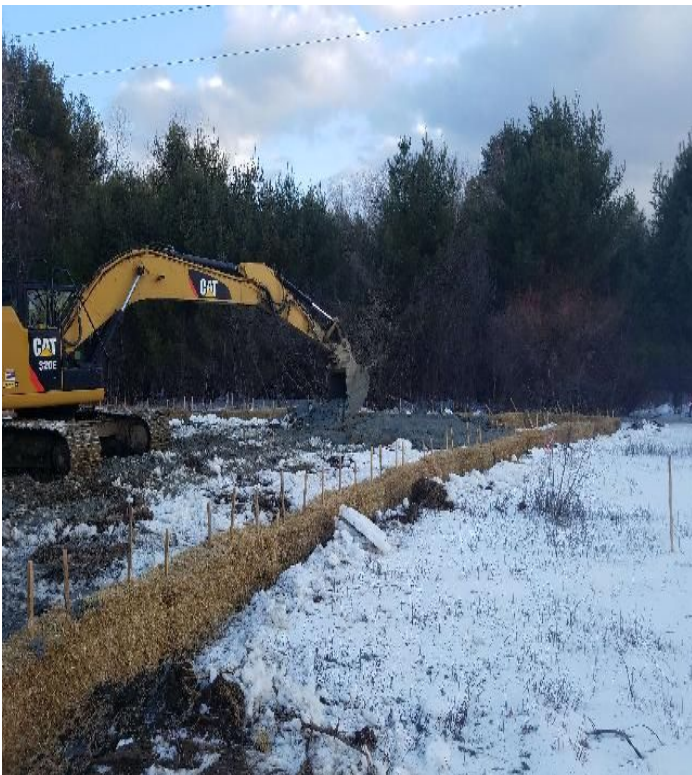
Fig 19: Crew spreading soils to build up designated turtle nesting area. Viewing south. (01-08-20).

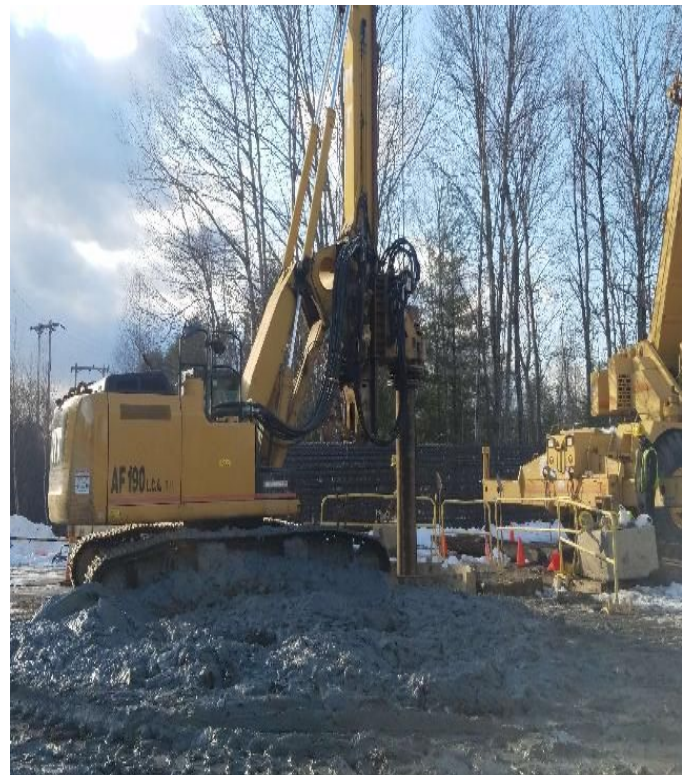
Fig 20: Drilling foundations for Str. 48. Viewing west. (01-08-20).

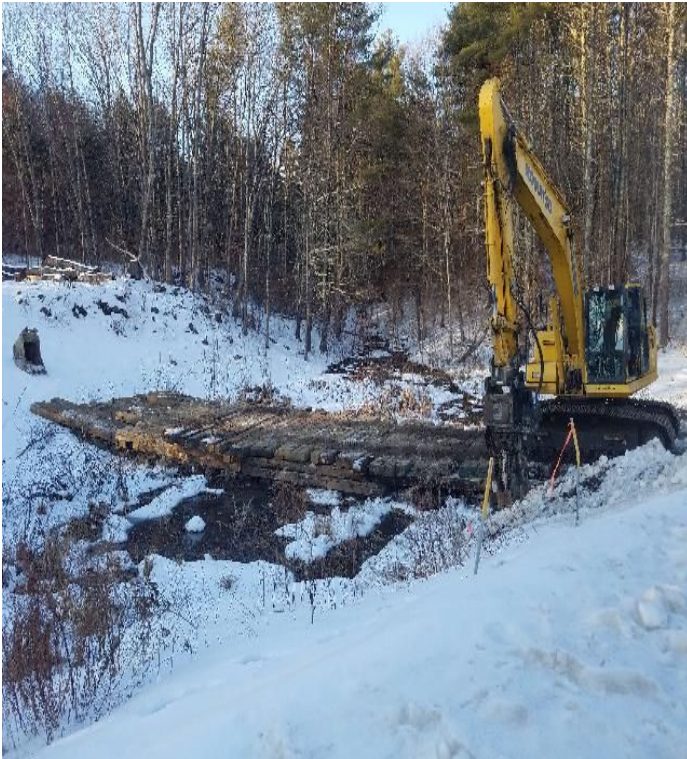
Fig 21: Crew building timber bridge over wetland DW29, off of route 108. Viewing west. (01-08-20).

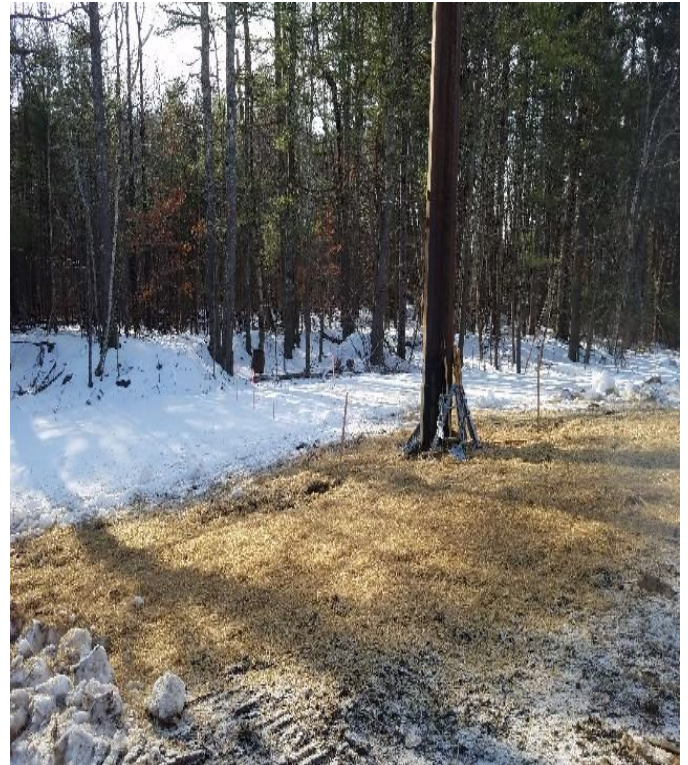
Fig 22: Str. 101 pole constructed. Viewing south. (01-08-20).

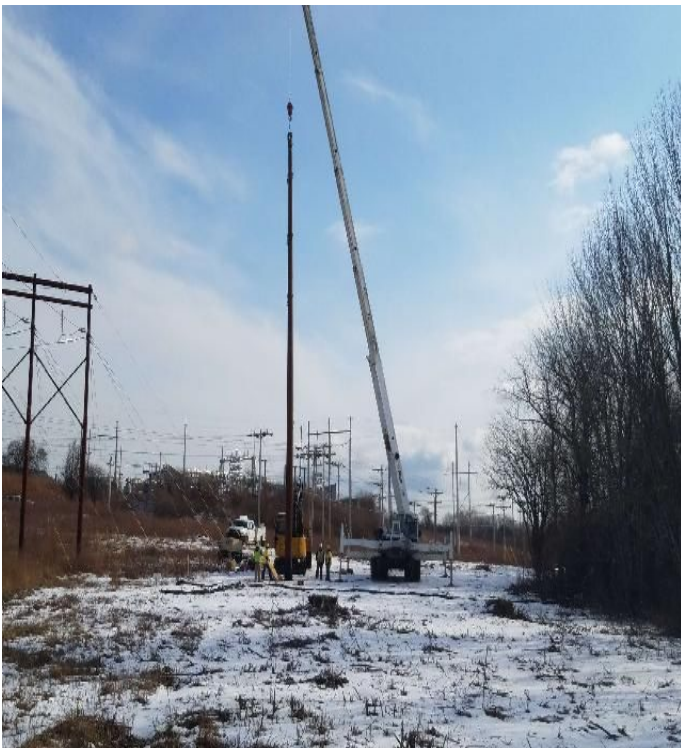
Fig 23: Crew standing pole for Str. 142. Viewing east. (01-08-20).
