CONSTRUCTION MONITORING REPORT

Eversource Transmission Lines:
F107

**Madbury, Durham,
Newington, Portsmouth, NH**

TYPE OF INSPECTION: Weekly Storm Event Incident Corrective Action

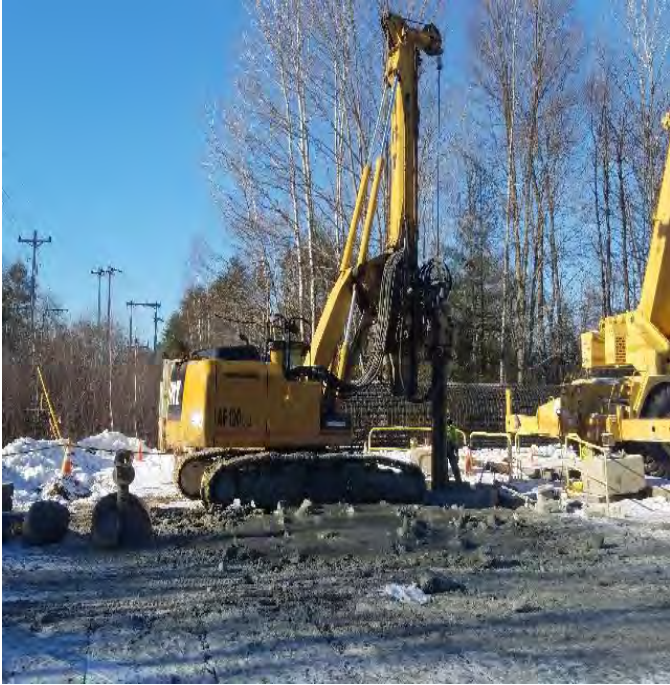
Fig 1: MJ drilling Str. 48. Viewing west. (01-09-20).

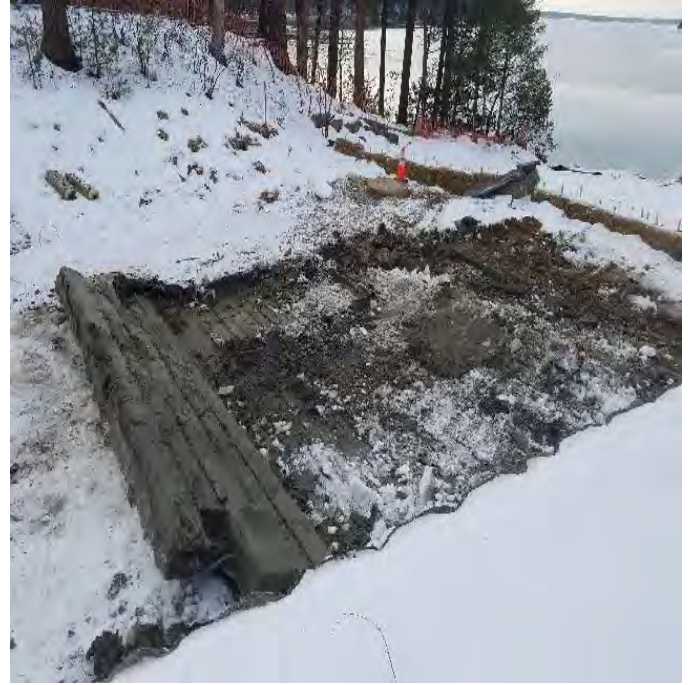
Fig 2: Removing timber mats from Gundalow landing/east side of the Bay. Viewing south. (01-10-20).

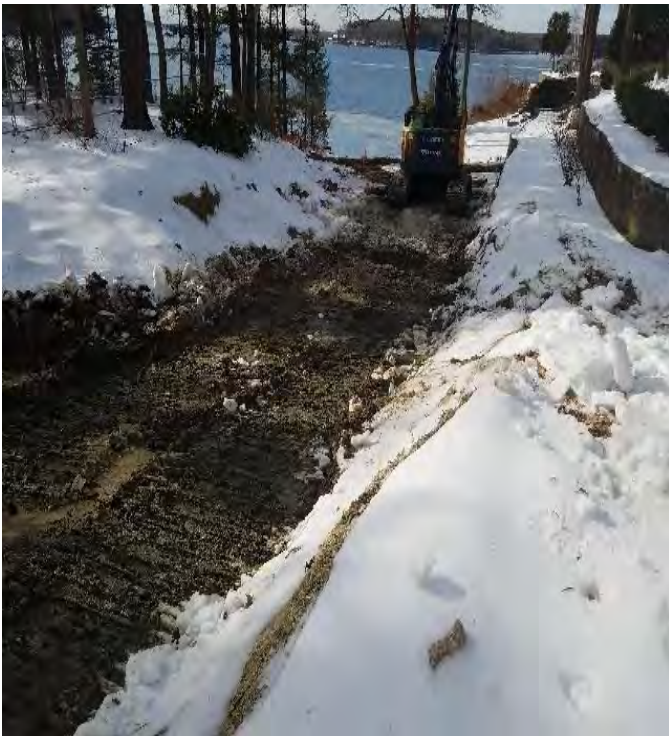
Fig 3: Removing timber mats from Gundalow landing/east side of the Bay. (01-10-20).

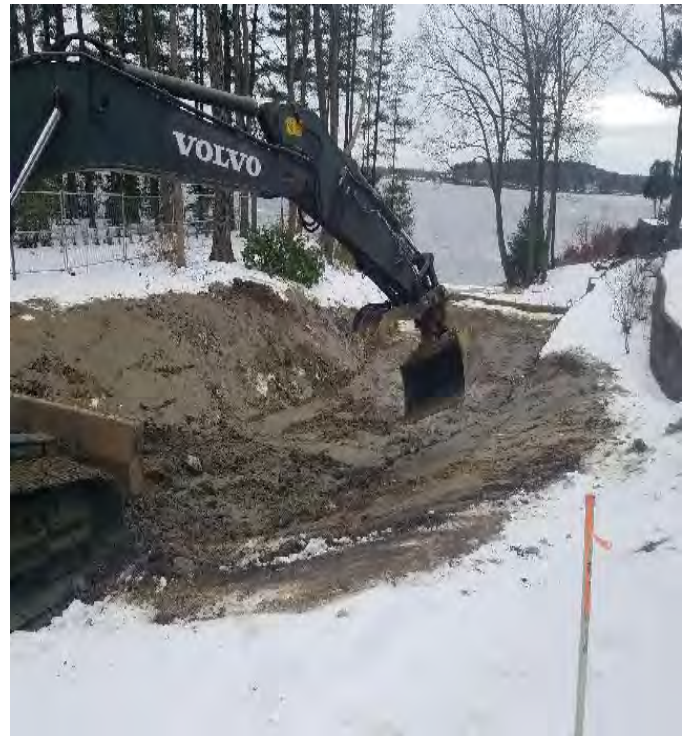
Fig 4: Restoring and shaping slope and banks at Gundalow landing/east side of the Bay. Viewing west. (01-10-20).

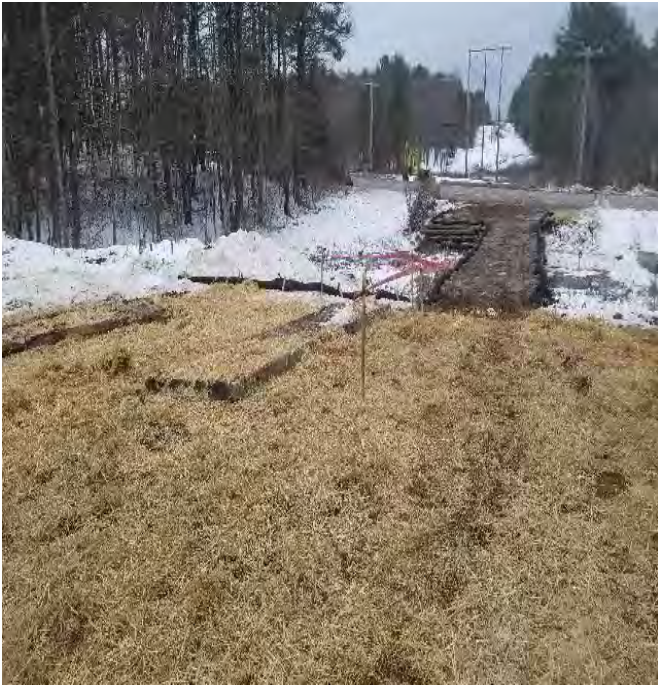
Fig 5: Crew set foundation cans and restored area around Str. 59. Viewing east. (01-10-20).

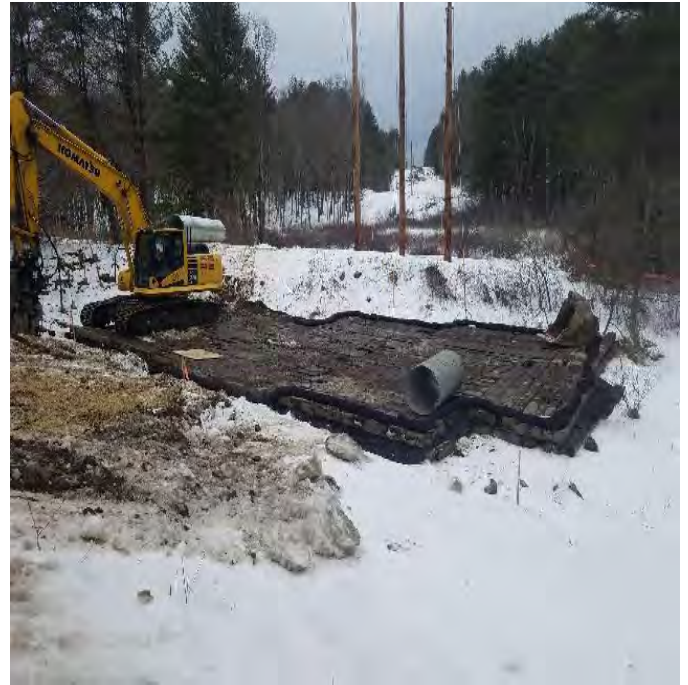
Fig 6: Work pad for Str. 3162-18 in wetland DW100. Viewing east. (01-10-20).

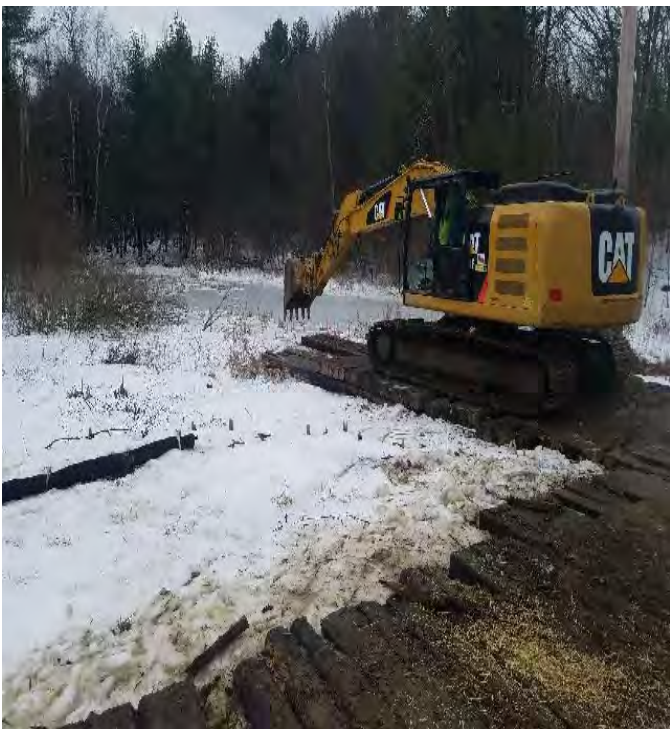
Fig 7: Crew building work pad for Str. 102. Viewing south. (01-11-20).

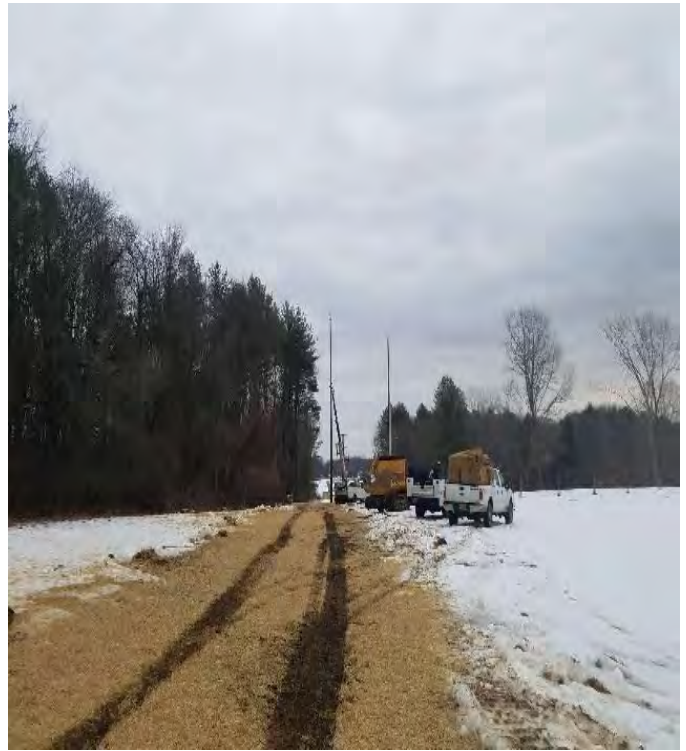
Fig 10: Access road to Str. 105. Viewing east. (01-11-20).

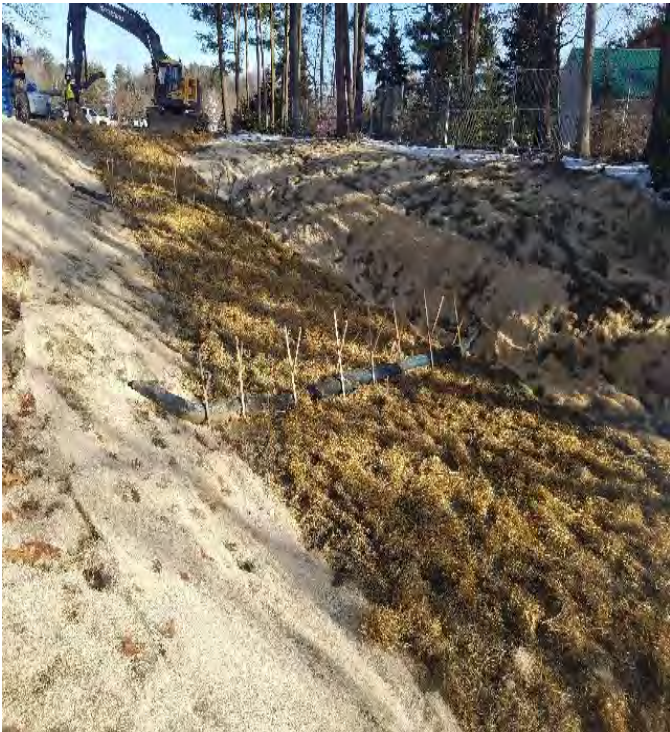
Fig 11: Crew installing BMPs on slope to vault at Gundalow landing/ east side of the Bay. Prepping for weekend rain. Viewing east. (01-11-20).

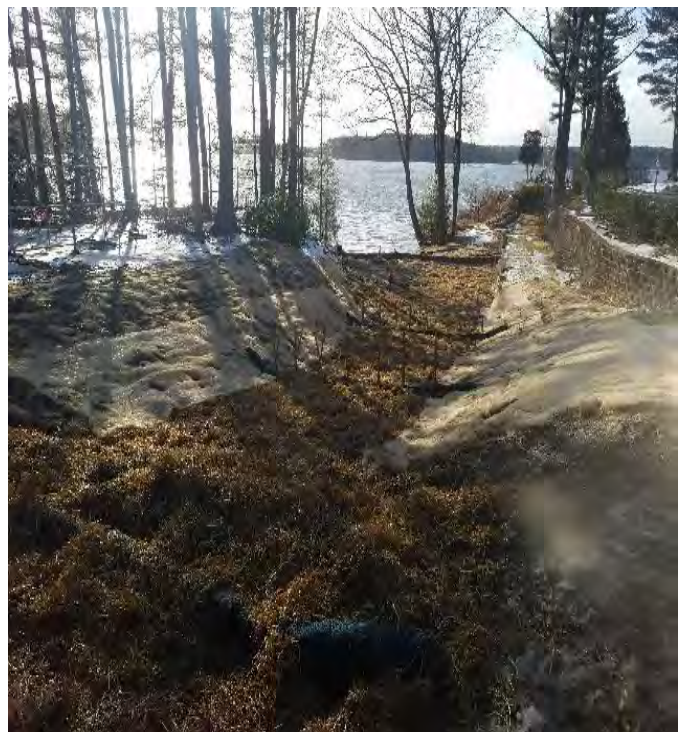
Fig 12: Crew installing BMPs on slope to vault at Gundalow landing/ east side of the Bay. Prepping for weekend rain. Viewing west. (01-11-20).

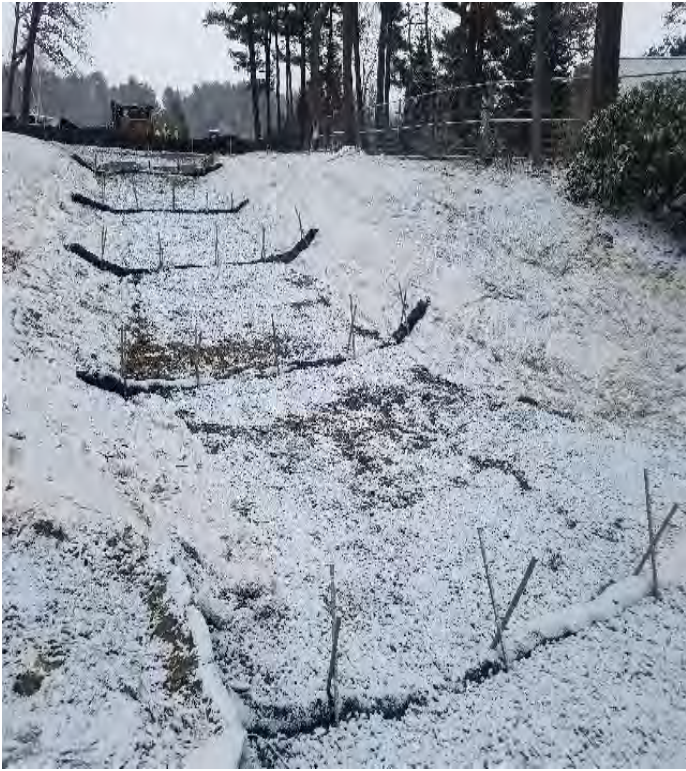
Fig 13: Finished winter stabilization and required BMPs at Gundalow landing/ east side of the Bay. Viewing east. (01-13-20).

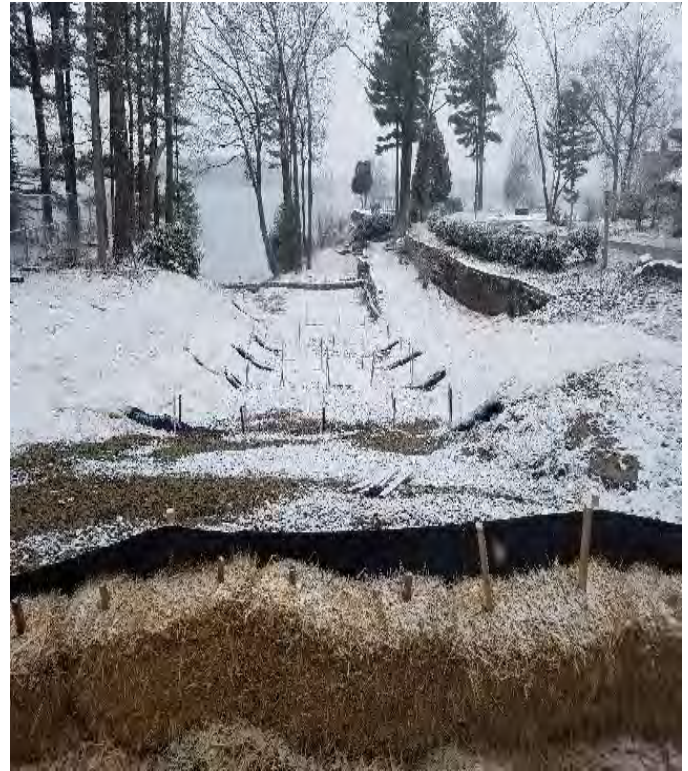
Fig 14: Finished winter stabilization and required BMPs at Gundalow Landing/east side of the Bay. Viewing west. (01-13-20).

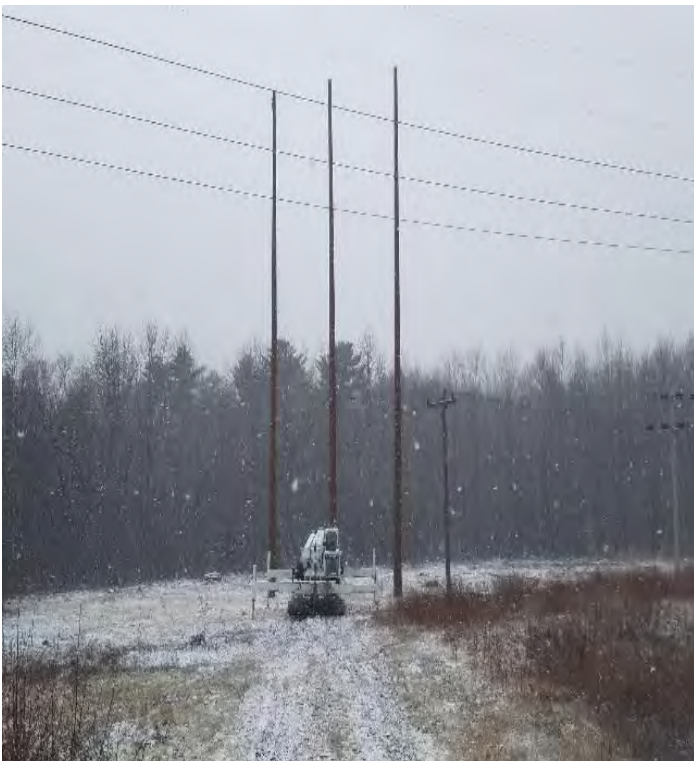
Fig 15: Foundation poles for Str. 143. Viewing west. (01-13-20).

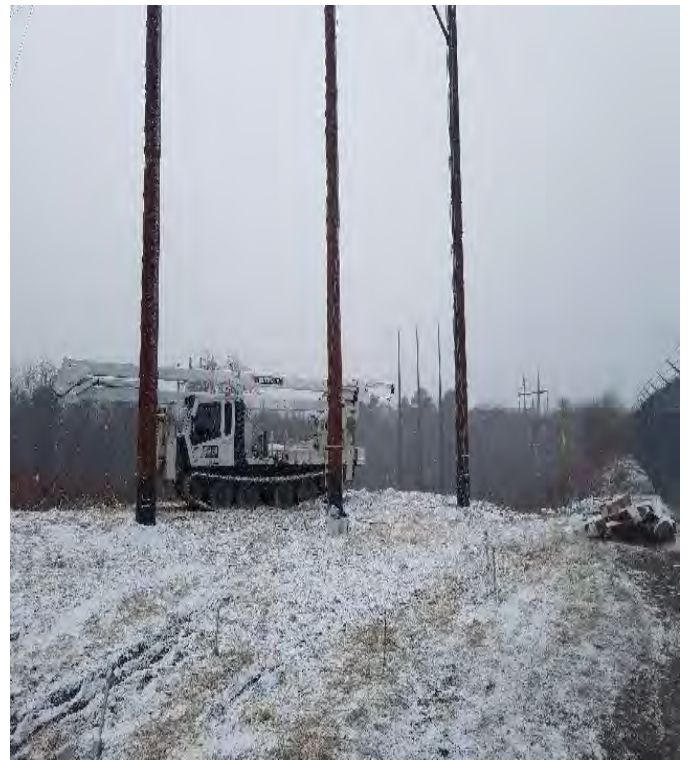
Fig 16: Foundation poles for Str. 144. Viewing west. (01-13-20).

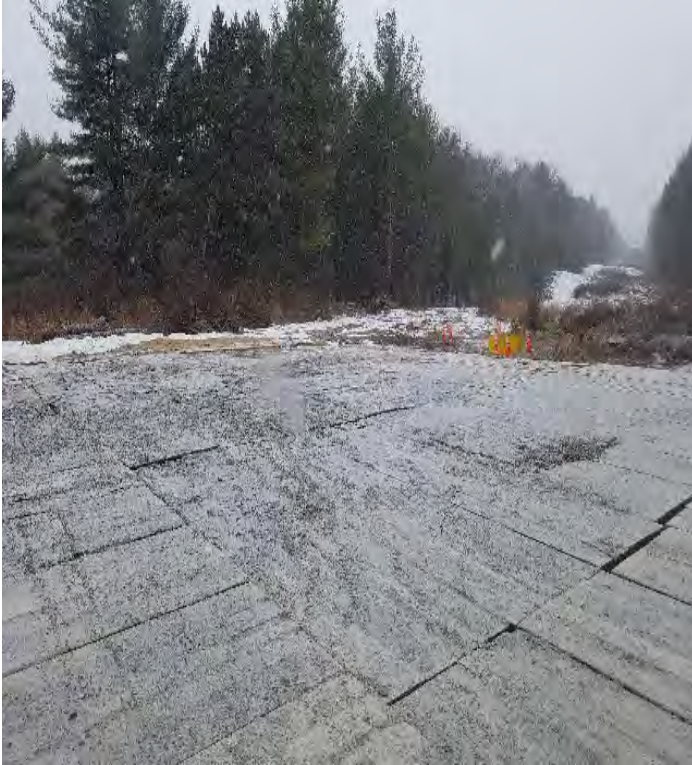
Fig 17: Soil pile removed from Str. 85 work pad. Viewing south. (01-13-20).

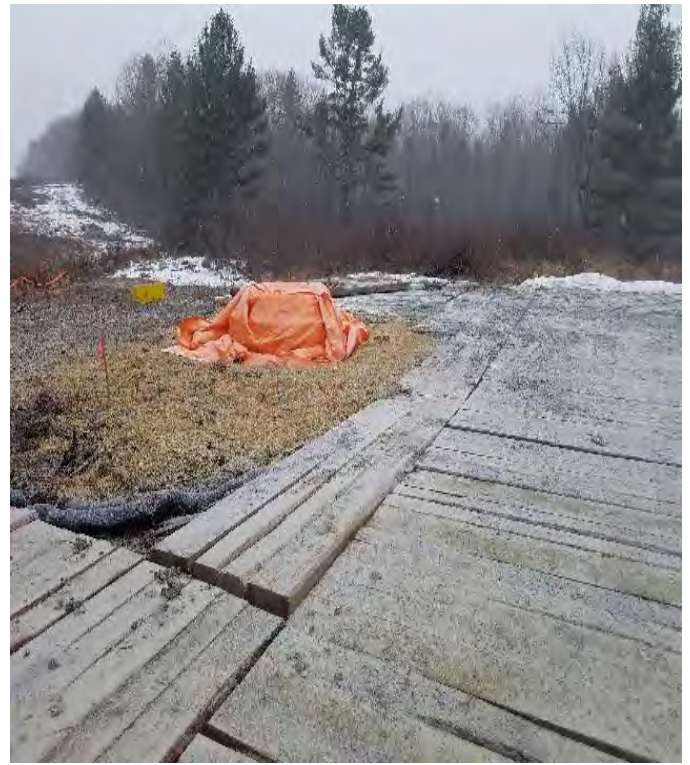
Fig 18: Poured foundation for Str. 85. Viewing south. (01-13-20).

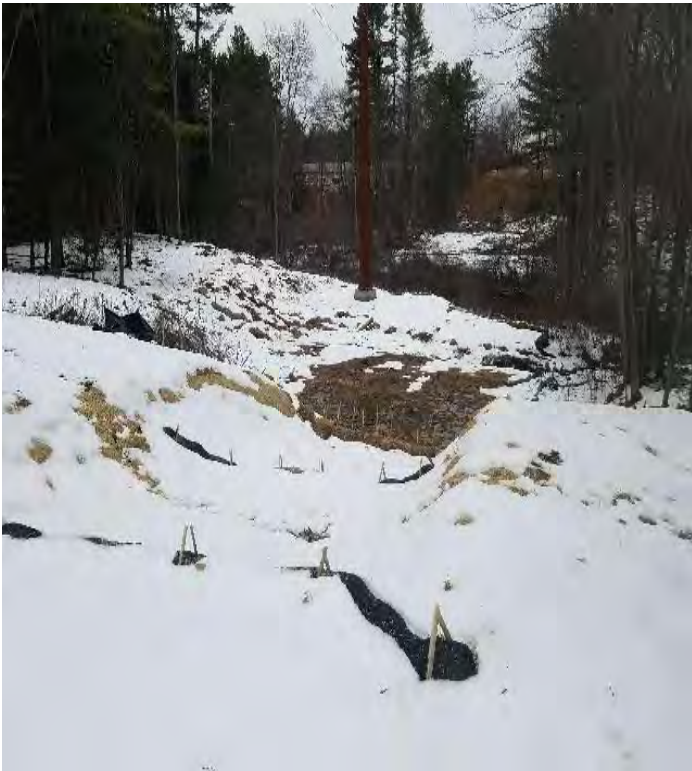
Areas that have been restored and mulched, but have little germination: Both sides of Little Bay. Trench between Strs. 106-107 (Frink farm-Hannah Lane). Strs. 28 & 29.

Fig 19: Str. 28 and surrounding area. Viewing north. (01-13-20).

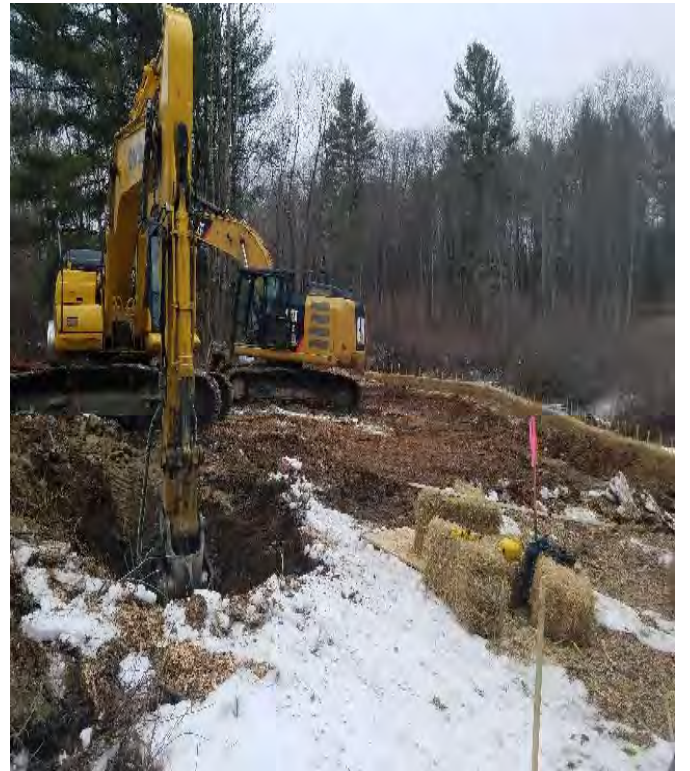
Fig 20: Crew excavating foundations for Str. 60. Viewing east. (01-13-20).

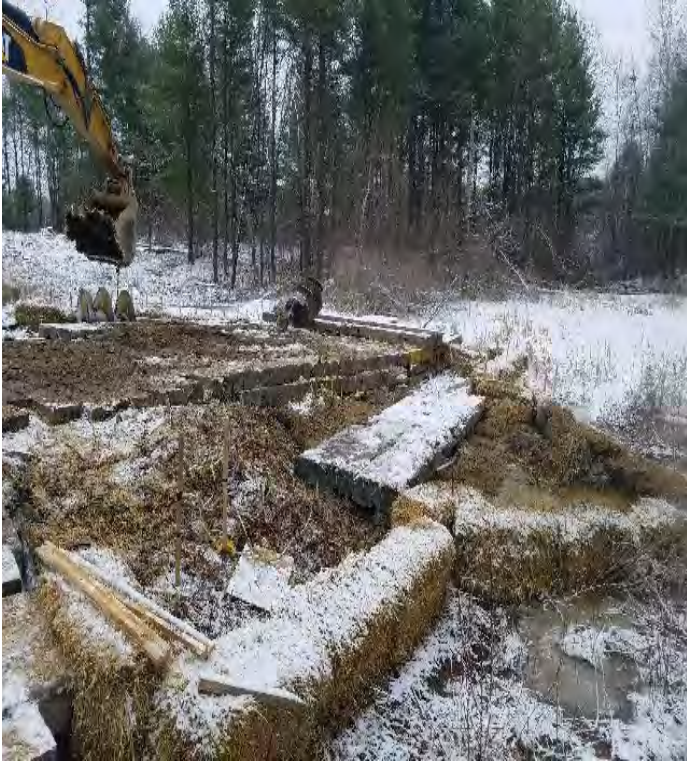
Fig 21: Crew setting foundation can for Str. 102. Viewing south. (01-14-20).

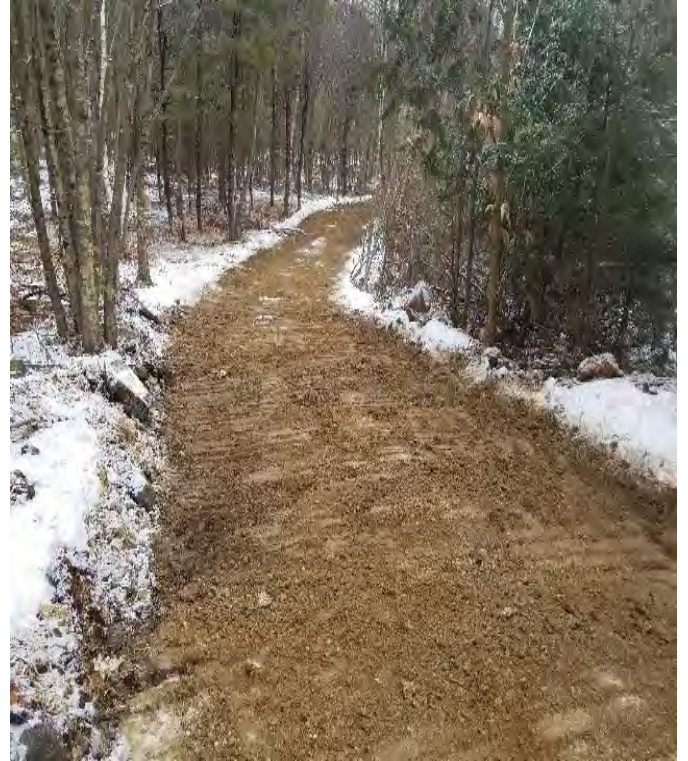
Fig 22: Removing mats on access road leading to Str. 10, of off route 4. Viewing east. (01-14-20).

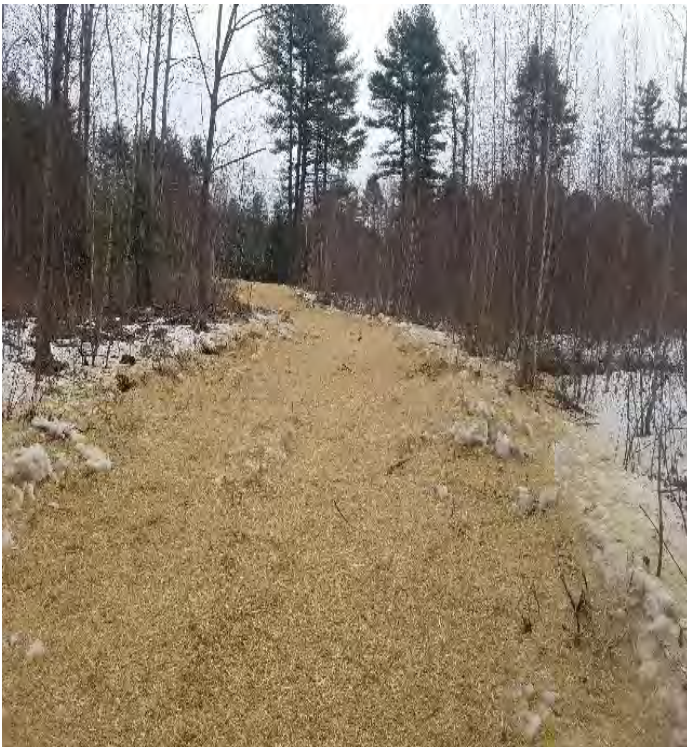
Fig 23: Straw spread over access road leading to Str. 10, off of Route 4. Viewing east. (01-14-20).

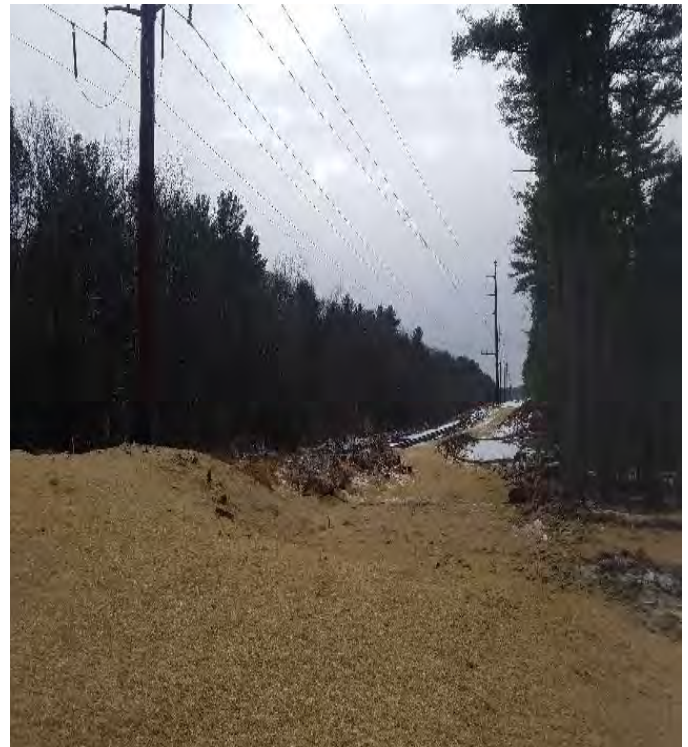
Fig 24: Strs 11 and 12. Viewing south. (01-14-20).

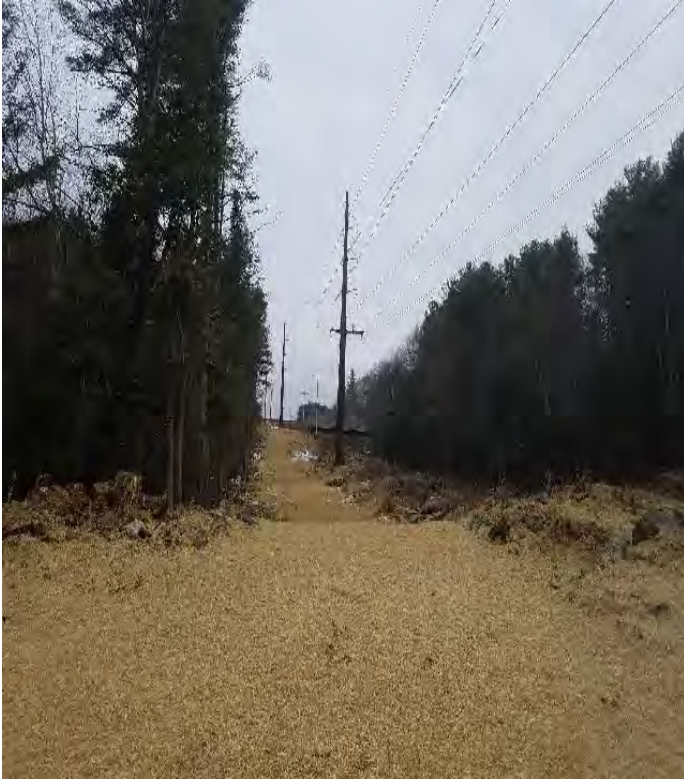
Fig 25: Strs. 10 and 9. Viewing north. (01-14-20).

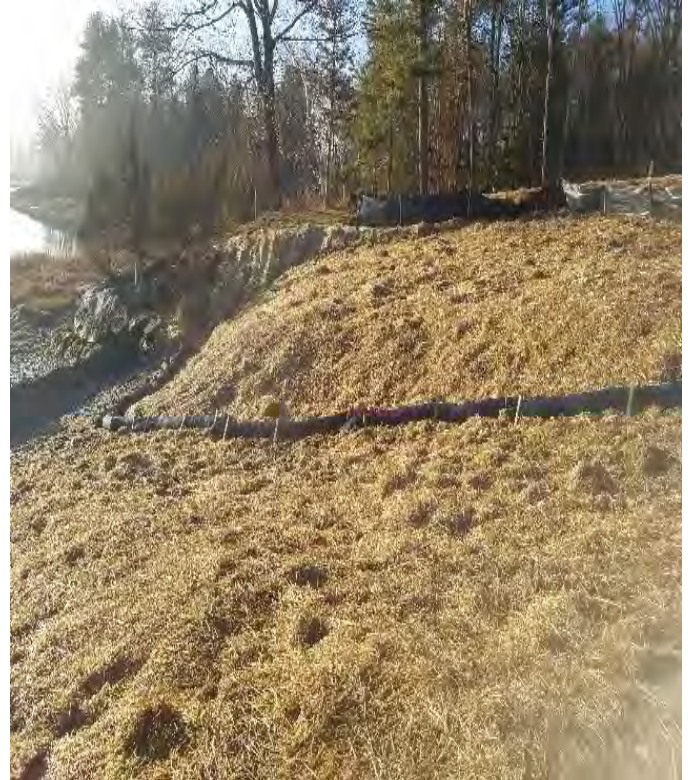
Fig 26: BMPs at Getchell property/west side of the Bay. Viewing south. (01-15-20).

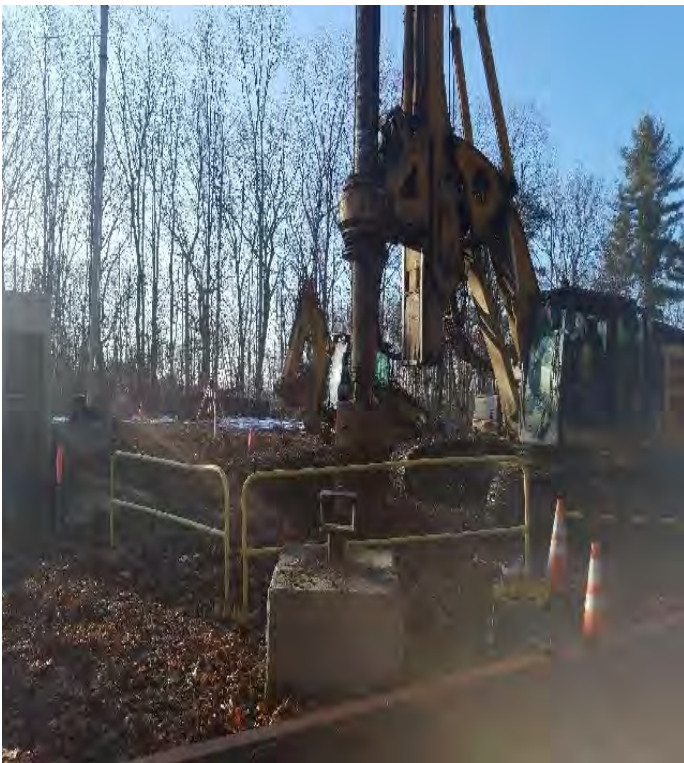
Fig 27: MJ drilling foundations for Str. 58. Viewing southwest. (01-15-20).

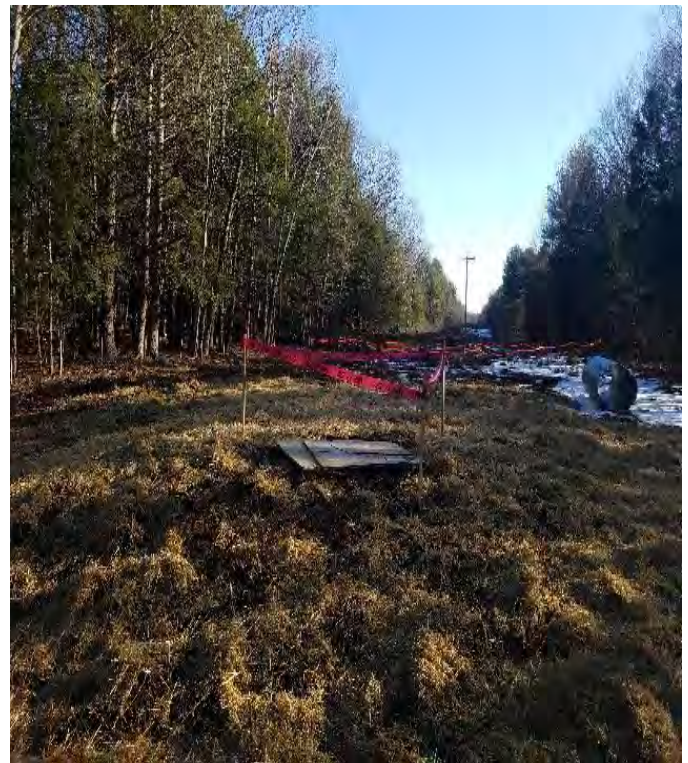
Fig 28: Foundation can set for Str. 73. Viewing east. (01-15-20).
