Eversource Transmission Lines: F107
TYPE OF INSPECTION:Weekly	/ X_Storm EventInc	identCorrective Action	
Date: 01/27/20 Time: 8:00am Does this report include a 0.25" storm event? X Yes No If yes, how did you determine whether a 0.25" storm event has occurred? Rain Gauge X Weather Station Storm event information is from Pease Air Force Base.			Madbury, Durham, Newington, Portsmouth, NH Alteration of Terrain Permit: SEC Docket No. 2015-004
+Storm event information (approx.):	Start date: 01-25-20 Start date: Start date:	Amount (inches): 1.19in Amount (inches): Amount (inches):	Environmental Permit: SEC Docket No. 2015-004 USEPA NOI Tracking No:
NOTE: *			NHR1000QN NHR1000QT NHR1000QO <u>NHR1000S6</u>
			NAI Project No: <u>23840.39</u>
Inspector name(s), title(s) and qualifications: Matthew Smith, Normandeau Environmental Inspector and Marc Jacobs, CPESC, NHCWS			
Others present/qualifications(s): Sam Eames, Eversource construction representative

Construction Monitoring Report #47

Eversource Seacoast Reliability Project

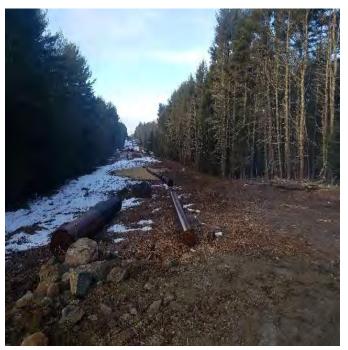
Fig 1: Access to Str. 71. Viewing west (01-27-20).

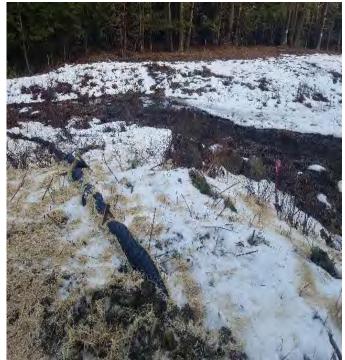
Fig 3: Stream DS19, east of Str. 70. No turbid water visible. (01-27-20).

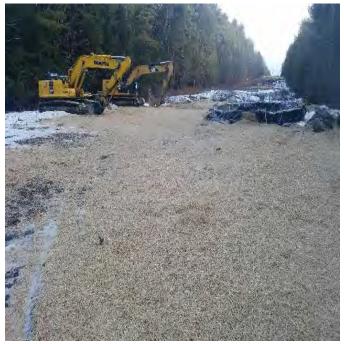
Fig 2: Str. 70 work area, note straw cover. Viewing east. (01-27-20).

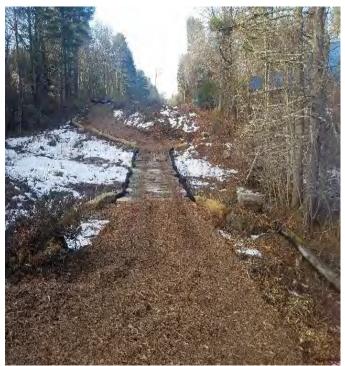
Fig 4: Access road through wetland DW9, between Strs. 65 and 66. Viewing west. Note stump grindings on slopes. (01-27-20).

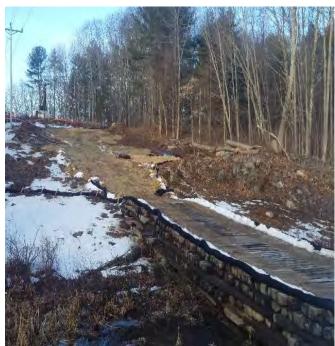
Fig 5: Access road to Str. 58 of off route 108. Bridge through wetland DW29. Viewing west. (01-27-20).

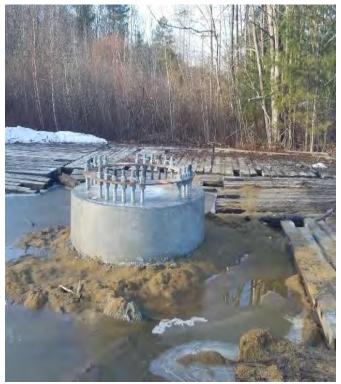
Fig 7: Str. 48. Viewing north. (01-27-20).

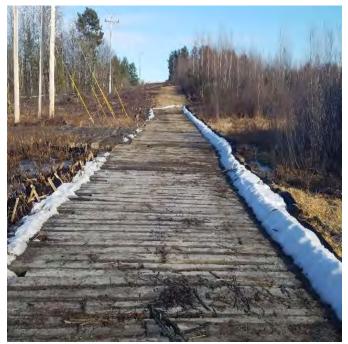
Fig 6: Access road to Str. 47. Viewing north. (01-27-20).

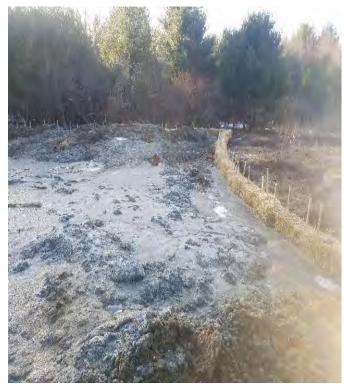
Fig 8: Soil spoils from drilling Str. 58 spread in turtle bed area between Strs. 48 and 49. Area is enclosed with straw bales. Turtle area is not Complete. Viewing west. (01-27-20).

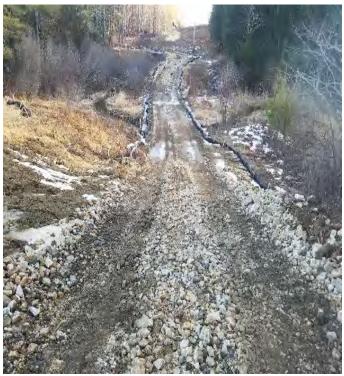
Fig 9: Access road between Strs. 51 and 52. Bridge over stream DS46. Viewing northeast. (01-27-20).

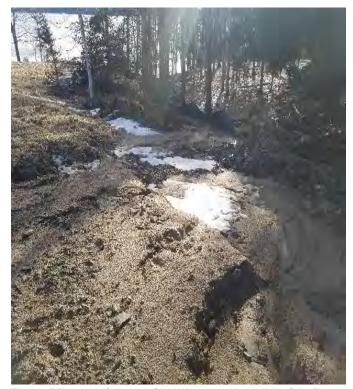
- BMPs
 - o All required BMPs need to be installed as access roads are being built, before construction starts.
 - Rill on upper slope resulted in sediment build up at silt fence at Getchell property/west side of the Bay.
 Location is on the south side, at the top of slope. Routine maintenance is warranted. See Figures 11 and 12.

Fig 11: Rill on top of slope at Getchell property/west side of the Bay. Viewing southwest. (01-27-20).

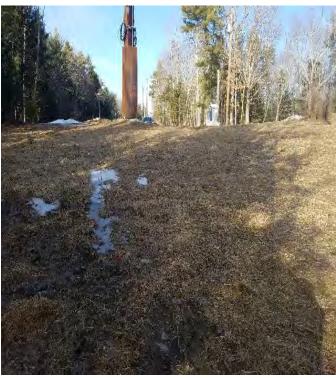
Fig 10: Str. 99 at Getchell property/west side of the Bay. Viewing west. (01-27-20).

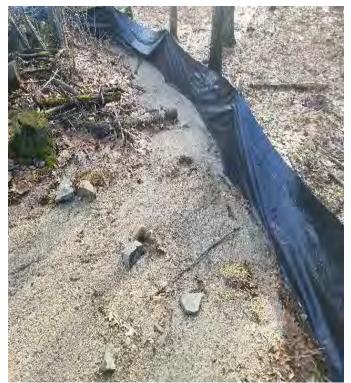
Fig 12: Sediment build-up on silt fence, runoff from rills at Getchell property/west side of the Bay. Viewing southeast. (01-27-20)

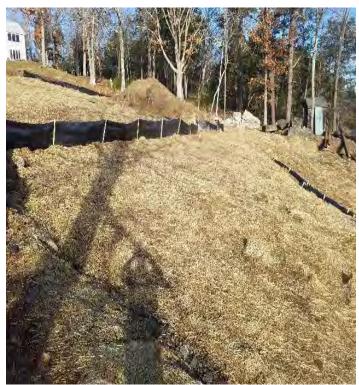
Fig 13: BMPs installed on slope at Getchell property/west side of the Bay. Viewing north. (01-27-20).

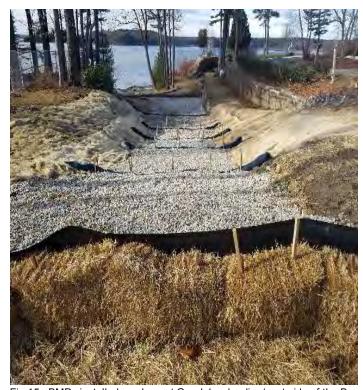
Fig 15: BMPs installed on slope at Gundalow landing/east side of the Bay. Viewing west. (01-27-20).

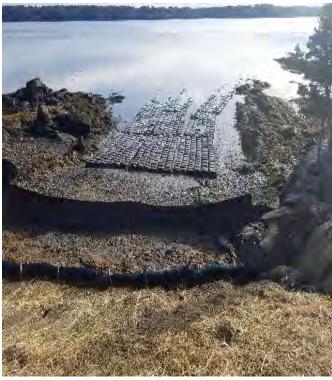
Fig 14: BMPs installed at toe of slope at Getchell property/west side of the Bay. Viewing east. (01-27-20).

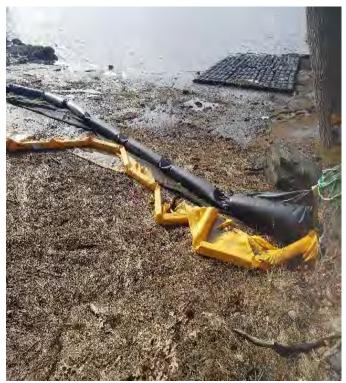
Fig 16: Turbidity barrier in intertidal zone at Gundalow landing/east side of the Bay. Viewing west. (01-27-20).
