CONSTRUCTION MONITORING REPORT

01/29/20 Time: 6:00pm 'Does this report include a 0.25" storm event? ___Yes X_No If yes, how did you determine whether a 0.25" storm event has occurred? __Rain Gauge X_Weather Station Eversource Transmission Lines: F107

Alteration of Terrain Permit: SEC Docket No. 2015-004

Eversource Seacoast Reliability Project

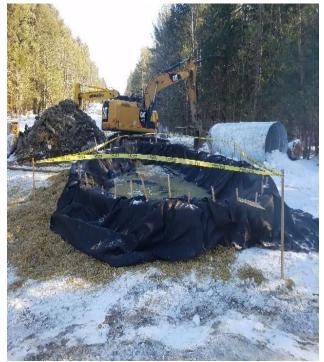
Fig 1: Dewatering basin at Str. 70. Viewing east. (01-23-20).

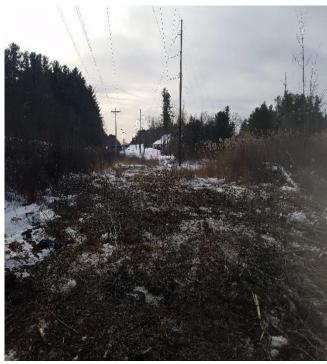
Fig 2: Wetland MW2 after timber mats were removed. Area between Strs. 2 and 3. Viewing south. (01-23-20).

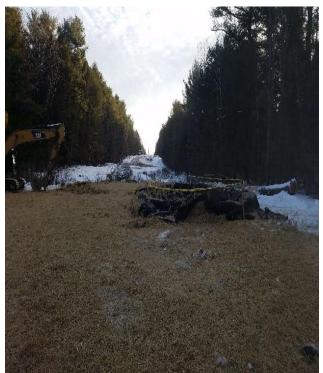
Fig 3: Str. 70 work area and dewatering basin. Viewing east. (01-24-20).

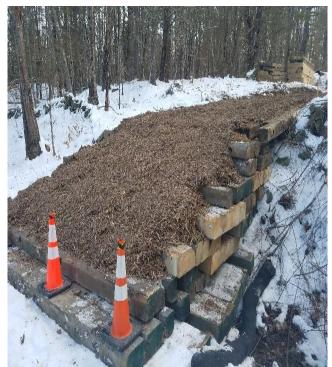
Fig 4: Access road off of Timber Brook Lane, over rock wall WP-22. Viewing northeast. (01-24-20).

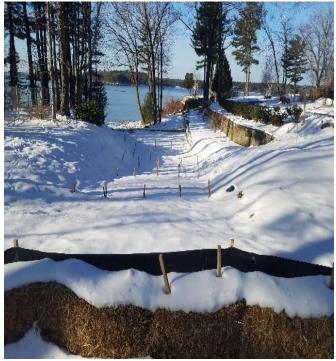
Fig 5: Slope down to vault at Gundalow landing/east side of the Bay. (01-24-20).

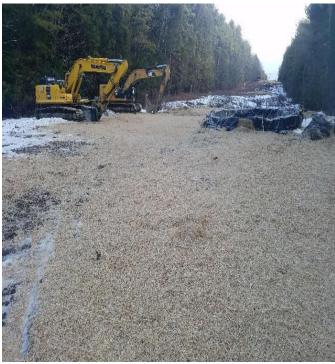
Fig 6: Str. 70 work area. Note straw cover. Viewing east. (01-27-20).

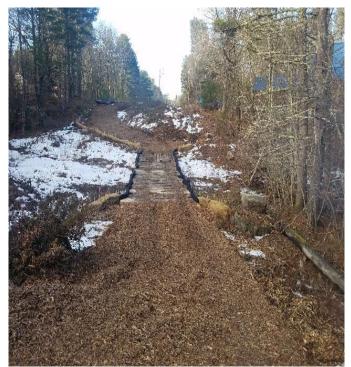
Fig 7: Access road through wetland DW9, between Strs. 65 and 66. Viewing west. Note stump grindings stabilizing slopes. (01-27-20).

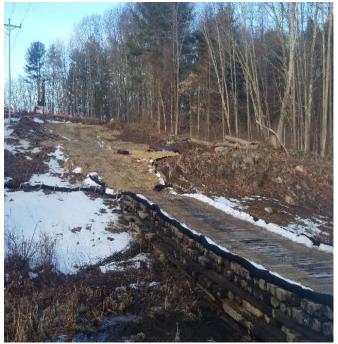
Fig 8: Access road to Str. 58 of off route 108. Bridge through wetland DW29. Viewing west. (01-27-20).

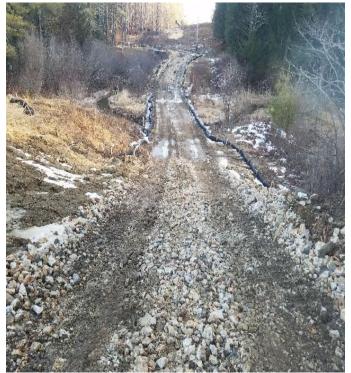
Fig 9 Access road between Strs. 51 and 52. Bridge over stream DS46. Viewing northeast. (01-27-20).

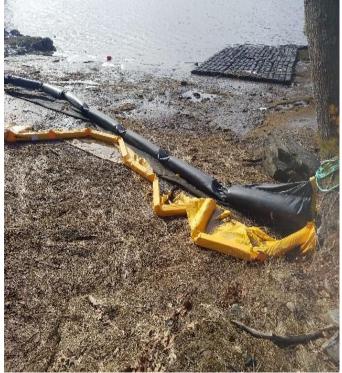
Fig 11: Turbidity barrier in intertidal zone at Gundalow landing/east side of the Bay. Viewing west. (01-27-20).

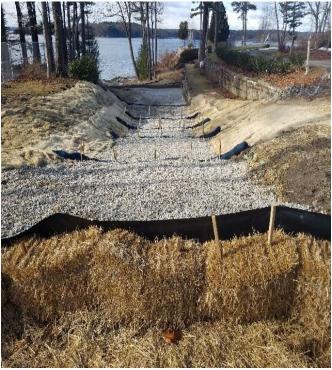
Fig 10: BMPs installed on slope at Gundalow landing/east side of the Bay. Viewing west. (01-27-20).

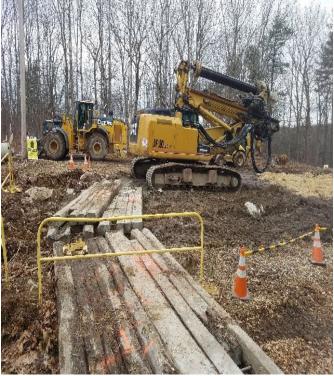
Fig 12: Str. 58 work area. Viewing south. (01-28-20).

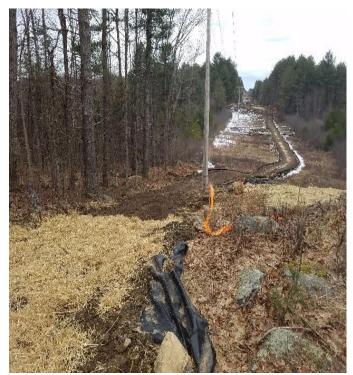
Fig 13: Crew spreading straw over exposed soils leading up to Str. 58. Viewing west. (01-28-20).

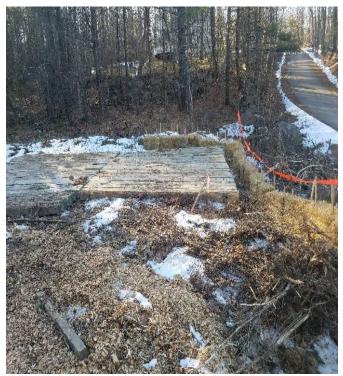
Fig 14: Work pad for Str. 63. Viewing south. (01-29-20).
