CONSTRUCTION MONITORING REPORT

Eversource Transmission Lines:
F107

**Madbury, Durham,
Newington, Portsmouth, NH**

TYPE OF INSPECTION: Weekly Storm Event Incident Corrective Action

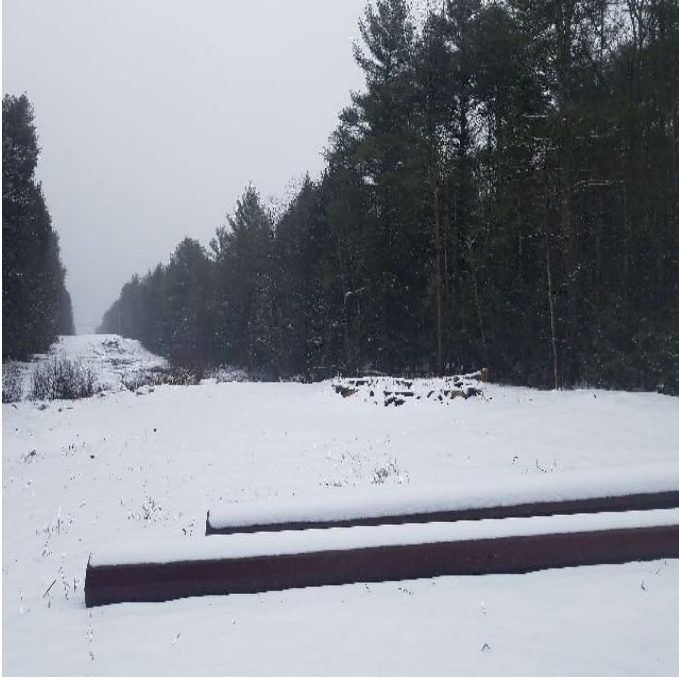
Fig 1: Str. 70. Viewing east. (02-06-20).

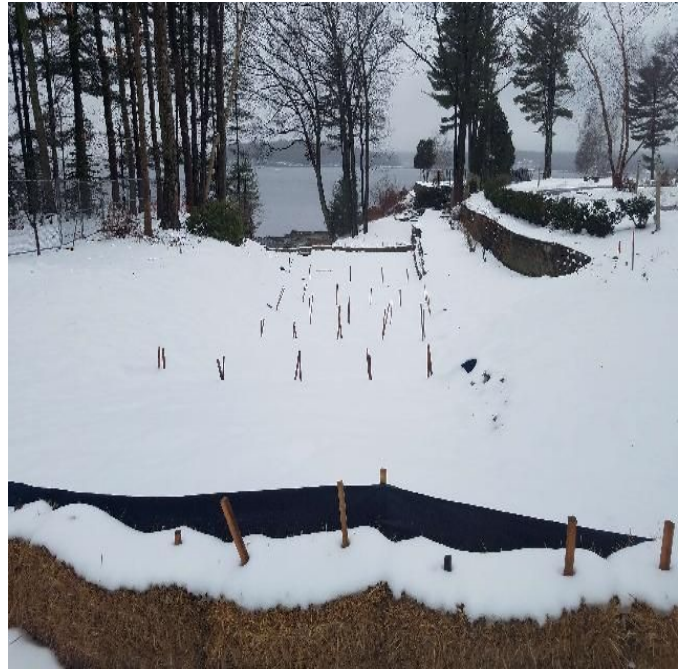
Fig 2: Slope at Gundalow landing/east side of the Bay. Viewing west. (02-06-20).

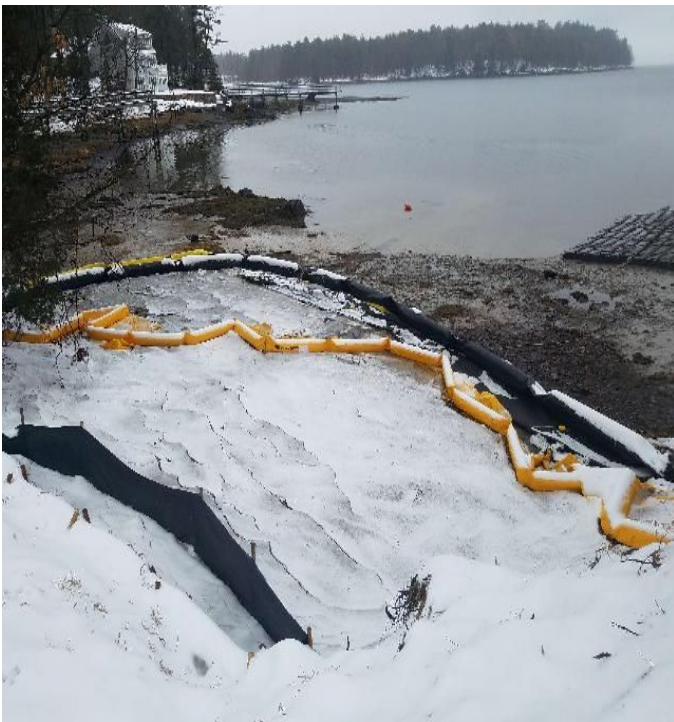
Fig 3: Turbidity barrier in intertidal zone at Gundalow landing/east side of the Bay. Viewing southwest. (02-06-20).

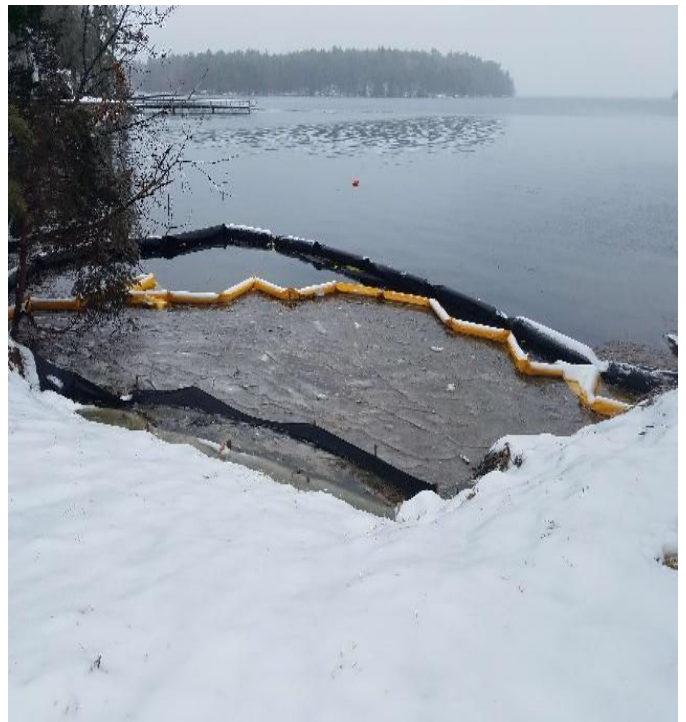
Fig 4: Turbidity barrier in intertidal zone at Gundalow landing/east side of the Bay. Viewing southwest. (02-07-20).

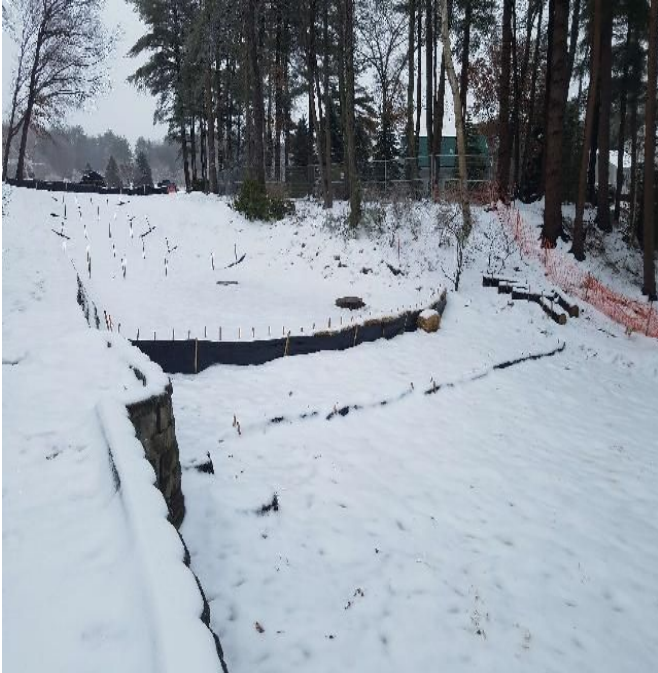
Fig 5: Slope at Gundalow landing/east side of the Bay. Viewing east. (02-07-20).

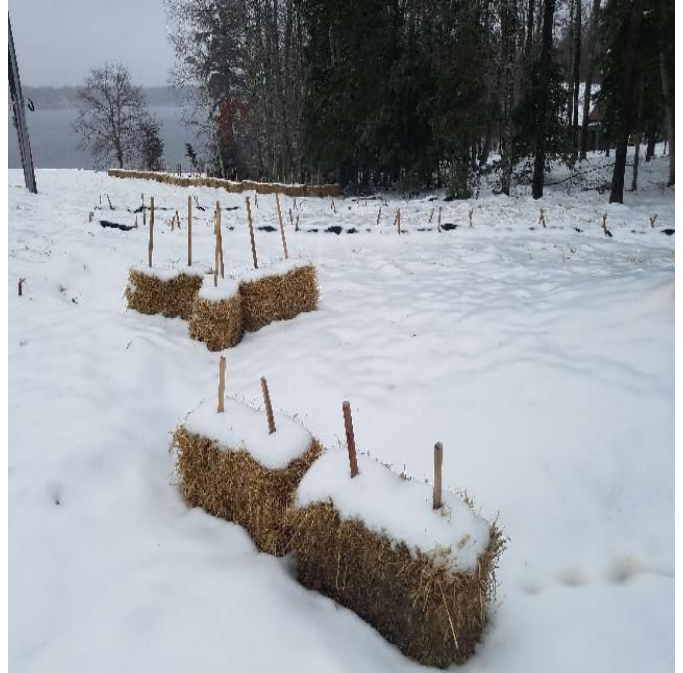
Fig 6: BMPs at Getchell property/west side of the Bay. Viewing east. (02-07-20).

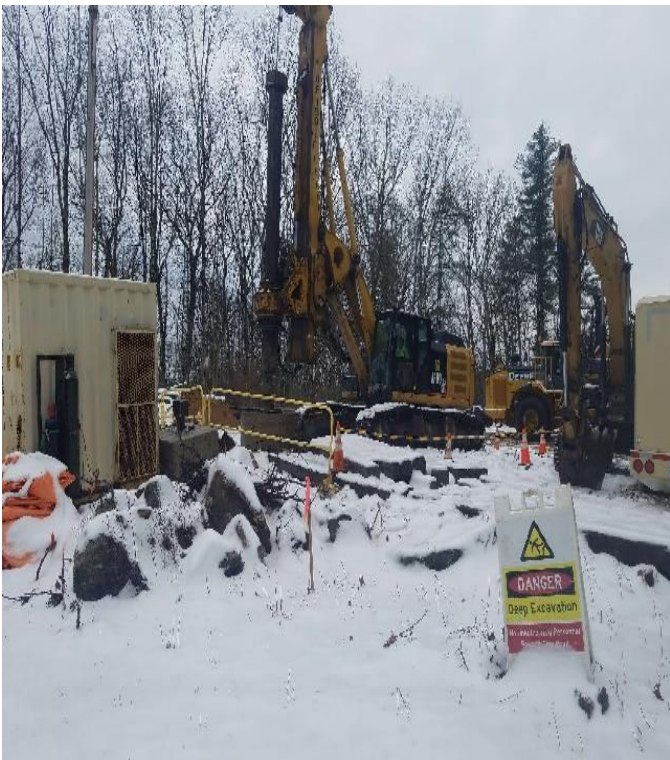
Fig 7: Crew continues to drill at Str. 58. Viewing south. (02-10-20).

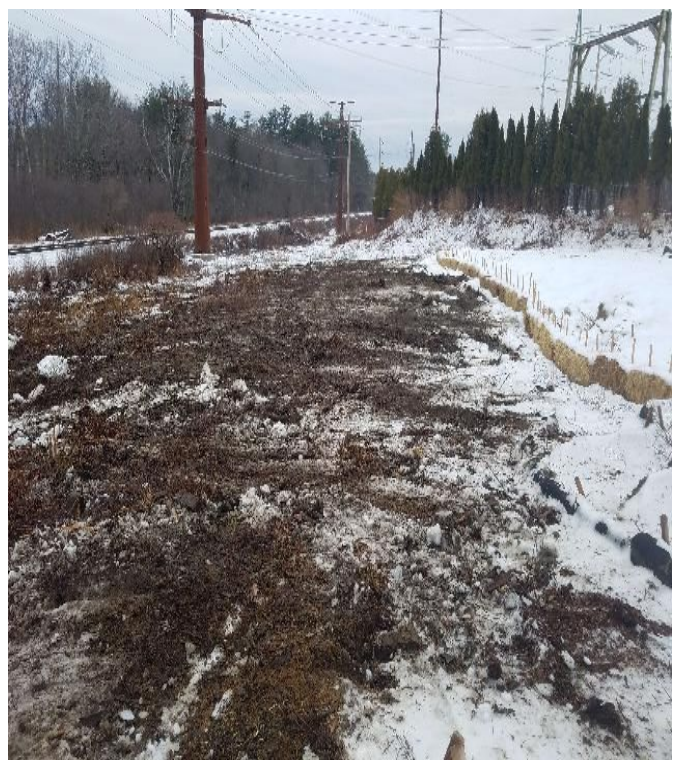
Fig 8: Crew continues to remove timber matted access road for Strs. 1 and 2. Viewing south. (02-10-20).

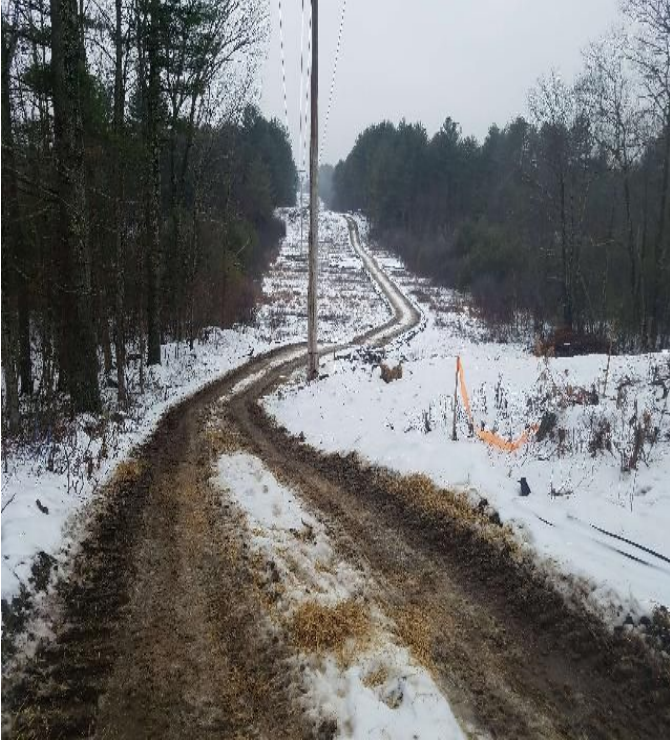
Fig 9: Access road between Strs. 57 and 58. Viewing west. (02-11-20).

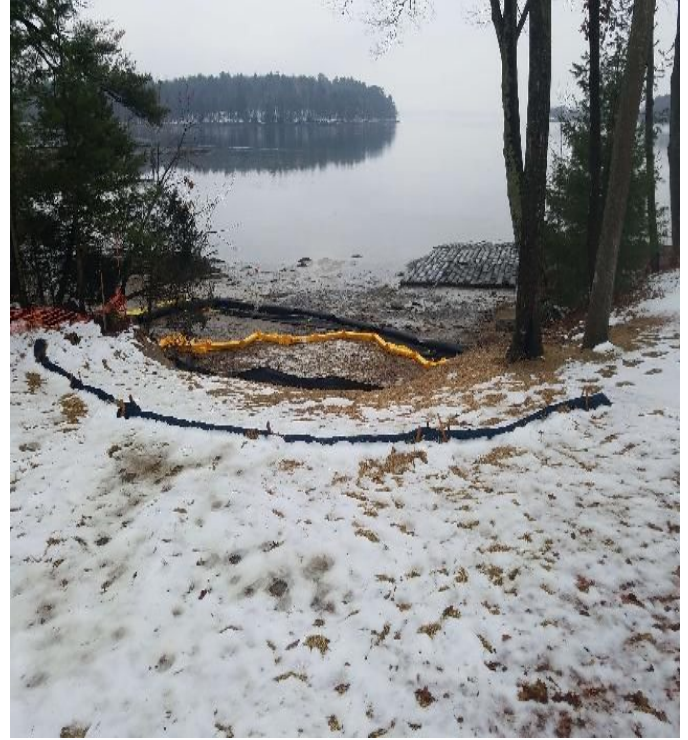
Fig 10: Turbidity barrier remains in place in intertidal zone at Gundalow landing/east side of the Bay. Viewing southwest. (02-11-20).

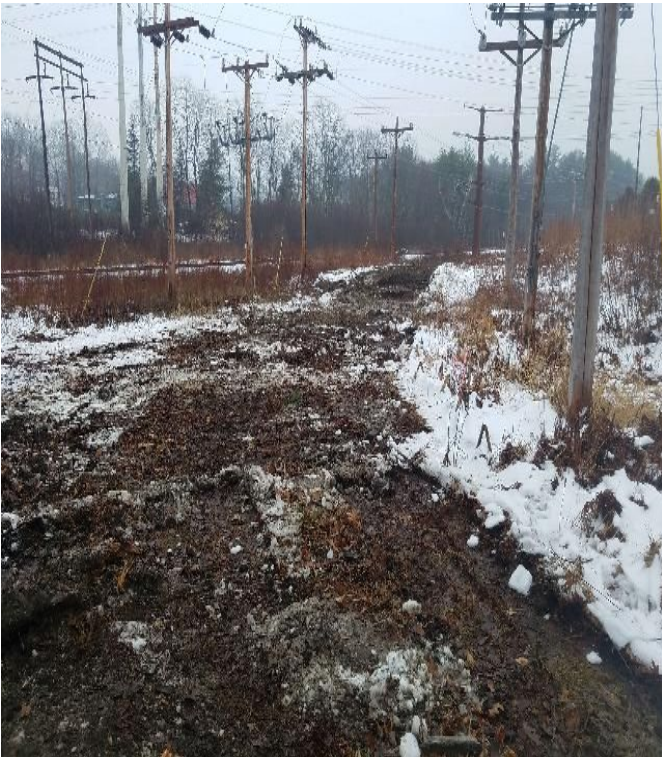
Fig 11: Timber mats have been removed from Madbury substation to Str. 3. Viewing south. (02-11-20).

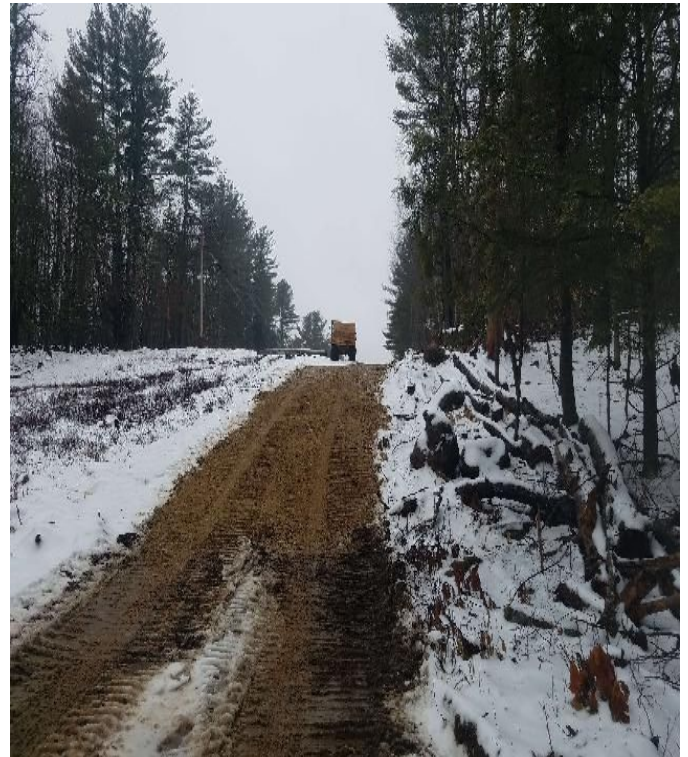
Fig 12: Crew installing stone on sloped sections of the access road between Strs. 52-58 for concrete truck access. This area is next to Str. 53. Viewing west. (02-11-20).

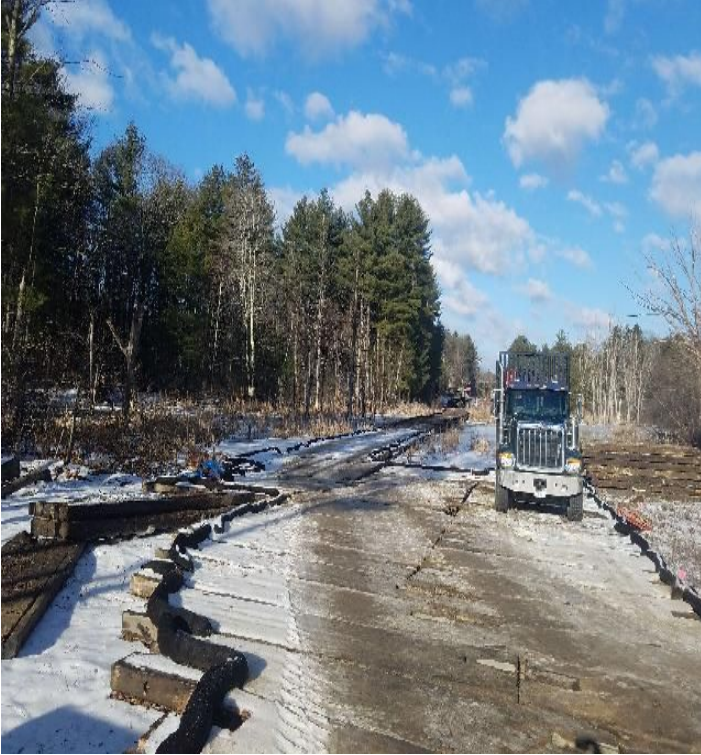
Fig 13: Crew building access road from Str. 116 to Str. 114. Through wetlands NW11 and NW13. Viewing north. (02-12-20).

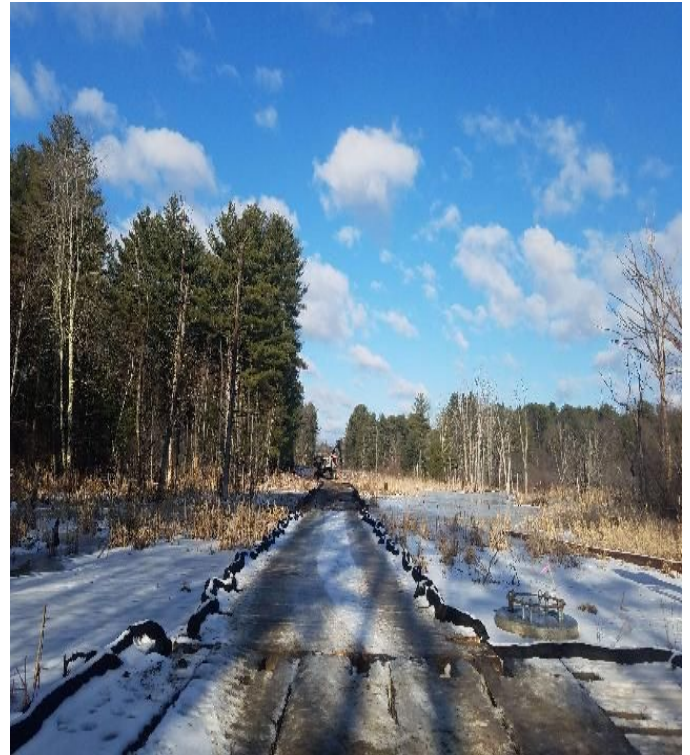
Fig 14: Building access road from Str. 116 to Str. 114. Through wetlands NW11 and NW13. Viewing north. (02-12-20).

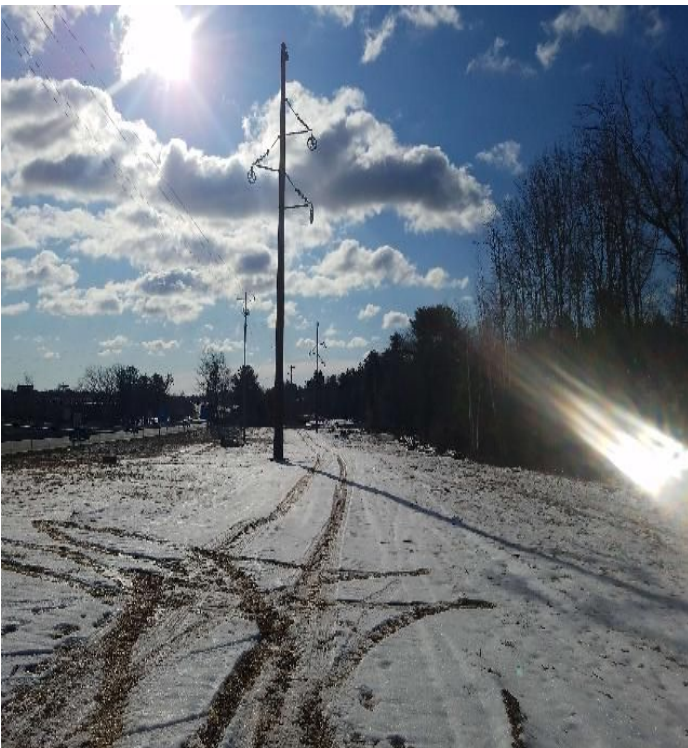
Fig 15: Strs. 123 and 124. Viewing south. (02-12-20).

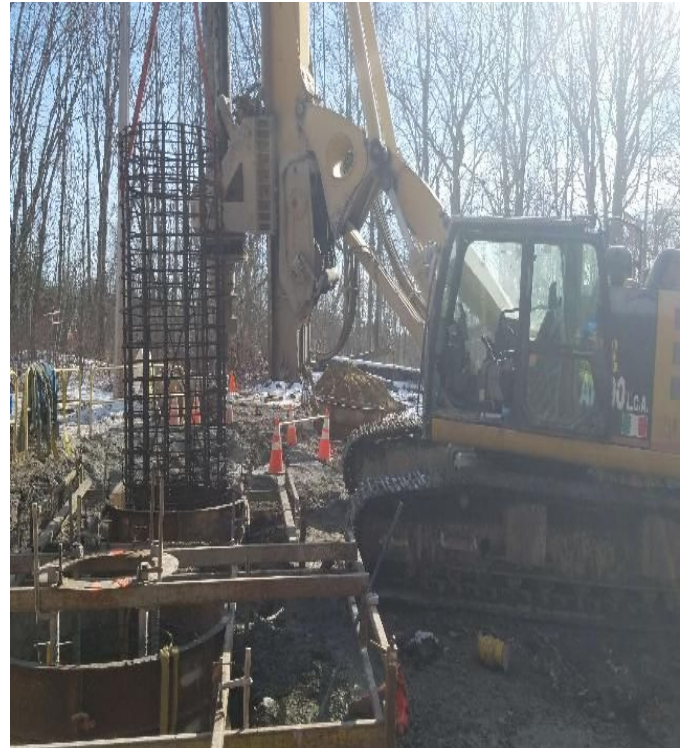
Fig 16: MJ prepping to pour foundations for Str. 58. Viewing south. (02-12-20).
