### CONSTRUCTION MONITORING REPORT

Eversource Transmission Lines:  
**F107**

**Madbury, Durham,  
Newington, Portsmouth, NH**

NAI Project No:  
**23840.39**

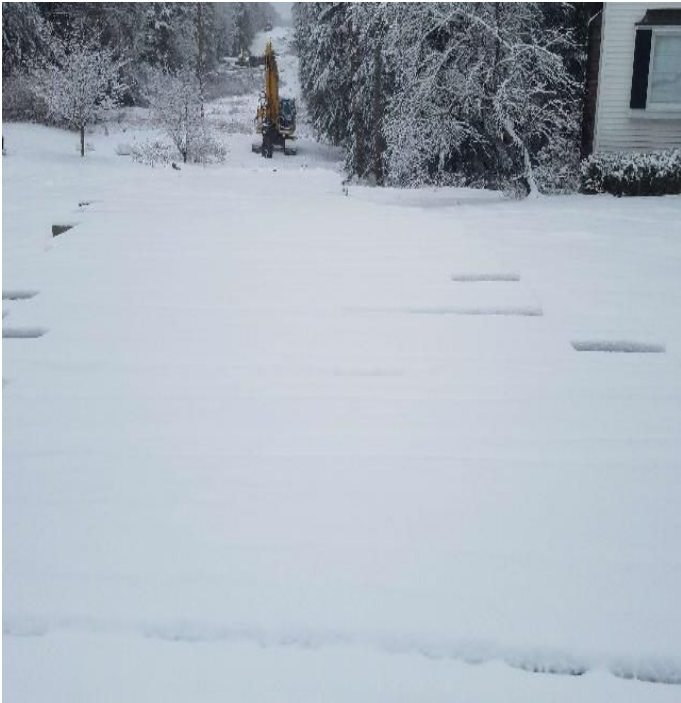
Fig 1: Access road to Str. 68, coming off of Frost Dr. Viewing east. (02-13-20).

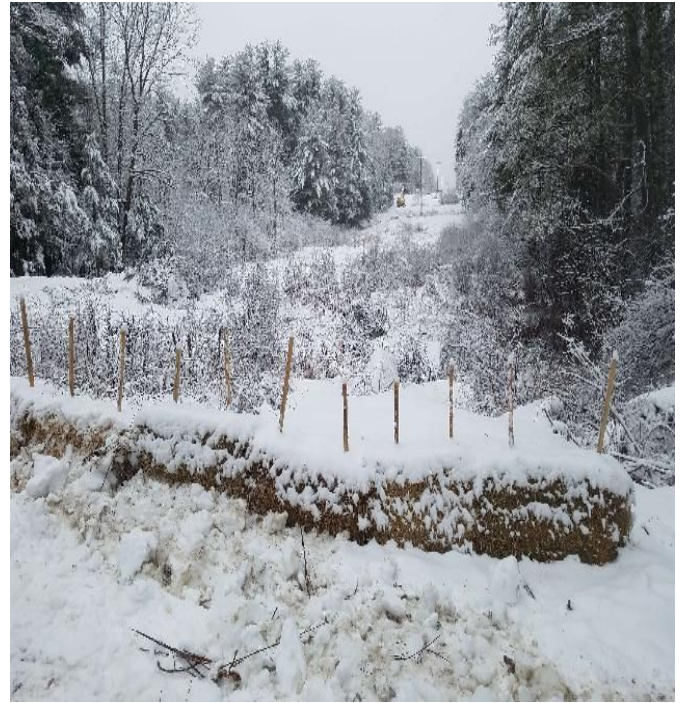
Fig 2: BMPs installed between Str. 69 work area and wetland DW13. Viewing west. (02-13-20).

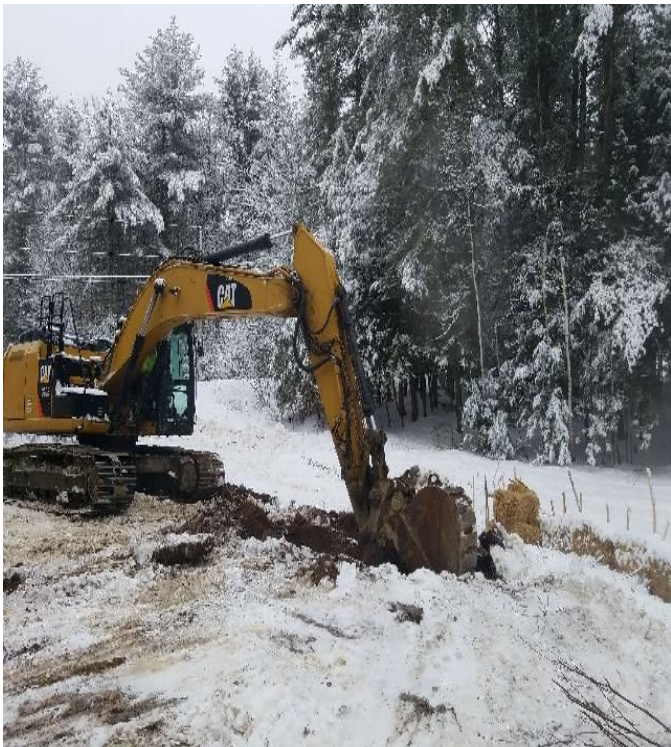
Fig 3: Crew excavating foundation for Str. 69. Viewing south. (02-13-20).

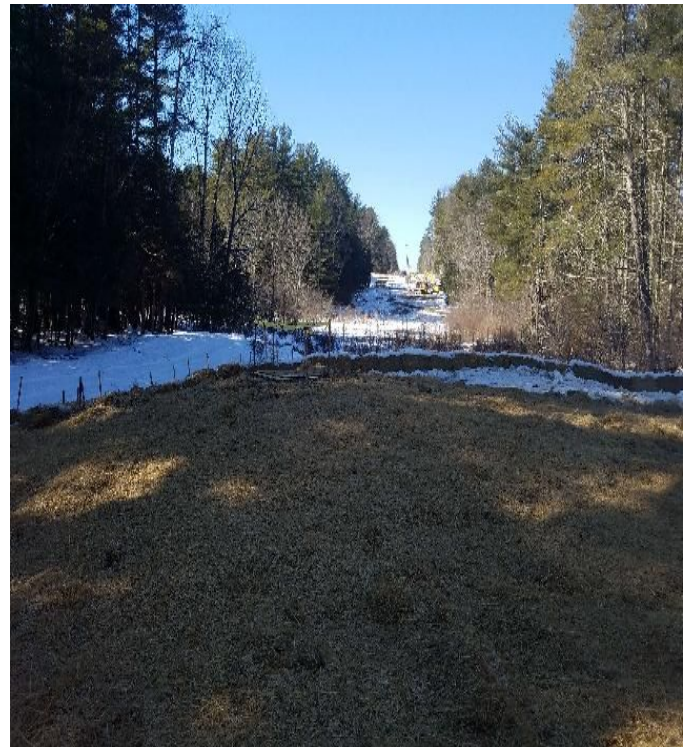
Fig 4: Straw spread over exposed soils at Str. 69. Viewing west. (02-14-20).

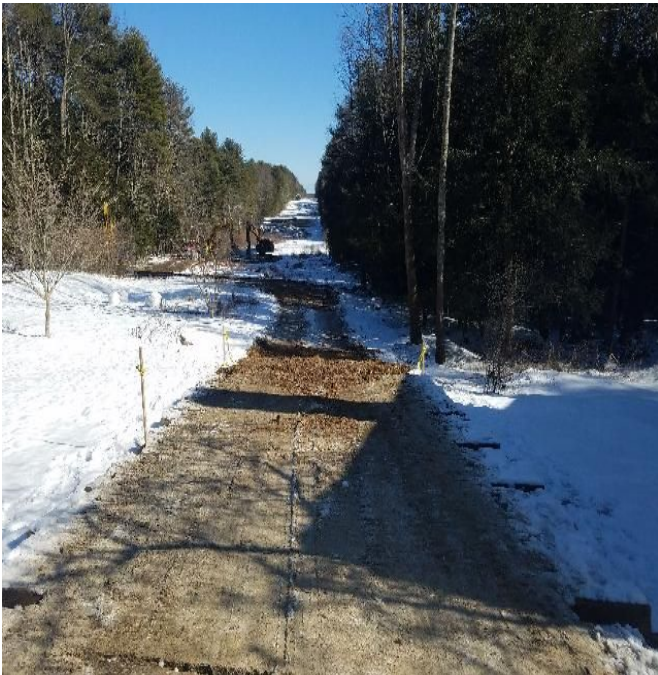
Fig 5: Access road to Str. 68. Viewing east. (02-14-20).

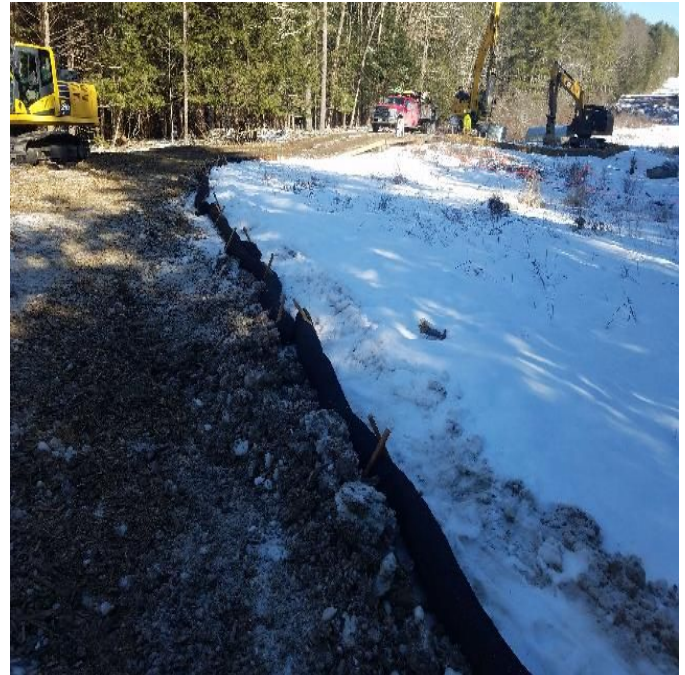
Fig 6: Filter sock installed downslope of access road to Str. 68. Viewing northeast. (02-14-20).

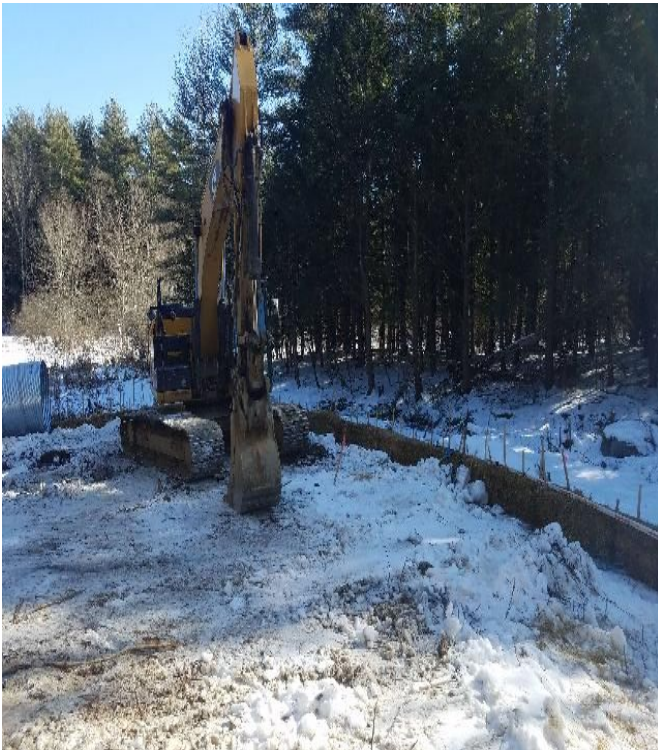
Fig 7: BMPs installed around the perimeter of the work area at Str. 68. Viewing east. (02-14-20).

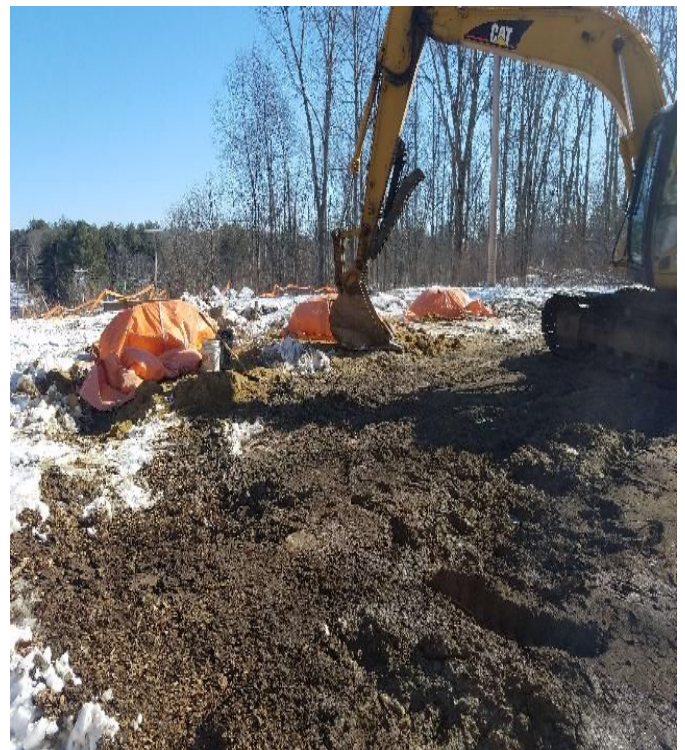
Fig 8: Crew restoring Str. 58 work area. Viewing northeast. (02-14-20).

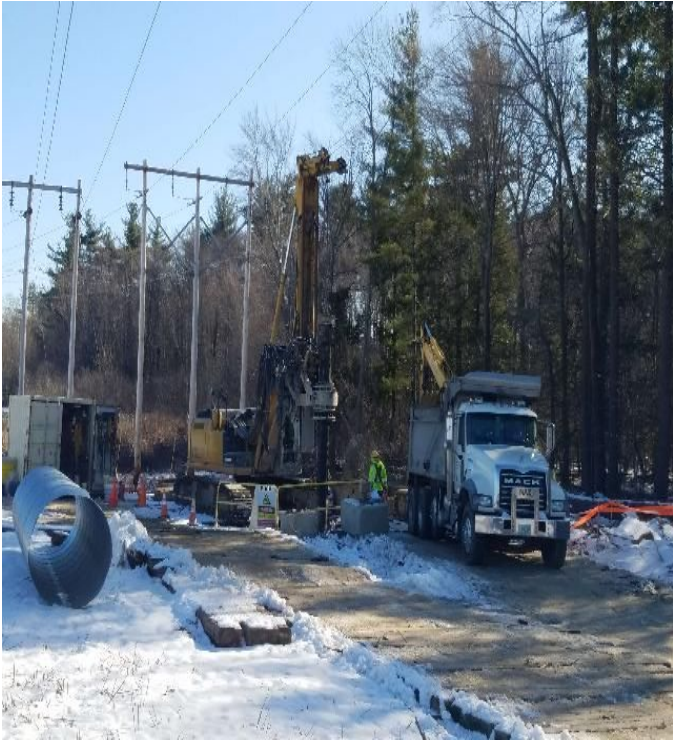
Fig 9: MJ drilling Str. 130. Viewing south. (02-14-20).

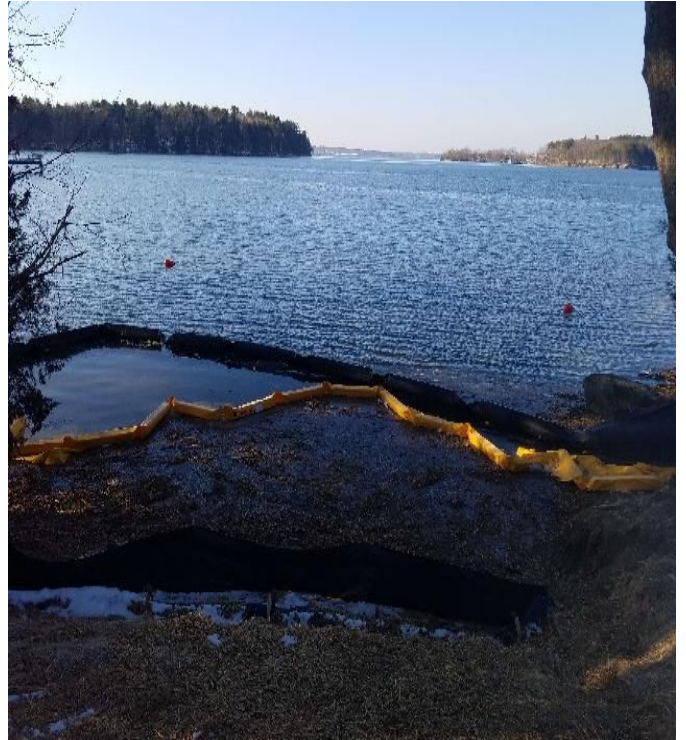
Fig 10: Turbidity barrier remains in place in intertidal zone at Gundalow landing/east side of the Bay. Viewing southwest. (02-17-20).

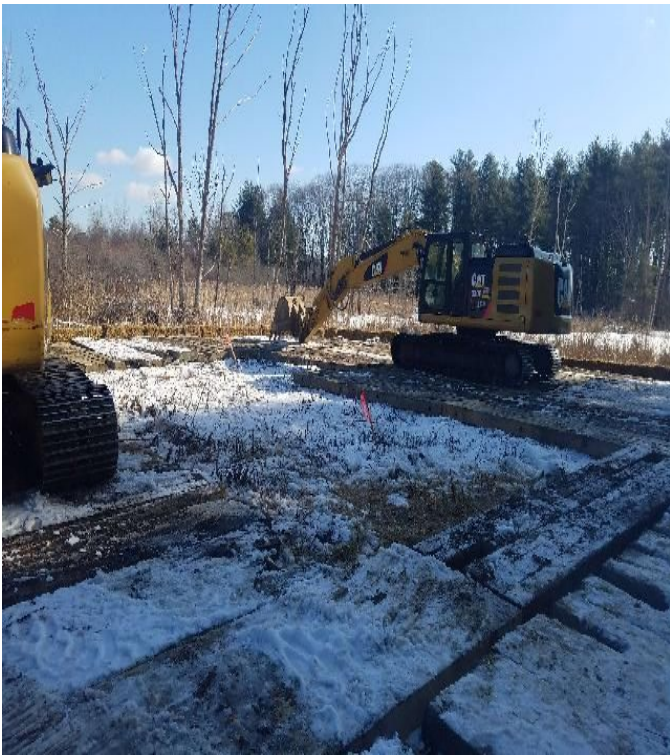
Fig 11: Str. 115 work pad. Viewing southwest. (02-17-20).

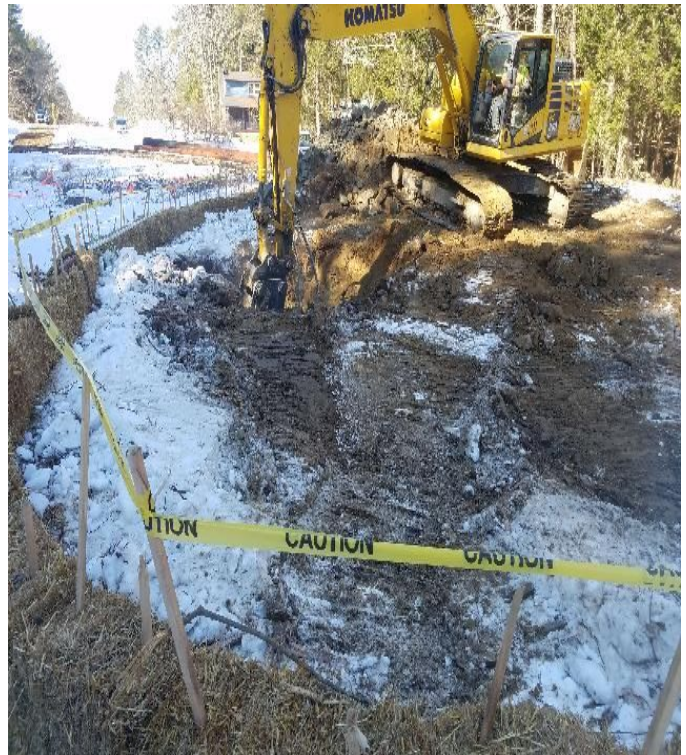
Fig 12: Crew excavating foundation for Str. 68. Viewing west. (02-17-20).

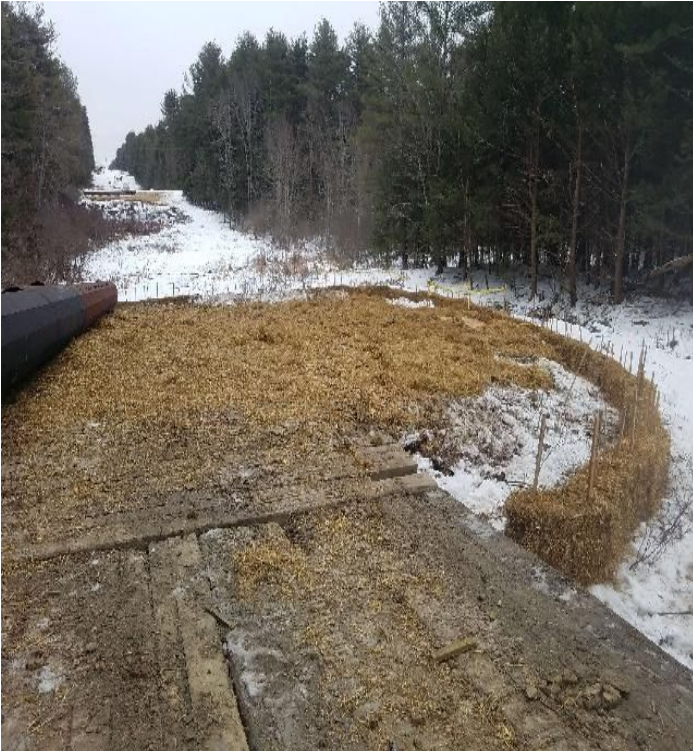
Fig 13: Straw spread over exposed soils at Str. 68. Viewing east. (02-18-20).

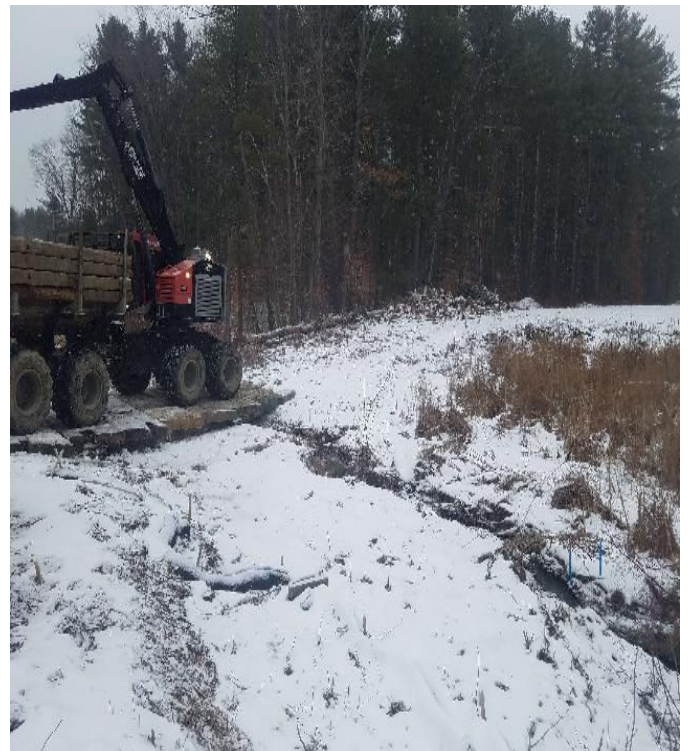
Fig 14: Crew beginning to build matted access road from Str. 112 to Str. 114. Viewing northeast. (02-18-20).

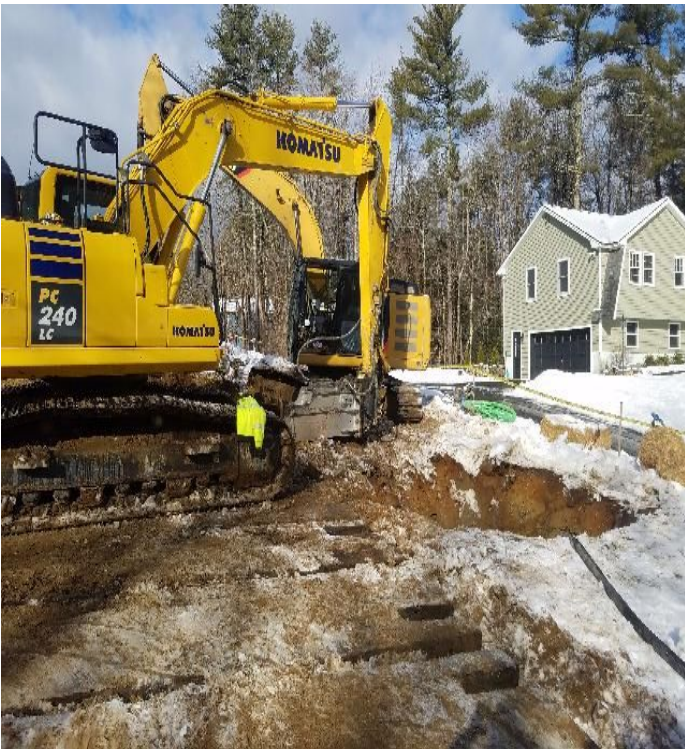
Fig 15: Excavating foundation for Str. 67. Viewing west. (02-19-20).

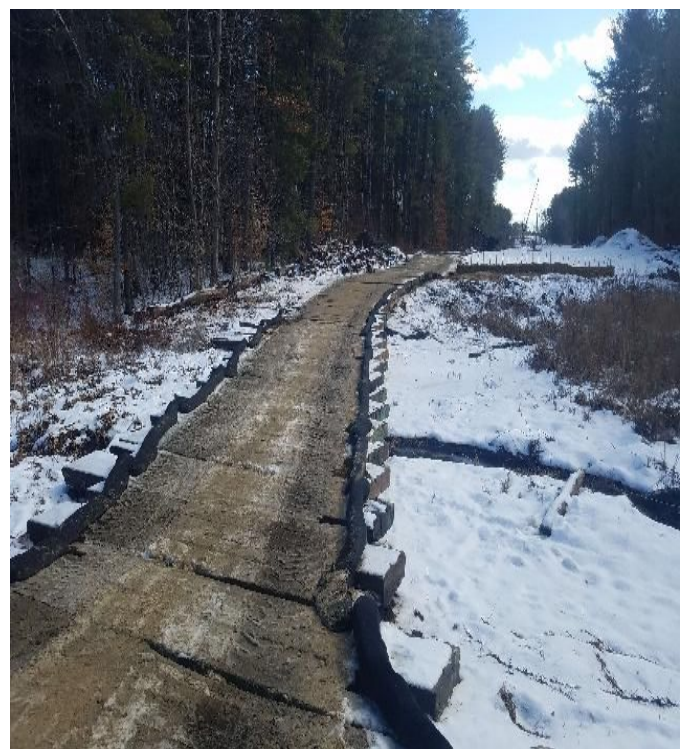
Fig 16: Access road to Str. 113 and 114, through wetland NW34. Viewing south. (02-19-20).

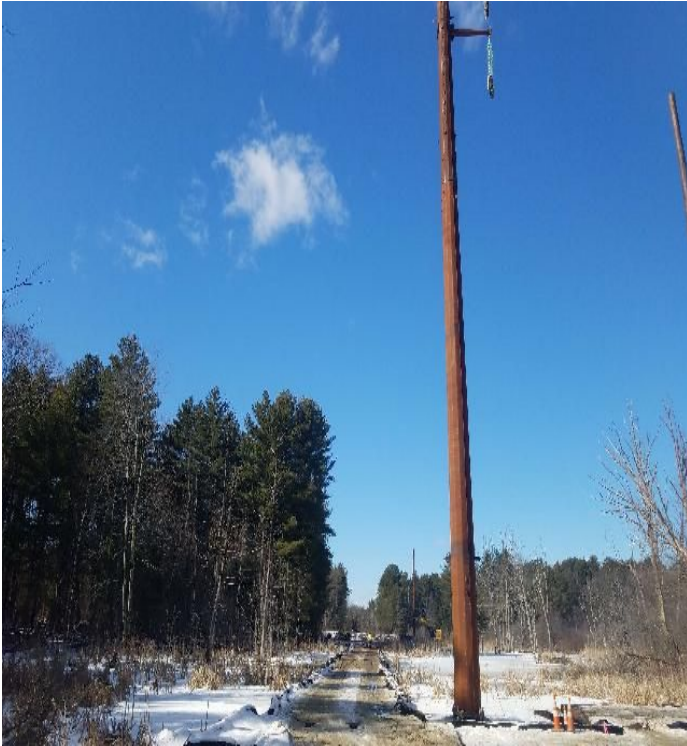
Fig 17: Str. 116. Viewing north. (02-19-20).

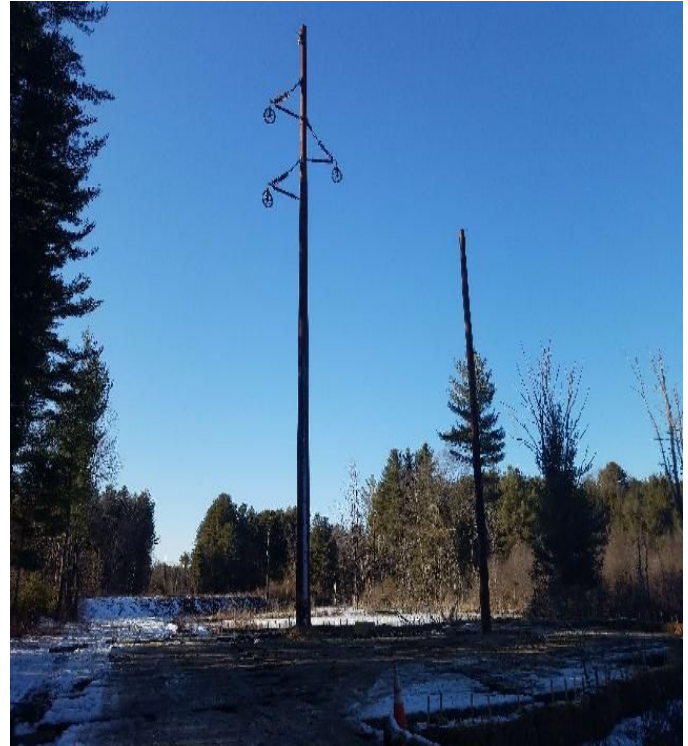
Fig 18: Str. 115 and distribution pole 3850-63. Viewing north. (02-19-20).
