### CONSTRUCTION MONITORING REPORT

Eversource Transmission Lines:  
**F107**

**Madbury, Durham,  
Newington, Portsmouth, NH**

**TYPE OF INSPECTION:**  Weekly  Storm Event  Incident  Corrective Action

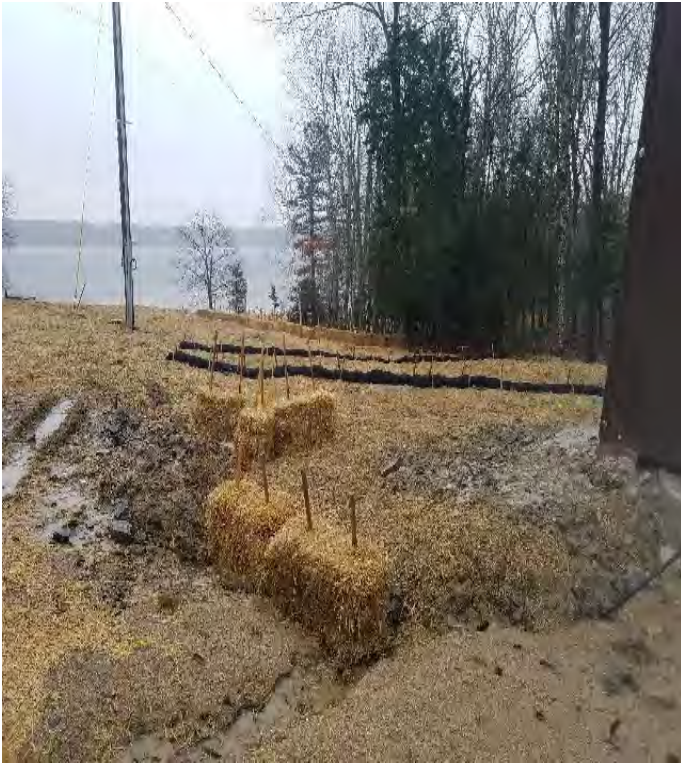
Fig 1: BMPs installed on slope at Getchell property/west side of the bay. Viewing east. (02-27-20).

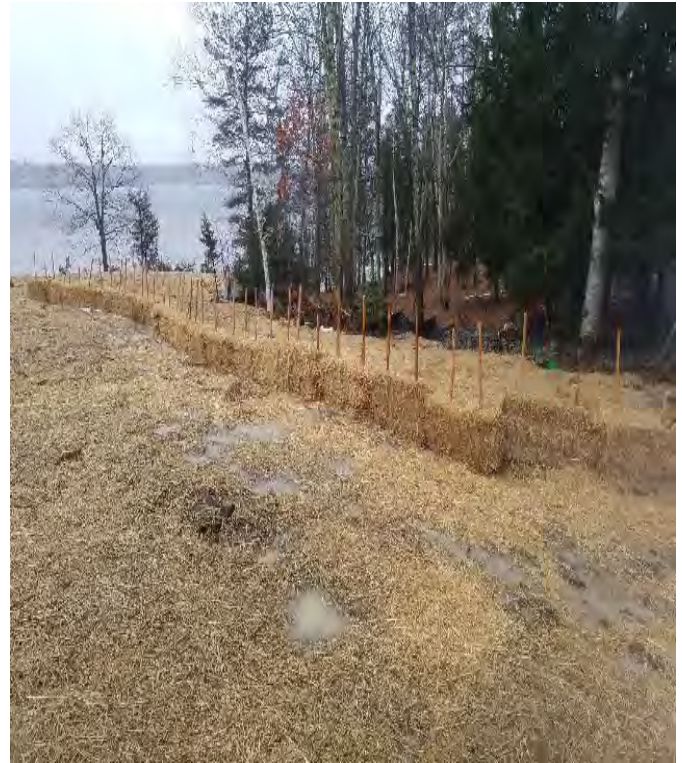
Fig 2: BMPs on slope at Getchell property/west side of the Bay, around area where previous erosion was observed. Viewing east. (02-27-20).

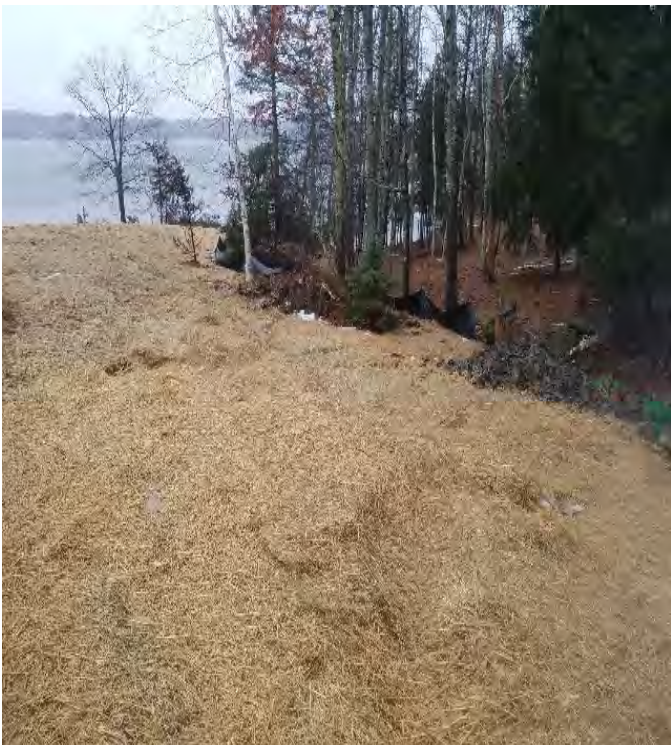
Fig 3: Erosion blanket preventing any further erosion at Getchell property/west side of the Bay. Viewing east. (02-27-20).

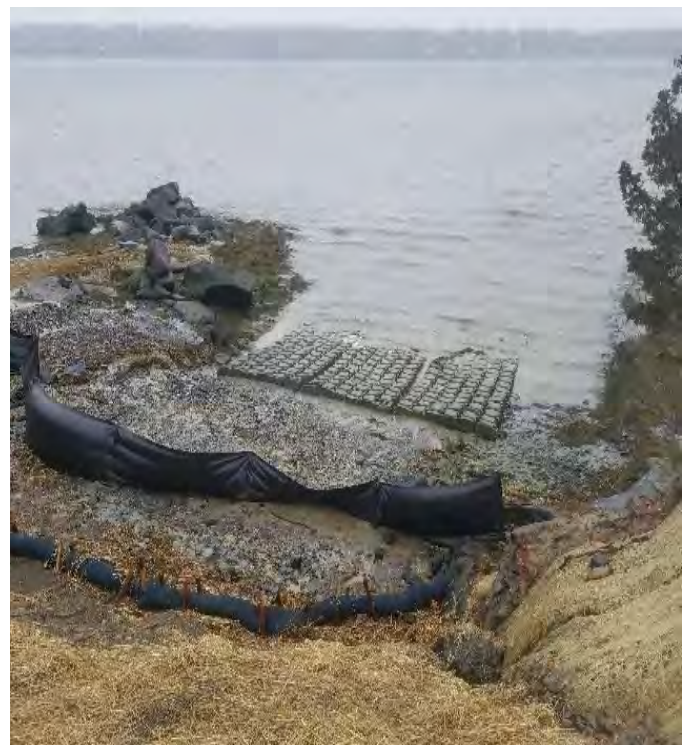
Fig 4: BMPs installed at toe of slope at Getchell property/west side of the Bay. Viewing east. (02-27-20).

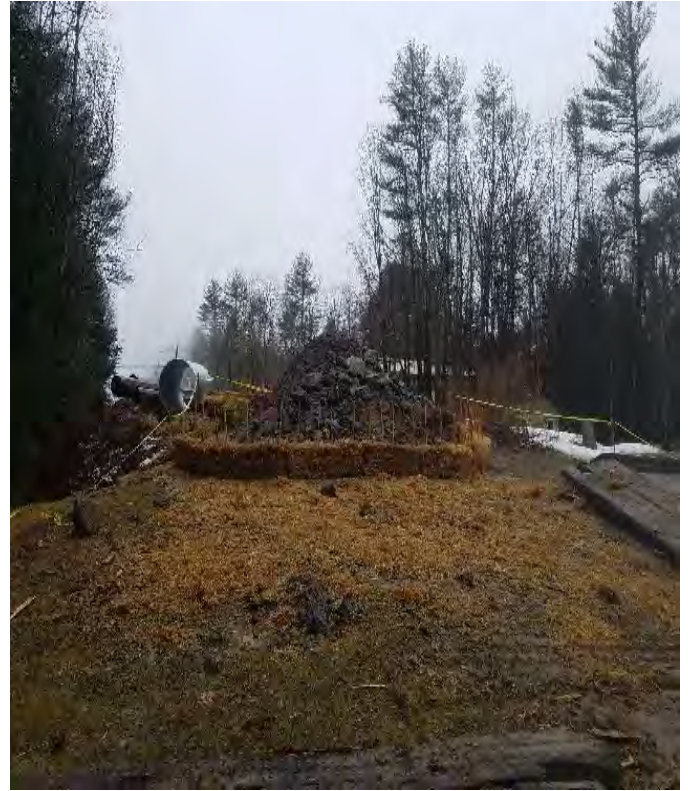
Fig 6: Rock pile at Str. 67. Viewing west. (02-27-20).

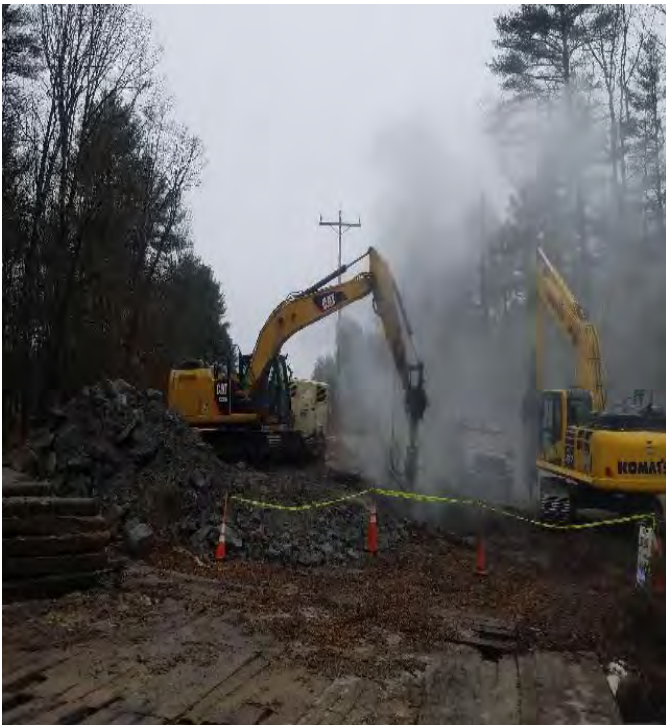
Fig 7: Crew drilling ledge at Str. 66. Viewing west. (02-27-20).

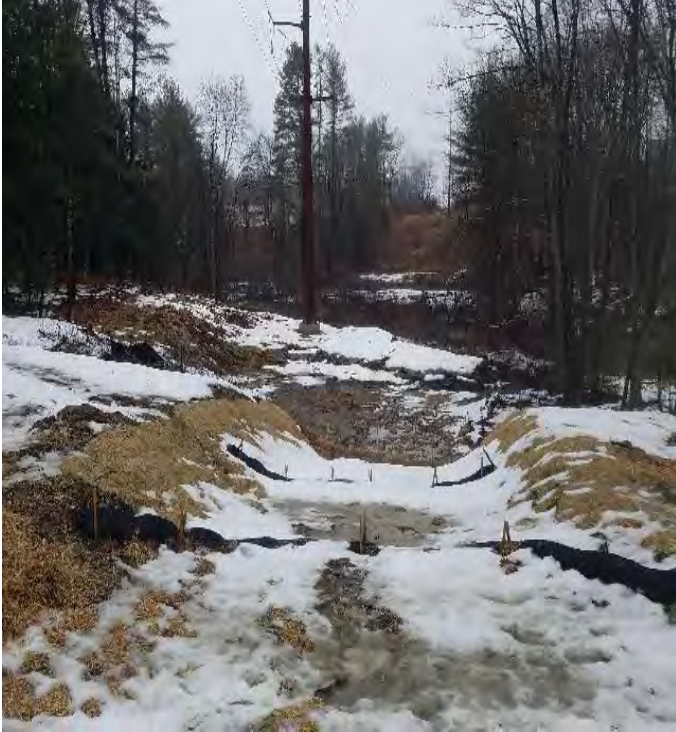
Fig 9: BMPs on access road to Str. 28. Viewing north. (02-27-20).

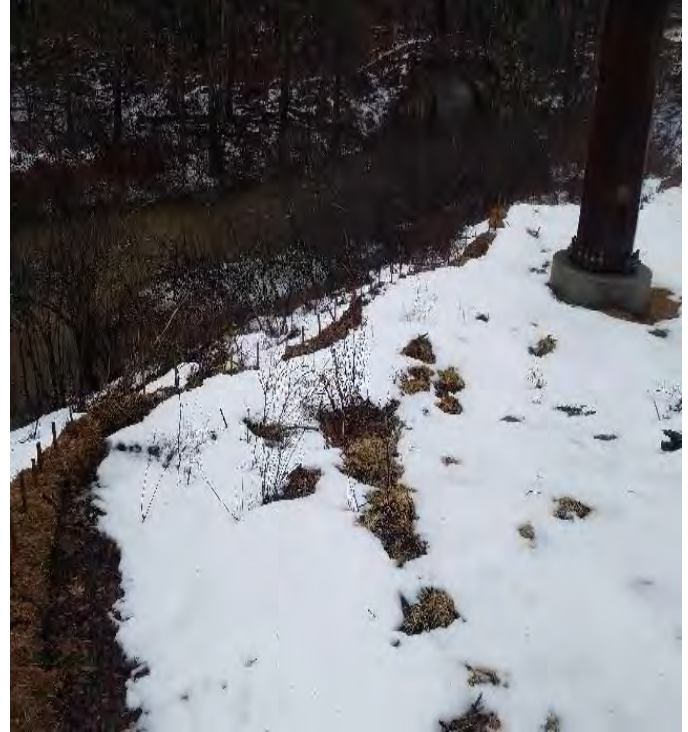
Fig 10: BMPs installed between Str. 28 and Oyster River. Viewing northeast. (02-27-20).

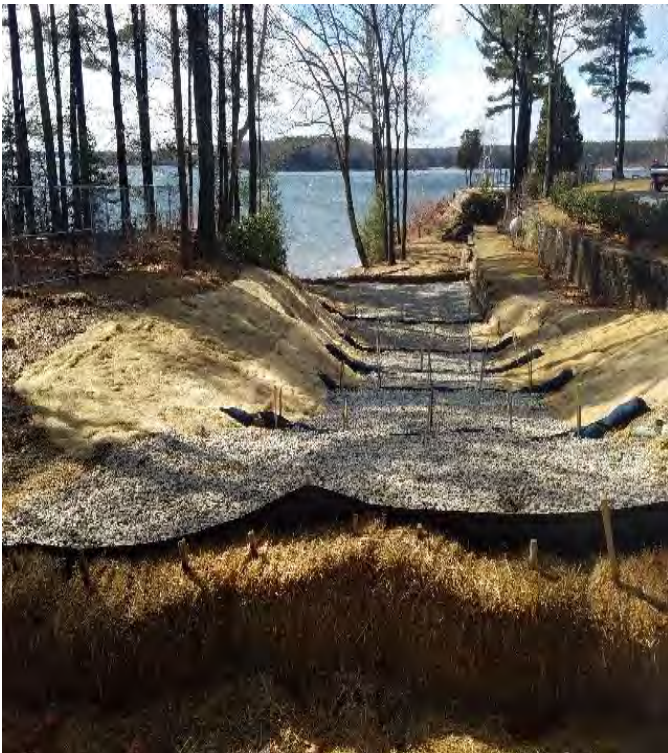
Fig 11: BMPs on slope to vault at Gundalow landing/east side of the Bay. Viewing west. (02-27-20).

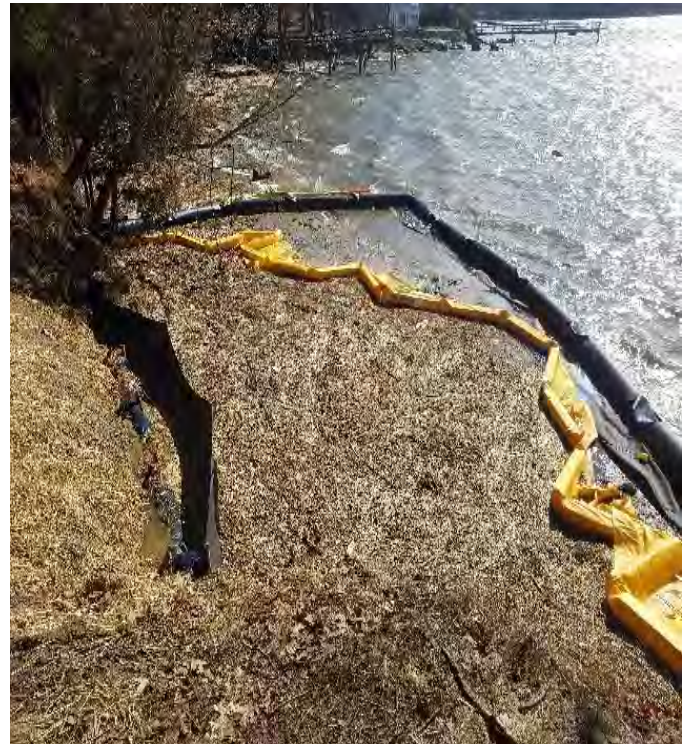
Fig 12: BMPs at toe of slope and turbidity barrier in intertidal zone at Gundalow landing/east side of the Bay. Viewing south. (02-27-20).
