CONSTRUCTION MONITORING REPORT

Eversource Transmission Lines: <u>F107</u>

Eversource Seacoast Reliability Project

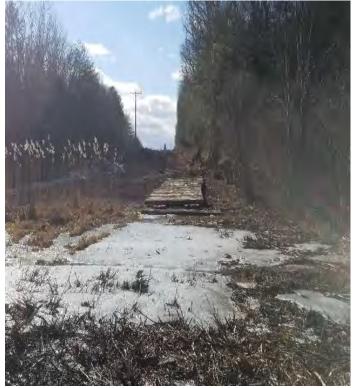
Fig 1: Building access road from Str. 74 to Str. 75. About to mat through wetland DW21. Viewing west. (02-28-20).

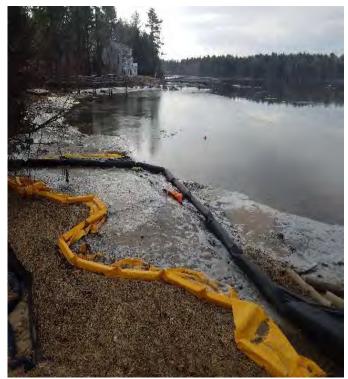
Fig 3: Turbidity curtain in intertidal zone at Gundalow landing/east side of the Bay. Viewing south. (03-02-20).

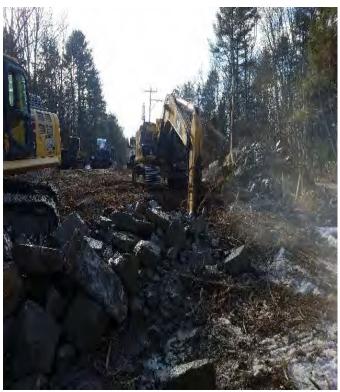
Fig 2: Excavating foundation for Str. 65. Viewing west. (02-28-20).

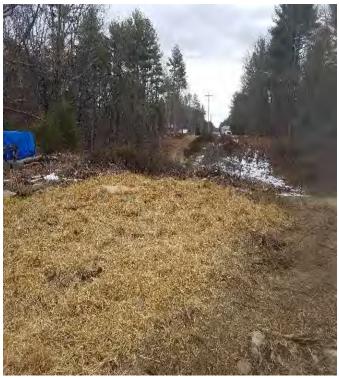
Fig 4: Straw spread over exposed soils at Str. 65. Viewing west. (03-02-20).

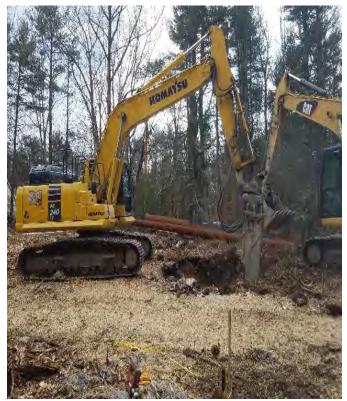
Fig 5: Beginning to excavate foundation for Str. 64. Viewing south. (03-02-20).

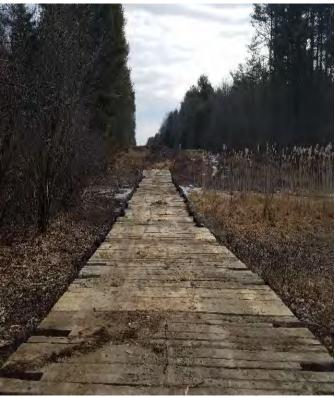
Fig 6: Access road leading to Str. 75, though wetland DW21. Viewing east. (03-02-20).

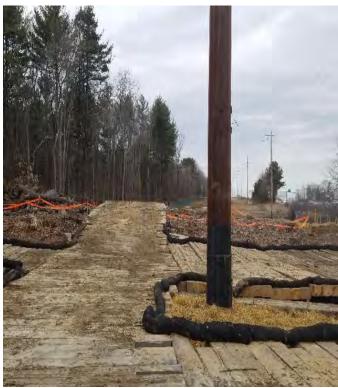
Fig 8: Standing Str. 126 foundation. Viewing northwest. (03-02-20).

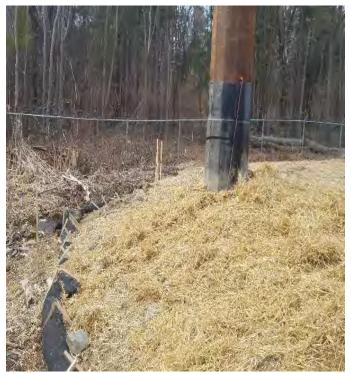
Fig 9: Str. 125 foundation. Viewing southwest. (03-02-20).

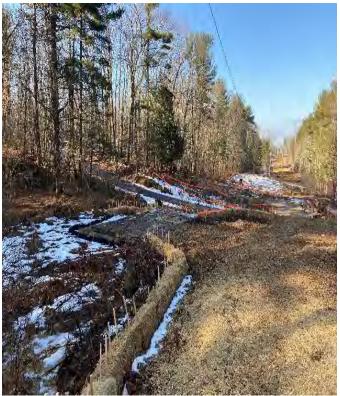
Fig 11: BMPs installed around wetland DW7 for work at Str. 63. Viewing west. (03-03-20).

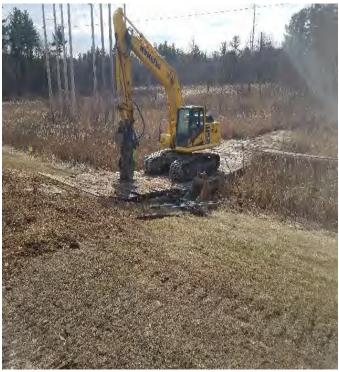
Fig 10: Crew beginning to build matted work pad for Str. 128, in wetland NW1. Viewing south. (03-02-20).

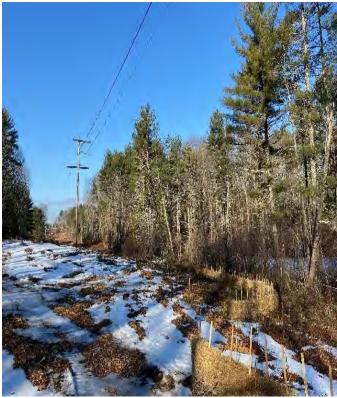
Fig 12: BMPs installed between Str. 62 work area and wetland DW5. Viewing northwest. (03-03-20).

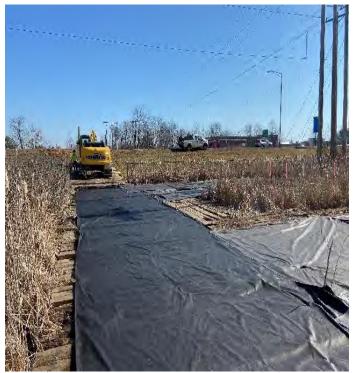
Fig 13: Installing filter fabric between timber mats at Str. 128. Viewing northeast. (03-03-20).

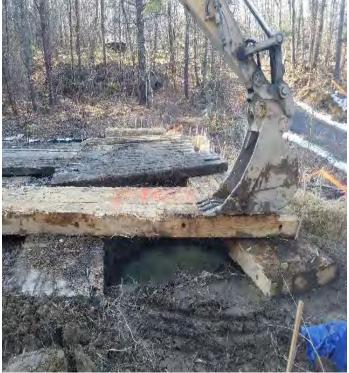
Fig 15: Groundwater in hole at Str. 63. Viewing south. (03-04-20).

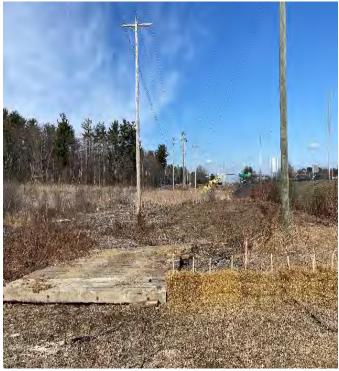
Fig 14: Str. 129 anchor point work pad. Viewing northwest. (03-03-20).

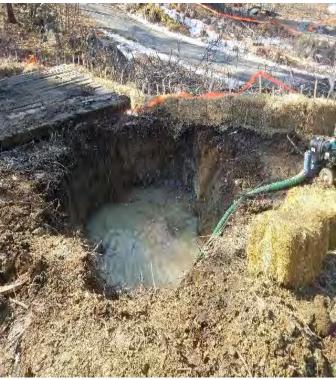
Fig 16: Pumping out water in hole at Str. 63. Viewing south. (03-04-20).

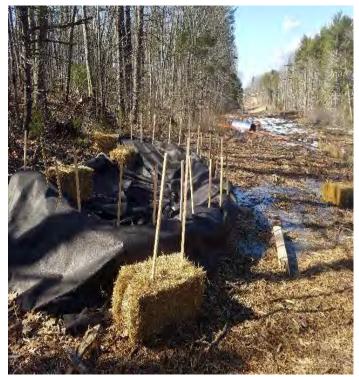
Fig 17: Dewatering basin built across Timber Brook Lane to dewater Str. 63. Viewing south. (03-04-20).

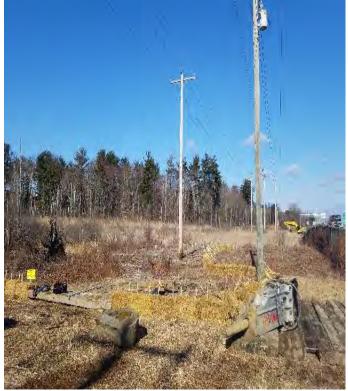
Fig 19: Prepping to excavate foundation for Str. 129. BMPs installed Between work area and wetland NW1. Viewing west. (03-04-20).

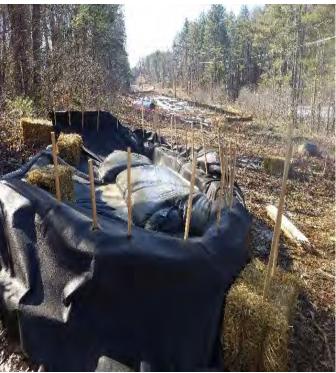
Fig 18: Pumping water from Str. 63 to dewatering basin. Viewing south. (03-04-20).

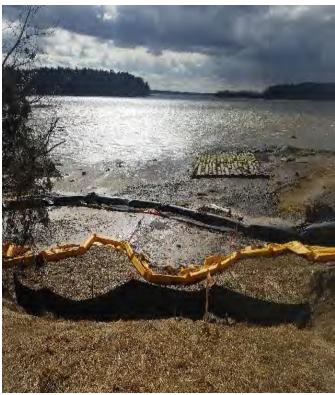
Fig 20: Turbidity barrier and concrete mattress at Gundalow landing/ east side of the Bay. Viewing southwest. (03-04-20).
