CONSTRUCTION MONITORING REPORT

Eversource Transmission Lines:
F107

**Madbury, Durham,
Newington, Portsmouth, NH**

TYPE OF INSPECTION: Weekly Storm Event Incident Corrective Action

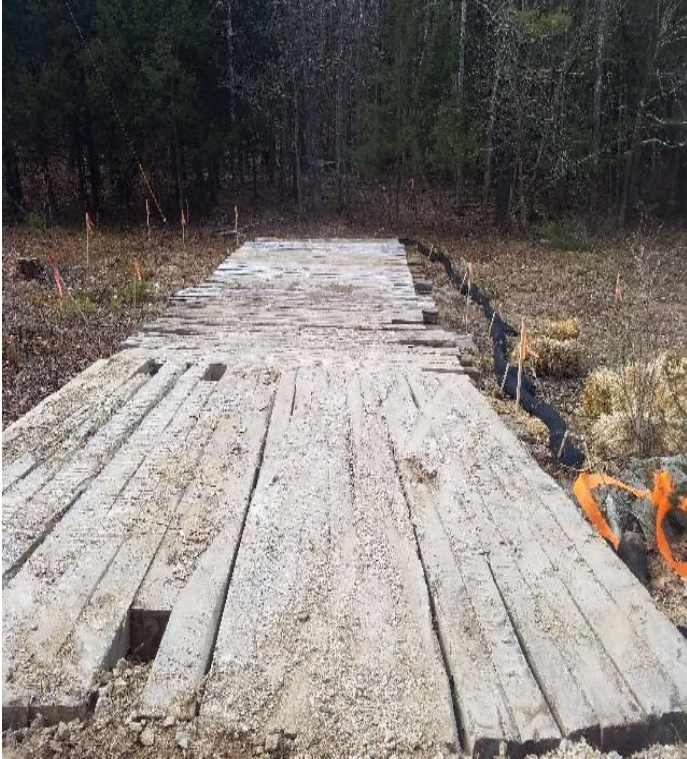
Fig 1: Work pad for Str. 98. Viewing south. (03-12-20).

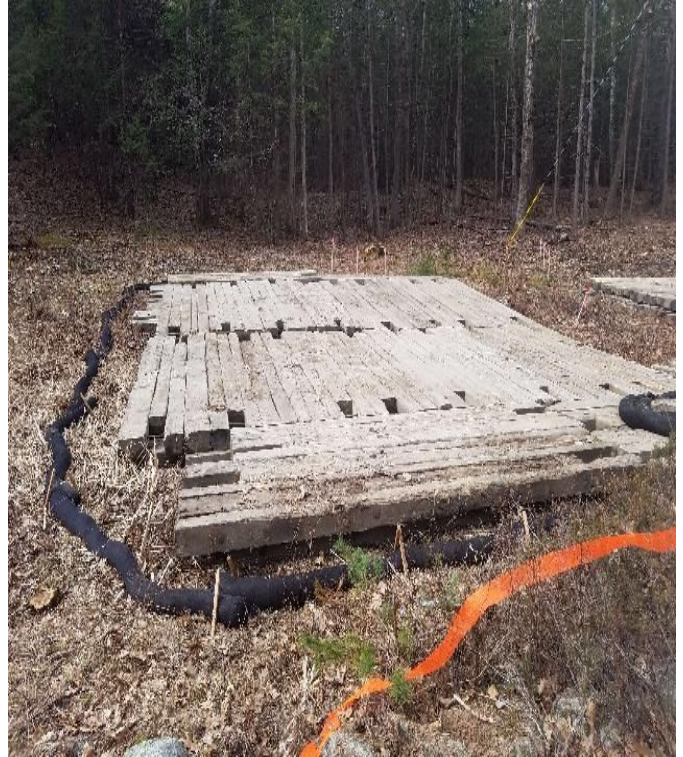
Fig 2: Work pad for Str. 97. Viewing south. (03-12-20).

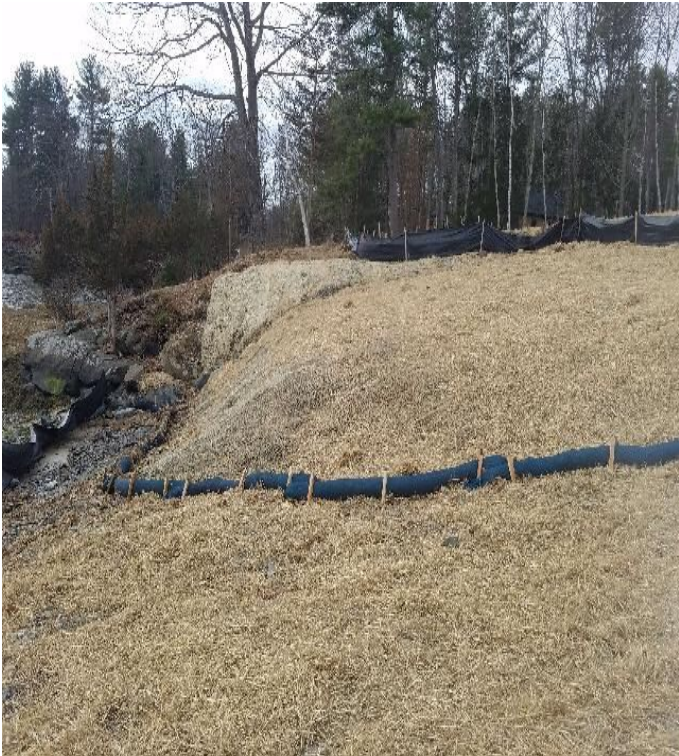
Fig 3: BMPs at toe of slope at Getchell property/west side of the Bay. Viewing south. (03-12-20).

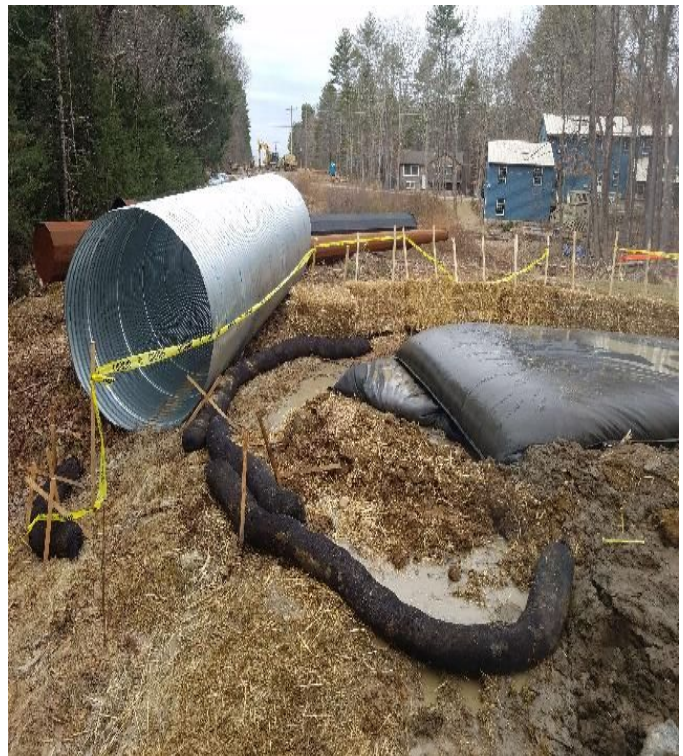
Fig 4: Using filter bag in upland area to dewater hole at Str.67. Viewing west. (03-12-20).

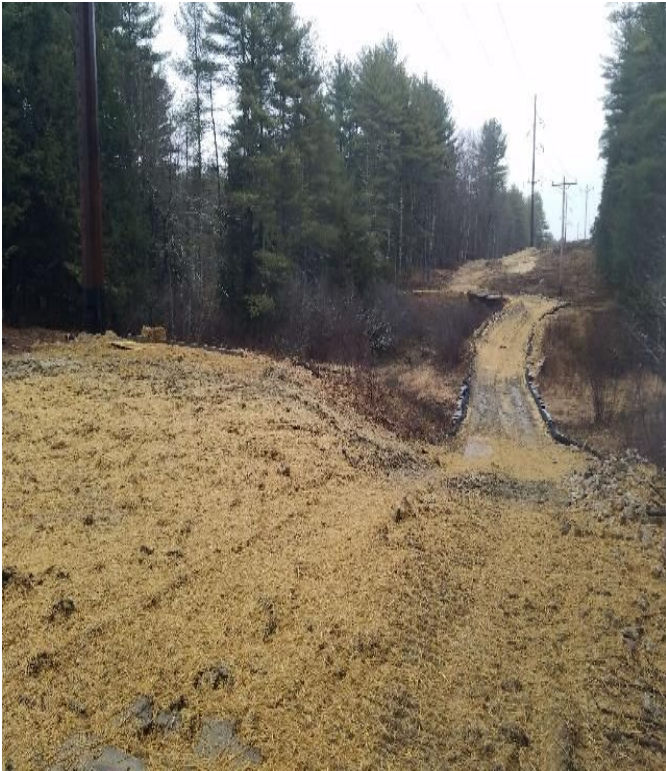
Fig 5: Access road between Strs. 51 and 52, over stream DS46. Viewing east. (03-13-20).

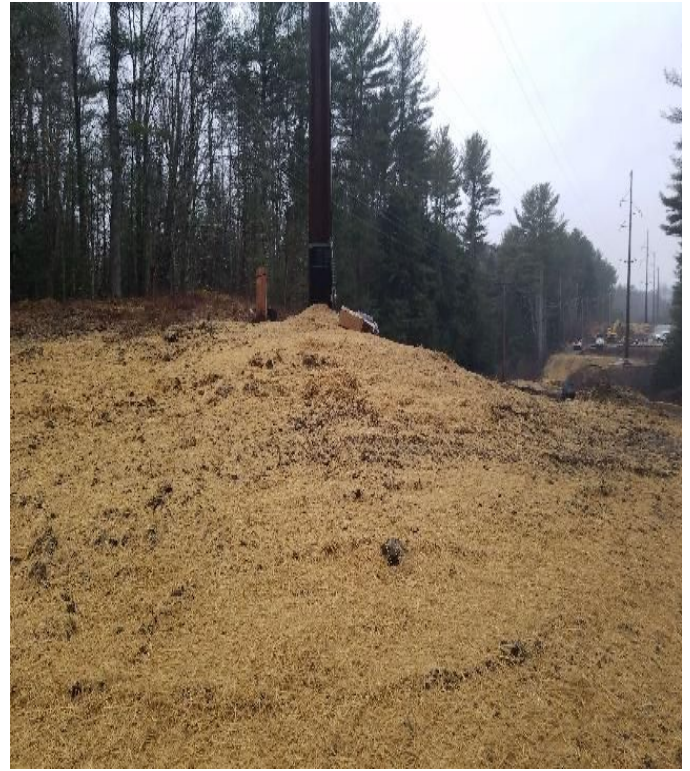
Fig 6: Exposed soils mulched with straw at Str. 52. Viewing southwest. (03-13-20).

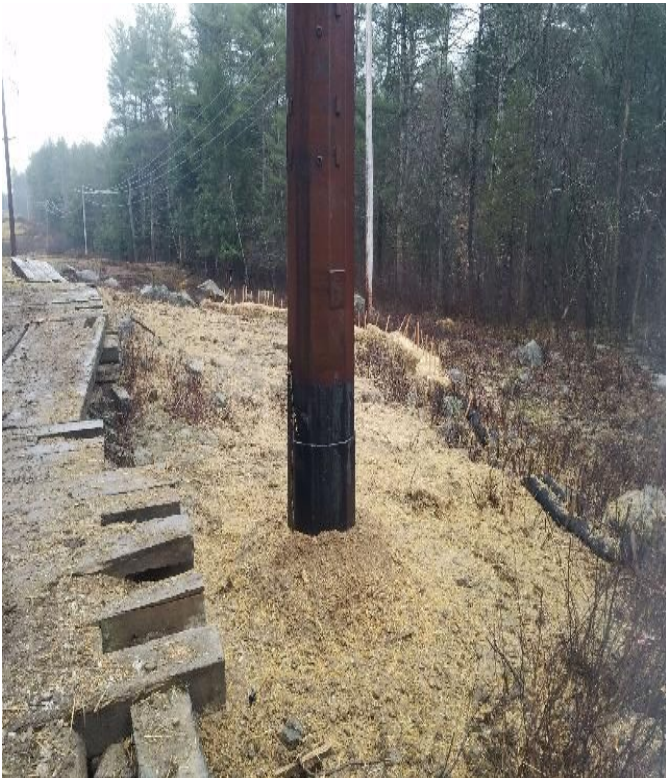
Fig 7: Exposed soils mulched with straw at Str. 53. Viewing southeast. (03-13-20).

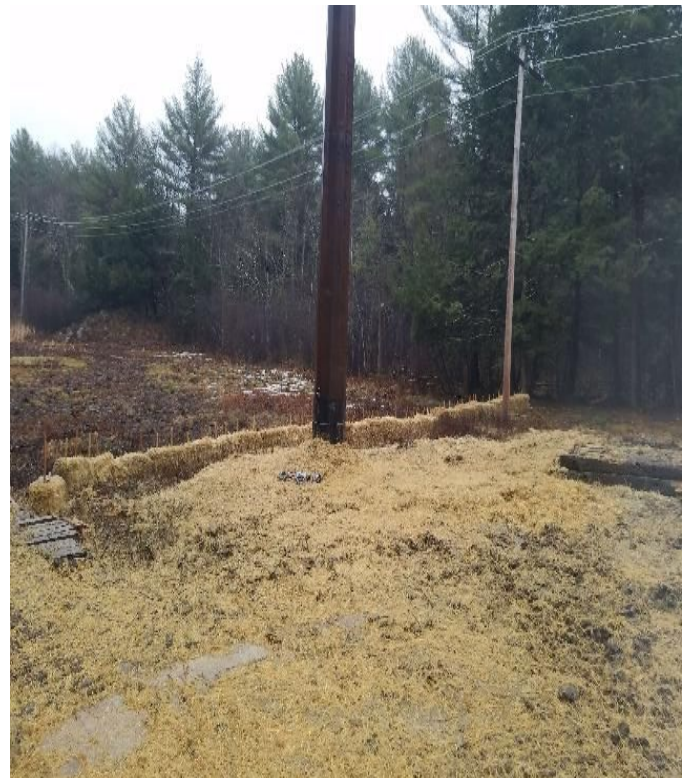
Fig 8: Exposed soils mulched with straw at Str. 54. Viewing east. (03-13-20).

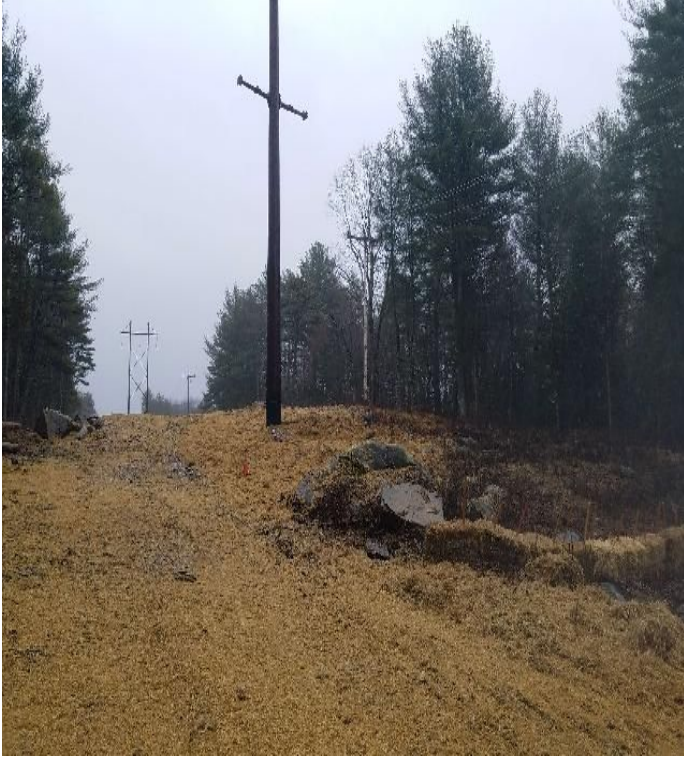
Fig 9: Exposed soils mulched with straw at Str. 55. Viewing east. (03-13-20).

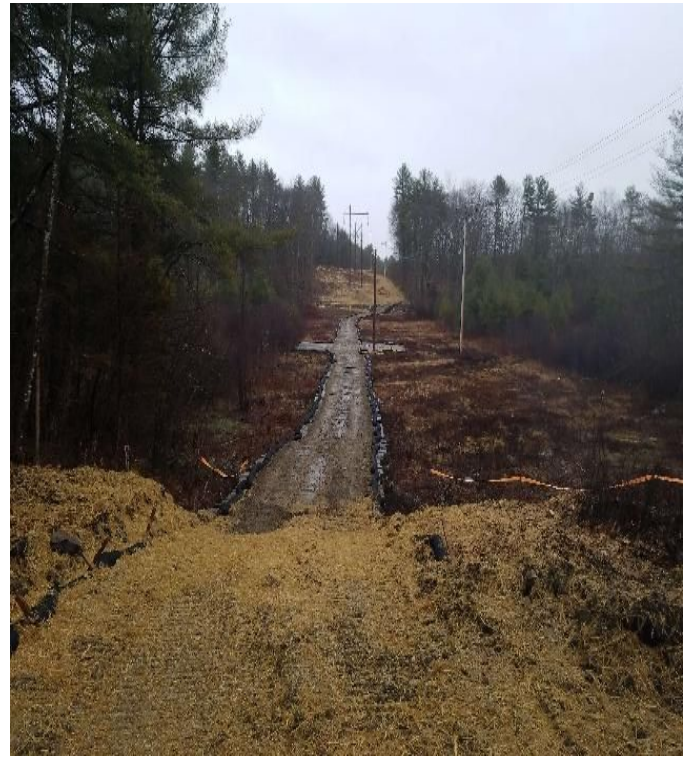
Fig 10: Access road through wetland DW31 and work pad for Str. 3162-13. Viewing east. (03-13-20).

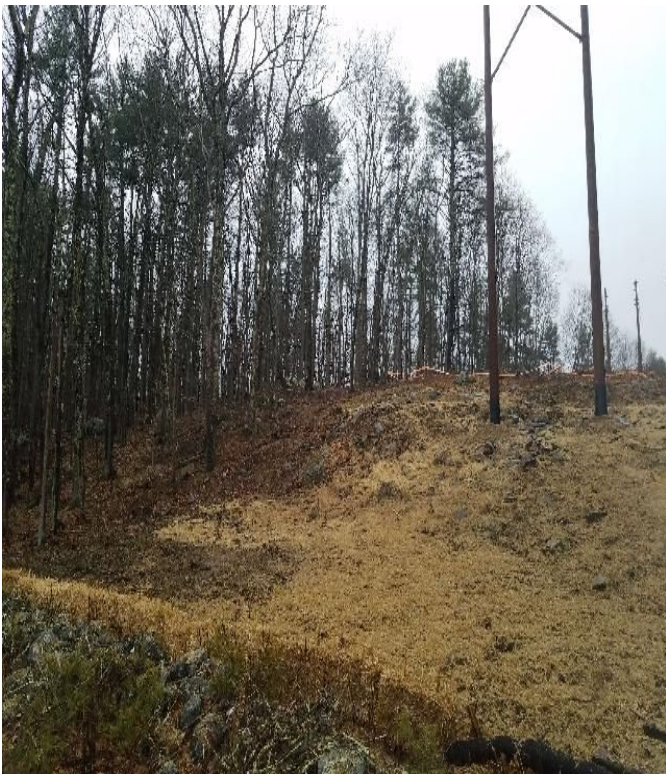
Fig 11: Exposed soils mulched with straw at Str. 57. Viewing northeast. (03-13-20).

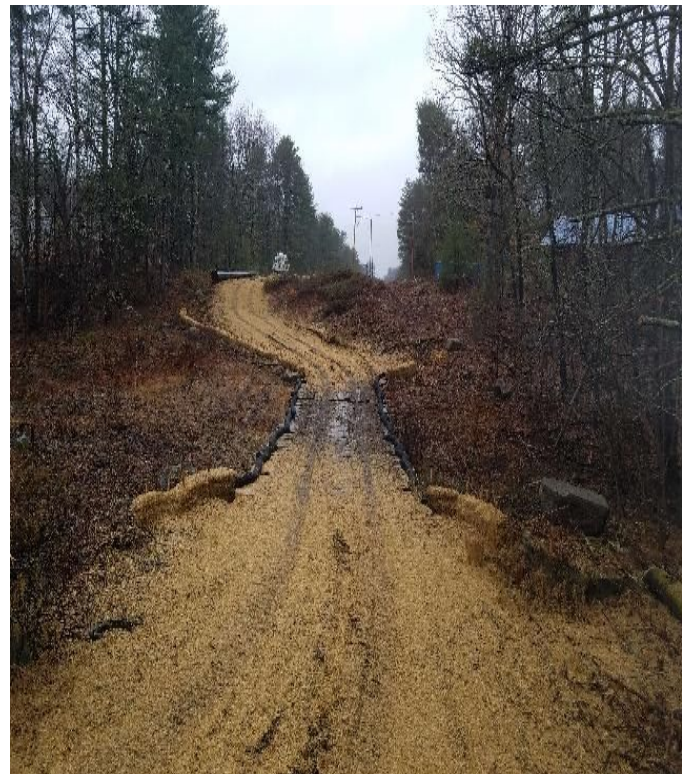
Fig 12: Access road through wetland DW48 Viewing west. (03-13-20).

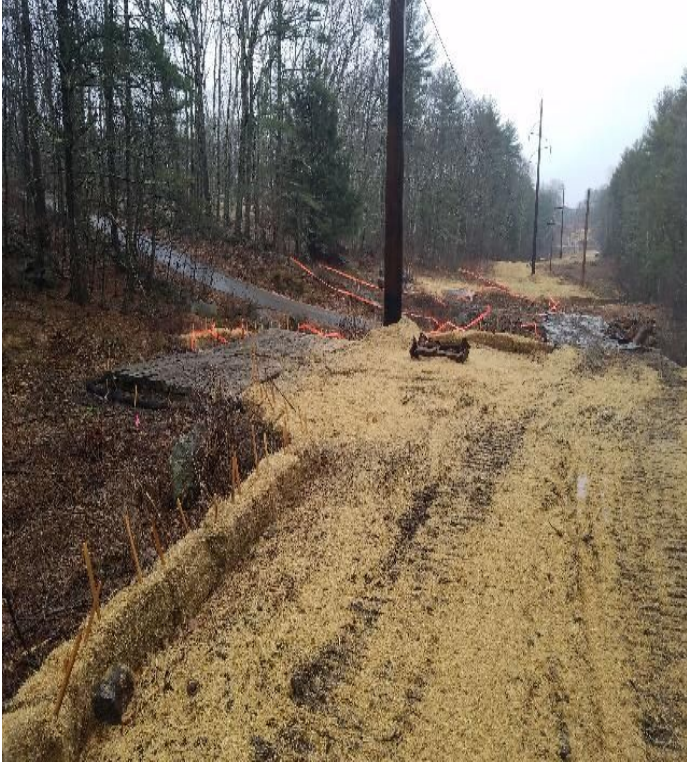
Fig 13: Exposed soils mulched with straw at Str. 63. Viewing west. (03-13-20).

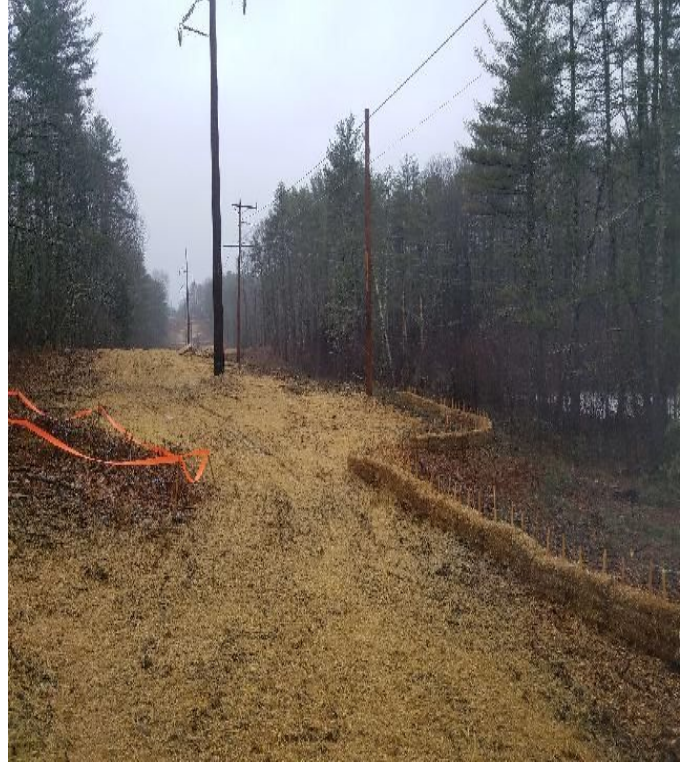
Fig 14: Exposed soils mulched with straw at Str. 62 and 3162-21. Viewing west. (03-13-20).

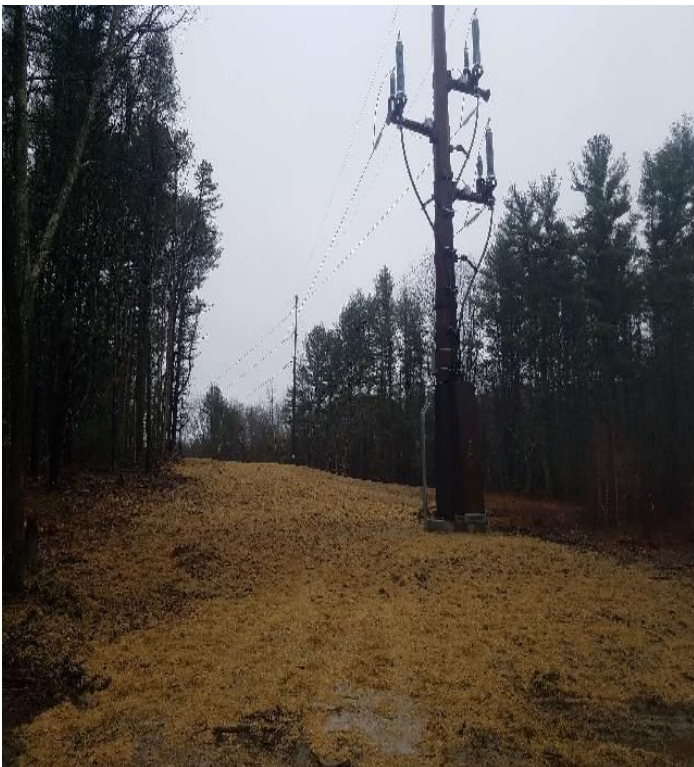
Fig 15: Exposed soils mulched with straw at Str. 100. Viewing east. (03-13-20).

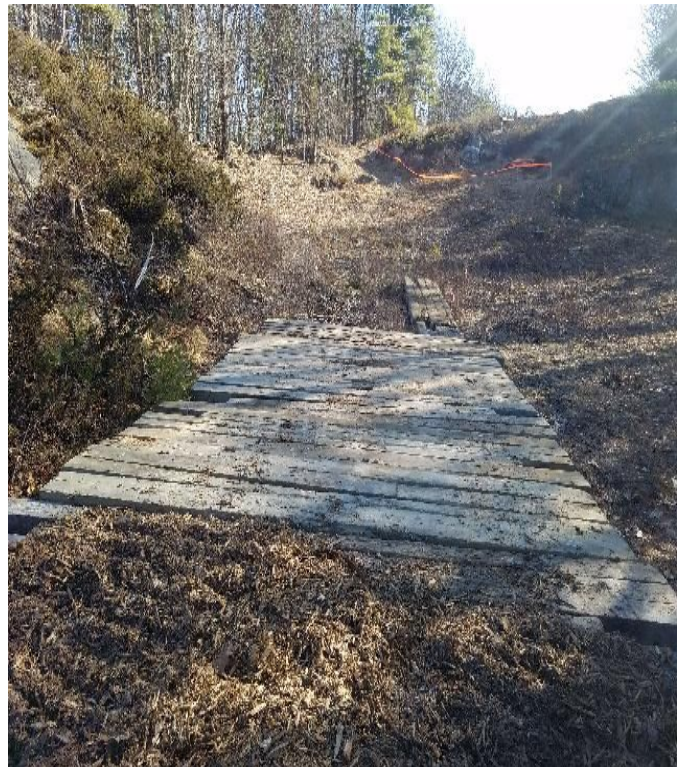
Fig 16: Access road next to wetland DW42, between Strs. 79 and 80. Viewing northeast. (03-16-20).

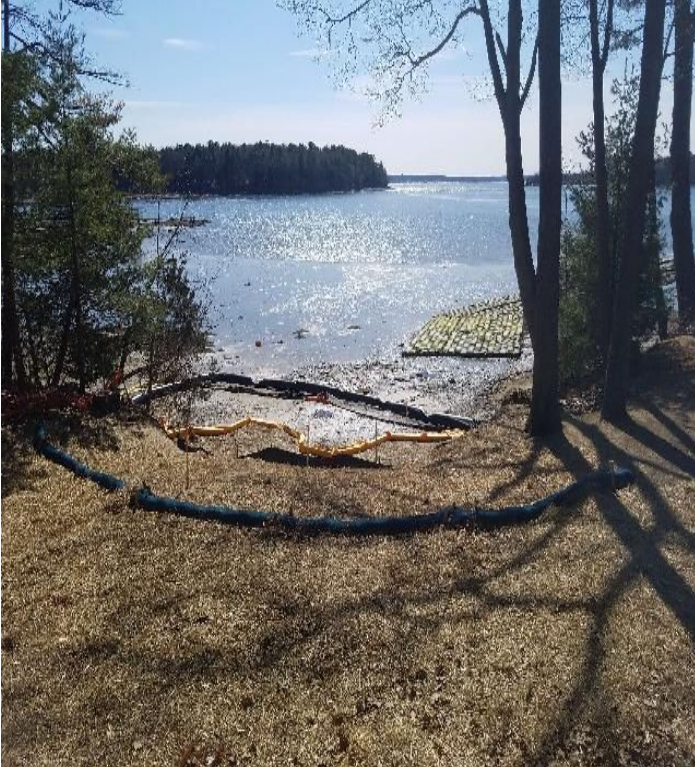
Fig 17: Gundalow landing/east side of the Bay. Viewing southwest. (03-16-20).

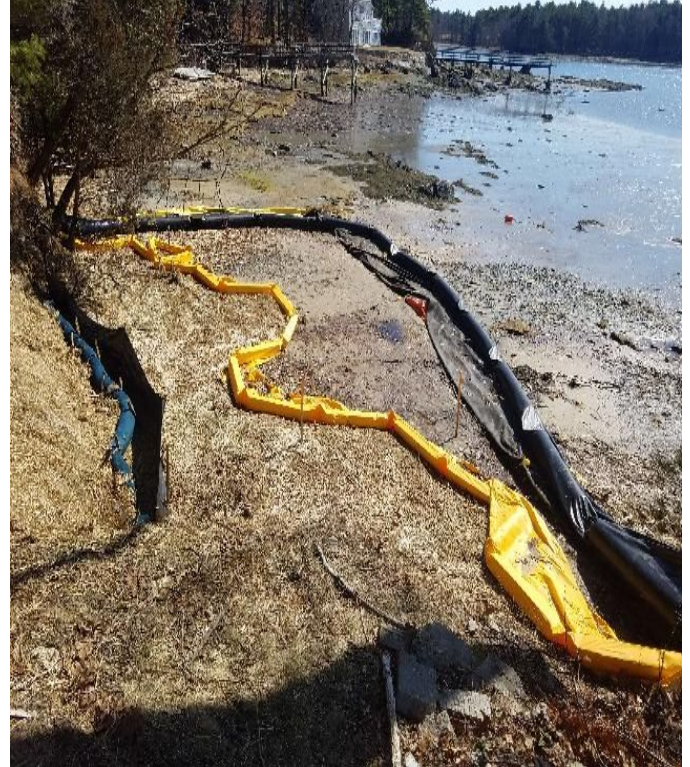
Fig 18: Turbidity barrier in intertidal zone at Gundalow landing/east side of the Bay. Viewing south. (03-16-20).

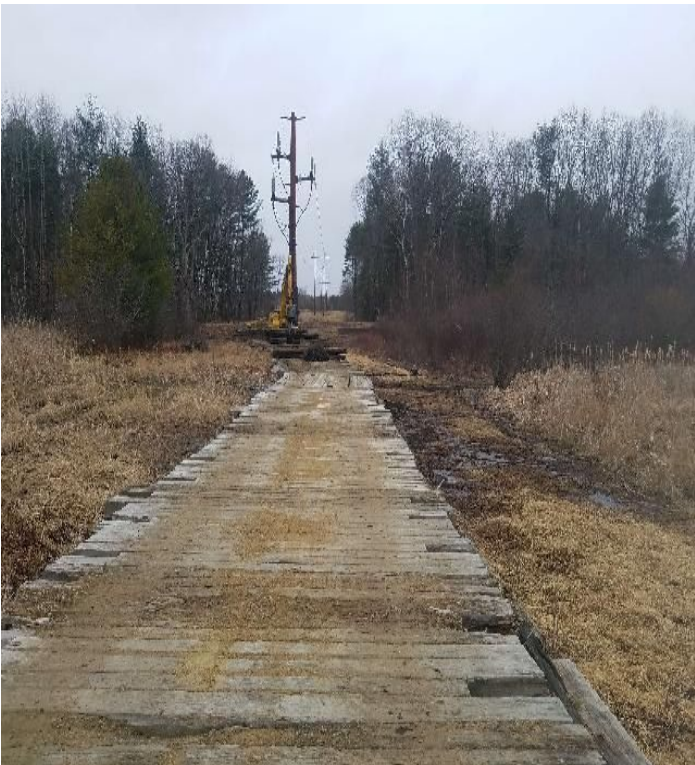
Fig 19: Beginning to remove timber mats at Frink farm and through Knights Brook. Viewing west. (03-17-20).

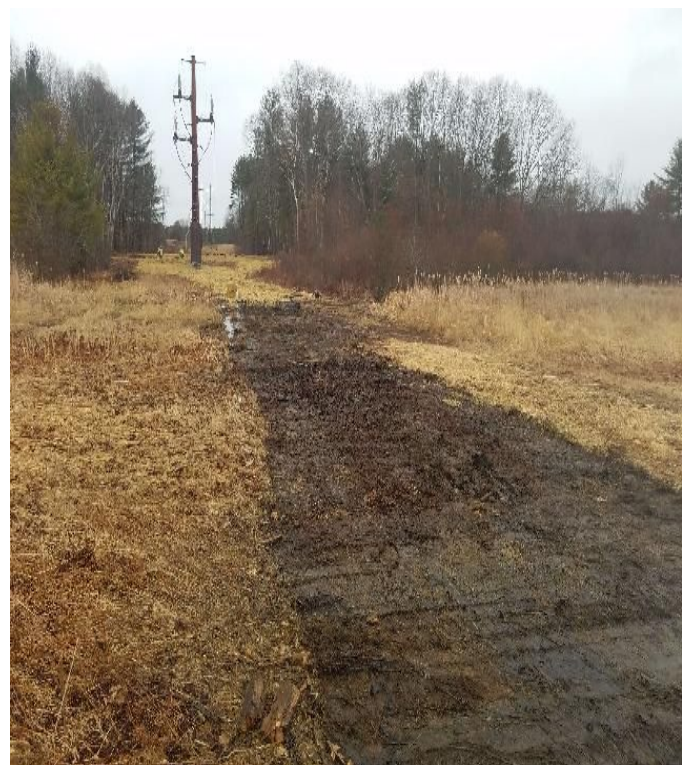
Fig 20: Continue removing timber mats at Frink farm. Viewing west. (03-17-20).

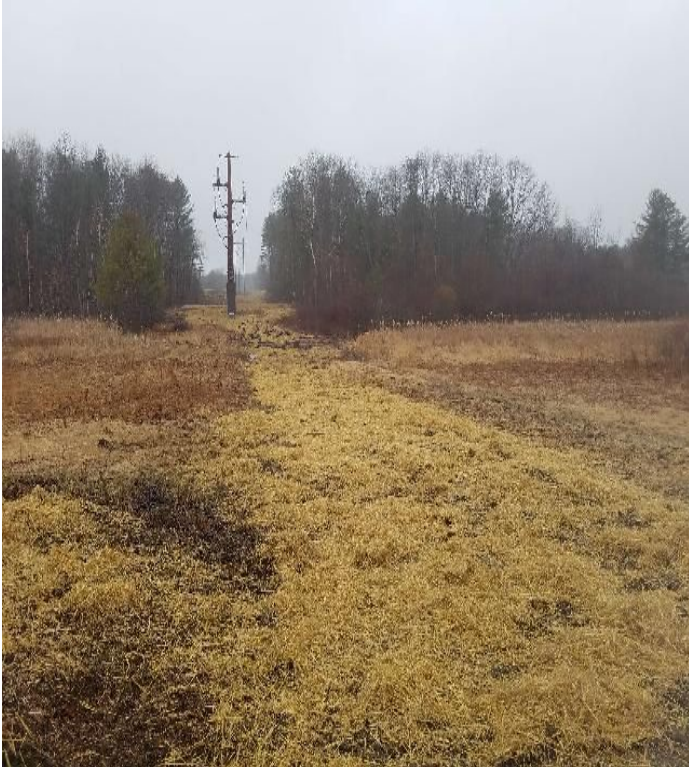
Fig 21: Crew seeded and mulched area after timber mats have been removed at Frink farm. Viewing west. (03-17-20).

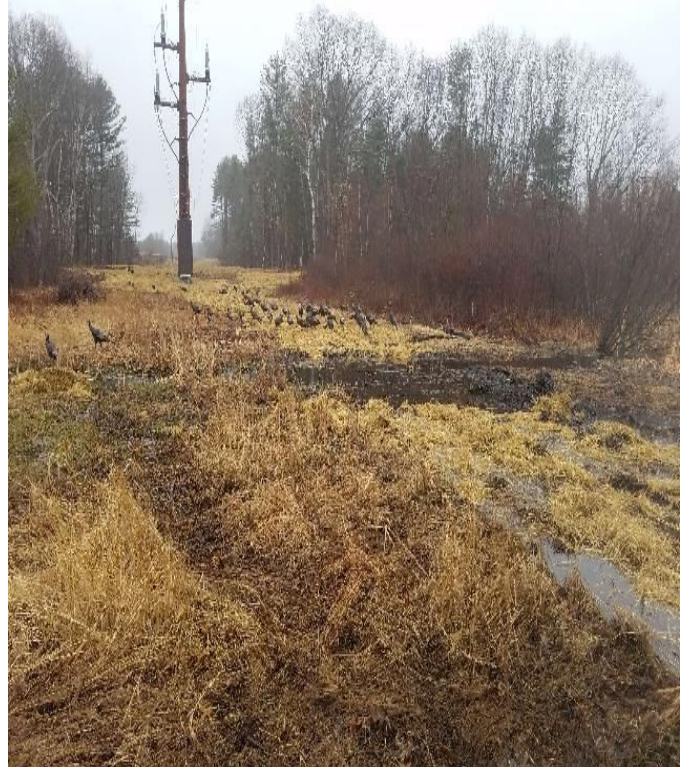
Fig 22: Knights Brook and wetland NW16. Note flock of turkeys. Viewing west. (03-17-20).

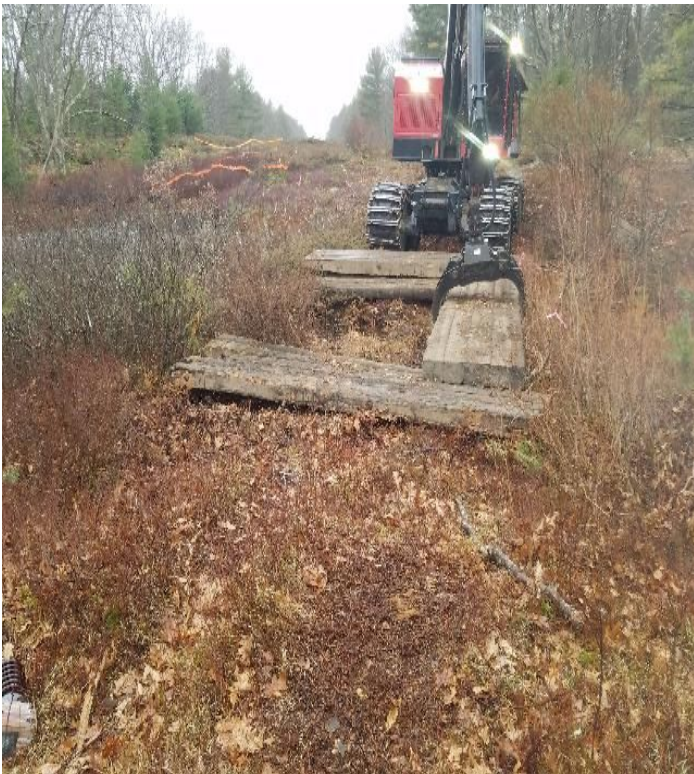
Fig 23: Beginning to bridge over wetland DW40 between Strs 80 and 81. Viewing west. (03-17-20).

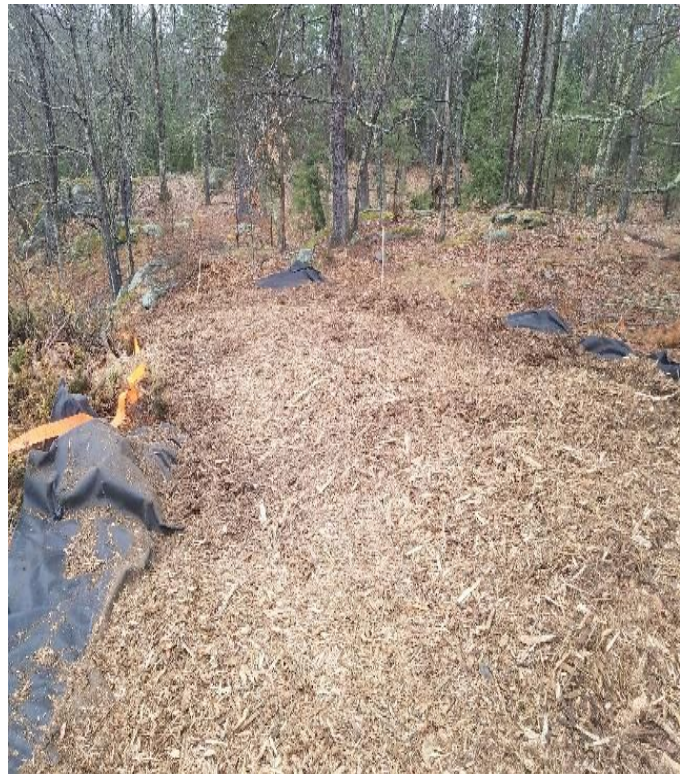
Fig 24: Stump grindings applied to off-right-of-way access between Strs 79 and 80. Viewing northwest. (03-17-20).

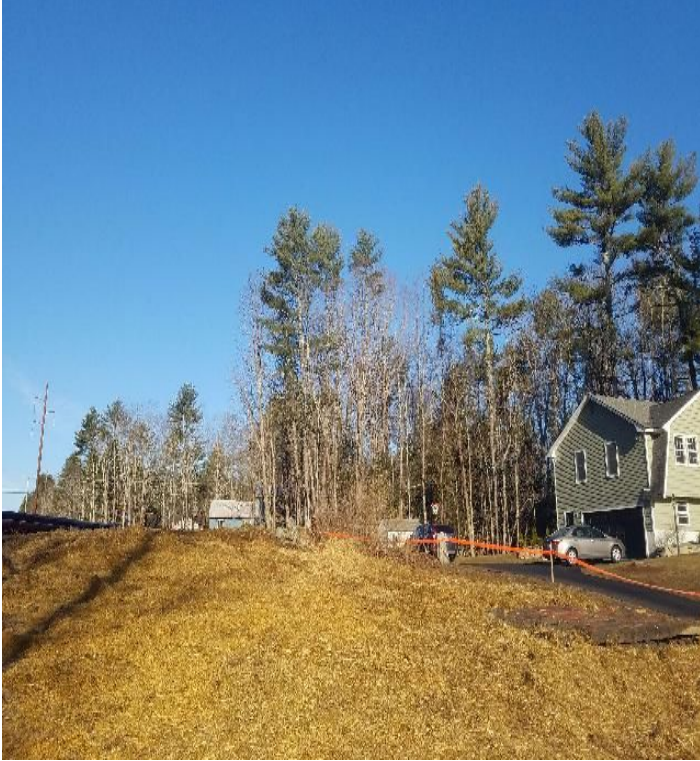
Fig 25: Exposed soils mulched with straw at Str. 67. Viewing west. (03-18-20).

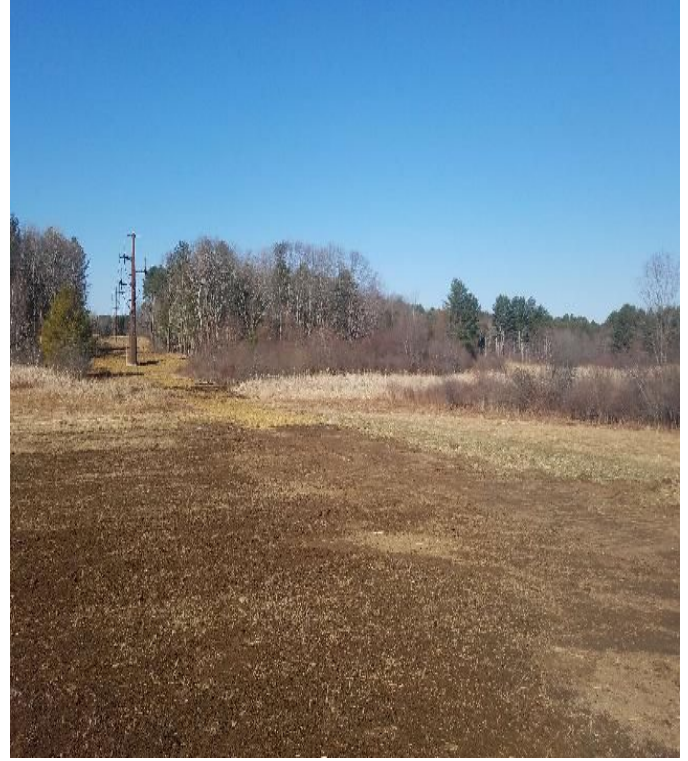
Fig 26: Removing timber mats at Frink farm. Viewing west. (03-18-20).

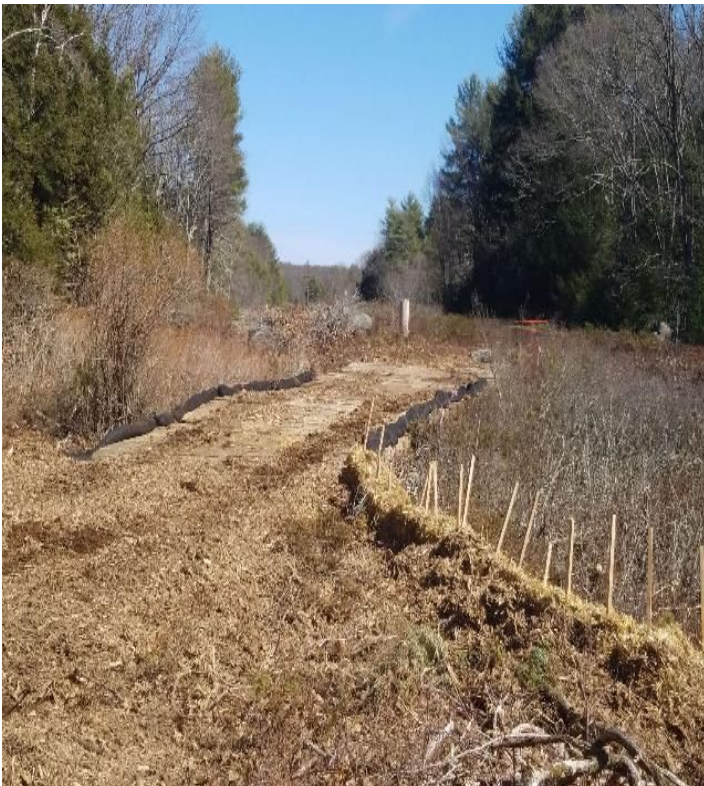
Fig 27: Access road, bridged over wetland DW40. Between Strs 80 and 81. Viewing east. (03-18-20).

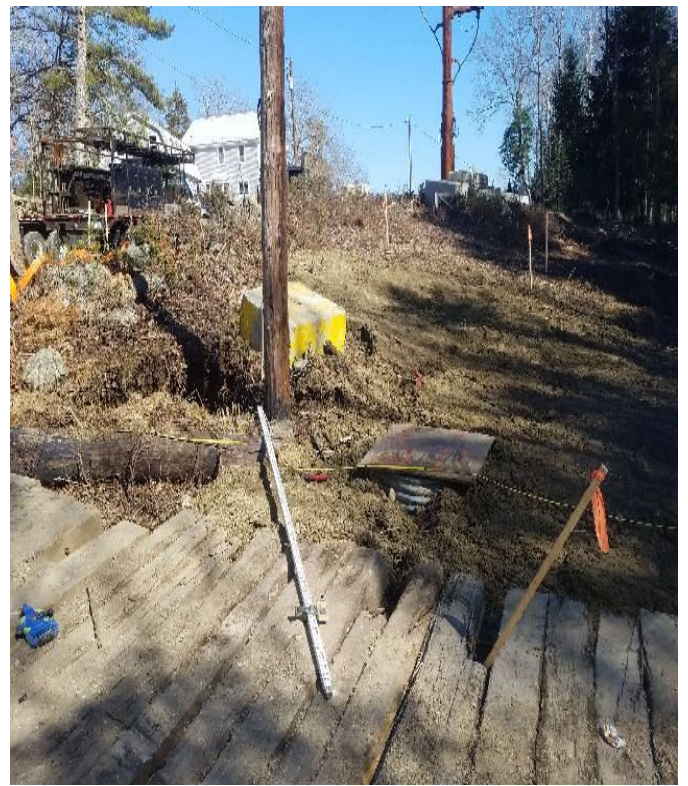
Fig 28: Excavating foundation for Str. 98. Viewing east. (03-18-20).
