CONSTRUCTION MONITORING REPORT

Eversource Transmission Lines:
F107

Eversource
Seacoast Reliability Project

Construction Monitoring Report #57

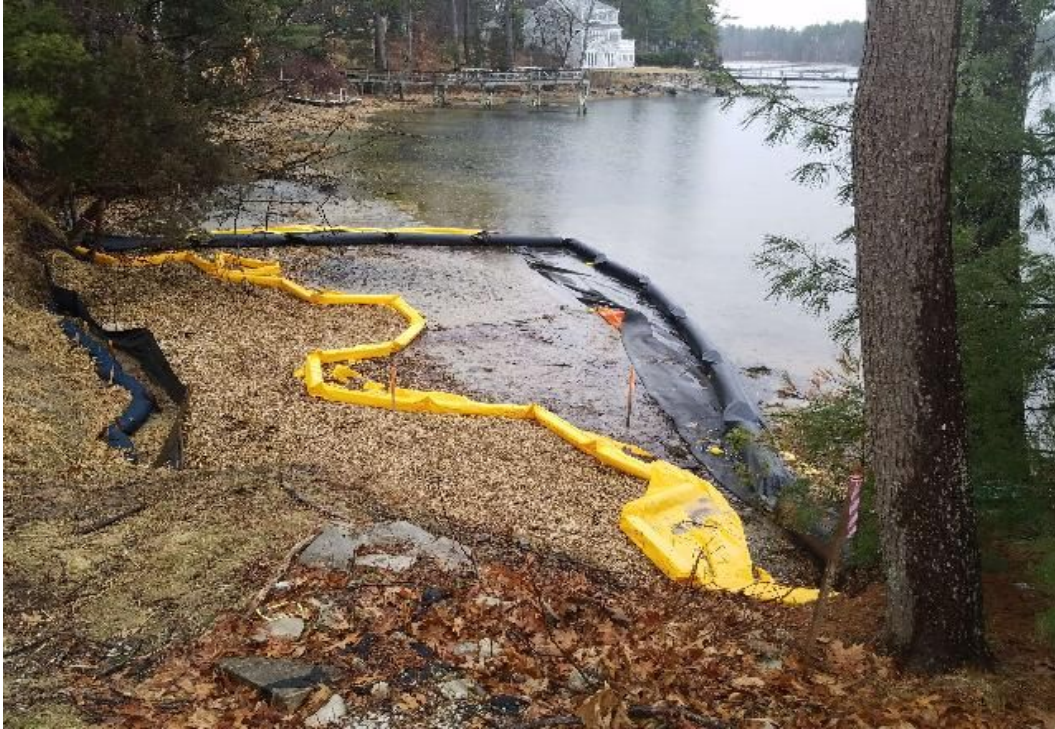
Fig 1: Turbidity curtain in intertidal zone at Gundalow landing/east side of the Bay. Viewing south. (03-19-20).

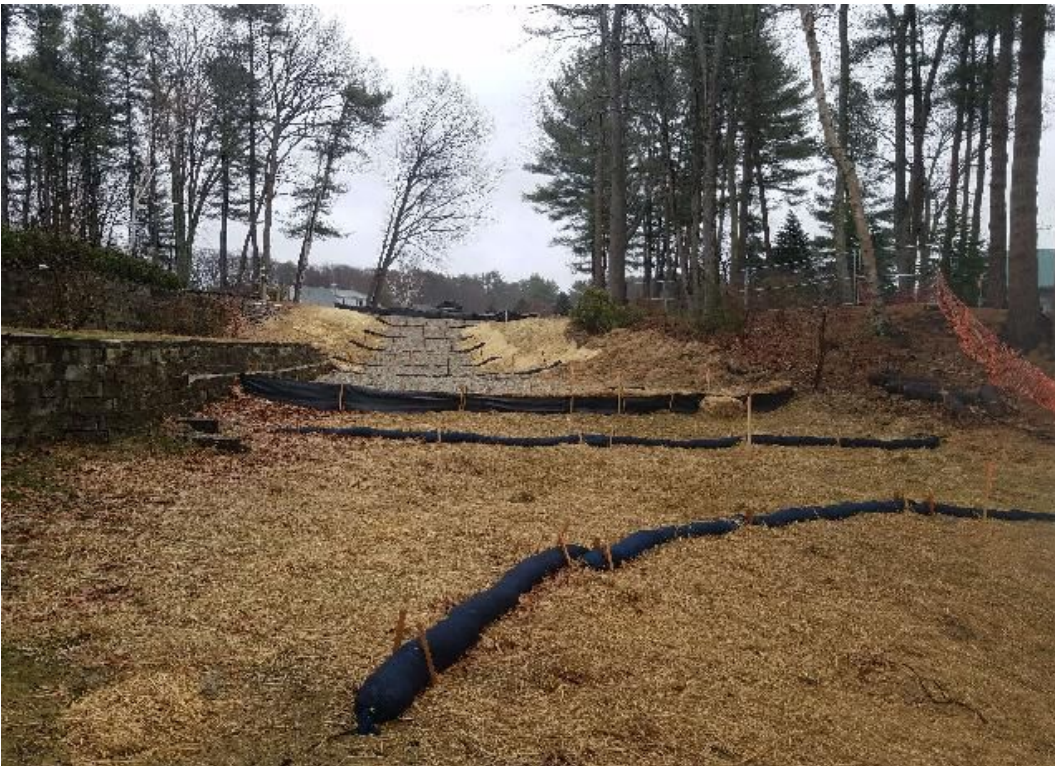
Fig 2: BMPs on slope at Gundalow landing/east side of the Bay. Viewing east. (03-19-20).

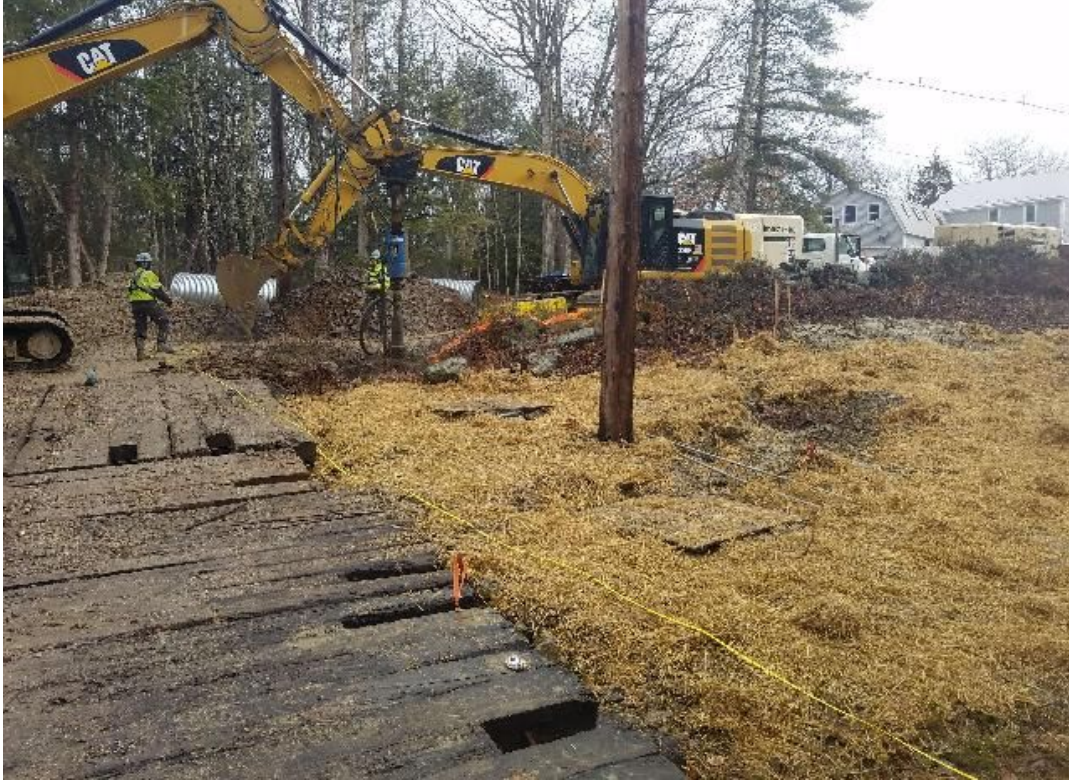
Fig 3: Foundation cans set at Str. 98. Viewing north. (03-19-20).

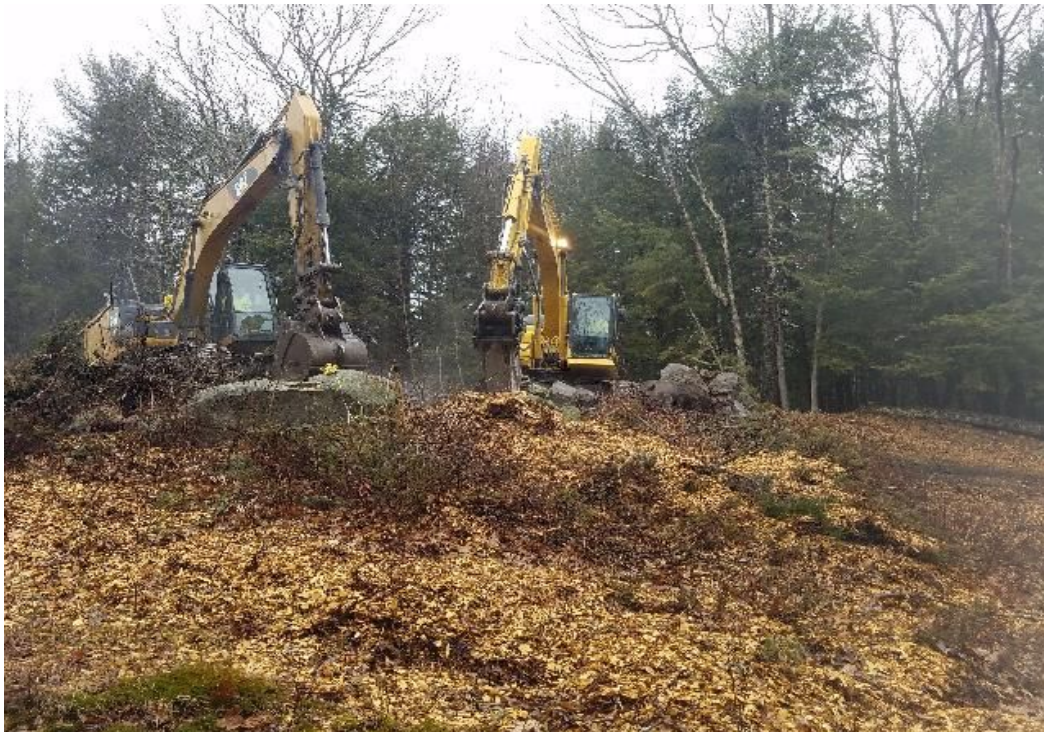
Fig 4: Crew beginning to excavate foundation for Str. 74. Viewing east. (03-19-20).

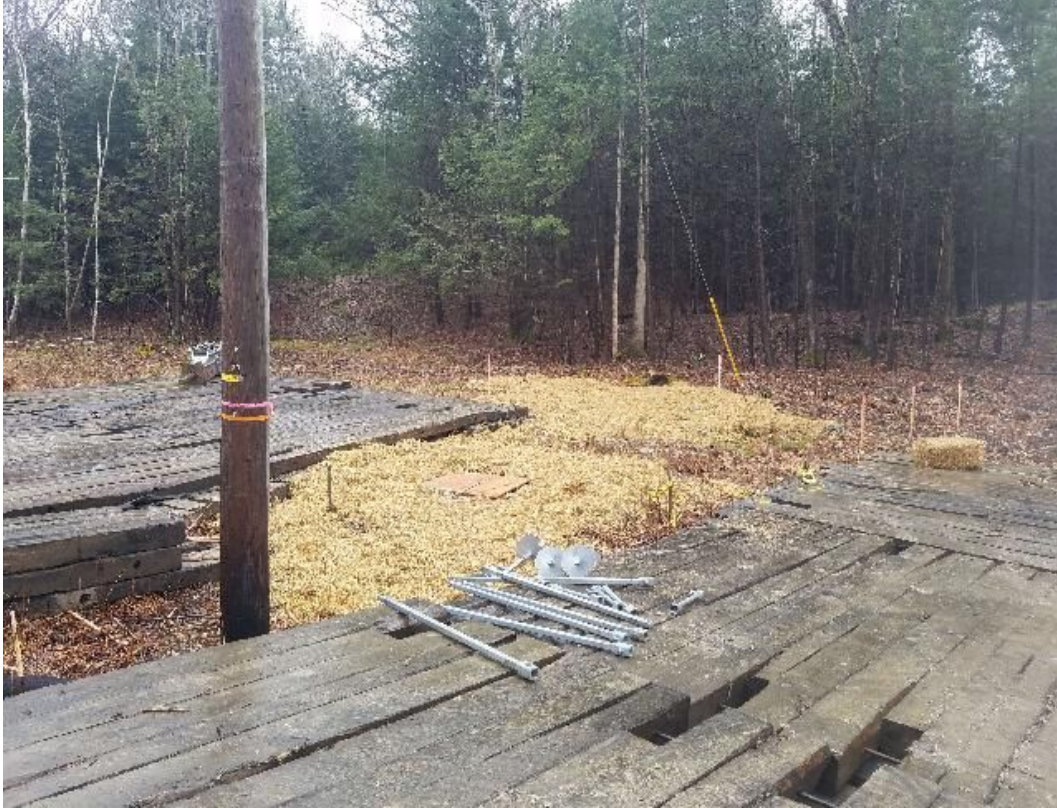
Fig 5: Foundation cans set at Str. 97. Viewing south. (03-20-20).

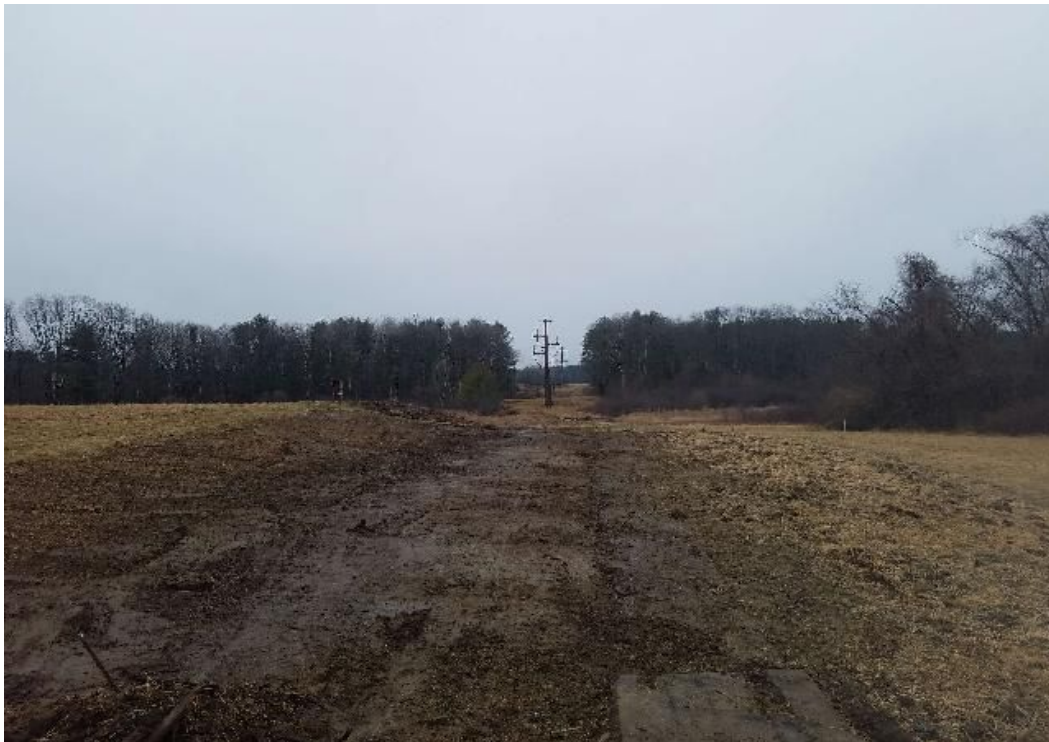
Fig 6: Removing timber mats at Frink farm. Viewing west. (03-20-20).

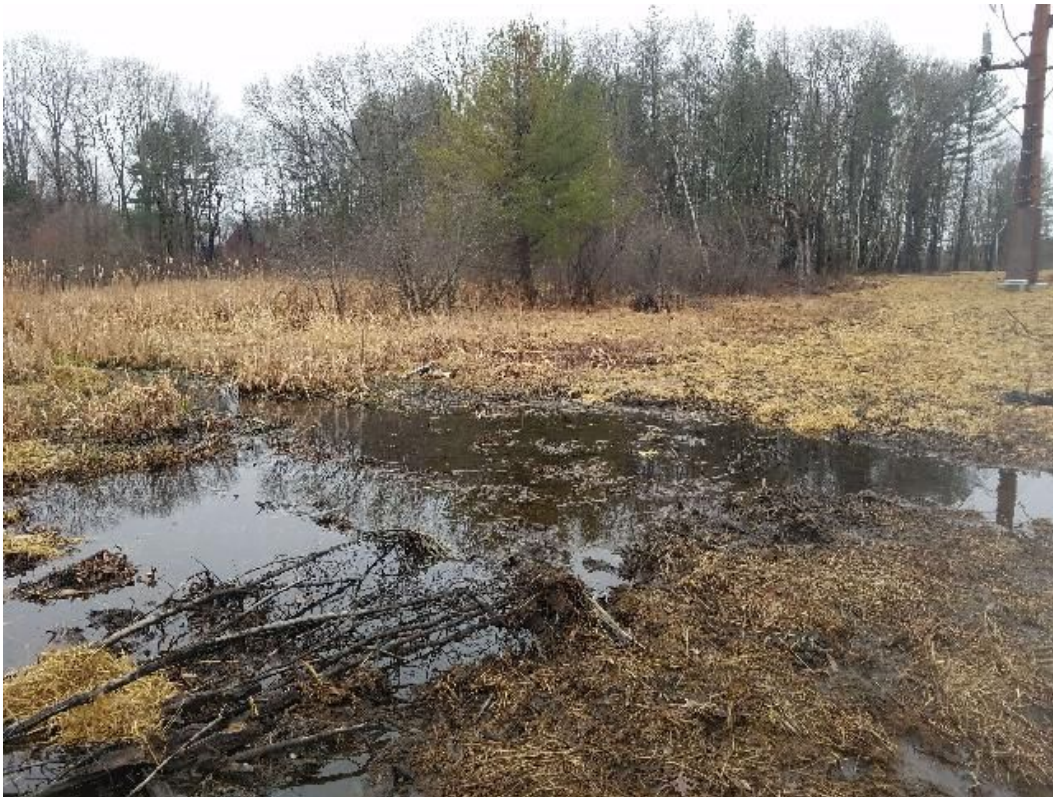
Fig 7: Knights Brook at Frink farm, after timber mats have been removed. Viewing southwest. (03-20-20).

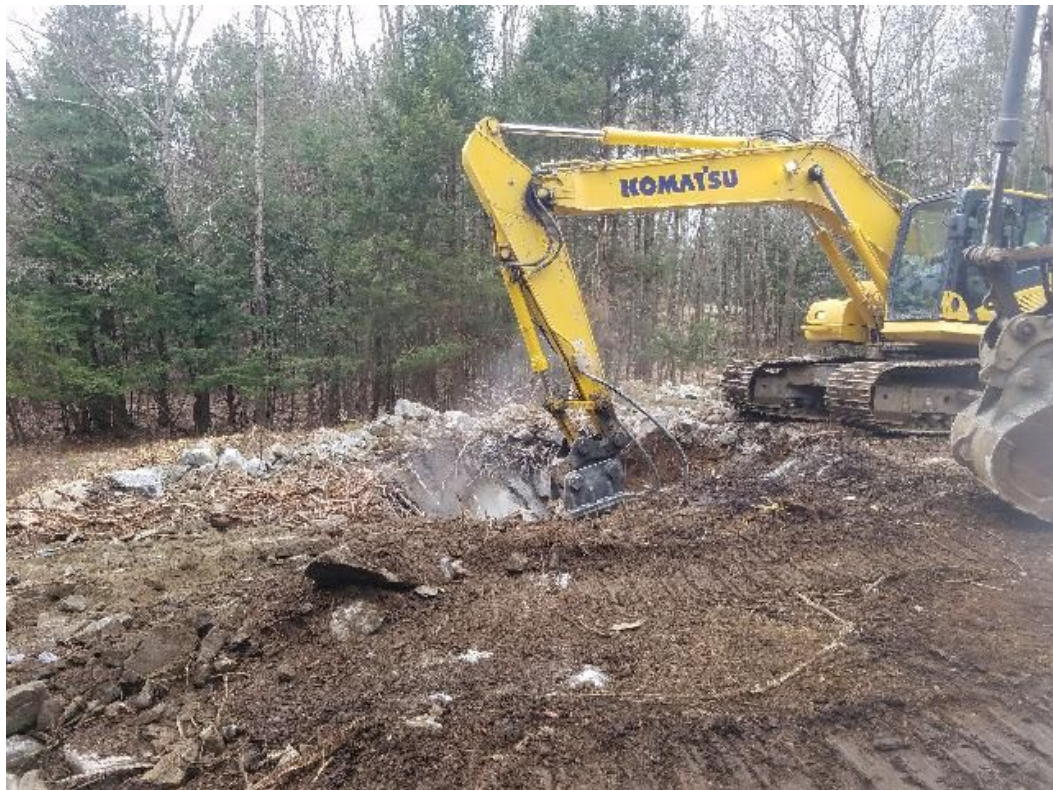
Fig 8: Crew hammering ledge at Str. 74. Viewing south. (03-23-20).

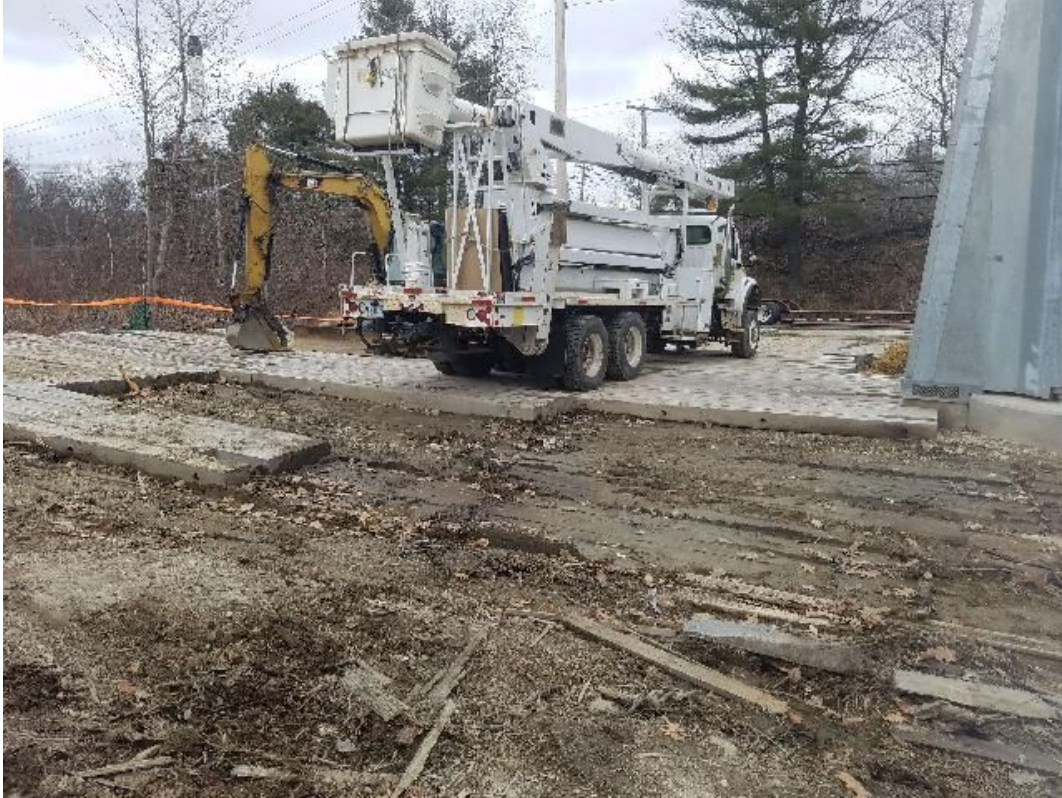
Fig 9: Beginning to remove timber mats at Str 23. Viewing east. (03-23-20).

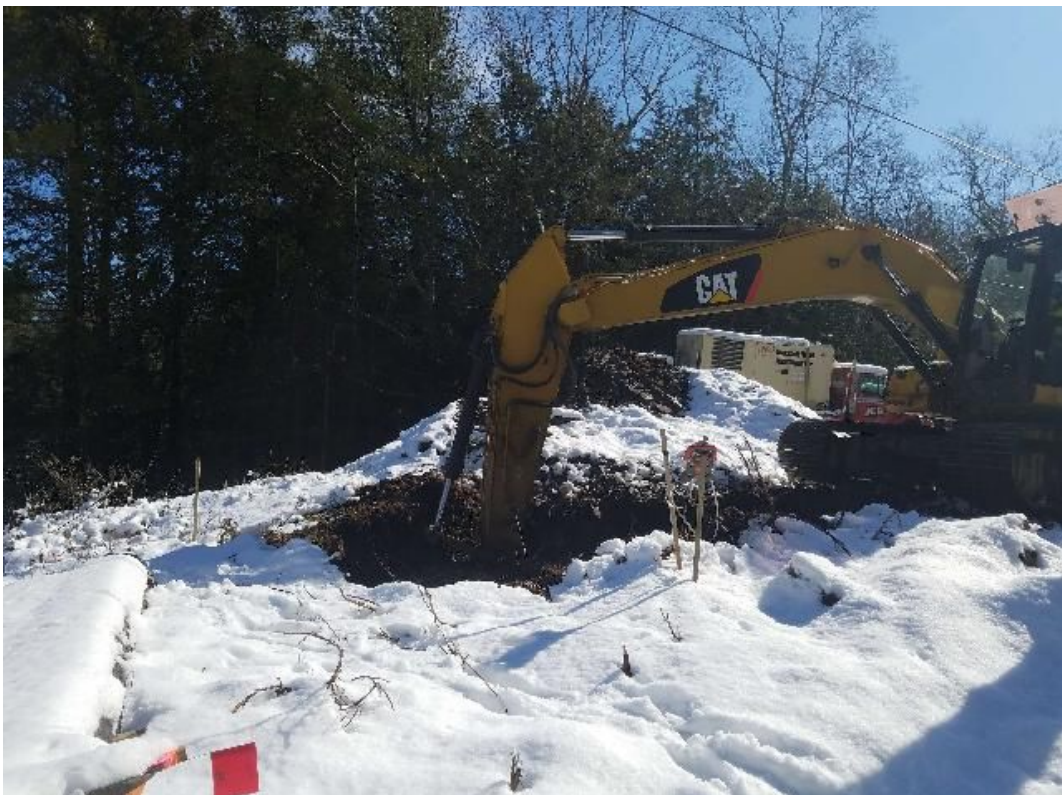
Fig 10: Hammering ledge at Str. 96. Viewing north. (03-24-20).

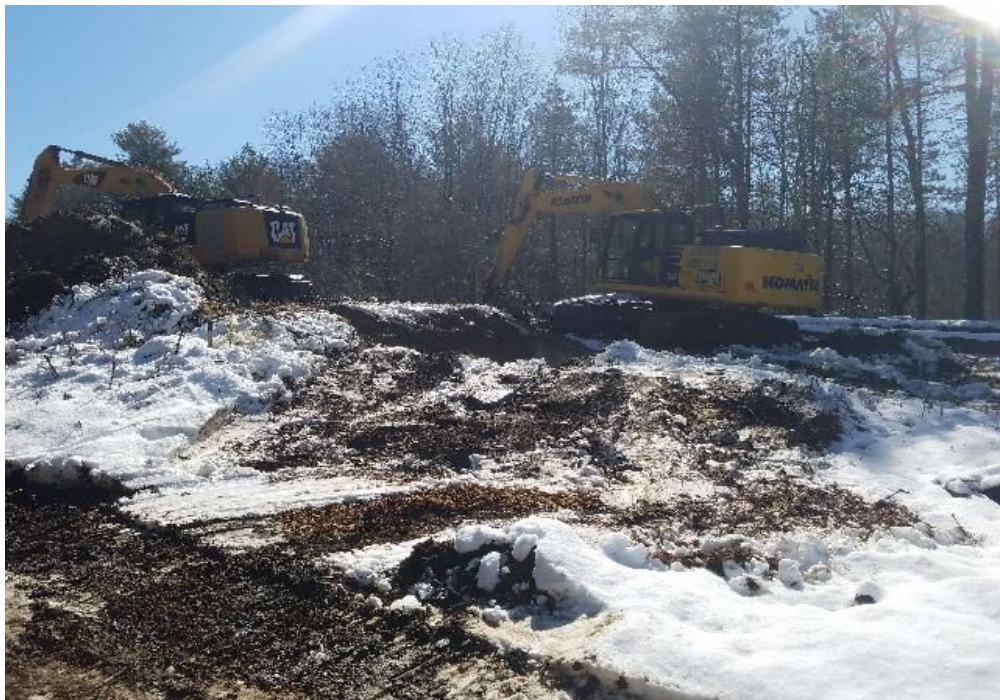
Fig 14: Hammering ledge at Str. 75. Viewing southeast. (03-24-20).

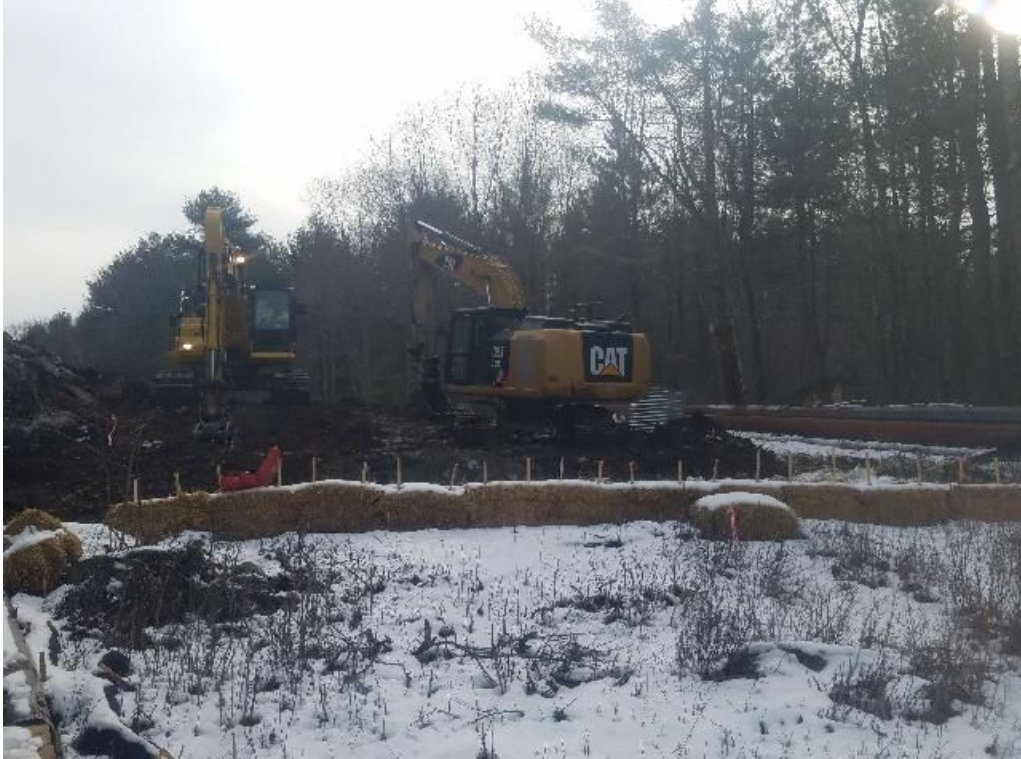
Fig 15: Crew continues to hammer ledge at Str. 75. Viewing east. (03-25-20).

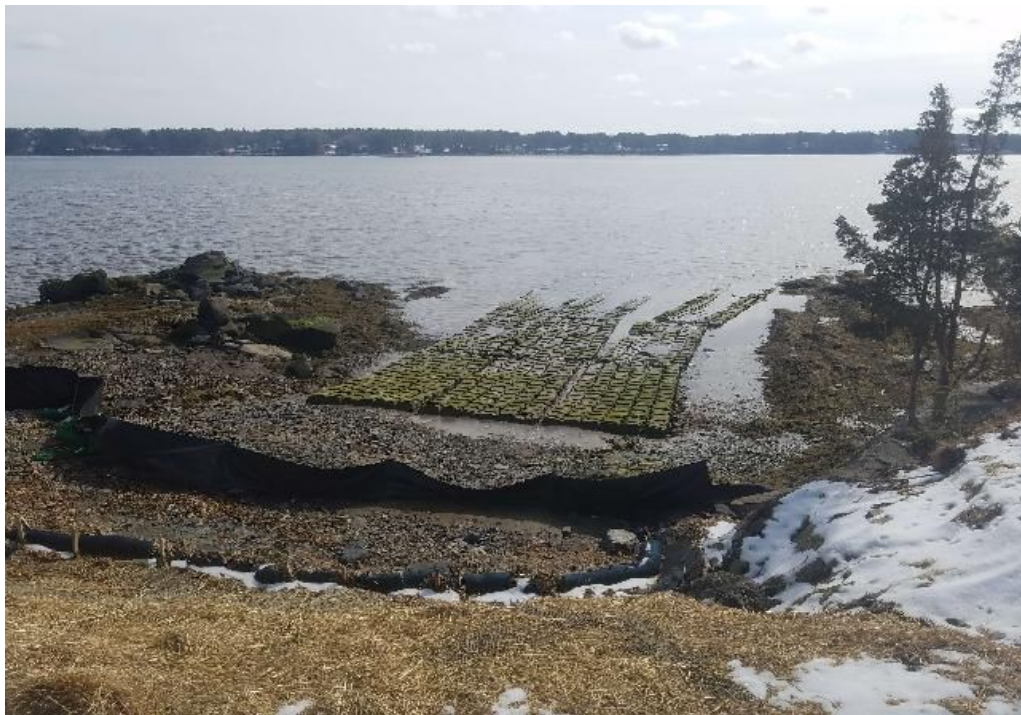
Fig 16: Intertidal zone at Getchell property/west side of the Bay. Viewing east. (03-25-20).

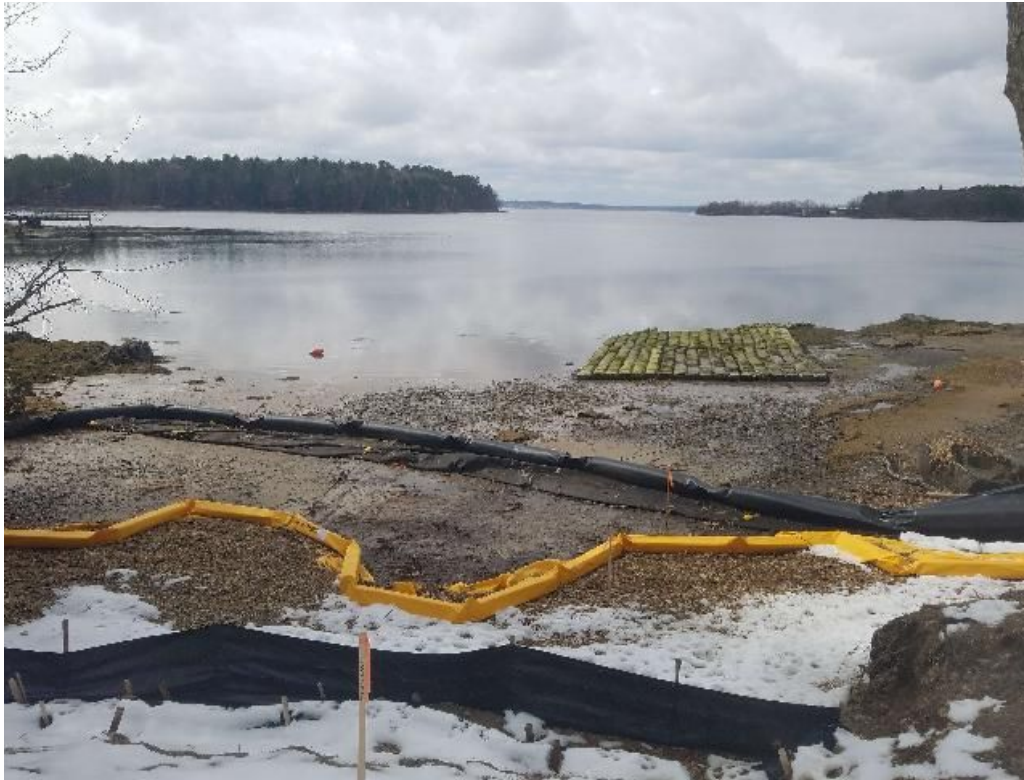
Fig 17: Intertidal zone at Gundalow landing/east side of the Bay. Viewing southwest. (03-25-20).
