Eversource Seacoast Reliability Project

#### **Construction Monitoring Report #58**

### Eversource Seacoast Reliability Project

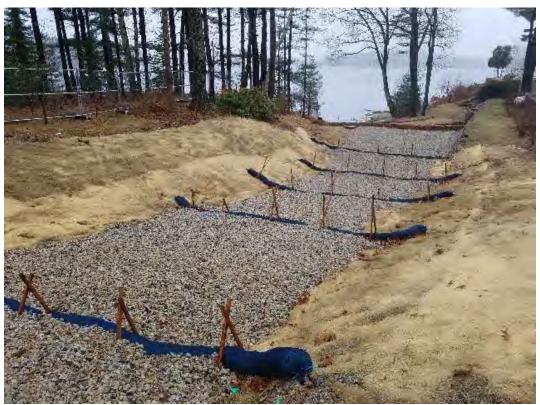
Fig 1: BMPs on slope at Gundalow landing/east side of the Bay. Viewing south. (03-30-20).

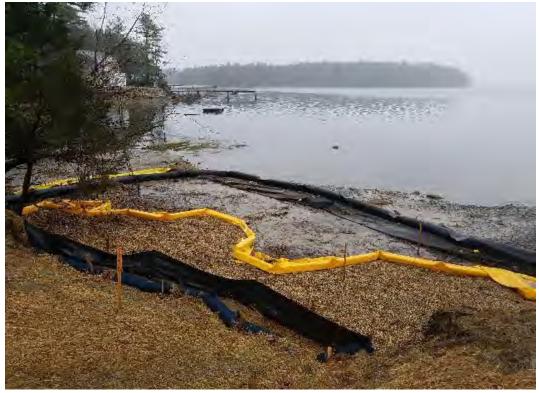
Fig 2: Turbidity curtain in intertidal zone at Gundalow landing/east side of the Bay. Viewing south. (03-30-20).

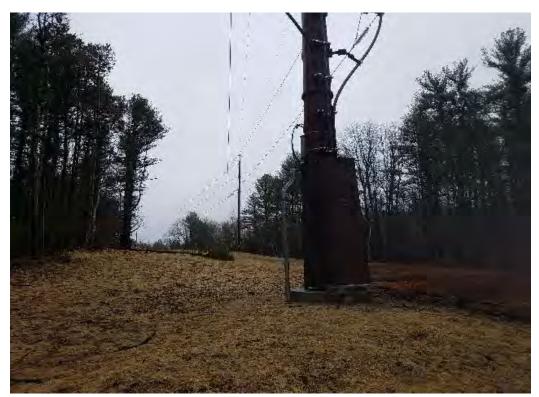
Fig 3: Str. 100 foundation. Viewing east. (03-30-20).

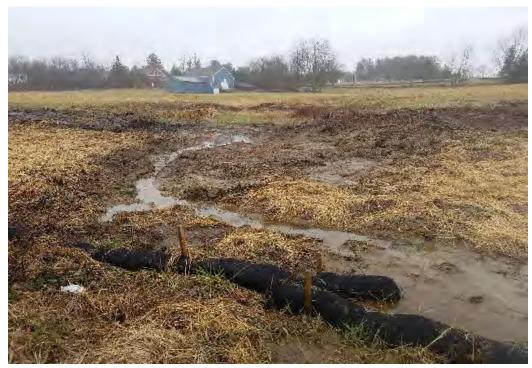
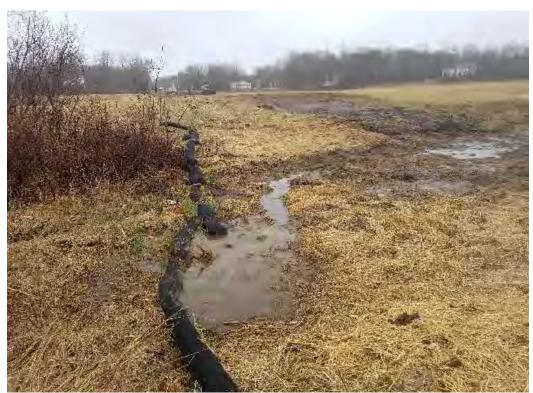
Fig 4: Erosion in wetland NW18 at Frink farm. See comments above. Viewing southeast. (03-30-20).

Fig 5: Erosion in wetland NW18 at Frink farm. See comments above. Viewing east. (03-30-20).

- Fig 4 & 5: Grade and reshape wetland to pre-existing conditions. Then install two short rows of filter sock and erosion blanket. Consult with the environmental monitor to coordinate schedules and for further direction.

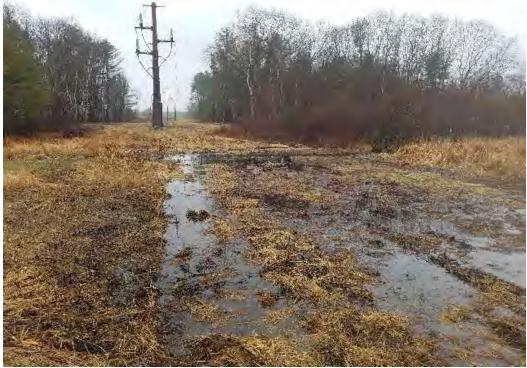
Fig 6: Wetland NW16 at Frink farm. Viewing southwest. (03-30-20).

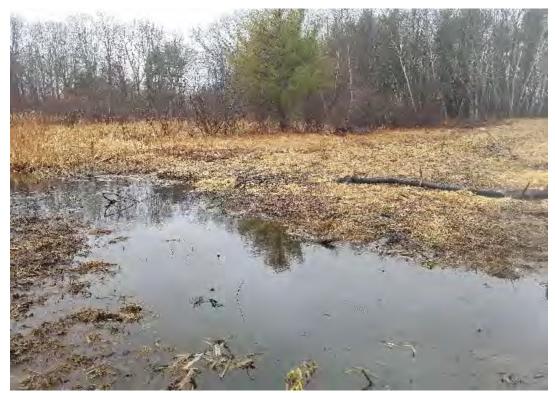
Fig 7: Knights Brook at Frink farm. Viewing southwest. (03-30-20).

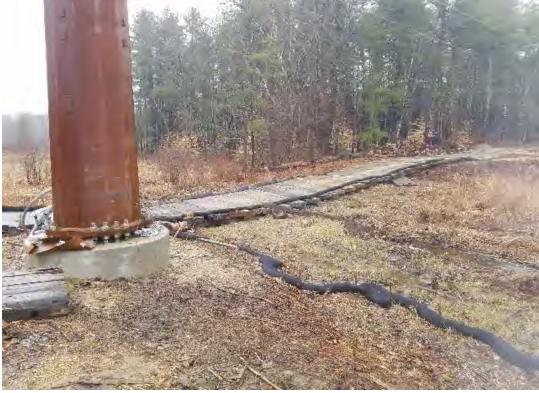
Fig 8: Str. 112 foundation. Viewing east. (03-30-20).

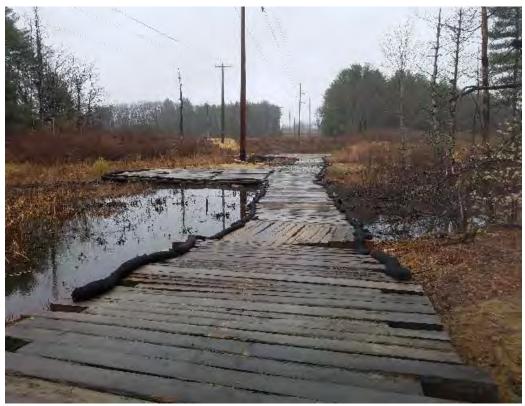
Fig 9: Access road to Str. 114, through wetland NW17. Viewing east. (03-30-20).

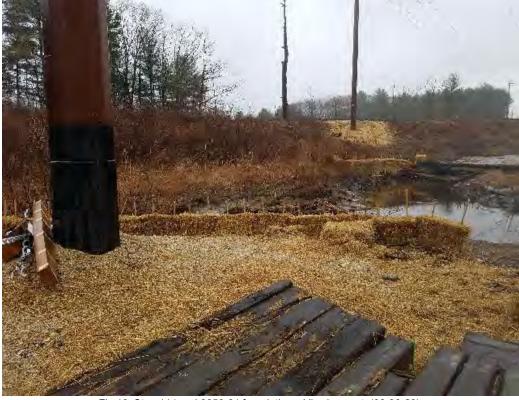
Fig 10: Strs. 114 and 3850-64 foundations. Viewing east. (03-30-20).

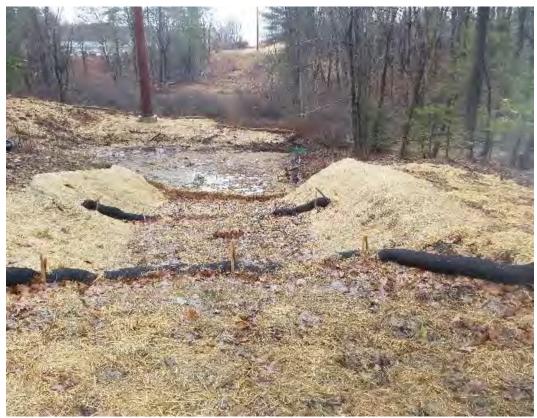
Fig 11: Access road to Str. 28 and wetland DW49. See comments above. Viewing north. (03-30-20).

- Fig 11: Install additional row of filter sock along up-slope side of straw bales on sloped access road to Str. 28. Consult with the environmental monitor to coordinate schedules and for further direction.

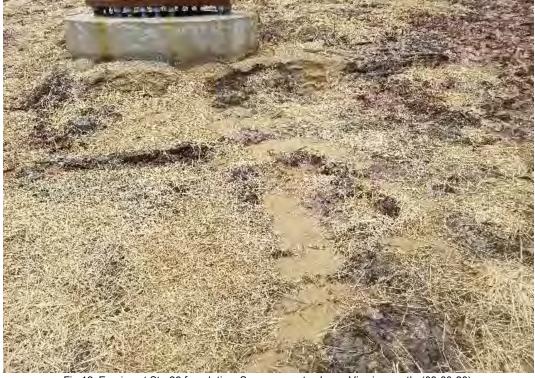
Fig 12: Erosion at Str. 29 foundation. See comments above. Viewing south. (03-30-20).

- Fig 12: Grade and reshape slope to pre-existing conditions. Then install filter sock downslope of Str. 29 Consult with the environmental monitor to coordinate schedules and for further direction.

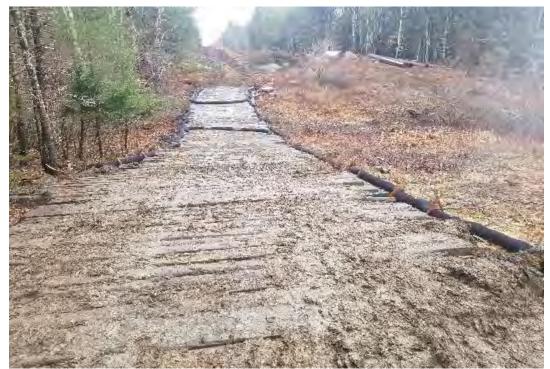
Fig 13: Access road between Strs. 85 and 84, through wetland DW30 and over stream DS32. Viewing west. (03-30-20).

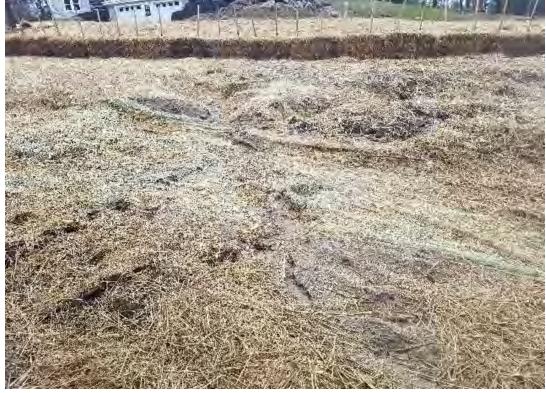
Fig 14: Erosion at Getchell property/west side of the Bay. See comments above. Viewing northwest. (03-30-20).

- Fig 14: Grade and reshape slope to pre-existing conditions. Then install filter sock downslope of straw bales. Consult with the environmental monitor to coordinate schedules and for further direction.

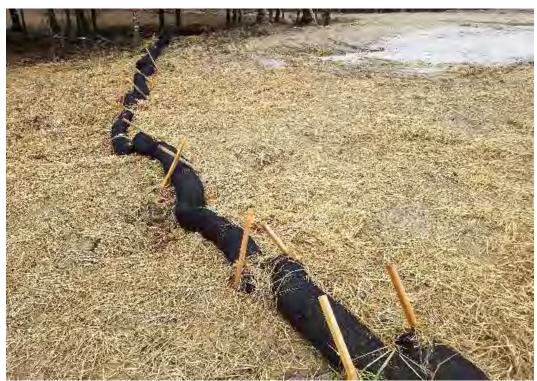
Fig 15: Erosion underneath filter sock downslope of Str. 99 at Getchell property/west side of the Bay. Ground surface in upper right corner is stable. See comments above. Viewing west. (03-30-20).

- Fig 15: Repair erosion area that undercut filter sock. Then add additional filter sock upslope. Consult with the environmental monitor to coordinate schedules and for further direction.

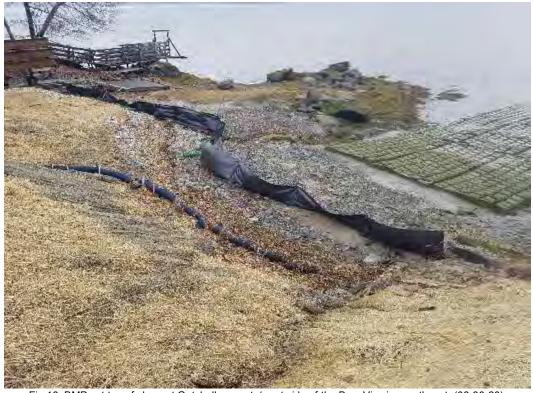
Fig 16: BMPs at toe of slope at Getchell property/west side of the Bay. Viewing northeast. (03-30-20).

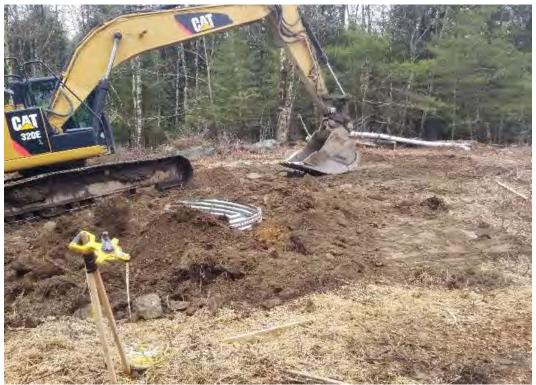
Fig 17: Crew restoring work area around Str. 76 foundation can. Viewing west. (03-30-20).
