CONSTRUCTION MONITORING REPORT

Eversource Transmission Lines:
F107

**Madbury, Durham,
Newington, Portsmouth, NH**

TYPE OF INSPECTION: Weekly Storm Event Incident Corrective Action

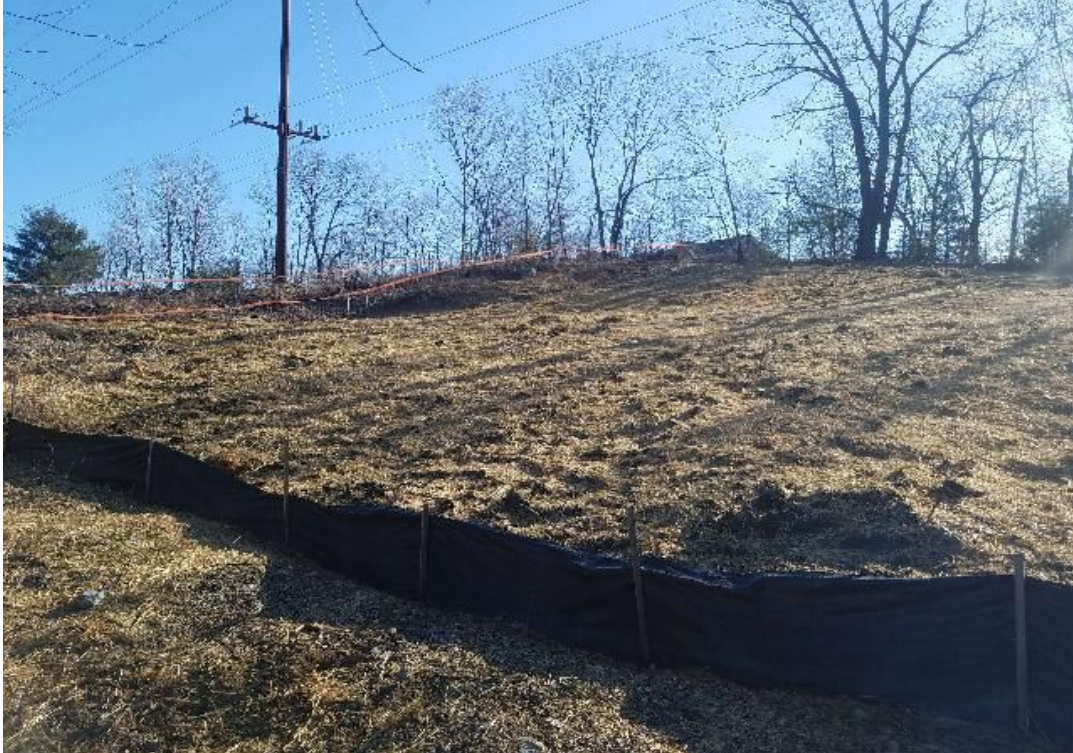
Fig 5: Soil pile blended into existing slope and area restored at Str. 27. Viewing northeast. (03-27-20).

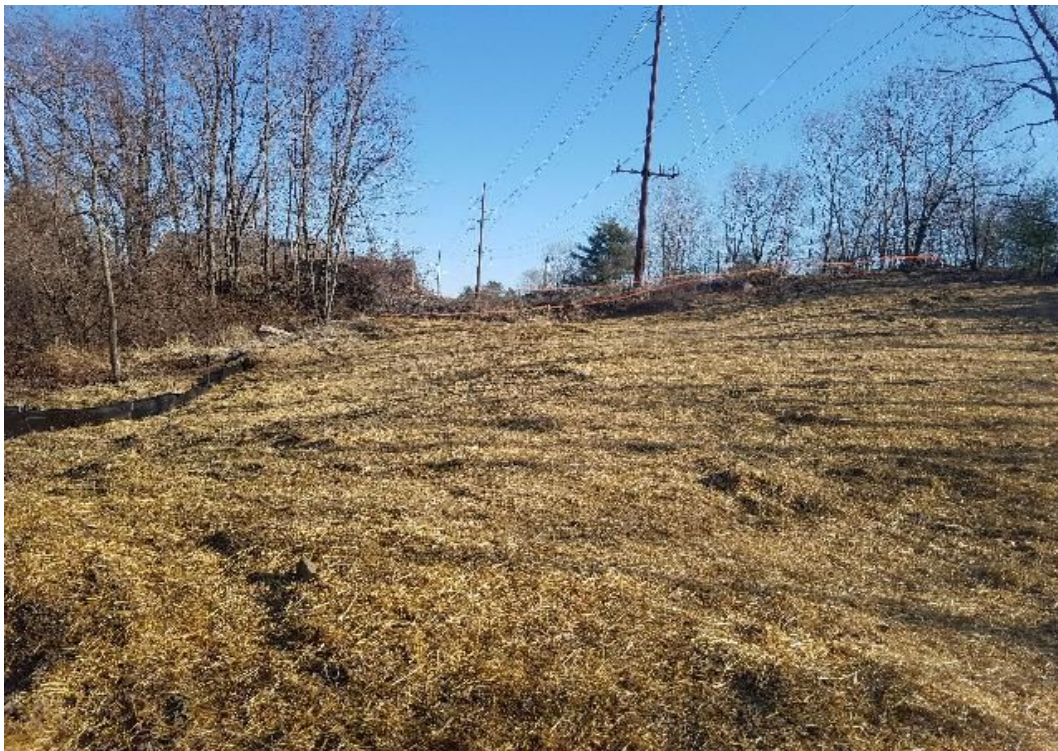
Fig 6: Soil pile blended into existing slope and area restored at Str. 27. Viewing north. (03-27-20).

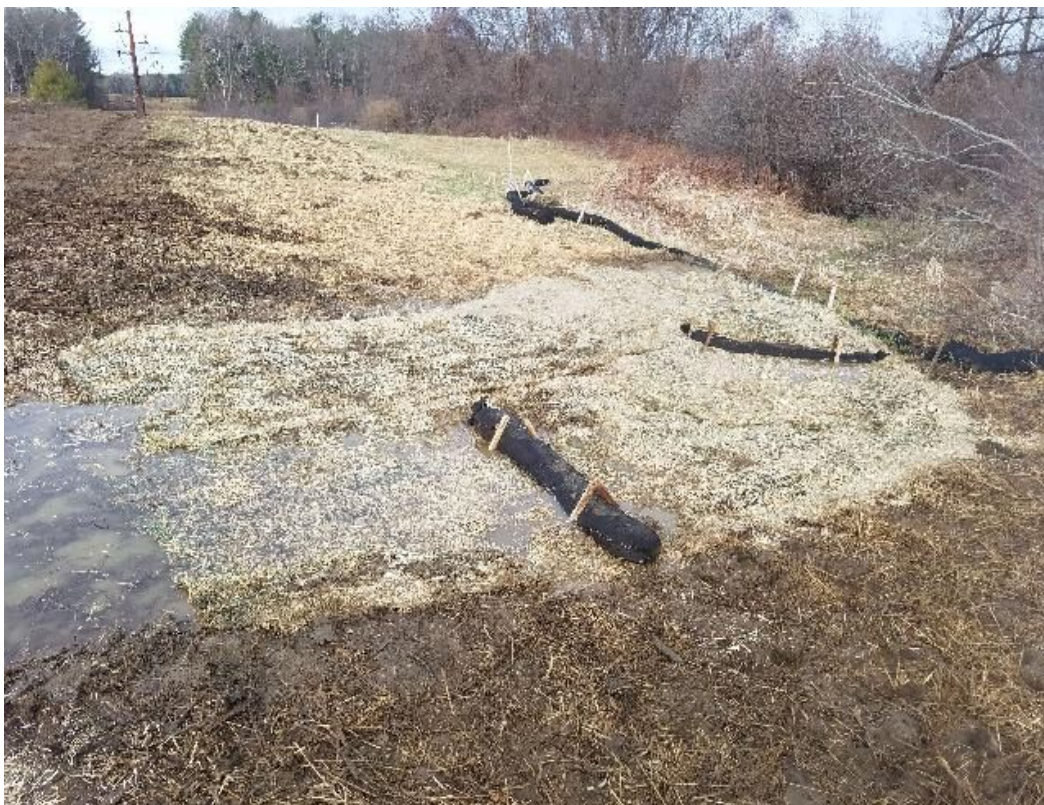
Fig 10: Repairs made to erosion in wetland NW18 at Frink farm. Viewing northwest. (03-31-20).

- Crew Addressed corrective action item in wetland NW18 at Frink farm on 03-31-20. See photo 10 below.
- Crew Addressed corrective action item on slope to Str. 28 on 03-31-20. See photo 13 below.
- Crew Addressed corrective action item for area around Str. 29 foundation on 03-31-20. See photo 14 below.
- Crew Addressed corrective action item downslope of Str. 99 on 04-01-20. See photo 22 below.
- Crew Addressed corrective action item on slope at Getchell property/west side of the bay on 04-01-20. See photo 23 below.

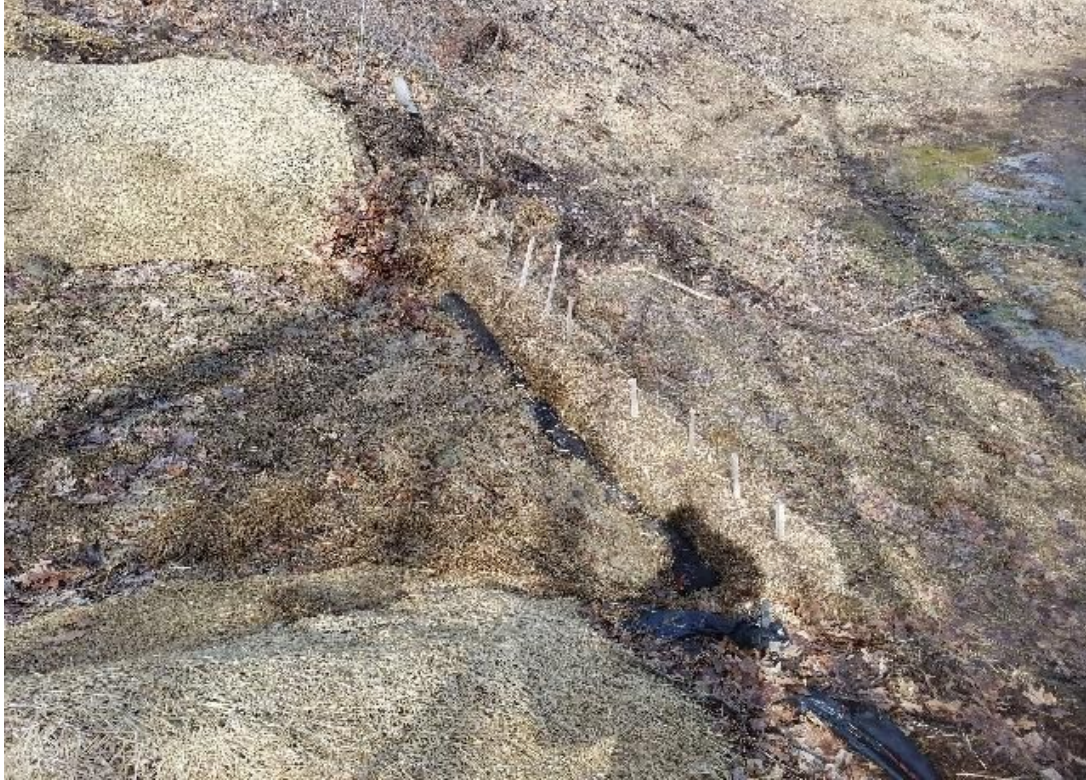
Fig 13: Filter sock installed on upslope side of bales on access road to Str. 28. Viewing east. (03-31-20).

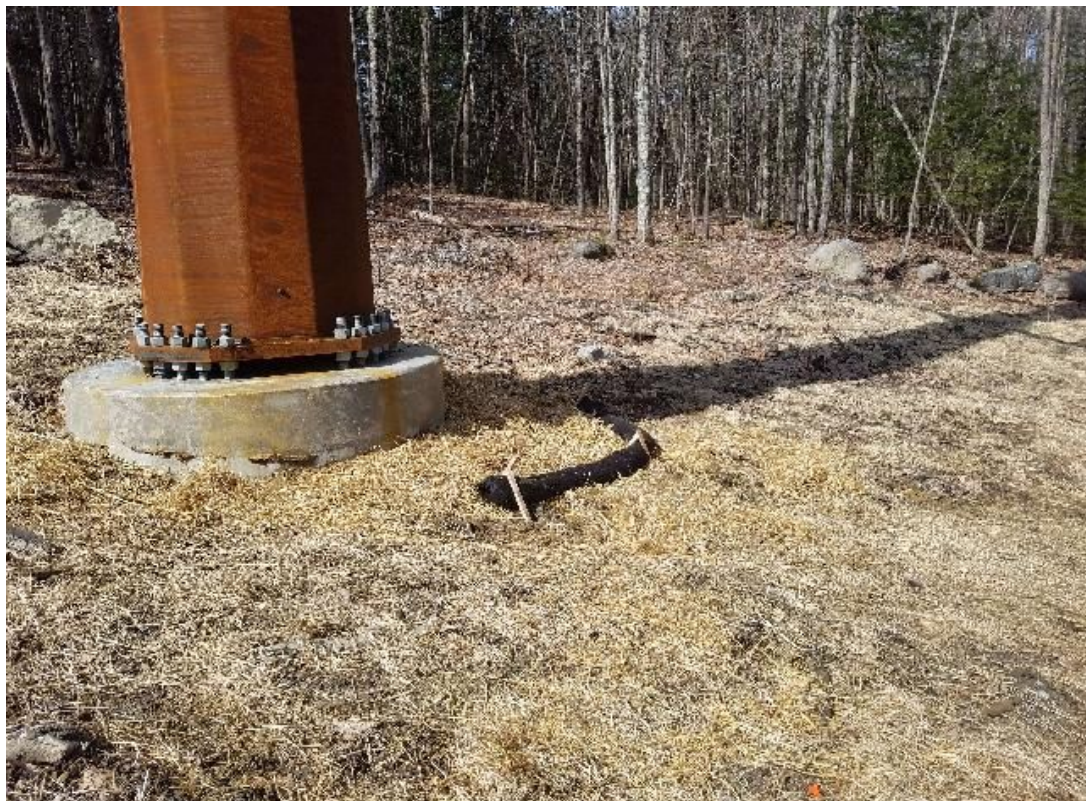
Fig 14: Erosion addressed at Str. 29, filter sock installed downslope of foundation. Viewing west. (03-31-20).

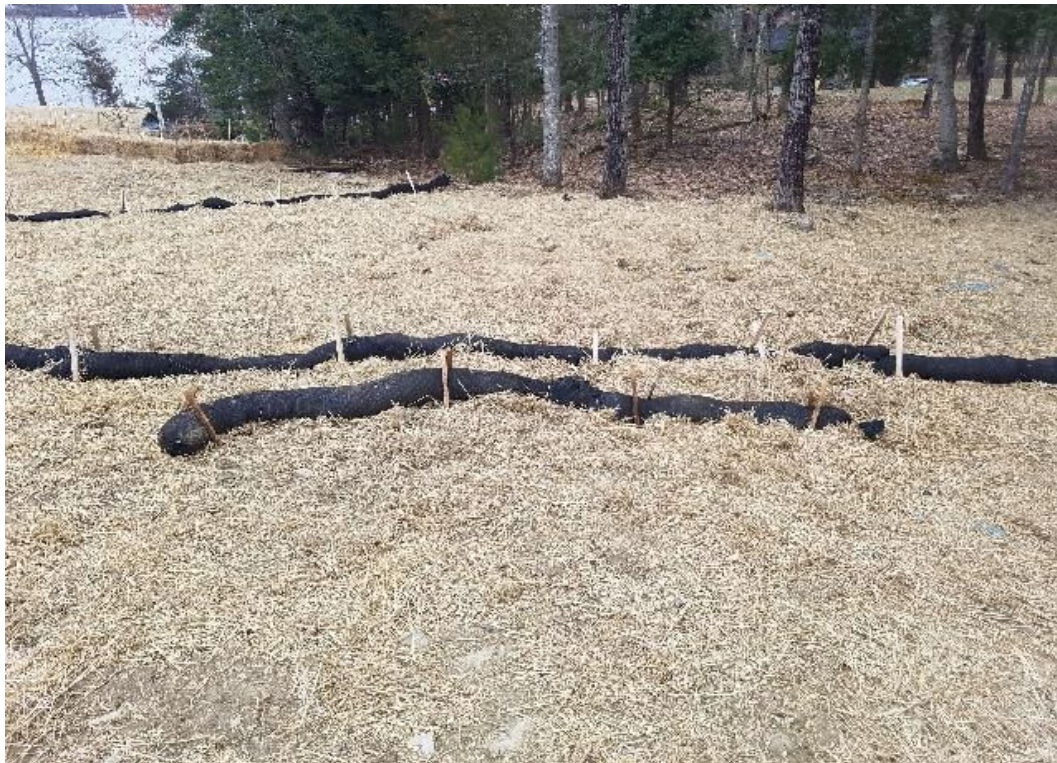
Fig 22: Erosion repaired downslope of Str. 99, filter sock added. Viewing east. (04-01-20).

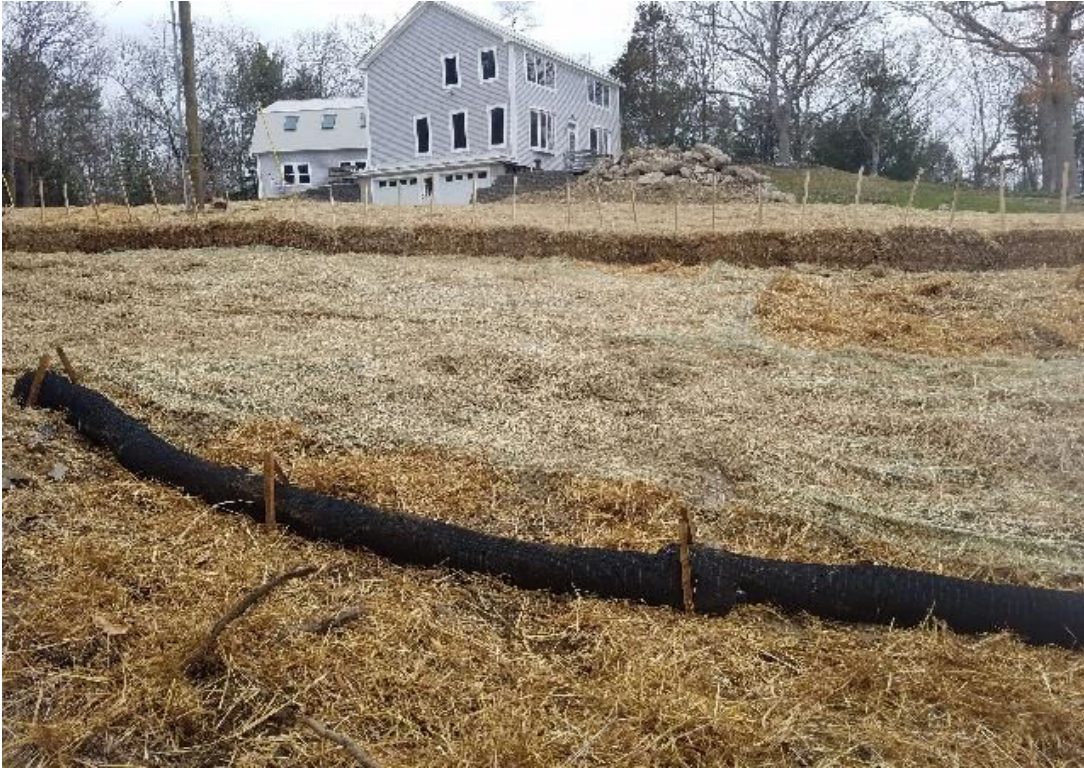
Fig 23: Erosion repaired on slope at Getchell property/west side of the Bay. Viewing north. (04-01-20).
