CONSTRUCTION MONITORING REPORT

Eversource Transmission Lines: F107

Alteration of Terrain Permit: SEC Docket No. 2015-004

Eversource Seacoast Reliability Project

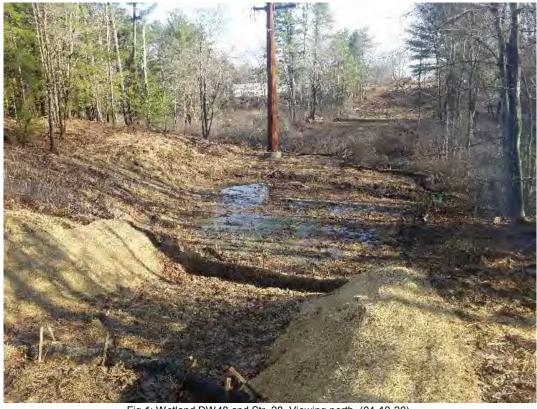
Fig 1: Wetland DW48 and Str. 28. Viewing north. (04-10-20).

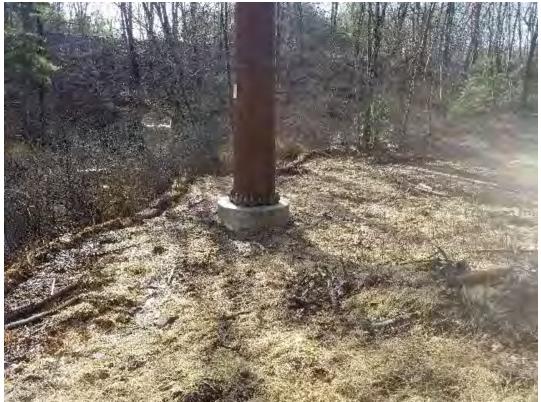
Fig 2: Str. 28 foundation. Viewing east. (04-10-20).

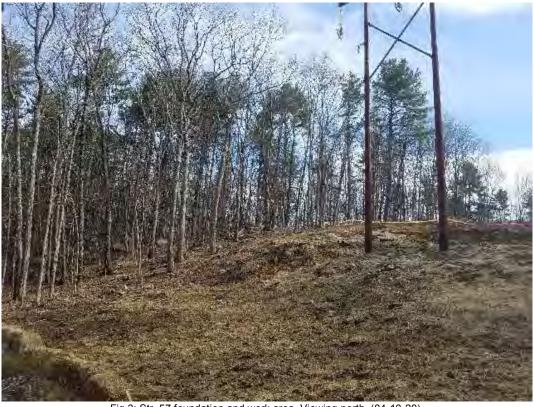
Fig 3: Str. 57 foundation and work area. Viewing north. (04-10-20).

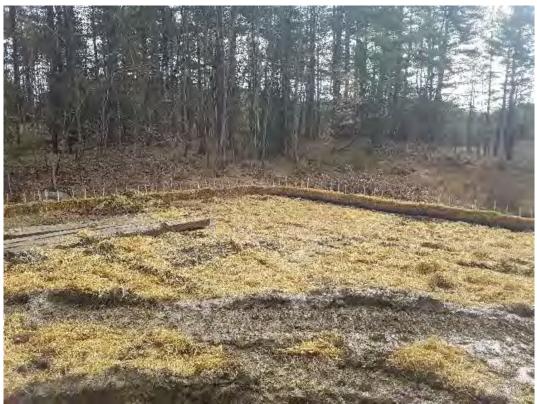
Fig 4: Str. 93 foundation can set and work area. Viewing east. (04-10-20).

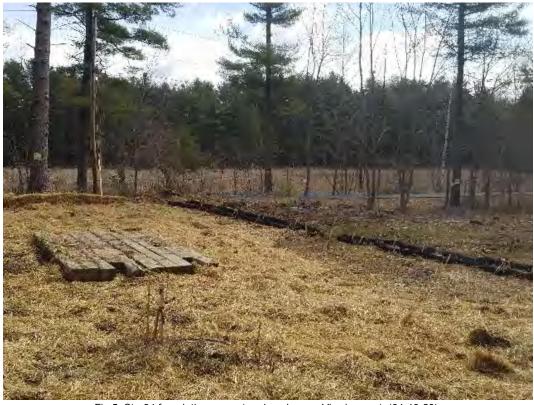
Fig 5: Str. 94 foundation can set and work area. Viewing east. (04-10-20).

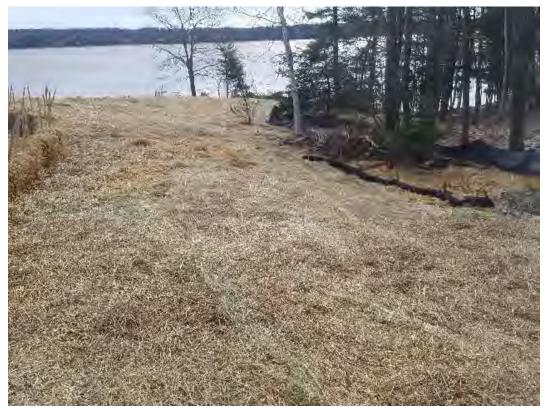
Fig 6: Previous erosion repairs are holding up on the slope at the Getchell property/west side of the Bay. Viewing east. (04-10-20).

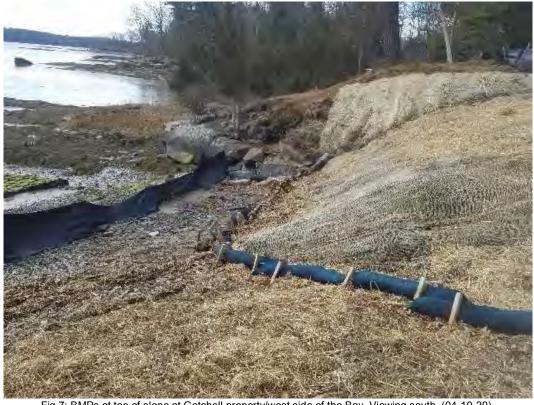
Fig 7: BMPs at toe of slope at Getchell property/west side of the Bay. Viewing south. (04-10-20).

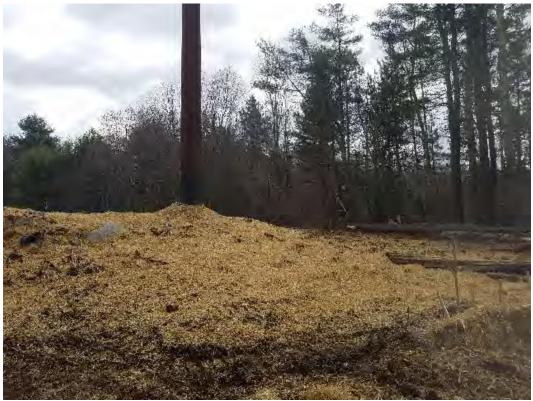
Fig 8: Str. 75 foundation. Viewing southeast. (04-10-20).

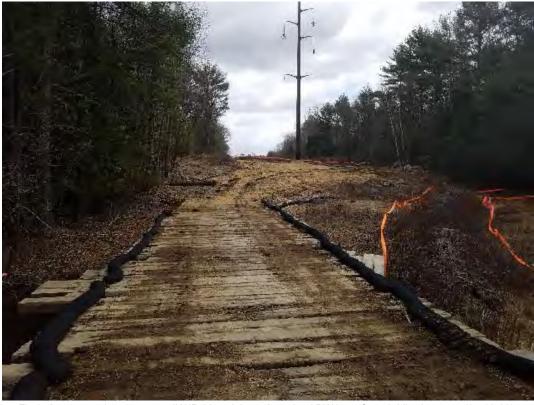
Fig 9: Access road over stonewall WP-28 and through wetland DW25 to Str. 76. Viewing east. (04-10-20).

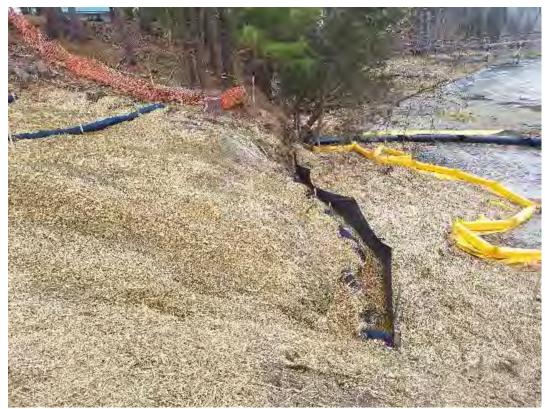
Fig 10: BMPs at toe of slope, east side of the Bay. Note marine wrack trapped behind silt curtain. Straw is stable on slope. Viewing south. (04-10-20).
