Eversource Seacoast Reliability Project

## **Construction Monitoring Report #65**

## Eversource Seacoast Reliability Project

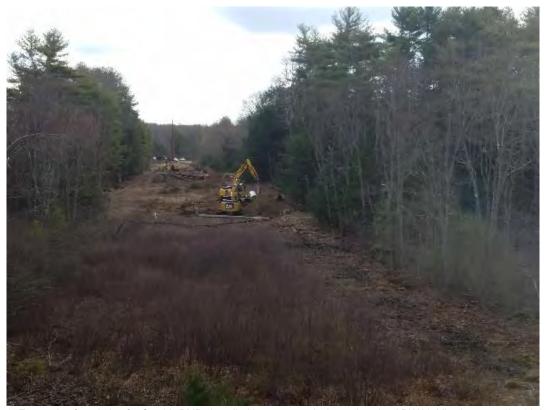
Fig 3: Excavating foundation for Str. 82. BMPs installed between work site and wetland DW38. Viewing east. (04-16-20).

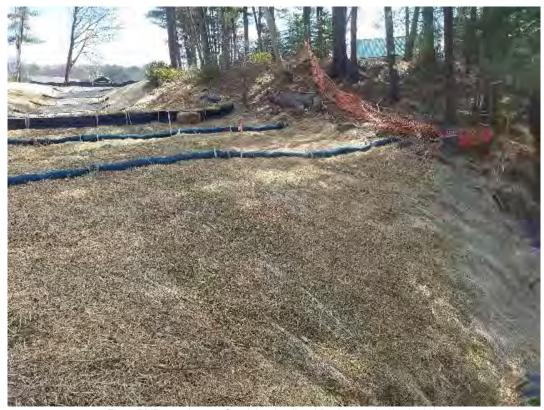
Fig 7: BMPs on slope at Gundalow landing. Viewing south. (04-17-20).

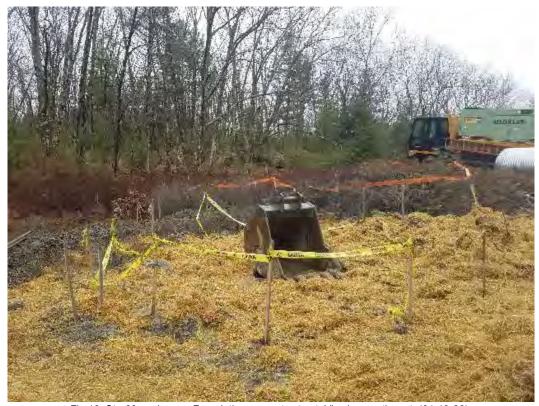
Fig 13: Str. 80 work area. Foundation can not set yet. Viewing southwest. (04-18-20).

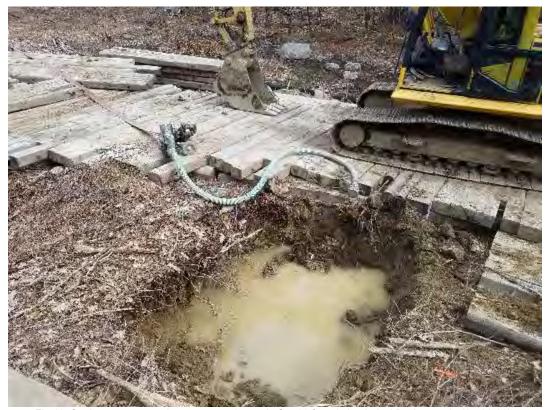
Fig 19: Setting up pump to dewater groundwater in Str. 89 foundation hole. Viewing north. (04-20-20).

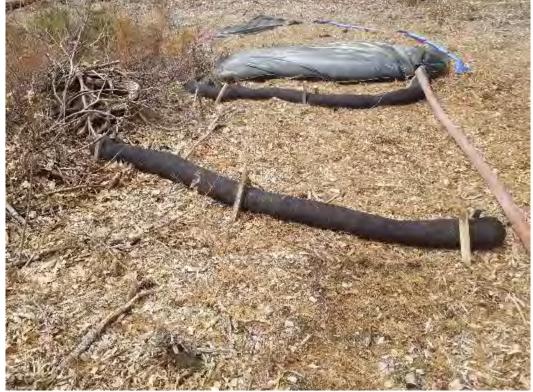
Fig 20: Filter bag and downslope BMPs installed for dewatering groundwater from Str. 89 foundation hole. Viewing northwest. (04-20-20).

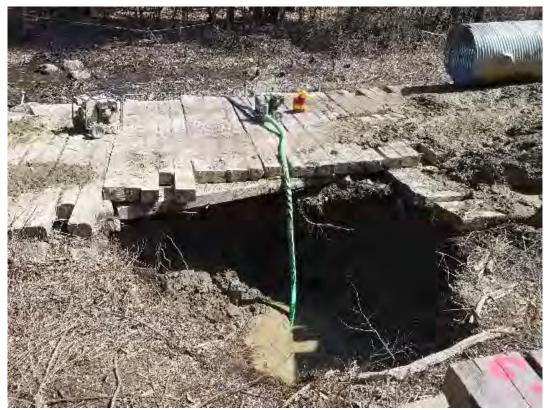
Fig 23: Pumping groundwater from Str. 89 foundation hole. Viewing north. (04-21-20).

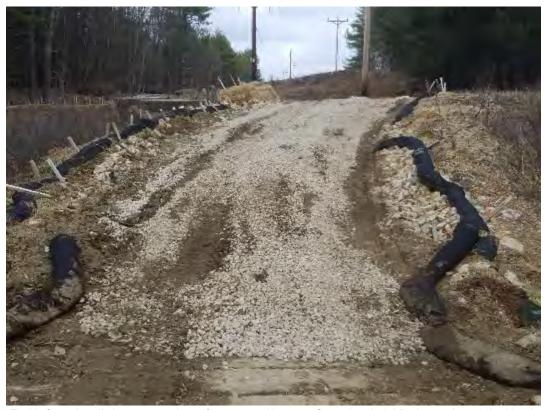
Fig 29: Stone installed on eastern slope of access road between Strs. 51 and 52. Viewing northeast. (04-22-20).

- Crew addressed corrective action item between Strs 51-52. See photo 29 below.
- Crew addressed corrective action item between Strs 53-54. See photo 30 below.

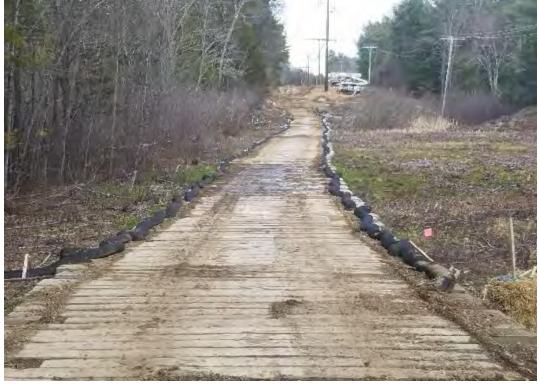
Fig 30: Crews cleaned timber matted access road between Strs. 54 and 55. Viewing northeast. (04-22-20).
