Eversource Seacoast Reliability Project

Construction Monitoring Report #67

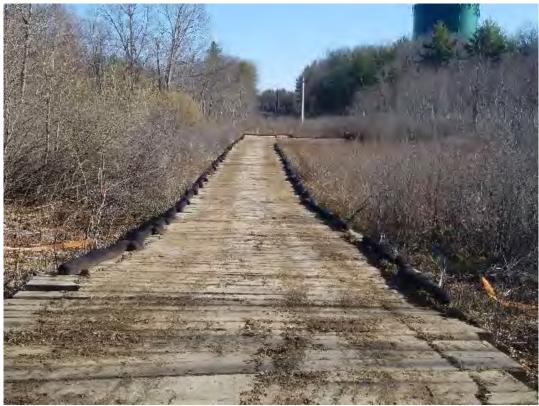
Fig 1: Access road to Str. 35, through wetland DW41. Viewing north. (04-23-20).

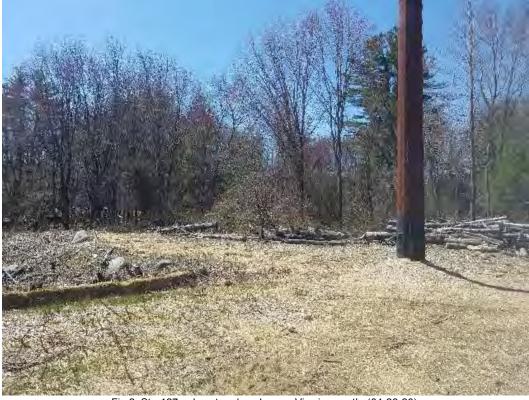
Fig 2: Str. 127 pole set and work area. Viewing south. (04-23-20).

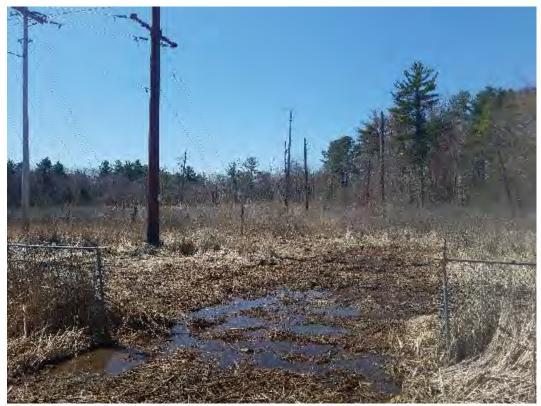
Fig 3: Str. 128 pole set and timber mats removed in wetland NW1. Viewing south (04-23-20).

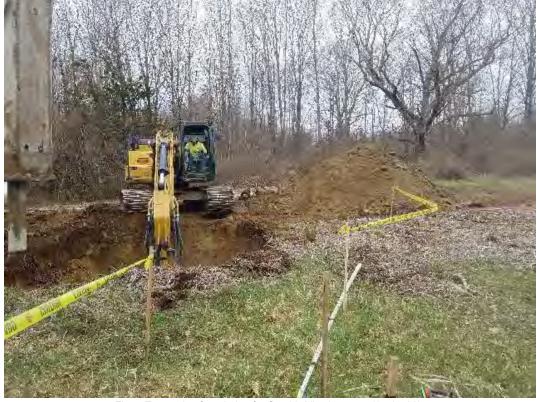
Fig 4: Excavating foundation for Str. 38. Viewing east. (04-24-20).

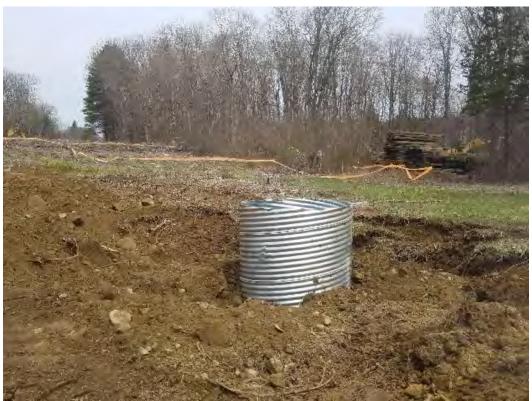
Fig 5: Foundation can set for Str. 38. Viewing northeast. (04-24-20).

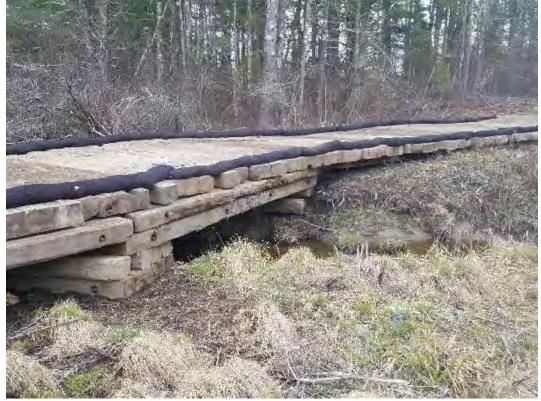
Fig 6: Timber mat bridge over stream DS60 in wetland DW58. Between Strs. 43-44. Viewing southeast. (04-24-20).

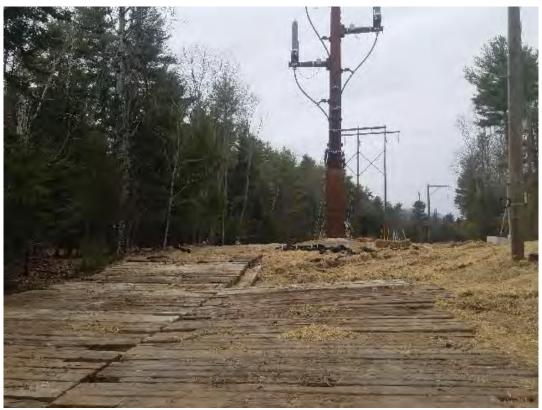
Fig 7: Crew installed timber mats for wire pull pad at Getchell property/west side of the Bay. Viewing west. (04-24-20).

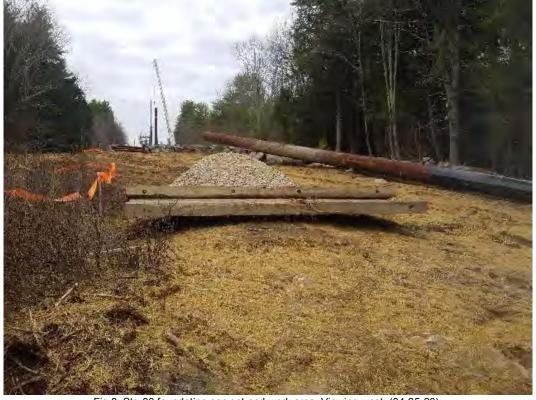
Fig 8: Str. 83 foundation can set and work area. Viewing west. (04-25-20).

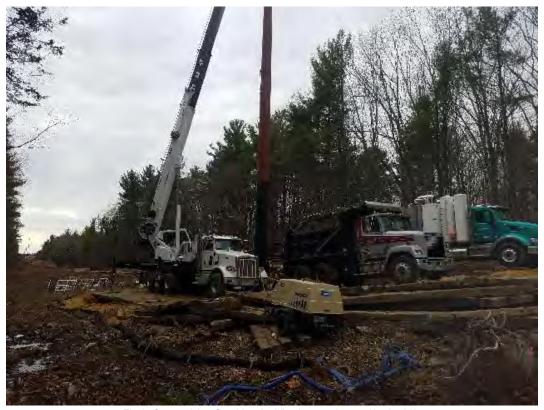
Fig 9: Crew raising Str. 89 pole. Viewing southeast. (04-25-20).

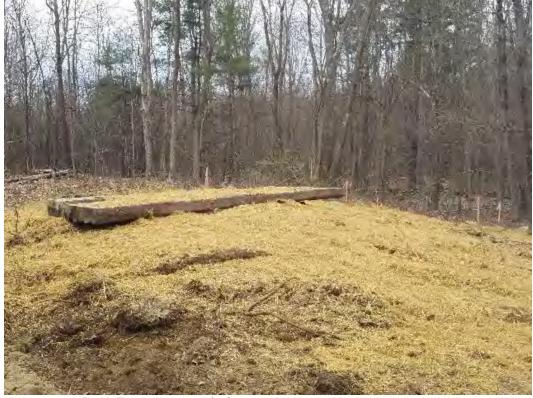
Fig 10: Foundation can set for Str. 41 and work area. Viewing west. (04-24-20).

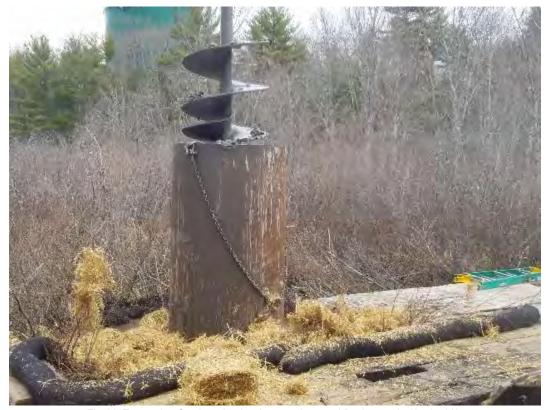
Fig 11: Excavating Str. 35 using hard can and auger. Viewing north. (04-25-20).

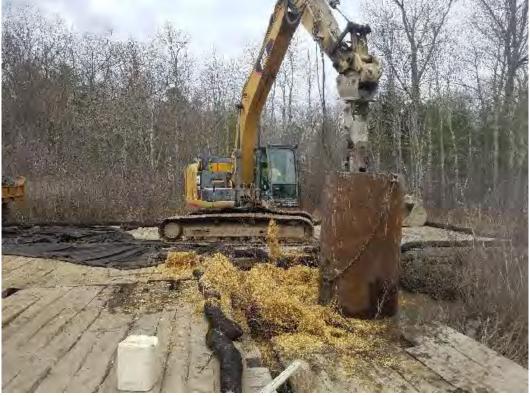
Fig 12: Excavating Str. 35 using hard can and auger. Viewing west. (04-25-20).

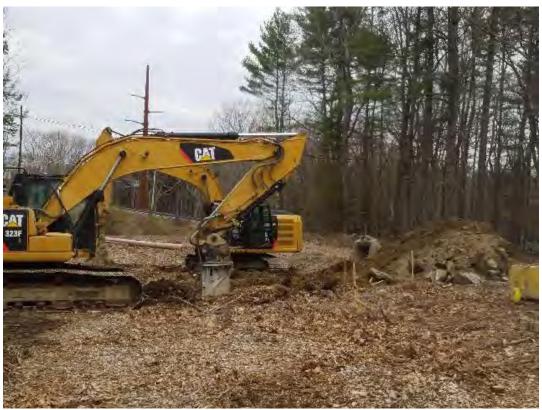
Fig 13: Hammering ledge for foundation at Str. 33. Viewing north. (04-25-20).

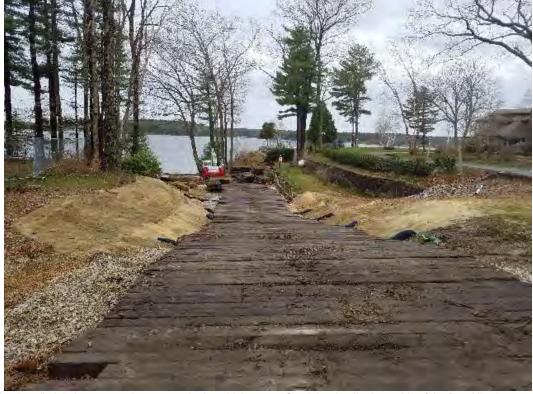
Fig 14: Blu Roc installed timber mat road to access the intertidal zone at Gundalow landing/east side of the Bay. Viewing west. (04-28-20).

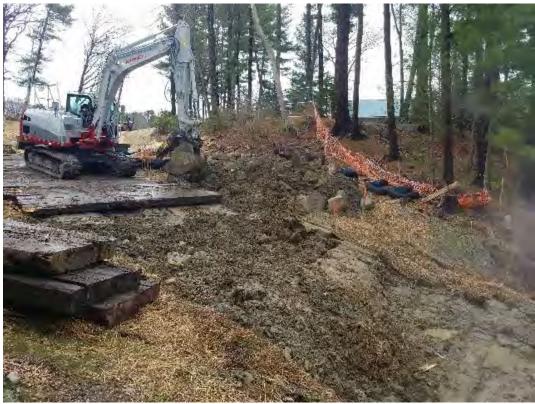
Fig 15: Blu Roc installing timber mat access road to access the intertidal zone at Gundalow landing/east side of the Bay. Viewing west. (04-28-20).

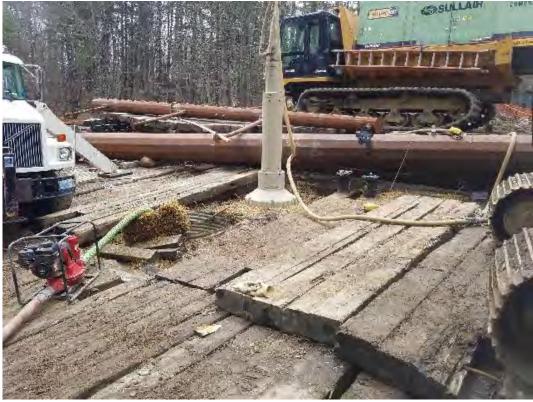
Fig 16: Pumping groundwater out of Str.89 foundation hole. Viewing south. (04-28-20).

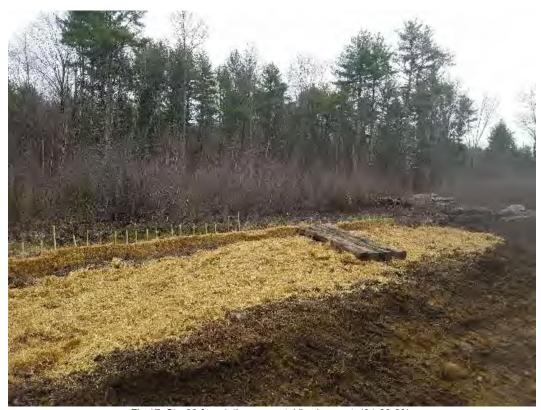
Fig 17: Str. 39 foundation can set. Viewing east. (04-28-20).

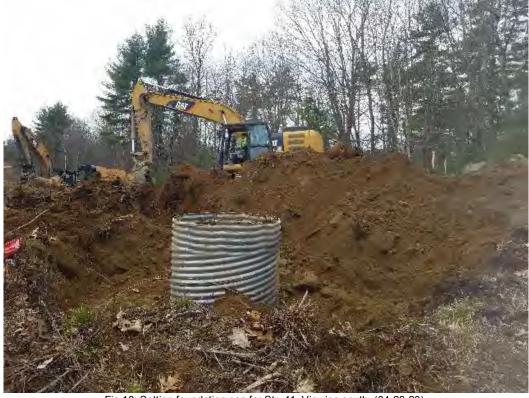
Fig 18: Setting foundation can for Str. 41. Viewing south. (04-28-20).

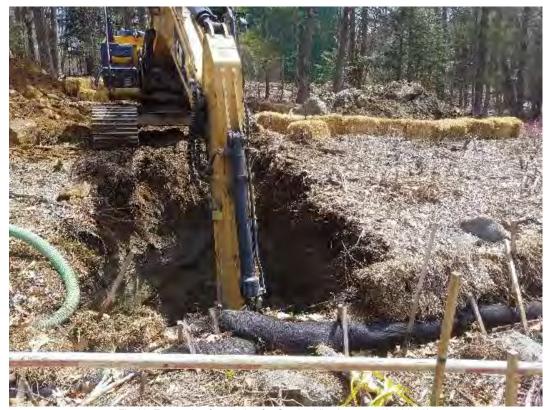
Fig 19: Excavating foundation for Str. 34. Viewing east. (04-29-20).

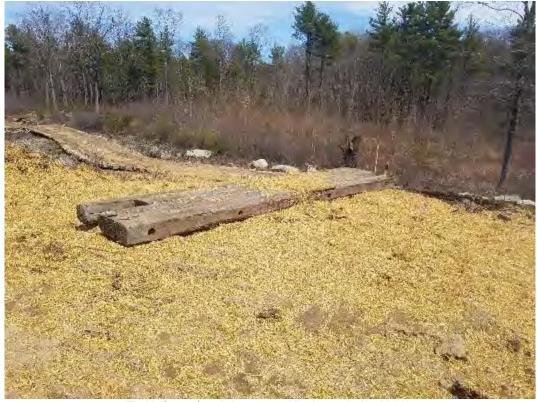
Fig 20: Str. 41 foundation can set. Viewing north. (04-29-20).

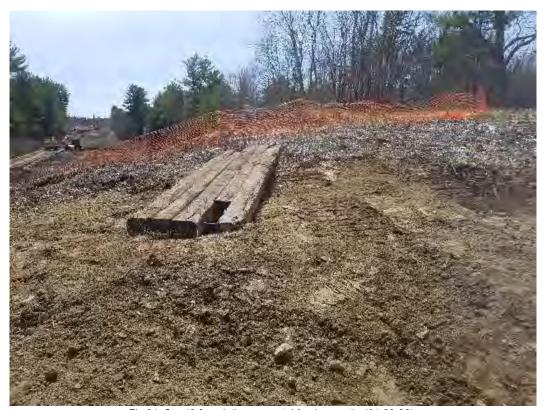
Fig 21: Str. 43 foundation can set. Viewing south. (04-29-20).

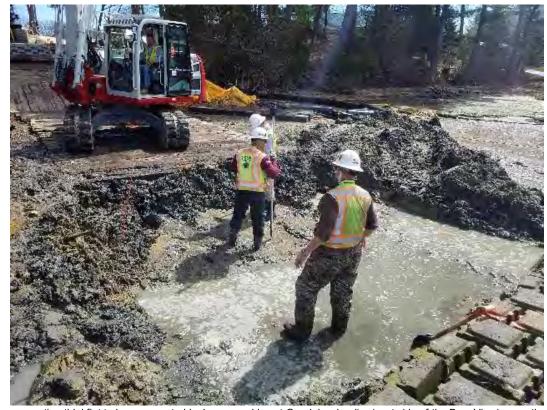
Fig 22: Blu Roc excavating tidal flat to bury concrete blocks over cables at Gundalow landing/east side of the Bay. Viewing southeast. (04-29-20).

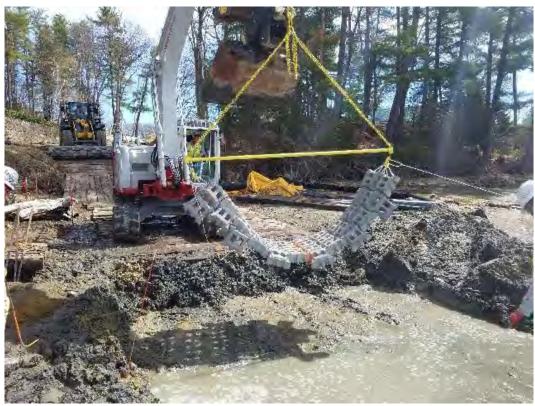
Fig 23: Blu Roc installing concrete blocks for submarine cable protection at Gundalow landing/east side of the Bay. Viewing southeast. (04-29-20).

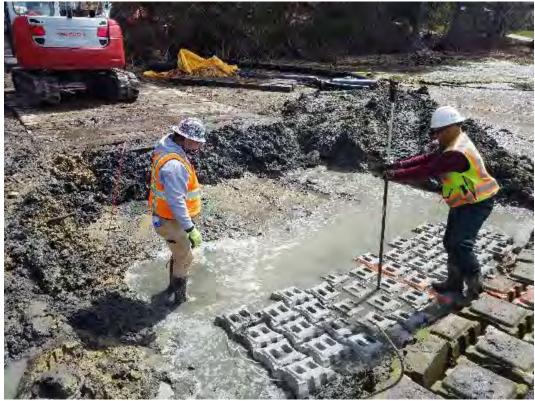
Fig 24: Blu Roc burying concrete blocks in tidal flat for cable protection at Gundalow landing/east side of the Bay. Viewing southeast. (04-29-20).

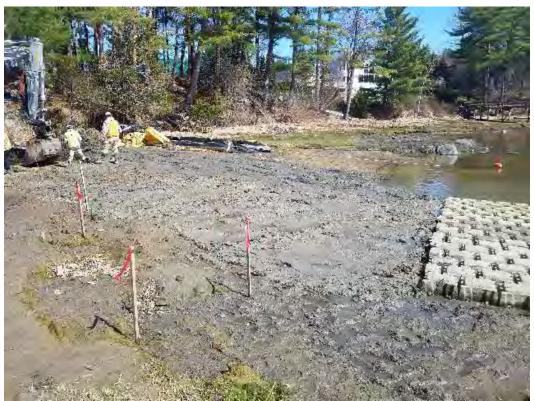
Fig 25: Concrete blocks installed in tidal flat and backfilled with native material at Gundalow landing/east side of the Bay.Viewing southeast.(04-21-20)

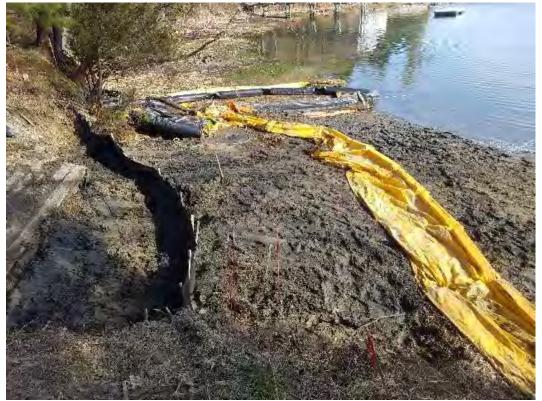
Fig 26: BMPs installed in intertidal zone at end of day at Gundalow landing/east side of the Bay. Viewing southeast. (04-29-20).
