CONSTRUCTION MONITORING REPORT

Eversource Transmission Lines: F107

NAI Project No: 23840.39

Eversource Seacoast Reliability Project

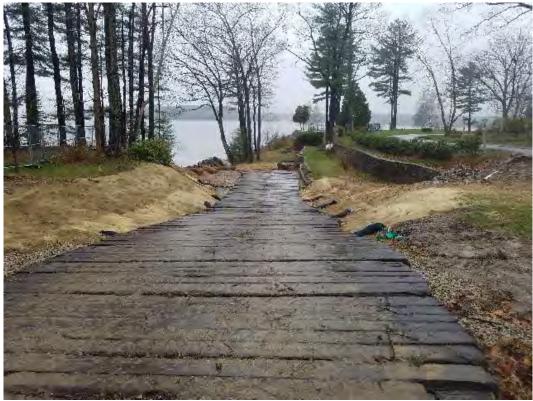
Fig 1: Timber mat access road to intertidal zone at Gundalow landing/east side of the Bay. Viewing southwest. (05-01-20).

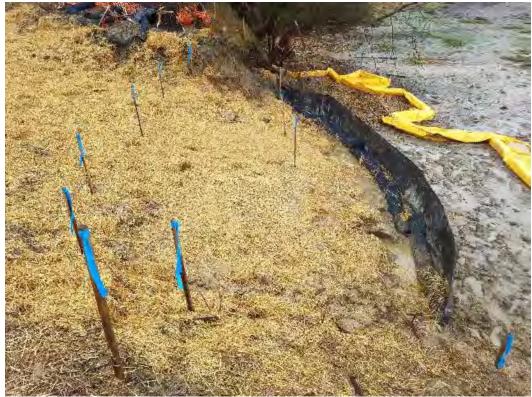
Fig 2: BMPs and exposed soils mulched at toe-of-slope at Gundalow landing/east side of the Bay. Viewing south. (05-01-20).

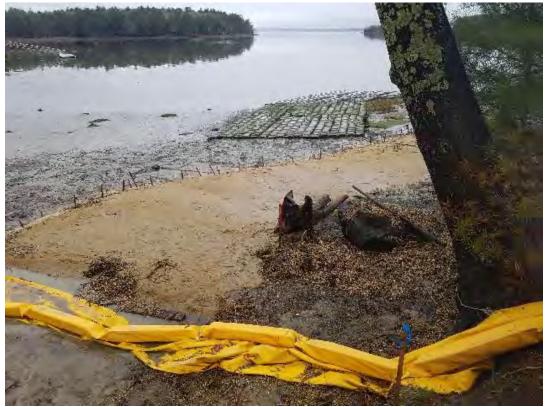
Fig 3: Salt marsh restoration in tidal flat at Gundalow landing/east side of the Bay. Viewing southwest. (05-01-20).

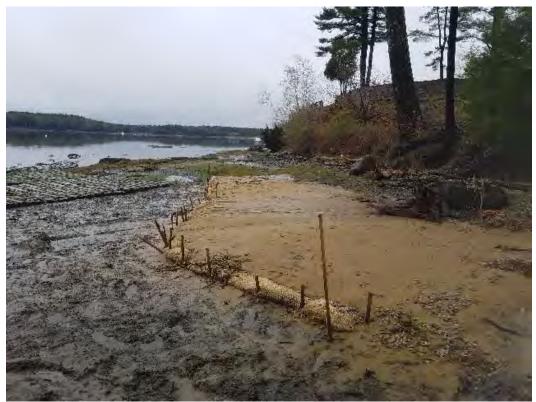
Fig 4: Salt marsh restoration in tidal flat at Gundalow landing/east side of the Bay. Viewing west. (05-01-20).

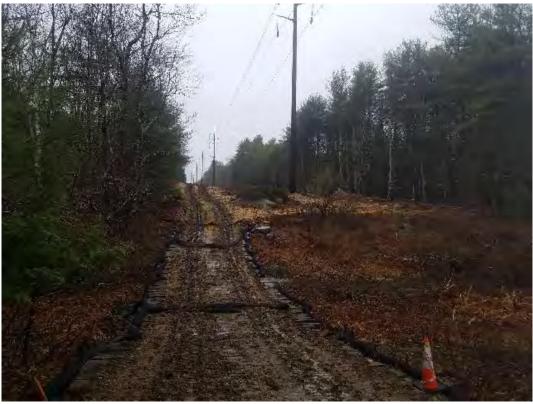
- Continued BMP maintenance and upkeep is a constant priority on shorelines of both sides of the Bay during the winter months.
- Housekeeping such as sweeping of timber mats and roads is a must. See photos 5, 16, 17 below.
- All contractors on site should have a copy of the construction drawings.
- During mat removal be sure to remove any remains of silt socks etc.

Fig 5: Access road between Strs 85-84, in wetland DW30. Mats need to be cleaned. Viewing west (05-01-20).

- Fig 5, 16 & 17: Clean and maintain timber mats installed in or in close proximity to wetlands. Consult with the environmental monitor to coordinate schedules and for further direction.
- Fig 7 & 8: Repair/upgrade BMPs. Recommend installing a combined berm or silt fence. Consult with the environmental monitor to coordinate schedules and for further direction.
- Fig 12 & 13: Repair/upgrade BMPs along access road to Str. 93. Recommend installing silt fence in swale to reduce sediment discharge into wetland DW16 through culvert. Consult with the environmental monitor to coordinate schedules and for further direction.

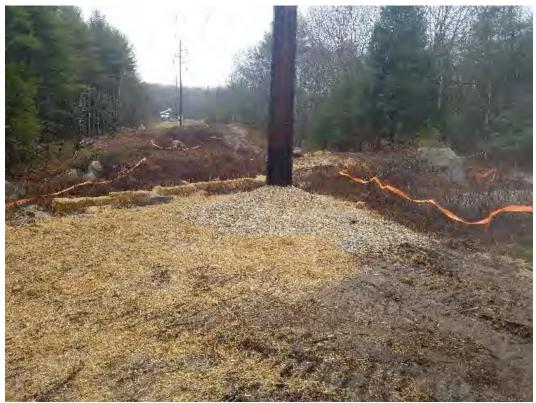
Fig 6: Str. 83 pole set and work area. Viewing east. (05-01-20).

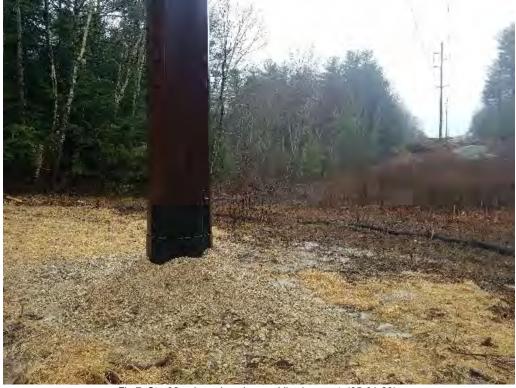
Fig 7: Str. 82 pole and work area. Viewing west. (05-01-20).

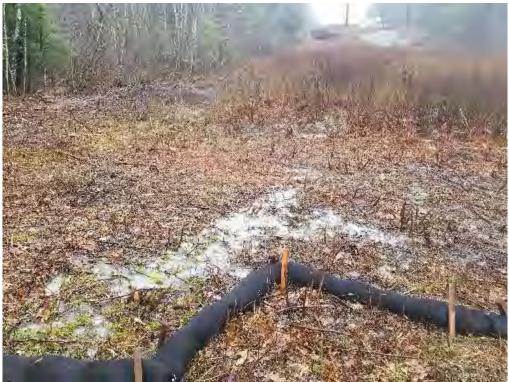
Fig 8: Minor turbid water flowing into wetland DW38; downslope of Str. 82. Viewing west. (05-01-20).

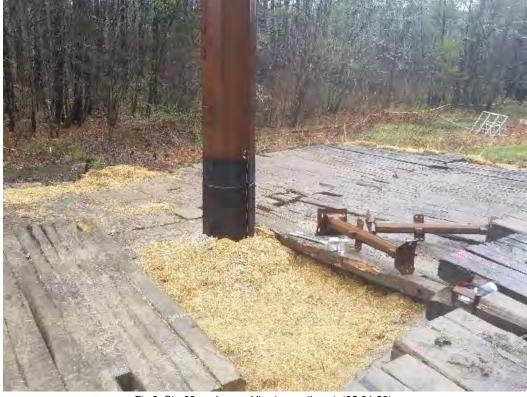
Fig 9: Str. 89 work area. Viewing northeast. (05-01-20).

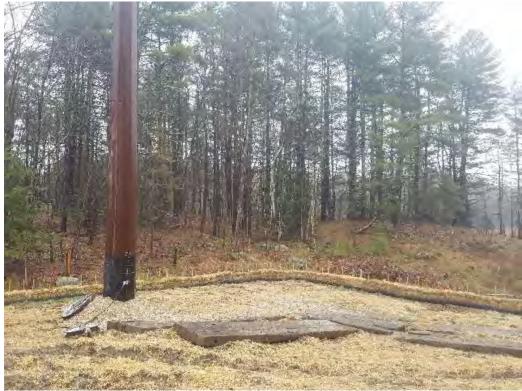
Fig 10: Str. 93 work area. Viewing east. (05-01-20).

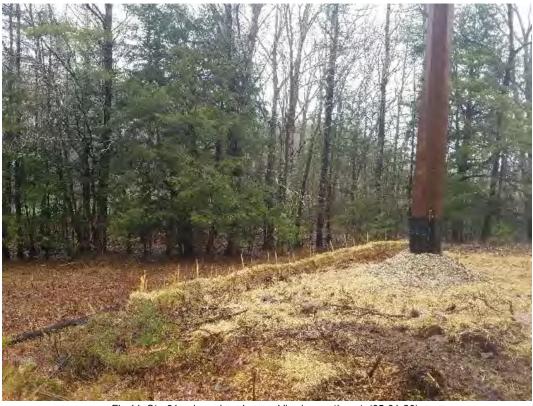
Fig 11: Str. 91 pole and work area. Viewing northeast. (05-01-20).

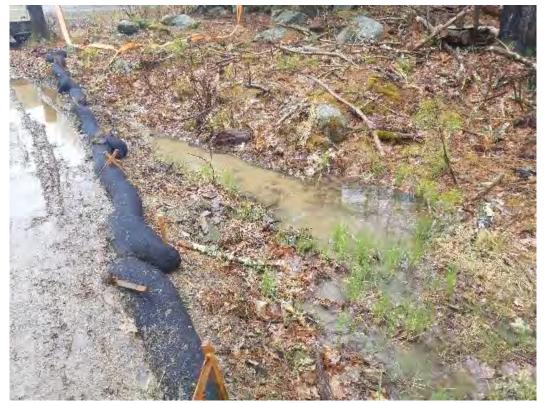
Fig 12: Turbid water entering culvert under access road to Str. 93. Wetland DW16. Viewing southeast. (05-01-20).

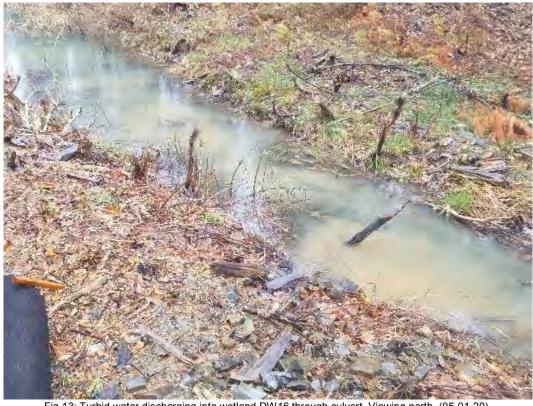
Fig 13: Turbid water discharging into wetland DW16 through culvert. Viewing north. (05-01-20).

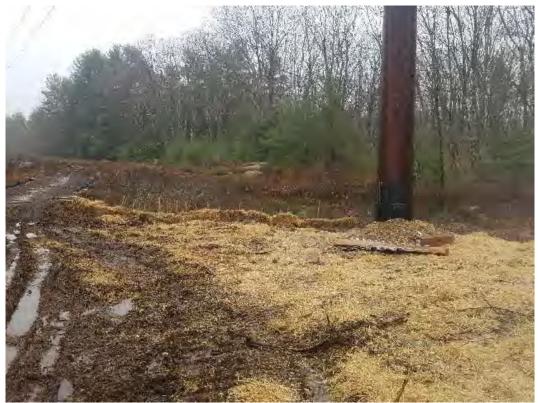
Fig 14: Str. 80 work area. Viewing southeast. (05-01-20).

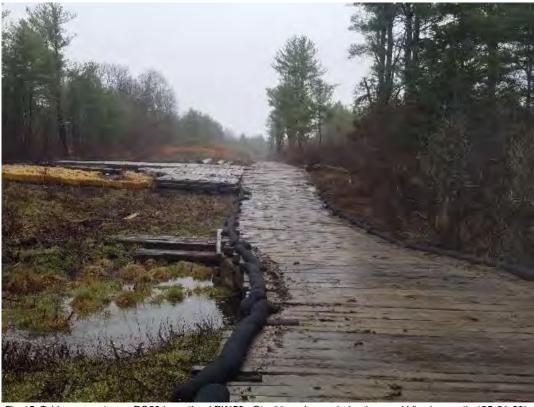
Fig 15: Bridge over stream DS60 in wetland DW58. Str. 44 work area in background Viewing north. (05-01-20).

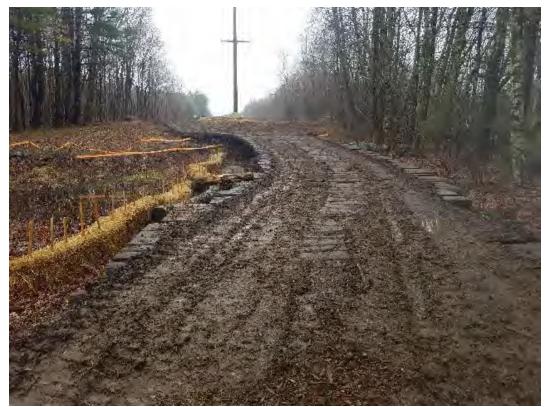
Fig 16: Access road adjacent to wetland DW43, between Strs. 36-37. Mats need to be cleaned. Viewing south. (05-01-20).

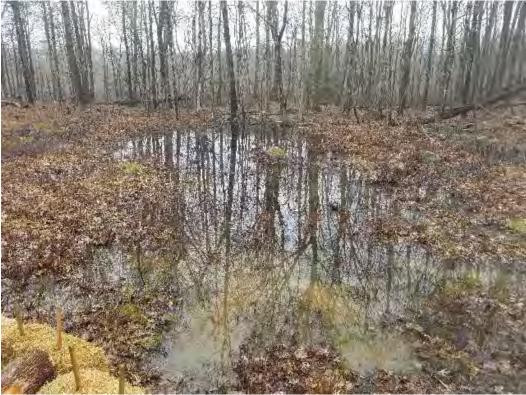
Fig 17: Wetland DW43, adjacent to access road between Strs. 36-37. Viewing east. (05-01-20).
