CONSTRUCTION MONITORING REPORT

Eversource Transmission Lines:
F107

**Madbury, Durham,
Newington, Portsmouth, NH**

NAI Project No:
23840.39

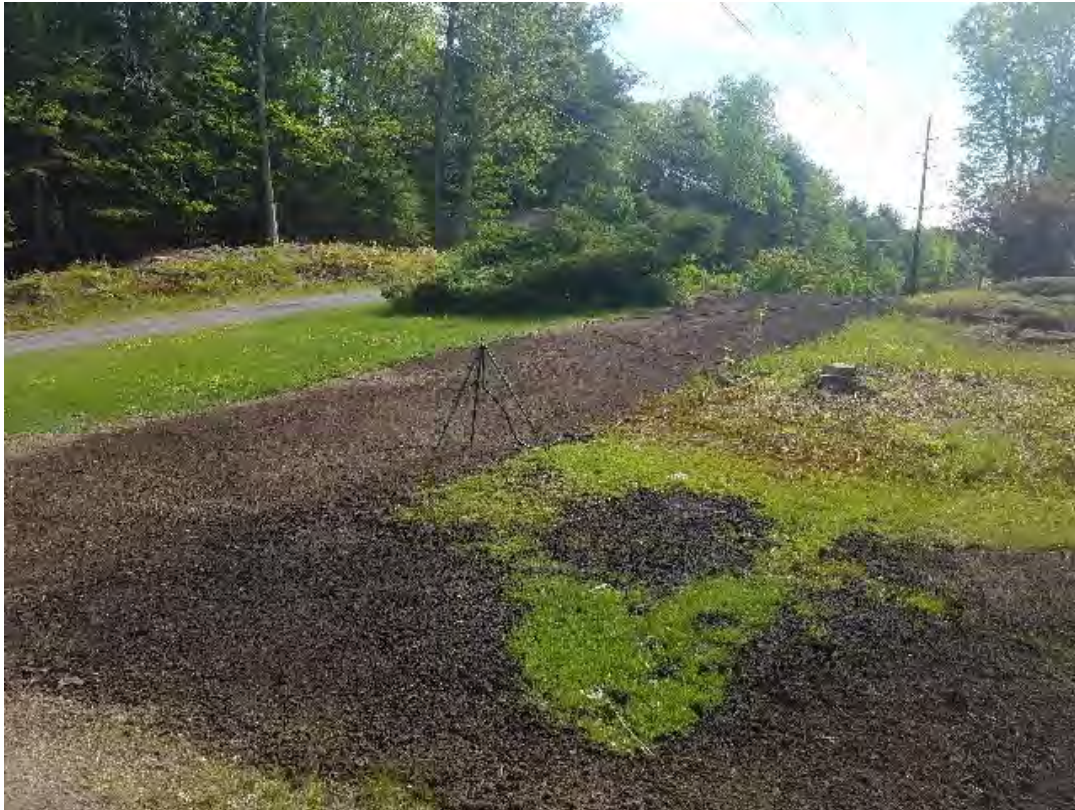
Fig 1: Sprinklers set up to water restored access road to Str. 65. Viewing east. (05-28-20).

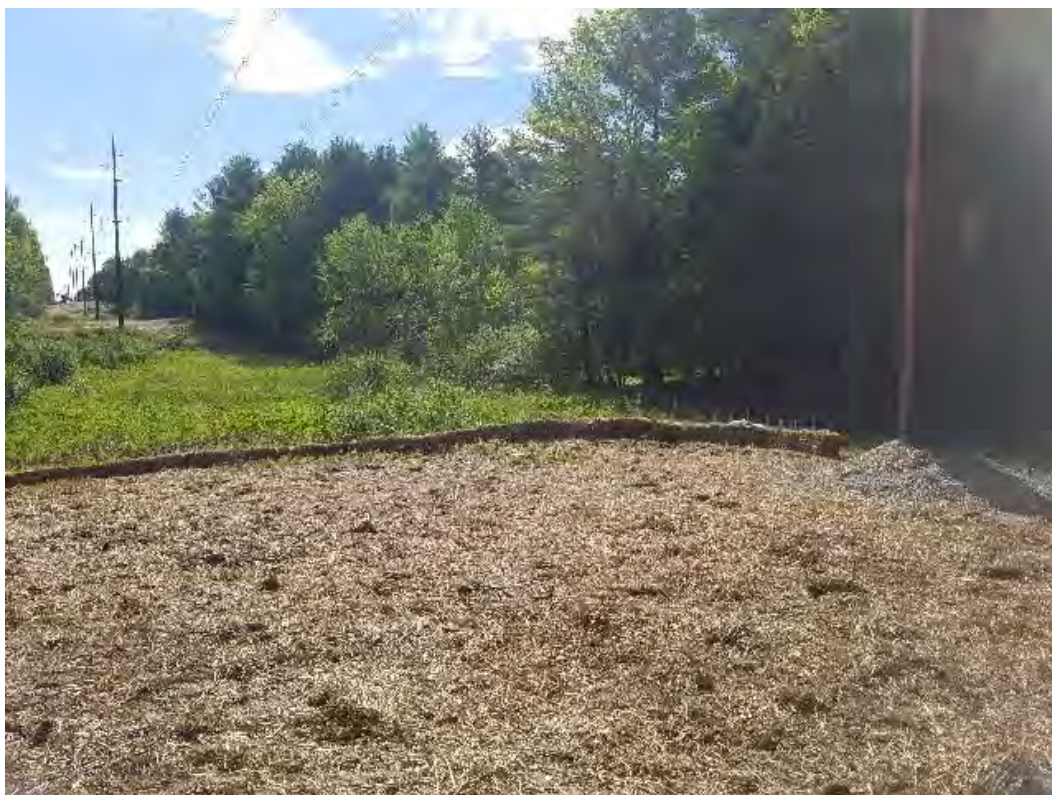
Fig 2: Str. 65 work area restored. Viewing east. (05-28-20).

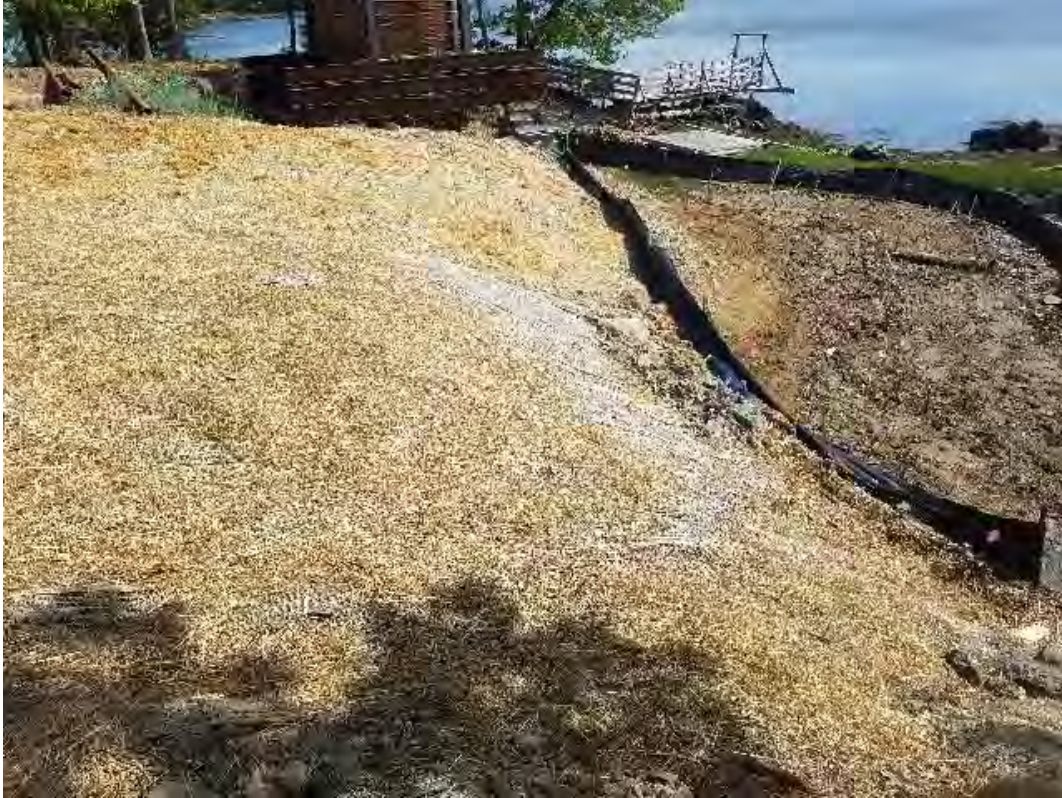
Fig 3: Toe of slope BMPs and salt marsh restoration at Getchell property/west side of the Bay. Viewing north. (05-28-20).

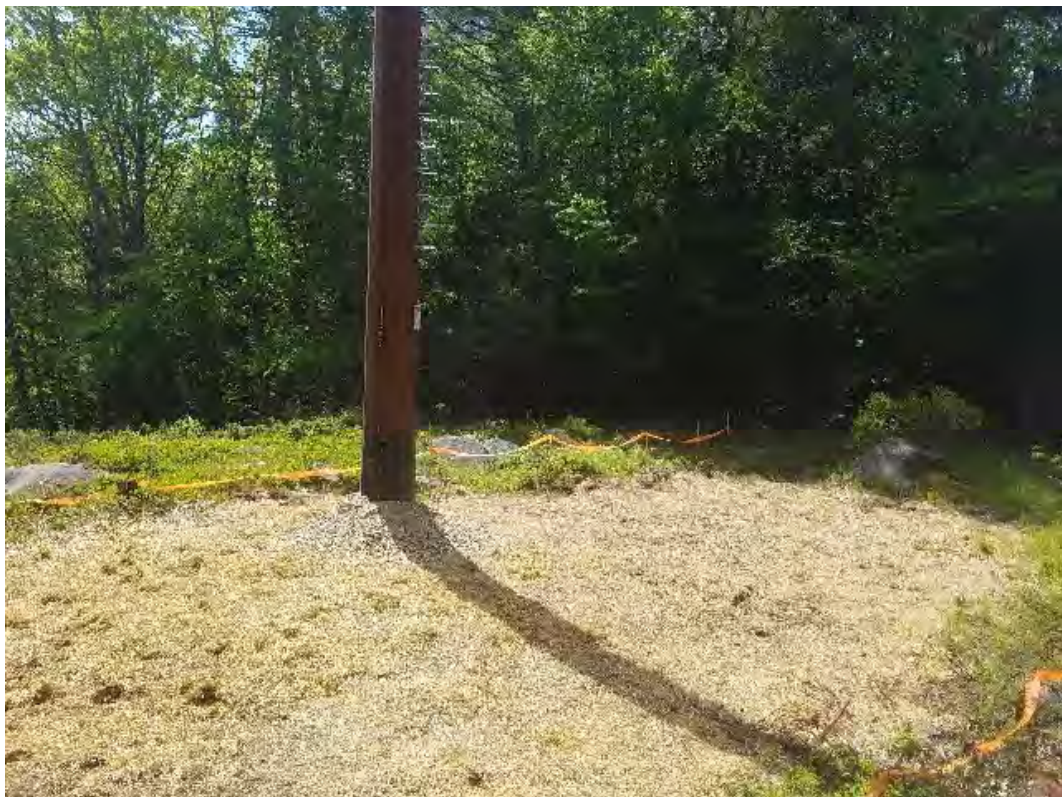
Fig 4: Str. 81 work area restored. Viewing south. (05-28-20).

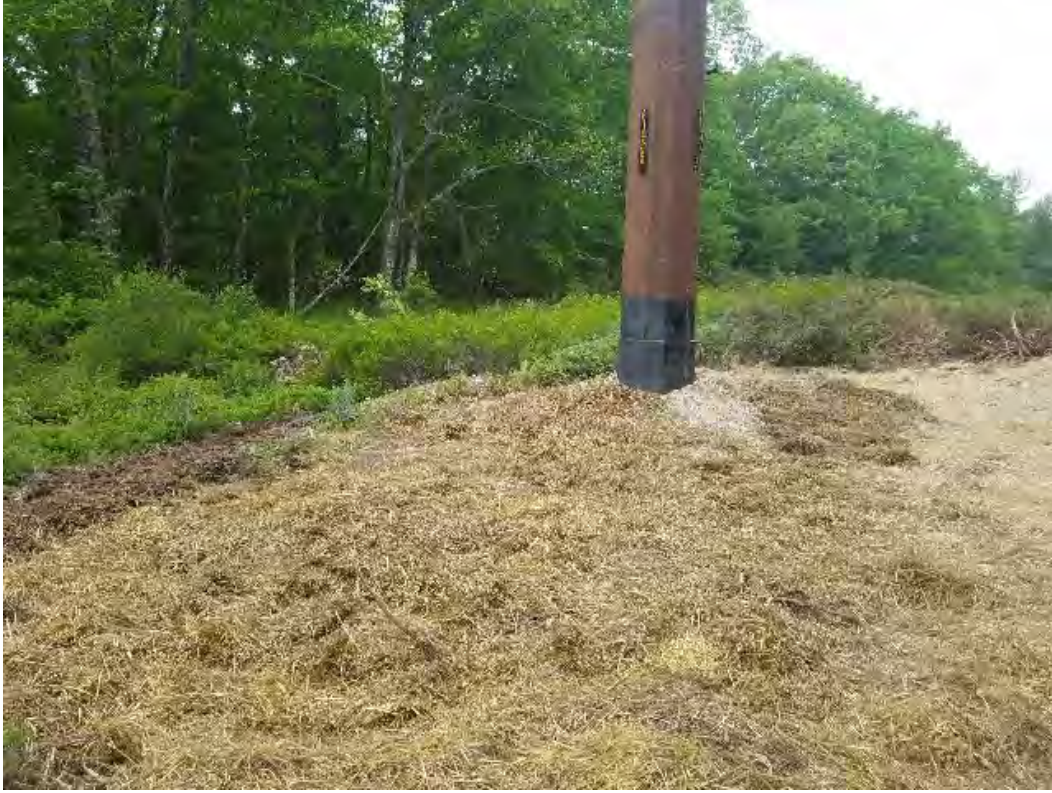
Fig 5: Str. 81 work area restored. Viewing southwest. (05-29-20).

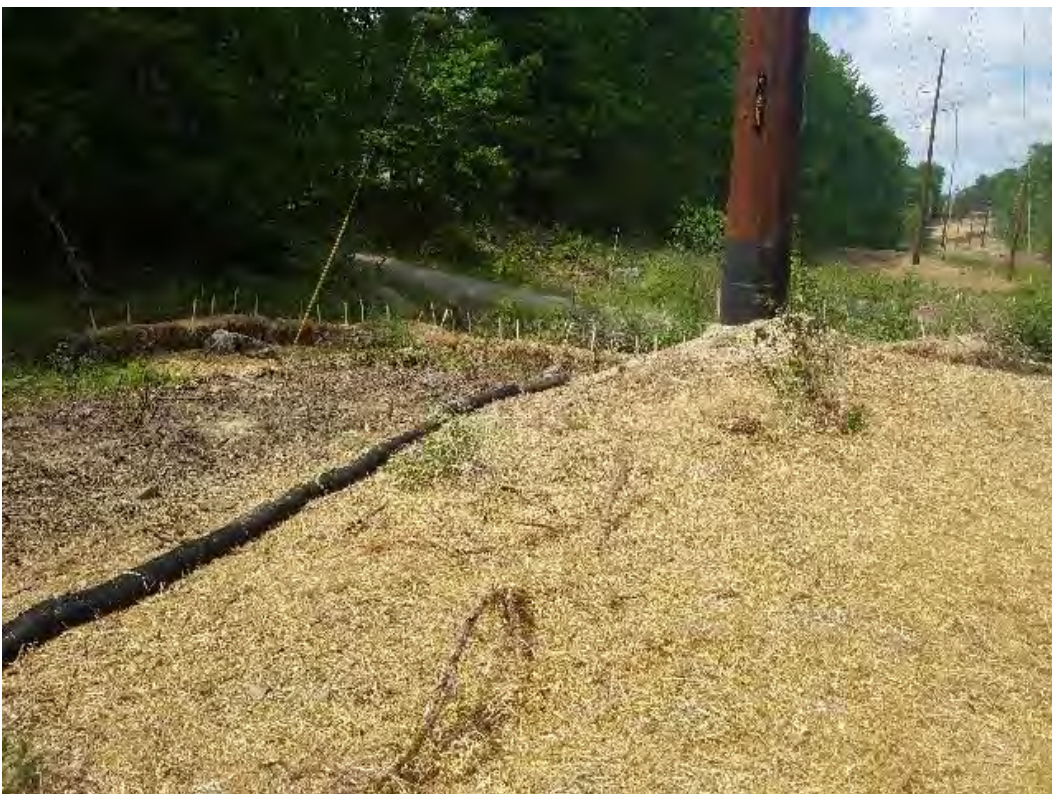
Fig 6: Str. 63 work area restored. Viewing west. (05-29-20).

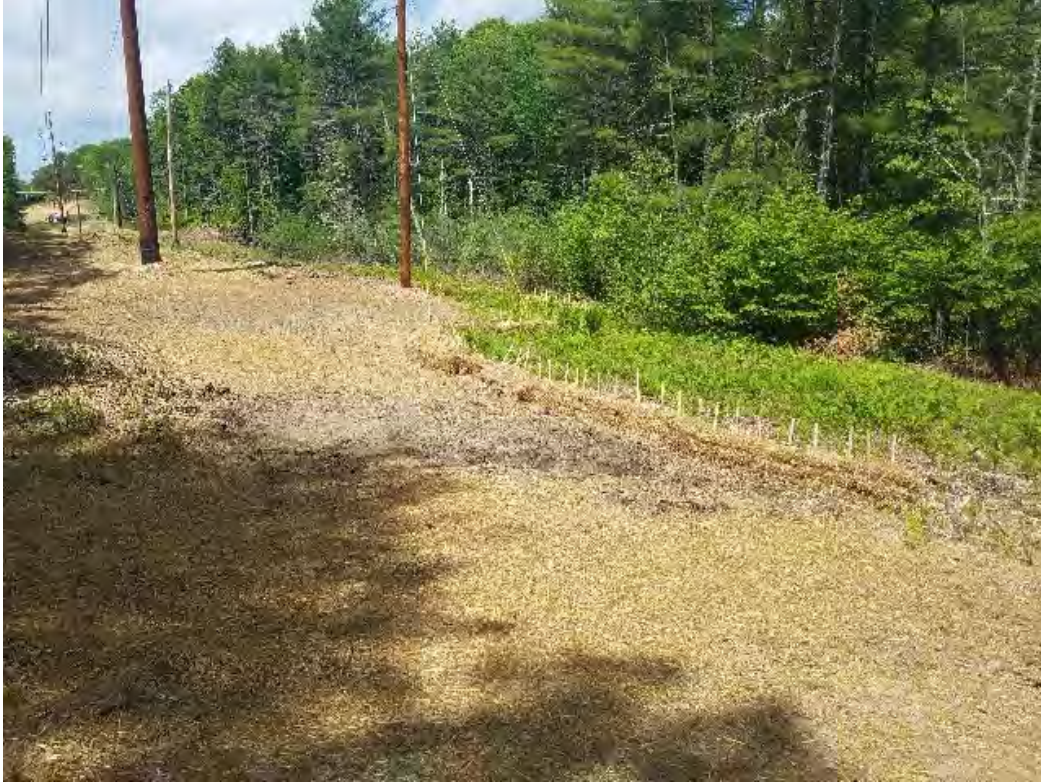
Fig 7: Str. 62 work area restored. Viewing west. (05-29-20).

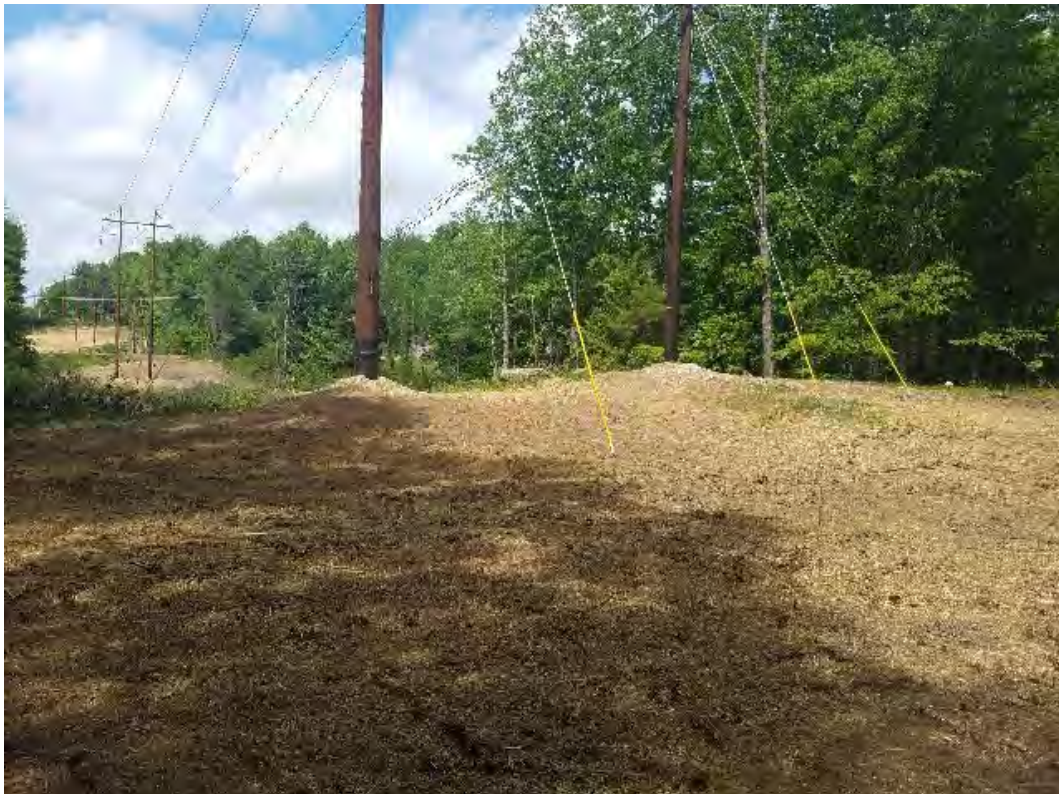
Fig 8: Str. 61 work area restored. Viewing west. (05-29-20).

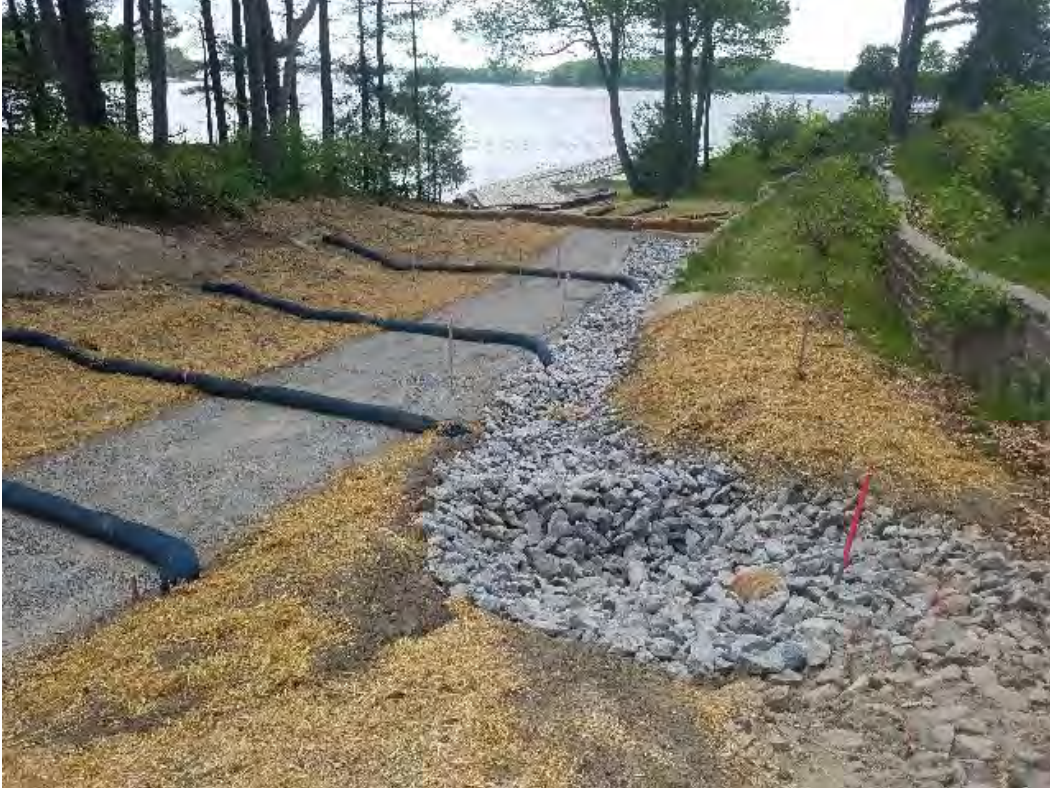
Fig 9: Rip rap swale installed along the slope at Gundalow landing/east side of the Bay. Viewing southwest. (05-29-20).

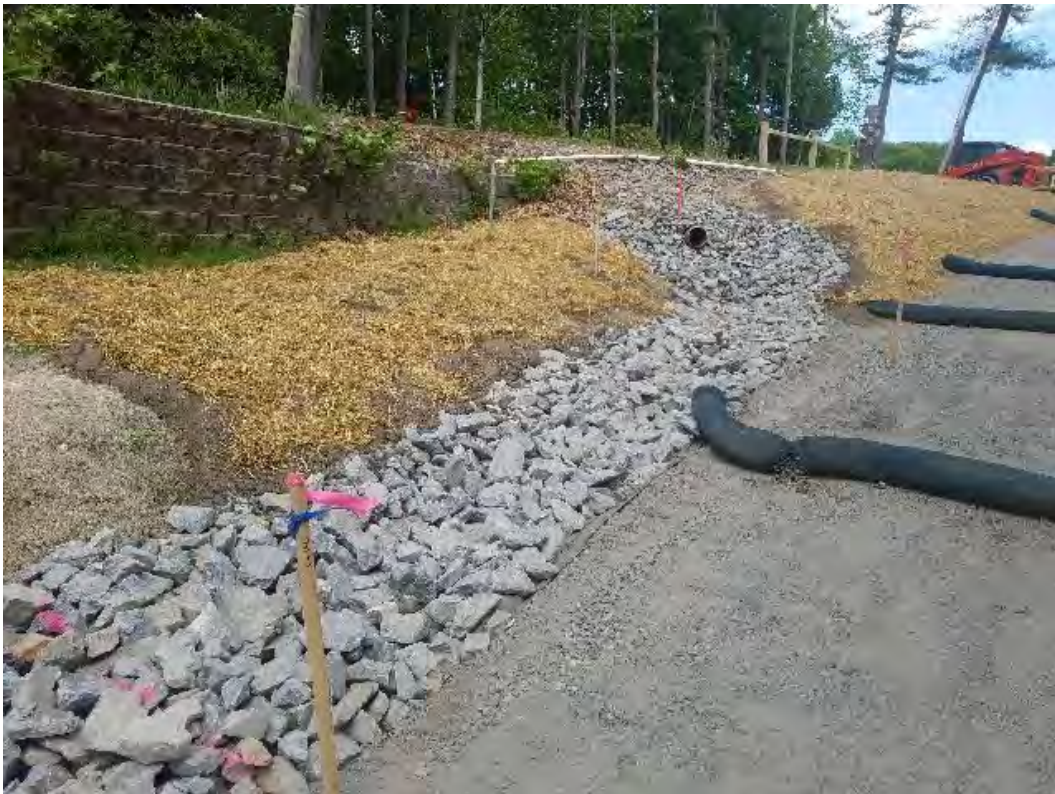
Fig 10: Rip rap swale installed along the slope at Gundalow landing/east side of the Bay. Viewing east. (05-29-20).

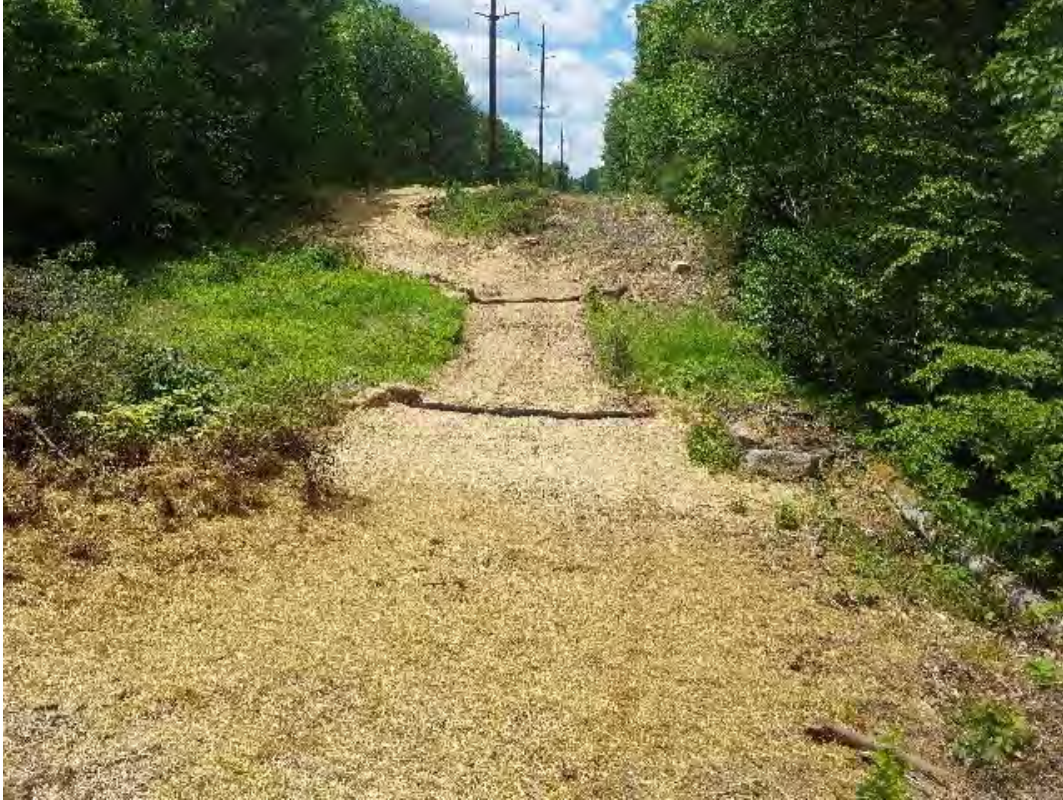
Fig 11: Restored access road between Strs. 65-66 and through wetland DW9. Viewing west. (06-01-20).

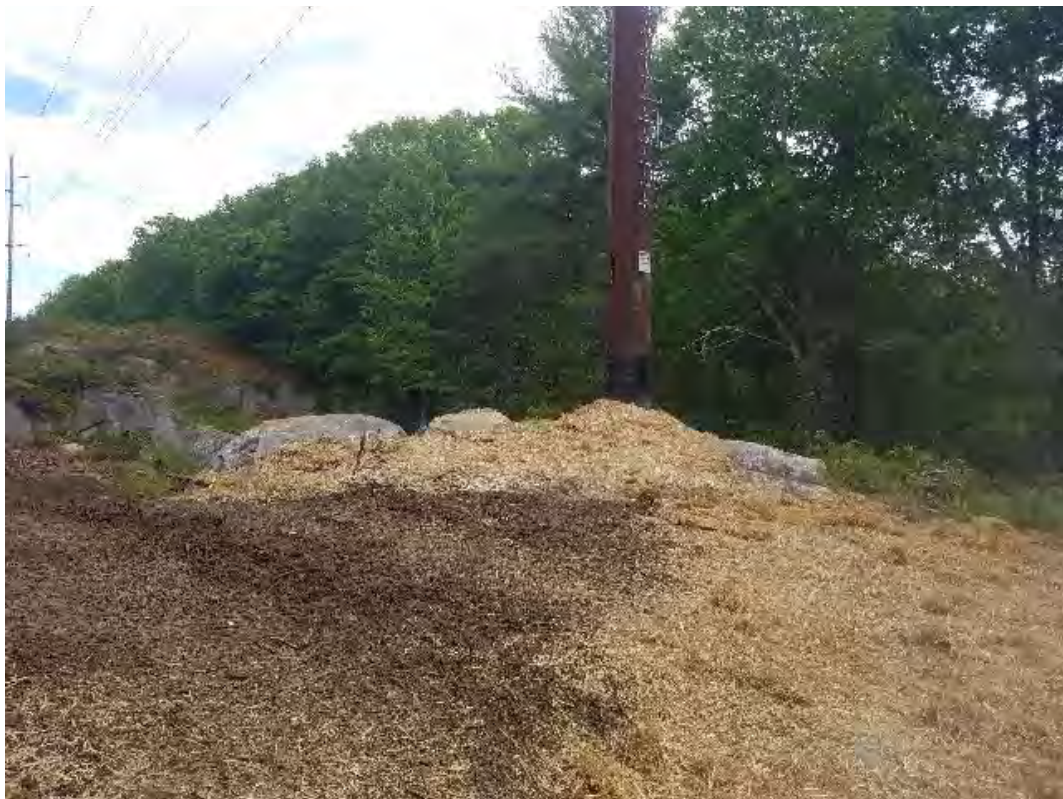
Fig 12: Str. 79 work area restored. Viewing east. (06-01-20).

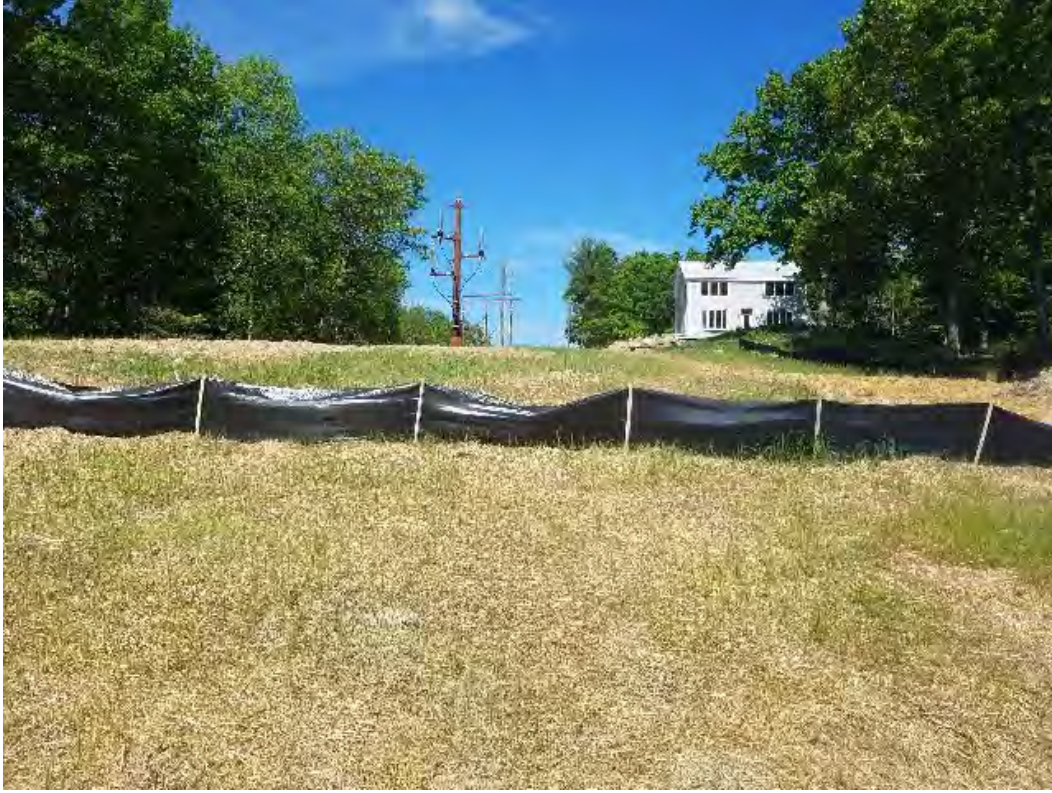
Fig 13: Vegetation on slope at Getchell property/west side of the Bay. Viewing west. (06-02-20).

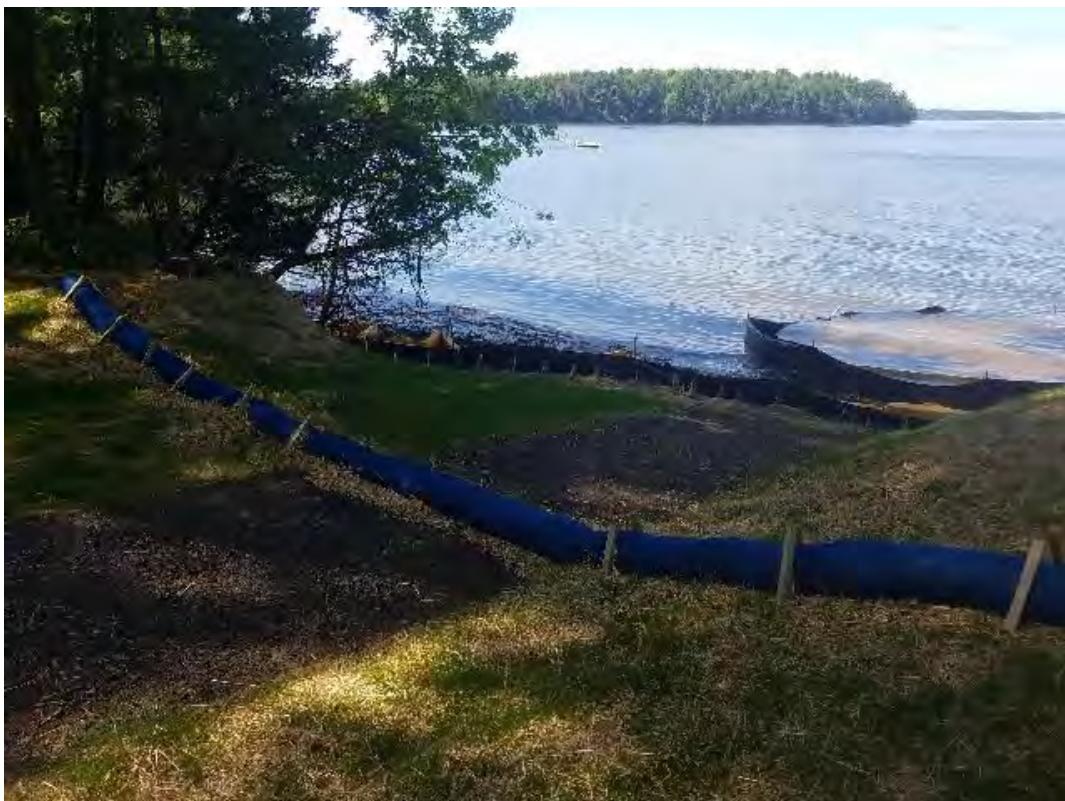
Fig 14: Vegetation on slope below man hole at Gundalow landing/east side of the Bay. Viewing southwest. (06-02-20).

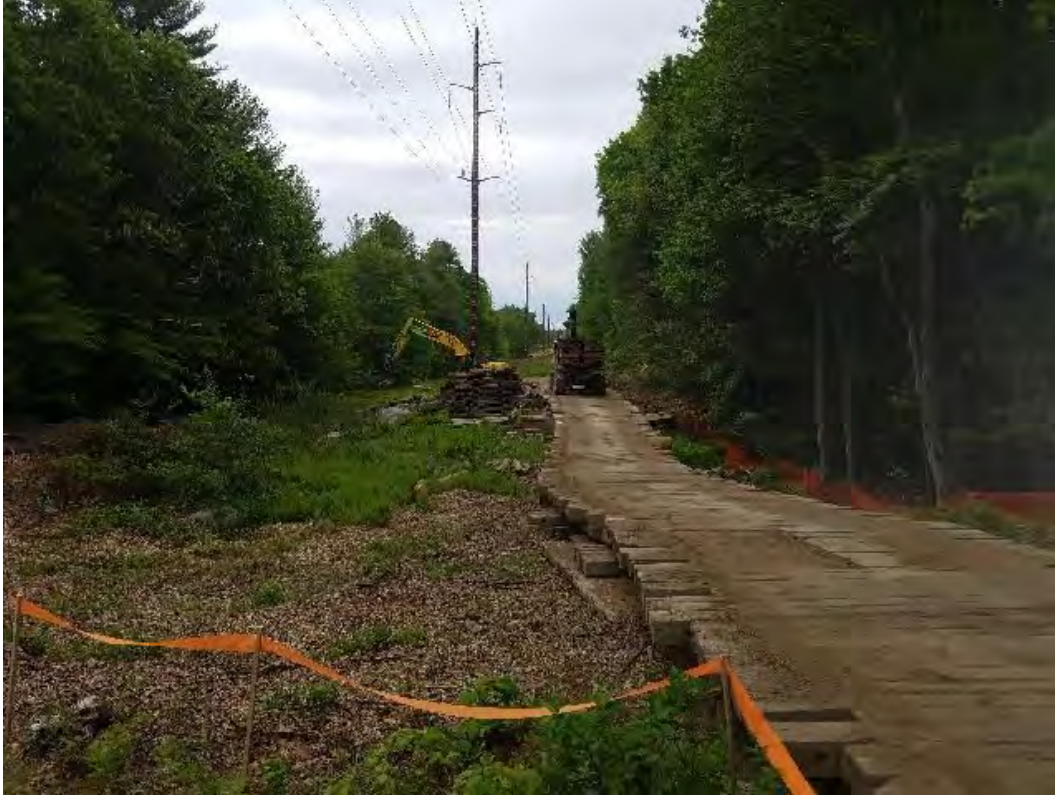
Fig 15: Removing timber mat access road and work pad at Str. 89. Viewing southeast. (06-03-20).

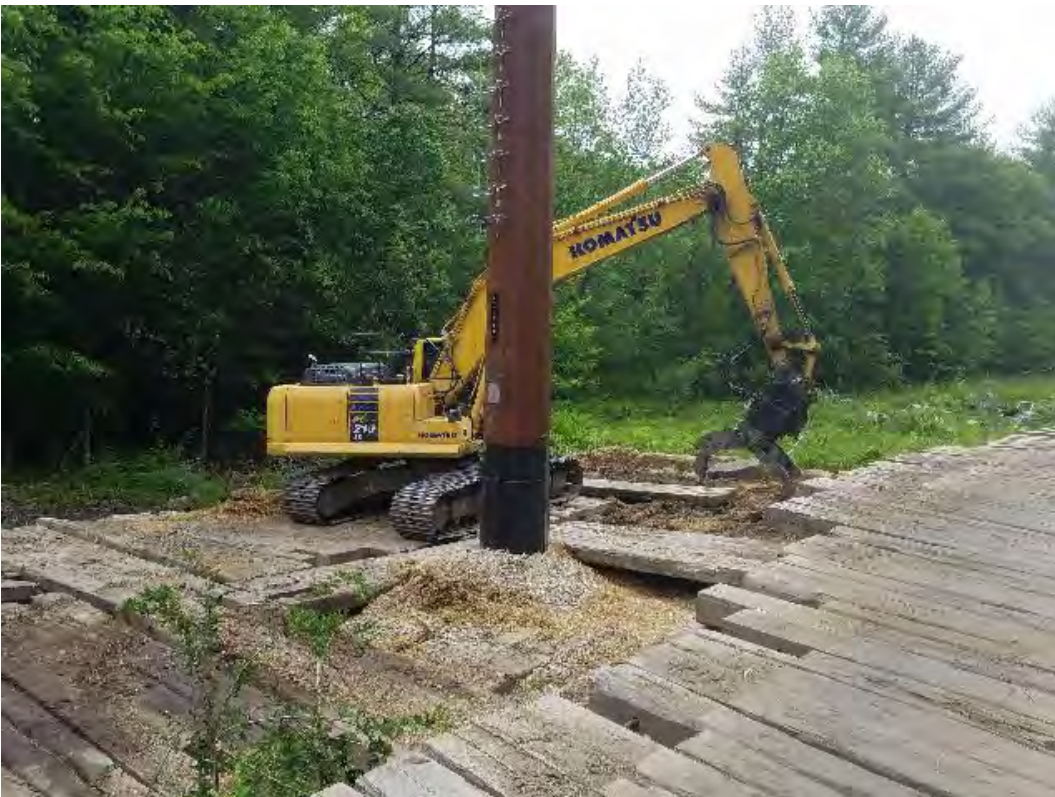
Fig 16: Removing timber mats used for work pad at Str. 89. Viewing northeast. (06-03-20).

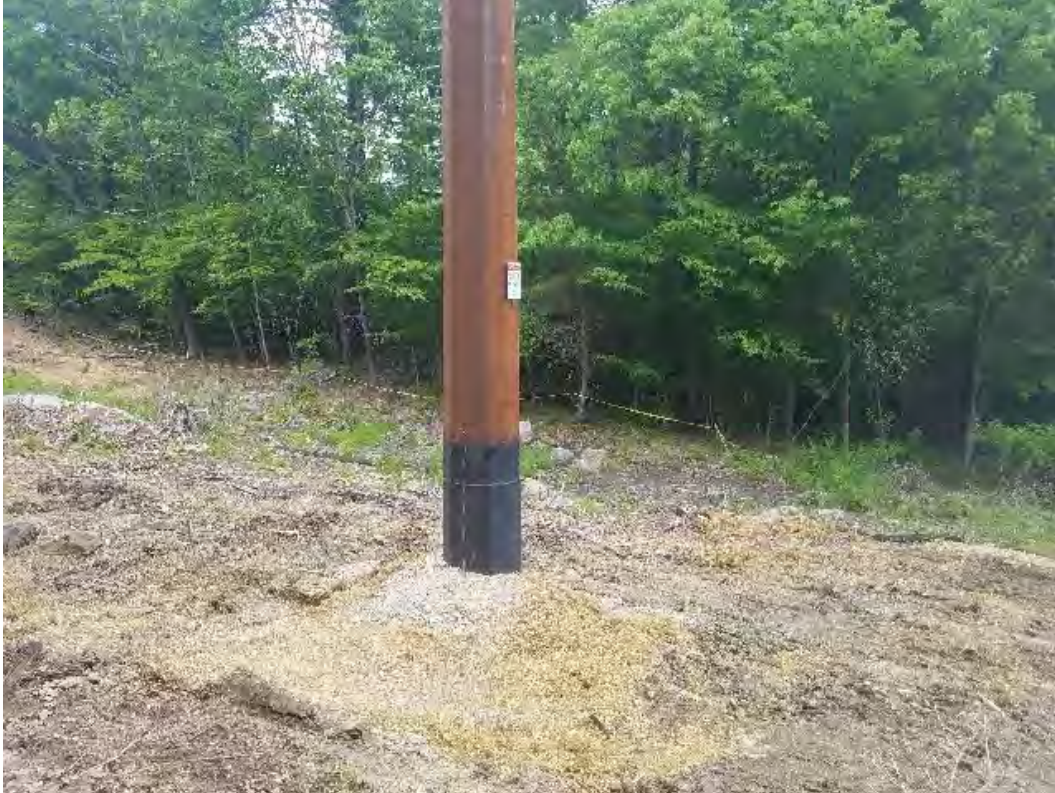
Fig 17: Timber mats removed around Str. 89. Viewing northeast. (06-03-20).

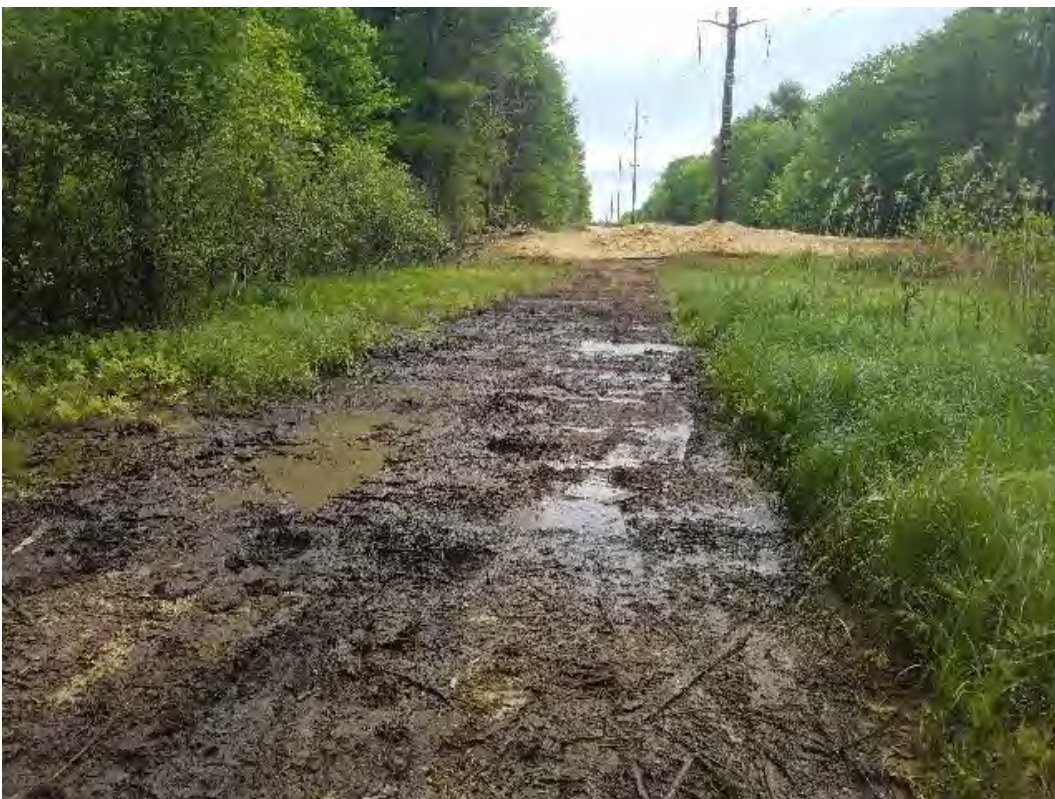
Fig 18: Timber mats removed from access road to Str. 75, through wetland DW21 Viewing east. (06-03-20).

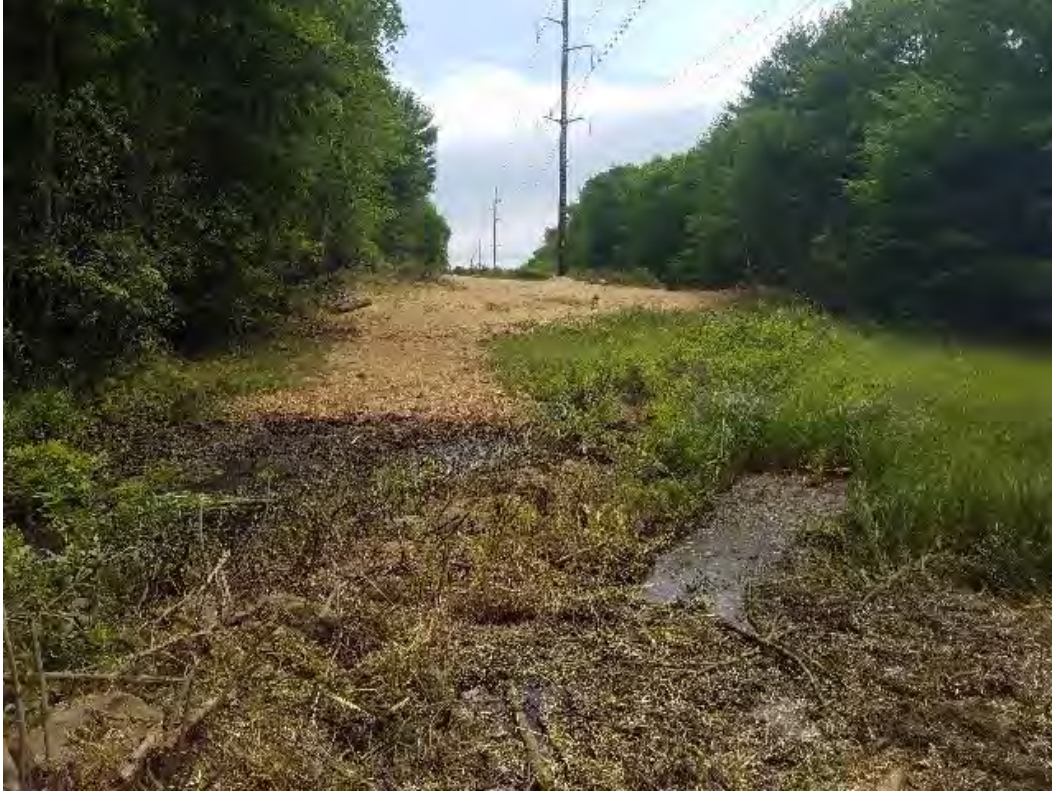
Fig 19: Timber mat bridge removed at stonewall WP-28 and through wetland DW25. Viewing east. (06-03-20).
