DRAINAGE MONITORING REPORT

F107 - Seacoast Reliability Project

Newington, New Hampshire

04.0190967.00

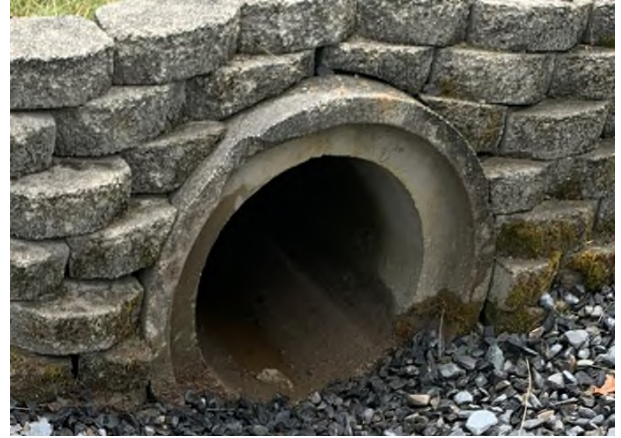
29 Gundalow -2 (Culvert)

Observations/Notes: Less than 0.5" if standing water in culvert

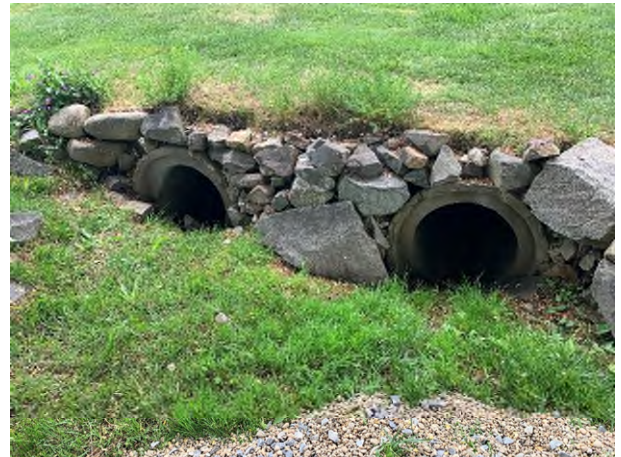
64 Gundalow -2 (Drainage Course)

Observations/Notes: Reading taken in culvert, with >0.5" of water. No surficial water in front of culvert inlet

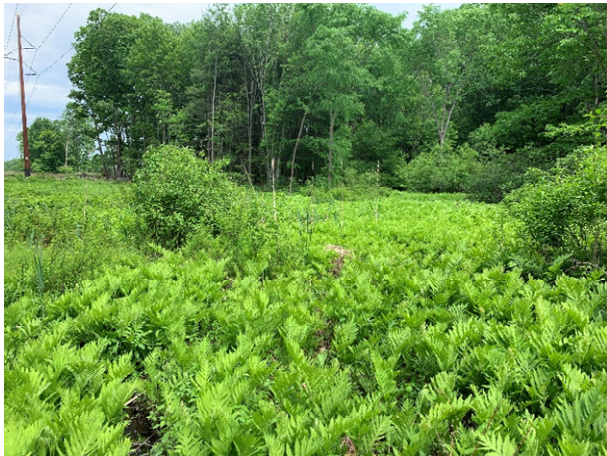
Hannah – 2 (Wetland NW-24)

Observations/Notes: Pockets of standing water in wetland

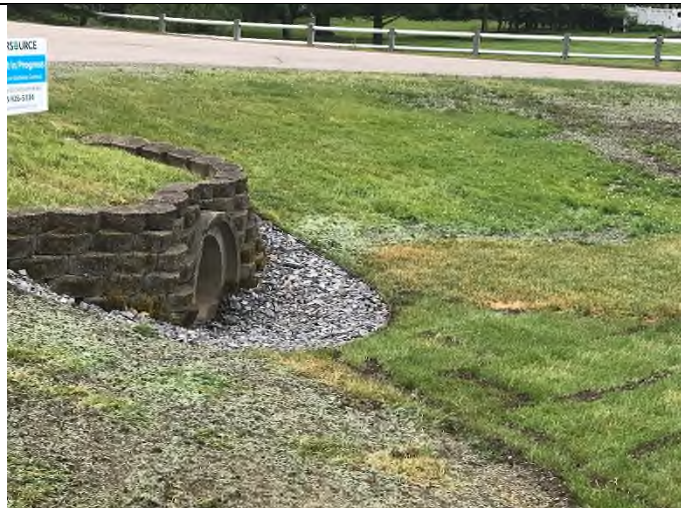
29 Gundalow -1 (Drainage Area)

Observations/Notes: No water at surface

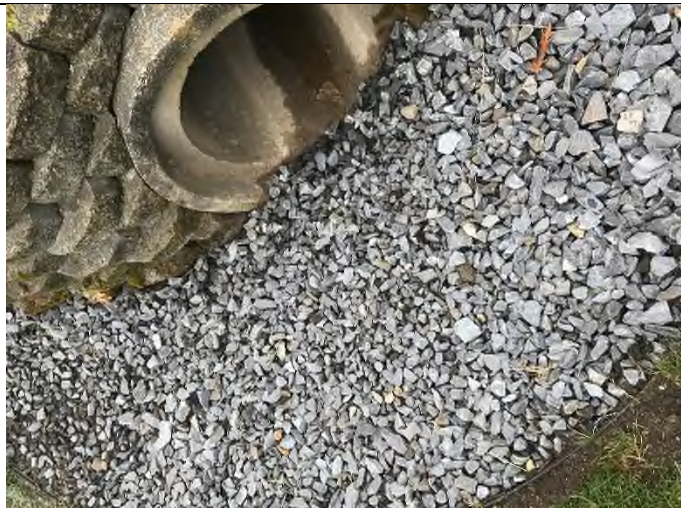
29 Gundalow -2 (Culvert)

Observations/Notes: ~0.5" of standing water in culvert

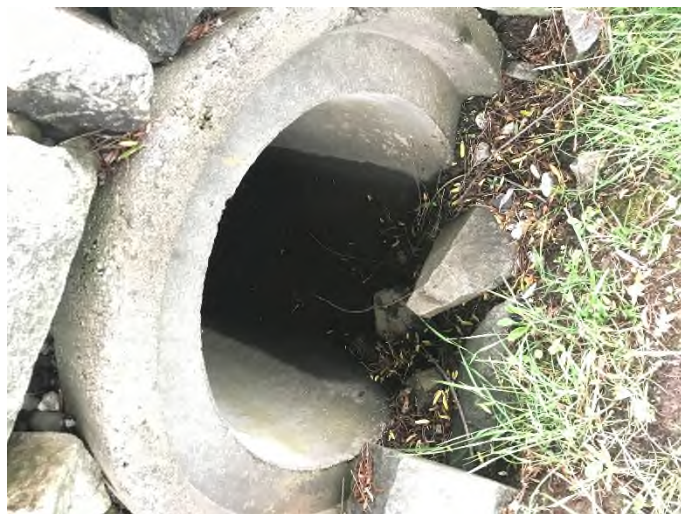
64 Gundalow - 1 (Drainage Course)

Observations/Notes: Standing water just after culvert outlet. No other surficial water observed in drainage course.

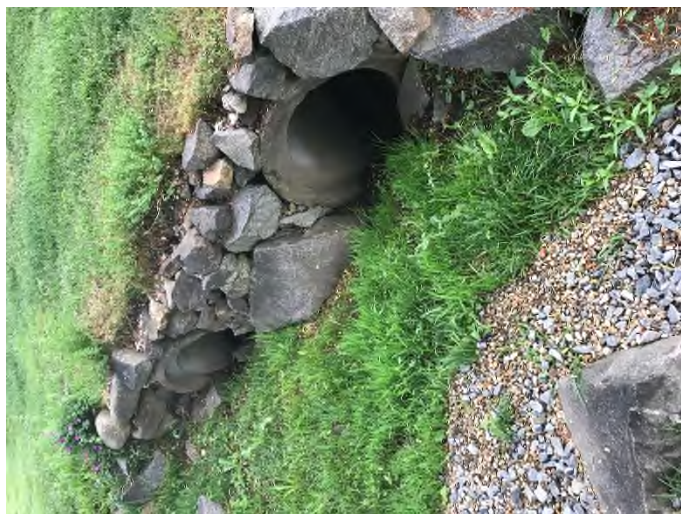
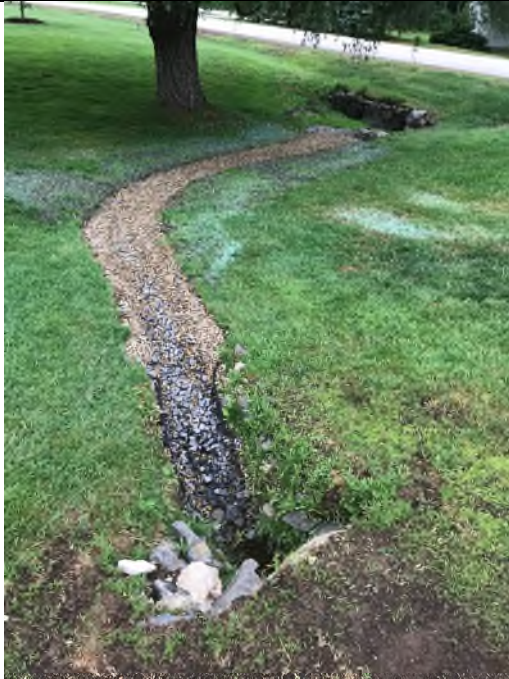
64 Gundalow -2 (Drainage Course)

Observations/Notes: ~1.5" of standing water at entrance to Brickyard culvert

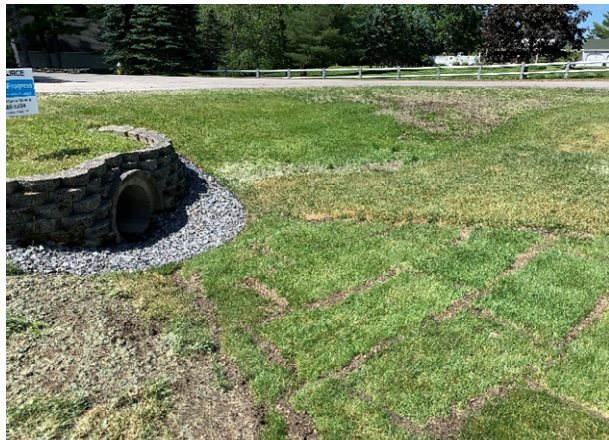
29 Gundalow -1 (Drainage Area)

Observations/Notes: No water at surface

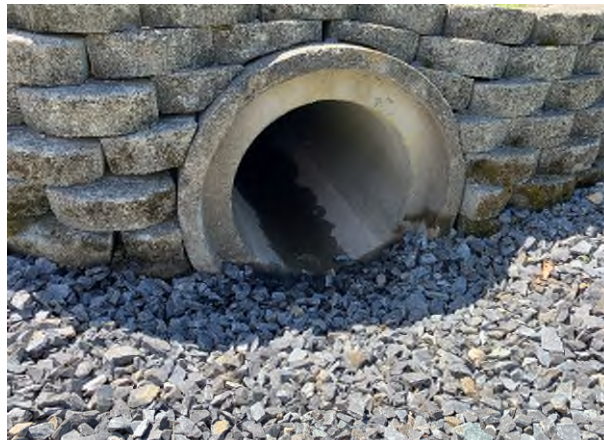
29 Gundalow -2 (Culvert)

Observations/Notes: Less than 0.5" of standing water in culvert

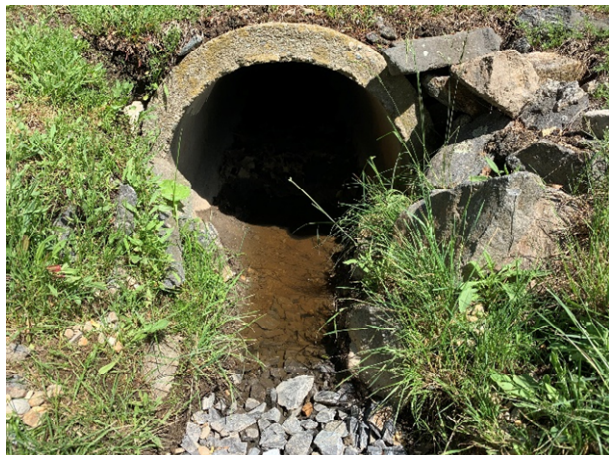
64 Gundalow - 1 (Drainage Course)

Observations/Notes: Water pooled approximately 18" from end of culvert. No other surficial water observed in drainage course.

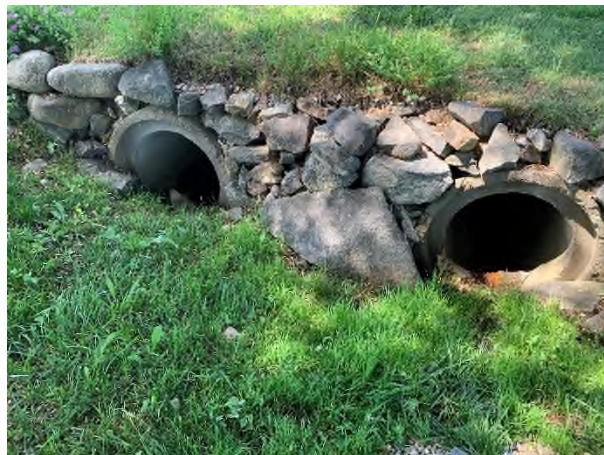
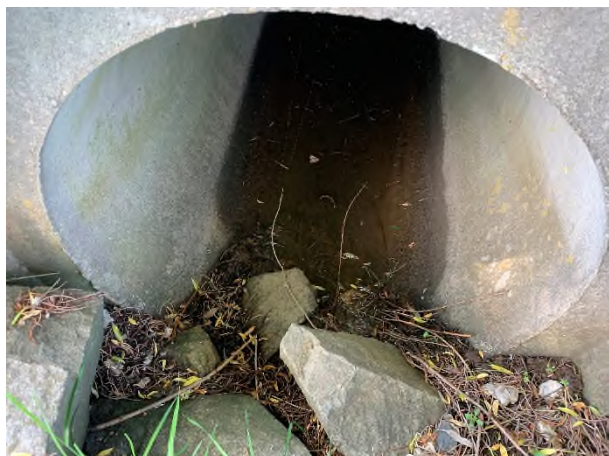
64 Gundalow -2 (Drainage Course)

Observations/Notes: Less than 0.5" of standing water at entrance to Brickyard culvert

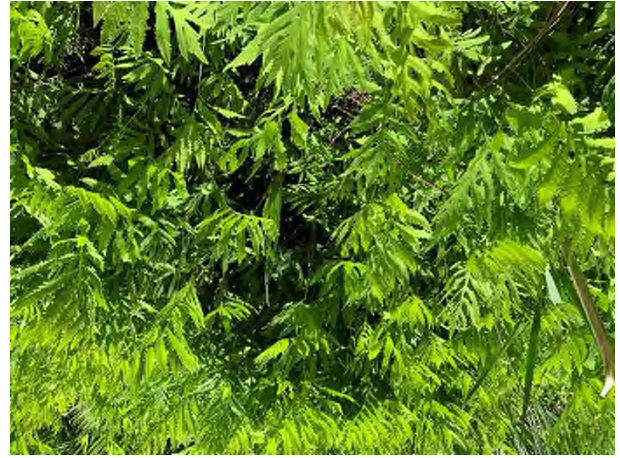
Hannah 2 – (Wetland NW-24)

Observations/Notes: Mostly dry, some small pockets of standing water less than 1" deep

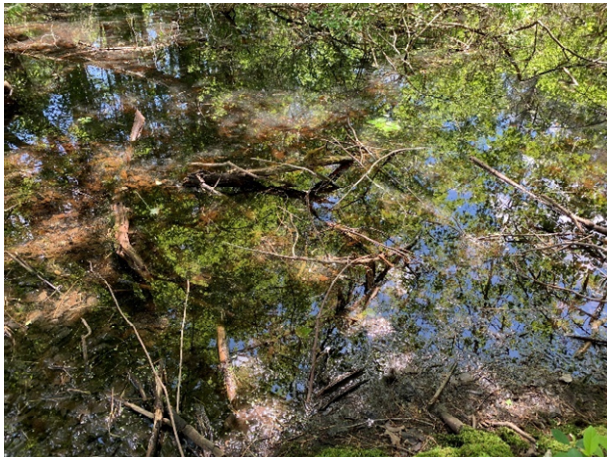
Flynn Pit 1 – (Wetland NW-4)

Observations/Notes: ~3" standing water

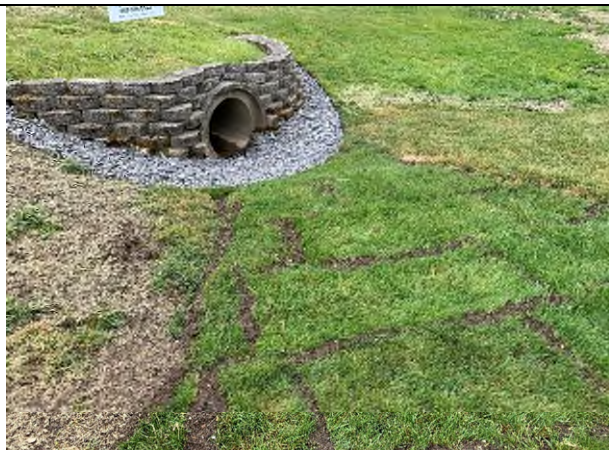
29 Gundalow -1 (Drainage Area)

Observations/Notes: No water at surface

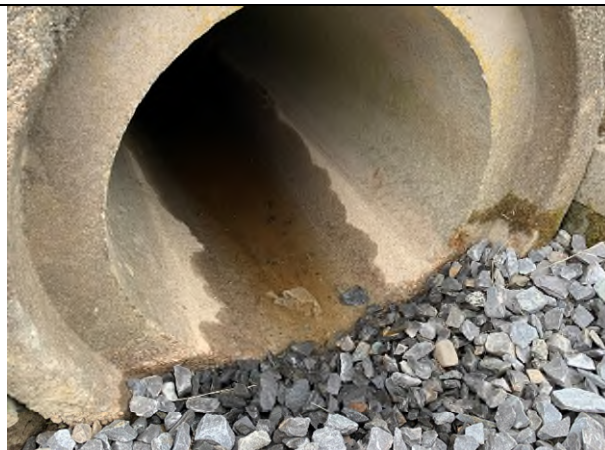
29 Gundalow -2 (Culvert)

Observations/Notes: Less than 0.5" of standing water in culvert

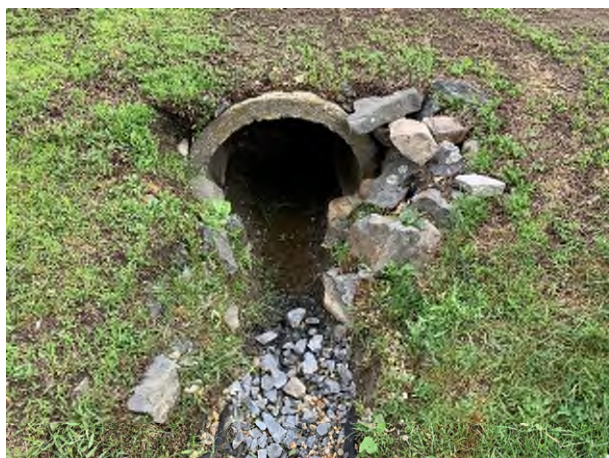
64 Gundalow - 1 (Drainage Course)

Observations/Notes: Water pooled approximately 12" from end of culvert. No other surficial water observed in drainage course.

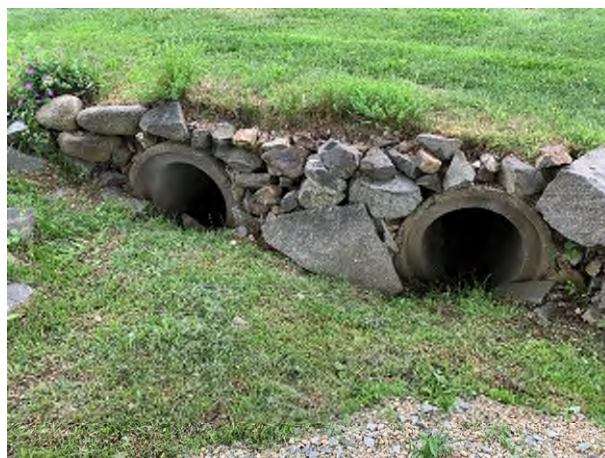
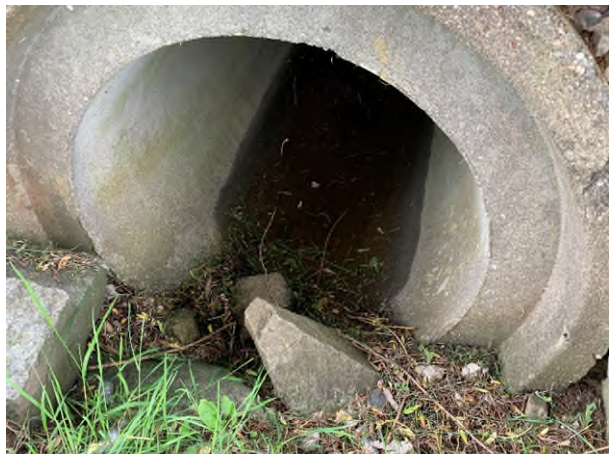
64 Gundalow -2 (Drainage Course)

Observations/Notes: Less than 0.5" of standing water inside Brickyard culvert

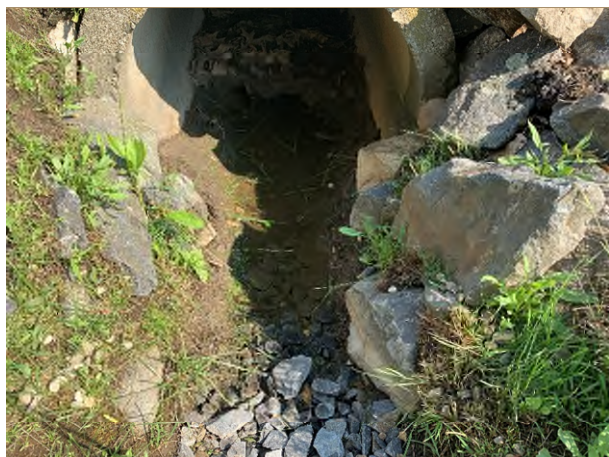
64 Gundalow - 1 (Drainage Course)

Observations/Notes: Water pooled approximately 1" from end of culvert. No other surficial water observed in drainage course.

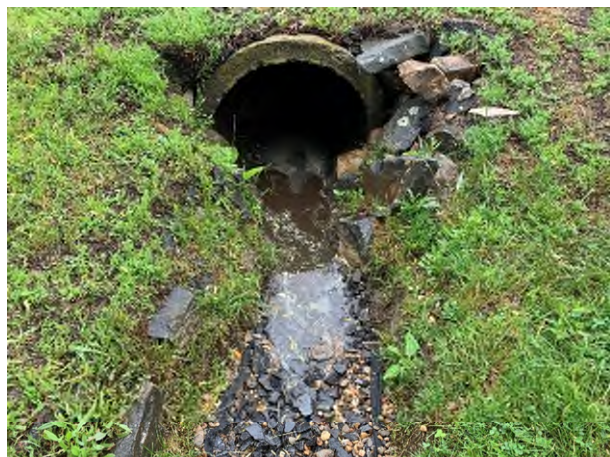
64 Gundalow - 1 (Drainage Course)

Observations/Notes: Water pooled approximately 48" from end of culvert. No other surficial water observed in drainage course.

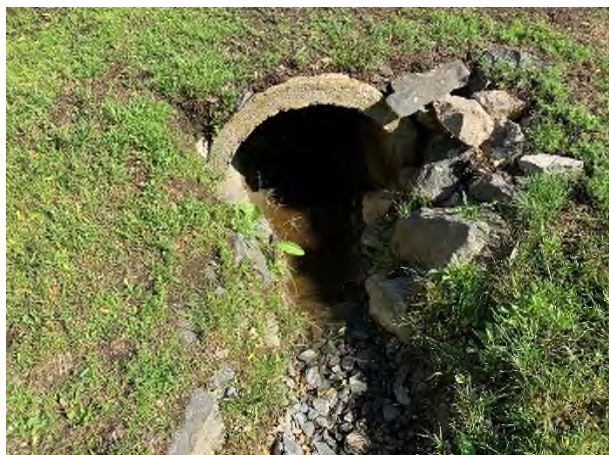
64 Gundalow - 1 (Drainage Course)

Observations/Notes: Standing water approx. 3-4" deep, pooled approx. 18" from end of culvert. No other surficial water observed in drainage course.
