CONSTRUCTION MONITORING REPORT

Eversource Transmission Lines:
F107

**Madbury, Durham,
Newington, Portsmouth, NH**

TYPE OF INSPECTION: Weekly Storm Event Incident Corrective Action

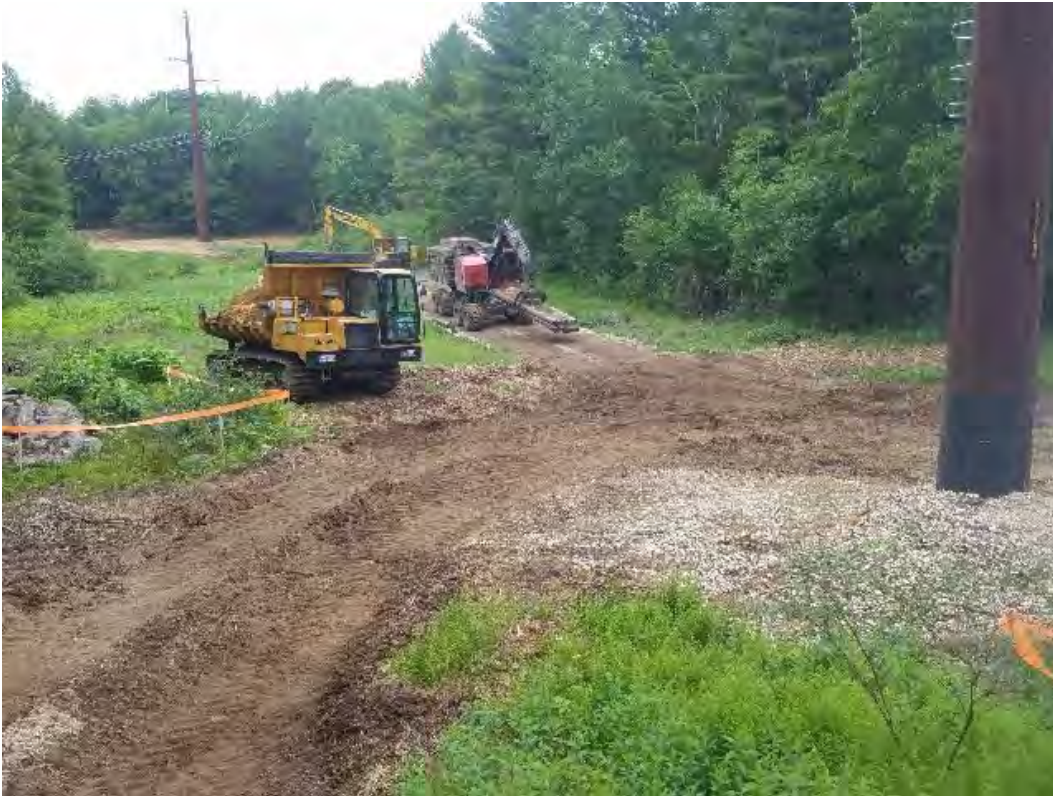
Fig 1: Crew beginning to remove timber mat access road between Strs.85-86, through wetland DW24. Viewing northwest. (06-11-20).

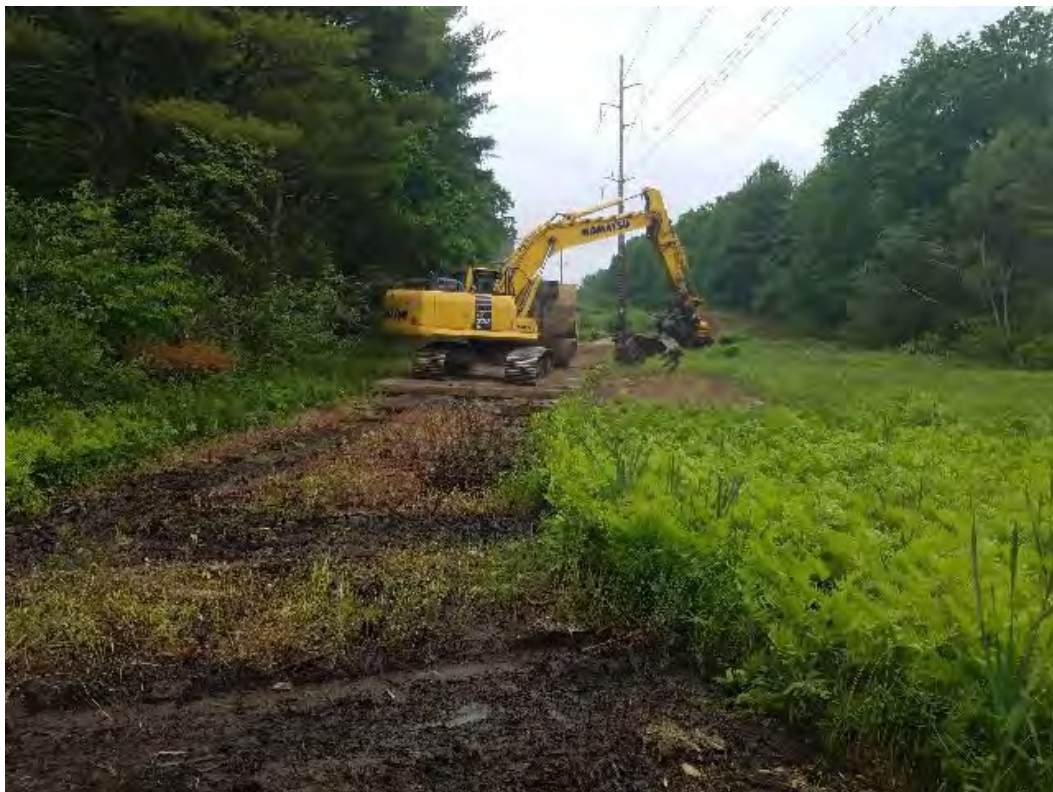
Fig 2: Crew removing timber mat access road between Strs.85-86, through wetland DW24. Viewing southeast. (06-11-20).

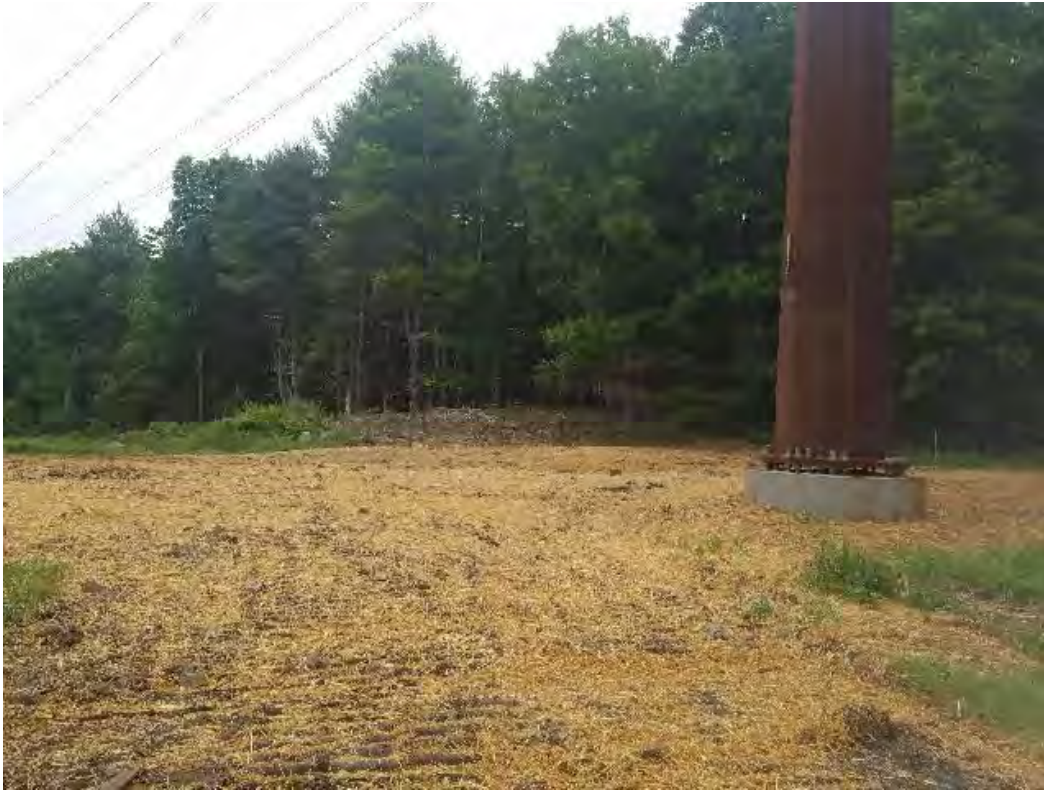
Fig 3: Str. 85 work area restored. Viewing northwest. (06-11-20).

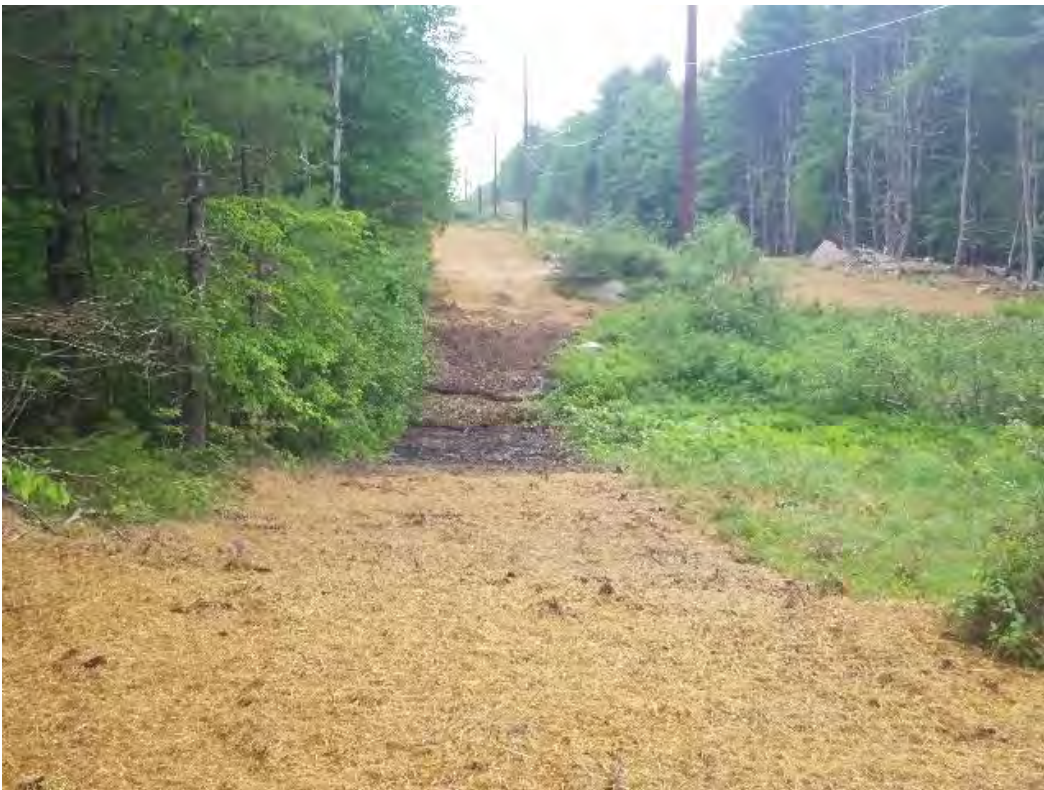
Fig 4: Access road between Strs. 85-84, through wetland DW30 restored. Viewing west. (06-11-20).

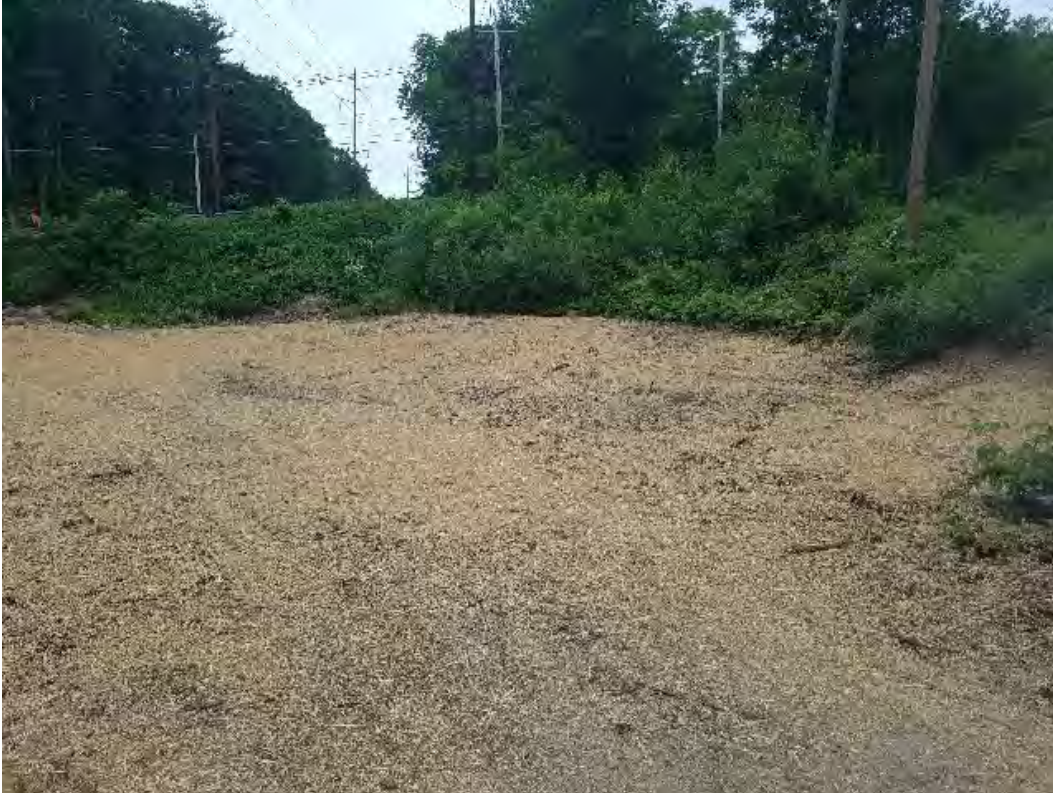
Fig 5: Dewatering basin location at Str. 32. Basin removed and restored. Viewing south. (06-11-20).

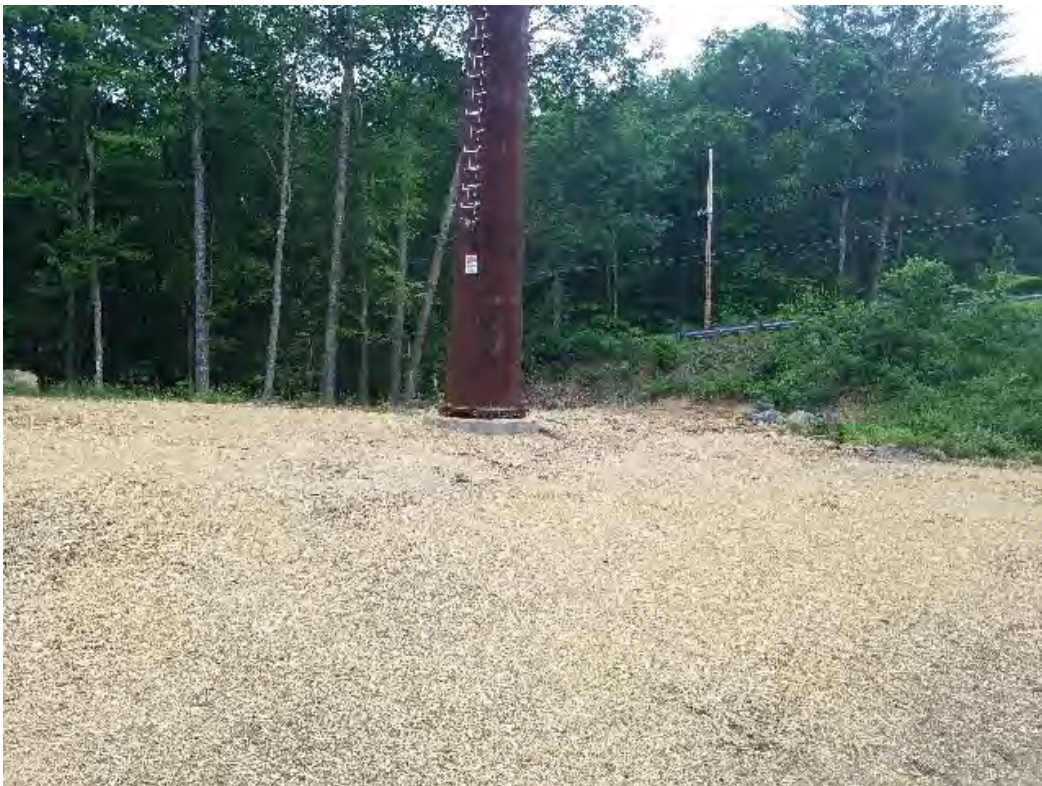
Fig 6: Str.32 work area restored. Viewing southeast. (06-11-20).

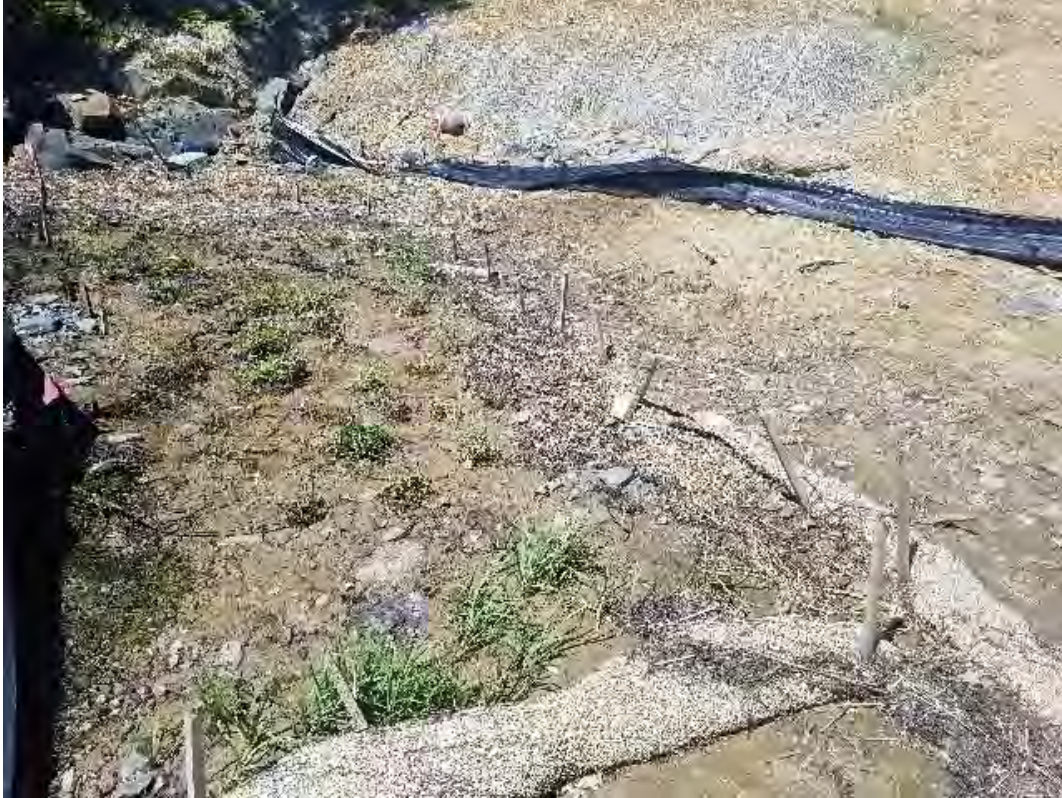
Fig 7: Salvaged salt marsh replanted at Getchell property/west side of the Bay. Viewing south. (06-15-20).

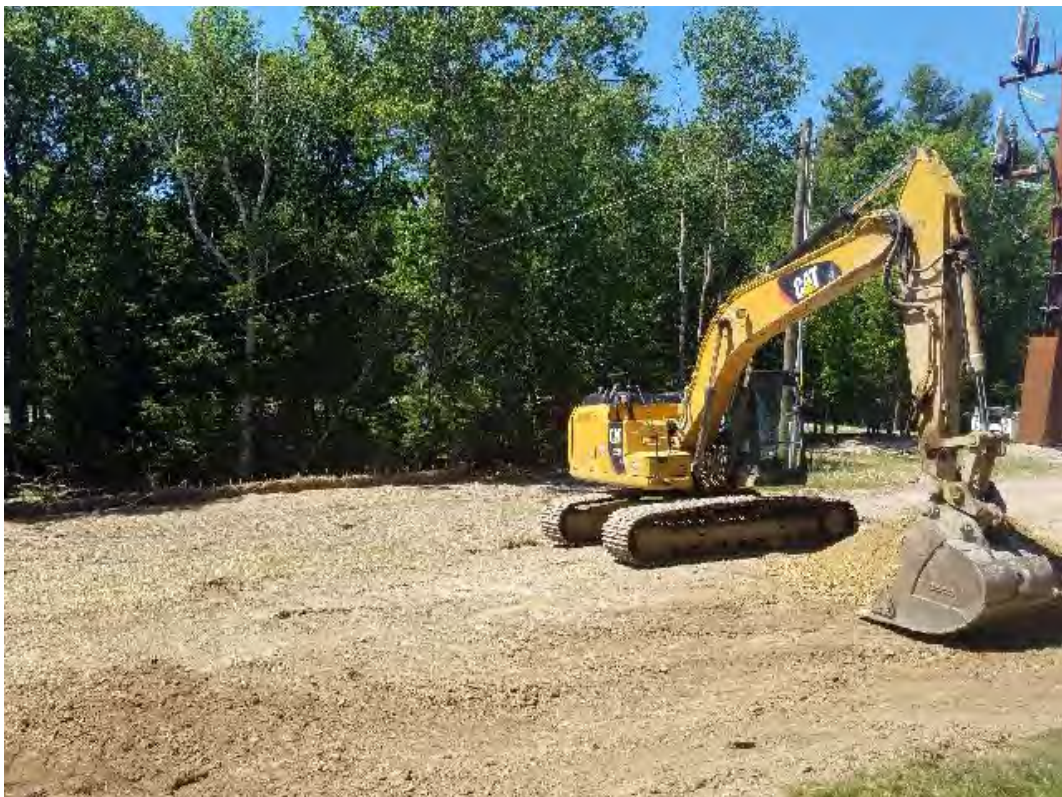
Fig 8: Removing timber mat pull pad at Str. 99 at Getchell property/west side of bay. Viewing south. (06-15-20).

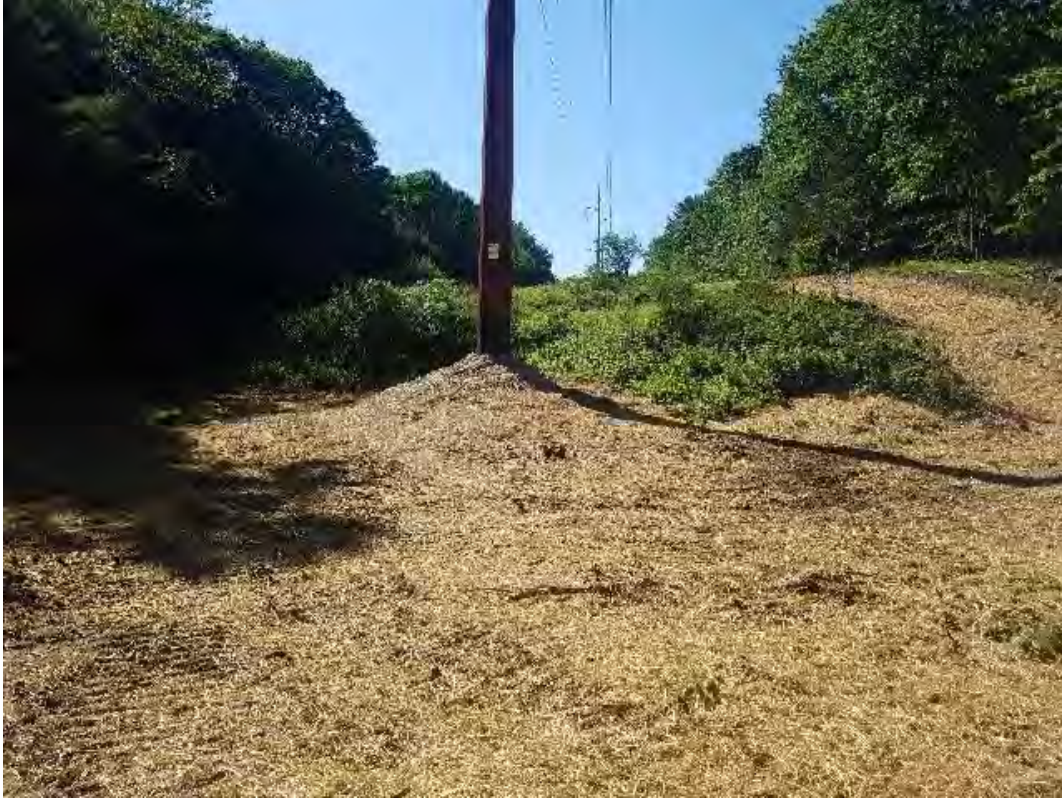
Fig 9: Str. 86 work area restored. Viewing south. (06-16-20).

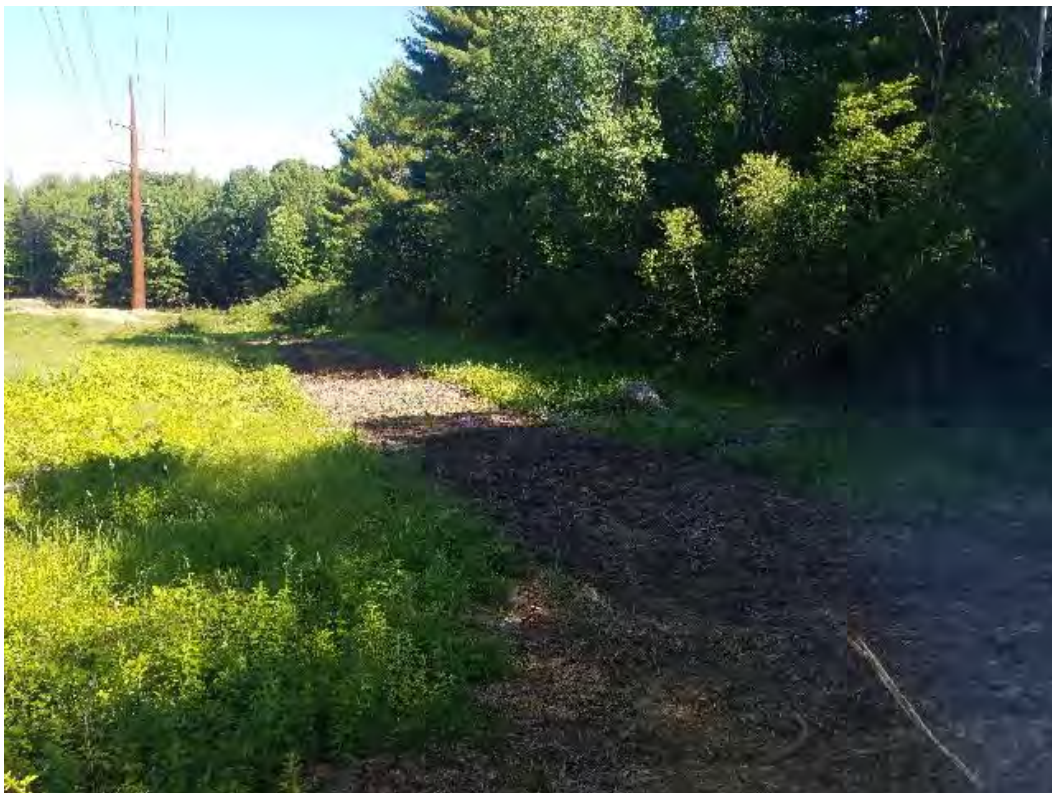
Fig 10: Wetland DW24 restored. Viewing northwest. (06-16-20).

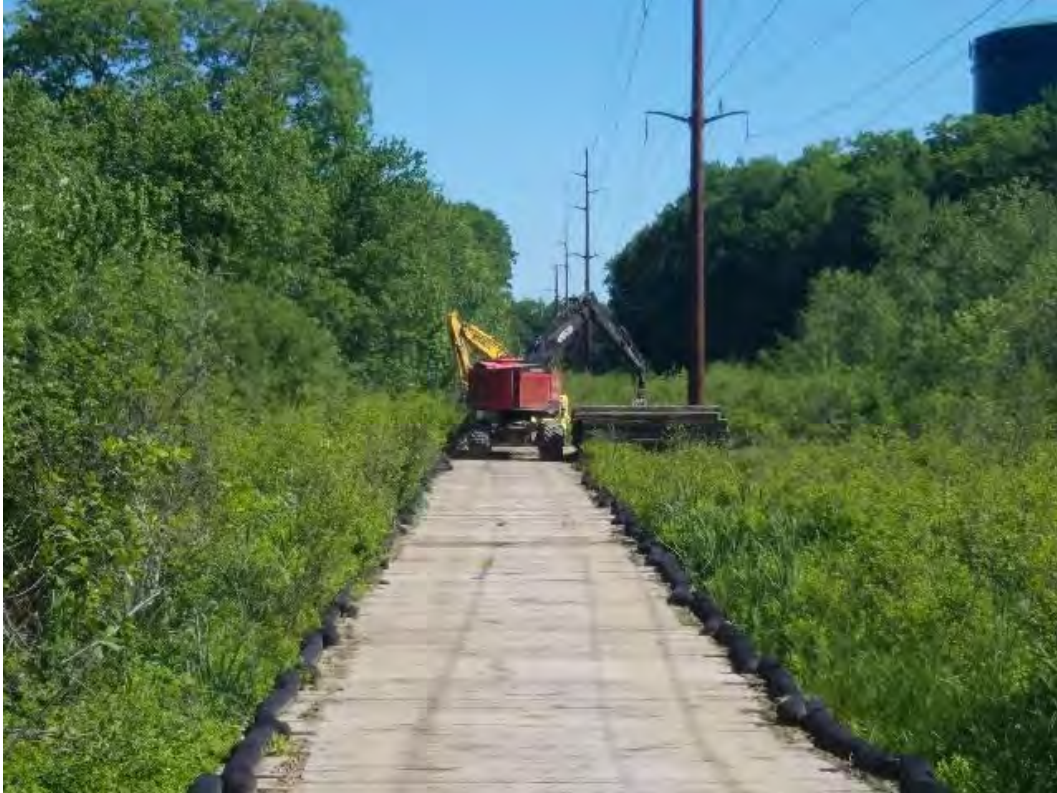
Fig 11: Crew beginning to remove timber mat access road to Str. 35, through wetland DW41. Viewing north. (06-16-20).

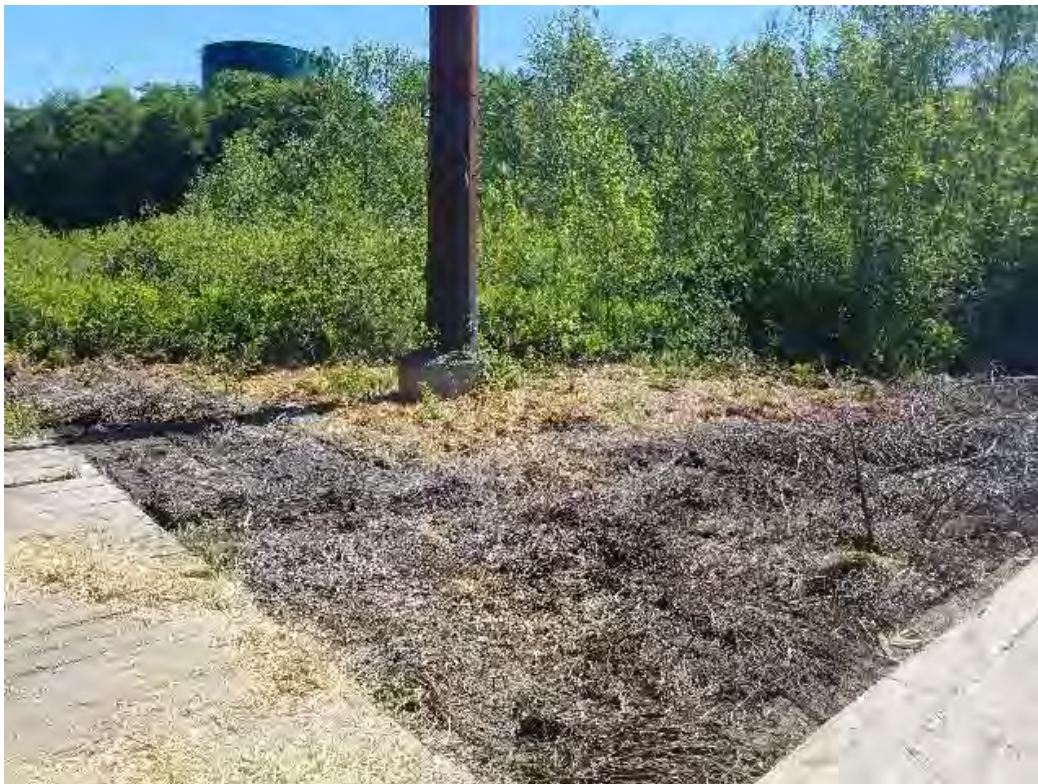
Fig 12: Timber mat work pad removed around Str. 35. Viewing northeast. (06-16-20).

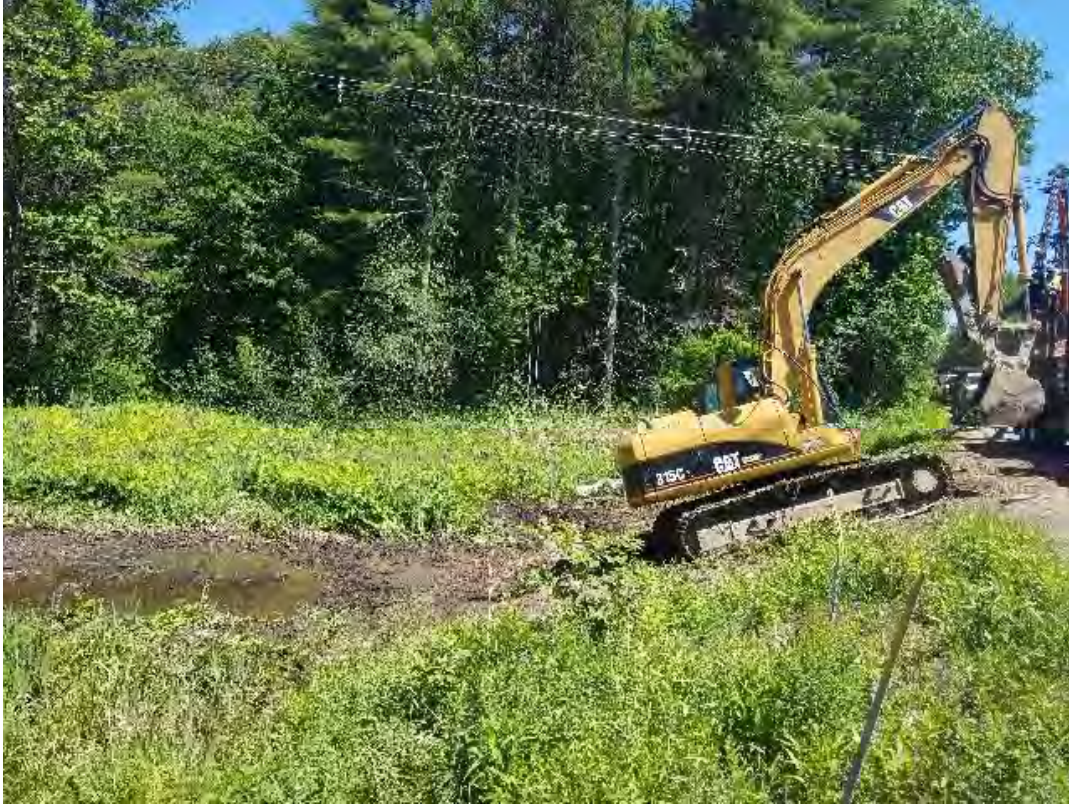
Fig 13: Crew removing timber mat bridge through wetland DW29, off of Route 108. Viewing north. (06-16-20).

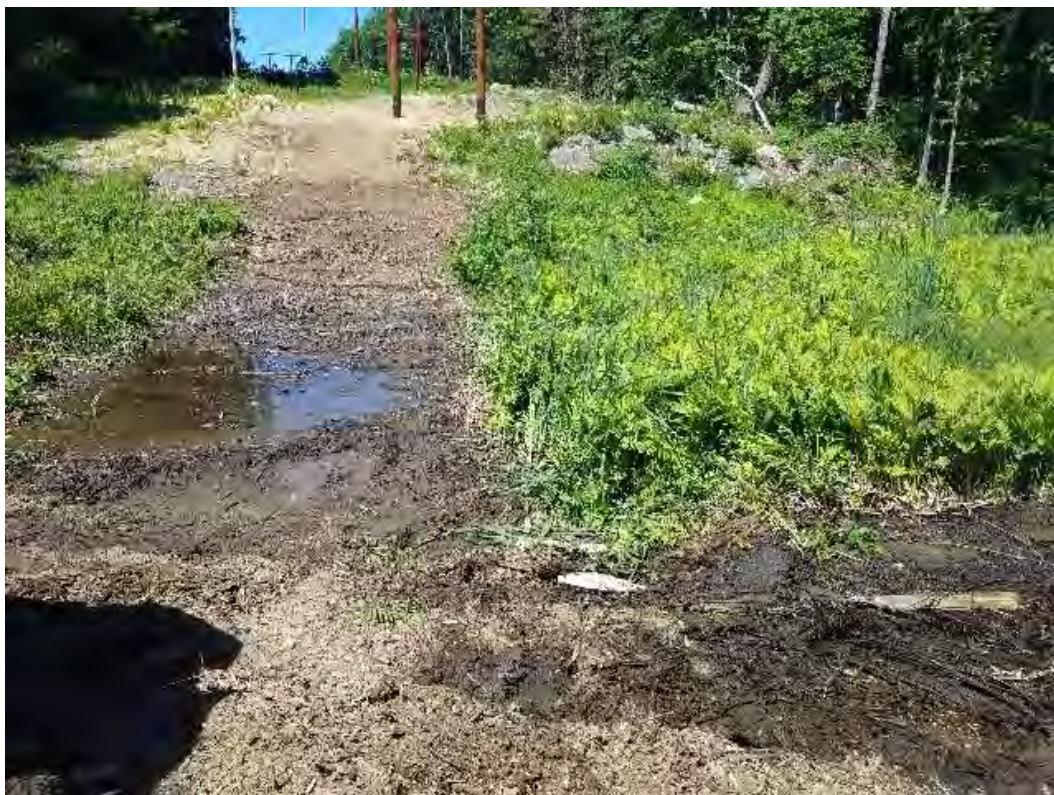
Fig 14: Crew removing timber mat bridge through wetland DW29, off of Route 108. Viewing west. (06-16-20).

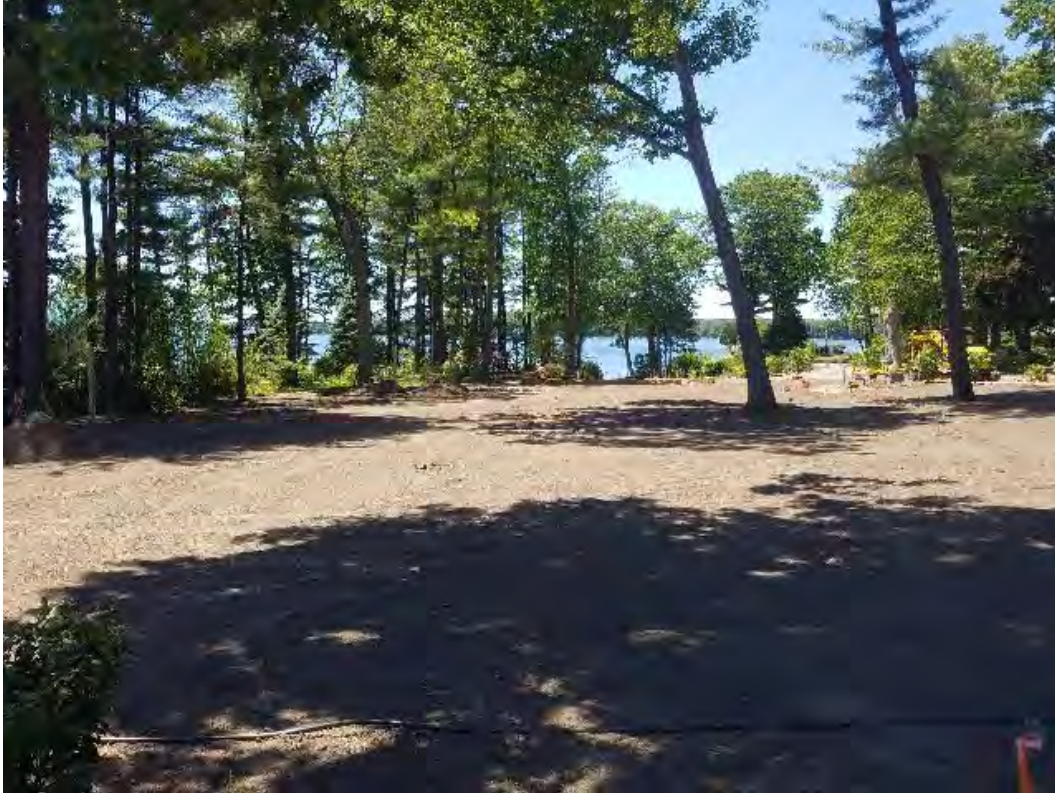
Fig 15: Landscape activities at Gundalow landing/east side of the Bay. Viewing west. (06-16-20).

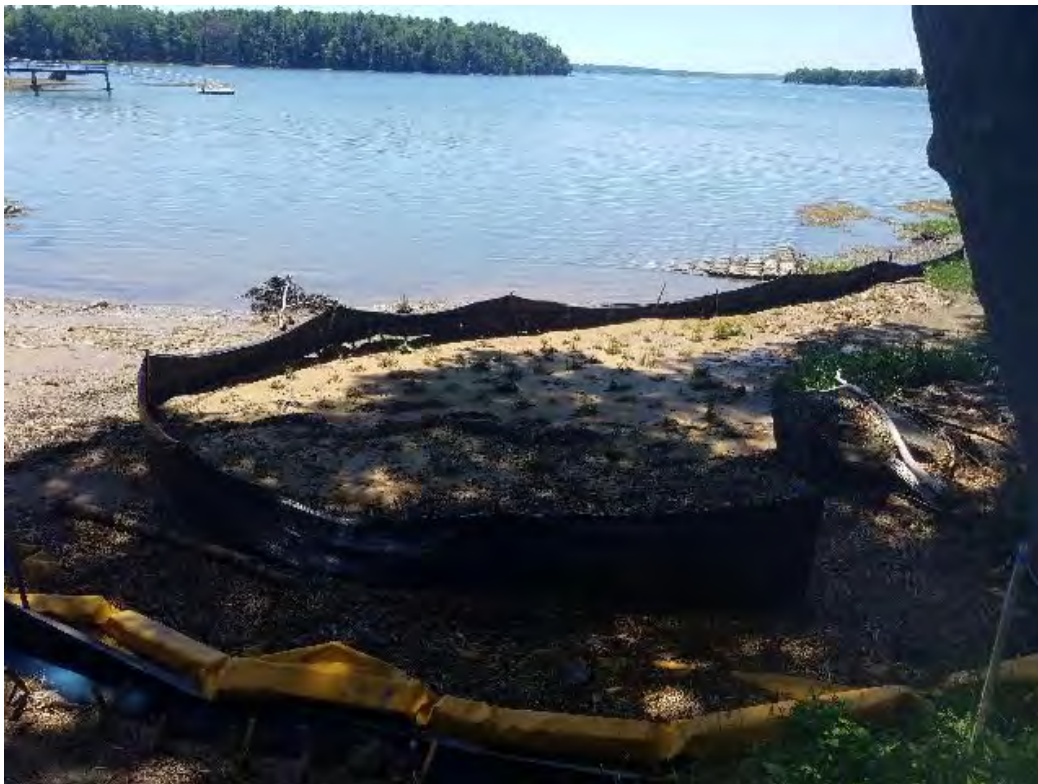
Fig 16: Salvaged salt marsh replanted at Gundalow landing/east side of the Bay. Viewing west. (06-16-20).

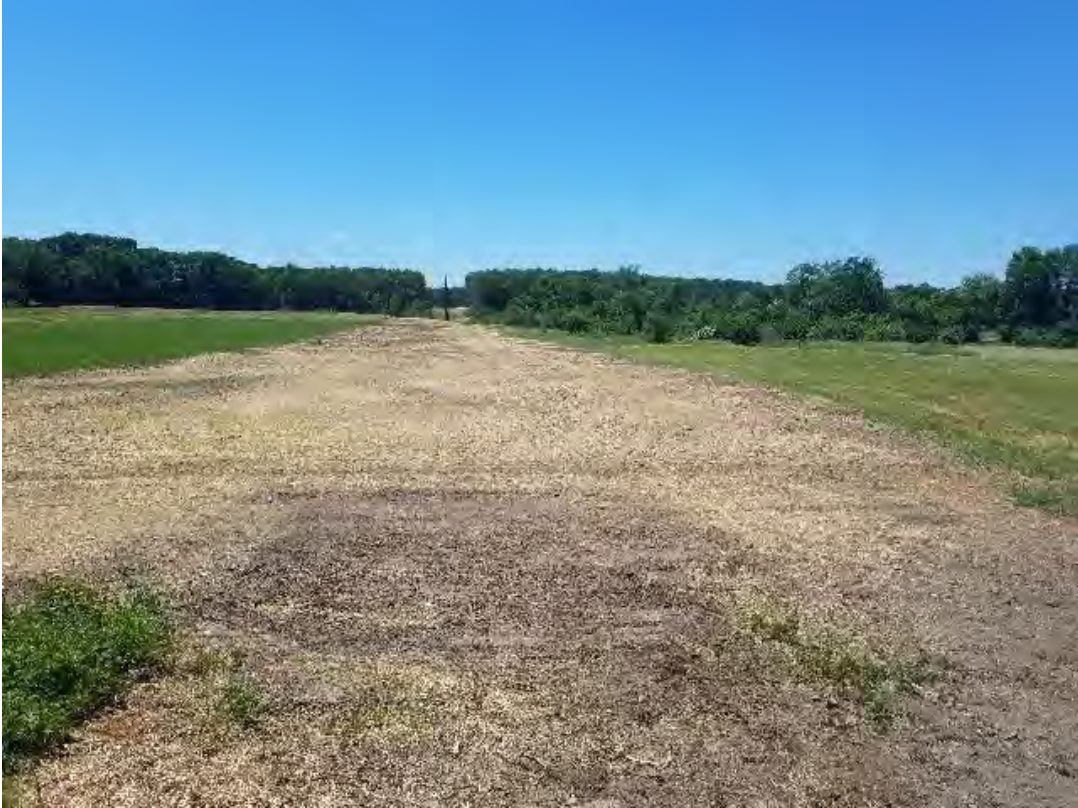
Fig 17: Frink farm restored. Viewing west. (06-16-20).

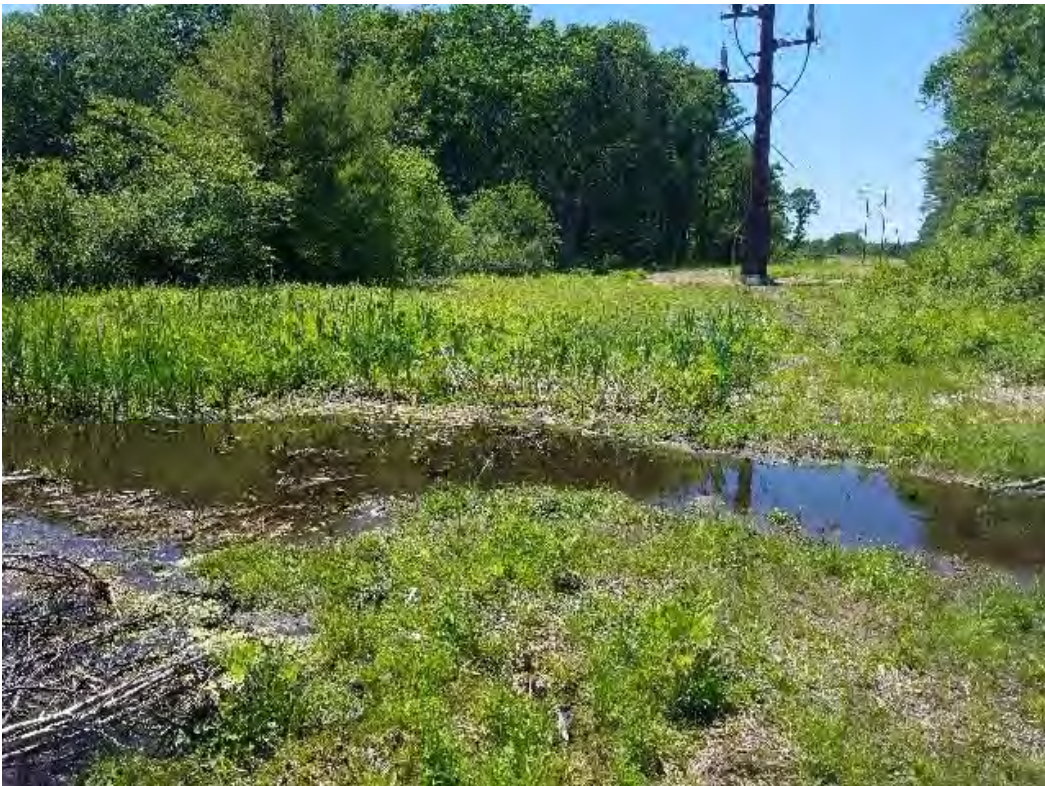
Fig 18: Wetland NW16 and Knights Brook at Frink farm. Viewing west. (06-16-20).

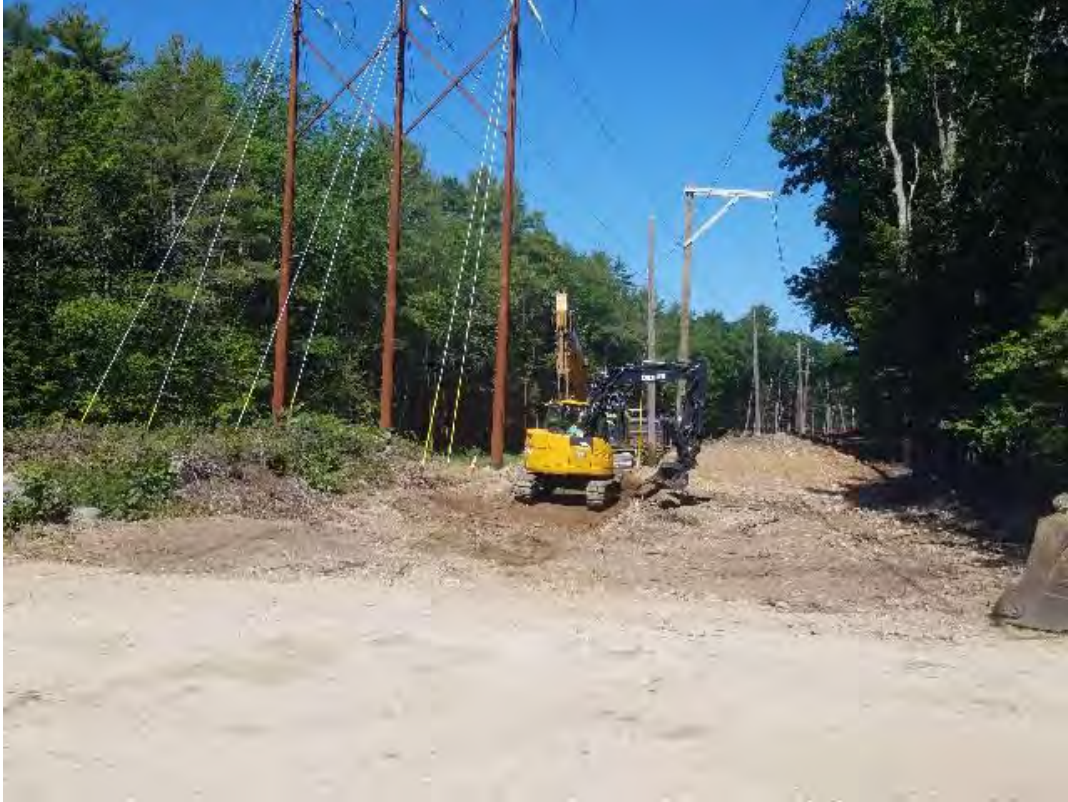
Fig 19: Crew beginning to remove access road to Str. 98. Viewing west. (06-17-20).

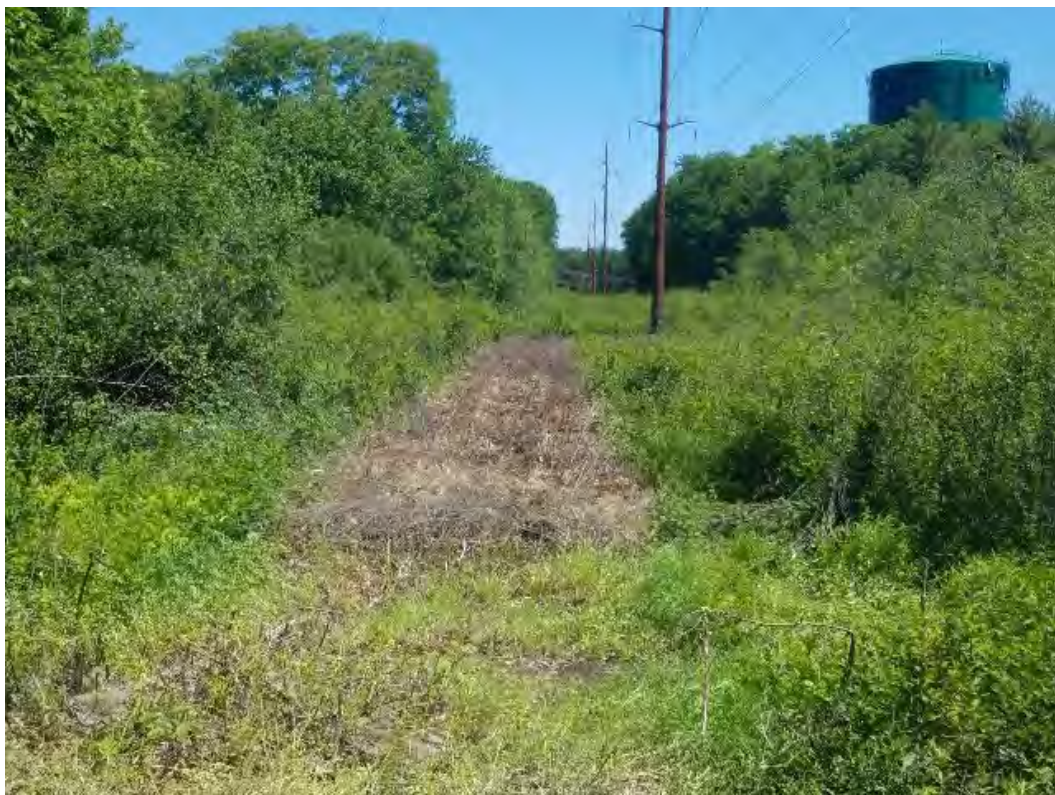
Fig 20: Access road to Str. 35, through wetland DW41 restored. Viewing north. (06-17-20).
