DRAINAGE MONITORING REPORT

F107 - Seacoast Reliability Project

Newington, New Hampshire

04.0190967.00

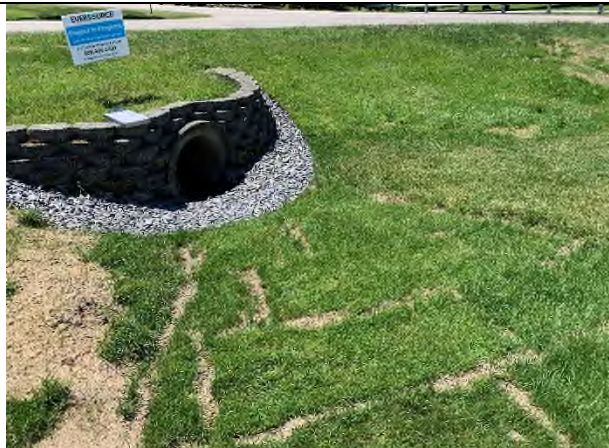
29 Gundalow -1 (Drainage Area)

Observations/Notes: No water at surface

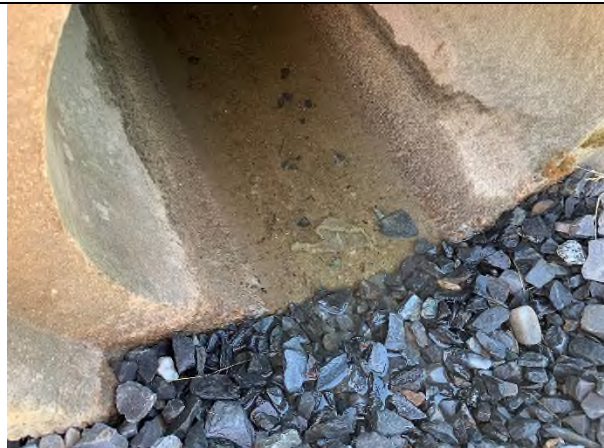
29 Gundalow -2 (Culvert)

pH: **8.2**

Observations/Notes: Standing water approx. 1" deep, extending 8" from end of inlet

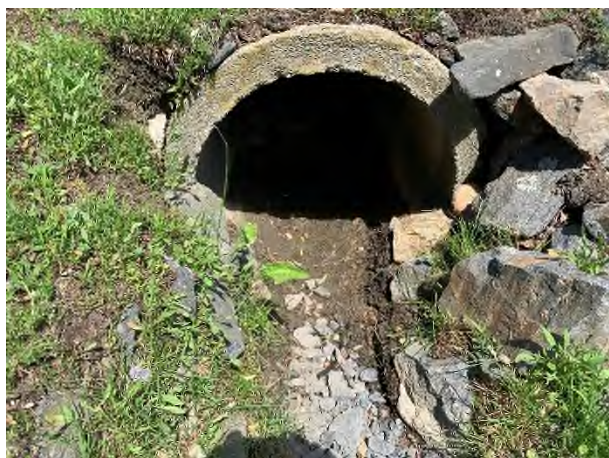
64 Gundalow - 1 (Drainage Course)

Observations/Notes: Observed dry for first time since daily monitoring began. No surficial water observed in drainage course.

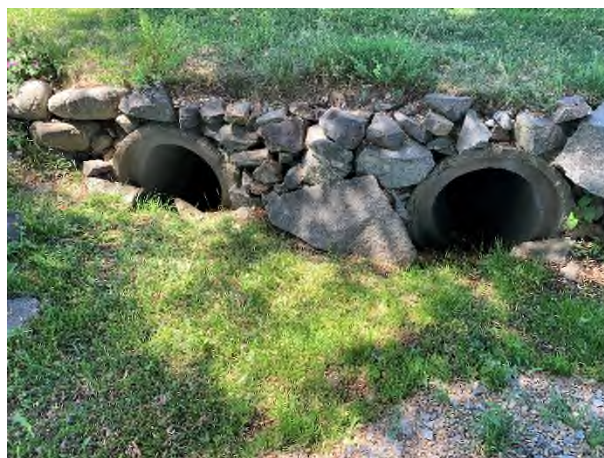
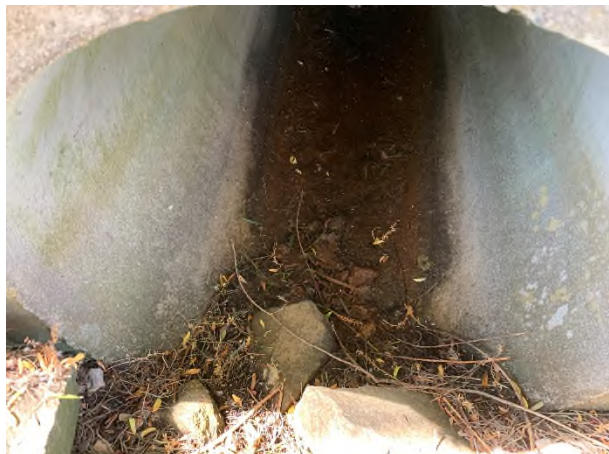
64 Gundalow -2 (Drainage Course)

Observations/Notes: Observed dry for first time since daily monitoring began

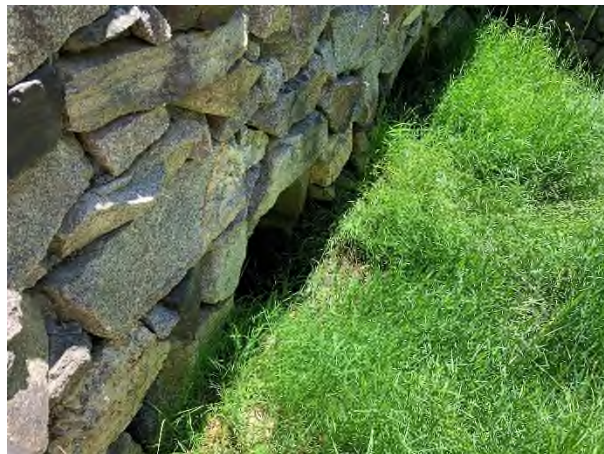
4 Brickyard Circle - 1 (Drainage Course)

pH: **7.3**

Observations/Notes: Approx. 1" of standing water

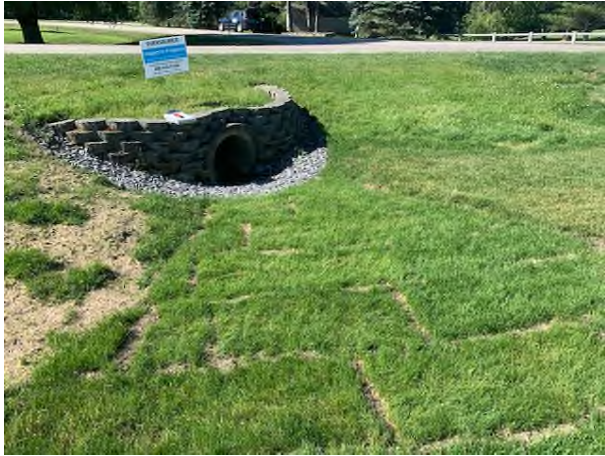
29 Gundalow -1 (Drainage Area)

Observations/Notes: No water at surface

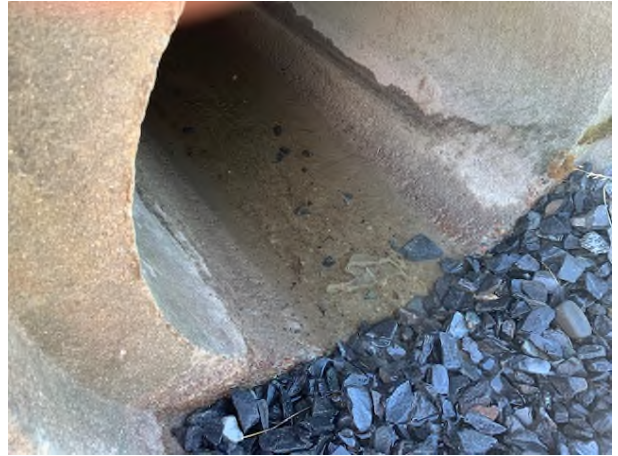
29 Gundalow -2 (Culvert)

pH: 8.3

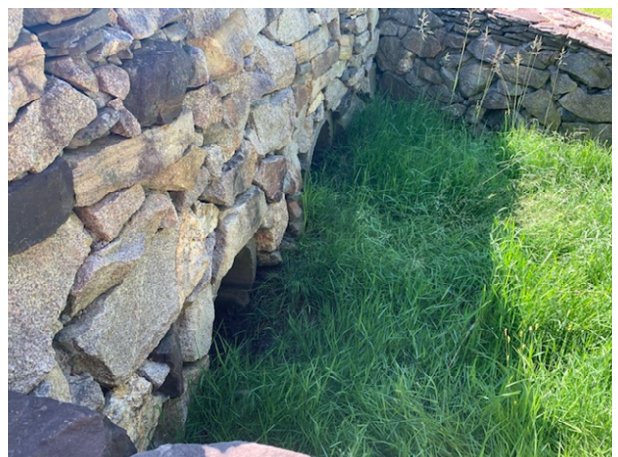
4 Brickyard Circle - 1 (Drainage Course)

- 4 Brickyard Circle – 1 (Drainage Course) dry for first time since monitoring began.

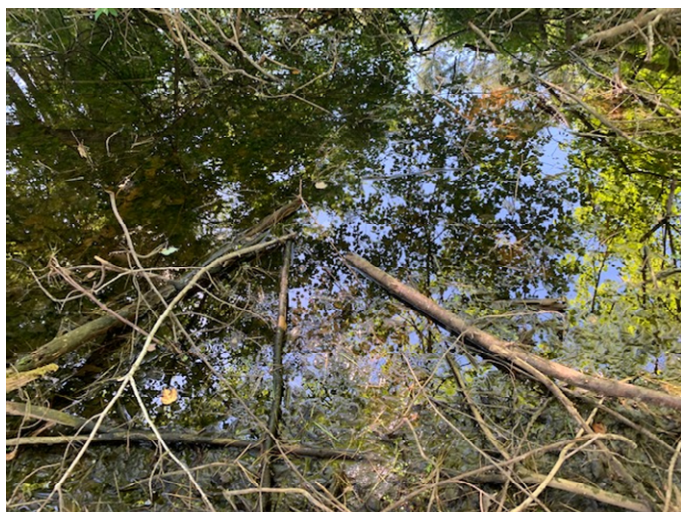
Flynn Pit (Wetland NW-4)

pH: **6.6**

Observations/Notes: Small isolated pockets of surface water

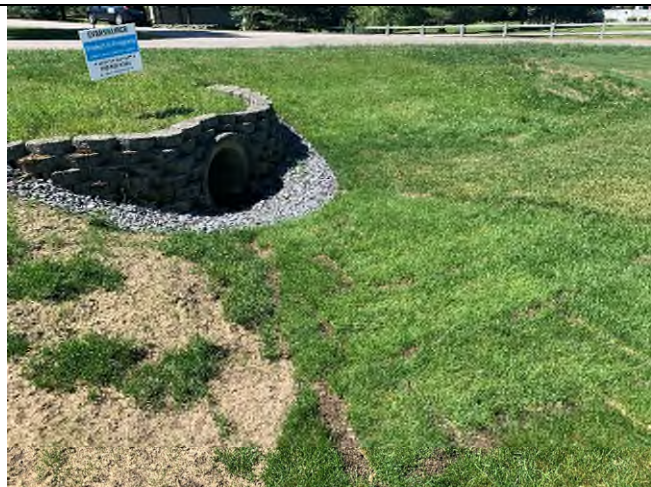
29 Gundalow -1 (Drainage Area)

Observations/Notes: No water at surface

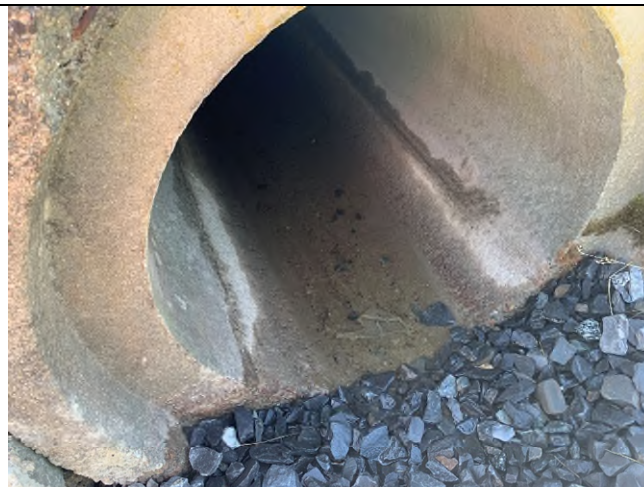
29 Gundalow -2 (Culvert)

pH: **7.8**

Observations/Notes: Standing water approx. 1" deep, extending 8" from end of inlet

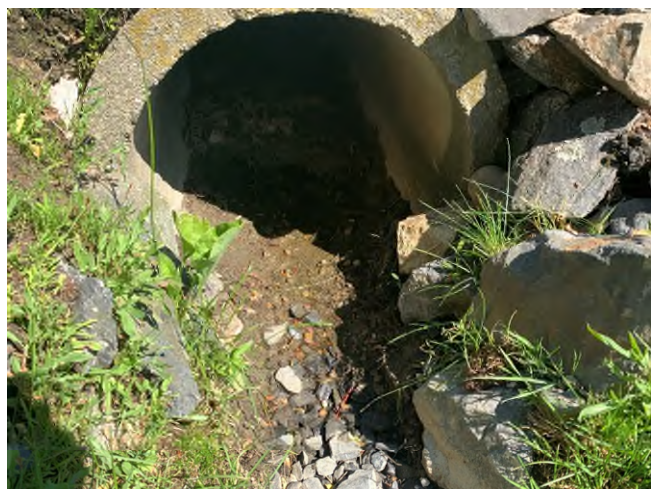
64 Gundalow - 1 (Drainage Course)

Observations/Notes: Observed dry for first time since daily monitoring began. No surficial water observed in drainage course.

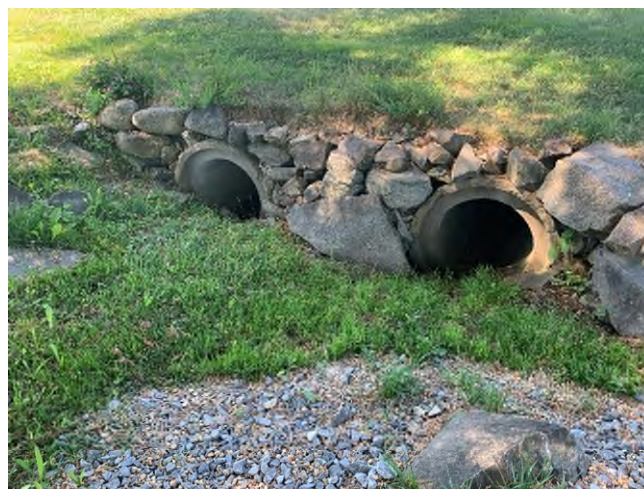
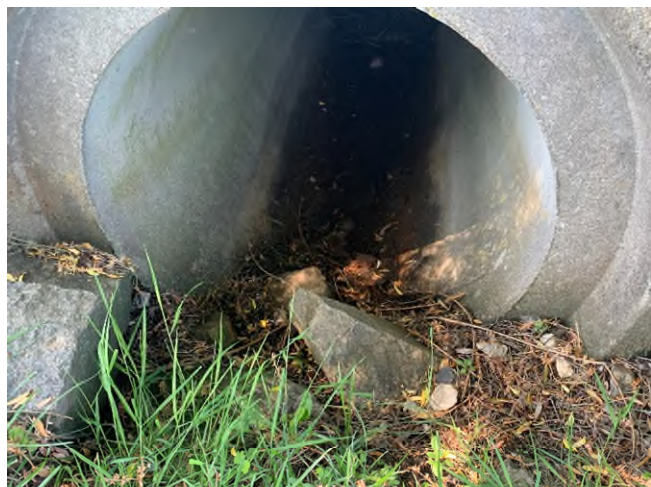
64 Gundalow -2 (Drainage Course)

Observations/Notes: Observed dry for first time since daily monitoring began

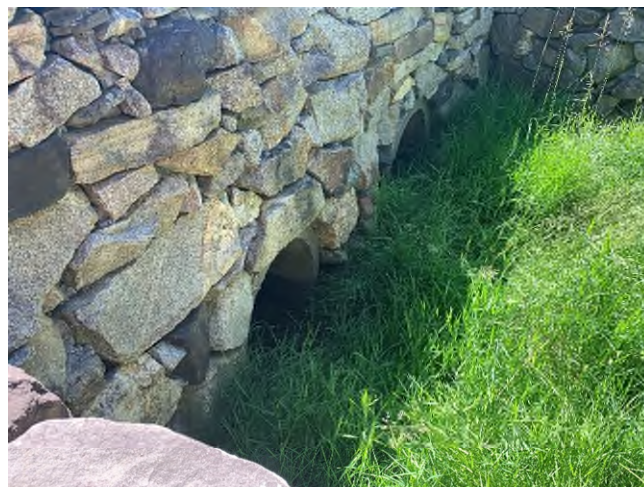
4 Brickyard Circle - 1 (Drainage Course)

pH: **7.0**

Observations/Notes: Approx. 1" of standing water

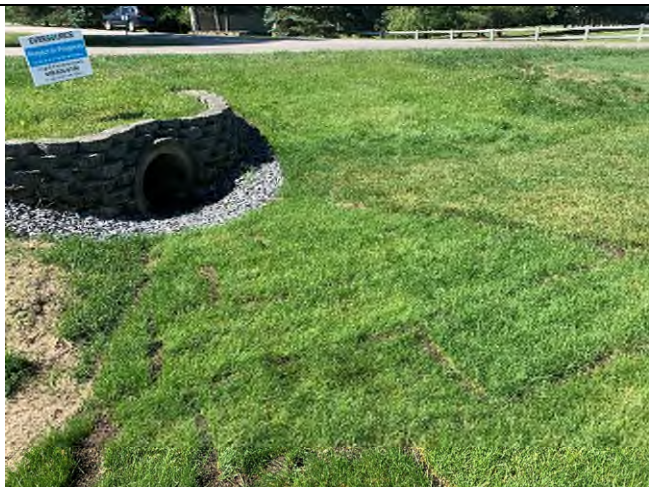
29 Gundalow -1 (Drainage Area)

Observations/Notes: No water at surface

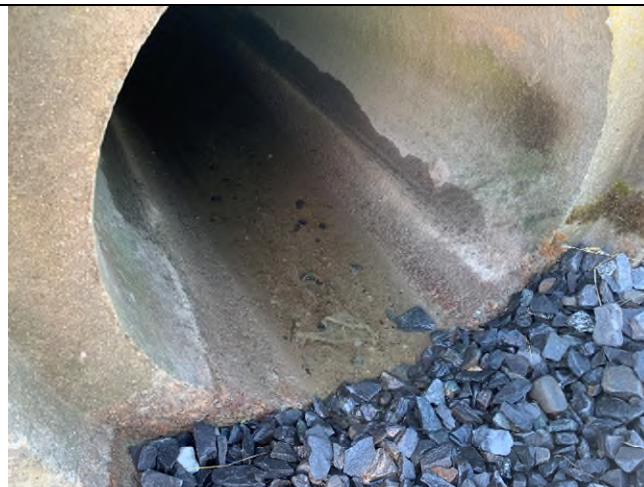
29 Gundalow -2 (Culvert)

pH: 7.3

Observations/Notes: Standing water approx. 1" deep, extending 8" from end of inlet

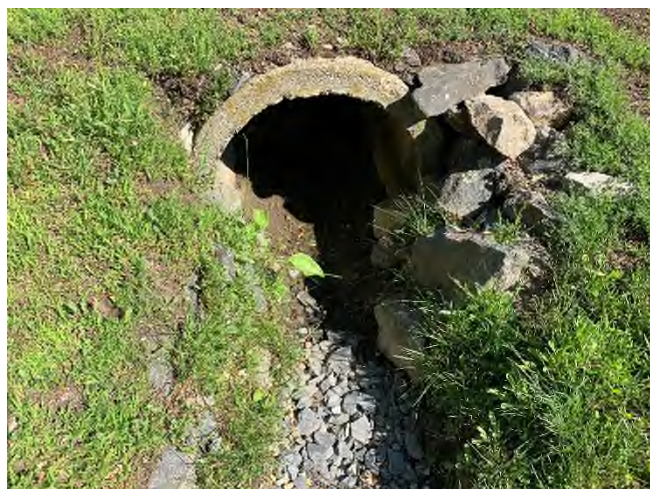
64 Gundalow - 1 (Drainage Course)

Observations/Notes: Observed dry for first time since daily monitoring began. No surficial water observed in drainage course.

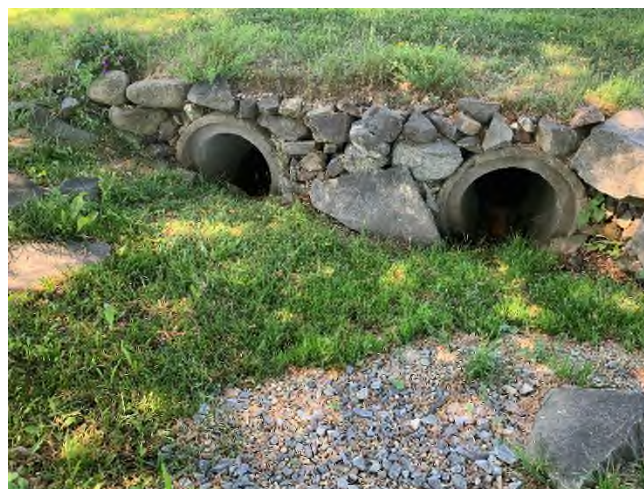
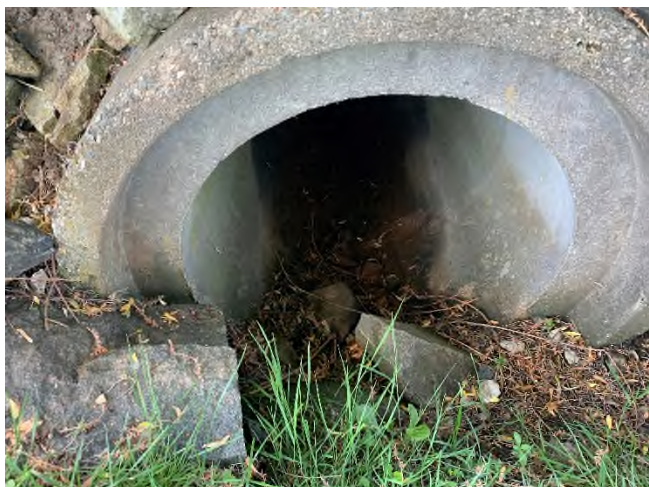
64 Gundalow -2 (Drainage Course)

Observations/Notes: Observed dry for first time since daily monitoring began

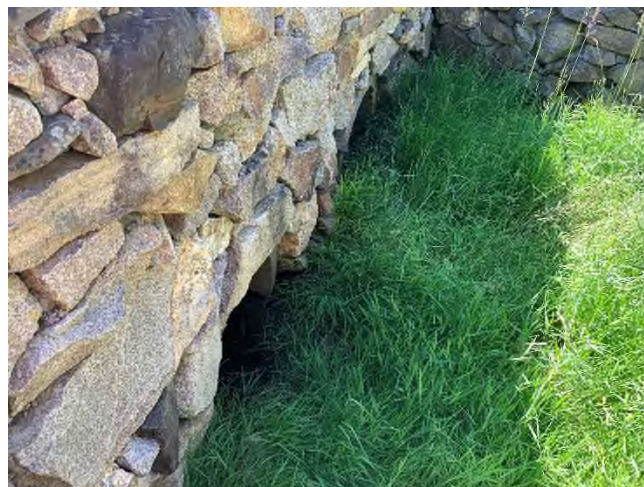
4 Brickyard Circle - 1 (Drainage Course)

Observations/Notes: Approx. 1" of standing water

- No visible standing water at 29 Gundalow – 1 (Drainage Area), 64 Gundalow – 1, and 64 Gundalow – 2. Minimal standing water at 4 Brickyard Circle – 1 but not enough to collect sample for pH measurement
