### CONSTRUCTION MONITORING REPORT

Eversource Transmission Lines:  
**F107**

**Madbury, Durham,  
Newington, Portsmouth, NH**

NAI Project No:  
**23840.39**

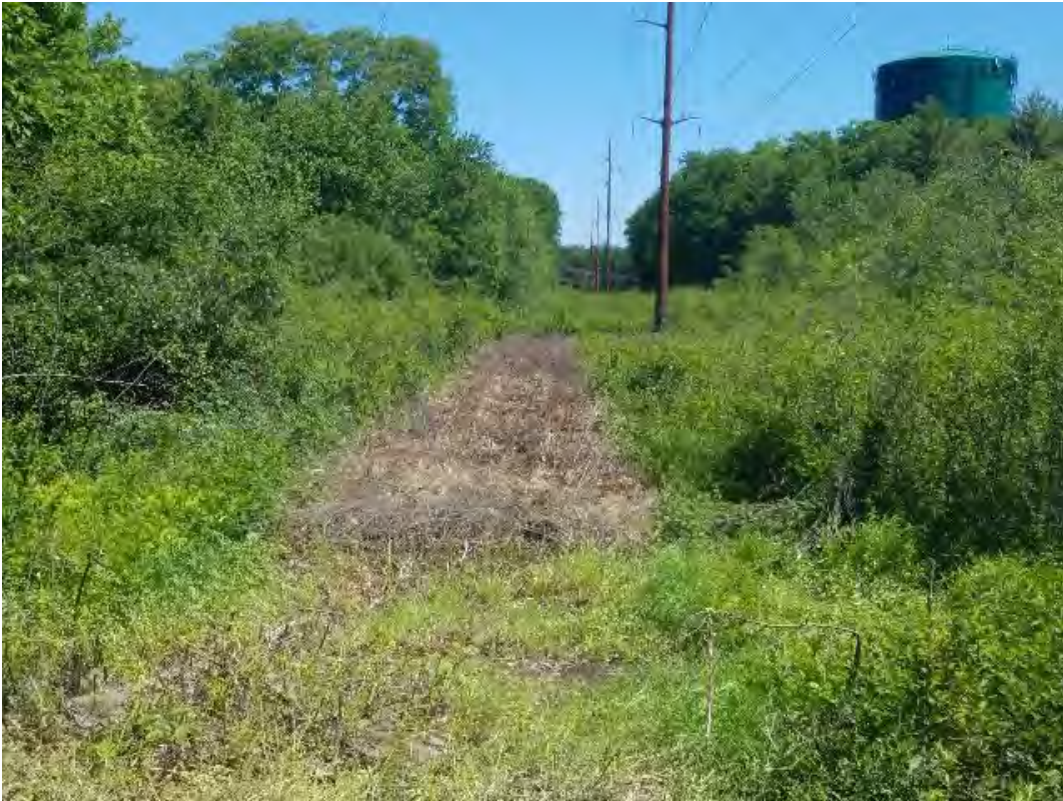
Fig 1: Vegetation recovering after timber mats have been removed in wetland DW41. Viewing north. (06-18-20).

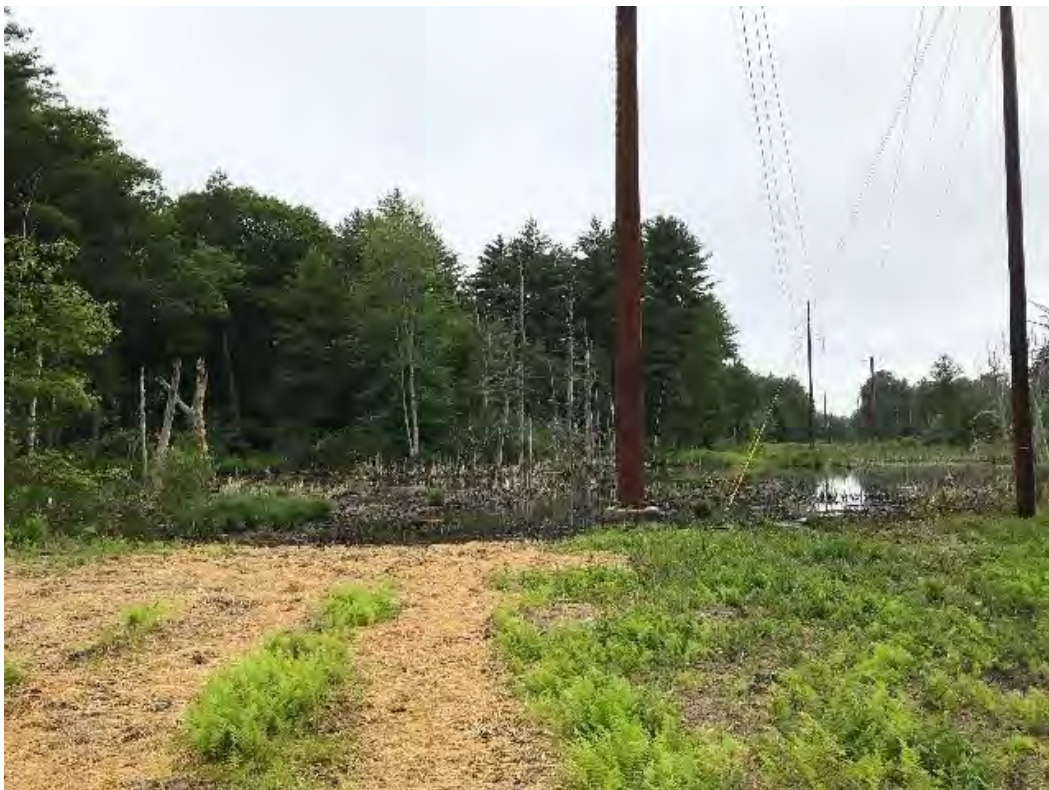
Fig 2: Str. 116 and wetland NW11. Viewing northwest. (06-22-20).

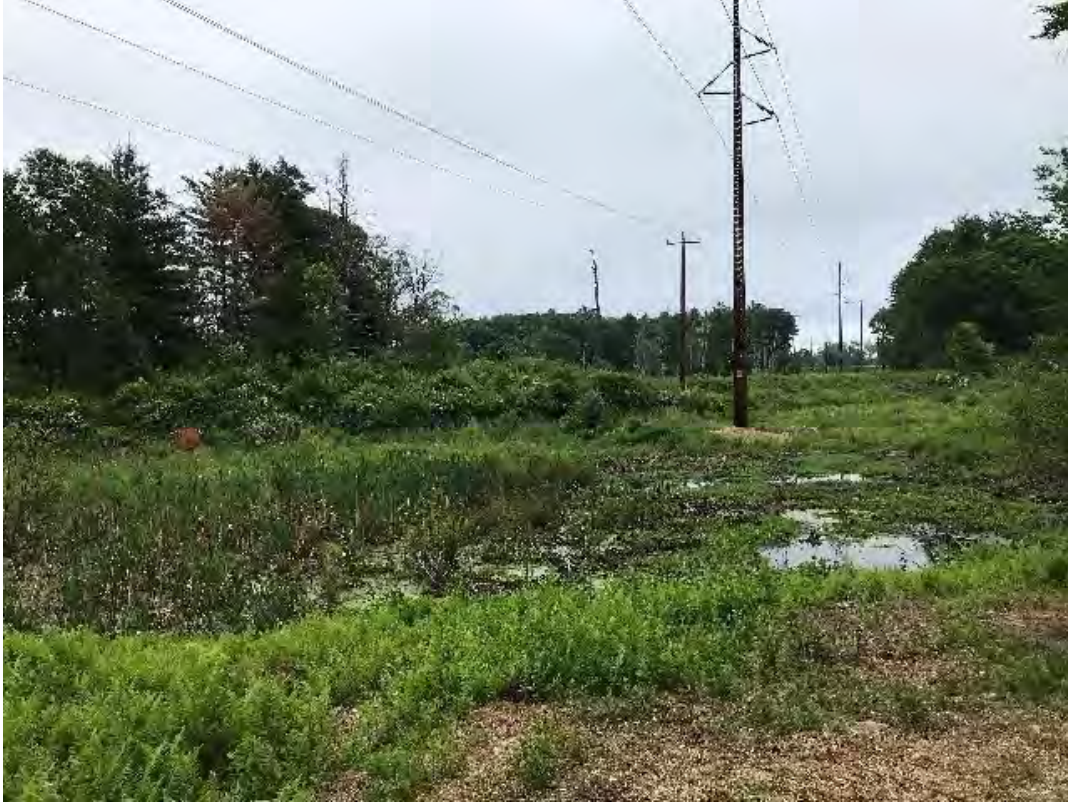
Fig 3: Str. 114 and wetland NW17. Viewing southeast. (06-22-20).

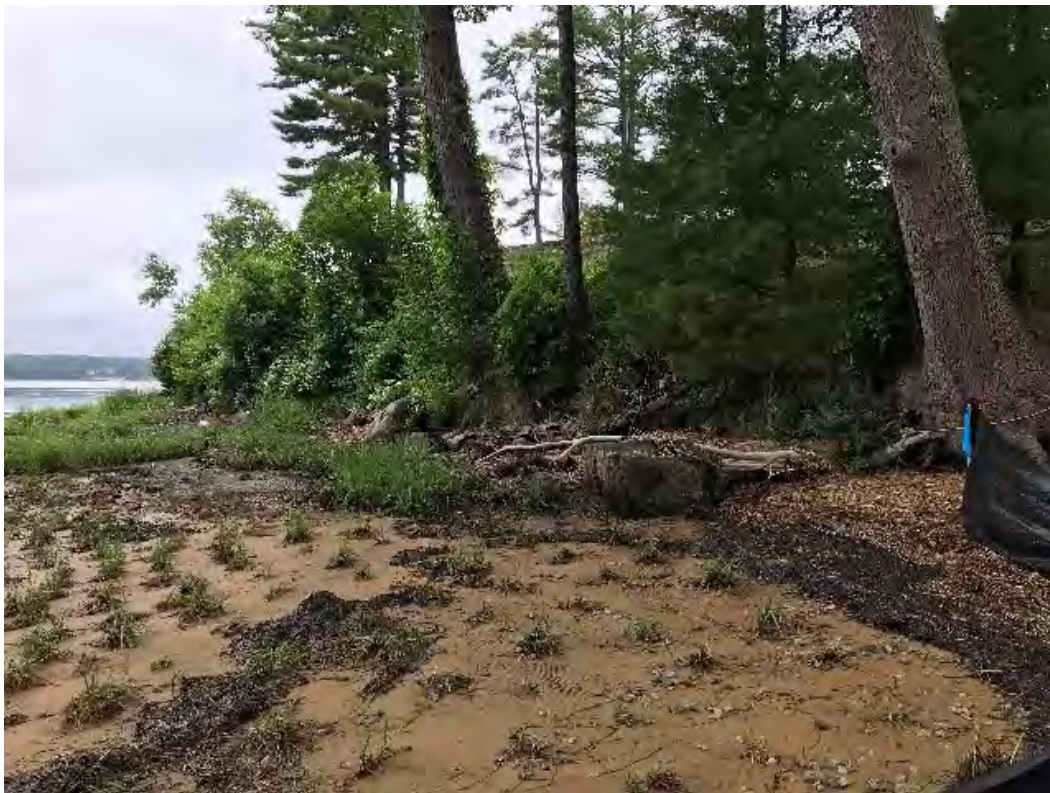
Fig 4: Salt marsh restoration at Gundalow landing/east side of the Bay. Viewing west. (06-22-20).

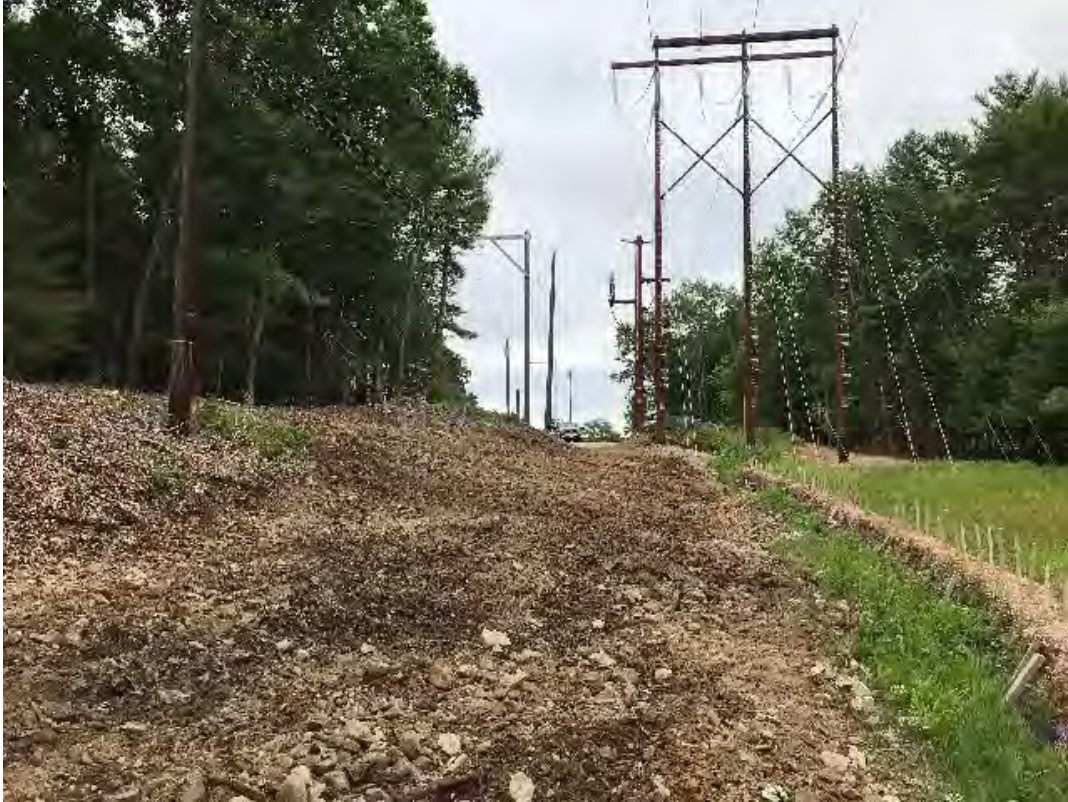
Fig 5: Crew removing access road between Strs. 97-99. Viewing east. (06-22-20).

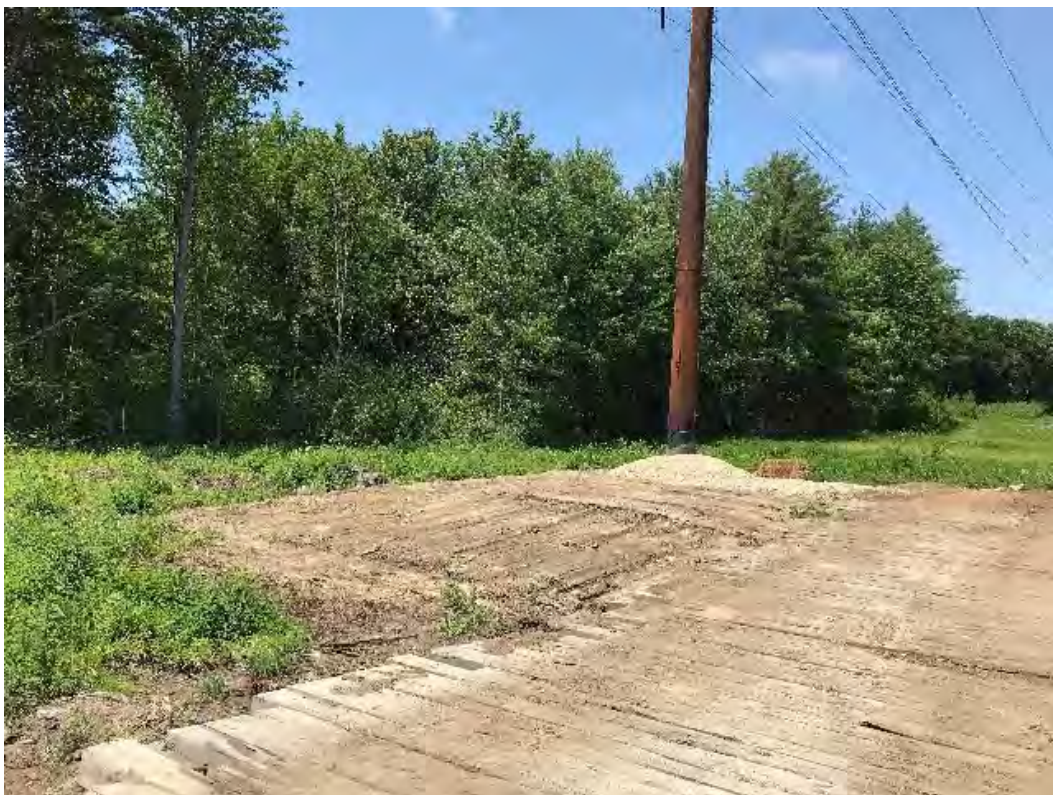
Fig 6: Crew removing timber mats used for Str. 40 work pad. Viewing northwest. (06-22-20).

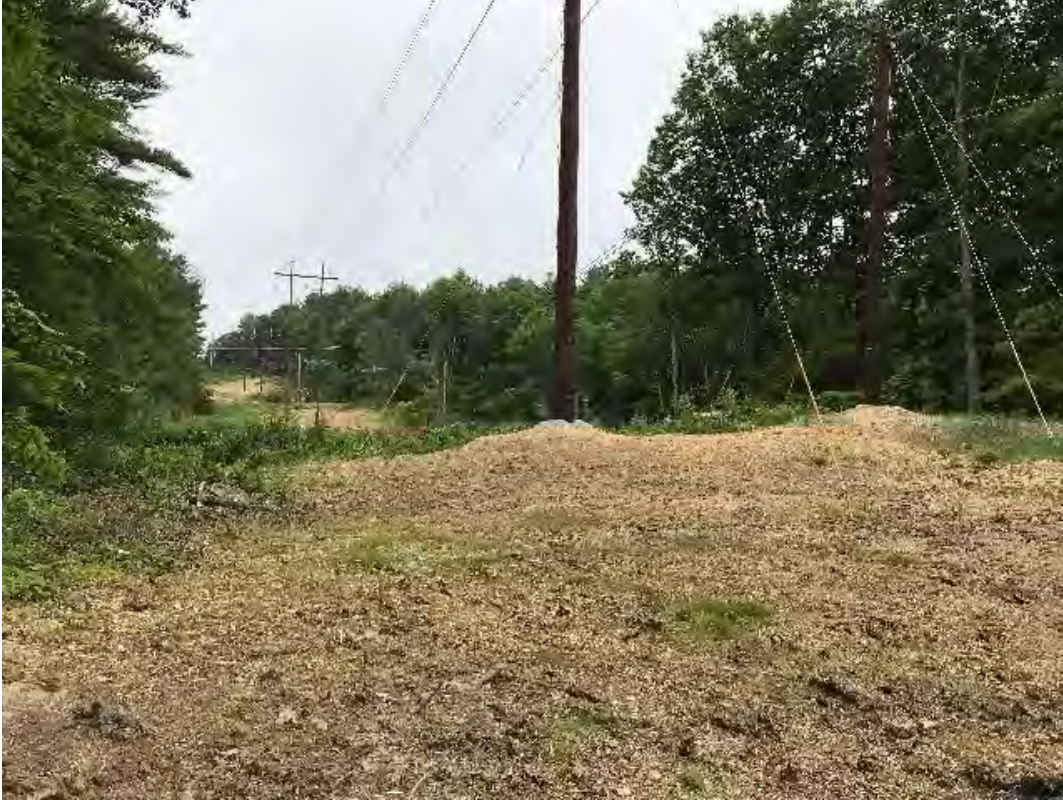
Fig 7: Str. 61 restored with some visible germination. Viewing west. (06-23-20).

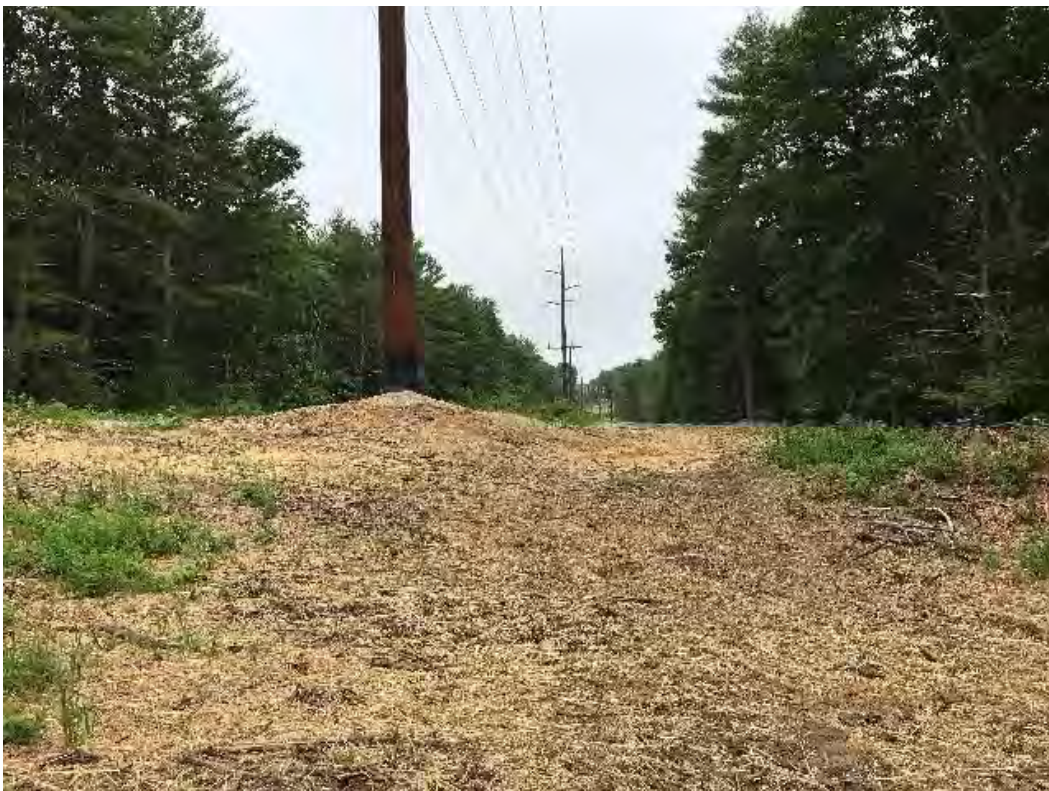
Fig 8: Str. 64 restored with some visible vegetation re-growth. Viewing west. (06-23-20).

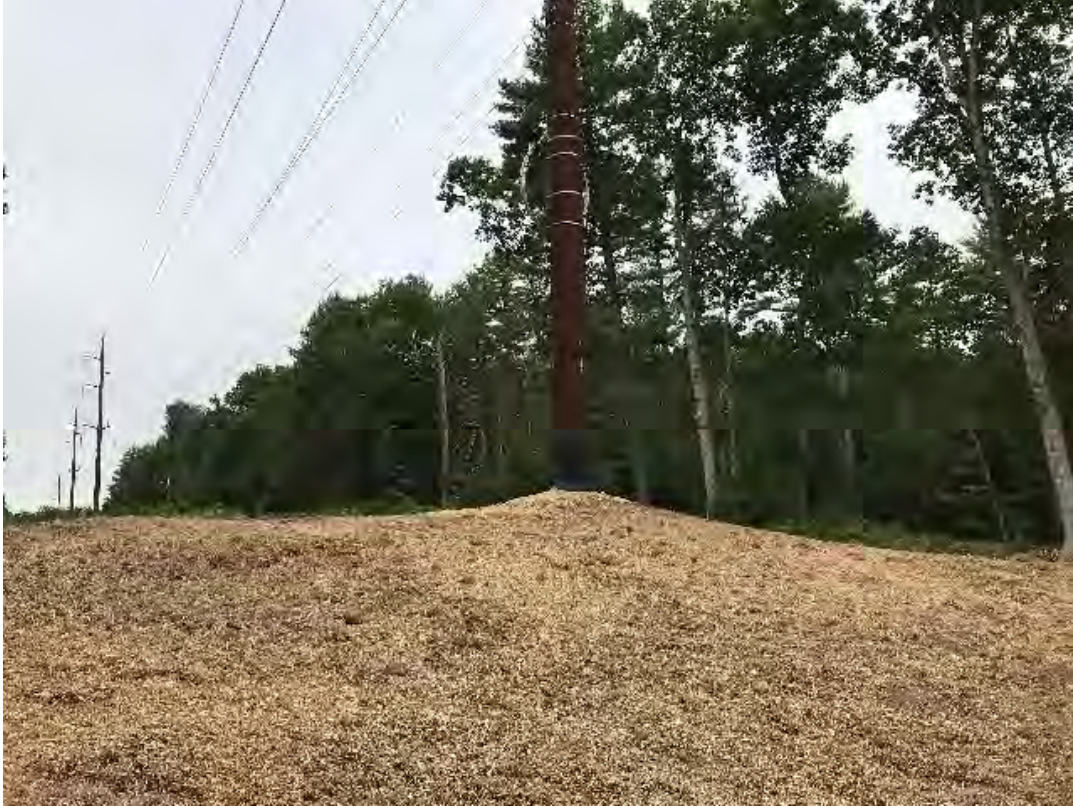
Fig 9: Str. 66 work area restored. Viewing west. (06-23-20).

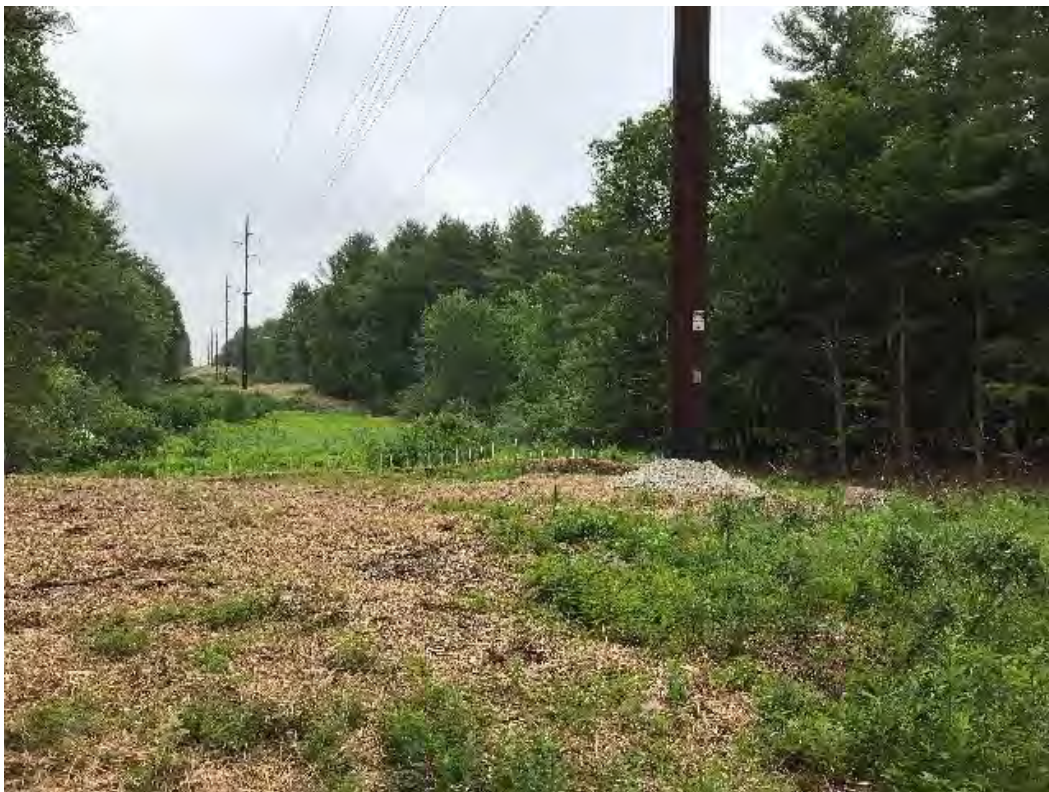
Fig 10: Str. 68 restored with some visible vegetation re-growth. Viewing northwest. (06-16-20).

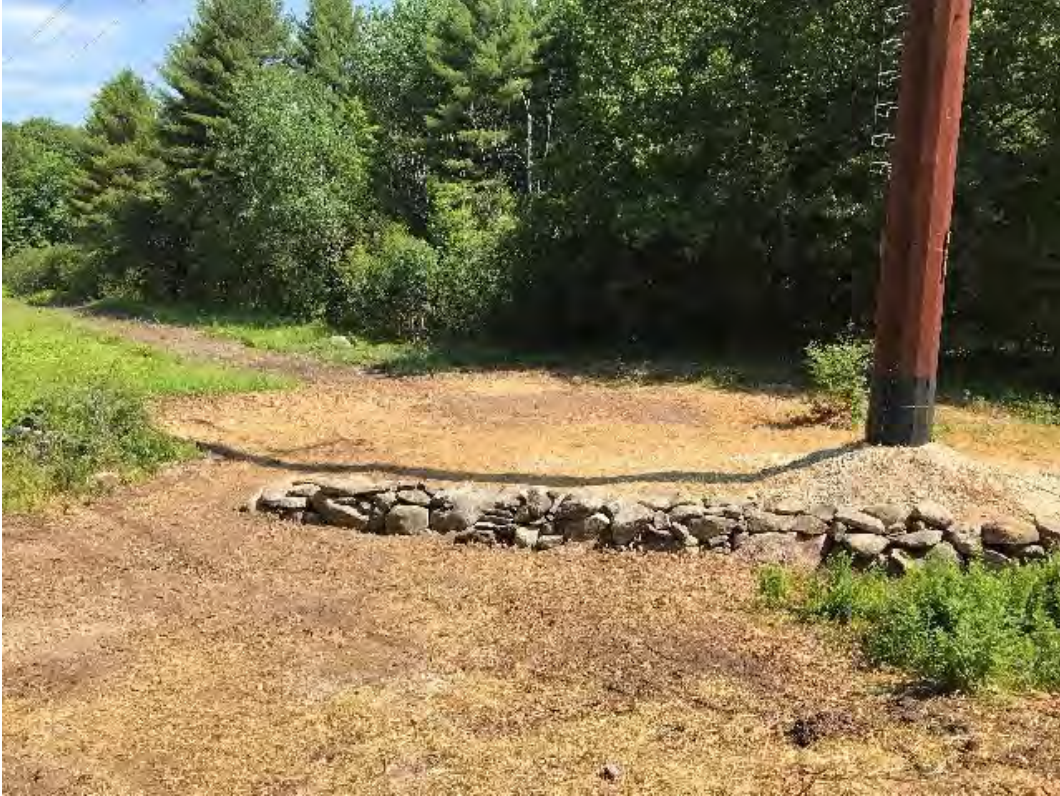
Fig 11: Stonewall WP-35 rebuilt, next to Str. 86. Viewing north. (06-23-20).

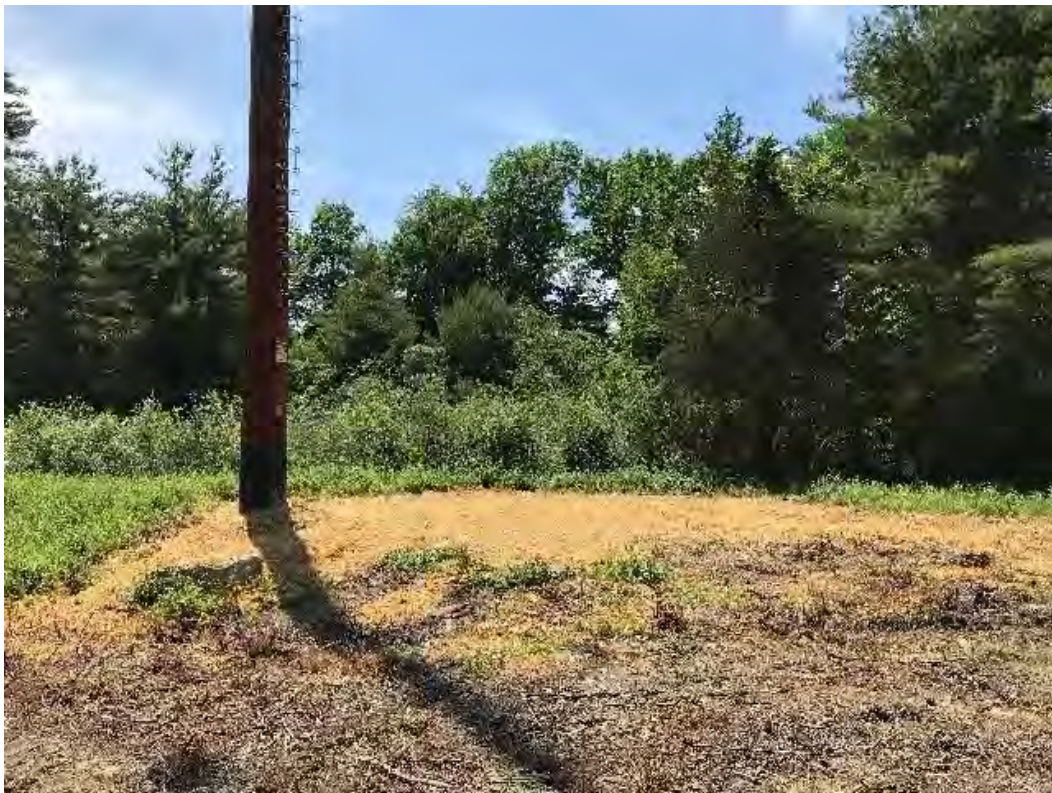
Fig 12: Str. 44 work area restored. Viewing northeast. (06-23-20).

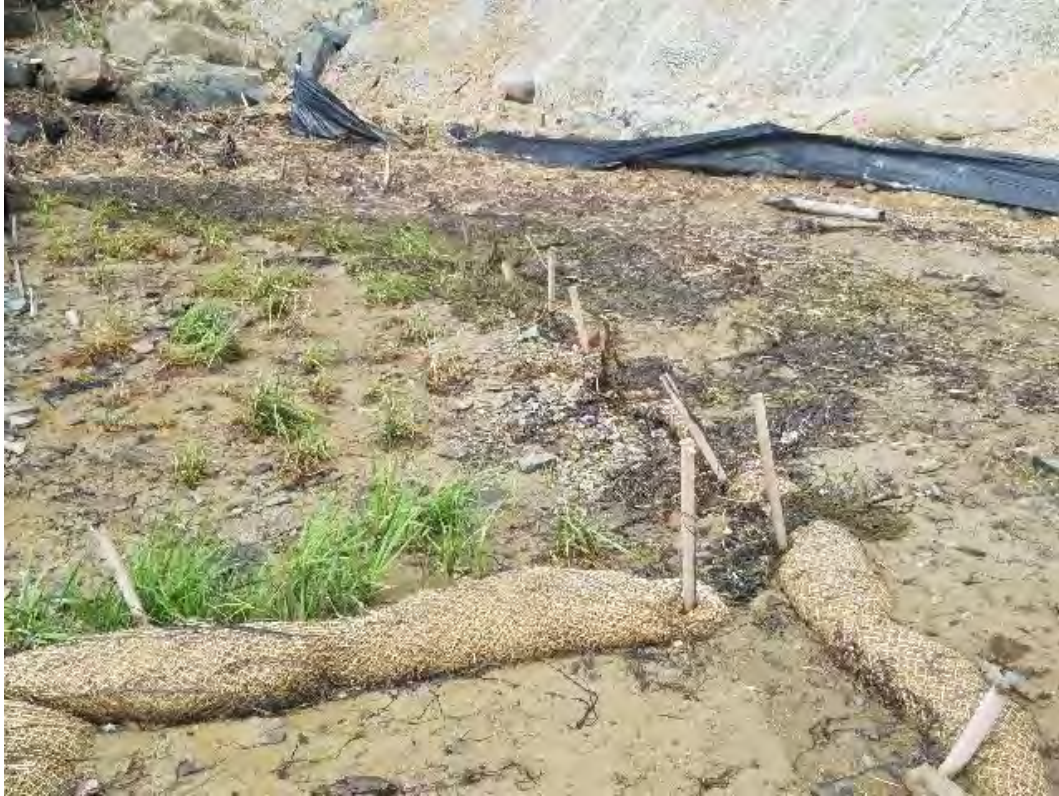
Fig 13: Salt marsh restoration at Getchell property/west side of the Bay. Viewing south. (06-23-20).

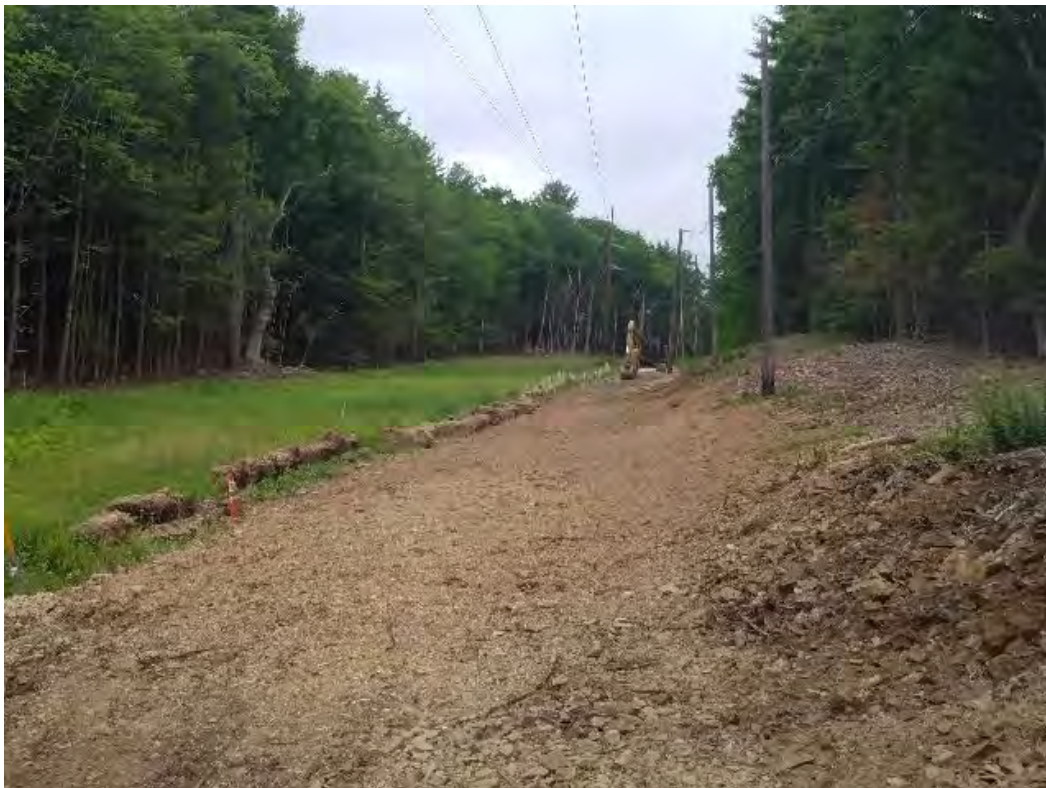
Fig 14: Crew continues to remove access road between Strs. 97-99. Viewing northwest. (06-23-20).
