DRAINAGE MONITORING REPORT

F107 - Seacoast Reliability Project

Newington, New Hampshire

04.0190967.00

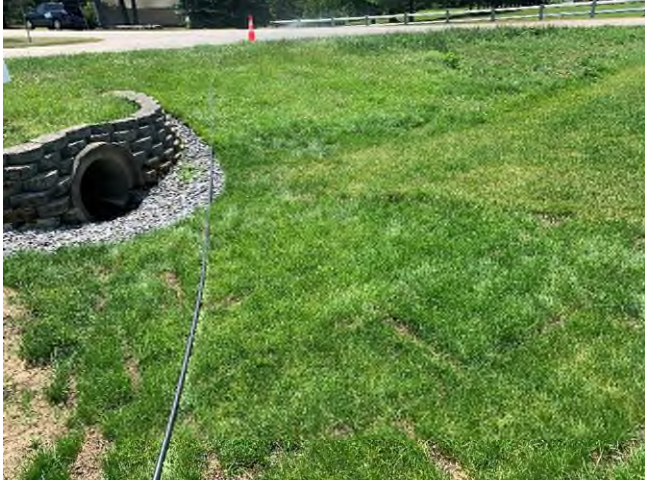
29 Gundalow -1 (Drainage Area)

Observations/Notes: No water at surface

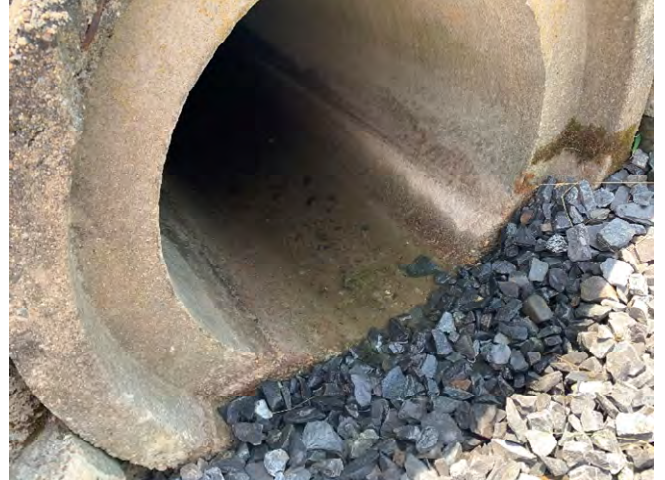
29 Gundalow -2 (Culvert)

Observations/Notes: Standing water approx. 1" deep, extending 8" from end of inlet

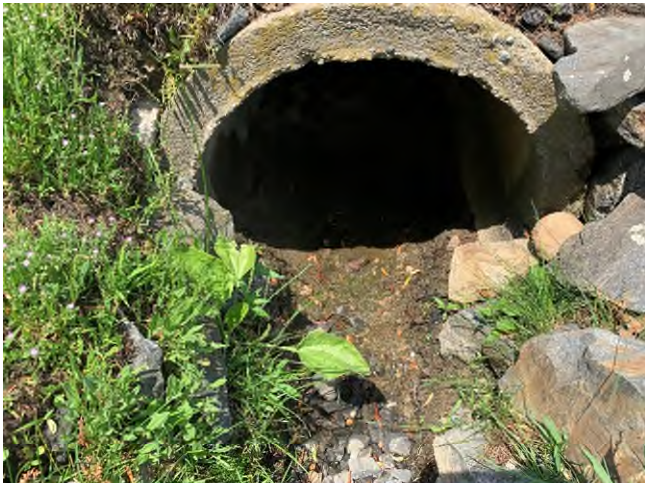
64 Gundalow - 1 (Drainage Course)

Observations/Notes: No visible standing water

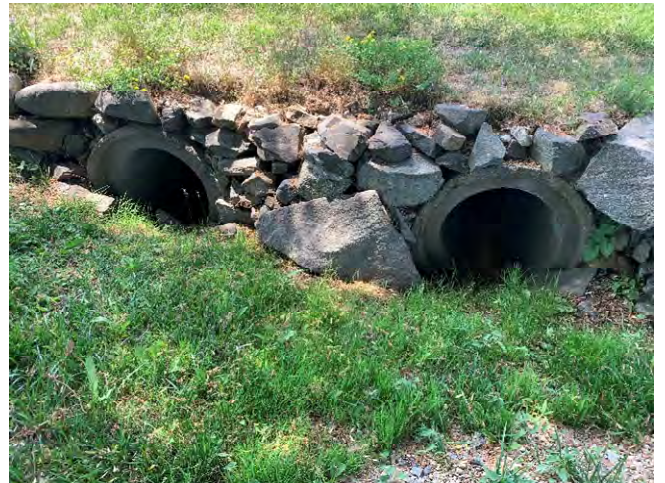
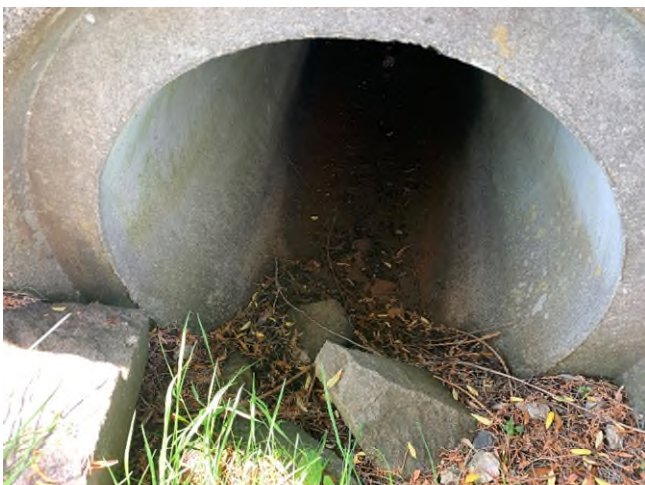
64 Gundalow -2 (Drainage Course)

Observations/Notes: No visible standing water

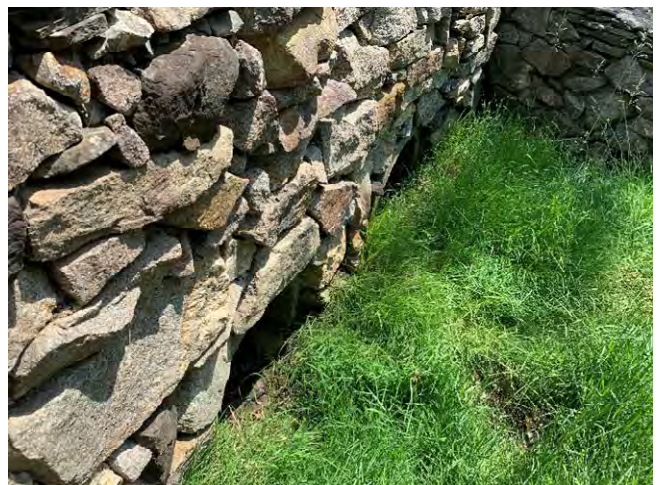
4 Brickyard Circle - 1 (Drainage Course)

Observations/Notes: No visible standing water

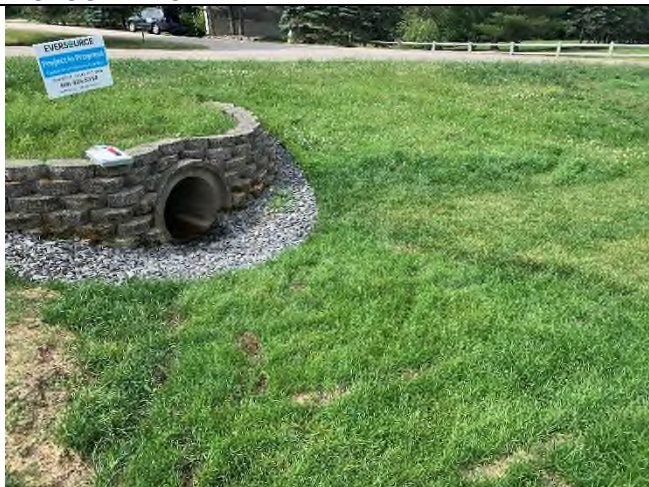
29 Gundalow -1 (Drainage Area)

Observations/Notes: No water at surface

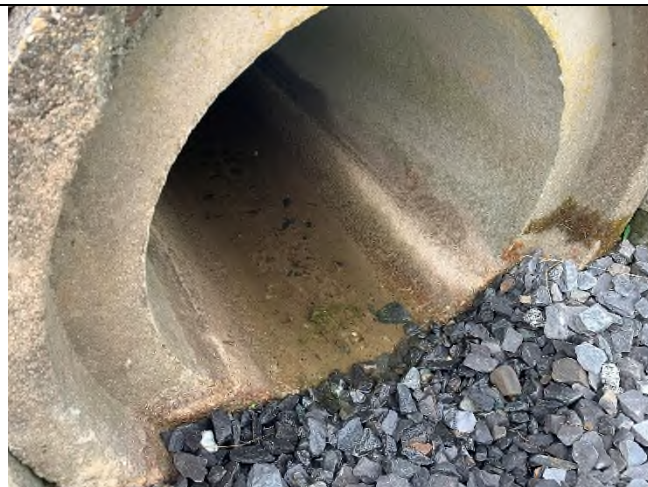
29 Gundalow -2 (Culvert)

Observations/Notes: Standing water approx. 1" deep, extending 8" from end of inlet

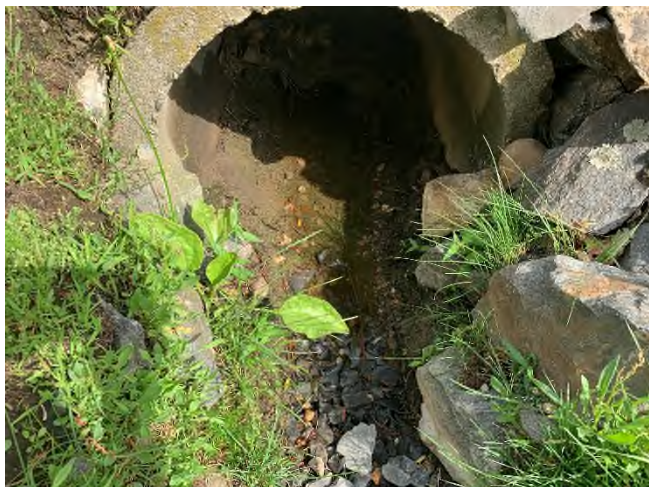
64 Gundalow - 1 (Drainage Course)

Observations/Notes: Standing water approx. 1" deep at culvert outlet.

- No visible standing water at 29 Gundalow – 1, 64 Gundalow – 2 and 4 Brickyard Circle – 1. Standing water visible in 64 Gundalow – 1 for first time since June 12 monitoring event, despite no recent measurable rain. Likely a result of lawn watering observed in proximity during June 22 monitoring event.

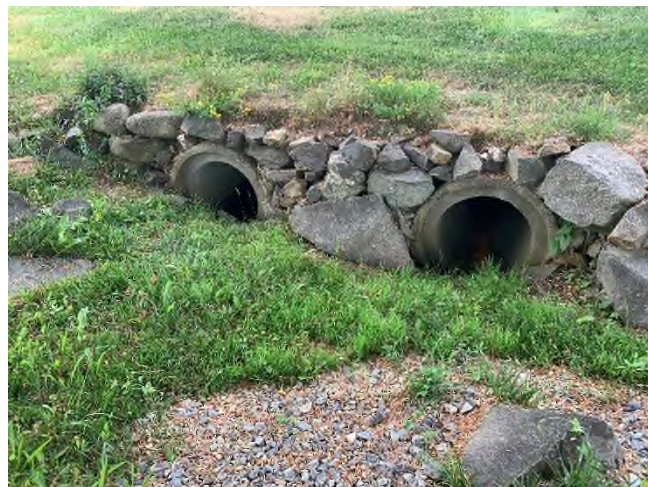
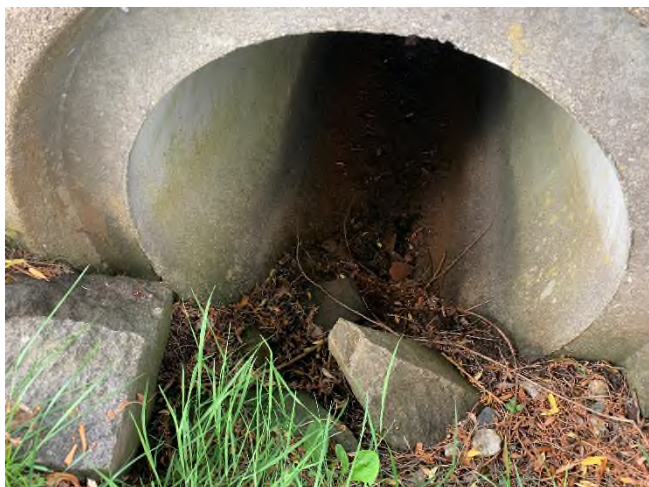
64 Gundalow -2 (Drainage Course)

Observations/Notes: No visible standing water

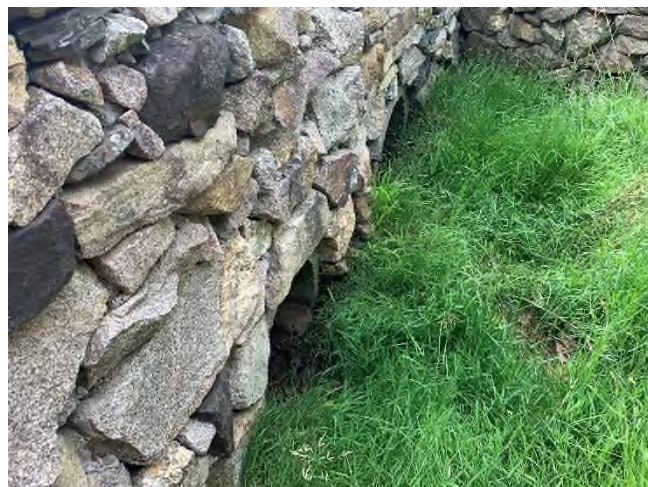
4 Brickyard Circle - 1 (Drainage Course)

Observations/Notes: No visible standing water

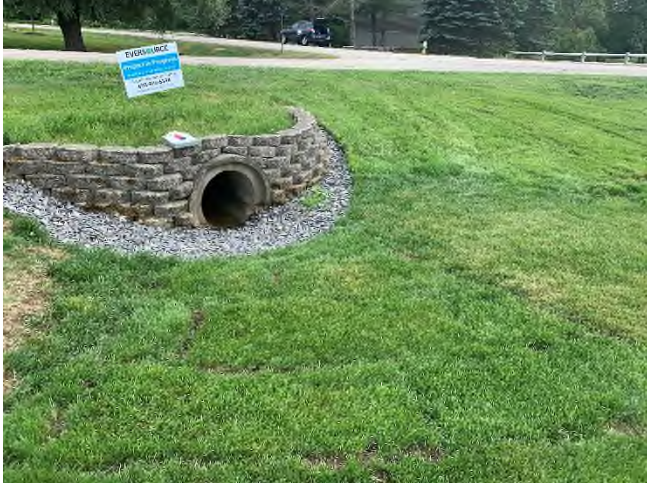
29 Gundalow -1 (Drainage Area)

Observations/Notes: No water at surface

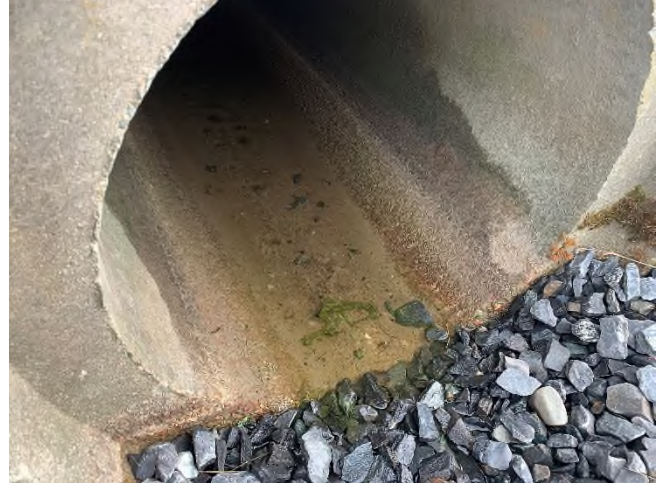
29 Gundalow -2 (Culvert)

Observations/Notes: ~ 1" of standing water in culvert

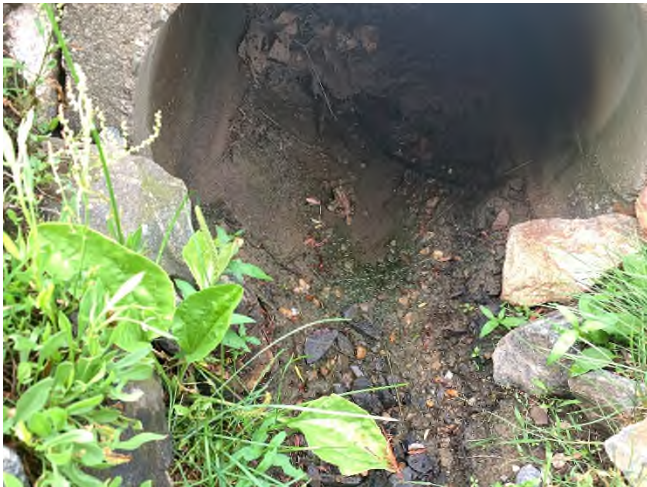
64 Gundalow – 1 (Drainage Course)

Observations/Notes: Less than 0.5" standing water, not enough to measure

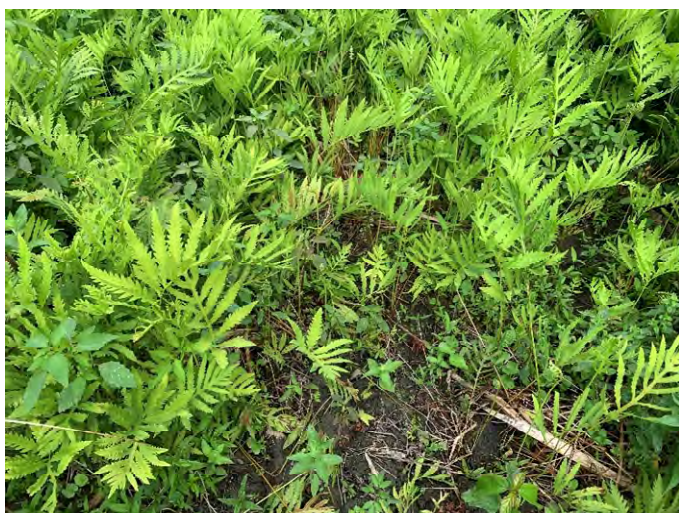
Hannah – 2 (Wetland NW-24)

Observations/Notes: No standing water, saturated soil

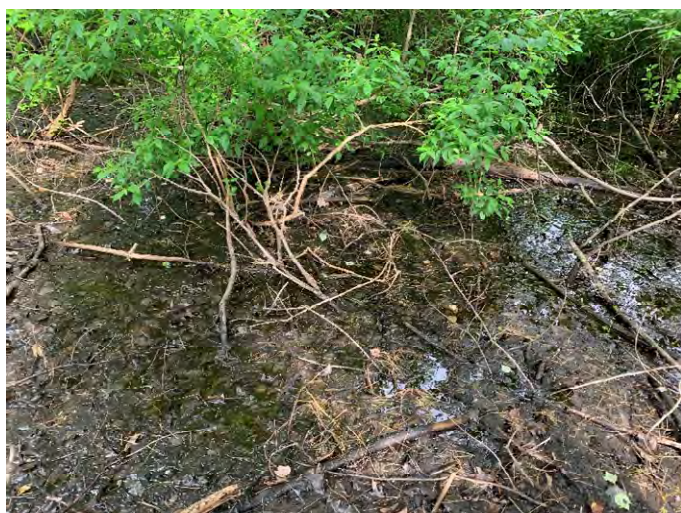
Flynn Pit (Wetland NW-4)

Observations/Notes: Small isolated pockets of surface water

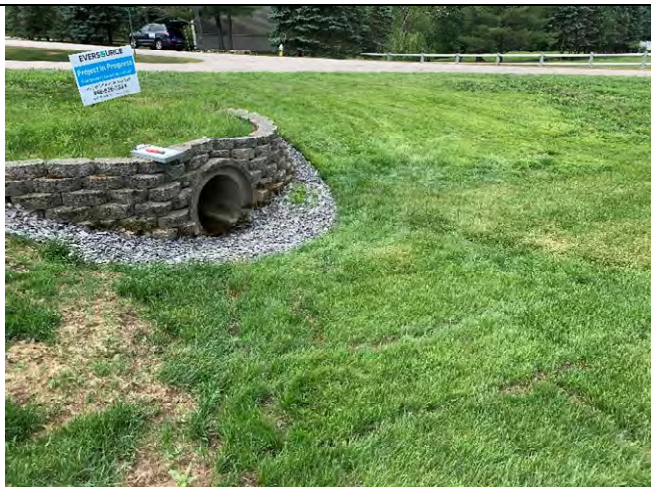
29 Gundalow -1 (Drainage Area)

Observations/Notes: No water at surface

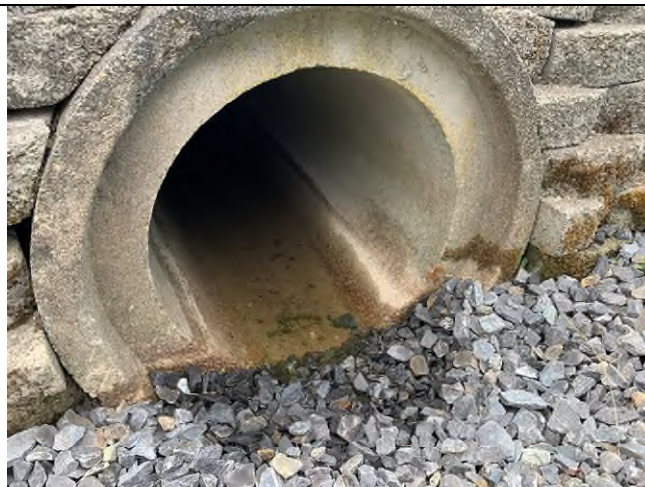
29 Gundalow -2 (Culvert)

Observations/Notes: ~ 1" of standing water in culvert

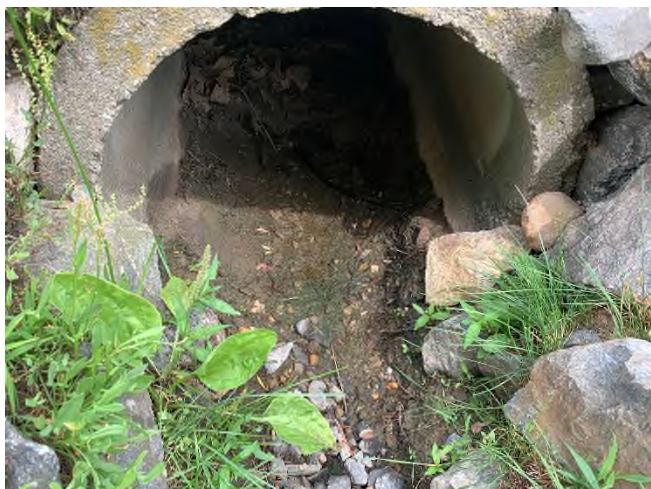
64 Gundalow - 1 (Drainage Course)

Observations/Notes: Less than 0.5" standing water, not enough to measure

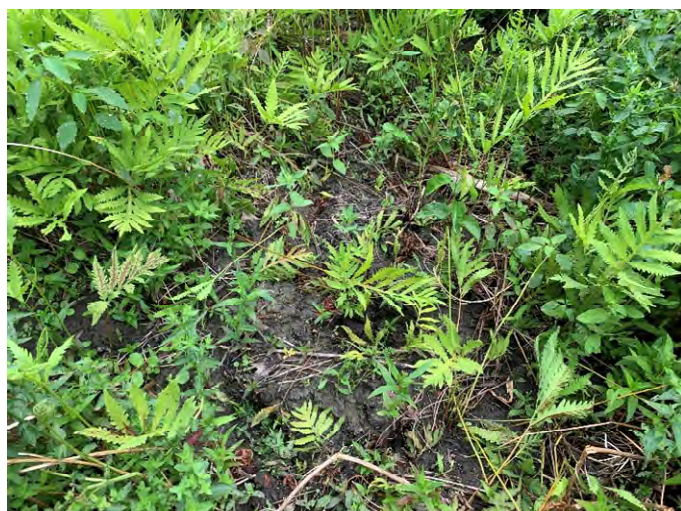
Hannah – 2 (Wetland NW-24)

Observations/Notes: No standing water, saturated soil

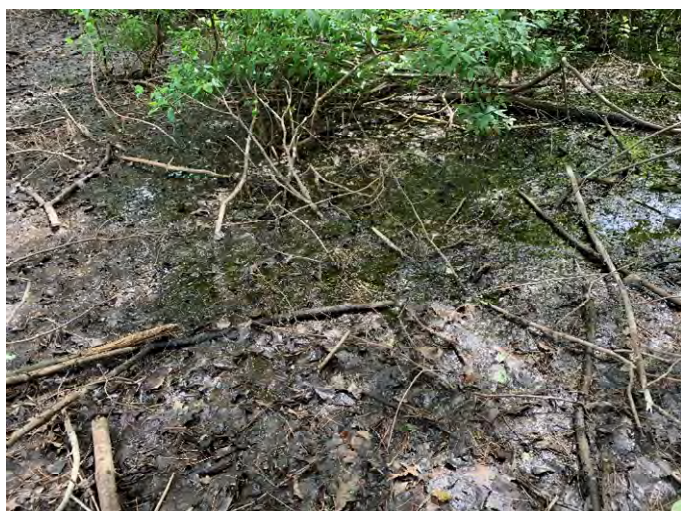
Flynn Pit (Wetland NW-4)

Observations/Notes: No standing water at monitoring location, reading taken approximately 5' southeast into wetland
