CONSTRUCTION MONITORING REPORT

Eversource Transmission Lines:
F107

**Madbury, Durham,
Newington, Portsmouth, NH**

TYPE OF INSPECTION: Weekly Storm Event Incident Corrective Action

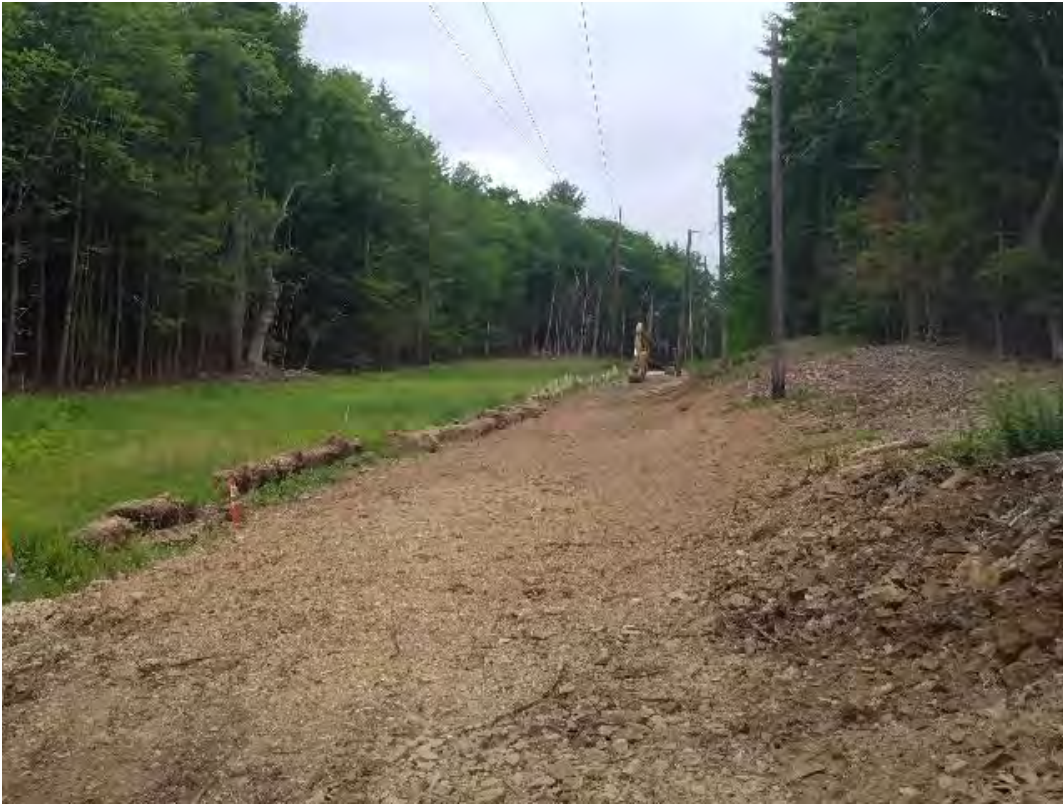
Fig 1: Removing gravel access road between Strs. 97-98. Viewing northwest. (06-25-20).

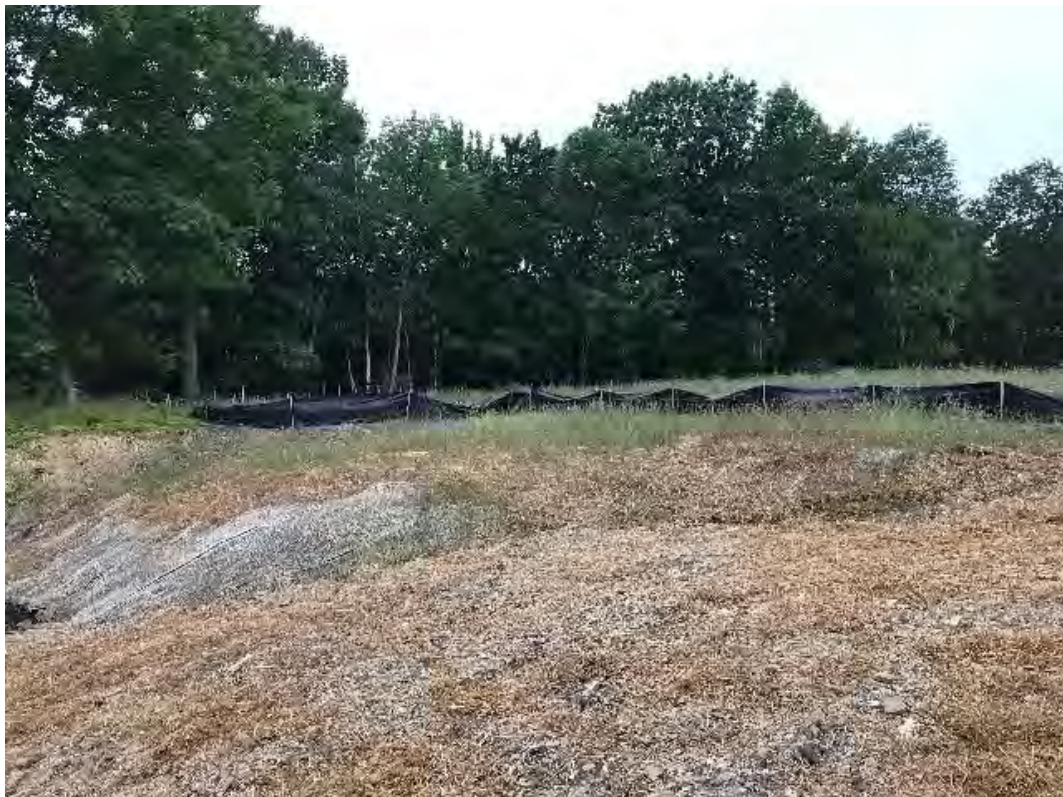
Fig 2: Slope down to intertidal zone at Getchell property/west side of the Bay. Viewing west. (06-29-20).

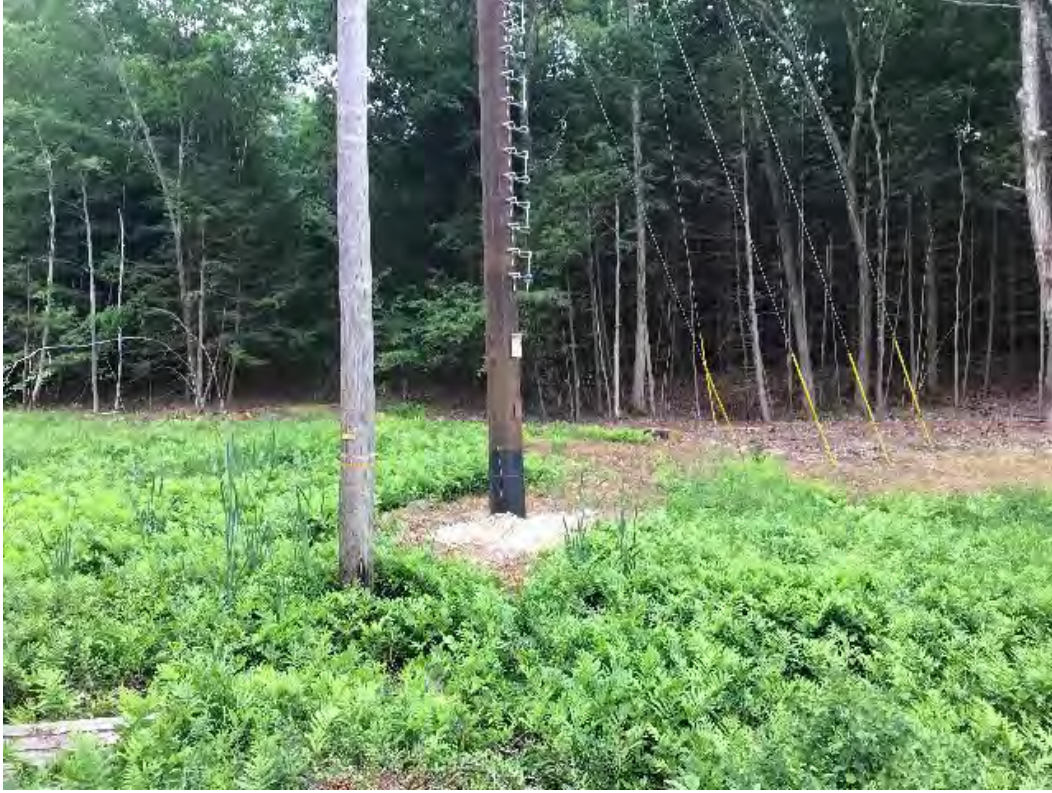
Fig 3: Str. 97 former work pad area, sensitive fern revegetation. Viewing south. (06-29-20).

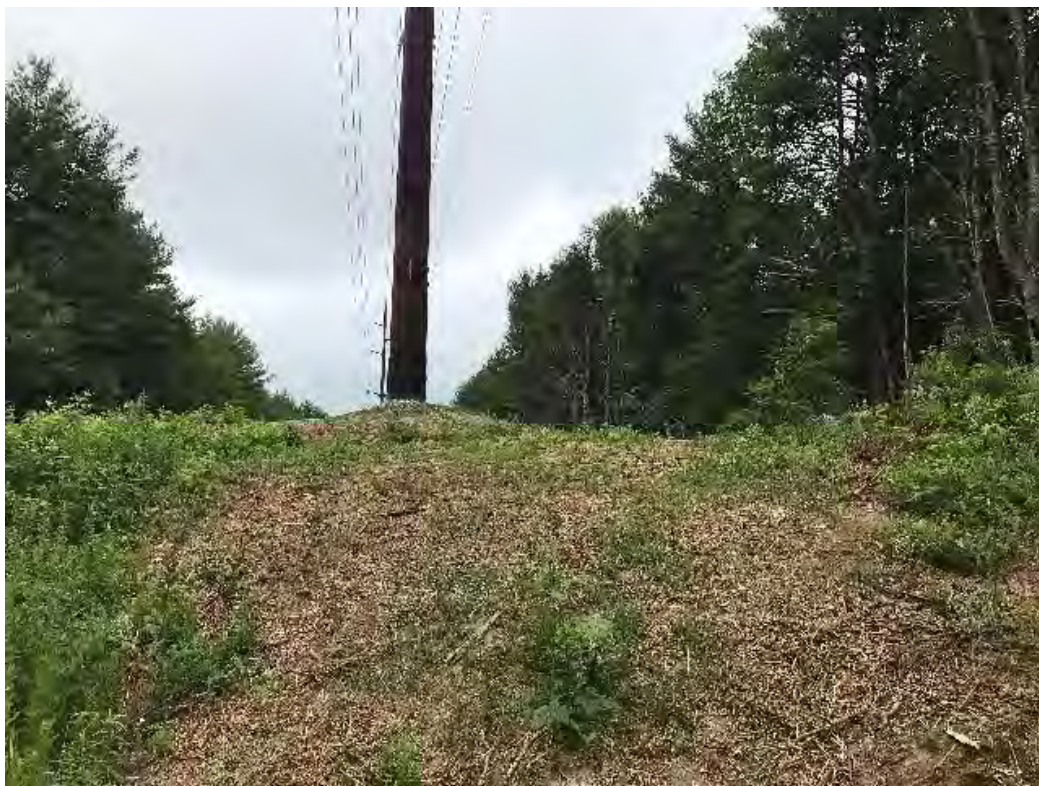
Fig 4: Str. 72, vegetation starting to grow. Viewing west. (06-29-20).

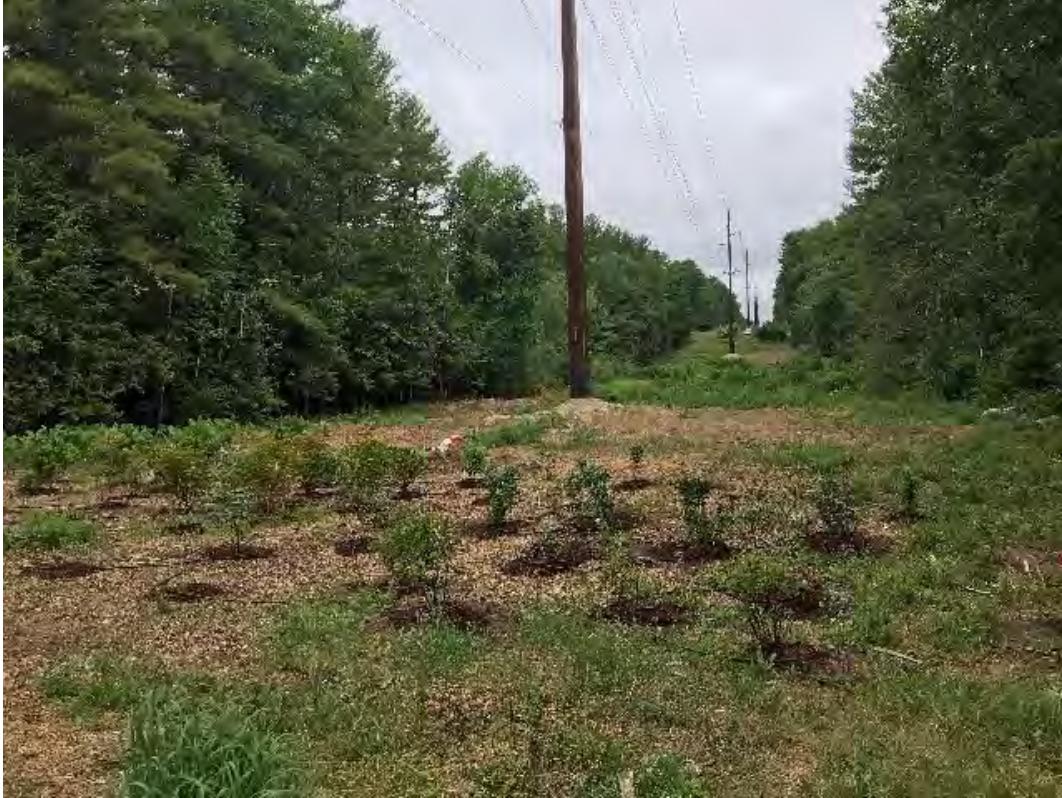
Fig 5: Rye Beach Landscaping planted a variety of shrubs at Str. 69. Viewing west. (06-29-20).

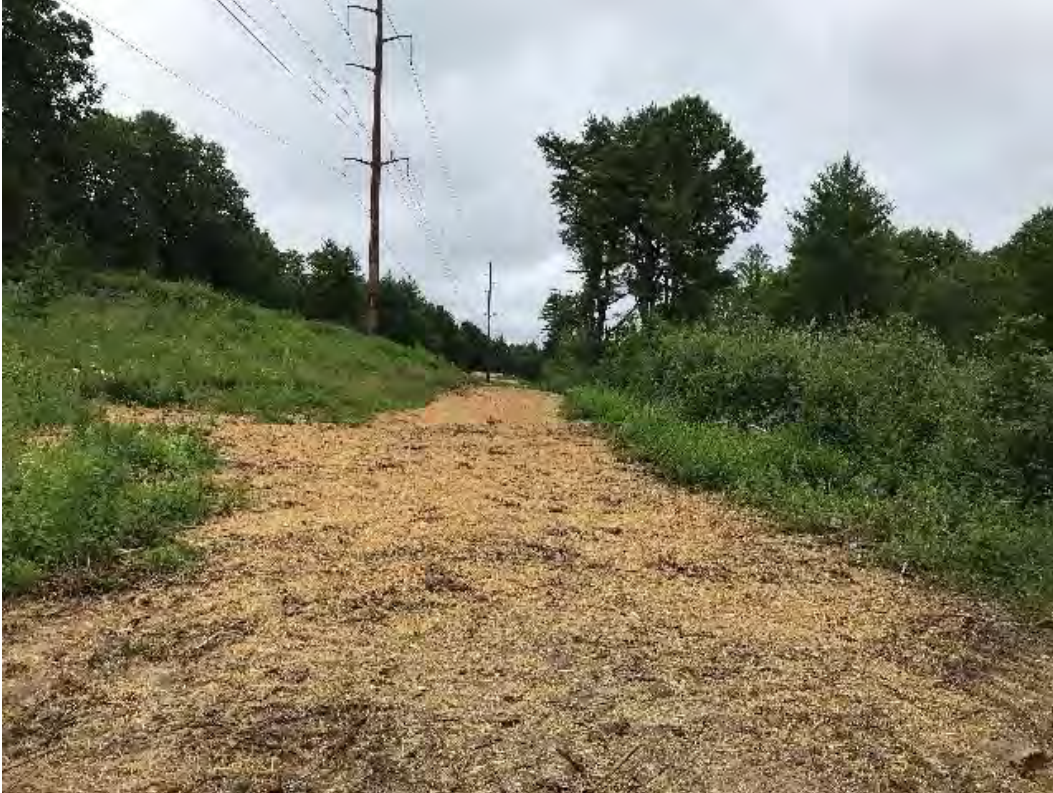
Fig 7: Restored access road between Strs. 44-43. Viewing north. (06-29-20).

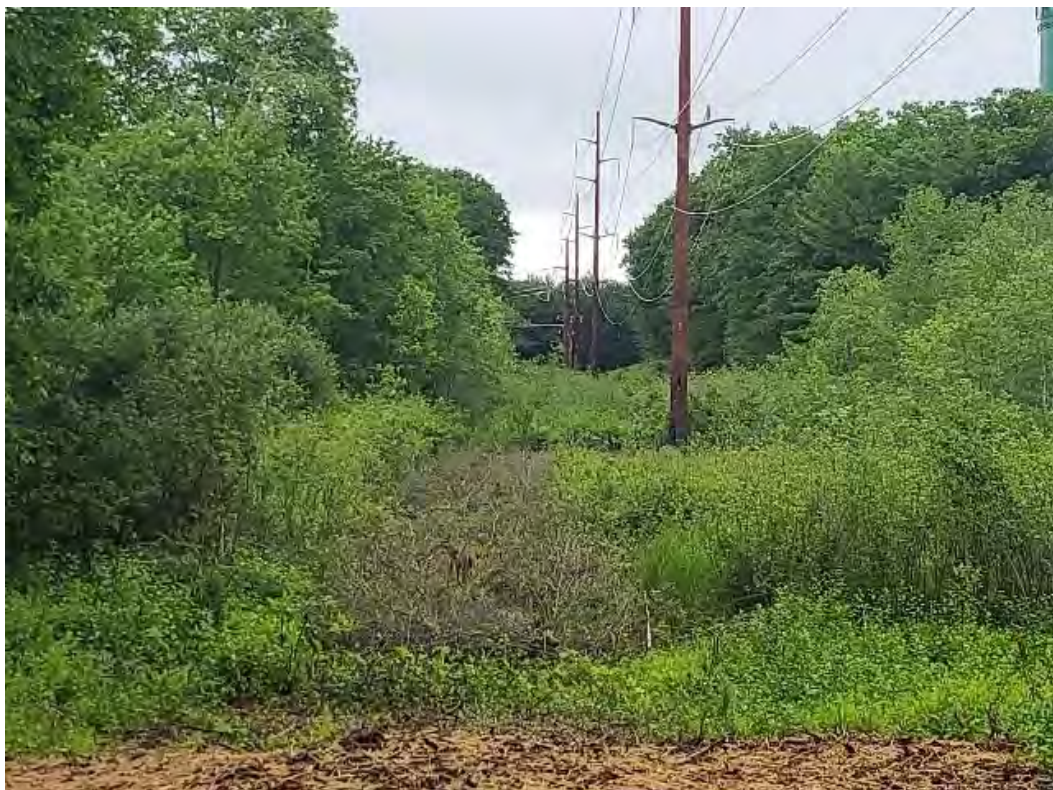
Fig 8: Vegetation re-growth where access road to Str. 35 was installed, wetland DW41. Viewing north. (06-30-20).

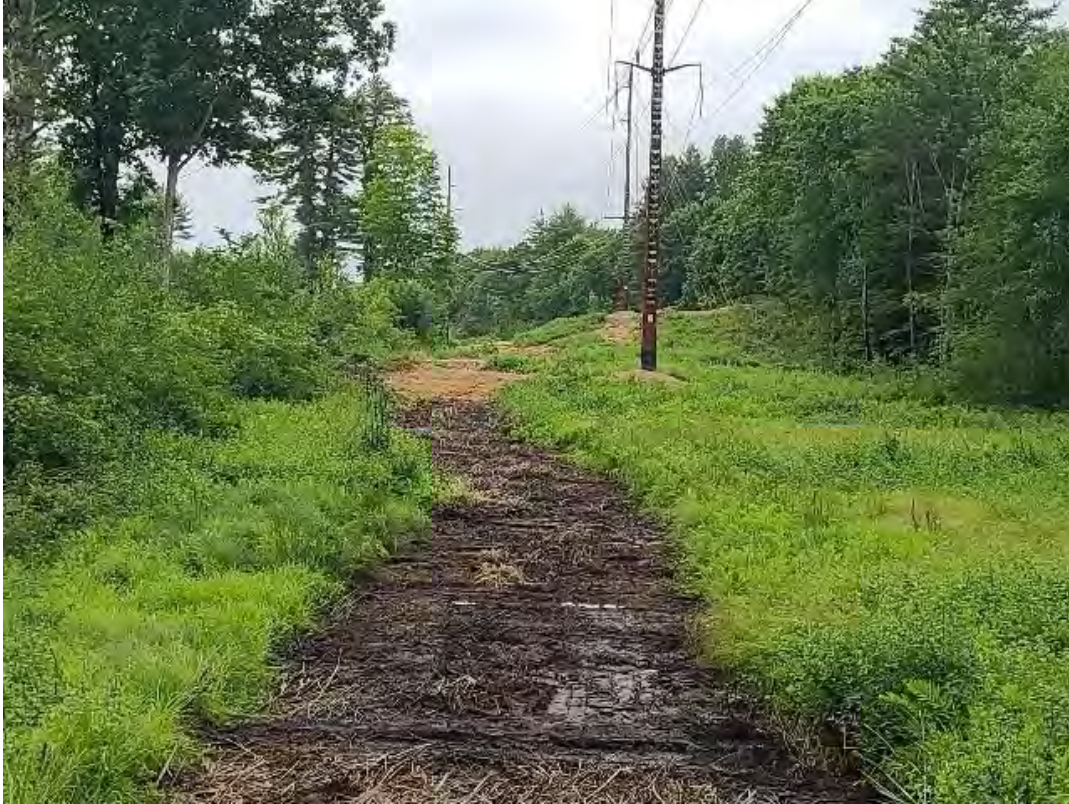
Fig 9: Crew removed timber mats from Wetland DW45, between Strs 39 and 40. Viewing north. (06-30-20).

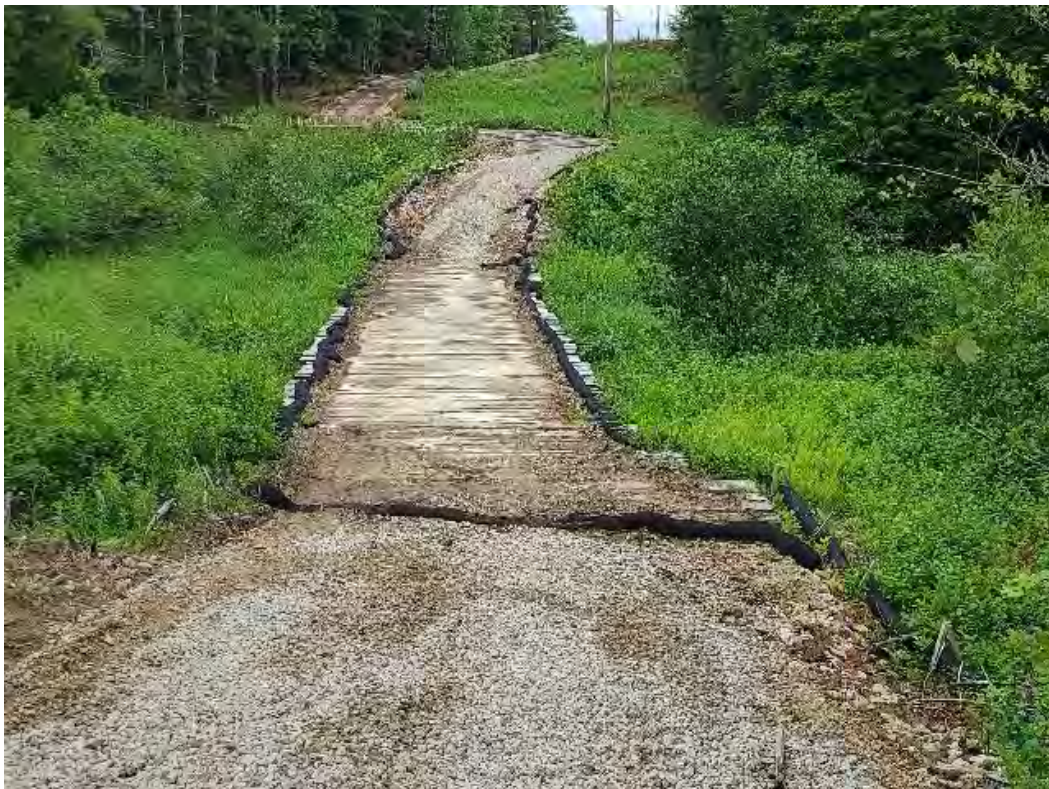
Fig 10: Access road over stream DS46, between Strs. 51-52. Viewing northeast. (06-30-20).

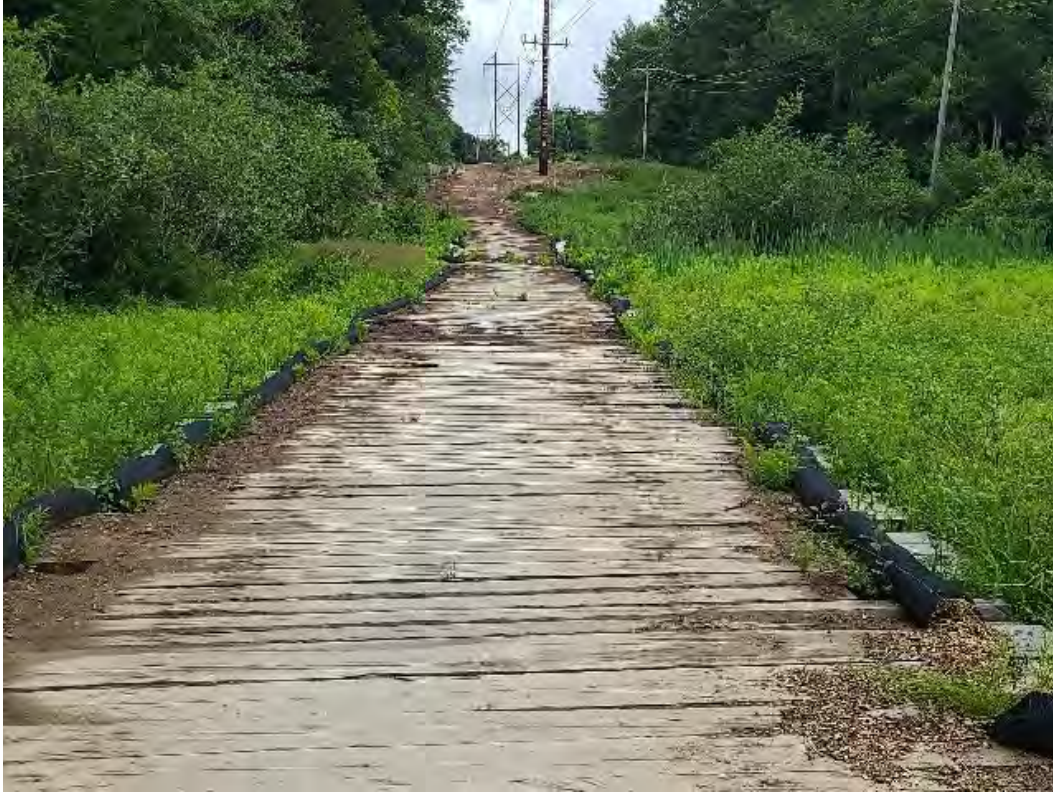
Fig 11: Access road through wetland DW33. Viewing northeast. (06-30-20).

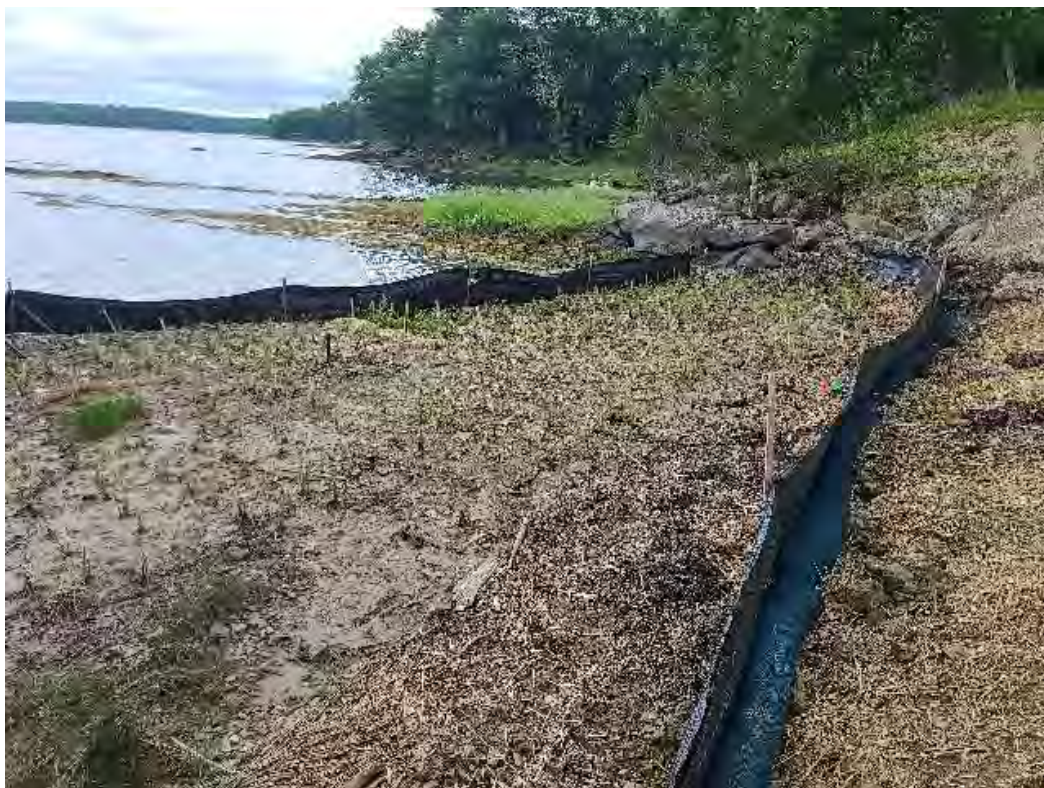
Fig 12: Salt marsh restoration at Getchell property/west side of the Bay. Viewing south. (06-30-20).

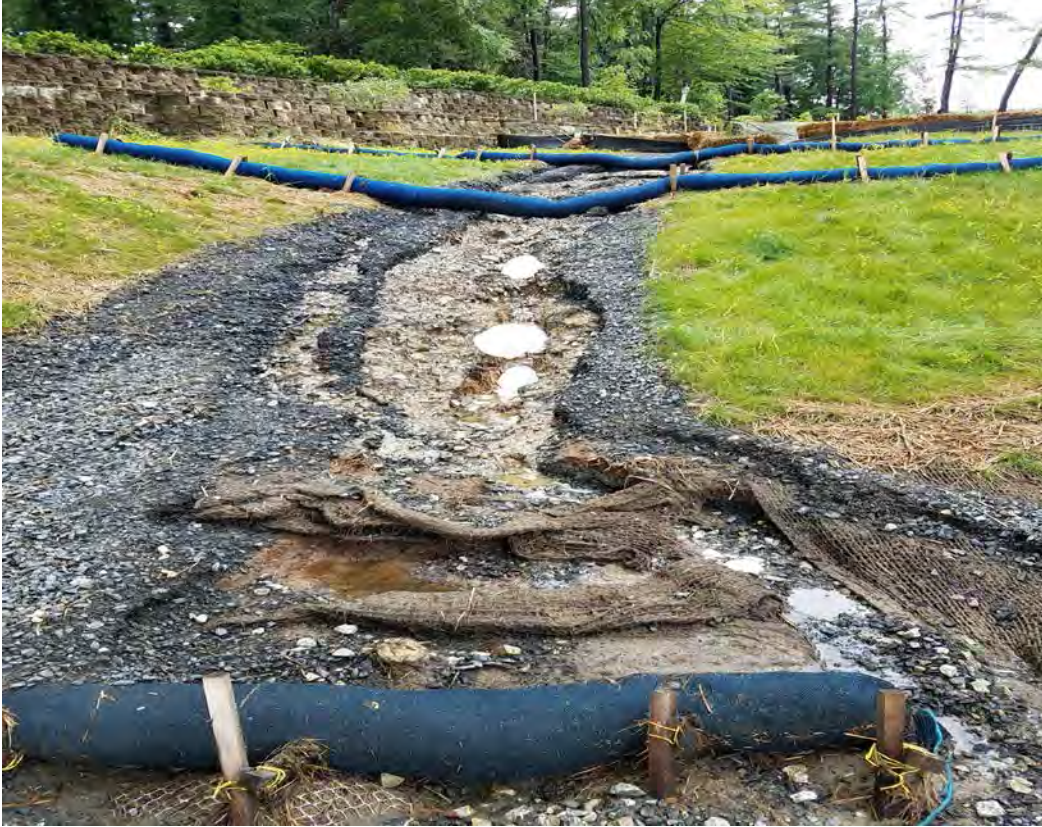
- On the night of 06-30-20 the site received 2.25 in of rain causing the gravel path on the slope at Gundalow landing to wash out, resulting in approximately 4 yards of gravel and loam being released into the intertidal zone. Almost all of the soil material was captured within 10'-12' of the turbidity curtain. On the morning of 07-01-20, Eversource, Normandeau and Rye Beach Landscaping developed and implemented a temporary stabilization plan. Rye Beach removed all released gravel from the intertidal zone and installed 6 inch crushed stone in the lower path in place of the smaller diameter gravel originally used. On 07-02-20, Rye Beach extended the culvert rock swale and installed multiple water bars on the slope down to the intertidal zone. These are temporary repairs; the team is currently working on a permanent stabilization plan. Regulatory agencies have been notified and will be provided a copy of the proposed stabilization plan for review and comment. Refer to photos 13-20 below.

Description: Approximately 4 yards of gravel was released into the intertidal zone at Gundalow landing/east side of the Bay.

Fig 13: Gravel path at Gundalow landing/east side of the Bay washed out due to the rain event on 06-30-20. Viewing east. (07-01-20).

Are any corrective actions required? YES NO if so, please describe? Rye Beach removed gravel and temporarily repaired gravel path and BMPs on slope at Gundalow landing/ease side of the Bay. Photos 13-20 below.

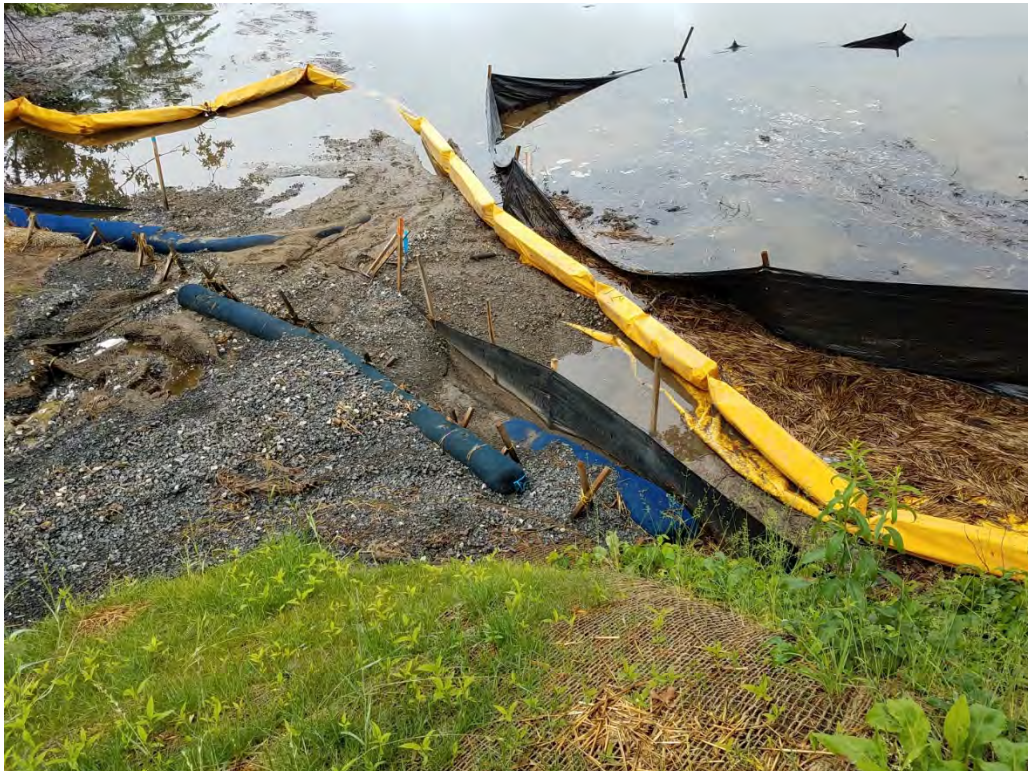
Fig 14: Gravel path erosion and deposition into the intertidal zone at Gundalow landing/east side of the Bay. Viewing southwest. (07-01-20).

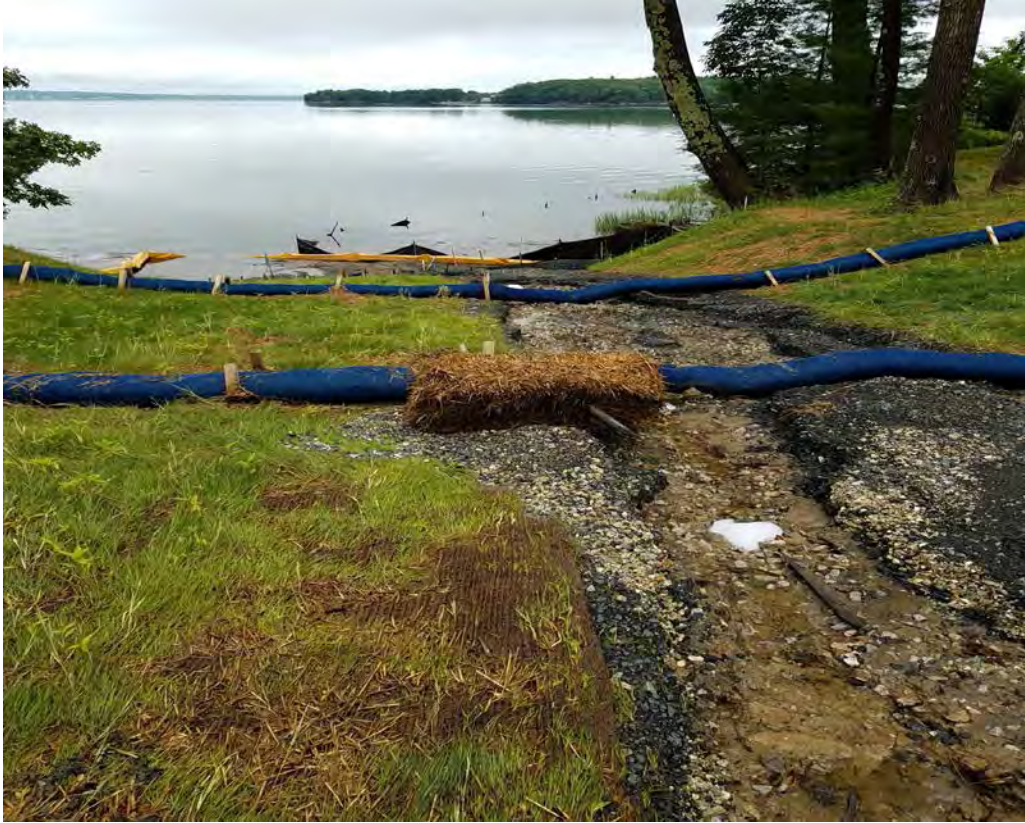
Fig 15: Gravel path erosion and deposition into the intertidal zone at Gundalow landing/east side of the Bay. Viewing west. (07-01-20).

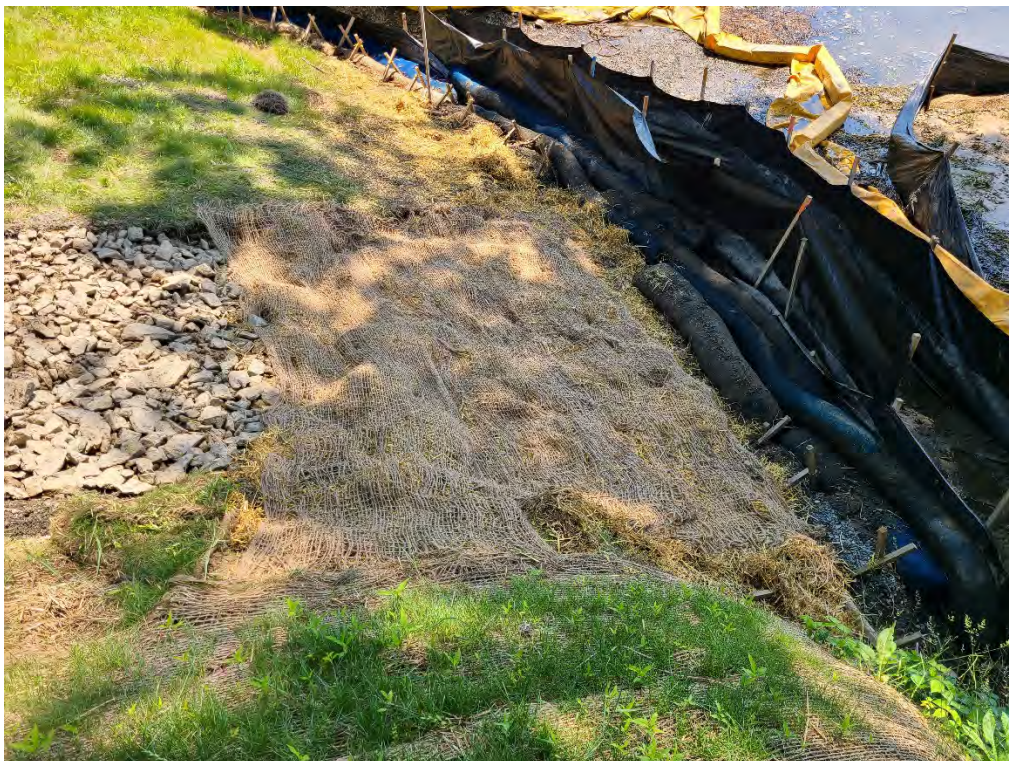
Fig 16: Corrective action repairs at toe-of-slope/intertidal zone at Gundalow landing/east side of the Bay. Viewing southwest. (07-01-20).

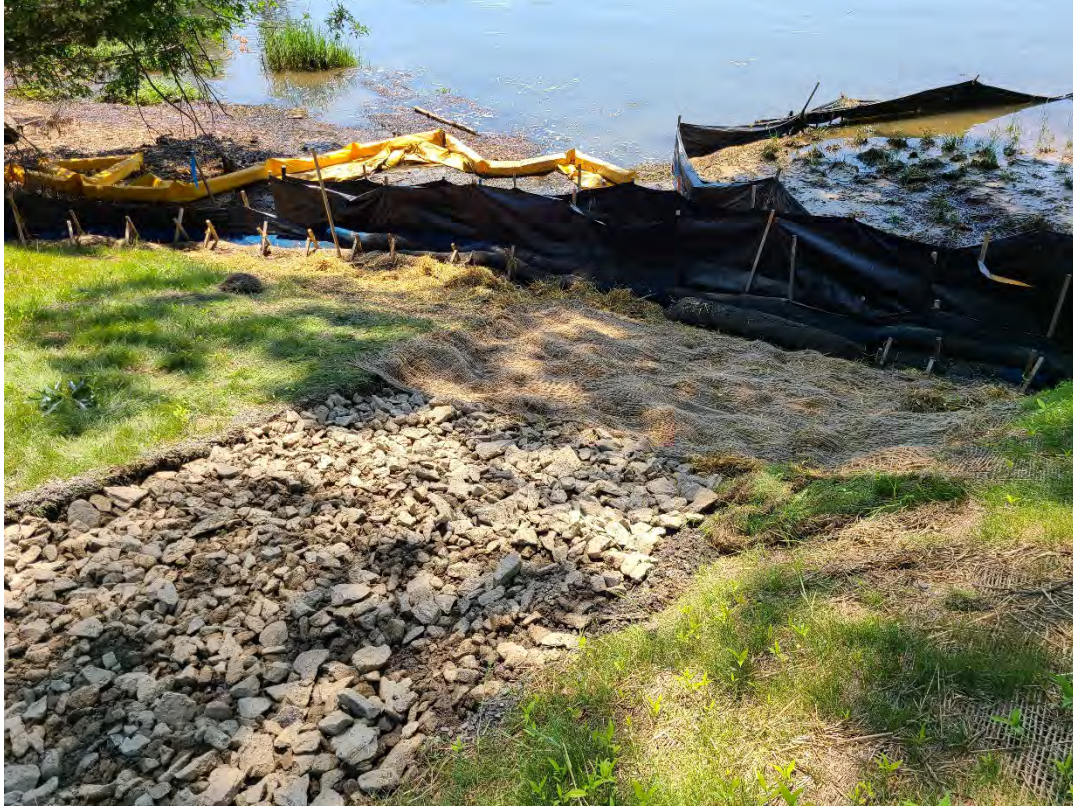
Fig 17: Corrective action repairs to gravel path below man hole at Gundalow landing/east side of the Bay. Viewing southwest. (07-01-20).

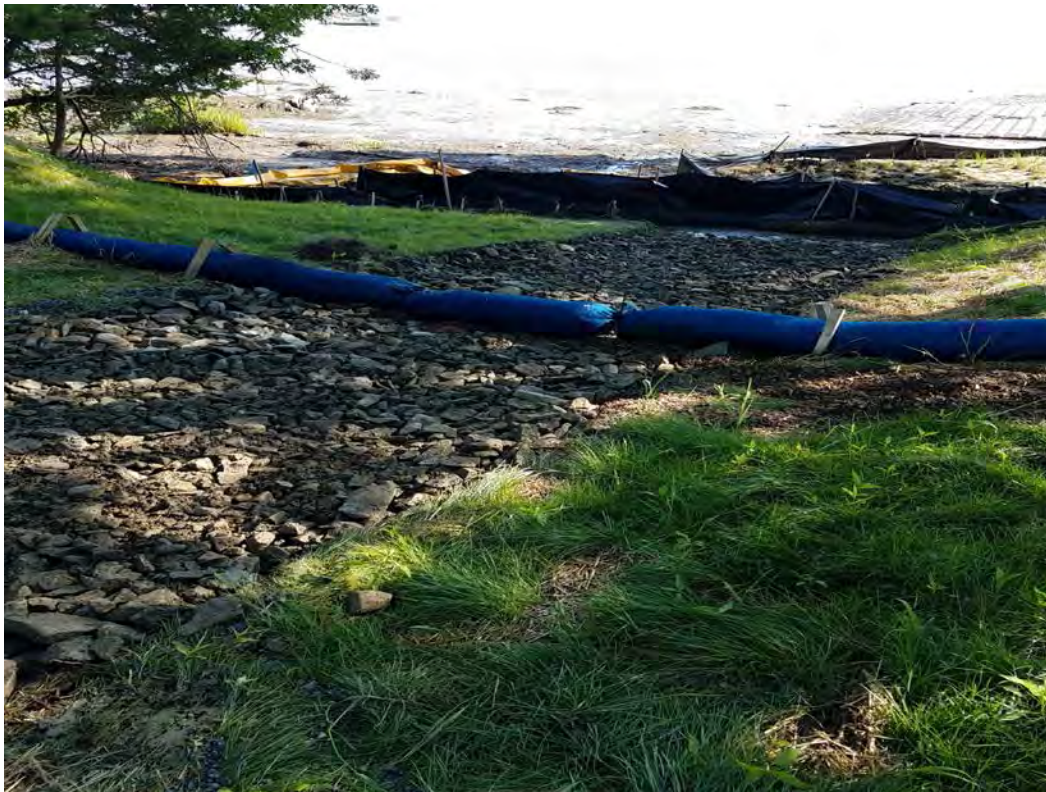
Fig 18: Corrective action repairs to gravel path below man hole at Gundalow landing/east side of the Bay. Viewing southwest. (07-01-20).

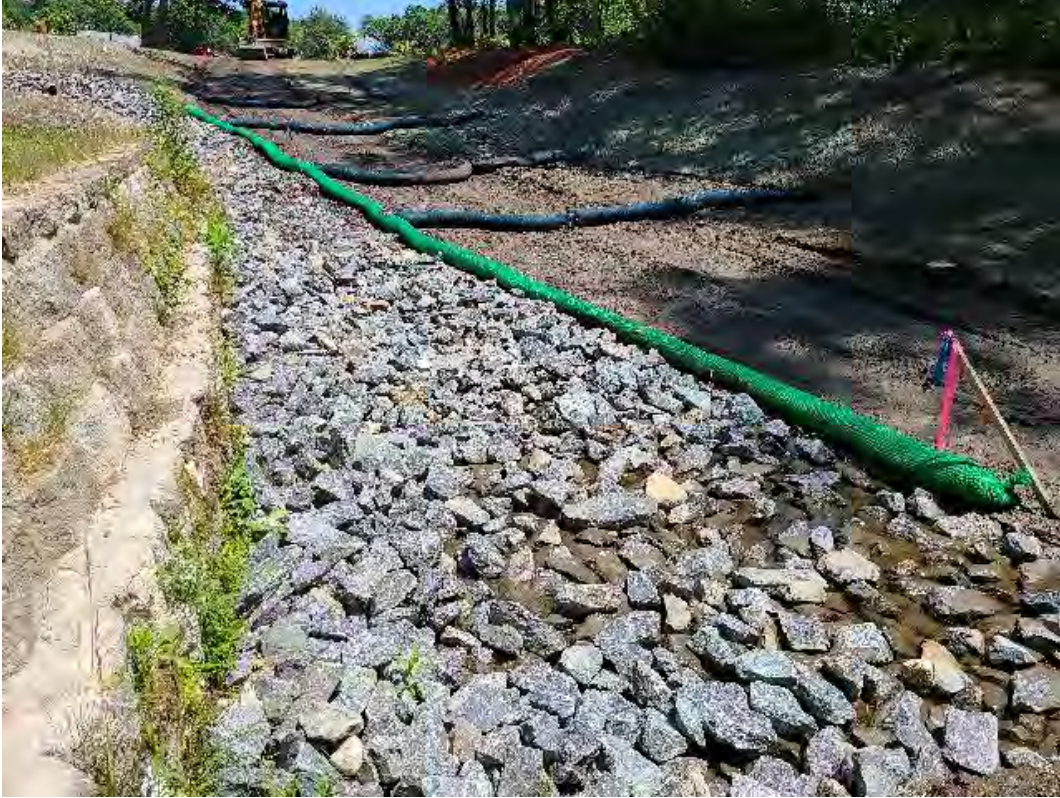
Fig 19: Rye Beach Landscaping repairing gravel path above man hole at Gundalow landing/east side of the Bay. Viewing east. (07-01-20).

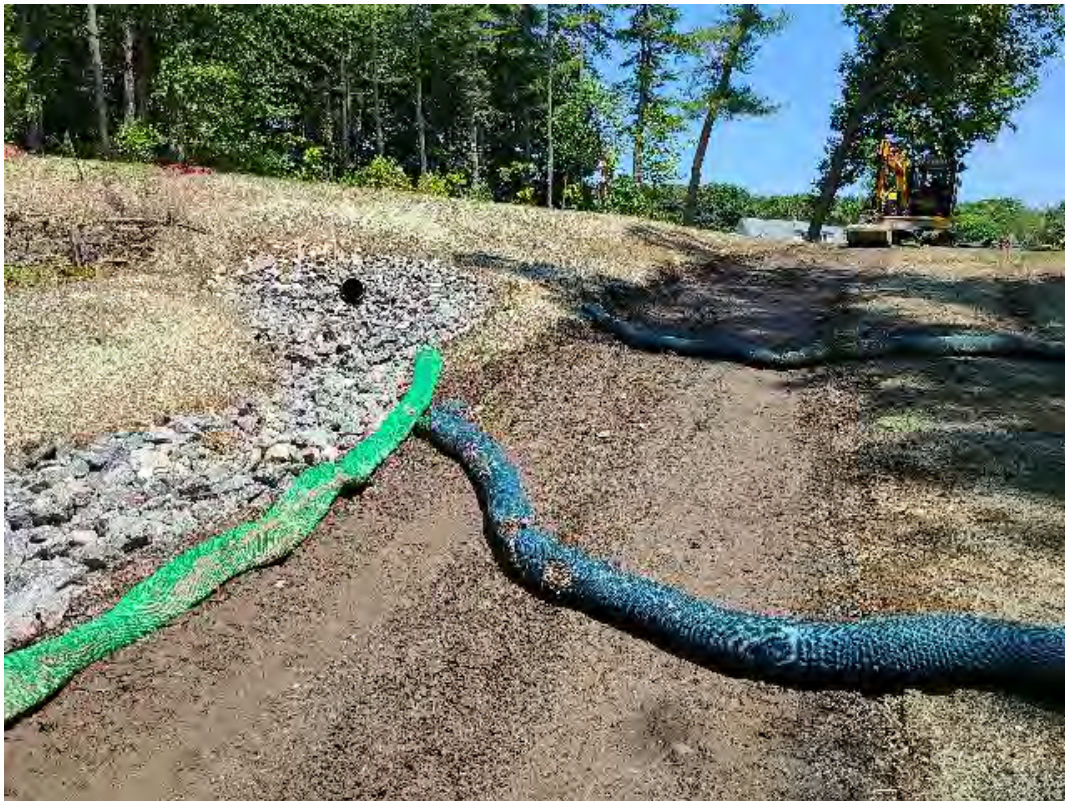
Fig 20: Repairing gravel path/culvert swale above man hole at Gundalow landing/east side of the Bay. Viewing east. (07-01-20).
