July 2, 2020

RE: Seacoast Reliability Project, Repair at Beswick Property, Newington (SEC Permit 2015-04; Corps Permit NAE-2015-00665)

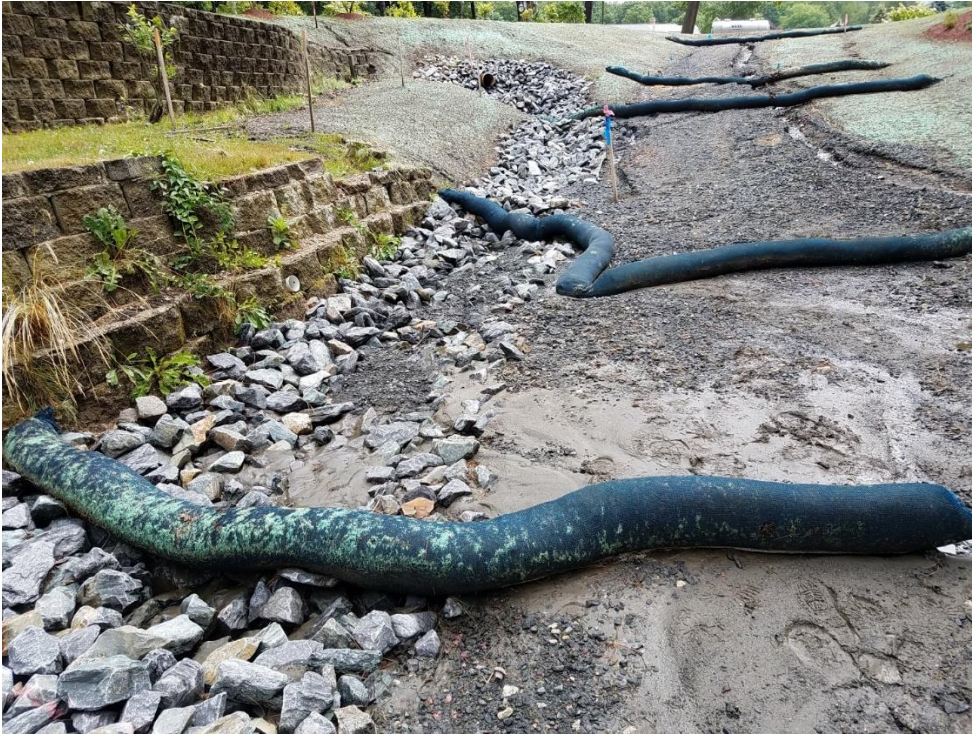
Figure 1. Erosion at top of slope above vault, July 1, 2020.

A more permanent solution is being developed by a civil engineer for the landscaper, and is expected early next week. Once finalized, we will forward to DES and the Corps. If any changes in the protected resource areas are proposed, we will highlight and work with you to determine if the changes require additional review or permitting.

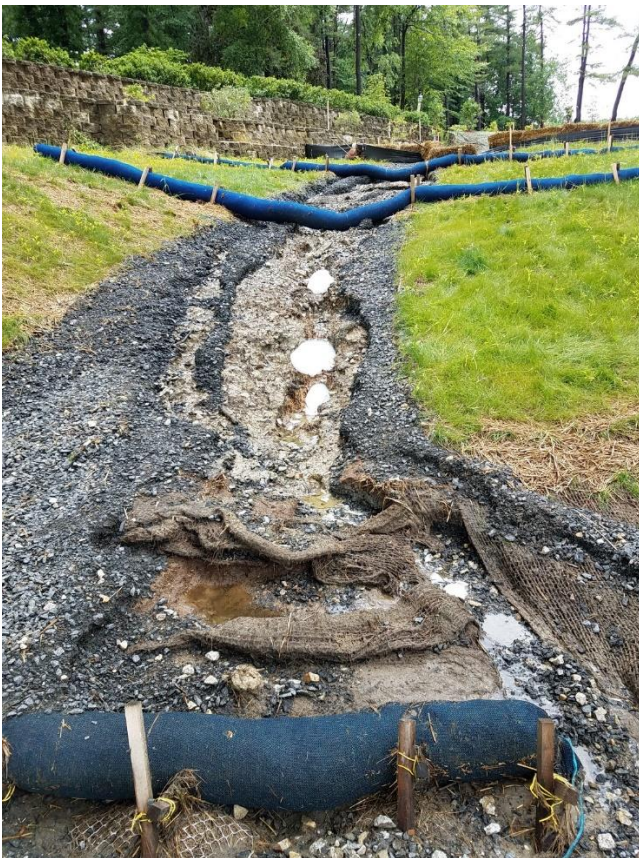
Figure 2. Erosion on lower slope below the vault, July 1, 2020.

The toe of slope was secured using a combination of a double row of silt fence and two rows of silt socks. The portion of the gravel path below the vault, approximately 30 feet, was most impacted. This was stabilized by a combination of smoothing and compacting the remaining gravel and securing with 6-inch minus stone. The section below the gravel path to the toe of slope was secured with straw held in place by jute mesh with long staples. The remainder of the site was smoothed to eliminate eroded channels, and erosion controls were adjusted to allow water to flow more evenly down the slope.

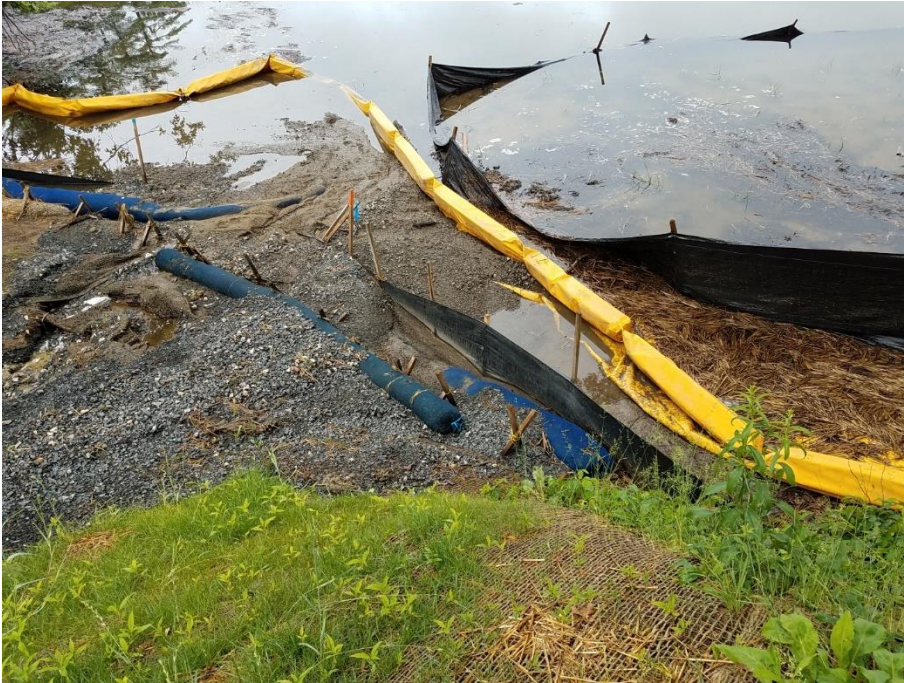
Figure 3. Deposition on tidal flat at toe of slope, July 1, 2020.

The material in the tidal flats was removed via a small excavator and bucket working from the upland, and finished by hand. Because the material was confined by the silt curtain, the limit of removal was easily ascertained; the depth was determined by a combination of color and texture change, and matching surrounding grades. The material was stockpiled on site, covered and surrounded by hay bales/silt socks until off-site disposal is arranged.

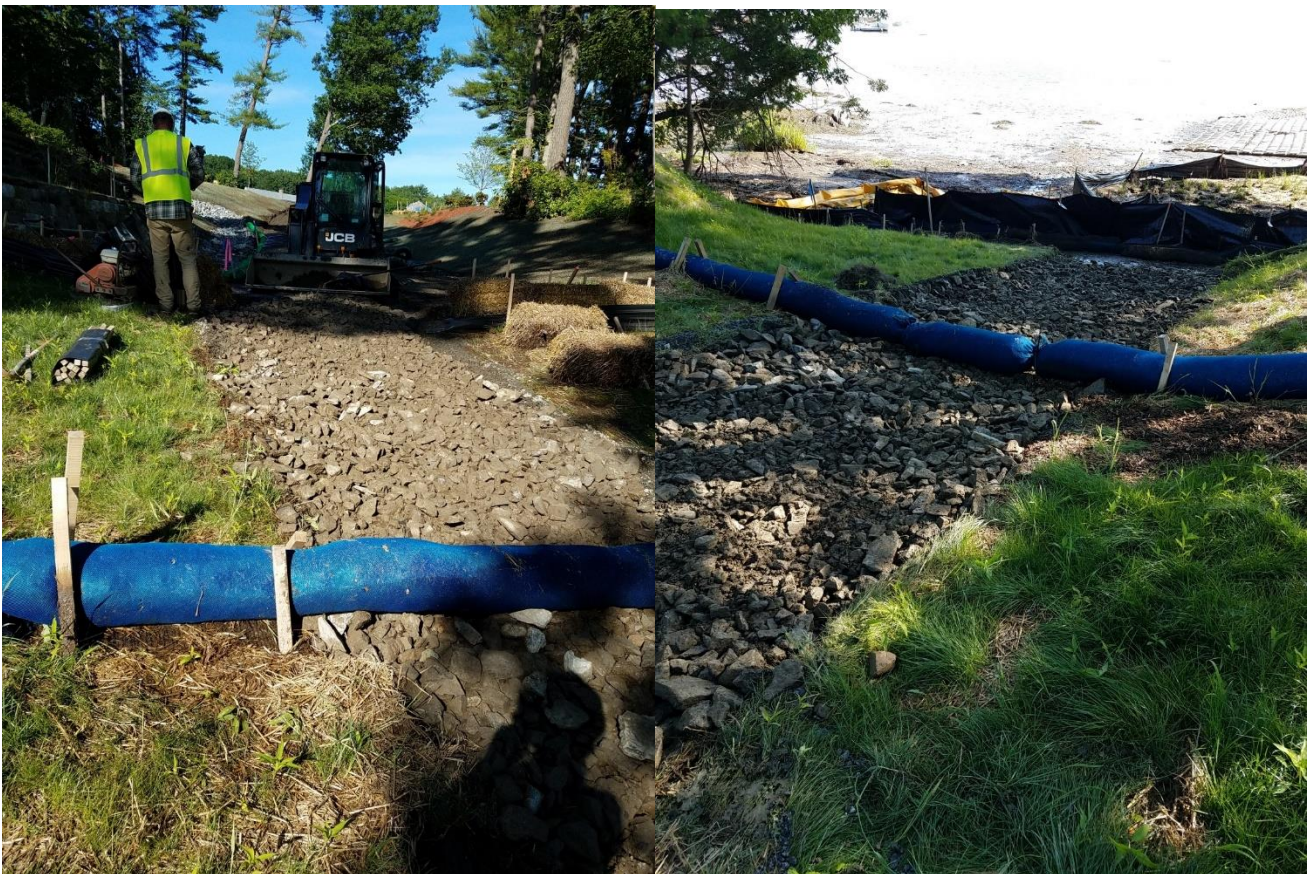
Figure 4. Restored lower slope, completed July 1, 2020. Remaining restoration was completed July 2, 2020.
