DRAINAGE MONITORING REPORT

F107 - Seacoast Reliability Project

Newington, New Hampshire

04.0190967.00

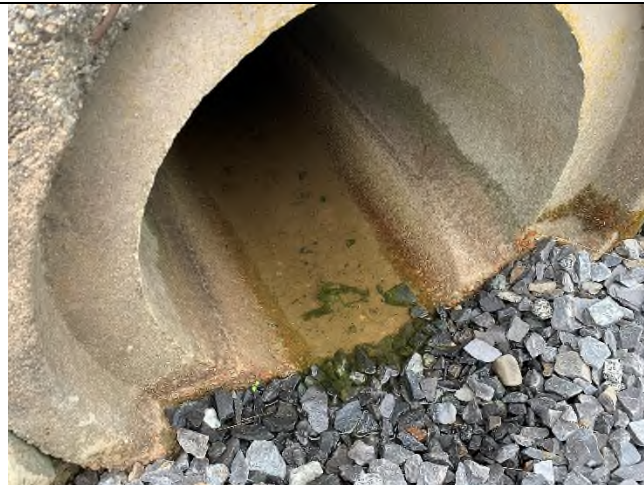
29 Gundalow -2 (Culvert)

Observations/Notes: Standing water approx. 1" deep, extending 8" from end of inlet

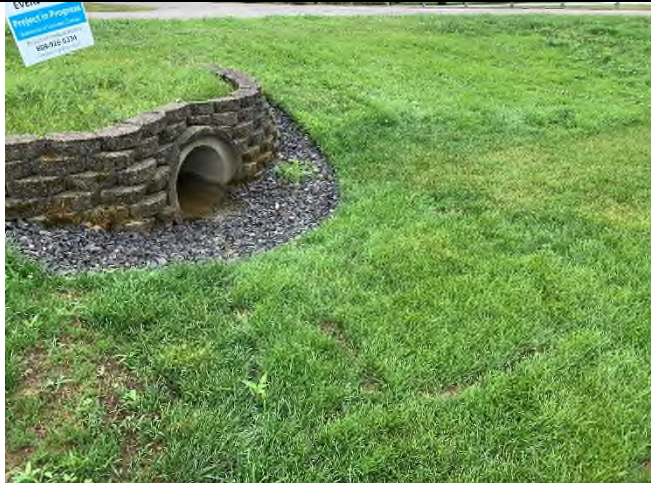
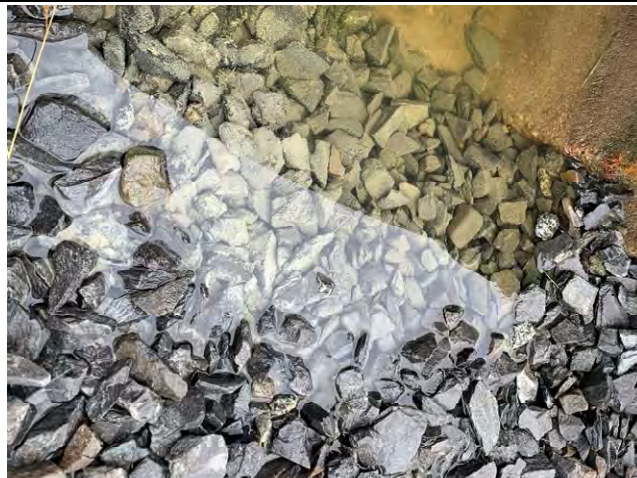
29 Gundalow -1 (Drainage Area)

Observations/Notes: Standing water ~4" deep, extending 18" beyond culvert inlet in stone drainage area

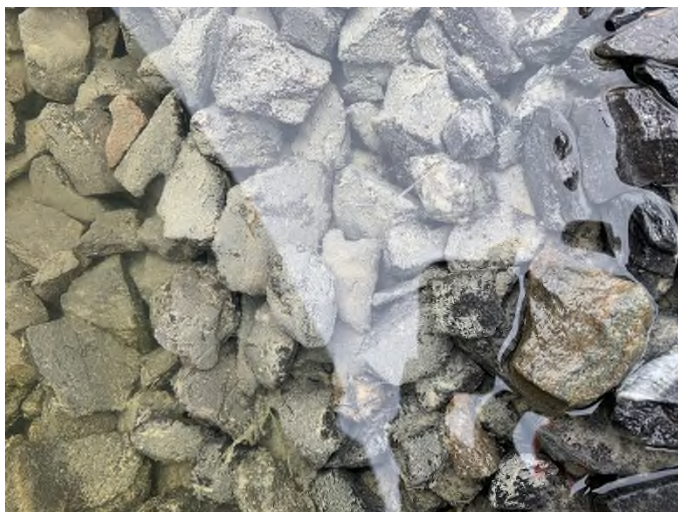
29 Gundalow -1 (Drainage Area) precipitate on stone close-up

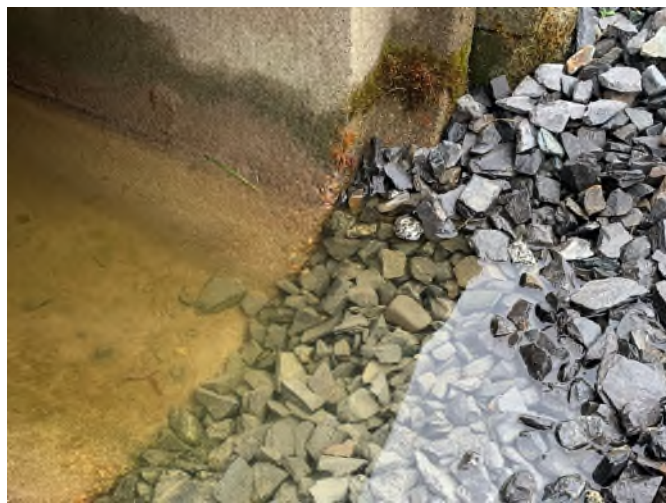
29 Gundalow -2 (Culvert)

Observations/Notes: ~ 4" of standing water in culvert

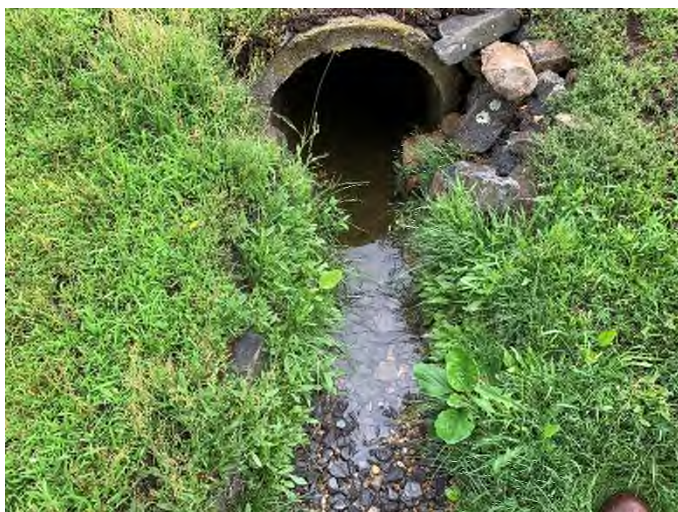
64 Gundalow -1 (Drainage Course)

Observations/Notes: ~ 8" of standing water extending ~36" beyond culvert outlet in stone drainage area

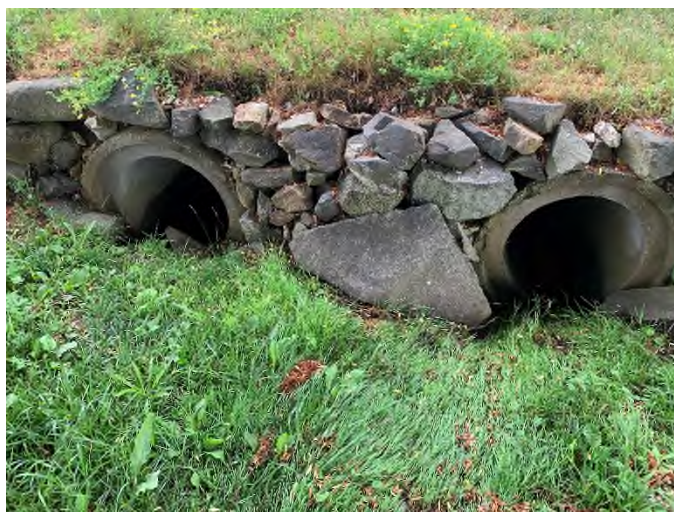
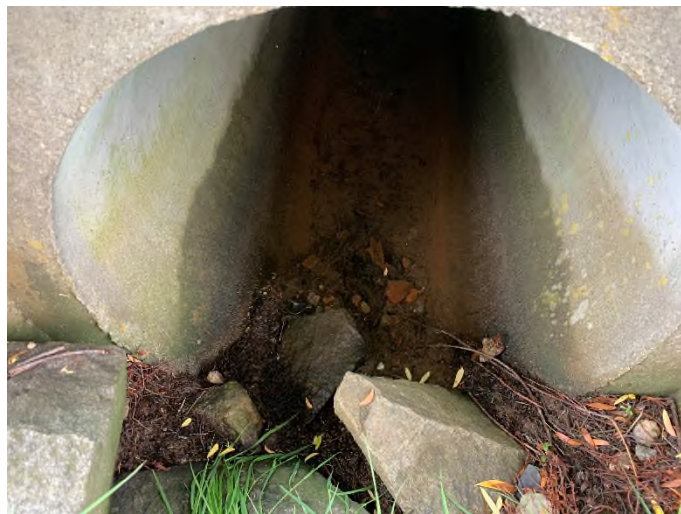
64 Gundalow -2 (Drainage Course)

Observations/Notes: ~2" of standing water at culvert inlet

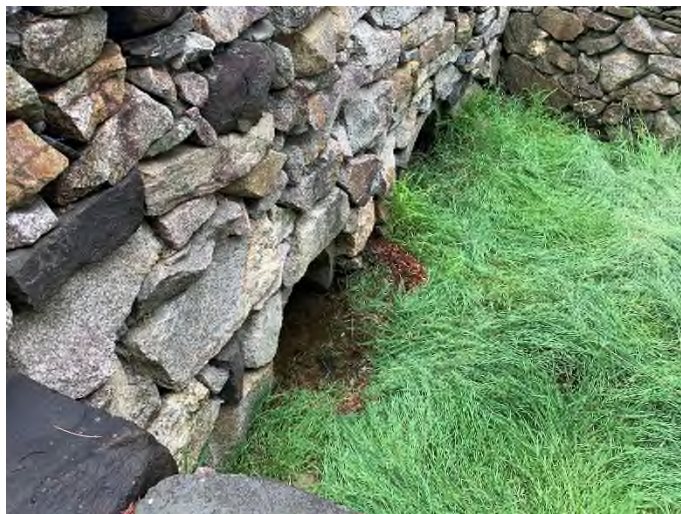
4 Brickyard Circle – 1 (Drainage Course)

Observations/Notes: ~ 5" of standing water extending ~ 10" beyond culvert outlet in grassed drainage way

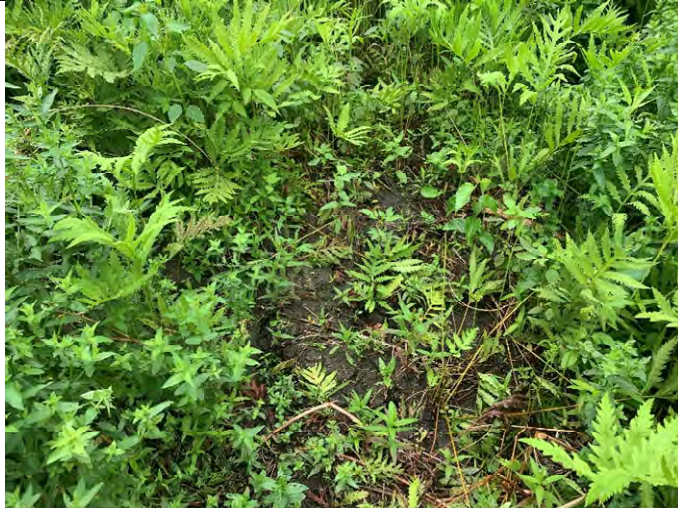
Hannah – 2 (Wetland NW-24)

Observations/Notes: No standing water, saturated soil

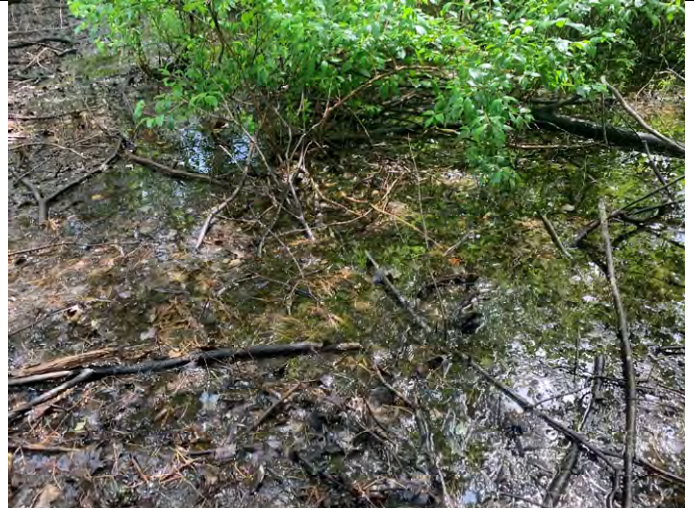
Flynn Pit (Wetland NW-4)

Observations/Notes: No standing water at monitoring location, reading taken approximately 4' southeast into wetland

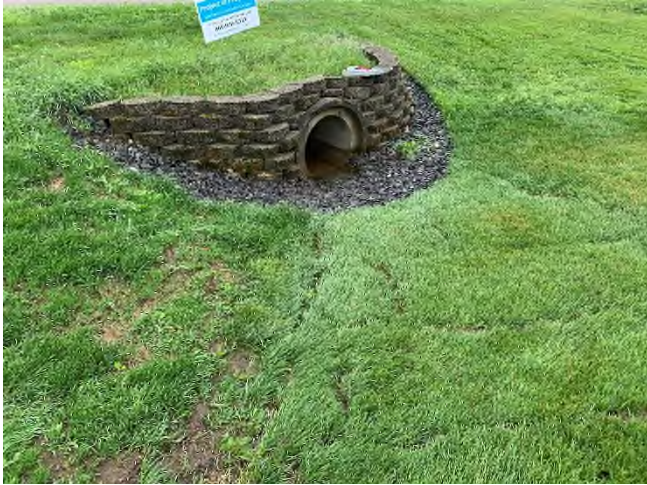
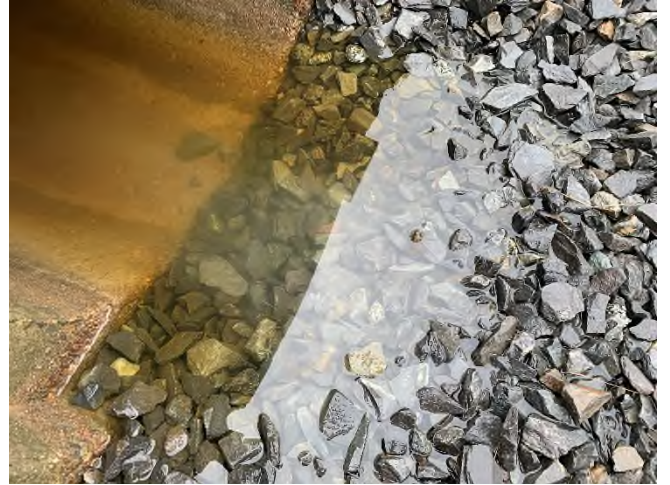
29 Gundalow -1 (Drainage Area)

Observations/Notes: Standing water ~4" deep, extending 18" beyond culvert inlet in stone drainage area

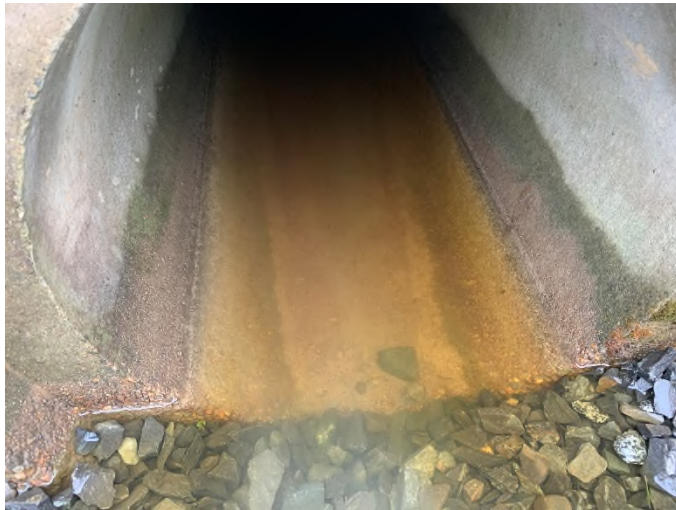
29 Gundalow -2 (Culvert)

Observations/Notes: ~ 5" of standing water in culvert

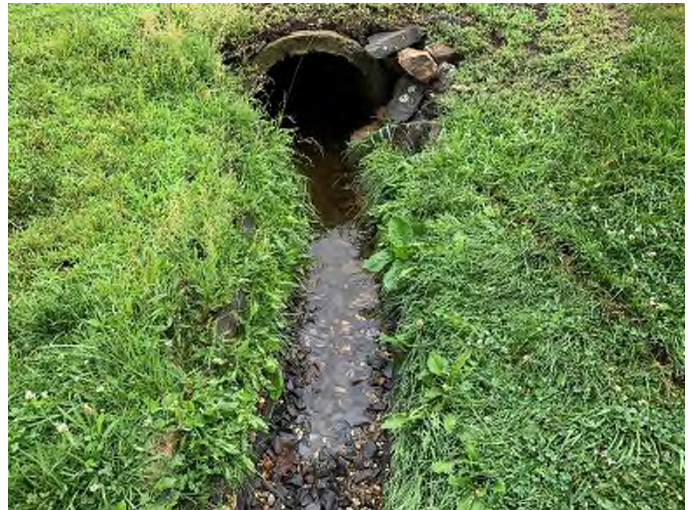
64 Gundalow - 1 (Drainage Course)

Observations/Notes: ~ 10" of standing water extending ~5' beyond culvert outlet in stone drainage area. Active flow observed through drainage course.

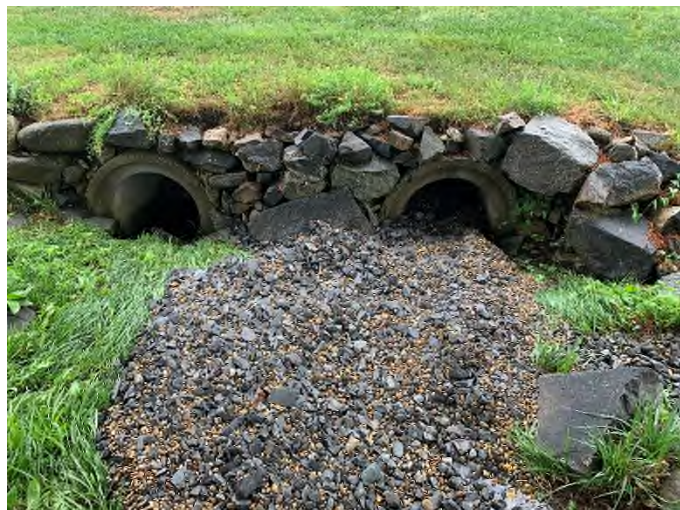
64 Gundalow – 2 (Drainage Course) with stone deposition

Observations/Notes: Approximately 10-12 linear feet of scour of stone drainage course observed. Crushed stone deposited near inlets to Brickyard Circle culverts. Active flow observed through drainage course.

- 2.25 inches of rain within 24 hours prior to inspection
- Approximately 10-12 linear feet of scour observed in 64 Gundalow drainage course. Stone scour was deposited in drainage way adjacent to Brickyard Circle culvert inlets. Stone does not appear to have been transported through culverts to the 4 Brickyard – 1 monitoring location.
- Water observed in all Newington monitoring locations for the first time since monitoring began.
- Active flow through Gundalow Landing and Brickyard Circle drainage way was observed for first time since monitoring began.

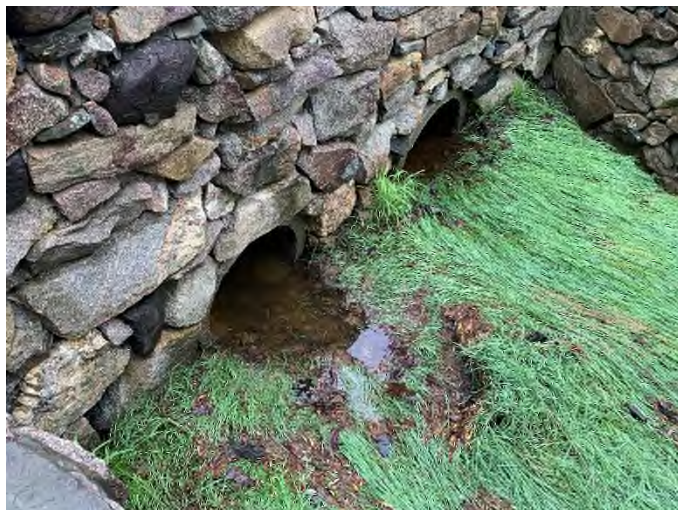
4 Brickyard Circle – 1 (Drainage Course)

Observations/Notes: ~ 8" of standing water extending ~ 12" beyond culvert outlet in grassed drainage area. Scoured crushed stone from 64 Gundalow does not appear to have transported through culverts to 4 Brickyard Circle drainage area.

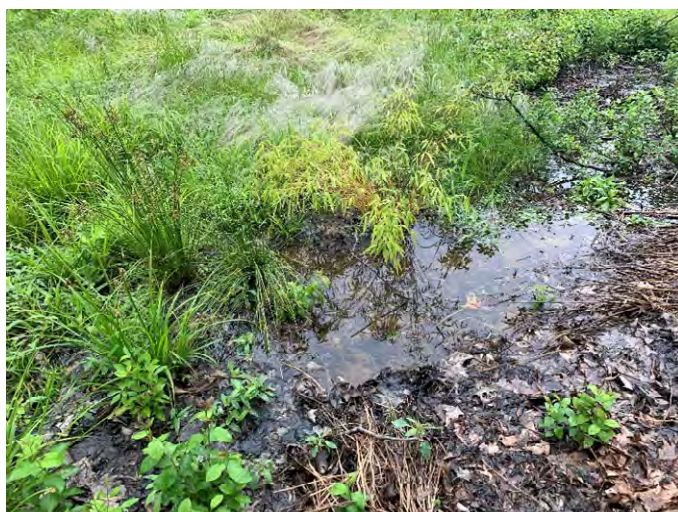
Hannah – 1 (Wetland NW-22)

Observations/Notes: Large area of standing water ~5" deep

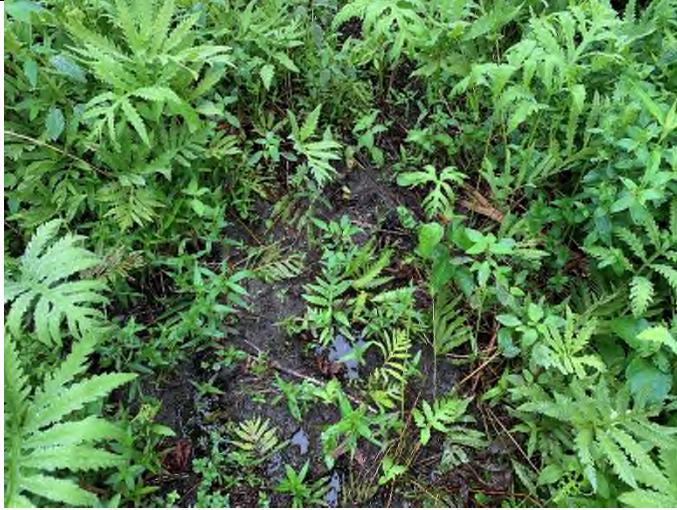
Hannah – 2 (Wetland NW-24)

Observations/Notes: Some small pockets of standing water ~1.5" deep

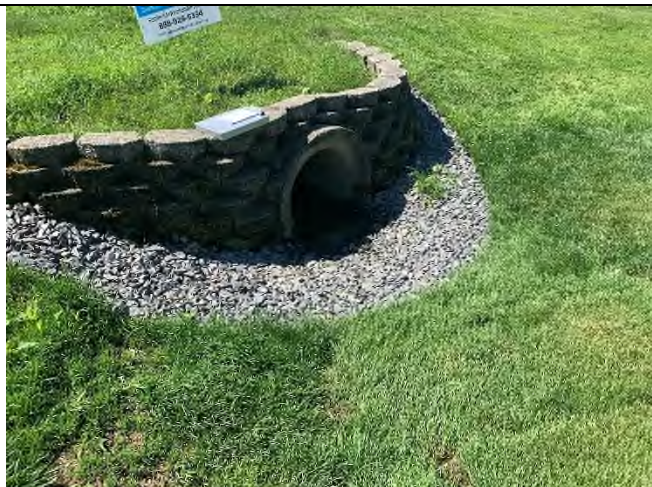
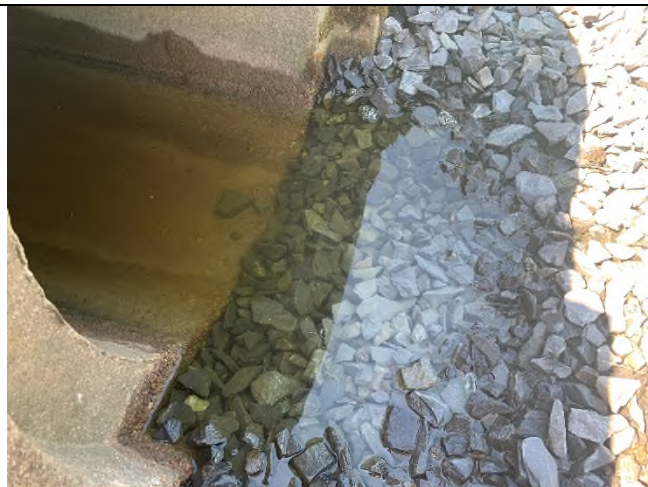
29 Gundalow - 1 (Drainage Area)

Observations/Notes: Standing water ~4" deep, extending 14" beyond culvert inlet in stone drainage area.

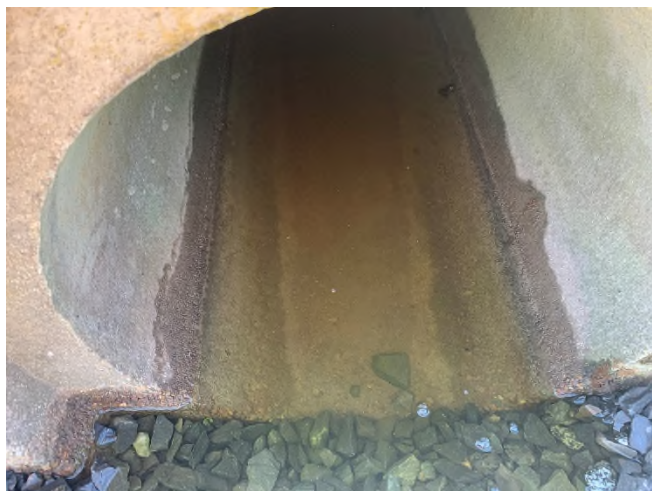
29 Gundalow - 2 (Culvert)

Observations/Notes: ~ 5" of standing water in culvert

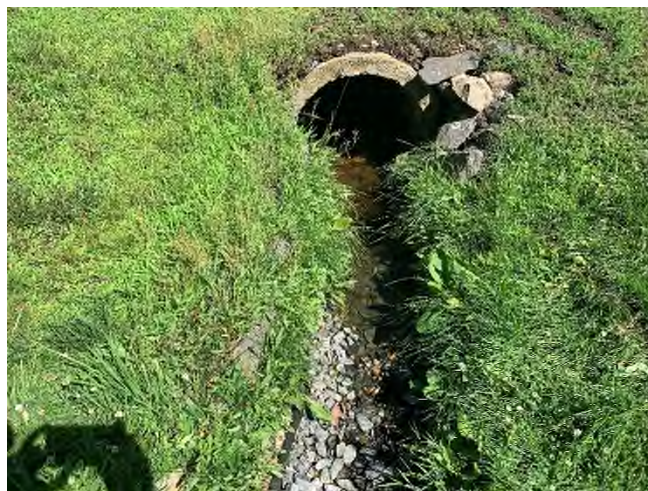
64 Gundalow - 1 (Drainage Course)

Observations/Notes: ~ 7" of standing water extending ~3' beyond culvert outlet in stone drainage course

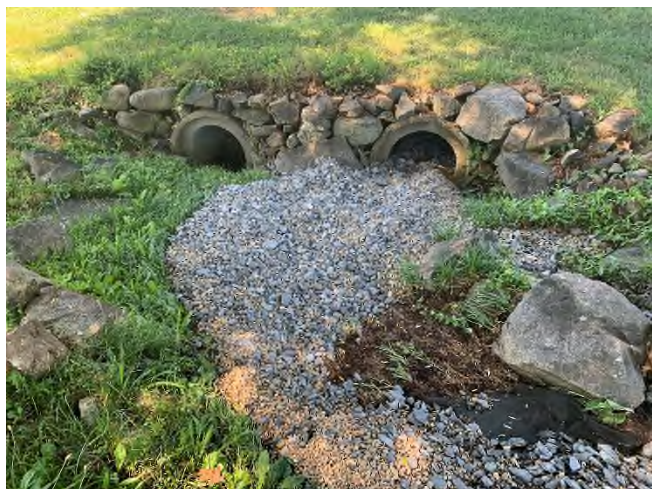
64 Gundalow - 2 (Drainage Course)

Observations/Notes: ~3" of standing water near culvert inlet

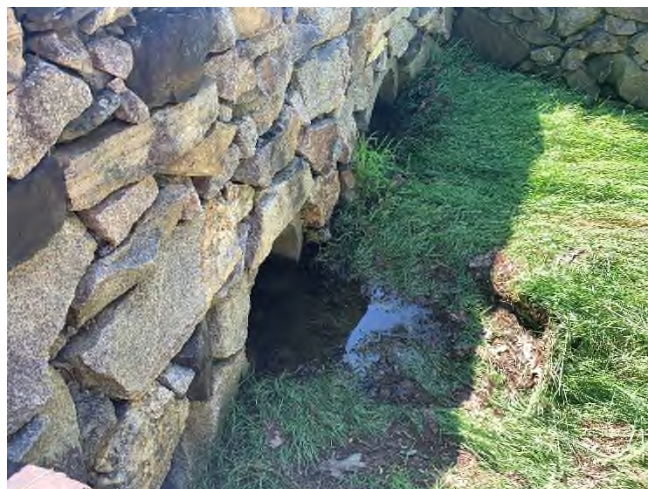
4 Brickyard Circle - 1 (Drainage Course)

Observations/Notes: ~ 6" of standing water extending ~ 10" beyond culvert outlet in grassed raceway
