DRAINAGE MONITORING REPORT

F107 - Seacoast Reliability Project

Newington, New Hampshire

Date: **7/6/2020** Time: **1105** ⁺Was this inspection triggered by a 0.25" storm event? Yes No

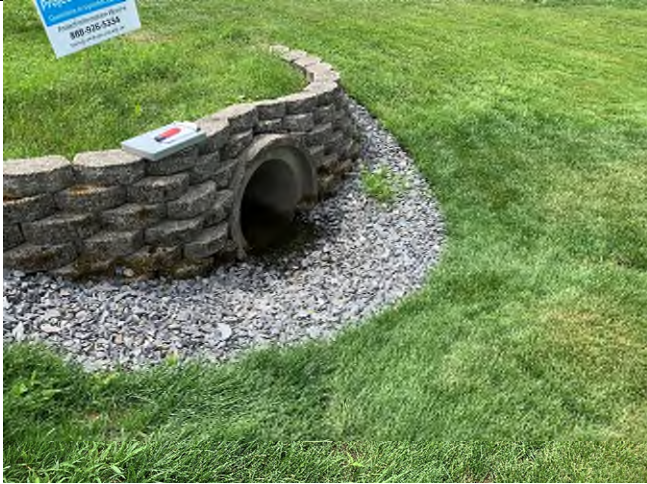
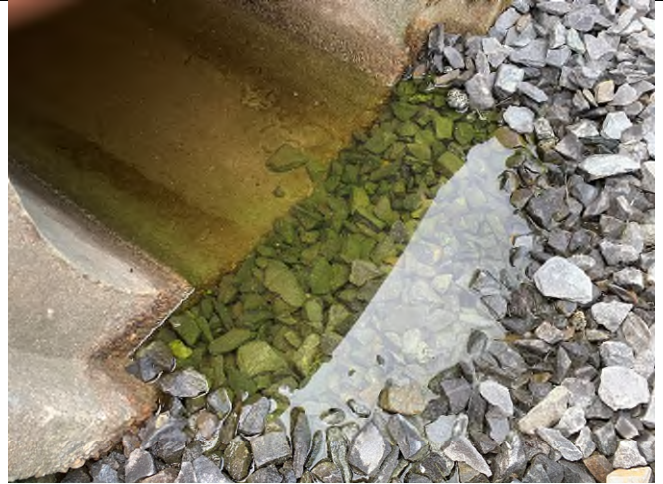
29 Gundalow -1 (Drainage Area)

pH: **8.6**

Observations/Notes: Standing water ~4" deep, extending 12" beyond culvert inlet in stone drainage area.

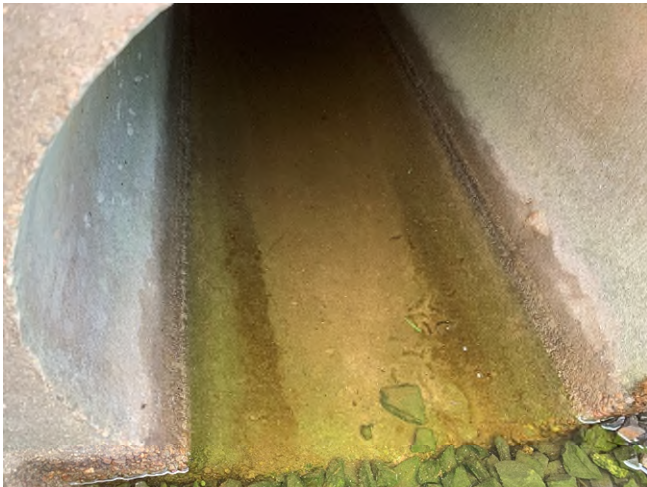
29 Gundalow -2 (Culvert)

pH: **8.6**

Observations/Notes: ~ 5" of standing water in culvert

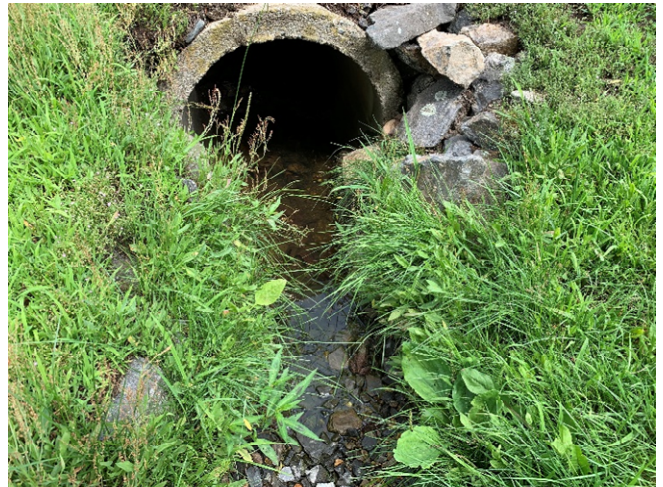
64 Gundalow - 1 (Drainage Course)

pH: **7.7**

Observations/Notes: ~ 7" of standing water extending ~2.5' beyond culvert outlet in stone drainage area

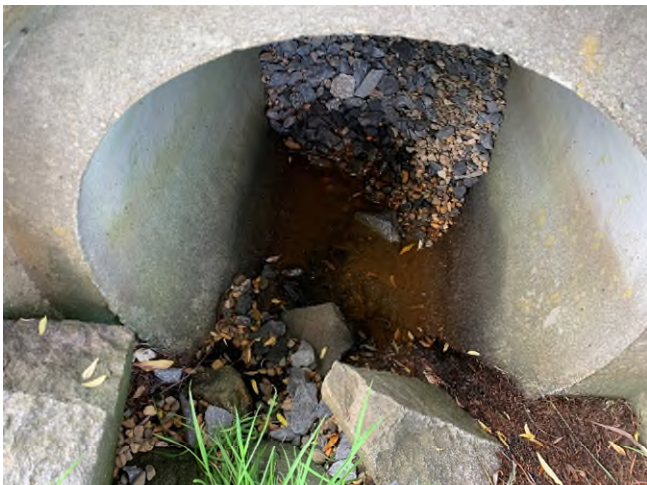
64 Gundalow - 2 (Drainage Course)

pH: **6.6**

Observations/Notes: ~3" of standing water near culvert inlet

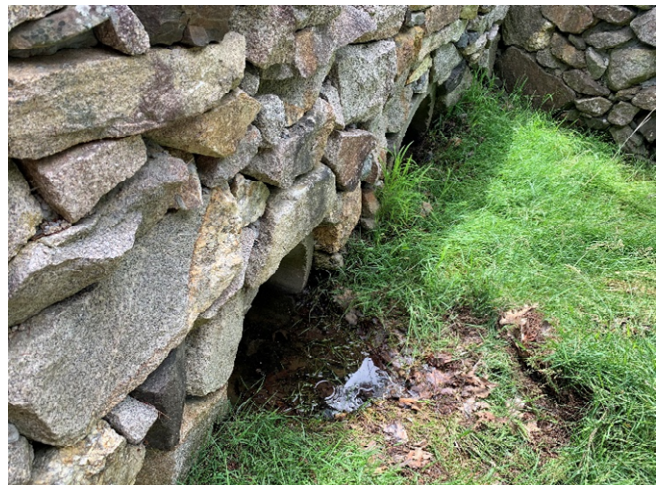
4 Brickyard Circle - 1 (Drainage Course)

pH: **6.9**

Observations/Notes: ~ 6" of standing water extending ~ 10" beyond culvert outlet in grassed raceway

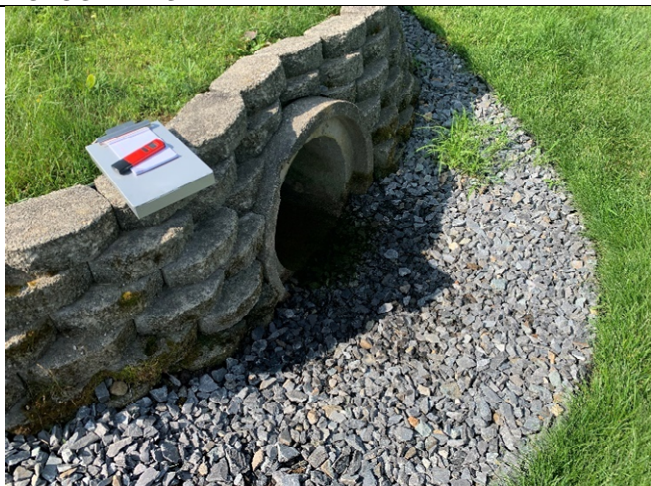
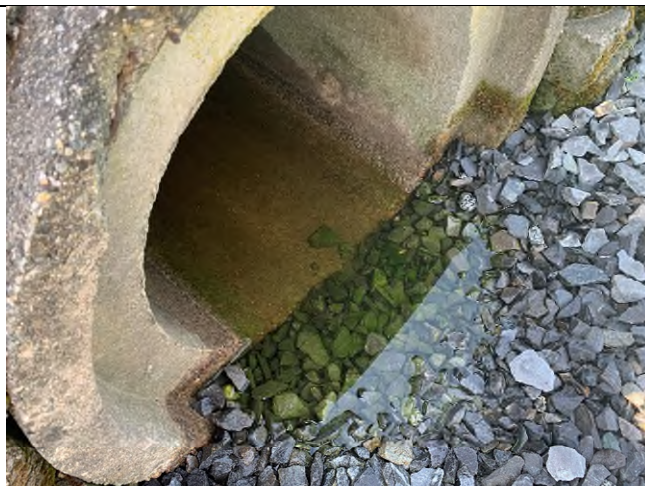
29 Gundalow -1 (Drainage Area)

pH: **8.5**

Observations/Notes: Standing water ~4" deep, extending 12" beyond culvert inlet in stone drainage area.

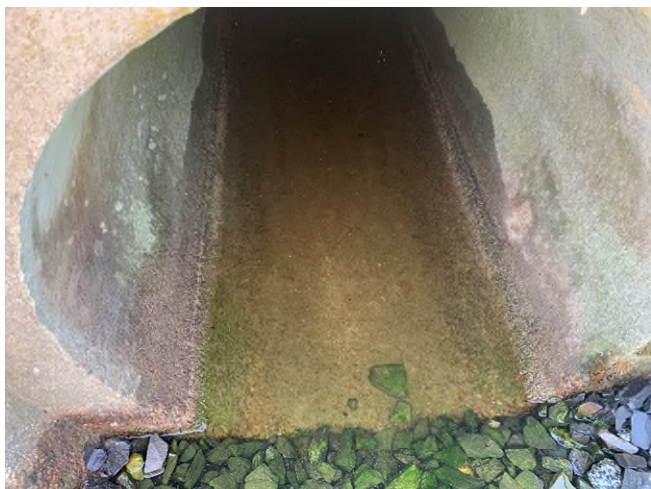
29 Gundalow -2 (Culvert)

pH: **8.5**

Observations/Notes: ~ 5" of standing water in culvert

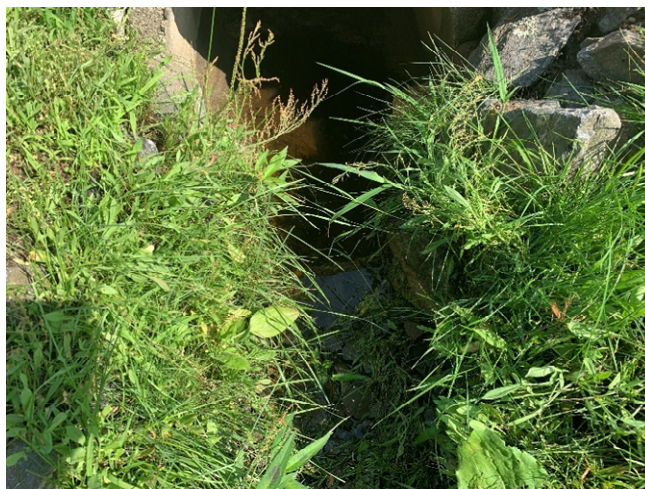
64 Gundalow - 1 (Drainage Course)

pH: **7.6**

Observations/Notes: ~ 4" of standing water extending ~18" beyond culvert outlet in stone drainage area

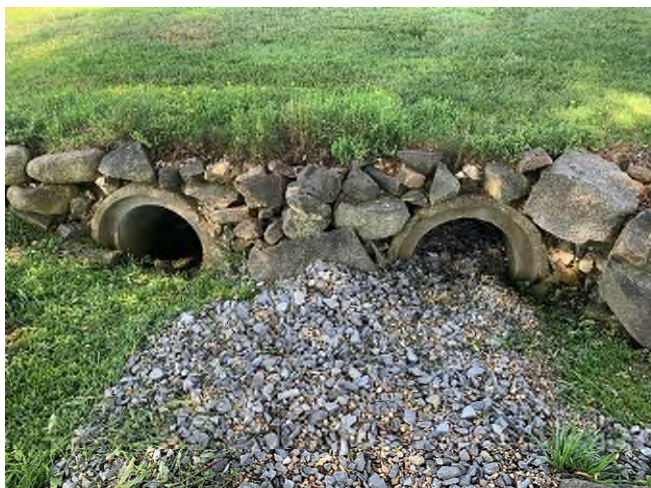
64 Gundalow - 2 (Drainage Course)

pH: **6.4**

Observations/Notes: ~0.5" of standing water near culvert inlet, grass clippings in culvert

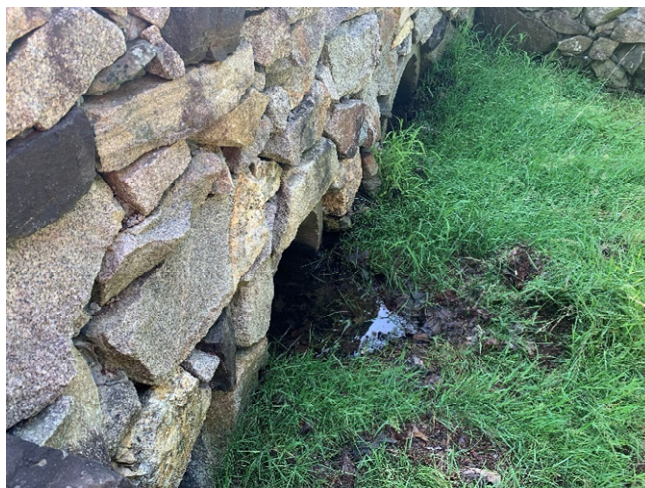
4 Brickyard Circle - 1 (Drainage Course)

pH: **6.9**

Observations/Notes: ~ 4" of standing water extending ~ 10" beyond culvert outlet in grassed raceway
